## **LAND AT RICHMOND LODGE, TATTERSHALL CASTLE, TATTERSHALL, LINCOLNSHIRE**

### **Archaeological Monitoring and Recording**

Site Code: TTRL17  
Planning Reference: Pre-planning  
NGR: TF 2096 5752  
OASIS ID: withamar1-297891

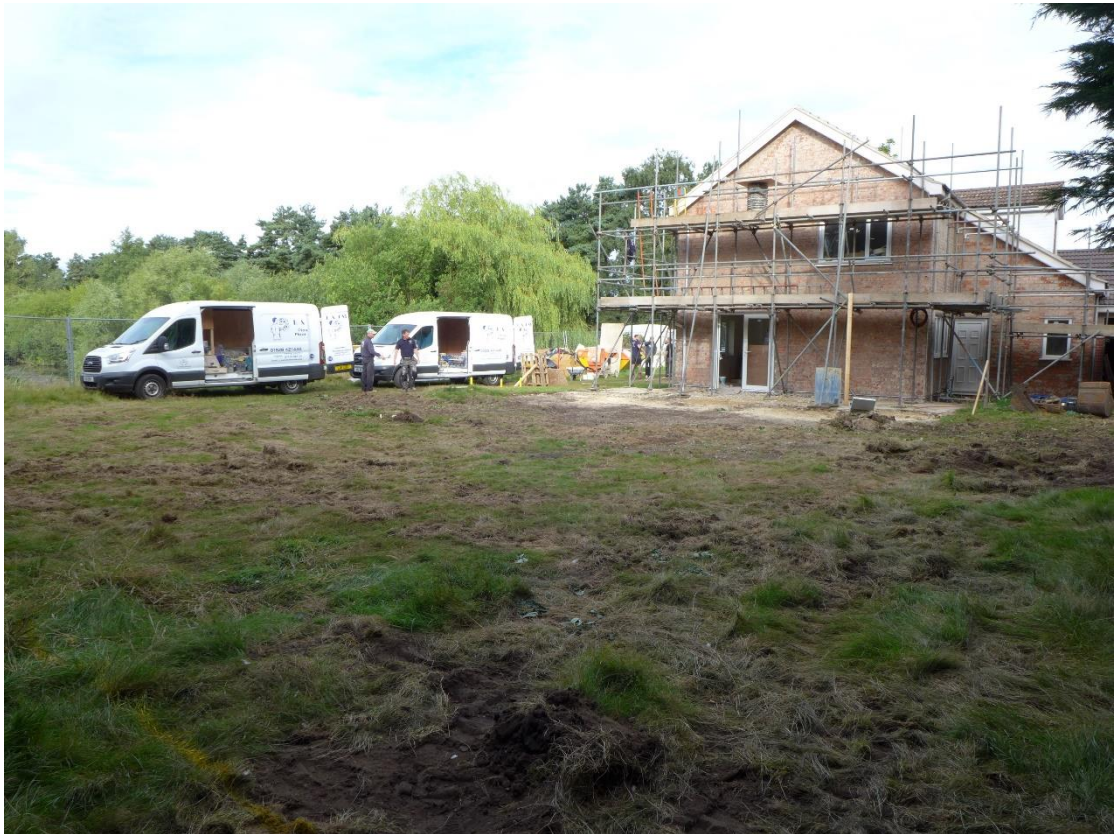
*Plate 1: General view of site before topsoil stripping for car park, looking northwest*

The footprint of the new car parking area was excavated to depths of approximately 0.45m to 0.53m below the existing ground level (Figure 2, Plate 1 and Plate 2).

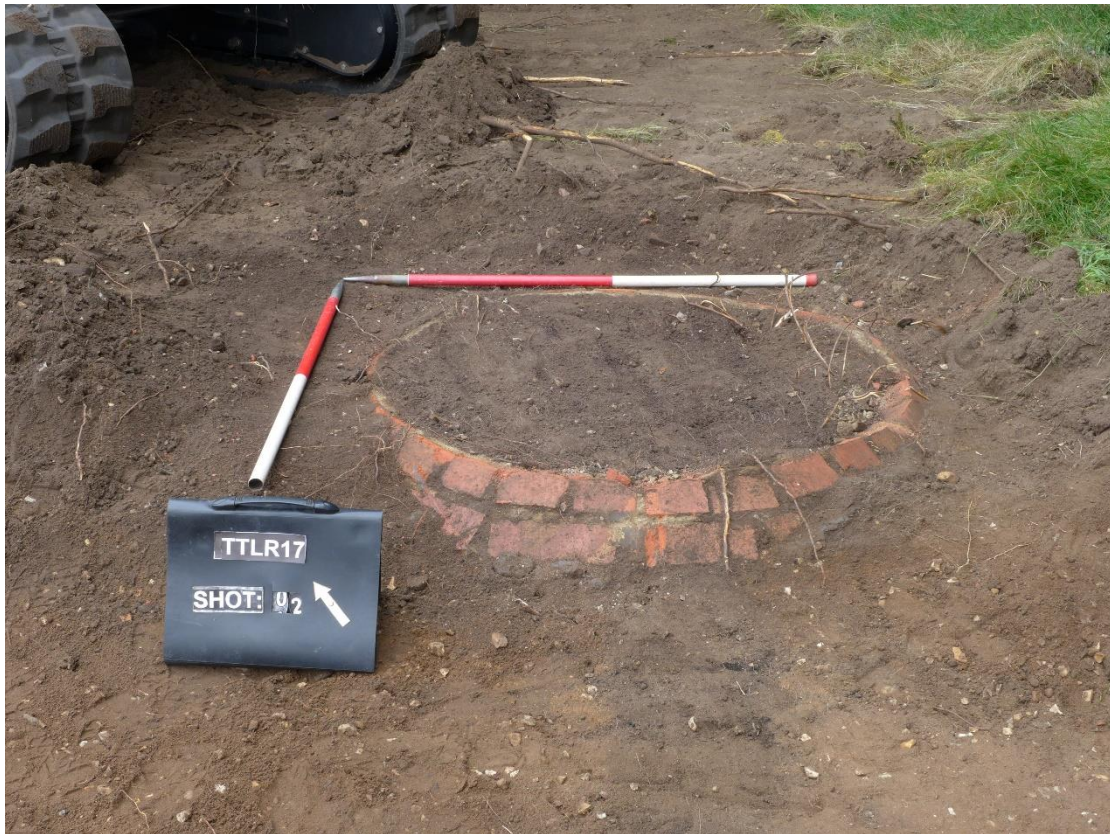
sand with angular flint. Sealing this was topsoil (001), a 0.30m thick soft dark blackish-brown clayey sandy silt with frequent angular flints and occasional mid-20<sup>th</sup> century rubbish (Plate 4, Figure). All of these deposits were recorded across the site. Part of a circular brick structure (004) was revealed in plan. It was 1.10m in diameter, comprising a course of header bricks above a course of stretcher bricks (Plate 3, Figure 3). The bricks were machine-made and the structure may have been a soakaway or septic tank serving Richmond Lodge. Two pipes were noted connecting to the structure, one to the northwest, presumably an inlet from Richmond Lodge, one to the southwest, presumably an outlet to or towards the adjacent lake.

Archaeological monitoring and recording of stripping for a car parking area revealed a simple sequence of topsoil and subsoil overlying natural geology. A modern brick-built structure was probably a soakaway or septic tank serving Richmond Lodge.

*Plate 3: Brick structure 004, possible septic tank, looking northeast, Scales 1m*

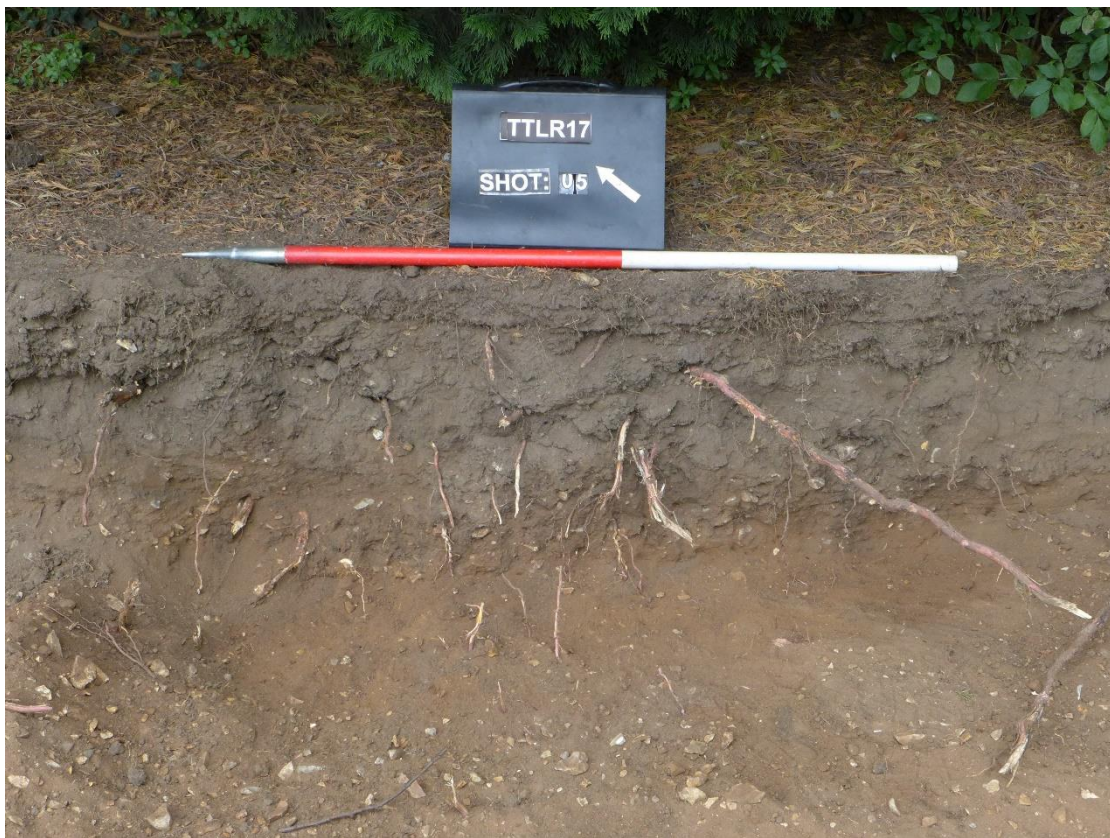
The earliest identified deposit was (003), a loose mid to light yellowish-brown sand and gravel, which was naturally deposited. This was overlain by subsoil (002), a 0.20m thick deposit of soft, mid brown

*Plate 4: Representative Section 1, looking northeast, 1m Scale*
