BARN AT BROOKSIDE HOUSE, 9 BROOK LANE, GREAT EASTON, LEICESTERSHIRE

Historic Building Recording

Site Code: GEBL17

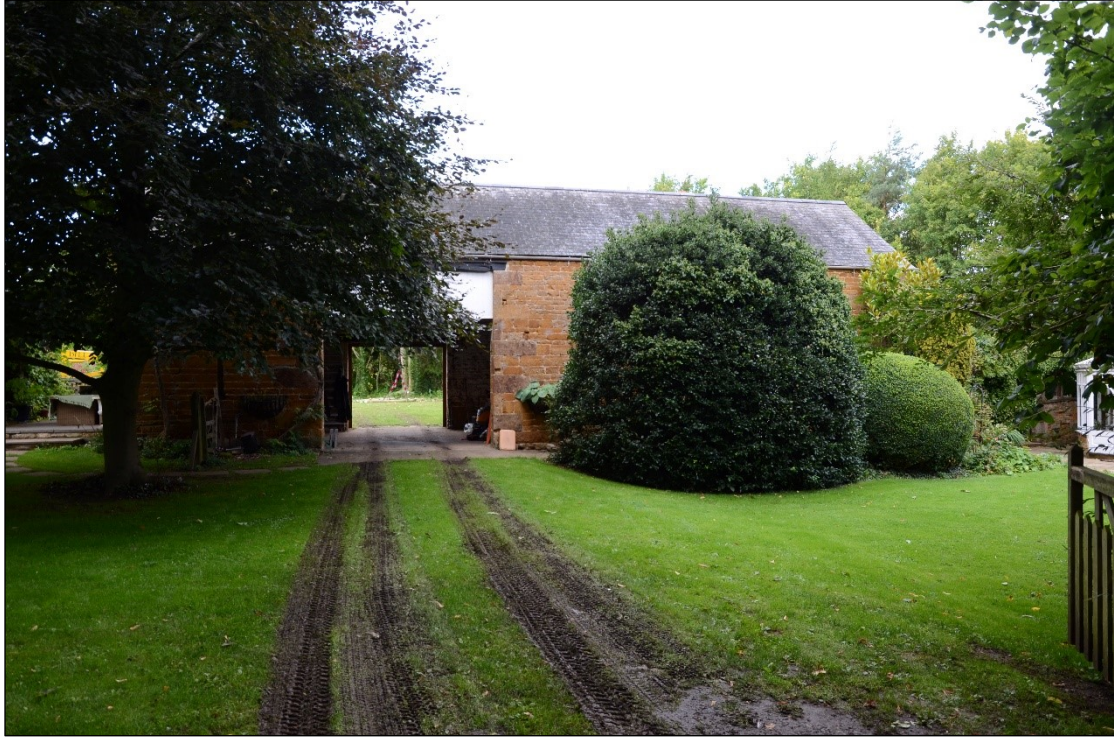
Plate 1: General view from the south

A modern raised patio has been constructed against the southwestern end of the building and wooden dog cage abuts the northeastern end. The southeast side (*Plates 1 and 2*) was heavily obscured by mature trees and shrubs, in full leaf at the time of the survey. Views of the other elevations were relatively

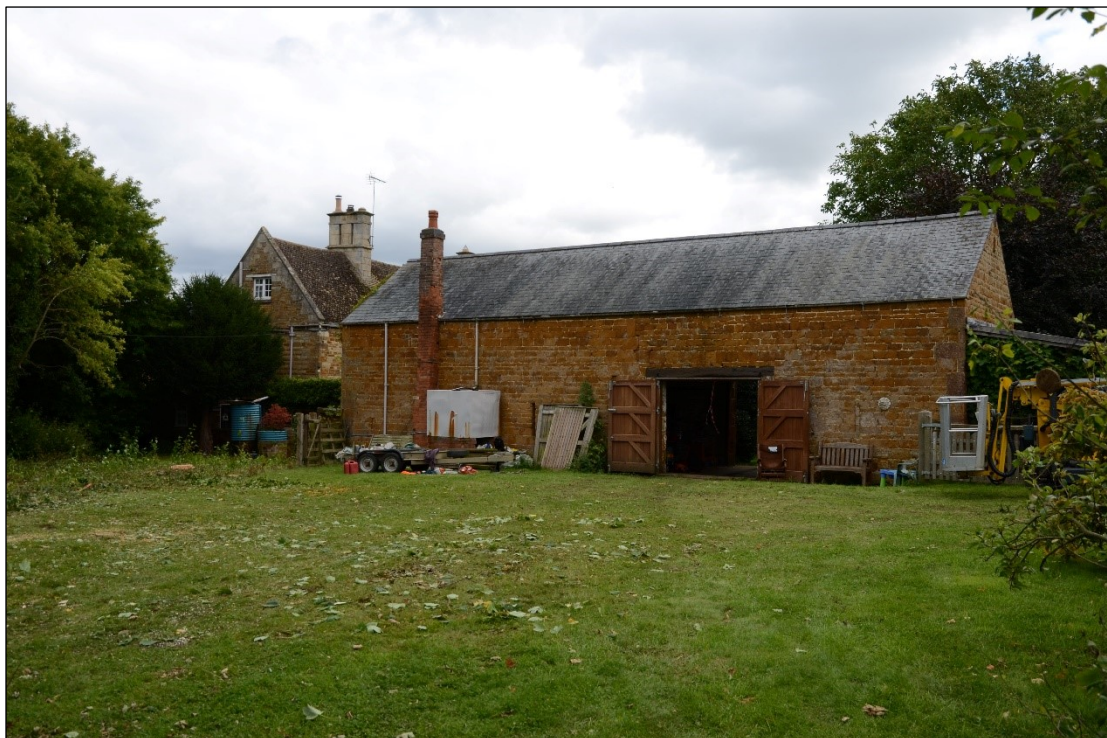
Plate 3: General view from the north-northwest

unhindered (*Plate 3*). A washroom (probably late 19th or early 20th century) is built into the northeastern end of the building.

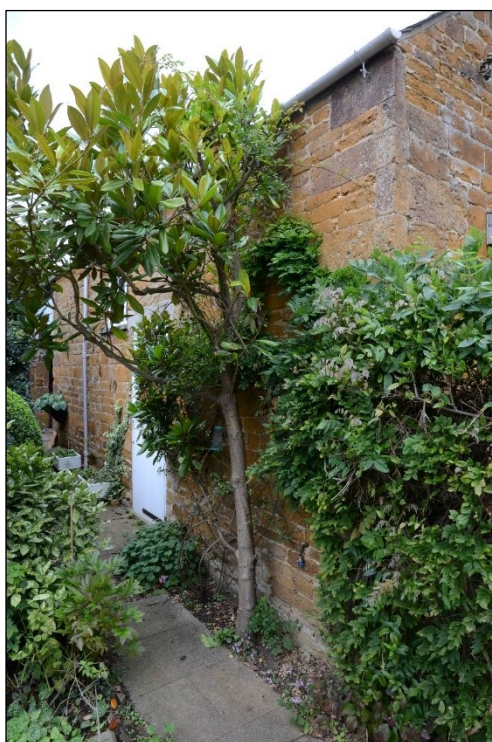
Plate 4: Southeast facing elevation, looking c. southwest

The southeast facing elevation (*Plates 4 and 5*) includes a single width door to the washroom (see above), located at the northeastern end of the building and flanked by the opening for a pitching door (now a window) at high level. The doorway to the washroom has a concrete lintel above and contains a plank stable-type door, and a transom window of eight lights in two rows. The opening for the pitching door, located immediately southwest of the door to the washroom, has a wooden lintel (probably the original)

above. Originally it would have contained wooden shutters, but now contains a modern window of nine lights over a (concrete?) sill.

The main door, which extends the full height of walls, has a substantial hand-worked wooden lintel above.

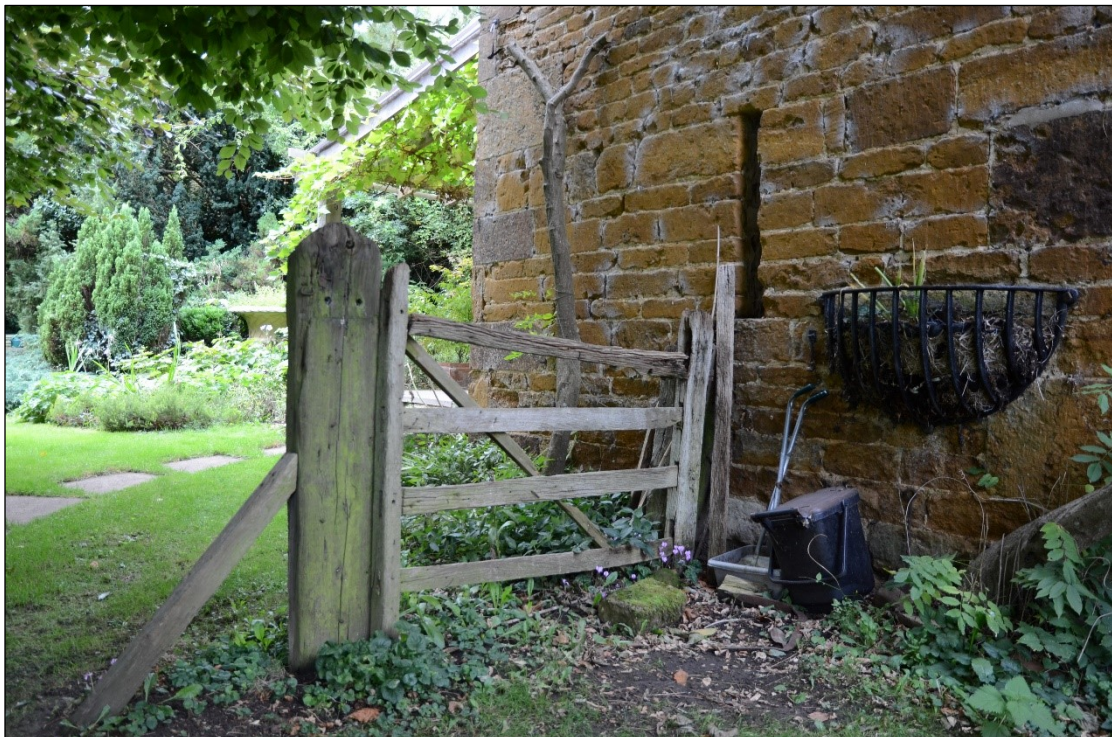
Plate 6: Southwestern end of the southeast facing elevation, looking west

Two ventilation slits are present in the southeast wall, located to each side of the main door. One of the slits (northeast of the door) is infilled with stone and is partially obscured by a plastic downpipe (*Plate 5*, centre of view). The other, located southwest of the door and still open (*Plate 6*), splays from 0.55m wide in the interior to 0.12m wide on the outside.

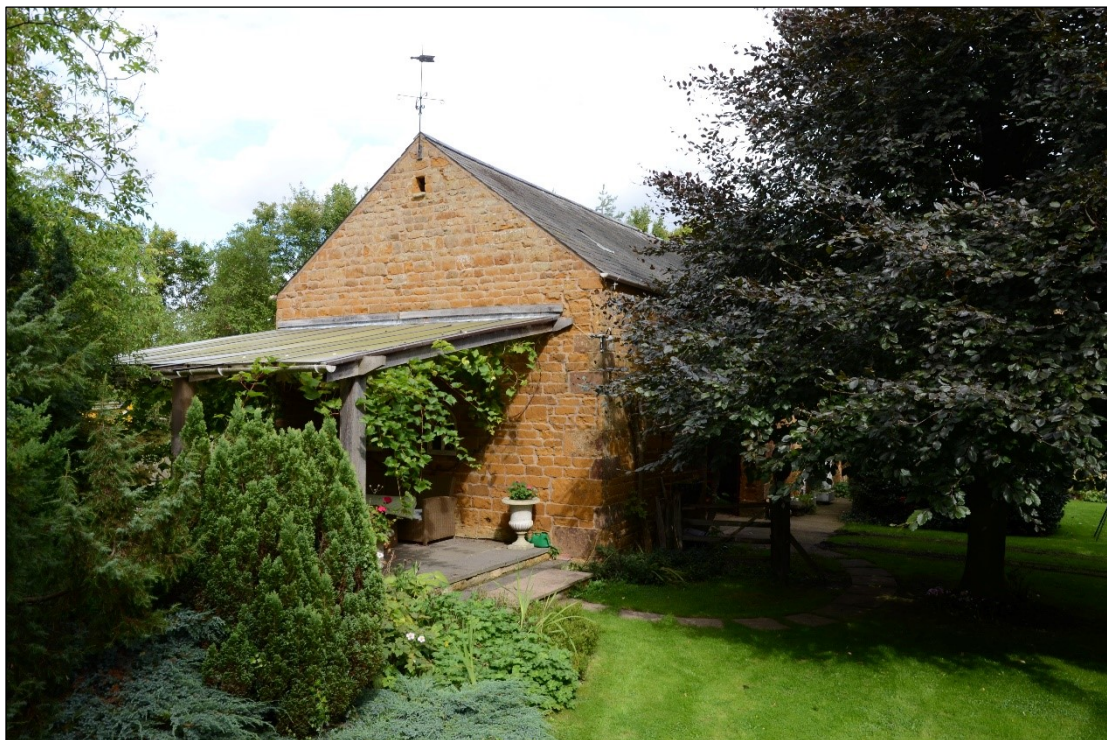
Plate 8: Southwest facing elevation, looking north

The southwest facing gable end (*Plates 8 and 9*) is obscured at lower level by the modern raised patio and an associated lean-to cover. However, the elevation appears featureless except for a small opening at high level – probably an owl hole - and a metal weather vane (probably late) above.

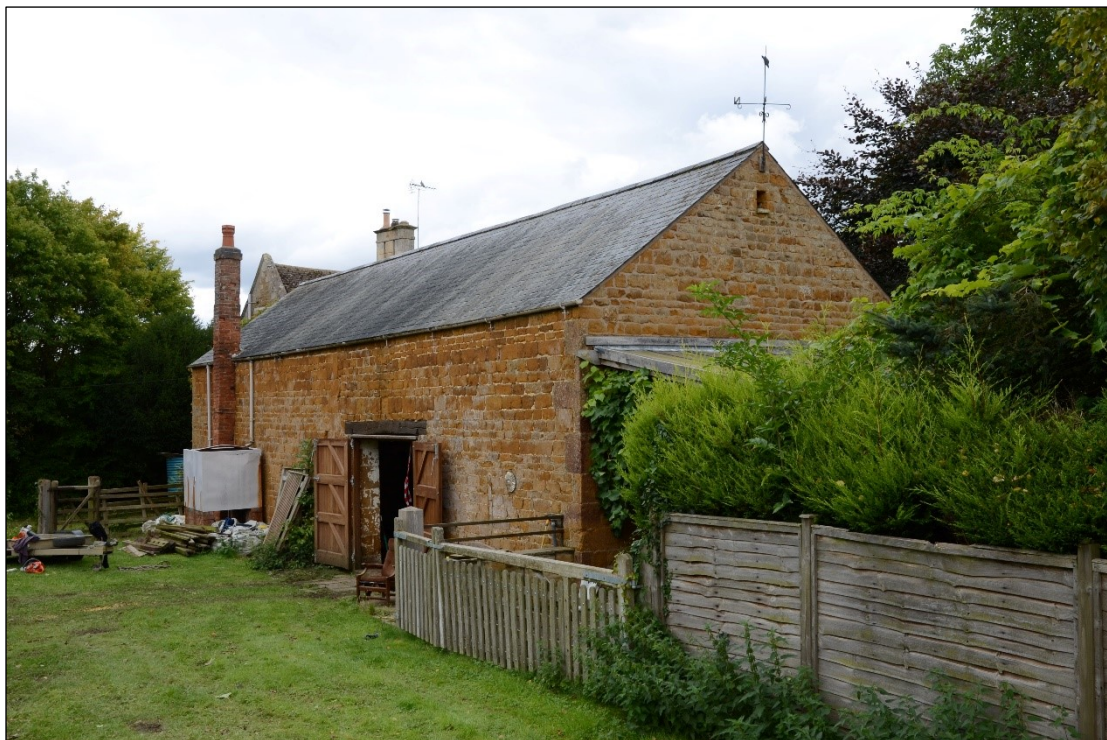
Plate 9: Northwest and southwest facing elevations, looking c. east-northeast

The northwest facing elevation (*Plates 9, 10 and 14*) contains the second of the large opposing doors, located near to the southwestern end of the building. With a hand-worked wooden lintel above (probably original), the doorway is slightly narrower than the opening in the opposite elevation and significantly

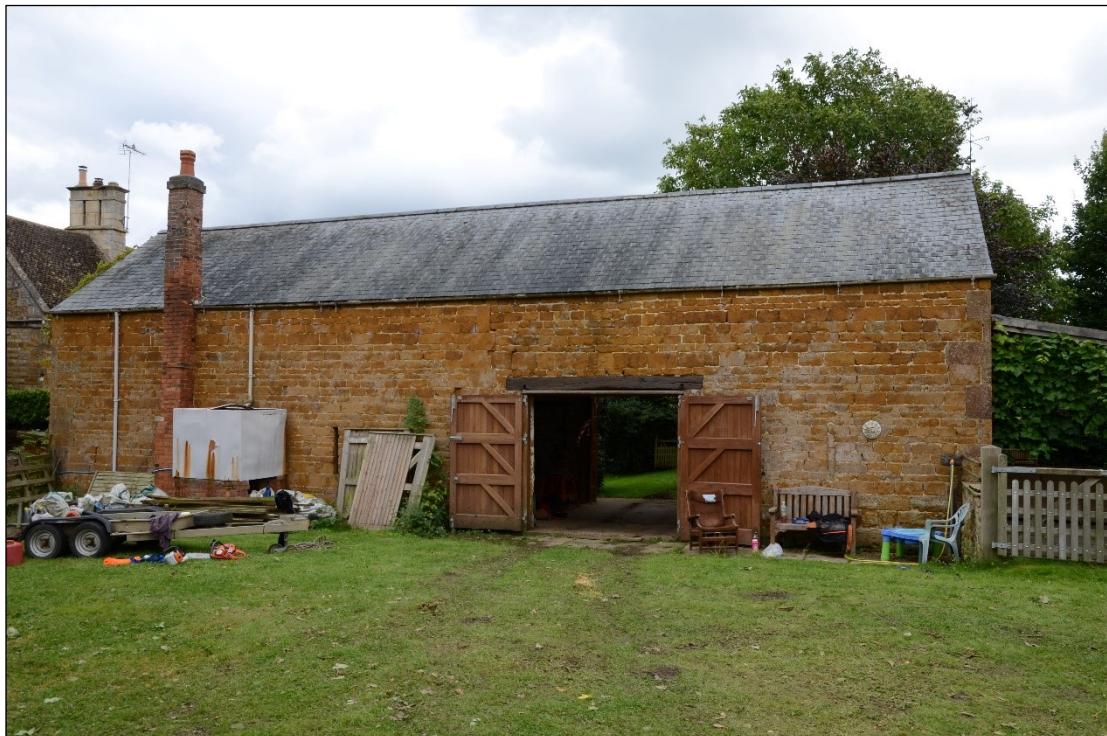
Plate 10: Northwest facing elevation, looking c. southeast

lower. The wooden plank doors are modern replacements. It is flanked by ventilation slits, infilled with stone on the southwest side (Plate 11), but still open to the northeast (Plate 13). A brick chimney stack from the fireplace/copper in the washroom abuts the wall near the northwestern end of the elevation, extending to well above the level of the eaves in height.

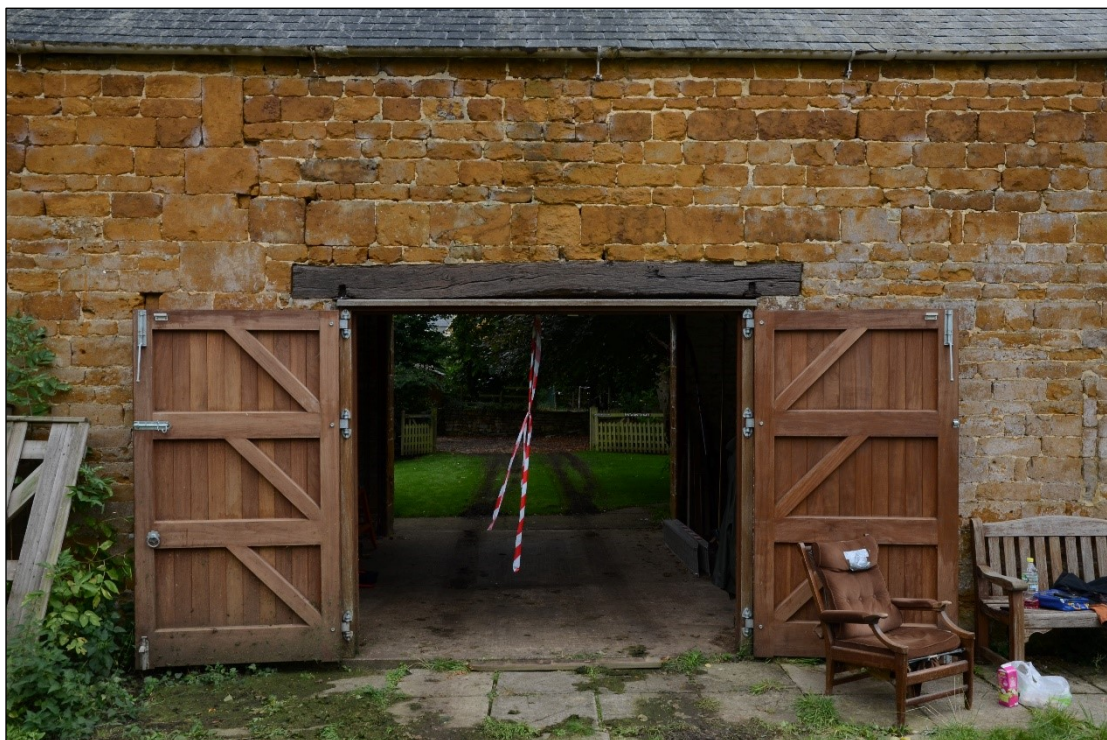
Plate 12: Door in the northwest wall, looking southeast (change in build, top left of door)

The northwest wall is in two contrasting builds, meeting at a point immediately northeast of the door. The builds vary in terms of their coursing and the point of transition is defined by an irregular column of

large blocks of ironstone (see *Plate 12*) rising from the northeastern end of the lintel. The variation in the fabric northeast and southwest of the join might indicate construction of the wall in two campaigns. The blocks in the join appear to be more closely tied into the wall northeast of the door and might, therefore, have terminated an initial phase of construction extending to the visible disjunction on the northwest side and to the northeast side of the door on the southeast.

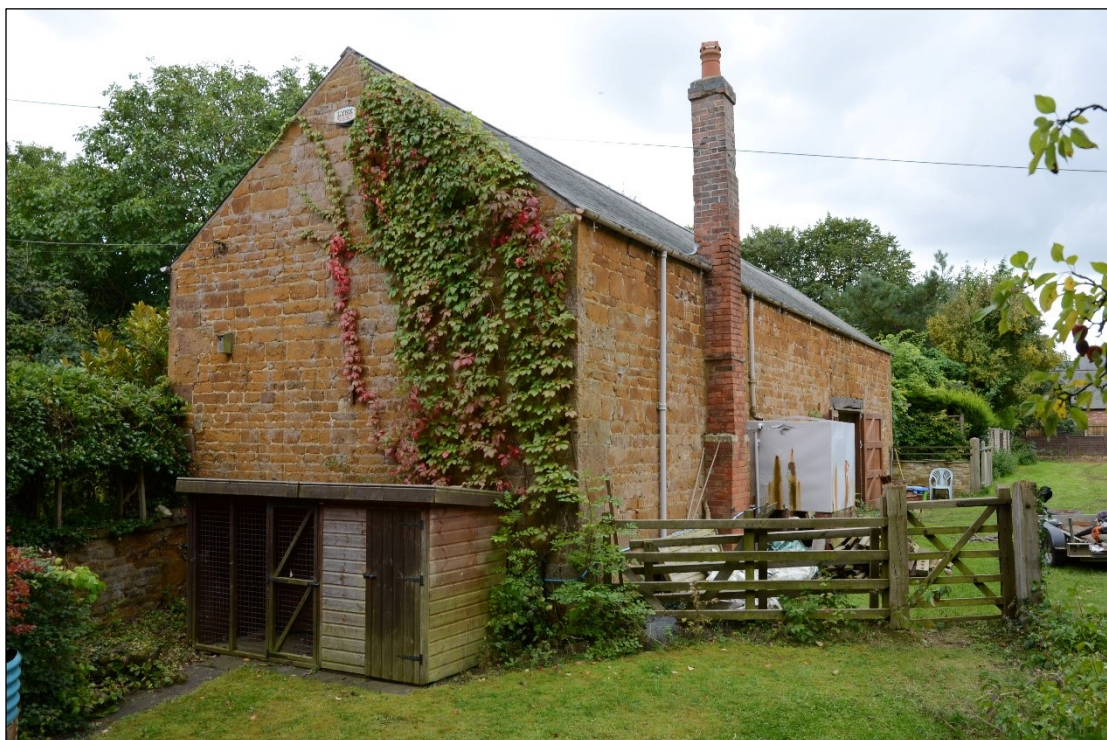
Plate 14: Northeast (left of view) and northwest (right of view) elevations, looking south

The northeast facing gable end (*Plate 14*) is partly obscured by ivy and, at lower levels, by a dog kennel extending to almost the width of the building. Despite the obstructions, it appeared that the wall was featureless.

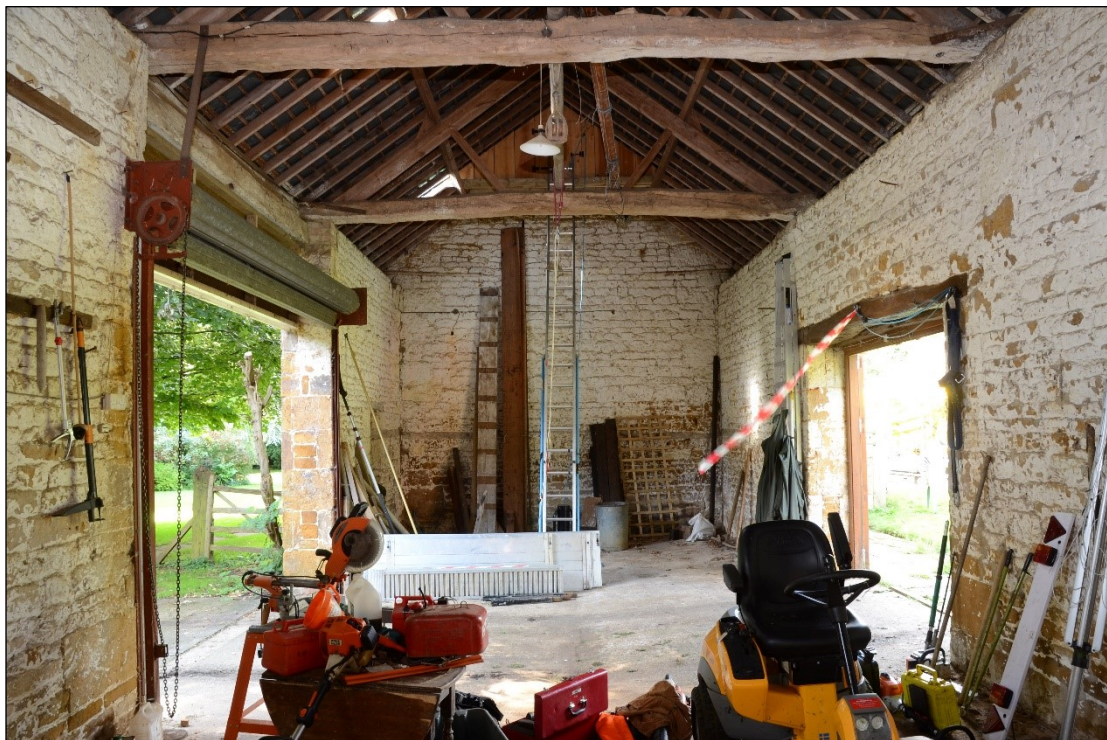
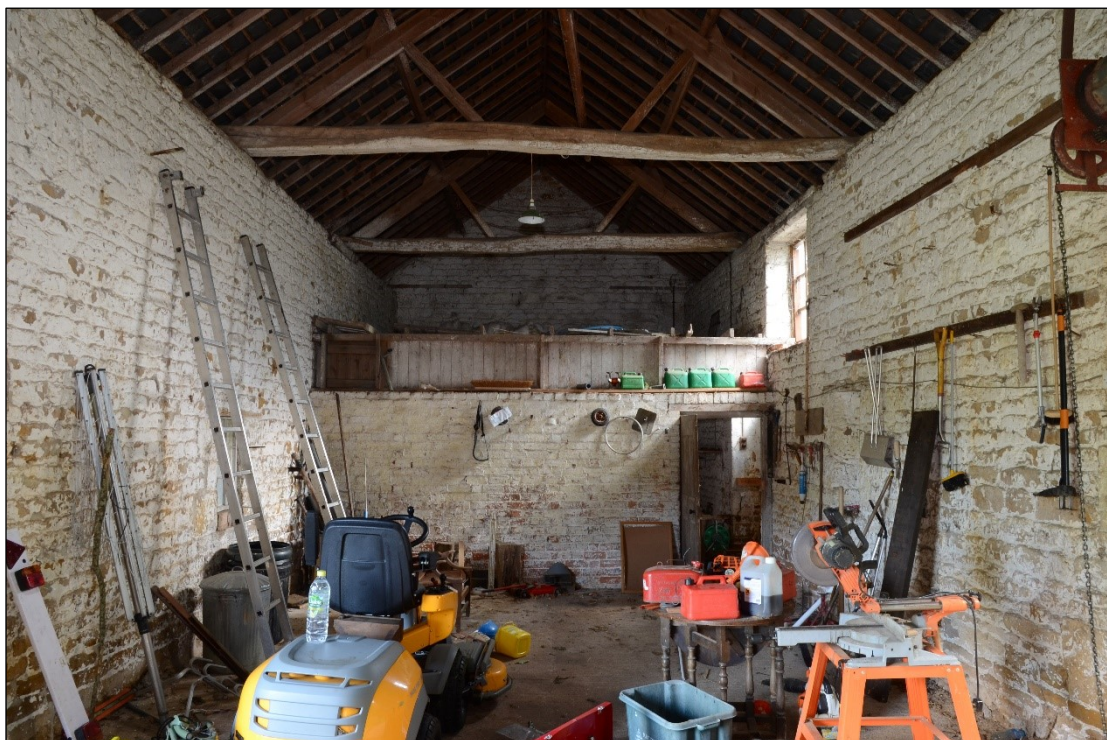
Plate 15: Interior of the barn, looking southwest

Internally, the barn is open to the roof and divided into five bays, with four trusses in the roof structure (*Plates 15 and 16*). The tie-beams are hand-worked and may be original, but the remainder of the structure, including the struts and principal rafters in the trusses, are clearly much later and probably contemporary with the reroofing of the building as a whole (*Plate 17*).

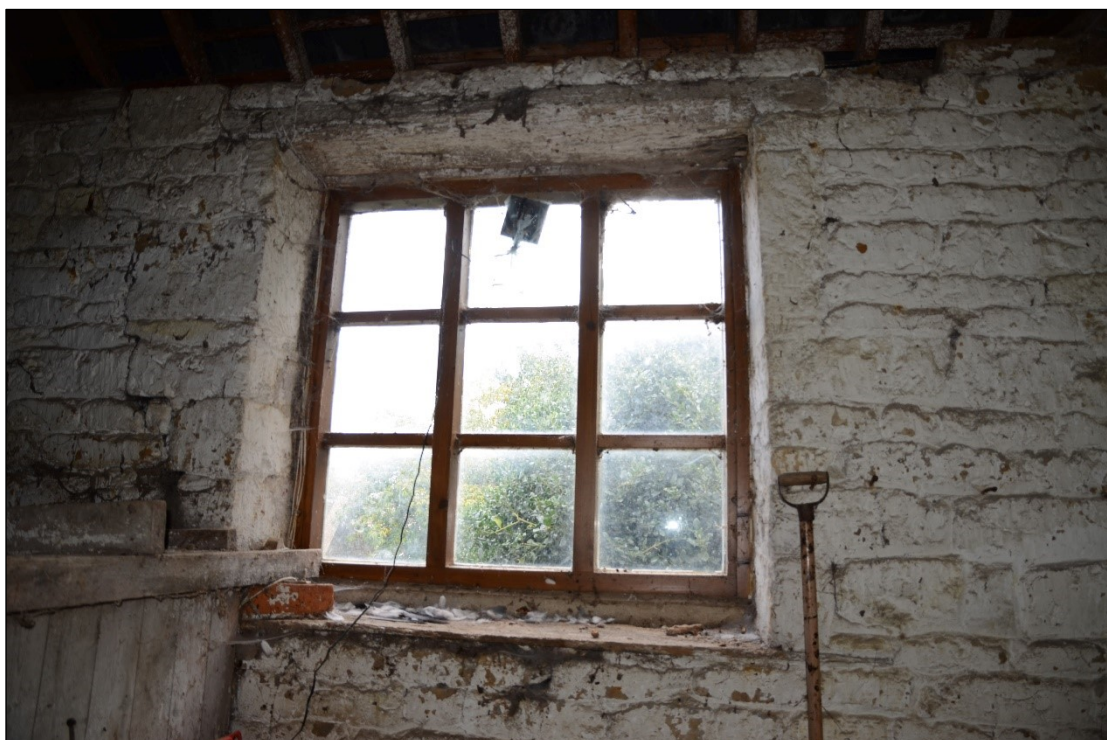
Plate 18: Former pitching door in the southeast wall, looking c. southeast

The washroom at the north-eastern end of the building is defined by a later brick partition on the southwest side, extending to around mid-height in relation to the barn walls. The partition, raised by a wooden section above (Plate 16), lay just beyond the pitching door. The latter retained the original thin wooden lintel above, but there are no surviving remains of the original shutters (Plate 18).

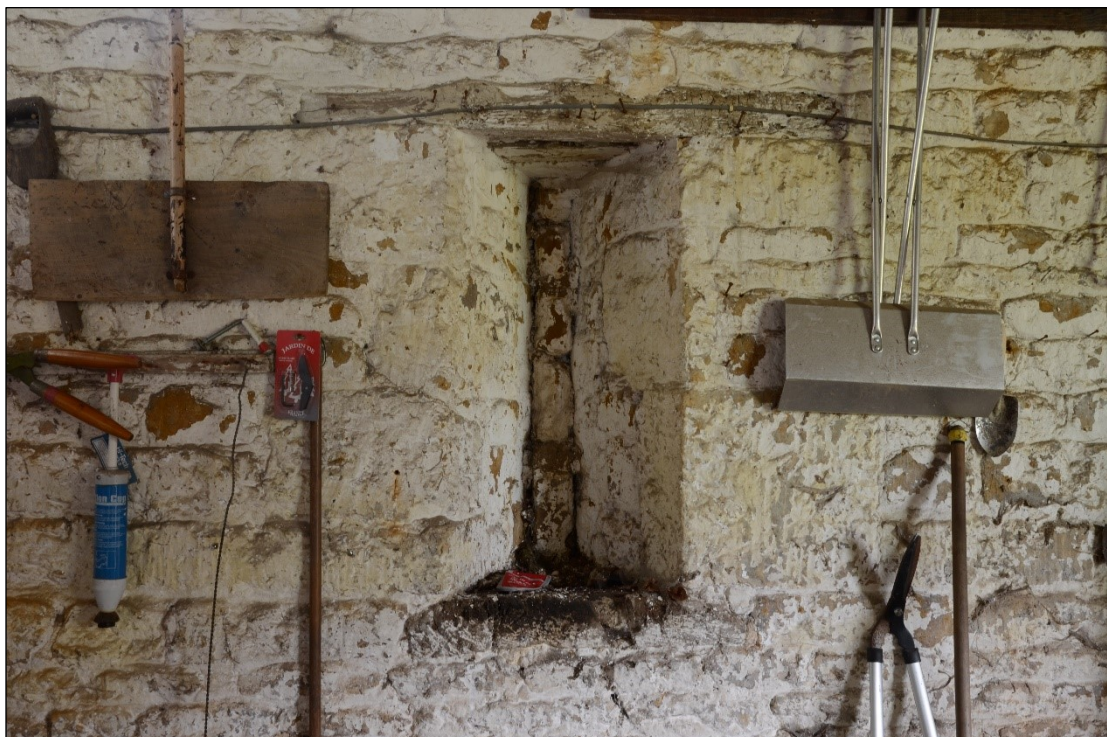
Plate 19: Blocked in vent in the southeast wall, northeast of the main door, looking southeast

The ventilation slits are splayed in the interior, with thin wooden lintels above. The splayed areas remain open in both slits in the southeast wall (Plates 19 and 20), although the actual aperture has been blocked

with stone in the one located northeast of the door (see *Plate 19*). In the northwest wall, the slit to the southwest of the door is completely infilled with stone (*Plate 21*), while the remaining feature northeast of the door is closed over by a modern window (*Plate 22*).

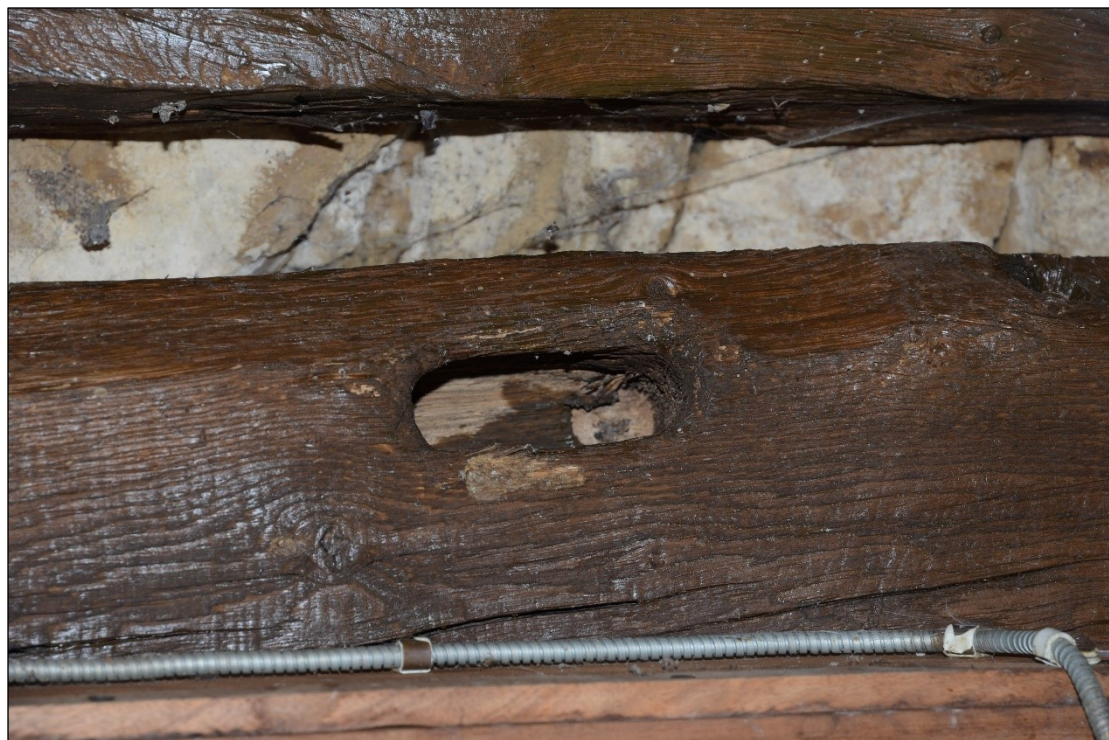
Plate 23: Recess midway along lintel over the northwest door, from directly below (northwest at bottom)

A recess situated midway along the underside the lintel over the northwest door (*Plate 23*) might originally have received a bolt attached to the original door, forming part of the retaining mechanism.

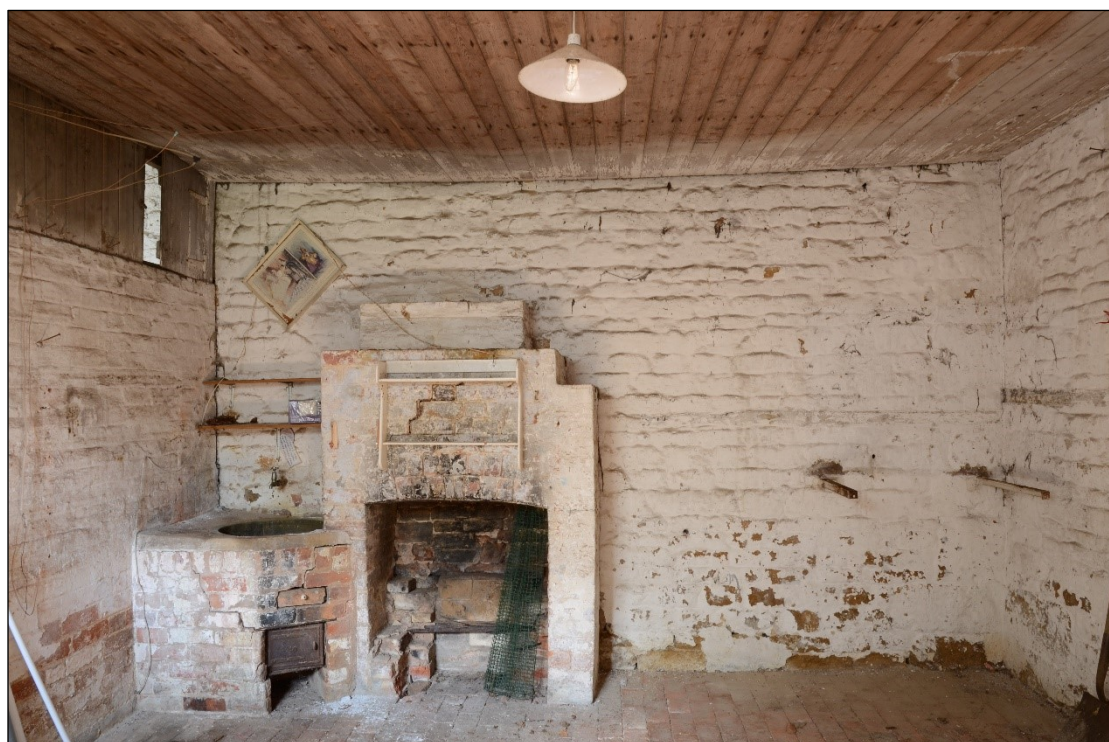
Plate 24: Northwestern side of the washroom, looking northwest

In the washroom, there is a fireplace situated against the northwest wall, with an adjoining late nineteenth or early twentieth century hot water copper located to the southwest, in the angle formed by the internal dividing wall. (*Plates 24 and 25*). The brick structure for the fireplace which would have heated the copper has two flat sides facing into the room, and includes a door at low level providing access to where the fire was lit, with an area below where the ashes would have collected. The fire for the copper and the adjacent fireplace would have shared the same chimney.

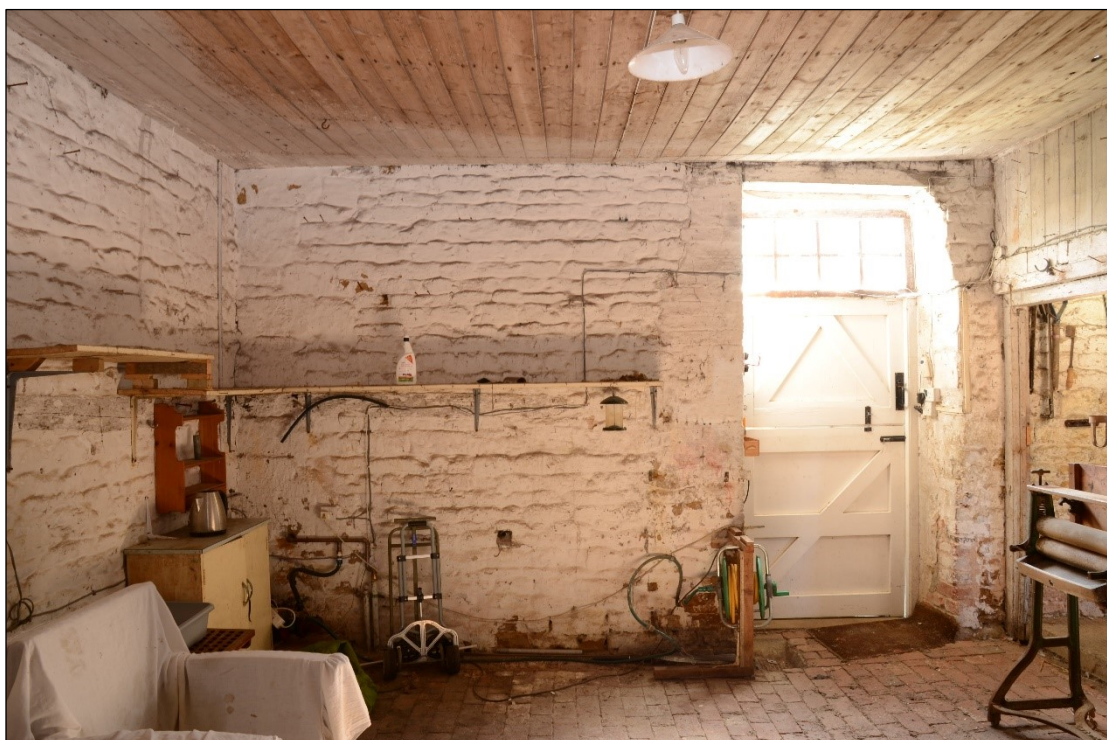
Plate 26: Southeastern side of the washroom, looking southeast

A mangle (manufactured by Ewbank) standing against the internal wall would appear to confirm use as a washroom (*Plate 26*, right of view and *Plate 27*). The precise date of the mangle has not been determined but it probably originates from around the earlier or middle part of the twentieth century. The floor of the washroom is in brick and the ceiling is constructed from wooden boards (*Plates 26 and 27*) matching the upper extent of the internal wall. The door to the outside, which is irregular around the

edges and roughly finished, is clearly an alteration to the original structure, presumably inserted as part works to form the washroom.

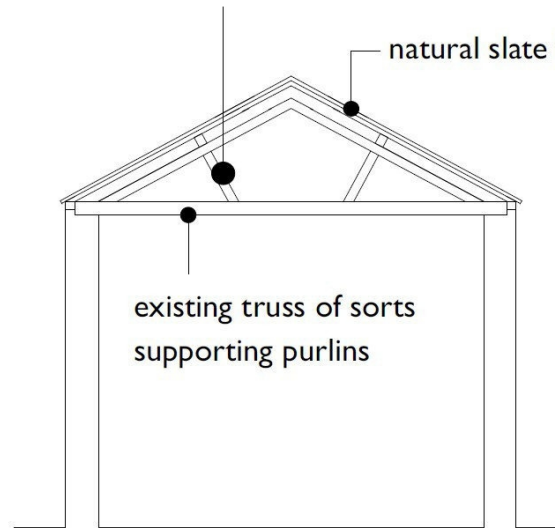
timbers from existing truss
to be integrated in proposed
design as decorative historic fabric

natural slate finish as existing barn

existing truss of sorts
supporting purlins
