# LAND ADJACENT TO NO. 5 VENOM ROAD, MANBY, LINCOLNSHIRE

**Archaeological Watching Brief**

WA Report No.: 17 Site Code: MAVR09 Museum Accession No.: 2009.123 OASIS ID: Withamar1-45192

# **ARCHAEOLOGICAL WATCHING BRIEF**

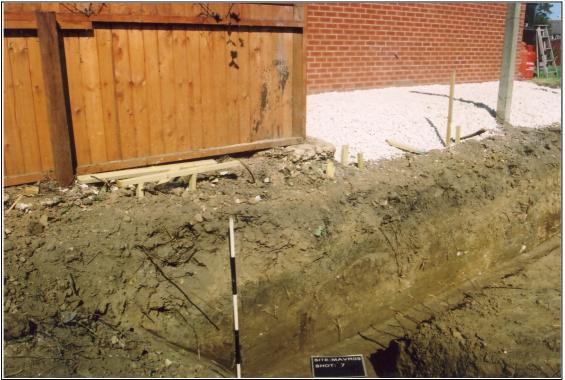
Plate 1 – View showing Section 1, looking northeast with 1m scale

On the western side of the plot, the clay had been truncated by a linear feature, [007], approximately 3.5m wide and at least 0.25m deep (only the upper levels were encountered), which was interpreted as a probable ditch. The earliest visible fills were stiff clays (008 and 013), which were overlain by clayey, sandy silt (006) from which two fragments of early twelfth to early thirteenth century pottery belonging to a single vessel were recovered, along with a piece of cattle bone.

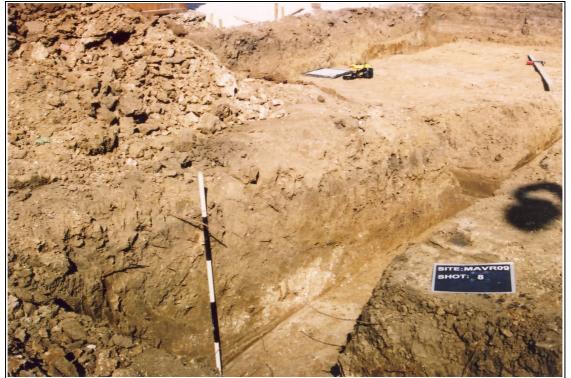
Plate 2 – View showing Section 2, looking northeast with 1m scale
