Museum of Somerset Project - Taunton Castle

Results of Archaeological Evaluation

August 2007

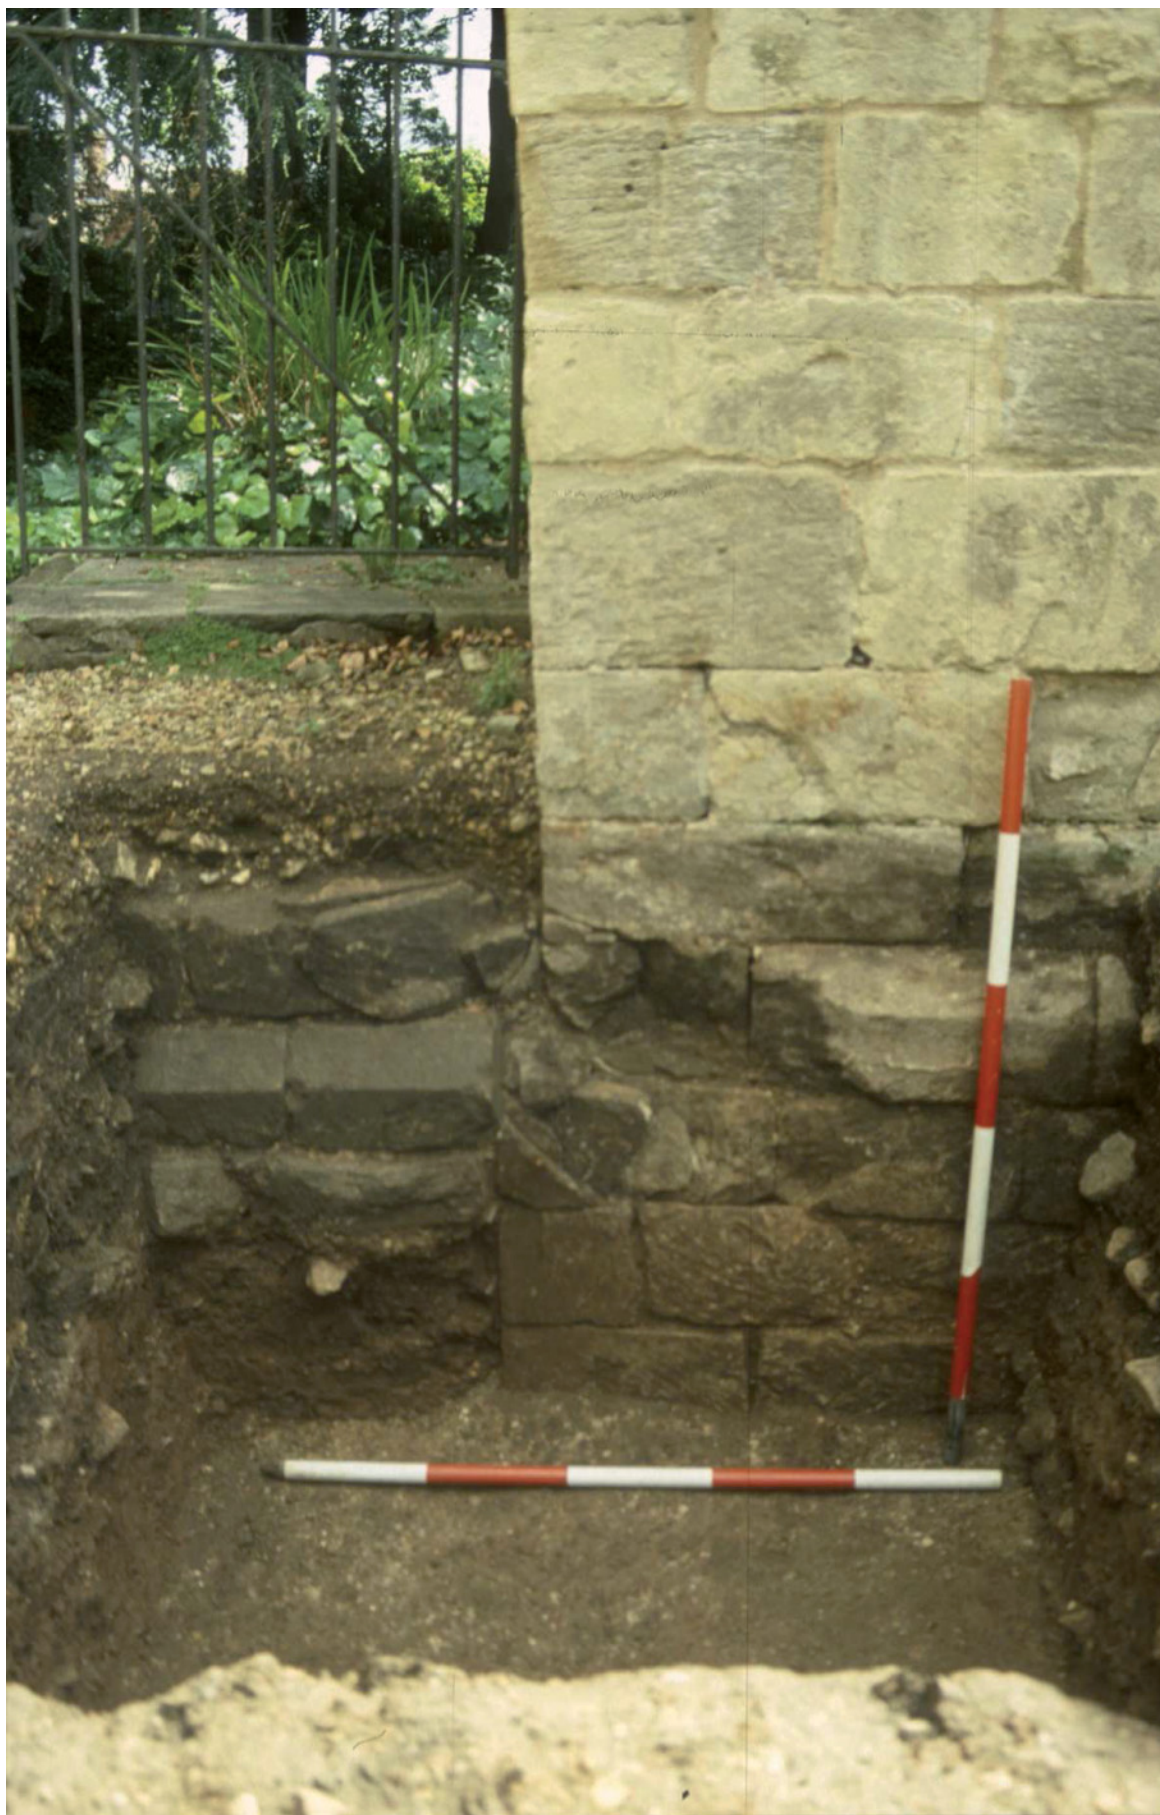
Figure 3: Wall C at the east end of Trench E showing its continuation (286) at a higher level

The area to the east of this was left undisturbed but a further area was excavated against the wall (285) to see if a continuation of the wall line, known from old photographs, had survived the construction of the Wyndham Gallery in 1934. This revealed a similar picture to that seen in Trench C (Webster 2005), with three foundation courses below the lowest chamfered course; again only the top of these was well laid and dressed. Below these was a wide offset (292) of two courses (it is possible that there were more but this was not confirmed) similar to that seen in 2005 and which appeared to turn around the end of the wall (although slightly narrower). The foundation also continued with a slightly different character, to the north (295). The stone of 295 was more mixed than that of 292, containing chert, lias and sandstone in contrast to the uniform sandstone of 292; the stones were also smaller. Above both foundations was a deposit of redeposited red marl which continued to the west to an unknown depth. Above this were deposits relating to building work on the wall: degraded sandstone chips, sand and a layer of mortar, probably from drops when pointing. Above this was a further layer of redeposited marl on which lay the foundations of a further wall (286) continuing the line of the courtyard wall (285) but clearly divorced from the foundations below (295). This wall comprised a rough foundation course on which lay a single chamfered course and then a vertical course. These were not coursed with wall 285 but the evidence of the early photographs, which show the wall dipping to the north, and the damaged end of wall 285, suggest that this wall has sunk by about half a course at the south end and more to the north.

It appears clear that the courtyard wall (285) originally returned east at this point, with a continuation to the north. The continuation was subsequently removed but later replaced with an ill-founded wall to match the alternate chamfered and vertical coursing further to the south.

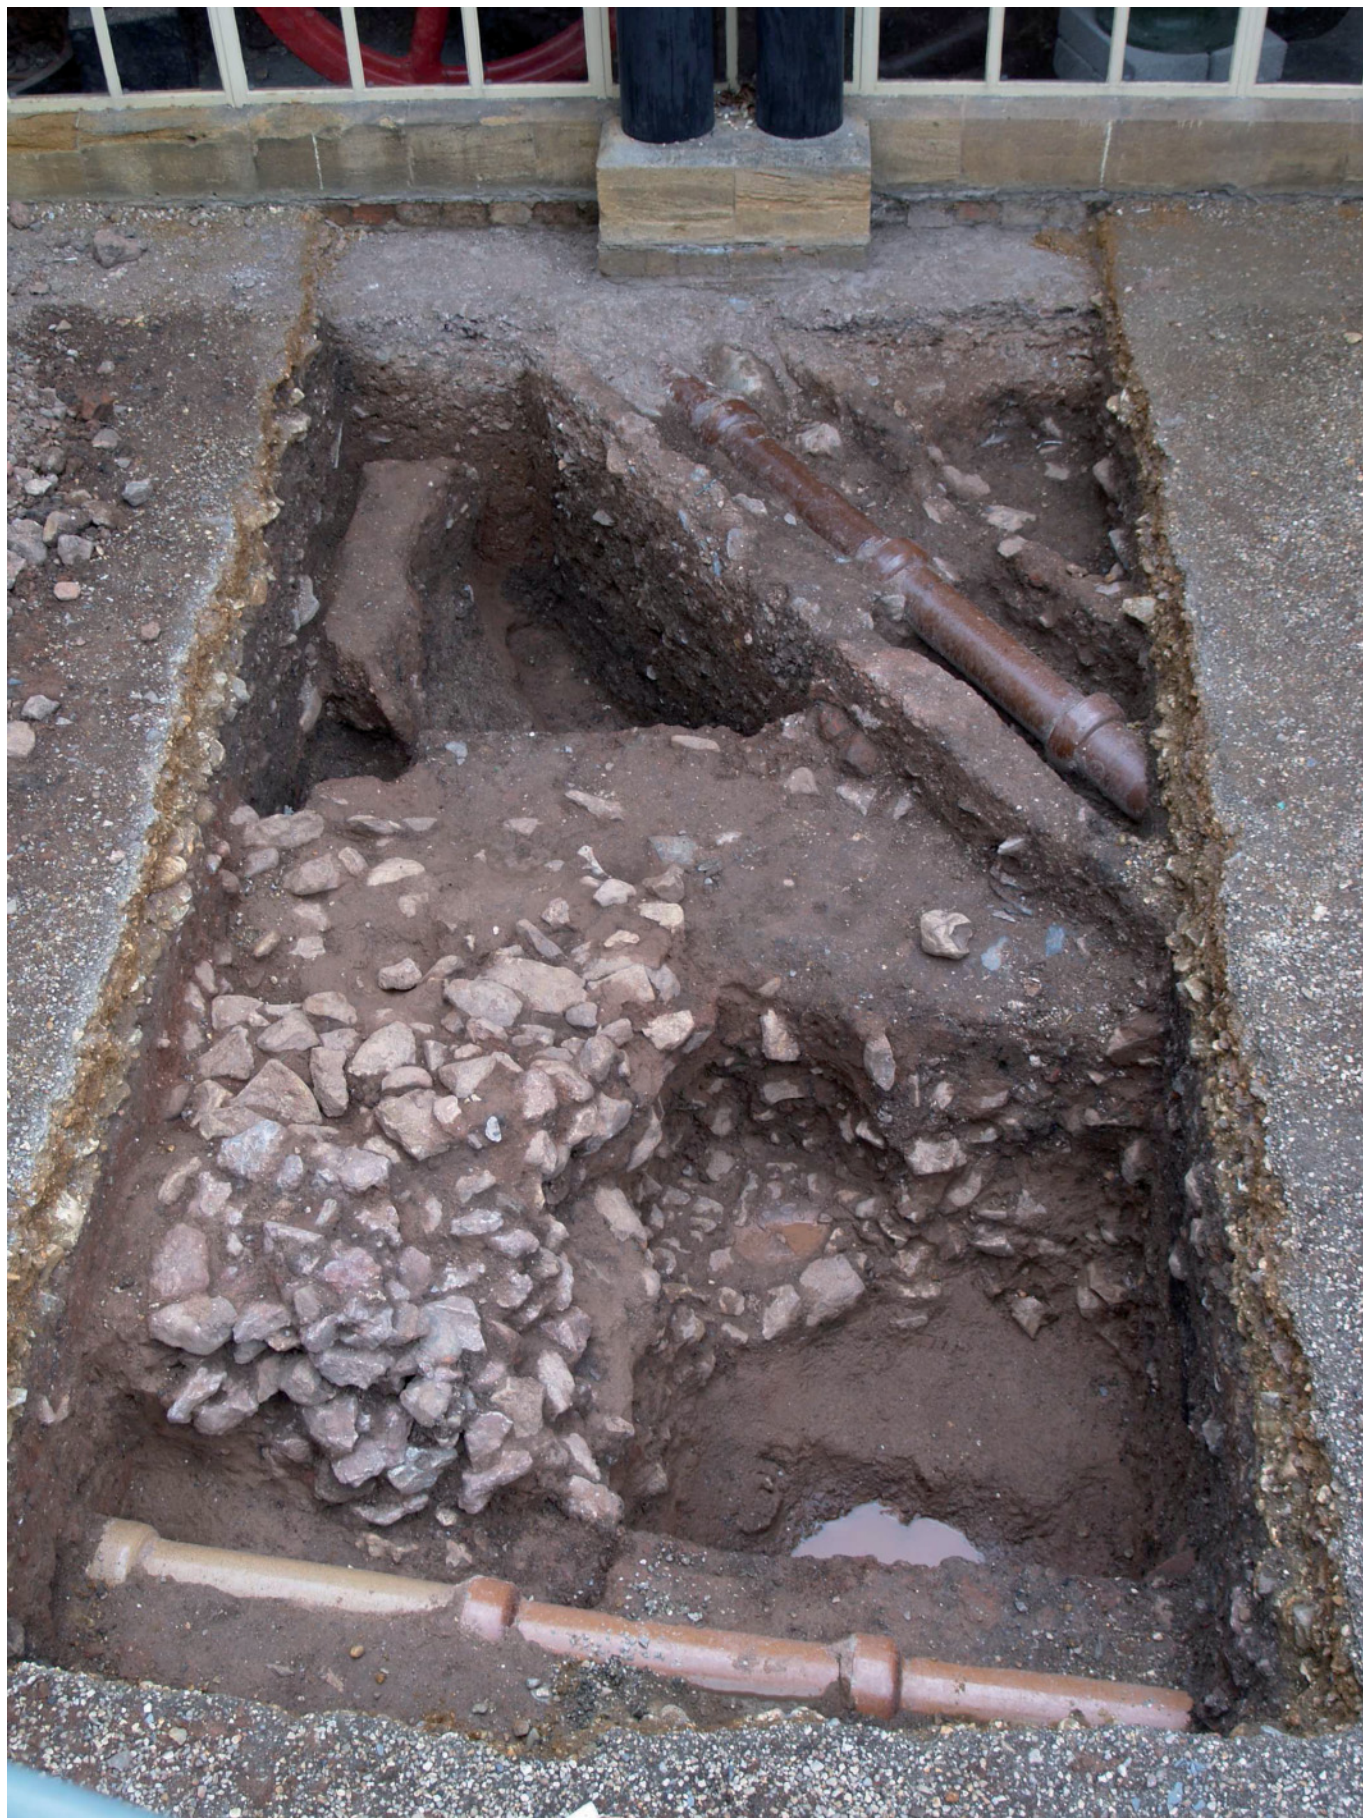
Figure 5: Trench F

Excavation in trench F proceeded through a very compact gravel layer forming the courtyard surface immediately below the present loose gravel. The gravel was in three distinctive layers: the base was formed of yellow gravel, succeeded by a layer of limestone scalplings and topped by a finer orange gravel. The two layers of gravel appeared to correspond to those found in Trench E (where, however, the scalplings were absent). Below this, excavation was immediately constrained by the presence of a rain-water drain in a trench [205] running diagonally across the trench. A further drain [236] was recognised later, running across the southern end of the trench; the similarity of the fill of this to its surroundings meant that it was not recognised at the higher level from which it was cut. The origin of this drain is not clear (it is aligned on the entrance door to the Harold St George Gray room) but to the east it appeared to lead to a damaged concrete slab covering an access chamber. The first drain [205] ran from a down-pipe within the gallery which drains the gutter of the Great Hall. Its south-east end was not aligned on the concrete cover. Both drains were constructed of salt-glazed stoneware pipes but were of different colours suggesting that they were not contemporary. It appears likely that 205 is related to the construction of the gallery whilst 236 may have been constructed to serve domestic accommodation known to have existed in the Somerset Room.

In the areas of the trench that were not disturbed (or made inaccessible) by the pipe trenches the area appeared to have been occupied by a group of intercutting pits. The fills of these were similar and appeared to comprise building debris, particularly slate. There was little in the way of domestic debris (although a few animal bones, pottery sherds and glass wine bottles were recovered) and the pits appeared from preliminary analysis of the pottery to be fairly contemporaneous and to date from the early 18th century. One large dump of stone (265),

superficially resembling a construction, also appeared to have been dumped in a pit, later cut by others. Natural alluvial deposits were reached in the bases of pits 251 and 245. The only other feature was a posthole (233) which was later than all the pits and retained the void of a post 7 inches by 4 inches (178 x 102mm).
