***A Watching Brief on
the Installation of New Path Furniture
along Offa's Dyke Path,
Shropshire, 2010***

Archaeology Service Report Number 290
© Shropshire County Council
February 2011

A WATCHING BRIEF ON THE INSTALLATION OF NEW PATH
FURNITURE ALONG OFFA'S DYKE PATH, SHROPSHIRE, 2010

A report for the
Outdoor Recreation Service,
Community Services,
Shropshire Council

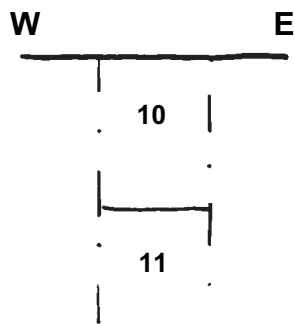
a) Kerry Ridgeway

The site at Kerry Ridgeway lay 6km west of Bishops Castle in southwest Shropshire on a field boundary 340m south of the Kerry Ridgeway road. The work here involved the replacement of a stile with a new wicket gate 1m to the east of the tail of the surviving earthwork bank. The new gate posts were cut in approximately the same place as the post holes for the old stile. Two postholes 0.7m deep by 0.3m in diameter were excavated by hand. A 0.4m thick layer of topsoil (10) sat over a light brown sandy clay (11), probably disturbed natural subsoil.

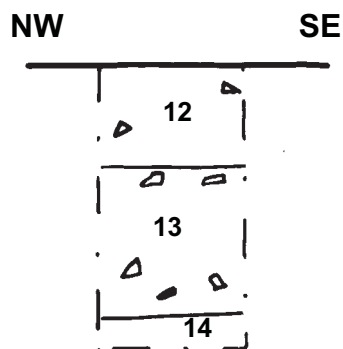
b) Nut Wood

The site at Nut Wood lay 6km west of Bishops Castle in southwest Shropshire on a field boundary 560m south of the Kerry Ridgeway road. The work here involved the replacement of a stile with a new kissing gate, sited between 1m and 2m to the east of the surviving earthwork bank. Six postholes were excavated by hand; two postholes 0.75m deep by 0.4m x 0.3m in plan for corner and strainer posts and four postholes 0.7m deep by 0.3m in diameter for the remaining posts.

The natural subsoil here comprised a light greyish brown to buff sandy clay (14) with angular stone fragments and was seen to lie 0.7m below the ground surface. It lay below 0.45m of a dark grayish brown sandy silty loam (13) with angular gravel and 0.25m of topsoil (12).

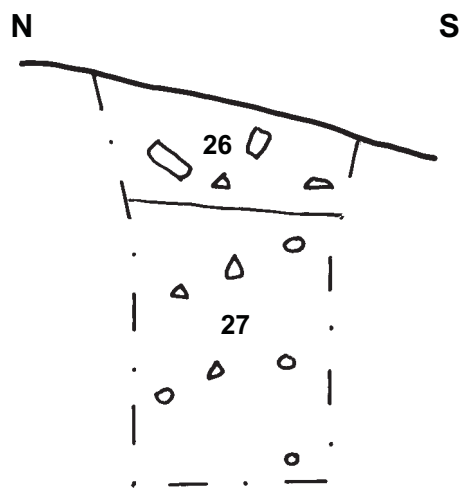
c) Brynorgan A

The site at Brynorgan A lay 5km southwest of Clun in southwest Shropshire at the entrance to an access track to a yard adjacent to Brynorgan Cottage. The work here involved the replacement of a metal farm gate across the gateway with a new metal Bristol 2 in 1 gate. The gateway was set across the entrance to the track 5m to the east of the tail of the earthwork bank. The existing eastern gatepost was left in situ and re-used. The western post was removed and a new post inserted in the posthole. This post hole was seen to have cut through a deposit of brown sandy clay and gravel (27) which lay beneath 0.3m of a brown sandy clay loam with gravel and stone fragments (26).

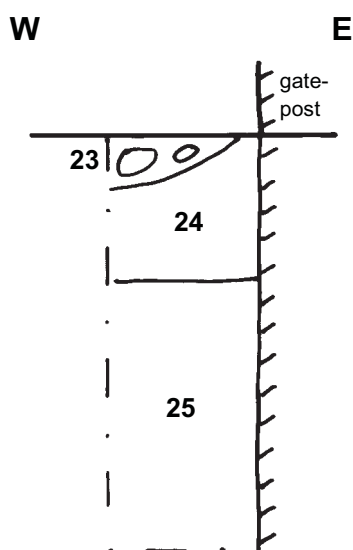
d) Brynorgan B

The site at Brynorgan B lay 5km southwest of Clun in southwest Shropshire. The work here involved the replacement of a stile and field gate on the north side of a yard west of Brynorgan cottage with a new metal Bristol 2 in 1 gate. The gate was sited on the edge of the farmyard 1m to the east of the surviving earthwork bank of the Dyke. Two postholes 1.1m deep by 0.4m in diameter were excavated by hand. The natural subsoil consisted of a grey silty clay (25) with gravel and was seen at a depth of 0.4m below the ground surface. This lay beneath up to 0.4m of a buried topsoil (24) of dark grey brown silty clay loam, which in turn lay beneath a yard surface (23) of pebbles and cobbles in grey silty loam.

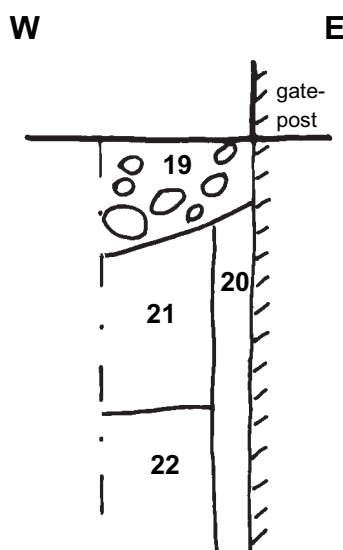
e) Brynorgan C

The site at Brynorgan C lay 5km southwest of Clun in southwest Shropshire. The work here involved the replacement of a stile and field gate on the south side of a yard west of Brynorgan cottage with a new metal Bristol 2 in 1 gate. The gate was sited on the edge of the farmyard 2.5m to the east of the ditch component of the dyke and on the line of the bank, which at this point no longer survived as an earthwork. Two postholes 1.1m deep by 0.4m in diameter were excavated by hand. The natural light brown silty clay (22) lay at a

depth of 0.7m below the ground surface, beneath a deposit 0.4m thick of a buried topsoil of grey brown silty clay loam (21). This was seen to have been cut by the post-hole (20) for the existing gate post. All these deposits lay beneath the yard surface of pebbles and cobbles (19) in a light brown silty clay.

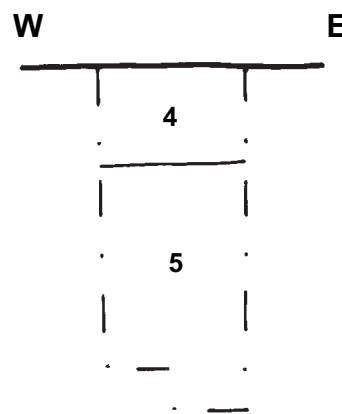
f) Middle Knuck A

2.6 Middle Knuck A: NGR: SO 2620 8695; SAM: 32596; Site Code: ODP10 MK-A
The site at Middle Knuck A lies about 6km west southwest of Bishop's Castle, on a field boundary 160m north of a lane running up to Knuck Bank. The work here involved replacing a stile with a kissing gate. The new kissing gate was located on the northwest edge of the ditch component of the Dyke. Six postholes were excavated by hand; two postholes 0.9m deep by 0.4m x 0.3m in plan for corner and strainer posts and four postholes 0.7m deep by 0.3m in diameter for the remaining posts. In the post-hole nearest the edge of the earthwork ditch 0.25m of topsoil (4) lay over a deposit over 0.6m thick of brown silty sand (5) with some angular gravel. Further away from the ditch edge the topsoil lay over brown silty sand (6) with a much higher proportion of angular gravel. Further to the south a distinct counterscarp is visible on the outer edge of the ditch and the deposit (5) seen in the easternmost posthole may have represented counterscarp material or possibly silting of the outer edge of the ditch.

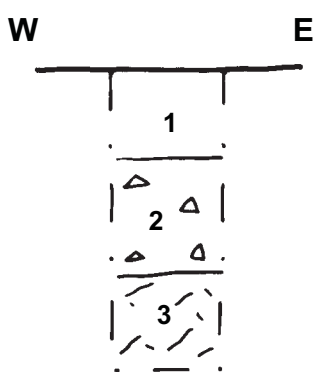
g) Middle Knuck B

2.7 Middle Knuck B: NGR: SO 2615 8679; SAM: 32596; Site Code: ODP10 MK-B
The site at Middle Knuck B lies about 6km west southwest of Bishop's Castle, on the north side of the lane running up to Knuck Bank. The work here involved replacing a stile with a kissing gate, sited over the ditch component of the dyke. Six postholes were excavated by hand; two postholes 0.8m deep by 0.4m x 0.3m in plan for corner and strainer posts and four postholes 0.7m deep by 0.3m in diameter for the remaining posts. The grey stone bedrock (3) lay 0.55m below the ground surface, beneath a layer of dark brown sandy loam (2) 0.3m thick, probably representing silting of the ditch, and a further 0.25m of topsoil (1).

2.10 Discussion In two of the above locations (at Middle Knuck B and C) the new footpath furniture was located on the line of the ditch component of the Dyke. In both of these locations the ditch appeared to be relatively shallow, with the natural bedrock being encountered at about 0.5m below the ground surface. The ditch fill in these locations was also relatively shallow (between 0.2m and 0.3m in thickness). Otherwise, no other significant archaeological features or deposits were seen in the excavations at any of the nine sites monitored during these works.

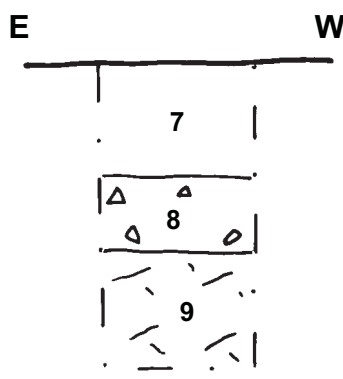
h) Middle Knuck C

2.8 Middle Knuck C: NGR: SO 2614 8678; SAM: 32596; Site Code: ODP10 MK-C
The site at Middle Knuck C lies about 6km west southwest of Bishop's Castle, on the south side of the lane running up to Knuck Bank. The work here involved installing a new kissing gate, sited over the ditch component of the dyke. Six postholes were excavated by hand; two postholes 0.8m deep by 0.4m x 0.3m in plan for corner and strainer posts and four postholes 0.8m deep by 0.3m in diameter for the remaining posts. A layer of brown sandy silt (9) with a high content of angular gravel and rock fragments was seen at a depth of between 0.35m and 0.7m below the ground surface; this deposit comprised the weathered and broken surface of the natural bedrock at the base of the ditch. It lay beneath a deposit of dark brown sandy loam with some angular gravel (8) representing silting of the ditch, and a topsoil layer (7) 0.2m thick.

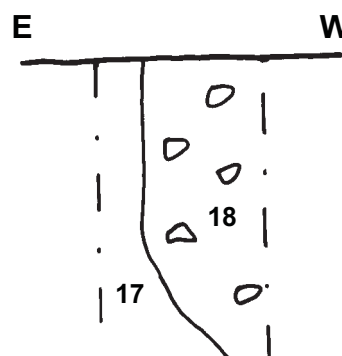
i) Middle Knuck D

2.9 Middle Knuck D: NGR: SO 2607 8630; SAM: 32597; Site Code: ODP10 MK-D
The site at Middle Knuck D lies about 6km west southwest of Bishop's Castle, some 90m south of Middle Knuck house on a terraced field boundary. The work here entailed the replacement of a stile with a new gate, located in the base of the ditch component of the Dyke. The postholes from the old stile posts were re-used, so that no new ground was broken. The western hole was seen to have been filled with a dark greyish brown sandy loam (15), and had been cut through a deep topsoil (17). The eastern posthole cut through chippings, mixed with some topsoil (18) which had been imported for steps installed some years earlier.
