***A Watching Brief on
the Installation of New Path Furniture
along Offa's Dyke Path,
Shropshire, 2010***

Archaeology Service Report Number 290
© Shropshire County Council
February 2011

A report for the
Outdoor Recreation Service,
Community Services,
Shropshire Council

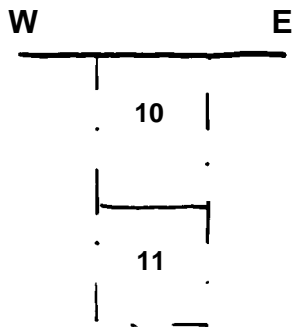
a) Kerry Ridgeway

The site at Kerry Ridgeway lay 6km west of Bishops Castle in southwest Shropshire on a field boundary 340m south of the Kerry Ridgeway road. The work here involved the replacement of a stile with a new wicket gate 1m to the east of the tail of the surviving earthwork bank. The new gate posts were cut in approximately the same place as the post holes for the old stile. Two postholes 0.7m deep by 0.3m in diameter were excavated by hand. A 0.4m thick layer of topsoil (10) sat over a light brown sandy clay (11), probably disturbed natural subsoil.

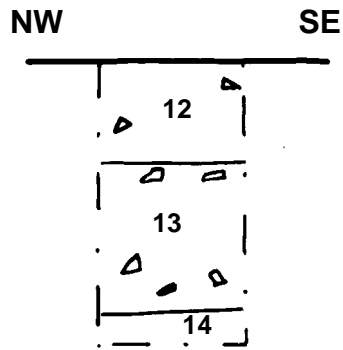
b) Nut Wood

The site at Nut Wood lay 6km west of Bishops Castle in southwest Shropshire on a field boundary 560m south of the Kerry Ridgeway road. The work here involved the replacement of a stile with a new kissing gate, sited between 1m and 2m to the east of the surviving earthwork bank. Six postholes were excavated by hand; two postholes 0.75m deep by 0.4m x 0.3m in plan for corner and strainer posts and four postholes 0.7m deep by 0.3m in diameter for the remaining posts.

The natural subsoil here comprised a light greyish brown to buff sandy clay (14) with angular stone fragments and was seen to lie 0.7m below the ground surface. It lay below 0.45m of a dark grayish brown sandy silty loam (13) with angular gravel and 0.25m of topsoil (12).

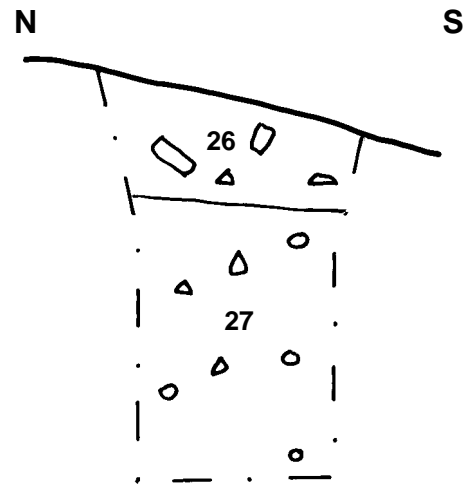
c) Brynorgan A

The site at Brynorgan A lay 5km southwest of Clun in southwest Shropshire at the entrance to an access track to a yard adjacent to Brynorgan Cottage. The work here involved the replacement of a metal farm gate across the gateway with a new metal Bristol 2 in 1 gate. The gateway was set across the entrance to the track 5m to the east of the tail of the earthwork bank. The existing eastern gatepost was left in situ and re-used. The western post was removed and a new post inserted in the posthole. This post hole was seen to have cut through a deposit of brown sandy clay and gravel (27) which lay beneath 0.3m of a brown sandy clay loam with gravel and stone fragments (26).

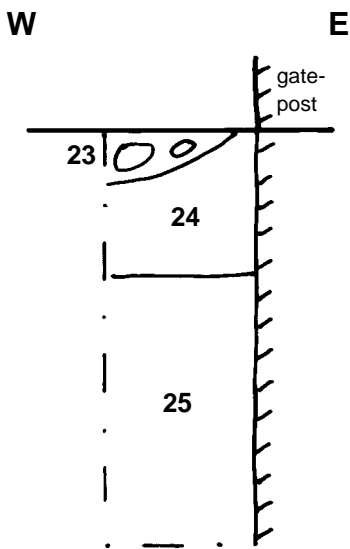
d) Brynorgan B

The site at Brynorgan B lay 5km southwest of Clun in southwest Shropshire. The work here involved the replacement of a stile and field gate on the north side of a yard west of Brynorgan cottage with a new metal Bristol 2 in 1 gate. The gate was sited on the edge of the farmyard 1m to the east of the surviving earthwork bank of the Dyke. Two postholes 1.1m deep by 0.4m in diameter were excavated by hand. The natural subsoil consisted of a grey silty clay (25) with gravel and was seen at a depth of 0.4m below the ground surface. This lay beneath up to 0.4m of a buried topsoil (24) of dark grey brown silty clay loam, which in turn lay beneath a yard surface (23) of pebbles and cobbles in grey silty loam.

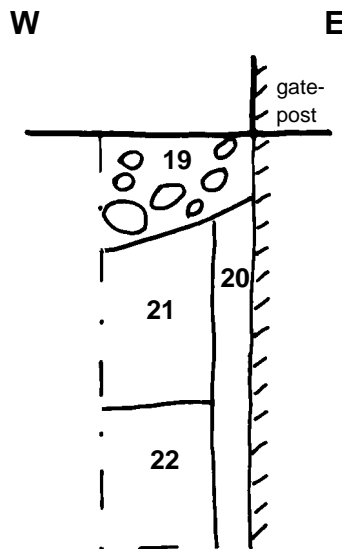
e) Brynorgan C

The site at Brynorgan C lay 5km southwest of Clun in southwest Shropshire. The work here involved the replacement of a stile and field gate on the south side of a yard west of Brynorgan cottage with a new metal Bristol 2 in 1 gate. The gate was sited on the edge of the farmyard 2.5m to the east of the ditch component of the dyke and on the line of the bank, which at this point no longer survived as an earthwork. Two postholes 1.1m deep by 0.4m in diameter were excavated by hand. The natural light brown silty clay (22) lay at a

depth of 0.7m below the ground surface, beneath a deposit 0.4m thick of a buried topsoil of grey brown silty clay loam (21). This was seen to have been cut by the post-hole (20) for the existing gate post. All these deposits lay beneath the yard surface of pebbles and cobbles (19) in a light brown silty clay.

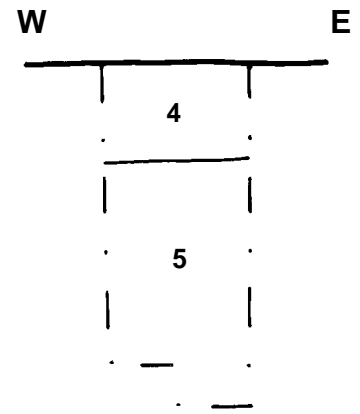
f) Middle Knuck A

2.6 Middle Knuck A: NGR: SO 2620 8695; SAM: 32596; Site Code: ODP10 MK-A
The site at Middle Knuck A lies about 6km west southwest of Bishop's Castle, on a field boundary 160m north of a lane running up to Knuck Bank. The work here involved replacing a stile with a kissing gate. The new kissing gate was located on the northwest edge of the ditch component of the Dyke. Six postholes were excavated by hand; two postholes 0.9m deep by 0.4m x 0.3m in plan for corner and strainer posts and four postholes 0.7m deep by 0.3m in diameter for the remaining posts. In the post-hole nearest the edge of the earthwork ditch 0.25m of topsoil (4) lay over a deposit over 0.6m thick of brown silty sand (5) with some angular gravel. Further away from the ditch edge the topsoil lay over brown silty sand (6) with a much higher proportion of angular gravel. Further to the south a distinct counterscarp is visible on the outer edge of the ditch and the deposit (5) seen in the easternmost posthole may have represented counterscarp material or possibly silting of the outer edge of the ditch.

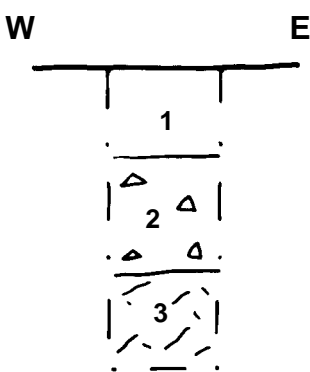
g) Middle Knuck B

2.7 Middle Knuck B: NGR: SO 2615 8679; SAM: 32596; Site Code: ODP10 MK-B
The site at Middle Knuck B lies about 6km west southwest of Bishop's Castle, on the north side of the lane running up to Knuck Bank. The work here involved replacing a stile with a kissing gate, sited over the ditch component of the dyke. Six postholes were excavated by hand; two postholes 0.8m deep by 0.4m x 0.3m in plan for corner and strainer posts and four postholes 0.7m deep by 0.3m in diameter for the remaining posts. The grey stone bedrock (3) lay 0.55m below the ground surface, beneath a layer of dark brown sandy loam (2) 0.3m thick, probably representing silting of the ditch, and a further 0.25m of topsoil (1).

2.10 Discussion In two of the above locations (at Middle Knuck B and C) the new footpath furniture was located on the line of the ditch component of the Dyke. In both of these locations the ditch appeared to be relatively shallow, with the natural bedrock being encountered at about 0.5m below the ground surface. The ditch fill in these locations was also relatively shallow (between 0.2m and 0.3m in thickness). Otherwise, no other significant archaeological features or deposits were seen in the excavations at any of the nine sites monitored during these works.

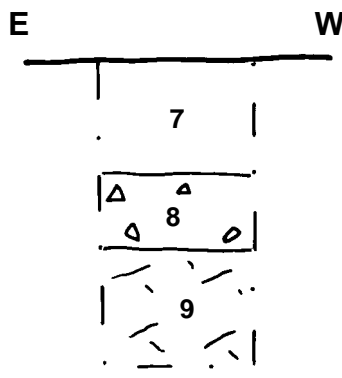
h) Middle Knuck C

2.8 Middle Knuck C: NGR: SO 2614 8678; SAM: 32596; Site Code: ODP10 MK-C
The site at Middle Knuck C lies about 6km west southwest of Bishop's Castle, on the south side of the lane running up to Knuck Bank. The work here involved installing a new kissing gate, sited over the ditch component of the dyke. Six postholes were excavated by hand; two postholes 0.8m deep by 0.4m x 0.3m in plan for corner and strainer posts and four postholes 0.8m deep by 0.3m in diameter for the remaining posts. A layer of brown sandy silt (9) with a high content of angular gravel and rock fragments was seen at a depth of between 0.35m and 0.7m below the ground surface; this deposit comprised the weathered and broken surface of the natural bedrock at the base of the ditch. It lay beneath a deposit of dark brown sandy loam with some angular gravel (8) representing silting of the ditch, and a topsoil layer (7) 0.2m thick.

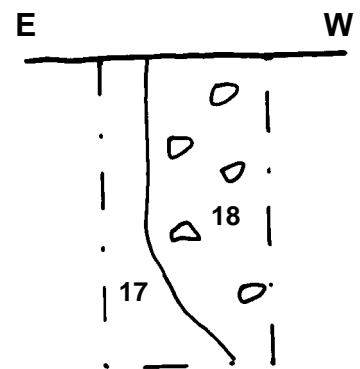
i) Middle Knuck D

2.9 Middle Knuck D: NGR: SO 2607 8630; SAM: 32597; Site Code: ODP10 MK-D
The site at Middle Knuck D lies about 6km west southwest of Bishop's Castle, some 90m south of Middle Knuck house on a terraced field boundary. The work here entailed the replacement of a stile with a new gate, located in the base of the ditch component of the Dyke. The postholes from the old stile posts were re-used, so that no new ground was broken. The western hole was seen to have been filled with a dark greyish brown sandy loam (15), and had been cut through a deep topsoil (17). The eastern posthole cut through chippings, mixed with some topsoil (18) which had been imported for steps installed some years earlier.
