***An Archaeological Watching Brief at
The Music Hall and Vaughan's Mansion,
Shrewsbury, 2010-11***

Archaeology Service Report Number 292
© Shropshire Council
February 2012

**AN ARCHAEOLOGICAL WATCHING BRIEF AT
THE MUSIC HALL AND VAUGHAN'S MANSION,
SHREWSBURY, 2010-11**

A Report for
Shropshire Council Museums Service,
Shropshire Council

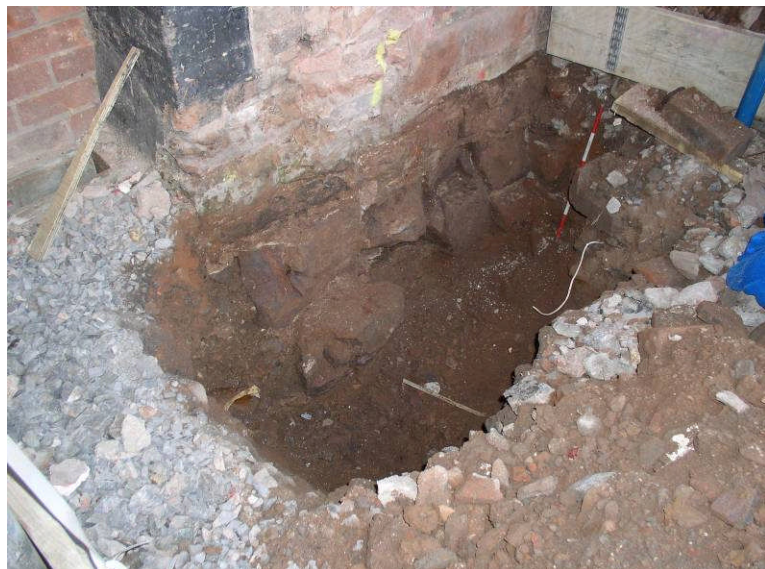
Photo 1: Test pit Z, looking southeast; scale 0.5m

3.3 Pit Z This test pit was excavated against the west (outer) face of the west wall of the Music Hall block. The test pit was cut through heavily disturbed ground (Figure 3a & 3b; 2), but revealed that the brick wall of the Music Hall rested on sandstone footings (1). These footings were of red sandstone blocks bonded in light greyish brown mortar. The outer face had been heavily cut about, but it appeared that the footings may have been earlier than the brickwork above – certainly the mortar was of different type. The footings were built up from the natural sandy silt subsoil (9); no trace of a foundation cut or stratified deposits survived the modern disturbance against the west face of the wall. It is possible that this wall may have been associated with the stairs and porch that formerly stood against the northeast corner of Vaughan's Mansion (see cover illustration).

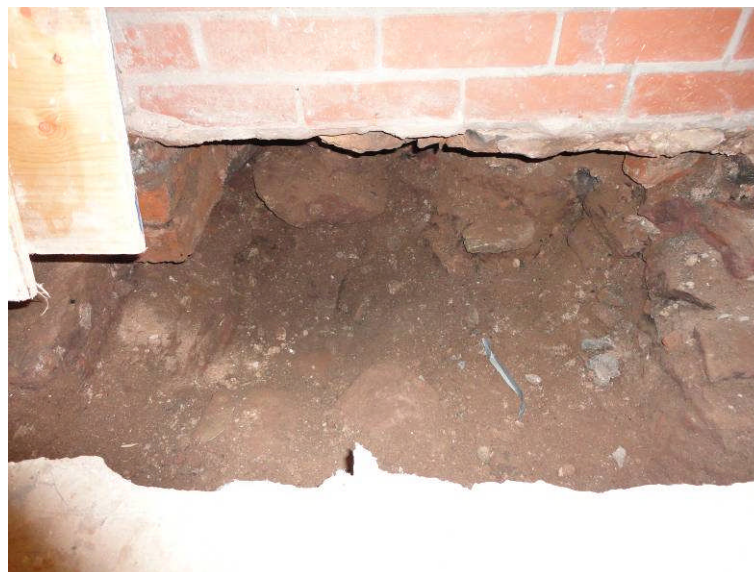
Photo 2: Test pit B, looking north

3.4 Pits A, B, & C Three test pits were dug against an internal east-west wall within the Music Hall block. The brick wall was seen to rest on red sandstone footings (10). At the western end of the wall (in pits A & B) these footings appeared to consist of un-coursed rubble, though the footings had been cut about by later disturbance, including drainage work. At the eastern end of the wall (pit C) the footings were of coursed stonework which stepped out to the south. The existing wall above floor level was of 19th century brick (with some 20th-century infilling); the sandstone footings at the east end certainly appeared to be of earlier construction, and may have been the remains of the north wall of the former east wing of Vaughan's Mansion.

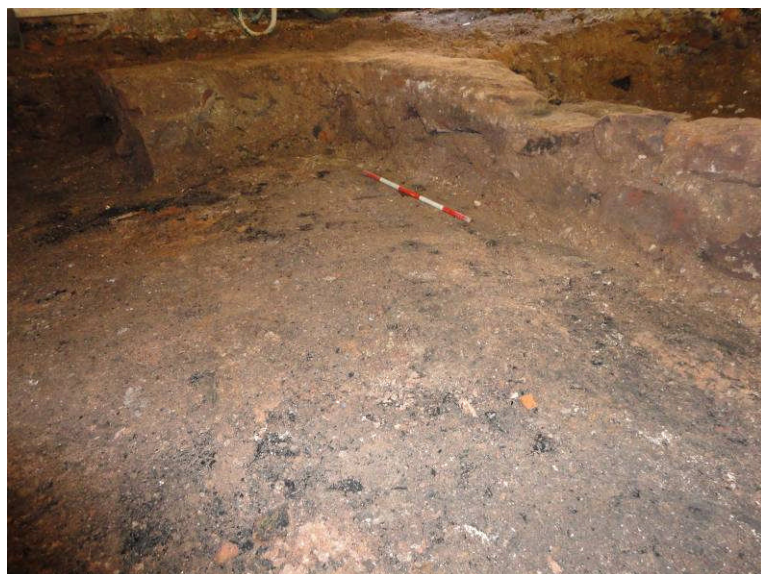
Photo 3: Wall 25 in area M, looking northwest; scale 0.5m

The western side of this area was bounded by the line of a former internal wall which had been removed to floor level. The above ground part of this wall was of 19th century brick - which had mostly been taken down at the time of the watching brief in this area, and continued in modern brick to the south of a former doorway. The foundations however comprised a substantial wall of red sandstone (Figure 5; 27) in a brown mortar. These foundations were bonded with another substantial sandstone foundation wall (25) running on an east-west alignment. This wall was 0.7m wide and up to two courses were exposed by the excavation. Wall 27 probably represented the remains of the foundations of the west wall of the east wing of Vaughan's Mansion. The north edge of wall 25 was set back c. 0.7m from the north face of the north wall of the standing part of Vaughan's Mansion. A stub wall (26) of sandstone projected 0.9m south from the east-west wall (25).

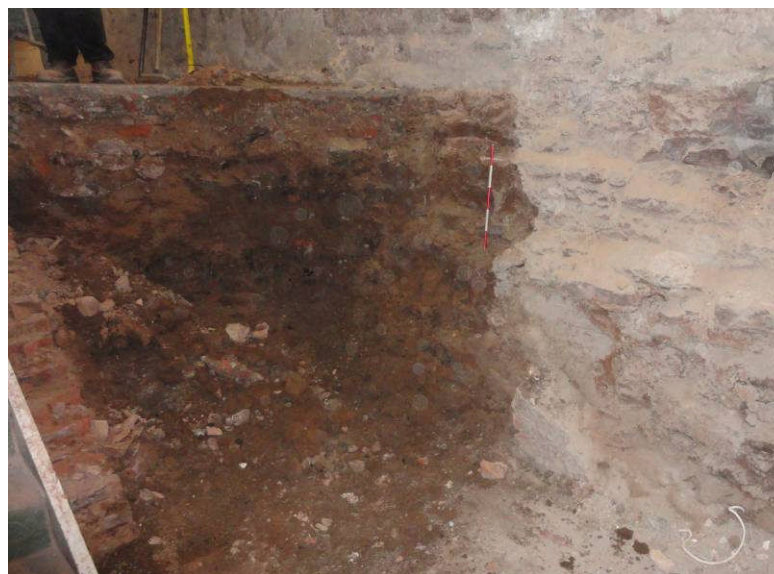
Photo 4: Pit O, looking northwest, showing Vaughan's Mansion south wall foundations; scale 0.5m

3.12 Pit O In September 2011 the storage area on the south side (outside) of the south wall of Vaughan's Mansion was enlarged to create a pit for a lift shaft. The pit was approximately 3.5m wide by 5m long by 1.7m deep. On the south side of the pit, a wall was taken down to reveal the natural reddish brown silty sand (Figure 6; 47) lying immediately beneath the concrete floor (48). A sewer pipe had been cut into the natural here. On the south side of the pit, the lowest deposit revealed in the excavation was a reddish brown sandy silt (46) with rounded gravel, probably the natural subsoil. Above this was a mixed deposit up to 1m thick of compressed dark greyish brown sandy silty loam (45) containing sandstone, brick, and tile fragments and post-medieval (late 17th – 19th century) pottery and glass. This deposit butted against the outer face of the foundations of the south wall of Vaughan's Mansion. It was clearly a disturbed deposit, probably representing excavation here in the 19th century; whatever the reason for this excavation, it had removed any trace of earlier stratigraphy – including evidence for foundation cuts – associated with the wall. This mixed deposit lay beneath a layer of concrete and hardcore (44) and the modern concrete floor (48).
