***A Watching Brief at  
33 Broad Street, Ludlow,  
Shropshire, 2011***

Archaeology Service Report Number 300  
© Shropshire Council  
October 2011

A report for  
PAV Building Restoration

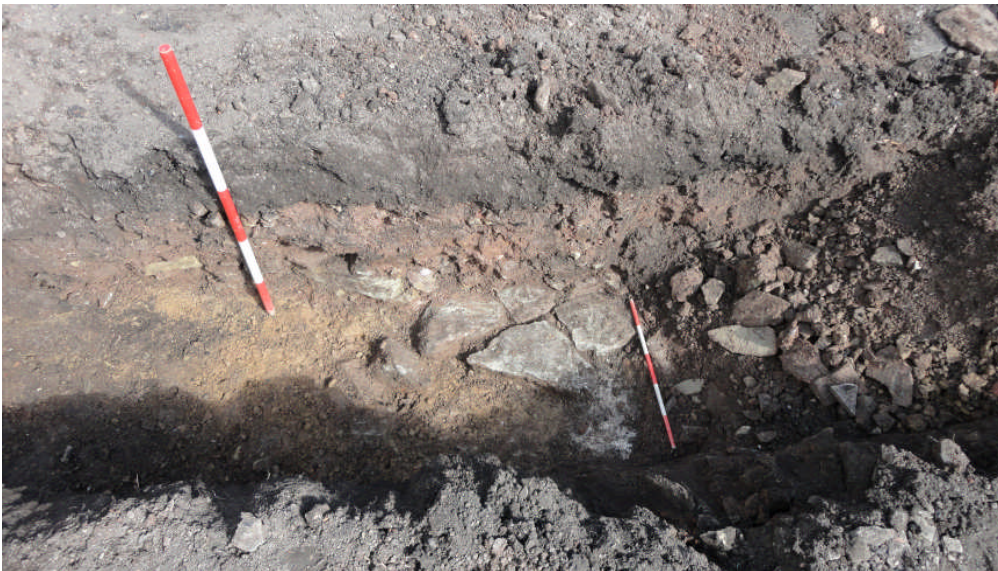
Photo 2: The remains of wall 38, looking northeast

The earliest deposits encountered during the watching brief were associated with the foundation remains of a stone wall running northwest-southeast in the southern part of the development area, i.e. roughly in the middle of the lawn. Only the lowest course of these foundations survived, and they were covered by a mixed yard-type deposit of post-medieval date. Elsewhere, the deposits encountered were of mixed yard soils, containing mainly post-medieval pottery, with a couple of post-medieval rubbish pits visible, one in the south east angle of the foundation trenches, one in the centre of the northern trench.
