*A Watching Brief at
St Michael and All Angels Church,
Woolstaston,
Shropshire, 2011*

Archaeology Service Report Number 304
© Shropshire Council
November 2011

A report for
Central Networks Infrastructure Services,
E.ON UK plc

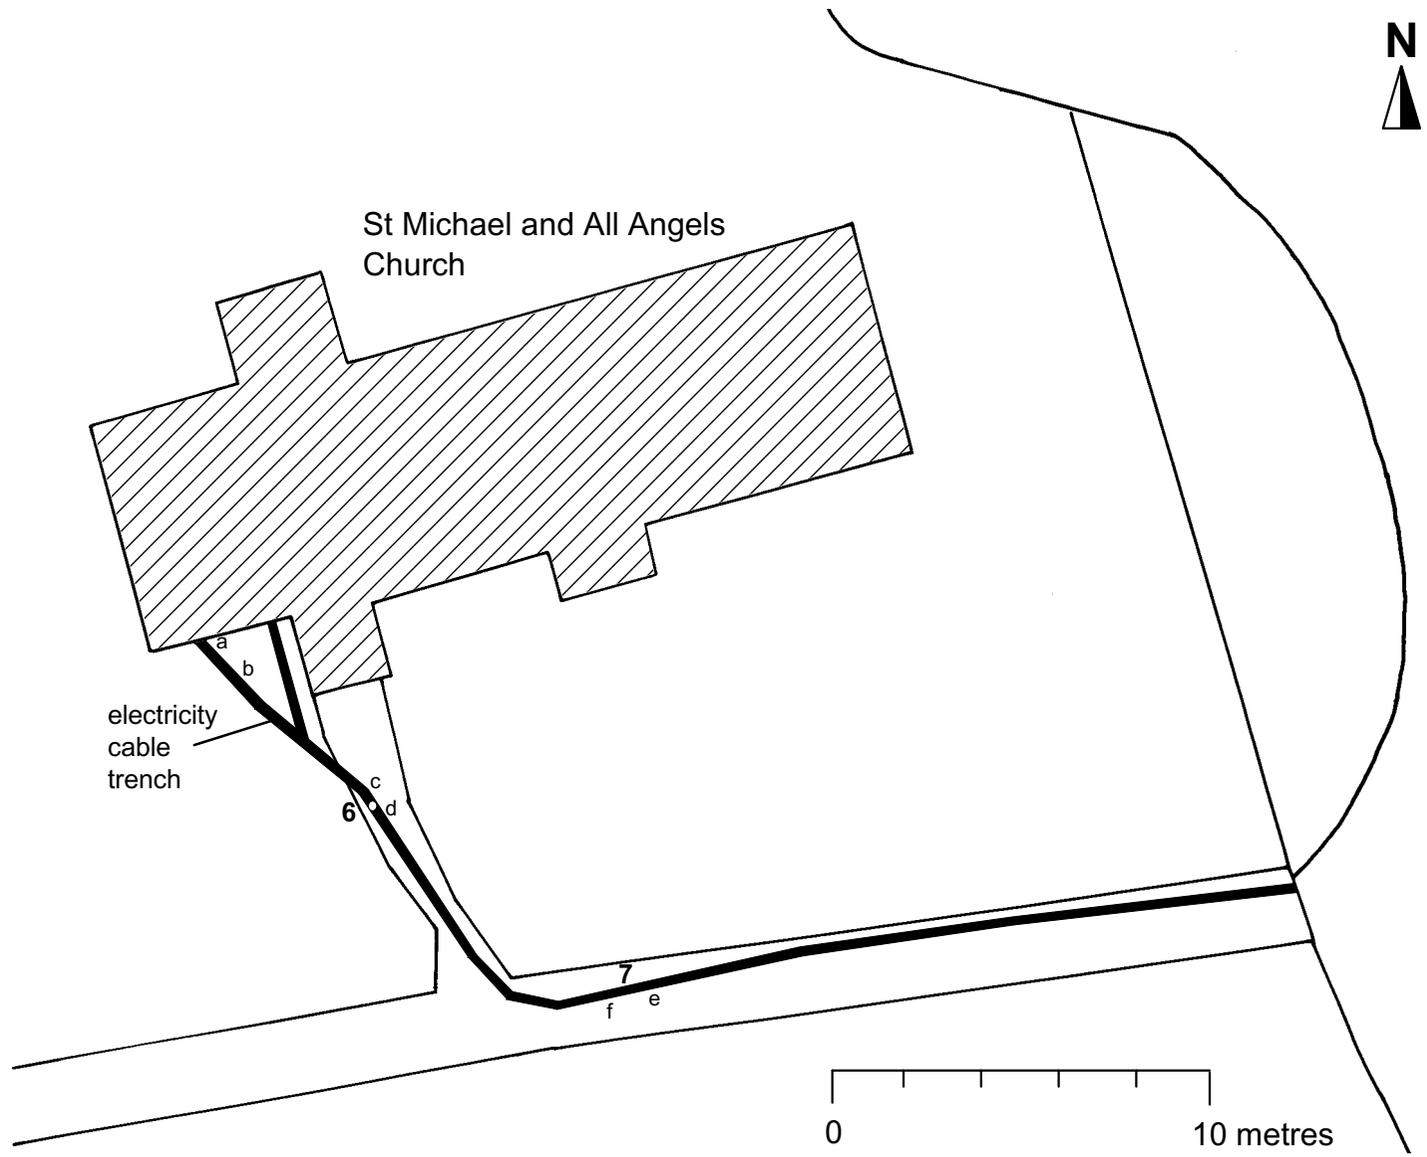
Figure 2: The study area, showing the location of the electricity cable trench; 1:200 scale

2.1 The foundation trenches for the current development were excavated by hand under archaeological supervision. The trenches were excavated to a depth of 0.6m and a width of 0.25m. The trench was excavated from the west side of the porch along the line of the path through the churchyard to the gateway at its southeast corner (Figure 2).

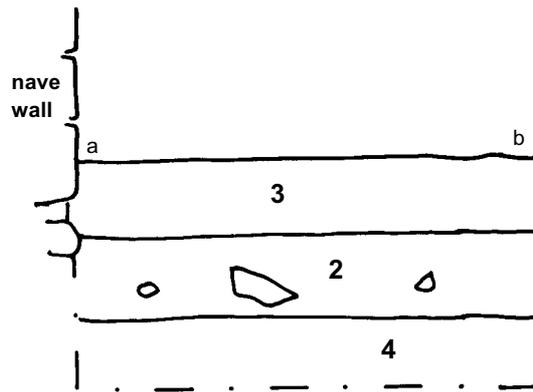
Figure 3: The cable trench; a) southwest-facing section at the north end of the trench; b) west facing section showing grave-cut 6; c) north-facing section showing surface 7; (for locations see Fig.2, a-b, c-d, & e-f); 1:20 scale

2.2 The natural subsoil consisted of an orange-brown to light brown silty sand (Figure 3; 4). The top of the natural sand lay at a depth of 0.4m below the existing ground surface. About 3m south of the porch a feature (Figures 2 & 3a; 6) was seen cut into the natural sand. The fill (5) was cleaned slightly to reveal the top of a skull. As the skull lay beneath the required finished level for the cable duct, it was re-covered and left *in situ*. The grave cut and natural were sealed beneath a deposit up to 0.3m thick of a light greyish brown sandy loam (2) with gravel and pebbles. A few single fragments of disarticulated human bone were recovered from this deposit. These were bagged and reburied within the natural sand below the level of the new cable duct. The loam (2) lay beneath the existing gravel churchyard path (1) and the topsoil (3) on the southwest side of the porch.

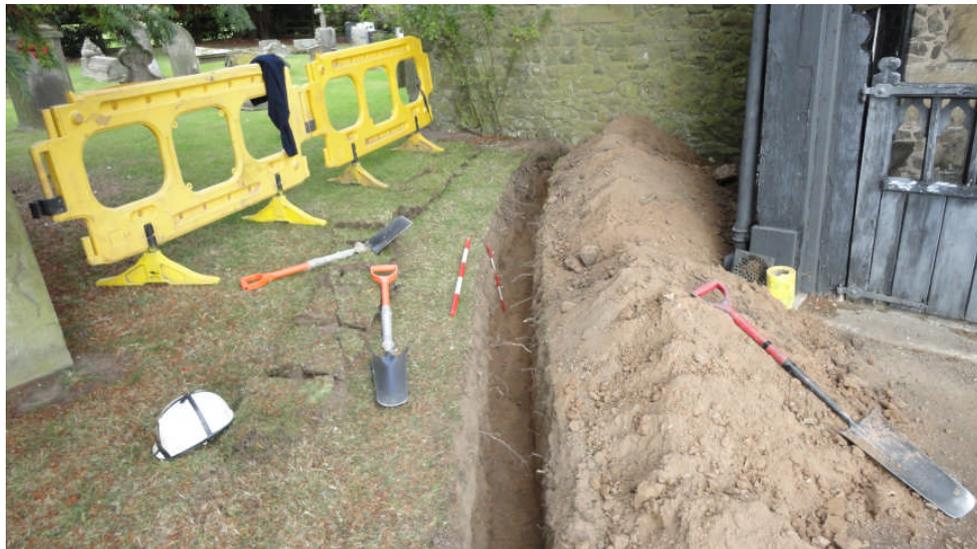
Photo 2: The cable trench, looking northwest (scale bars 1m & 0.5m)

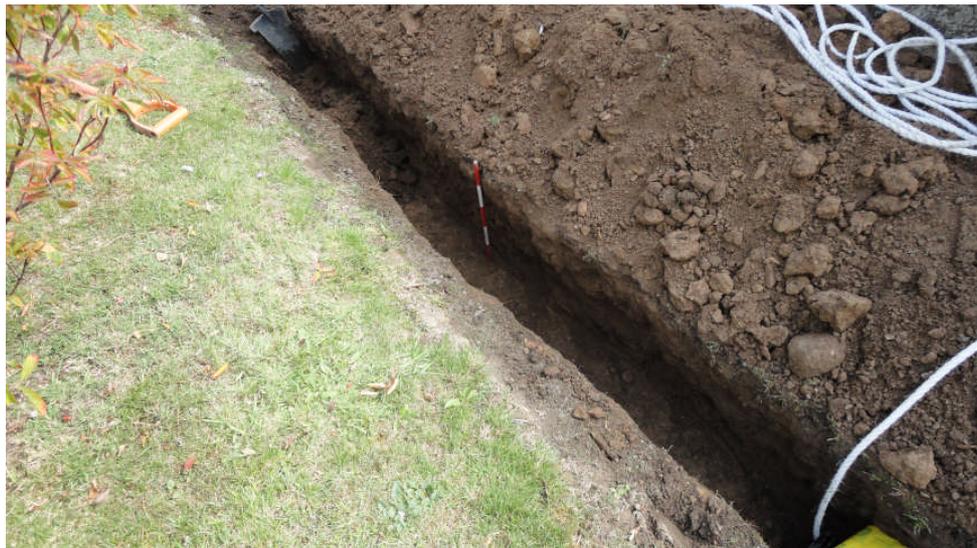
Photo 3: The eastern end of the cable trench looking southeast (scale bar 0.5m)

2.4 At the southeastern corner of the churchyard, the light brown natural sand (4) gave way to a natural yellowish brown sandy clay silt (8) and then a dark brown sandy silt with gravel (9).
