Archaeology Service Report Number 306
© Shropshire Council
November 2011

**AN ARCHAEOLOGICAL EVALUATION AT
98 CARTWAY, BRIDGNORTH, SHROPSHIRE, 2011**

B.J.M.M. DEVELOPMENTS LTD

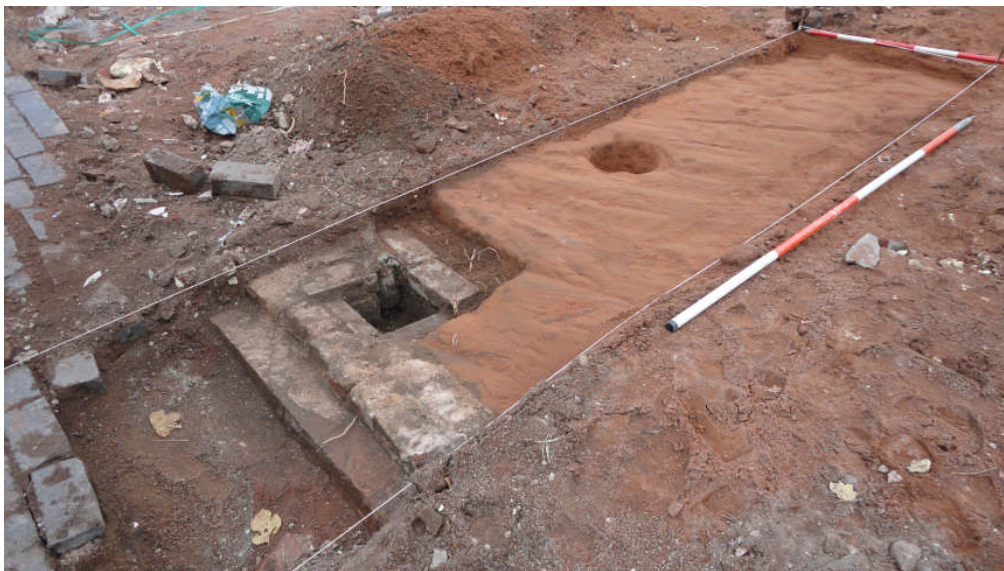
Photo 2: The evaluation trench, looking northwest

4.1 A single trench 5m long by 1m wide was excavated by hand at right angles back from the street frontage (Figure 2). The exposed features and deposits were cleaned by hand and recorded. A thin layer of demolition deposit (Figure 3; 1) just 0.05 to 0.1m thick made up of rubble mixed with natural red sand covered the entire trench. Beneath this, on the street frontage the brick wall (4) of the frontage of the former building on the site was seen at the south end of the trench. The wall incorporated an internal drain (3). The wall and drain had been cut directly into the natural sandstone bedrock (7), which also lay immediately beneath the demolition debris (1). A single posthole (11) was cut into the bedrock in the central part of the trench. The posthole was sectioned and revealed the fill (9) of a post-pipe (the deposit created when the post was removed from the hole) which consisted of dark grey sandy loam with mortar flecks and brick fragments. The primary fill (10) around the post-pipe comprised red sand with two in-situ pebbles for packing the post. There were no finds from the post-hole to assist with dating the feature. No other archaeological features or deposits were encountered in the evaluation trench.

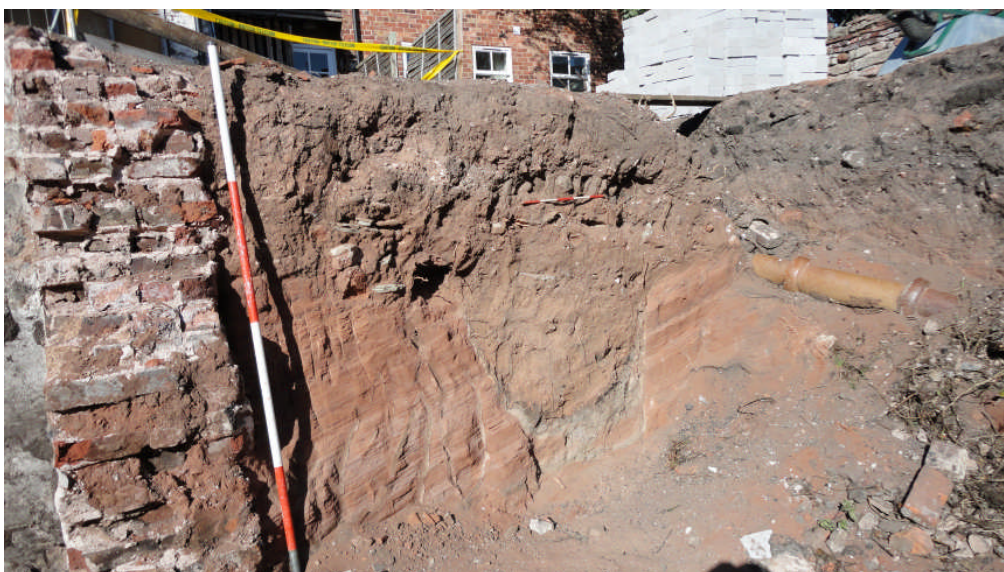
Photo 3: The cess pit (34) and other features in the northeast corner, looking northeast

4.4.2 The earliest feature revealed was a pit (Figure 4; 34) 1.1m wide by 0.8m deep that had been cut into the natural bedrock (7). The pit was filled with a series of yellowish-grey sandy silt lenses (27, 28, 29, 31, & 33) likely to have been cess deposits interleaved with deposits of red sand (30 & 32). The lower deposit (33) ran in a thin line vertically down the east side of the pit, suggesting that the contents of the pit had been almost completely emptied at least once. The upper fill of the pit (26) comprised a greyish brown sandy loam. No finds were visible in these deposits.

5.2 However, demolition work had exposed a thin section of deposits in the northeast corner of the site, including a medieval cess-pit (34), the remains of the foundation courses of a medieval wall (24), and a post-medieval cobble path (21). Only a thin slice of these deposits had survived later 19th- and 20th-century building and drainage work.
