*Archaeological Recording at
**Sunderton Pool, Sundorne,
Shrewsbury***

Archaeology Service Report Number 314
© Shropshire Council
April 2012

1.2 In February 2012 the Environment Agency undertook work to modify a failing weir structure at Sunderton Pool (NGR SJ 5265 1606). The works involved the lowering of the crest of the existing weir.

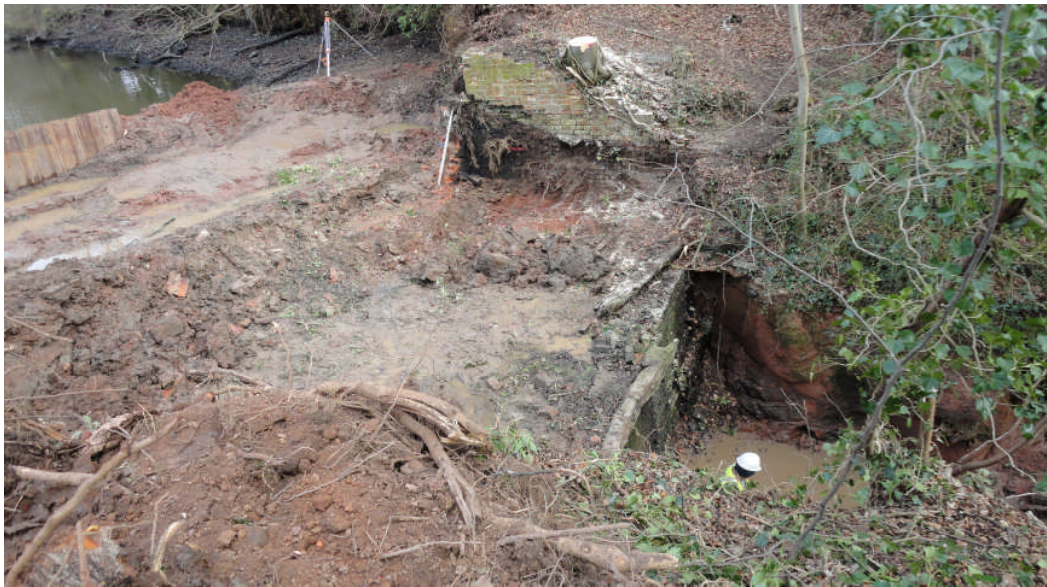
Photo 5: The weir and spillway during work to reduce the crest of the weir, looking NE

3.1 A photographic record was made of the existing weir structure prior to the commencement of the modification work. The removal of the crest of the weir was monitored and recorded.
