Offa's Dyke Path 2011

***A Watching Brief on the Installation of New Path Furniture
at Churchtown, Edenhope Hill, and Selley Hall***

Archaeology Service Report Number 315
© Shropshire Council
May 2012

A report for
Countryside Recreation Team, Outdoor Recreation,
Shropshire Council

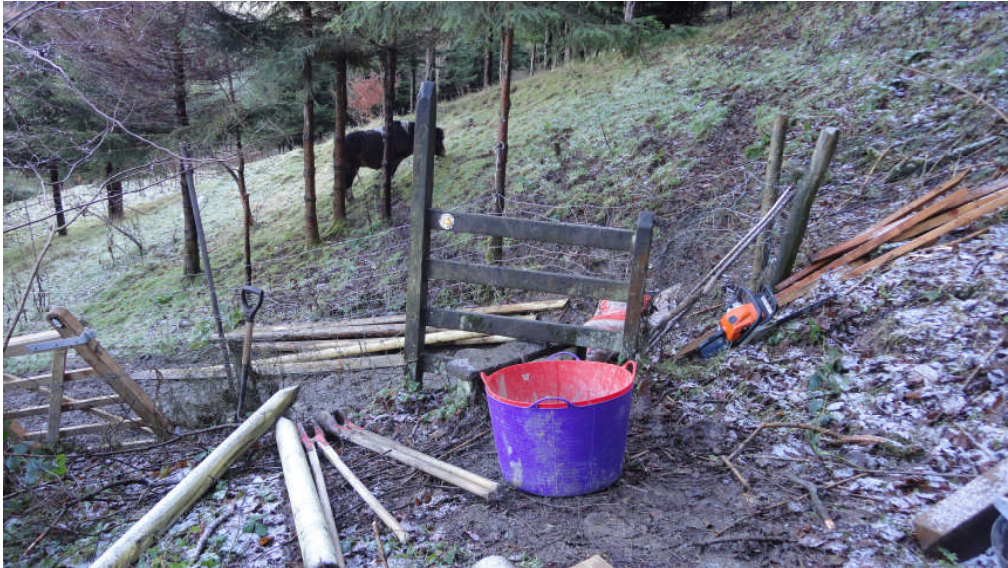
Photo 1: Location of the old stile at Churchtown, looking NE

The site at Churchtown lay on a steep hillside overlooking Churchtown and a tributary stream of the River Unk to the north. The footpath work here involved the replacement of a stile with an oak wicket gate. Although the gate was situated on the line of the bank element of the dyke, no above-ground remains survived in the immediate location; the bank emerges as an earthwork c. 10m south of the gate.

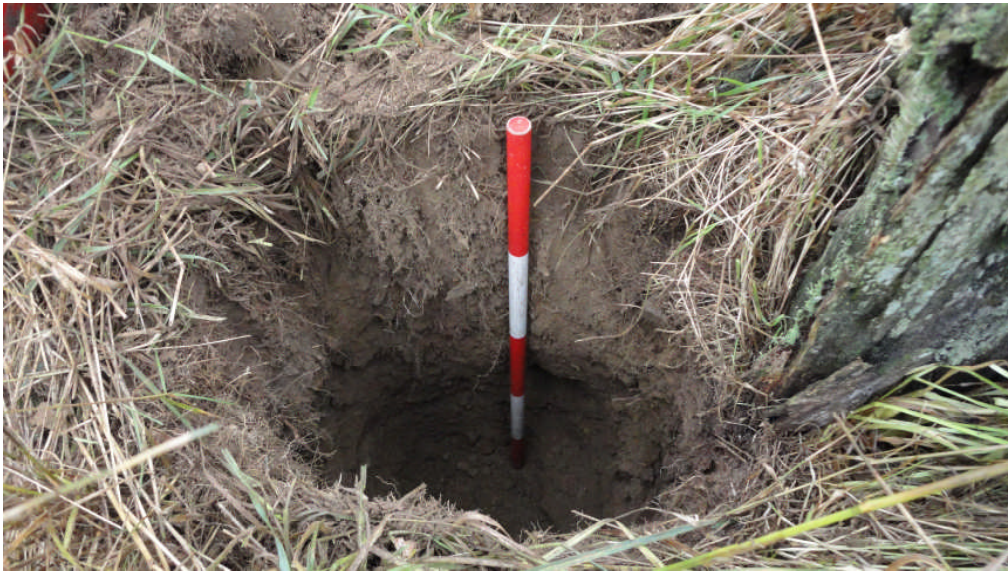
Photo 2: One of the deeper postholes at Edenhope Hill B, looking N (scale 1m)

Six postholes for the new gate were excavated by hand; two postholes 1.00m deep by 0.4m x 0.3m in plan, for the corner and strainer posts and four postholes 0.7m deep by 0.3m in diameter for the remaining posts. In the deeper postholes, the lowest deposit, seen at c. 0.95m depth, was a light brown silty sand (28) with stone chippings. Above this was a layer 0.4m thick of brown sandy loam (27) with stone chippings and a similar layer with fewer chippings (26) about 0.35m thick. These deposits may have represented fills of the Dyke ditch but were not considered to have significant environmental potential. The latter deposit (26) was absent in the post holes in the centre of the gate, along the centre-line of the ditch, where there was instead a deposit 0.1m thick of a thin deposit of dark grey-brown very humic loam (29). This deposit had more potential for holding environmental information, however, its insubstantial nature, its late position in the stratigraphic sequence, and its proximity to the ground surface decided against sampling it for analysis. The uppermost deposit in all the postholes was a topsoil 0.15m thick of dark brown humic loam (25).

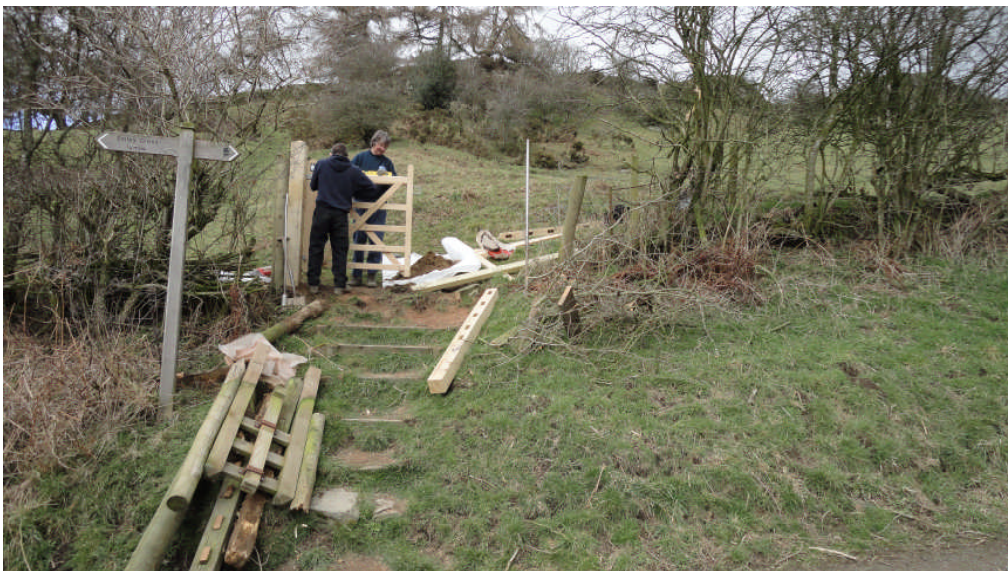
Photo 3: The location of the new gate at Selley Hall A, looking N

The work here comprised the removal of an old stile and dog gate and its replacement with a new kissing gate. New raised stone filled steps were to be built up in front of the gate and a stone-filled stepway made down the bank to the stream. The gate was situated on a hedgeline on the hillside above the north edge of the lane to Selley Hall. No archaeological provision was required for the installation of the steps and stepway.

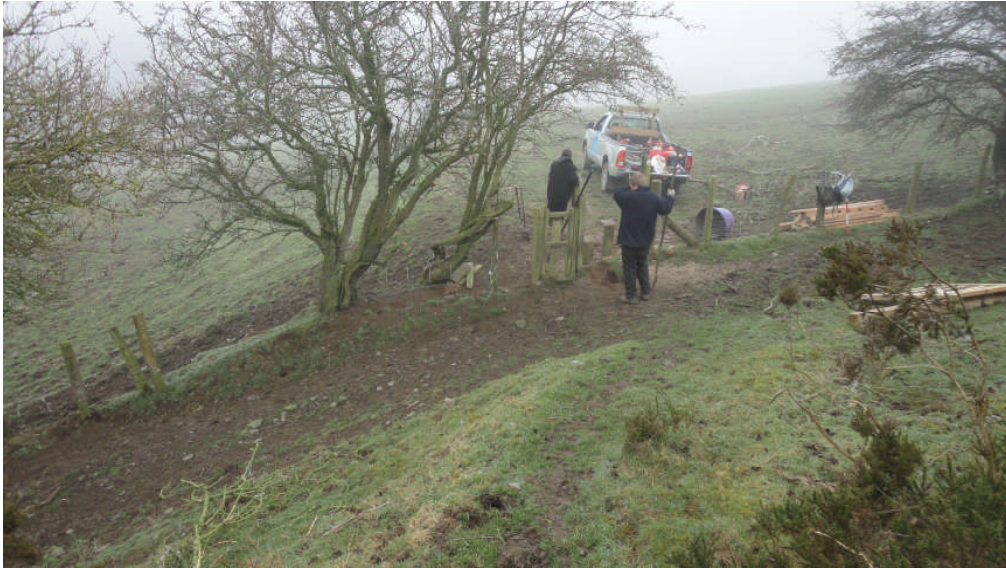
Photo 4: The location of the old stile at Selley Hall B

The work here comprised the removal of an old stile and dog gate and its replacement with a new kissing gate. The gate here was situated on the line of the bank component of the dyke, although this was apparent only as a level berm on the hillside, with a substantial ditch up to 8m wide on the west (downslope) side.

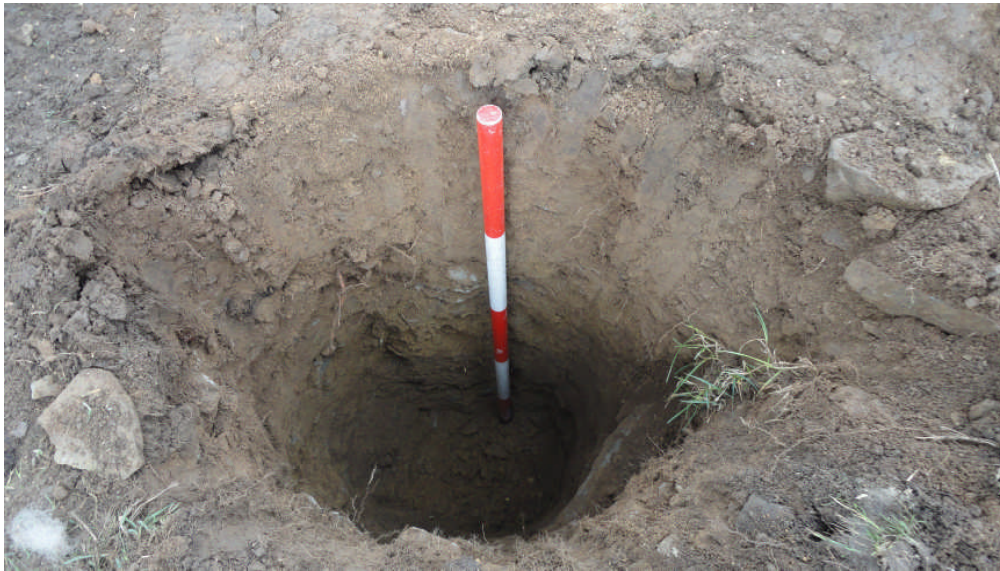
Photo 5: One of the postholes at Selley Hall B, looking N (scale 1m)

Six postholes were excavated by hand; two postholes 0.90m & 1.00m deep by 0.4m x 0.3m in plan, for the corner and strainer posts, and four postholes between 0.70 and 0.9m deep by 0.3m in diameter for the remaining posts. The lowest deposit encountered was a light brown sandy silty clay (44) with small stone fragments, possibly the natural subsoil, seen at a depth of between 0.4m and 0.7m below the ground surface. In the northern three postholes this lay beneath a deposit of brown sandy loam (43) up to 0.3m thick with many stone fragments, and a similar almost stone-free deposit (42) up to 0.35m thick, both almost certainly part of the fabric of the bank. In the southern three post-holes, the subsoil lay below a deposit 0.3m to 0.55m thick of stone fragments in a light brown silty loam (42), again probably part of the composition of the bank. These all lay beneath a thin topsoil layer (41) between 0.5 and 0.15m thick.

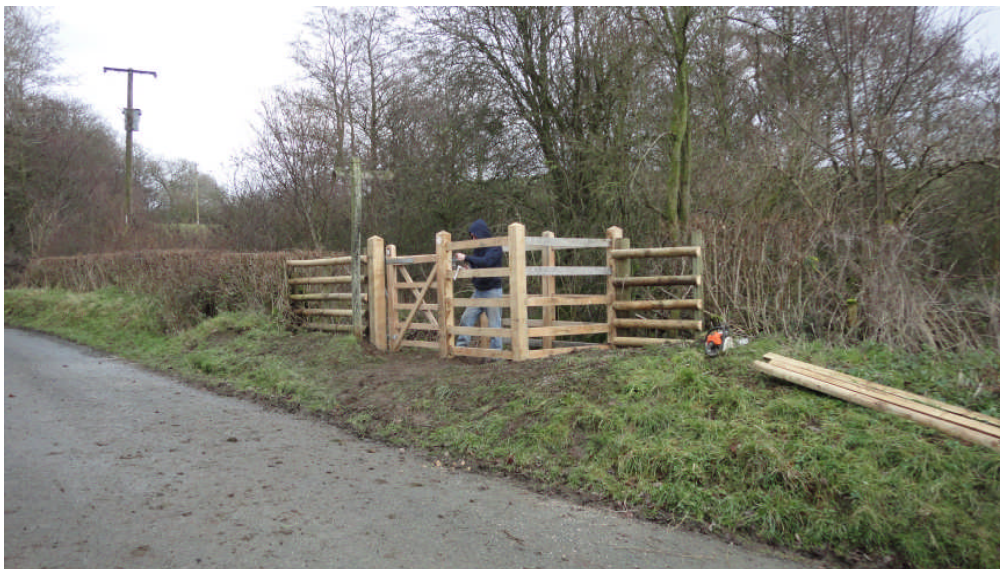
Photo 6: The new gate at Selley Hall D, looking NE

The work here comprised the removal of an old stile and dog gate and its replacement with a new kissing gate, situated on a hedgebank on the east side of the road opposite Garbett Hall. The new gate was sited on the line of the bank, although this did not survive as an earthwork feature in the location of the gate. The six postholes for the new gate were excavated by hand; two postholes 1.00m deep by 0.4m x 0.3m in plan, for the corner and strainer posts, and four postholes between 0.70 and 1.0m deep by 0.3m in diameter for the remaining posts. The grey clay or siltstone bedrock (37) was seen in the base of the deeper holes for the cornerposts. This lay below a deposit 0.2m thick of broken greyish brown clay 0.2m thick (36) and a dark brown silty loam (35) 0.25m thick, and a topsoil layer of dark greyish brown loam (34) up to 0.55m thick.
