# A Watching Brief at The Old Vicarage, Baschurch, Shropshire, 2012

A Report for

**Select Healthcare Developments Ltd**

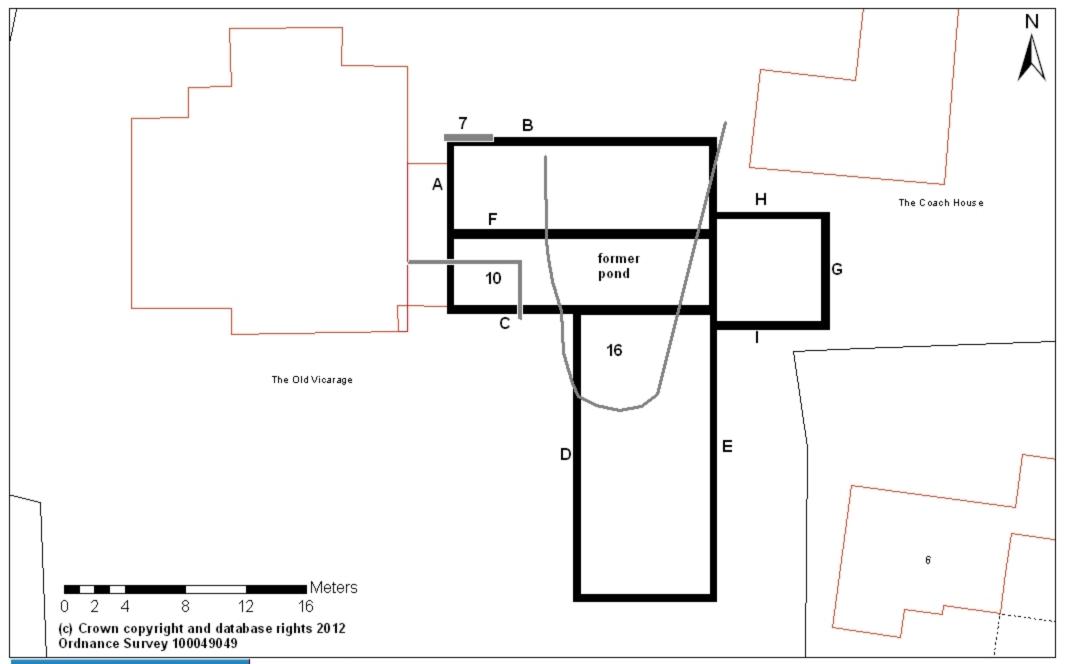
Figure 2: The location of features noted in the text

- **3.3** The natural clay deposits were cut by the former pond (Fig.2; 16). The southern edge of the pond was seen in the two southern trenches (Fig. 2, D & E) and its western edge in the foundation trenches running west-east (trenches C & F). At its centre (in trenches C & F) the bottom of the pond was seen to lie 3.7m below the ground surface. The pond was also seen in the northeastern corner of the development site (in the junction of trenches B & E), and here the pond deposits were seen to extend to a depth of 3.25m below ground level. The western edge of the pond had clearly been cut, indicating that even if the pond was of natural origin, it had at some time in the past been managed. The pond had completely silted up and was filled with an organic peaty deposit (12).

- **3.5** In the western part of the site, the remains of the cellarage (Fig. 2; 10) beneath the demolished eastern extension of The Old Vicarage were exposed in the foundation trenches. The cellar had been filled with loose brick demolition rubble.

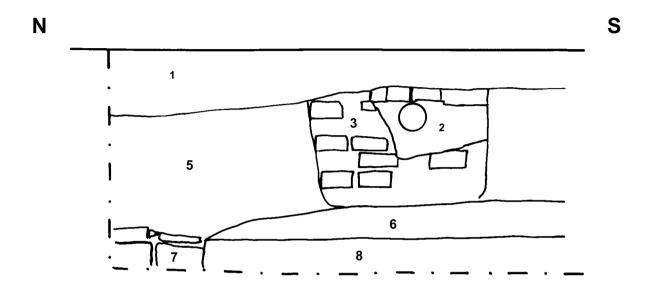
Figure 3: West-facing section at the NW corner of the development site; 1:20 scale

- **3.2** The natural grey clay (Fig. 3; 8) was seen in the western part of the study area at a depth of 0.8m below the ground surface. Here it lay beneath a deposit 0.2m thick of a sticky, buff clay (6), probably a weathered surface to the natural clay. In the eastern part of the development site, the natural comprised a light yellowish brown sandy clay (25) and lay at 1.2m below the ground surface. The natural was similar in the southern part of the site (20) and here lay at a depth of 0.6m below the ground surface.

- **3.4** In the northwest corner of the development, a wall (Figs. 2 & 3; 7) was seen cut into the natural clay (8). The wall was seen to run west to east and was made of mainly red sandstone fragments (some of which were faced and with toolmarks), with some buff Grinshill sandstone, and some brick, indicating a probable 18<sup>th</sup>-century date for this feature. The wall pre-dated the current Old Vicarage building.

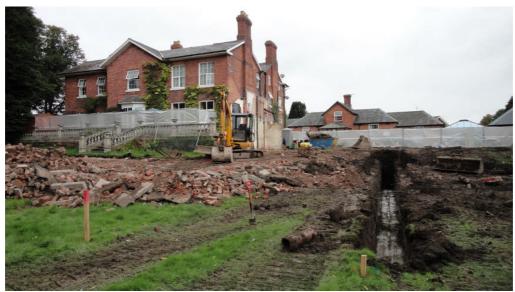
Photo 1: The development site, looking N

- **3.1** An archaeological watching brief was carried out on the excavation of the foundation trenches for the new development in October 2012. The foundation trenches were excavated to a width of c. 0.6m. The depth varied according to the depth of the natural clay subsoil. The northern half of the site was roughly level, but then dropped away to the south, following the line of a terrace on the south side of The Old Vicarage building.
