**A WATCHING BRIEF AT CHURCH FARM,  
STANTON LACY, SHROPSHIRE 2013**

A report for  
**EARL OF PLYMOUTH ESTATES (HOLDINGS) LTD**

**Archaeology Service Report Number 343**  
**© Shropshire Council**  
**September 2013**

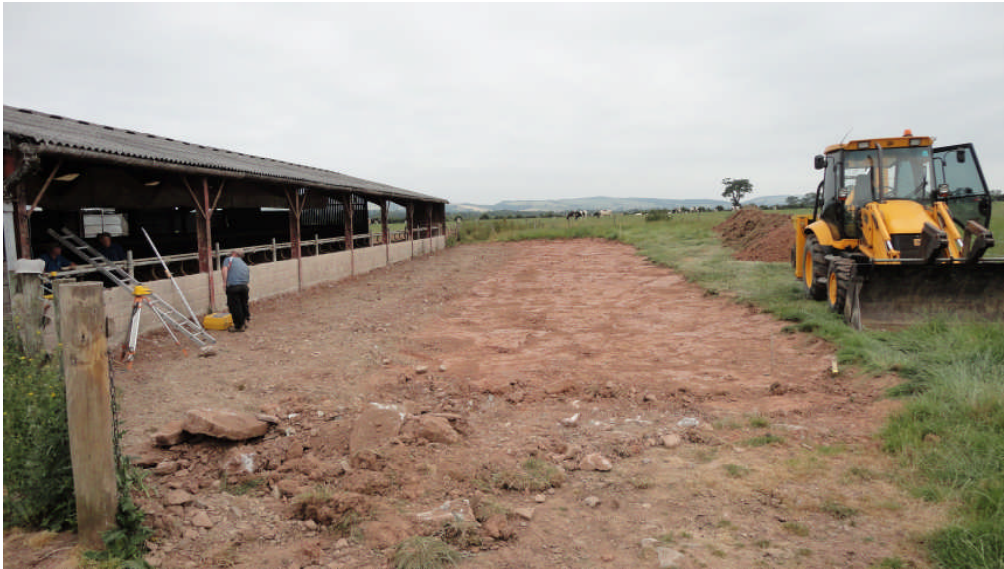
Photo 1: The development site, looking N

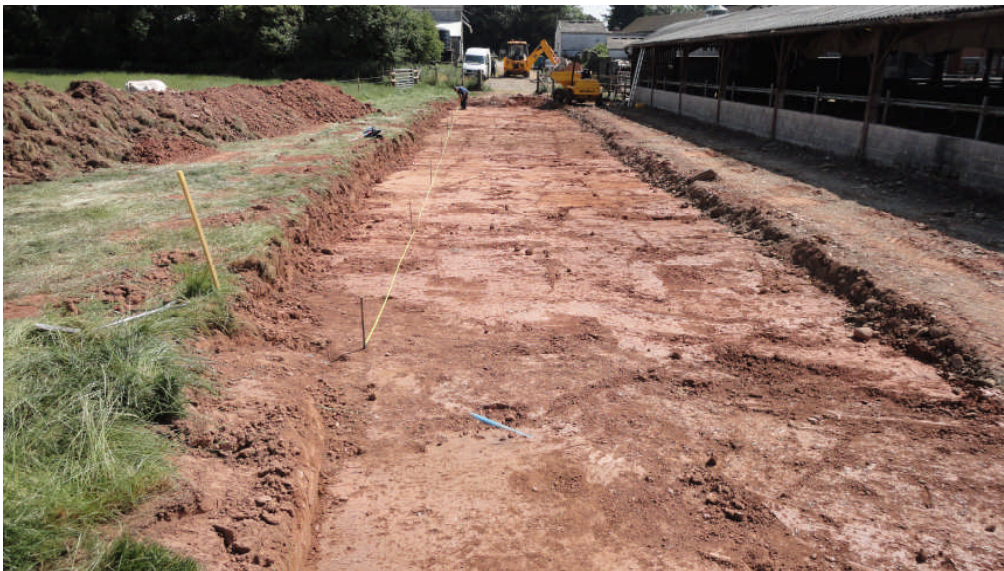
**2.1** The excavations for the extension to the agricultural building were carried out on the 16<sup>th</sup> July 2013. The excavation was carried out with a JCB excavator under archaeological supervision. The turf and topsoil (Figure 4; 1) were removed from an area 10m wide by 36m long to a depth of up to 0.1m along the east side of the existing barn (Figure 3). The area was then reduced by a further 0.4m depth. These removed deposits comprised a subsoil of dark reddish brown clay loam (4) 0.2m thick over a dark reddish brown compact sandy clay (5) 0.2m thick. Along the western edge of the area was a band of modern stone chippings (Figure 3; 2) laid down when the existing barn was erected. Elsewhere these deposits rested on a compact reddish brown clay glacial natural (8). A water pipe ran at a depth of 0.5m below the ground surface in a cut 0.15m wide (9) across the northern end of the area.

Photo 2: The site stripped of topsoil and overburden, looking S

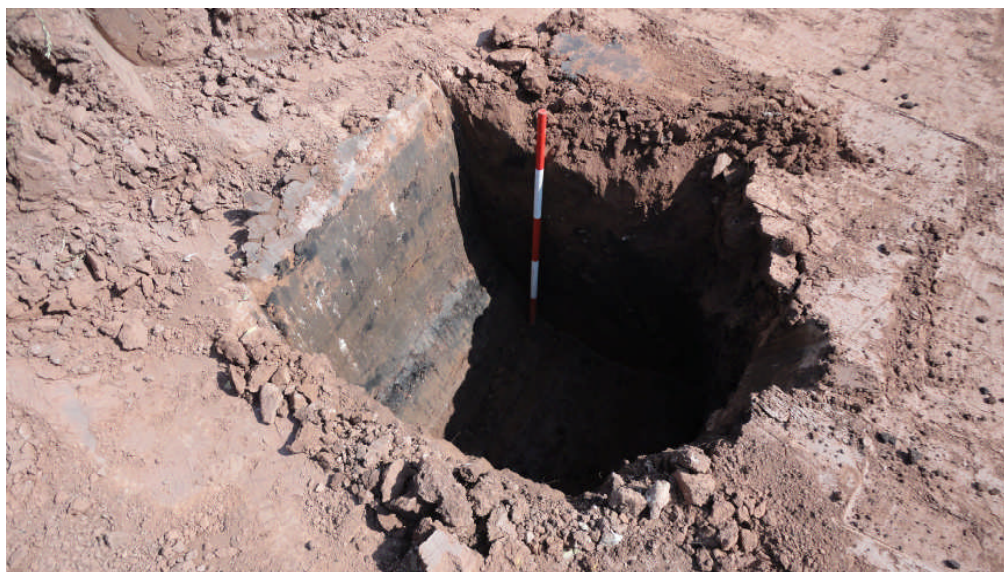
Photo 3: Foundation pit 6, looking SE, scale bar 1m
