Shrewsbury Town Walls

A Conservation Management Plan

Historic England

SHREWSBURY TOWN WALLS CONSERVATION MANAGEMENT PLAN: GAZETTEER

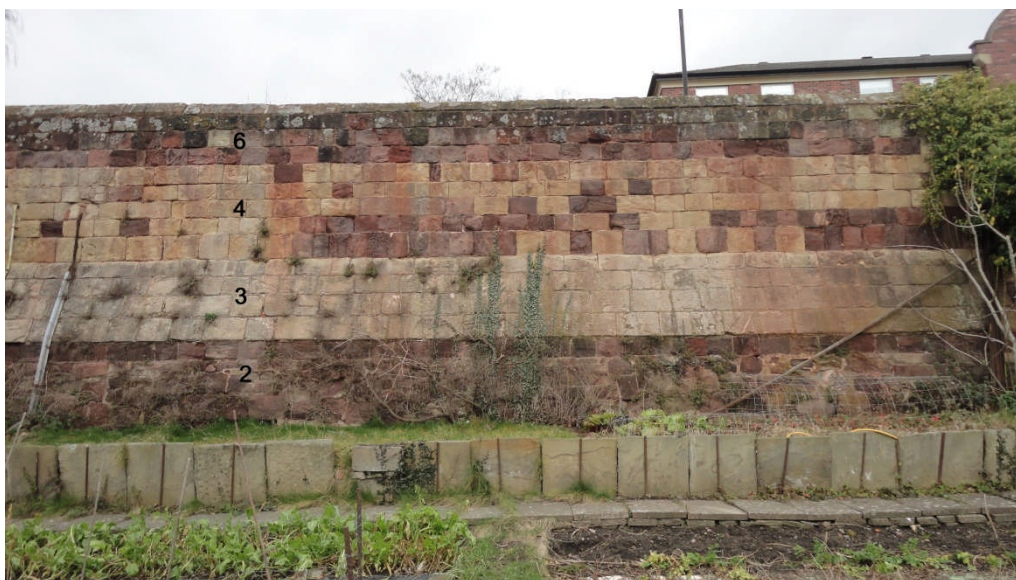
Photo 1: The wall (Gaz. Ref. 11 c) along Town Walls, showing phases 2, 3, 4 & 6

2.6.4 Phase 4 Late medieval and post medieval reinforcement Above this course of battered Grinshill masonry are five courses of mixed red and buff Grinshill sandstone masonry (Photo 1; 4). In places this stonework is banded elsewhere it is mixed with an almost chequerboard effect. Where the battered Grinshill courses are absent, there are sections of mixed though predominantly red sandstone masonry reaching down from this level to the base of the wall.

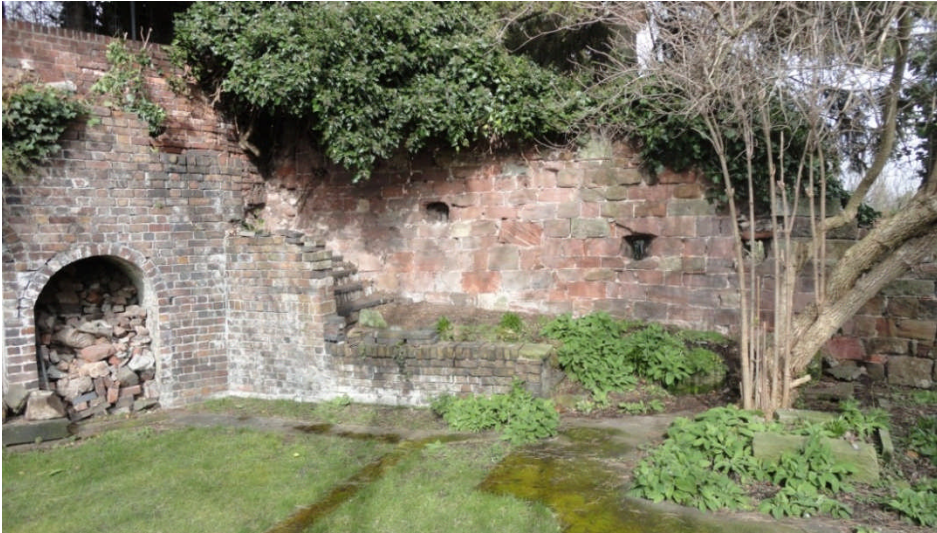
2.6.5 Phase 5 Civil War The documented Civil War repairs to the town have not been identified either within the standing sections of wall or archaeologically. However, the Roushill Wall (Gaz. Ref. 2 d), built following the capture of Shrewsbury by Parliamentary forces in 1645, was identified in salvage recording in 1989 (Gaz. Ref. 2 f) and was seen to comprise red sandstone bonded in lime mortar. The wall was 1.65m wide and its outer face was of well-dressed uniform blocks, with a rubble core of mainly red sandstone (Brown & Watson, 1989). At the top of Wyle Cop, three possible musket loopholes (Photo 2) which may date to the Civil War period are cut through the town wall (Gaz. Ref. 13 d); these would have given enfilading fire along the outer face of the wall behind Dogpole.

Photo 2: Possible musket loopholes in the wall at the top of Wyle Cop (Gaz. Ref. 13 d), seen from the inner side of the wall.

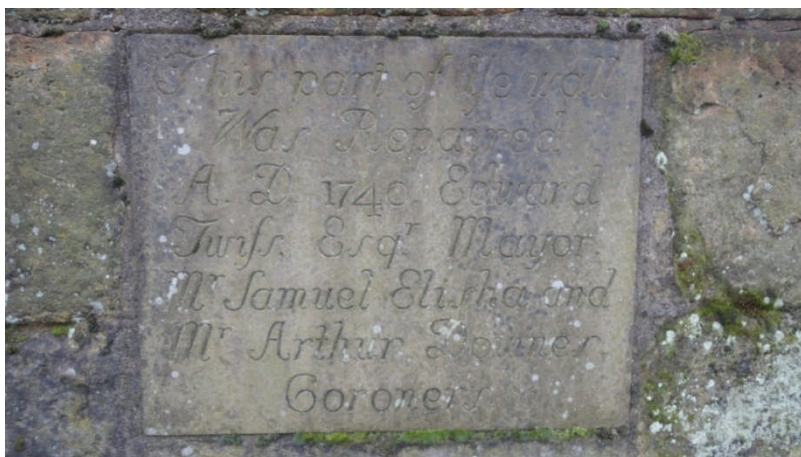
2.2.5 Post-medieval defences In 1715 the town gates were renewed and strengthened following the Jacobite Rebellion, while later in 1740 a section of the wall east of 21a Town Walls (Gaz. Ref. 11) was repaired by the Corporation. This may mark the last episode of rebuilding and major repairs. Although the Corporation also ordered the repair of the wall between Swan Hill and St John's Hill (Murivance, Gaz. Ref. 9) in 1745 (possibly as a reaction to the second Jacobite Rebellion), it is debatable whether this was actually done as Quarry Gate (at the end of St John's Hill) had been demolished by 1746, and St Chad's Terrace which overlies the town ditch to the northwest of this section is of mid-18th century date and the road outside the terrace would appear to have been extended over the line of the town wall here at about this time.

Photo 3: The stone in the parapet on Town Walls road, recording repairs in 1740: "This part of the wall Was Repaired A. D. 1740. Edward Twiss, Esq. Mayor, M Samuel Elisha and M Arthur Downer, Coroners"

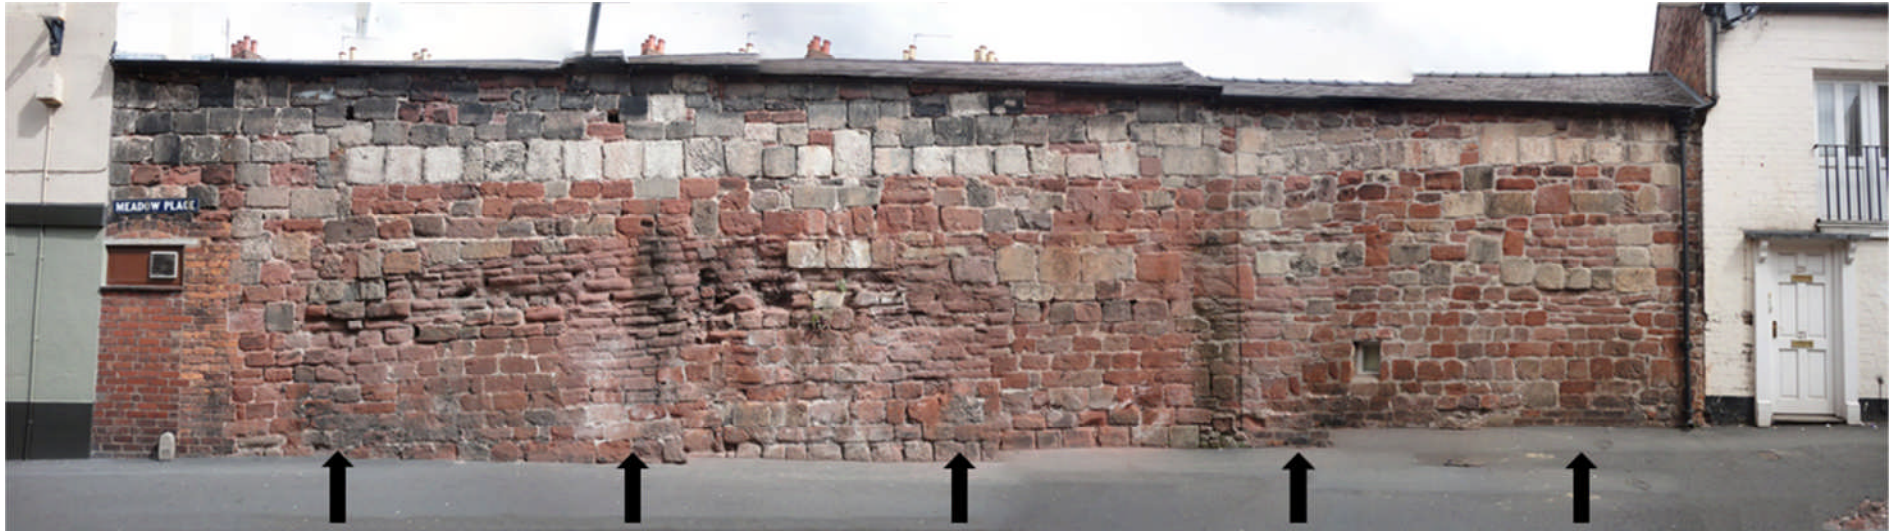
The section of the town wall (1 e) at the bottom end of Meadow Place adjacent to The Albert PH. Amongst the patching and rebuilding, there are traces of possible crenellations (marked by arrows). The upper courses of the wall are a late 18th to 19th century addition when the wall was incorporated into outbuildings.

- It is proposed that the work collated as part of the CMP is used to support the case for designation to the town wall at Meadow Place (Gaz. Ref. 1 e). It is recommended that this section be designated in order to provide protection to the historic defences on the northern side of the town.

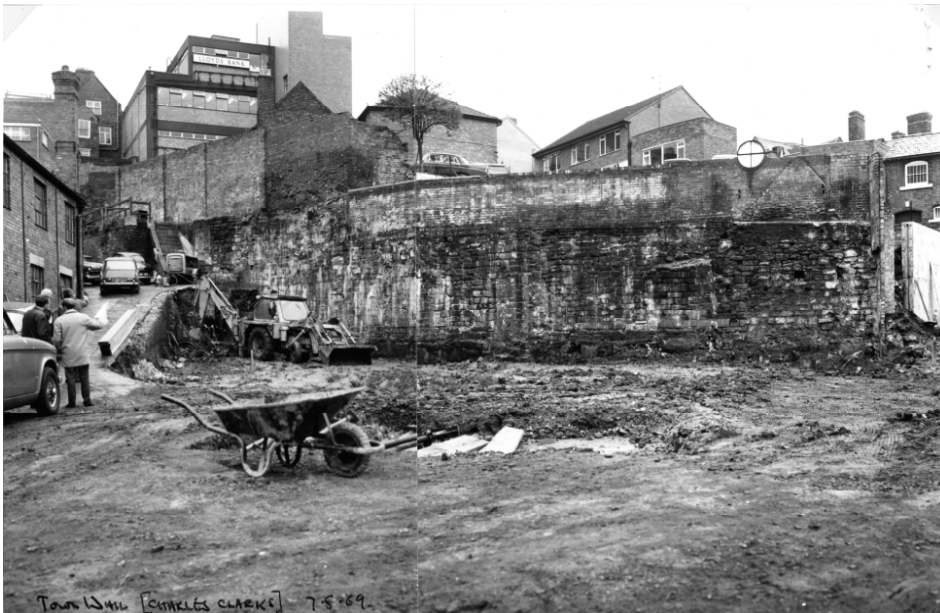
The town wall on the Charles Clarke garage site (4 d) in 1969, looking southwest towards the rear of the properties at the bottom end of Pride Hill.

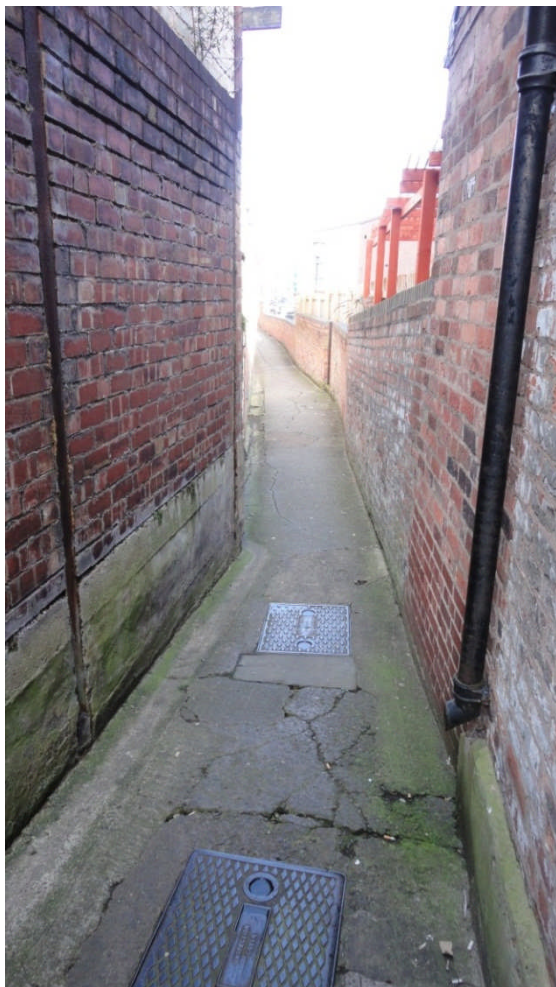
King's Head Passage, on the east side of Mardol, looking northeast. A dip in the ground surface in the middle distance may mark the line of the underlying town ditch (5 g), and is prone to flooding in wet weather.

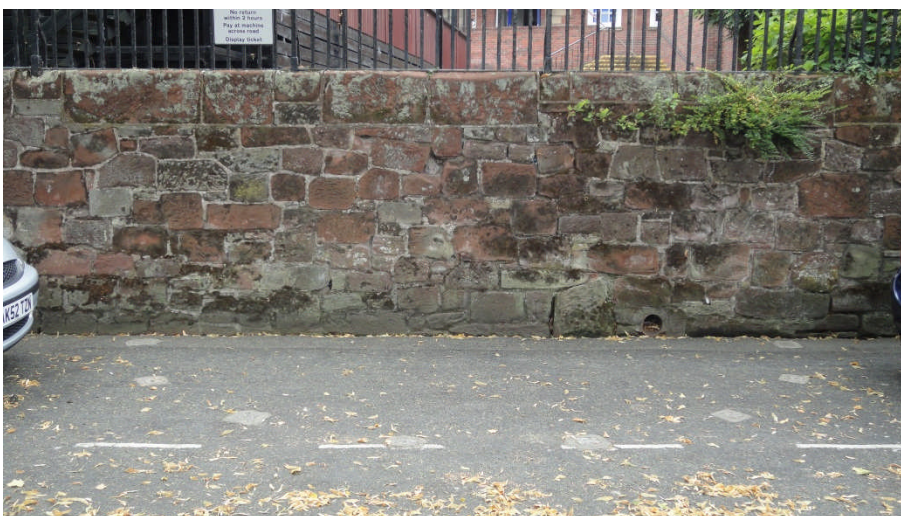
The standing wall on Victoria Avenue (7 a), and the site of the tower (7 b) at the west end of the New Work, marked in stone setts.

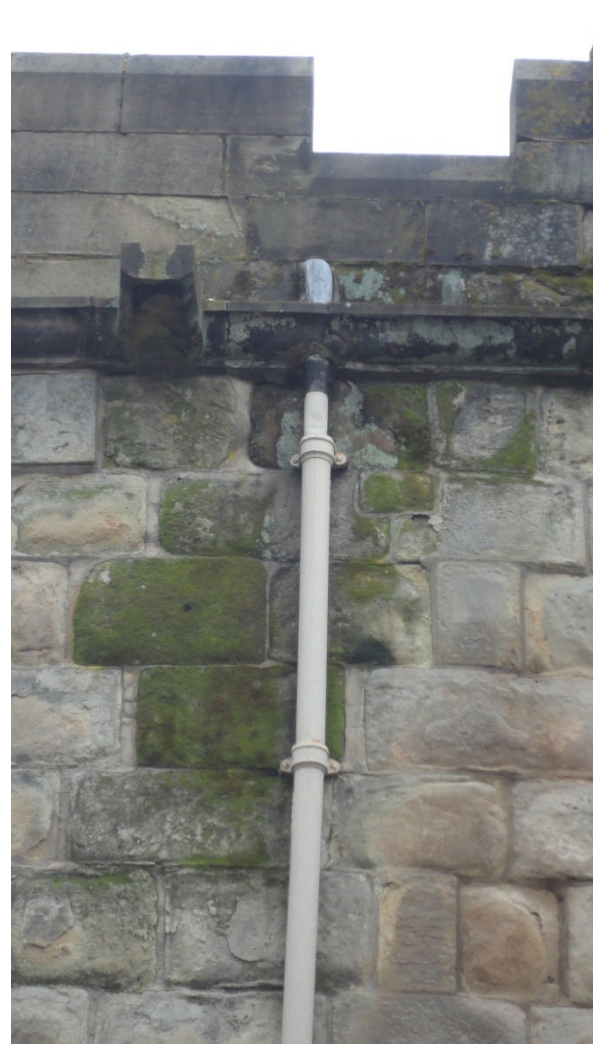
Detail of Wingfield's Tower showing damp on the northwest face

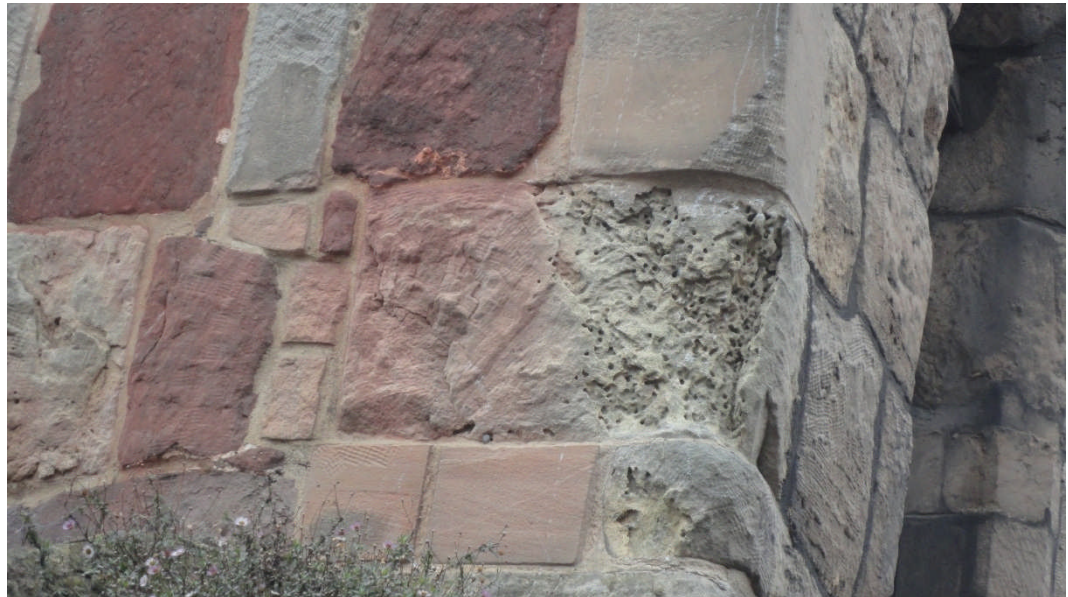
Detail of Wingfield's Tower showing damage from mason bees and spalling on the corner of the southeast face

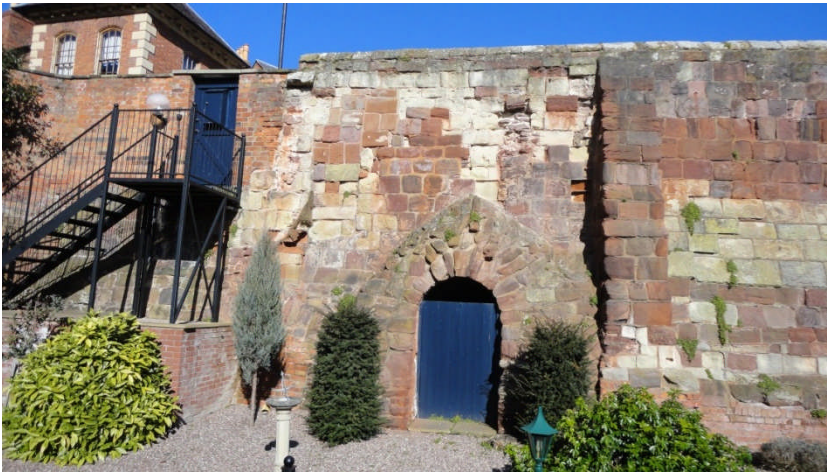
The town wall at 21a Town Walls, showing the tunnel cut under the road in c. 1904

- Clear the ivy from the face of the town wall, in particular along Town Walls road adjacent to No 21a Town Walls (Gaz. Ref. 11 b). The cleared section should then be assessed for condition and stability. Other sections of ivy growth along the Town Walls length of the wall should also be removed.
- Attempt to initiate a programme of ivy control for St Mary's Water Gate (Gaz. Ref. 16 b).
- Other shrubby vegetation growing on the wall should be removed in line with the advice above (5.5.4 & 5.5.5).
- Trees and shrubs growing adjacent to the wall should be assessed and treated as necessary.

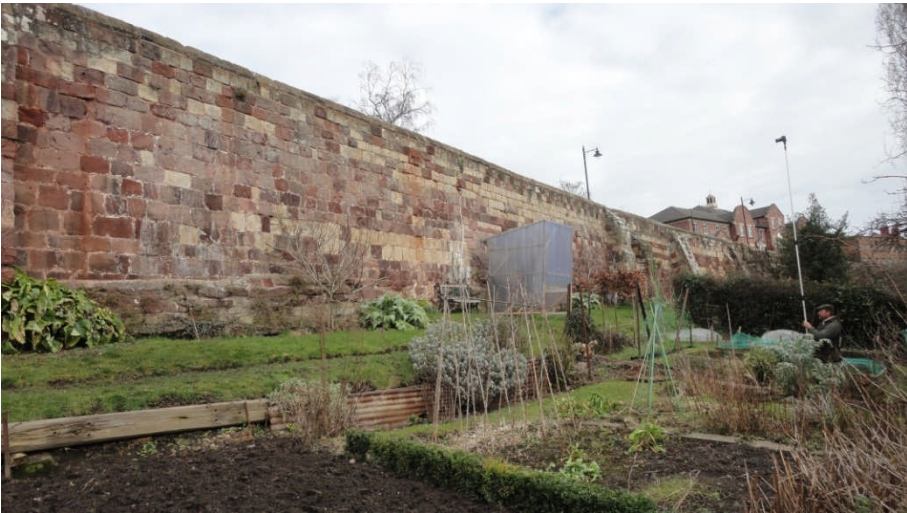
A section of the wall along Town Walls (11 a) showing the patchwork use of buff Grinshill and red sandstones in episodes of repairs (looking NE).

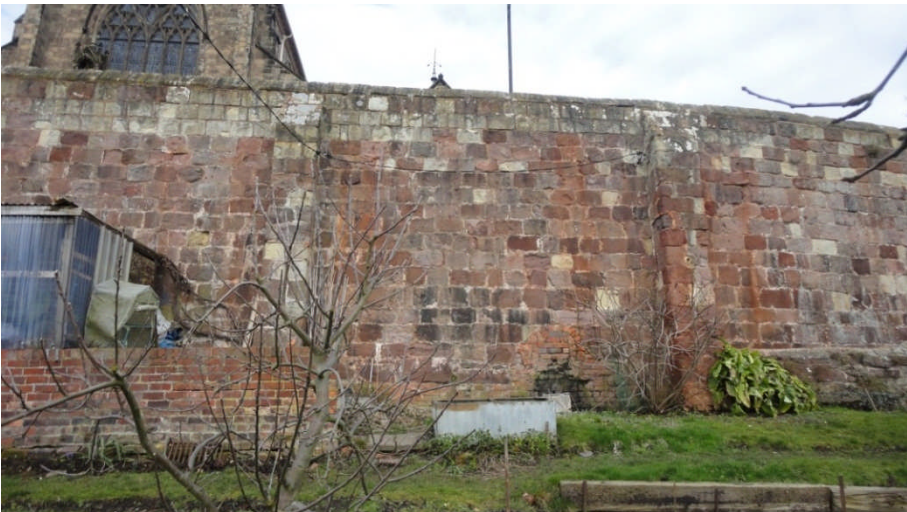
Location of crack in masonry (11 d) opposite Shrewsbury Cathedral

5.4.3 Cracks in masonry that are moderate or greater (5mm or more in width), or that are of any complexity in shape, orientation and continuous movement should be professionally investigated at the earliest opportunity (see Appendix 1, para. 1.3).

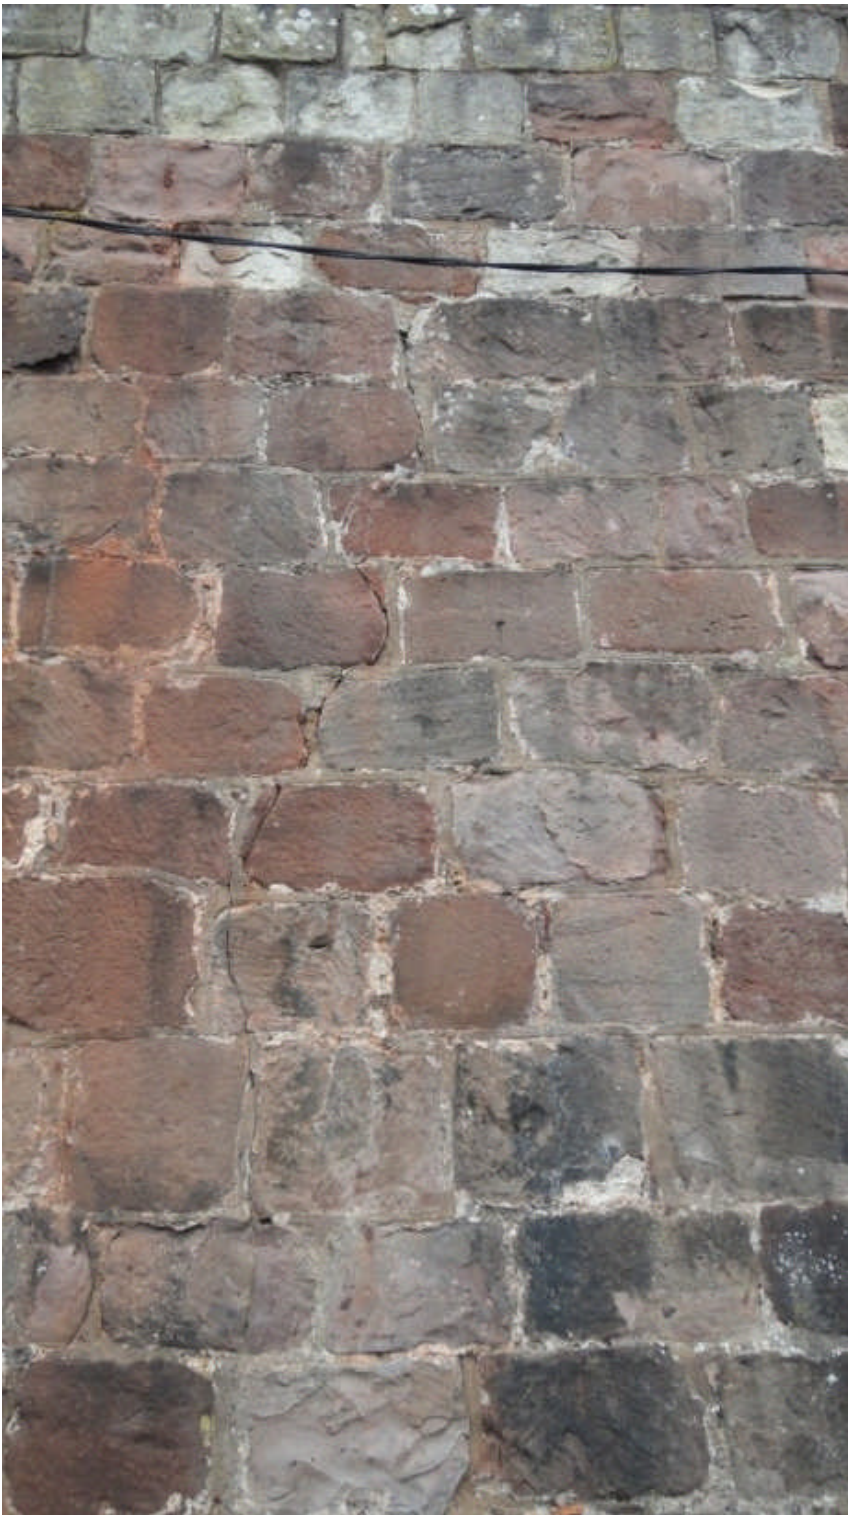
Detail of the crack in the masonry (11 d) in the wall opposite Shrewsbury Cathedral

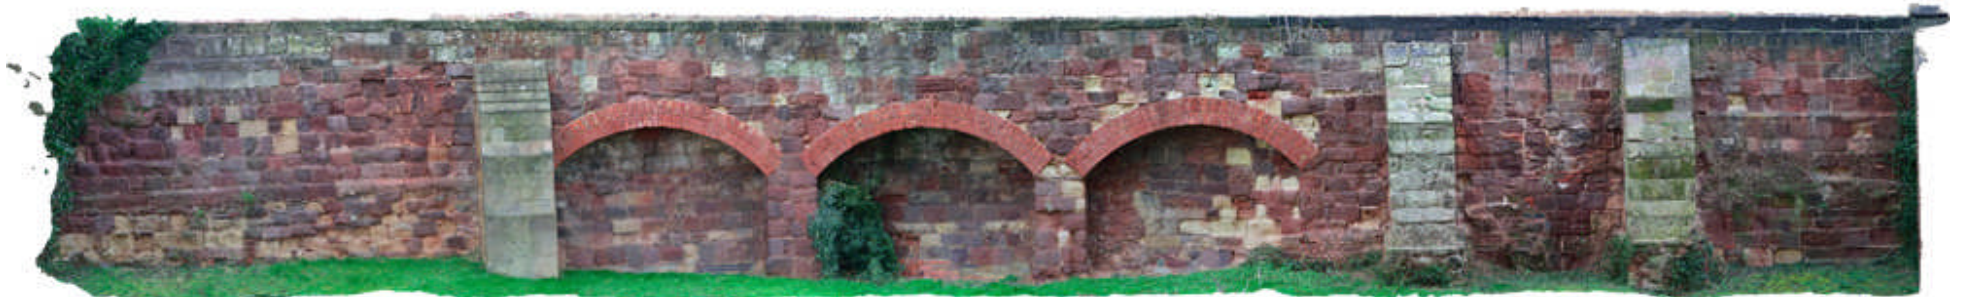
The town wall and the jettied section of the parapet (11e) in front of Telecom House on Town Walls. © Aerial-Cam Ltd

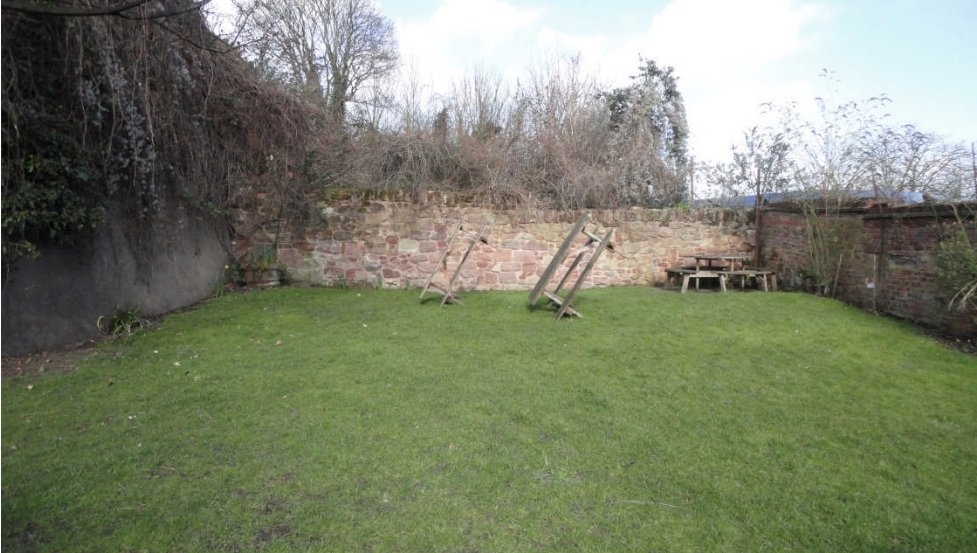
The inner face of the rebuilt (1995) wall at the rear of the Nag's Head PH (13 c)

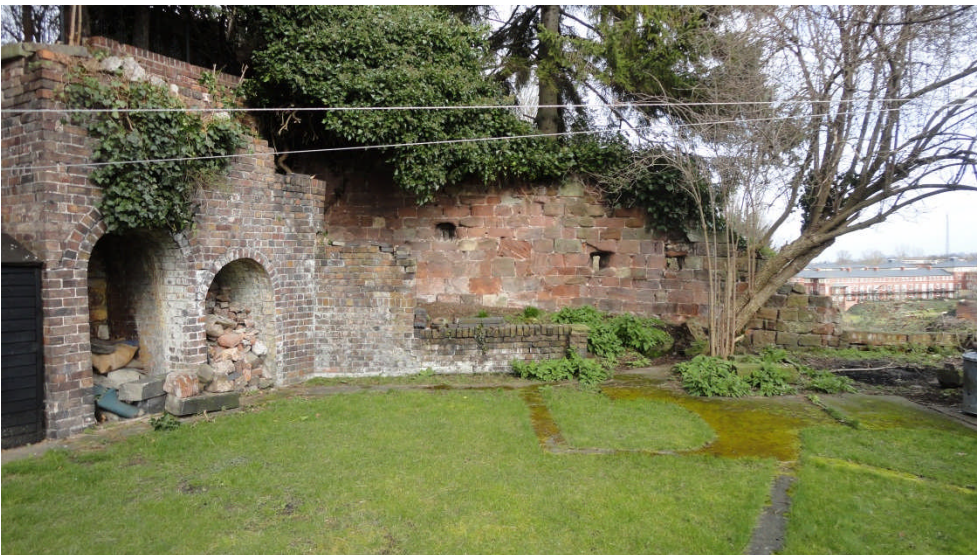
The inner face of the wall at the top of Wyle Cop (13 d), showing musket loopholes
