## A WATCHING BRIEF AT SHREWSBURY CASTLE 2015

by  
H R HANNAFORD MifA

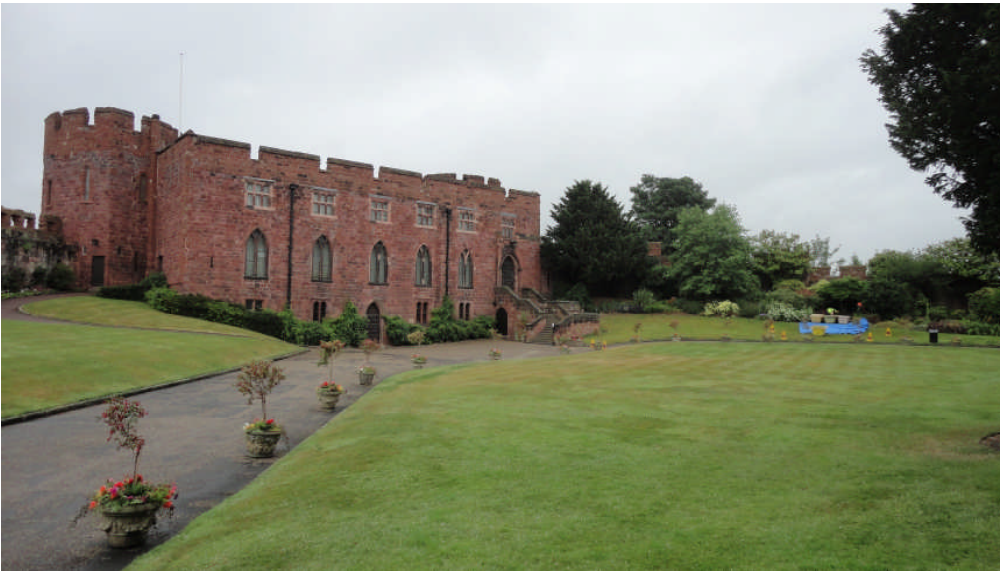
**2.1** A test-pit was excavated on 8<sup>th</sup> June, with the main excavation on the 14<sup>th</sup> July. The pit for the foundation for the monument was located some 24m southeast of the eastern corner of the main hall of the castle, in an area of sloping ground running down from the bailey curtain wall. The pit was dug by hand about 1.5m square to a depth of about 0.65m at its lower (southwestern) corner and 1m on its upper (northeastern) corner.

Photo 1: The location of the foundation pit (centre right), looking NE across the castle inner bailey.

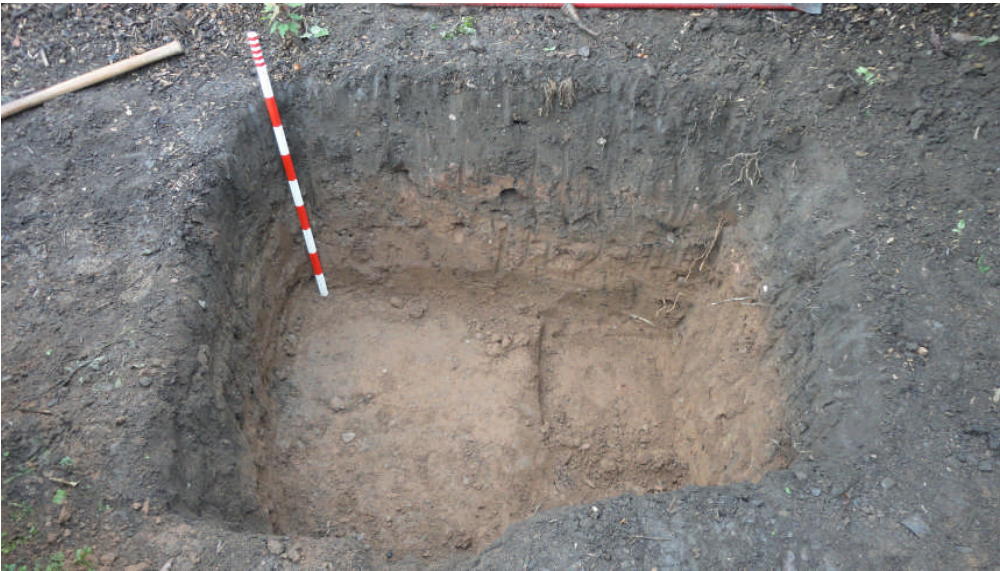
Photo 2: The south-facing section of the foundation pit, looking N; scale bar 1m

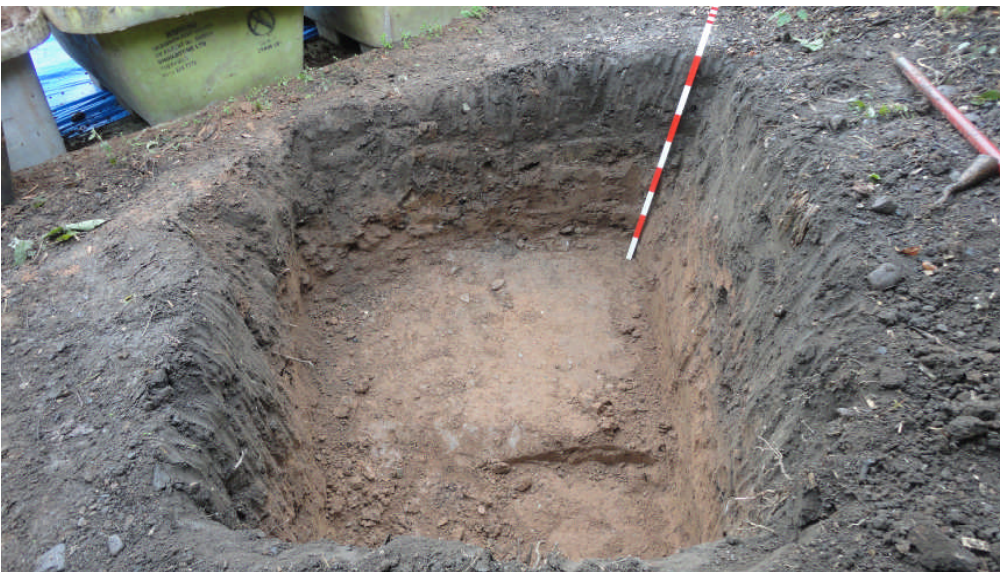
Photo 3: The east-facing section of the foundation pit, looking W; scale bar 1m
