**A WATCHING BRIEF ON
EMERGENCY WATER MAIN REPAIRS AT
WROXETER, SHROPSHIRE 2015**

by
H R HANNAFORD MCIfA

A Report for
SEVERN TRENT WATER Ltd.

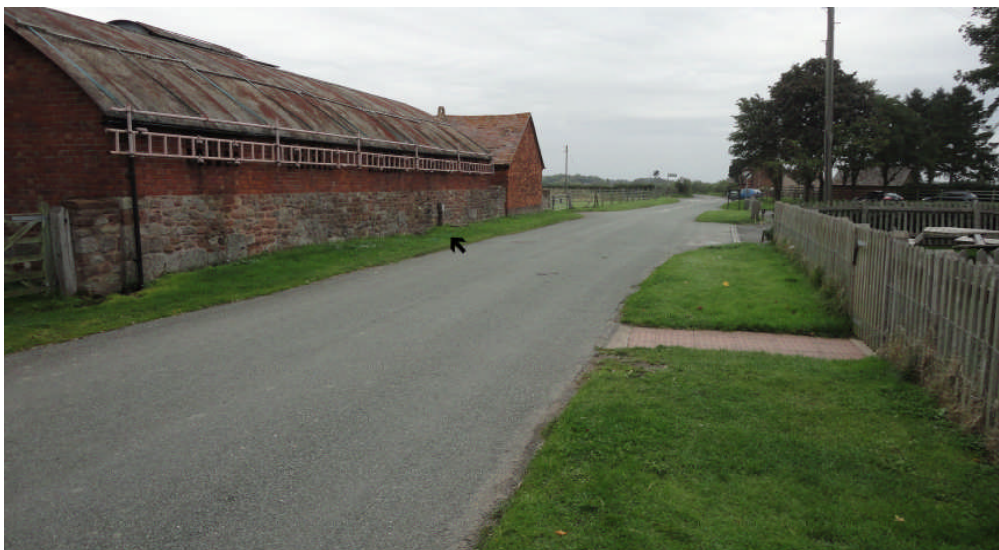
1.4 On 16th September 2015 Severn Trent Water Ltd carried out emergency repairs to a burst water main at Wroxeter. The burst main was located in the grass verge on the west side of the road opposite the Wroxeter Roman City office and museum. The groundworks involved the excavation of a small trench to access and repair the burst water main.

Photo 1: The location of the burst main (arrowed), looking NW

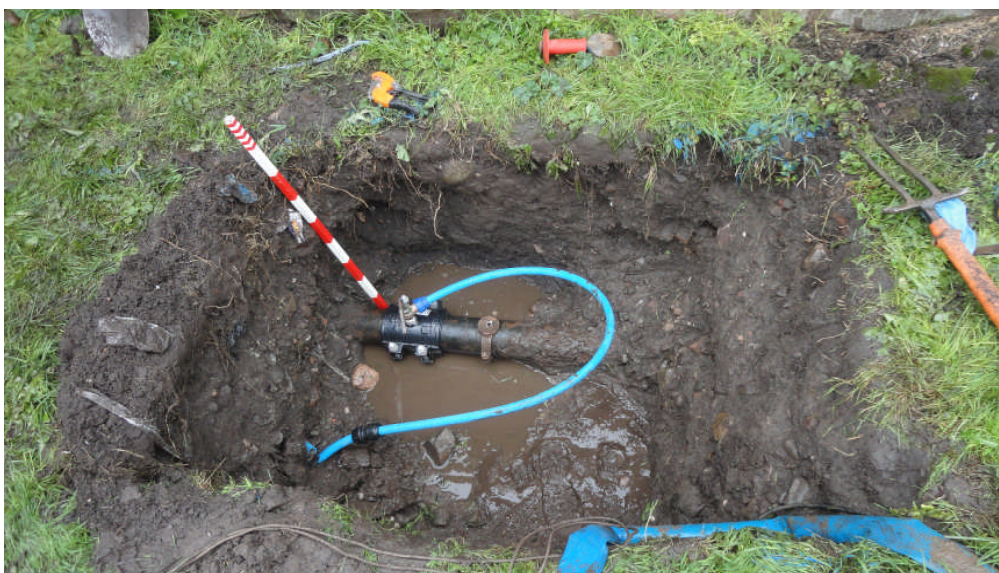
2.1 The excavations to locate and repair the burst main were carried out using mechanical mini excavator and by hand. The excavations were made in the grass verge on the west side of the road. A trench 1m long by 0.8m wide was excavated by machine to a depth of 0.45m, then by hand to a depth of 0.8m. The 6" main was located at a depth of 0.6m below the ground surface. The feeder main to the Wroxeter Roman Site office and museum ran east from the top of this main dropping to a depth of 0.85m. The trench was extended 0.5m to the east to follow this feeder main to the principal leak.

2.2 A layer of dark grey humic topsoil 0.3m deep contained a mix of materials including stones, cobbles, pebbles, a fragment of Roman roof tile and crushed drink cans and sweet wrappers. This lay over a mixed fill of very dark greyish brown sandy loam with similar inclusions.

Photo 2: The excavation, looking W; (scale bar 1m)

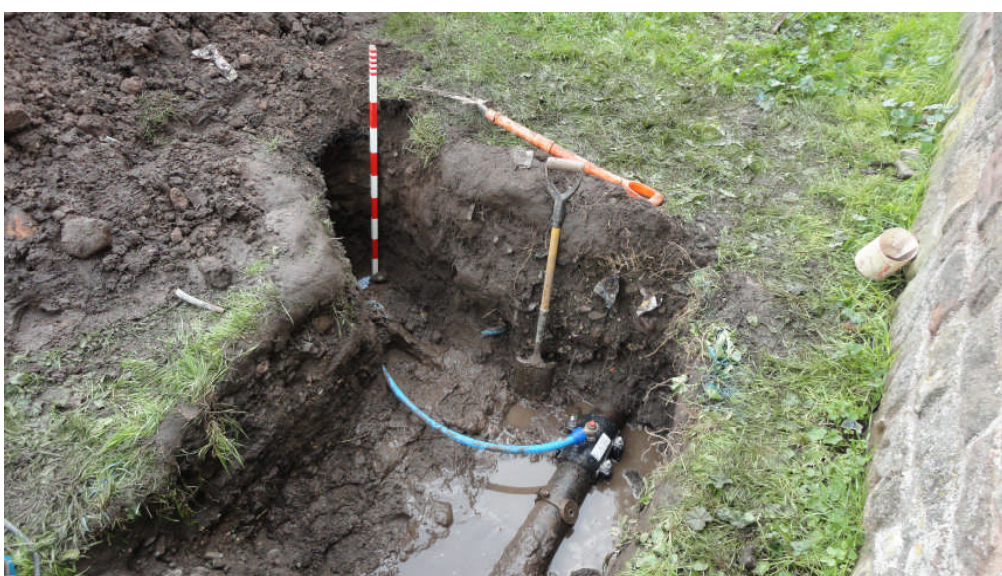
2.3 All the excavations were carried out entirely within ground that had previously been disturbed, comprising the backfill of trenches previously excavated for the laying or relining of the water mains. No significant archaeological features or deposits were recorded during the watching brief.

Photo 3: The excavation, looking SE; (scale bar 1m)
