A Watching Brief at Victoria Avenue, Shrewsbury, 2015

**A WATCHING BRIEF AT
VICTORIA AVENUE, SHREWSBURY, 2015**

WESTERN POWER DISTRIBUTION plc

Archaeology Service Report Number 377
© Shropshire Council
November 2015

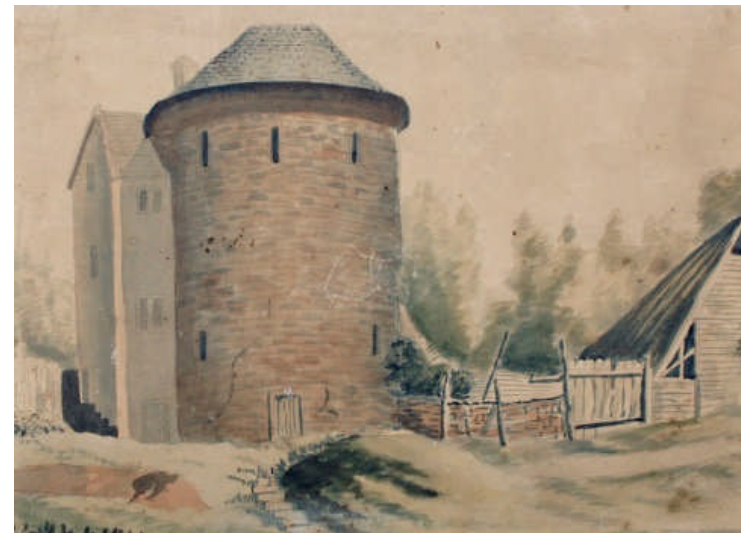
18th century view of the Round House looking southwest

2.2 The "New Work" was an outlying stretch of the town defences that were constructed in the late 13th century to defend a ford across the River Severn in the vicinity of the Augustinian Friary. The line of the wall is now marked by the boundary of the Shrewsbury Sixth Form College along Victoria Avenue. The New Work comprised a stretch of wall some 100m long with a circular tower at each end. In 1337 the Borough granted the Augustinian Friars the New Work, on the condition that they built an "embattled house" there and allowed it to be garrisoned in time of war (Baker, 2010, p146). In 1342 the wall was referred to in inquisitions, which described the wall as being 20 perches long (c. 100m) with two round towers. By 1620 the post-Dissolution owner of the friary, the barrister Roger Pope, had converted one of the round towers of the New Work into a tanning room. The western tower is shown on several 18th-century engravings and paintings with a building adjoining its east side, aligned north-south (see Fig. 5 and front cover). The painting by John Bowen of 1720 also shows boatbuilding on the land to the west of the tower. The tower, by then known as the Round House, was demolished in c. 1790.

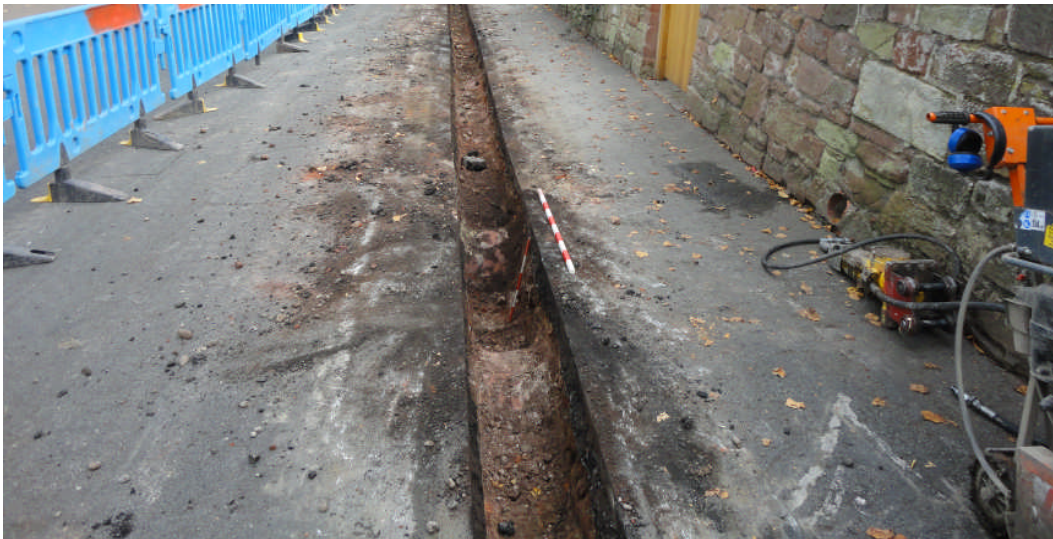
3.3 The red clay deposit (Fig. 4a, 6) butted against the east face of a sandstone and brick wall (5) about 2m thick aligned north-south. The top of this wall lay at a depth of 0.3m below the road surface, 48m west of St Austin's Friars road (at SJ 48722 12671).

4.3 The foundation remains of the house attached to the tower also appear to survive beneath the road surface. The brick and sandstone construction of these walls suggest an early post-medieval date, which would be consistent with the pictorial evidence. The house would thus have been about 19m long, southwest-northeast, if indeed wall 5 represented the eastern wall of the house, though this would make the building longer than the one depicted in the 18th century illustrations. There was no evidence as to whether these remains were also associated with the late medieval embattled house (if it were ever actually built by the Augustinian Friary).

Photo 2: Wall 5, looking E; scale bars 1m & 0.5m

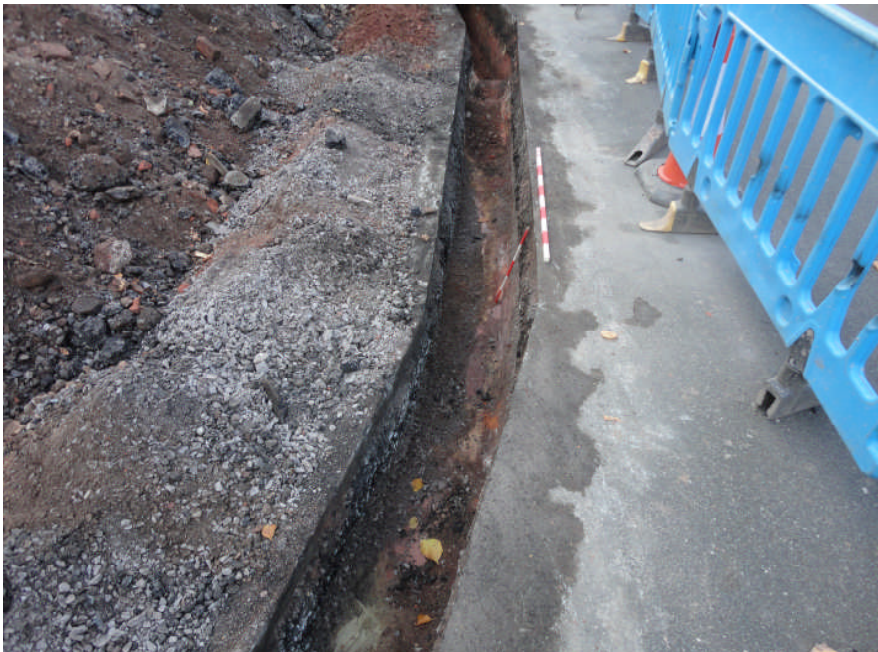
4.2 The curved red sandstone wall of the tower was seen to lie 68m west from the junction of Victoria Avenue and St Austin's Friars. The remains of the tower lay at a depth of 0.5m below the ground surface (and were left intact by the current work). The tower had previously been rediscovered and excavated in 1911, probably when Victoria Avenue was widened to its present extent. The 1927 OS 25" (3rd Edition) through to the 1964 1:1250 OS maps show the arc of the tower extending out from the face of the college boundary wall. By 1971 these remains appear to have been removed or buried as the arc of the tower is no longer shown and its location is marked as "Tower (site of)" on succeeding OS maps. This would explain both the precision of the Scheduled area around the actual remains of the tower and the recent appearance of the deposit of stone chippings that buried and filled the tower. Whilst only part of the northern half of the tower was seen in the cable trench, the exposed arc suggested an approximate diameter of 7.5m for the tower (see Fig. 2), slightly larger than the 18 feet diameter suggested in 1911. The stone setts in the road do not quite accurately reflect the location of the tower, being placed a little too far to the west, and their arc being of too small a diameter.

Photo 3: The remains of the west tower of the New Work (wall 16), looking W; scale bars 1m & 0.5m
