*Archaeological recording at*  
***The Old Rectory, College Street,  
Ludlow, Shropshire, 2016***

**ARCHAEOLOGICAL RECORDING AT  
THE OLD RECTORY, COLLEGE STREET,  
LUDLOW, SHROPSHIRE, 2016**

**MR SIMON GRAY**

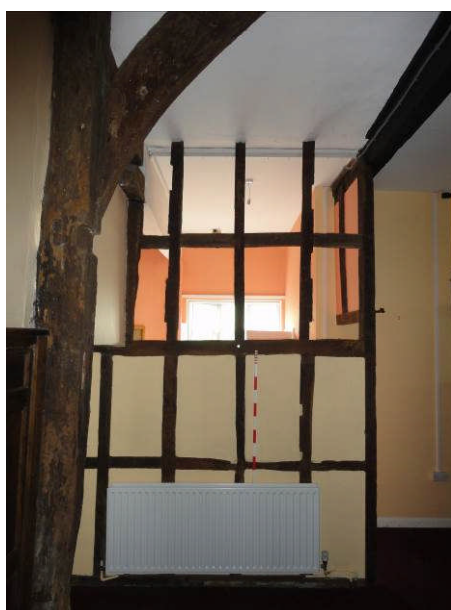
**3.2.1 Entrance Hall.** A drawn and photographic record was made of a partition screen in the entrance hall prior to its removal. The partition did not appear to be original, and was made of re-used timbers. (See Figs. 4 & 5 and Photos 2 & 3)

Photo 2: The hall partition looking W;  
scale bar 1m

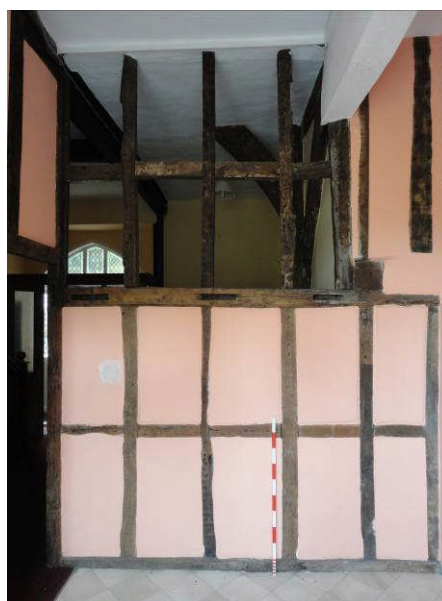
Photo 3: The hall partition looking E;  
scale bar 1m

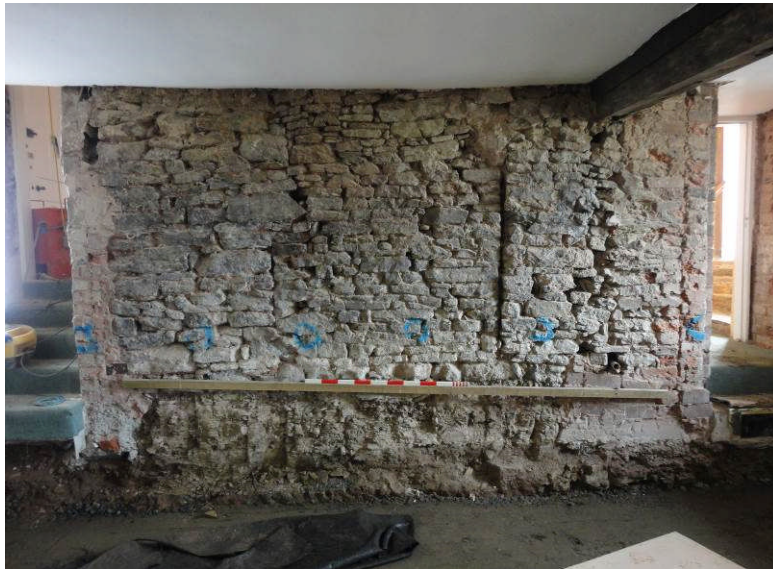
**3.2.3 Undercroft.** A possible former fireplace was suspected in the south wall of the undercroft. The modern plaster was removed to reveal a possible blocked opening, with a vertical join on its west side, but an irregular joint on its eastern side. There was no sign of a chimney space rising from this so it was decided not attempt to open up this feature. (Photo 5.)

Photo 5: The chimney base in the undercroft, looking S; scale bar 1m

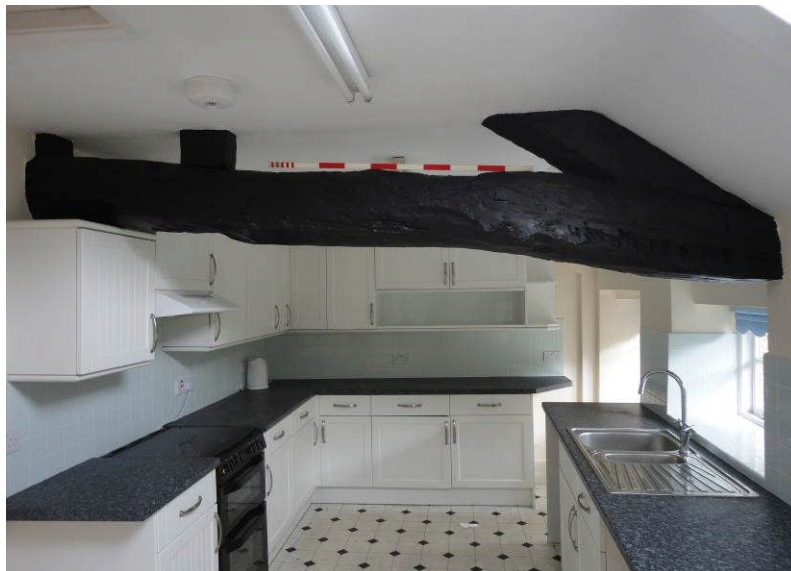
**3.2.4 Kitchen/Outshot extension.** The interior of the kitchen was photographed before demolition (Photo 6.), and an inspection made of the ground following removal of the existing floor. The soils beneath the floor comprised 20cms of disturbed brown clay loam over the top of the natural siltstone bedrock surface. The only feature revealed was a stone-lined well with an internal diameter of about 0.7m (Fig. 2; Photo 14).

Photo 6: The outshot kitchen, looking S; scale bar 1m

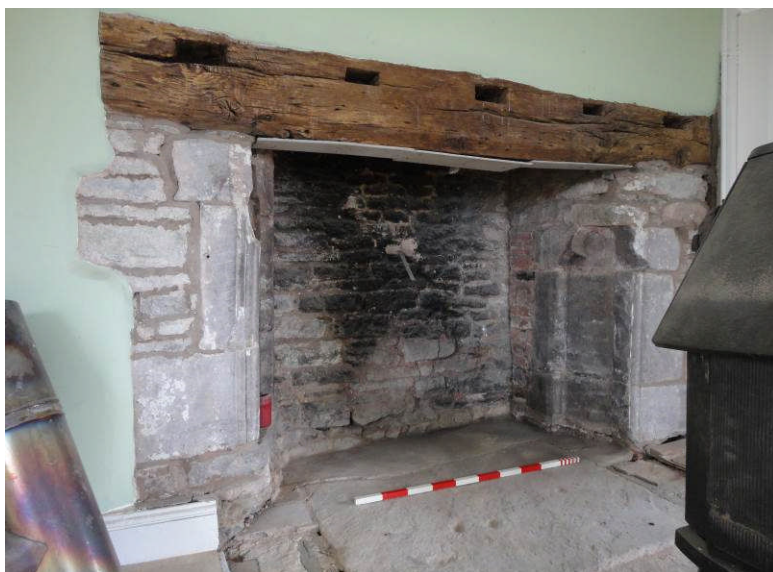
**3.3.1 Hall (drawing room).** There was limited work proposed in the In the hall (drawing room). The central ceiling beam below the partition between bedrooms 1 and 2 required repairs and a wood-burning stove was to be installed in the fireplace. The opportunity was taken to record the fireplace in the south end of the room (Figure 7; Photo 7). The sides of the fireplace are of grey sandstone with trefoil headed side panels, of probable late medieval date. The lintel comprised a timber beam.

Photo 7: The fireplace in the hall

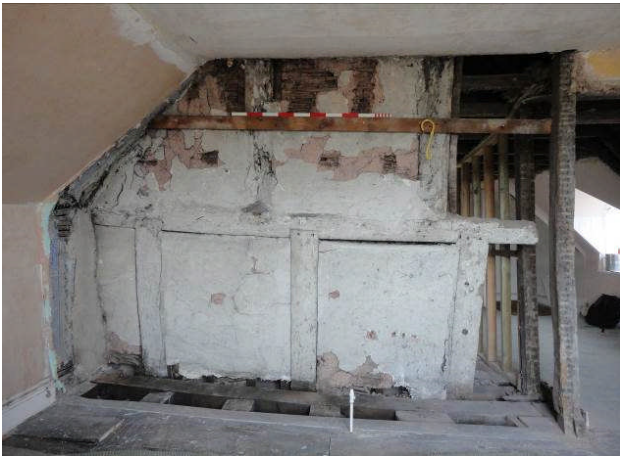
**3.4.1** The partition between bedrooms 1 and 2 was about 60cms thick, and the removal of the modern plasterboard revealed why this partition was so unusually thick. The modern plasterboard had been masking a timber frame leaning to the north. The exposed frame was photographed and a measured sketch drawing made (Fig. 6; Photos 8 & 9). The intention was to re-instate the leaning frame to the vertical.

Photo 8: The frame between bedrooms 1 & 2, looking S

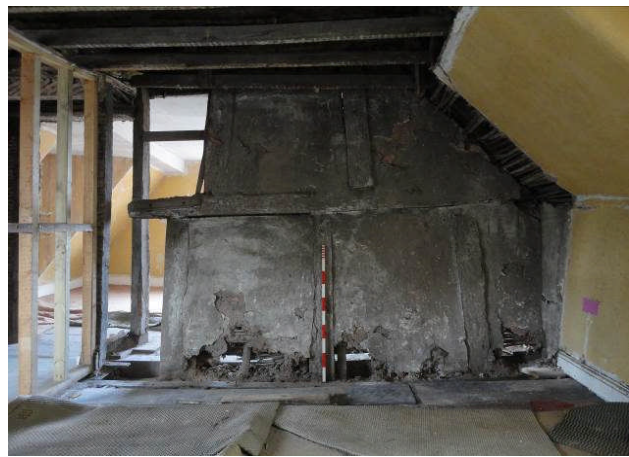
Photo 9: The frame between bedrooms 1 & 2, looking N

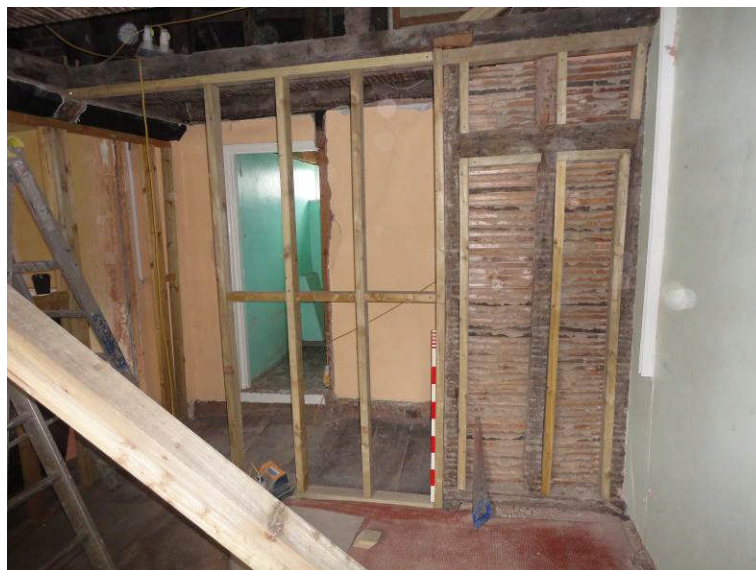
**3.4.2** A new stairwell was inserted in bedroom 4 up in to the roof-space above the bedroom in the southern range (Photo 11). The location of the new stairwell was positioned to minimise the need for alterations to the historic fabric of the ceiling joists. There was limited opportunity to photograph the roof space (Photo 12). Looking south, an earlier truss has been incorporated into the 18<sup>th</sup> or early 19<sup>th</sup> century brickwork at the end of the building representing the party wall with the adjoining property (Photo13). It has been suggested that this may be a remnant of an earlier open hall in this location.

Photo 11: The location of the new stairwell in bedroom 4, looking SW

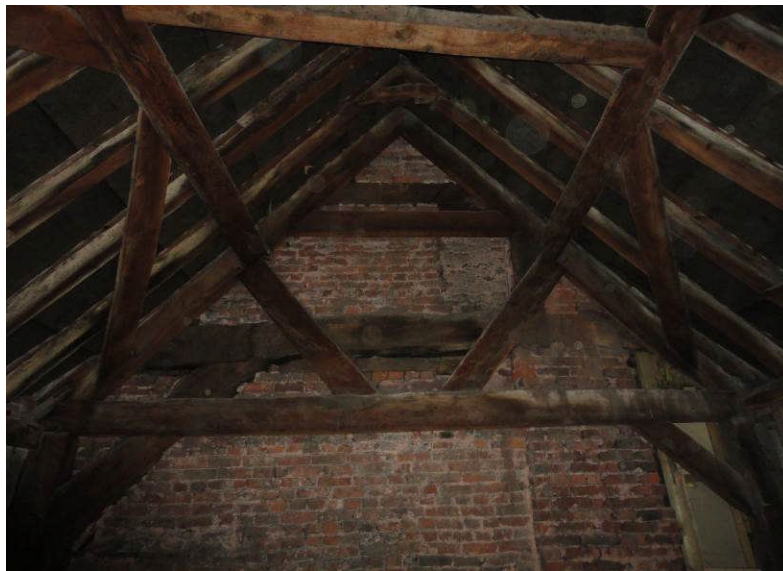
Photo 13: The truss in the S end wall above bedroom 5, looking S

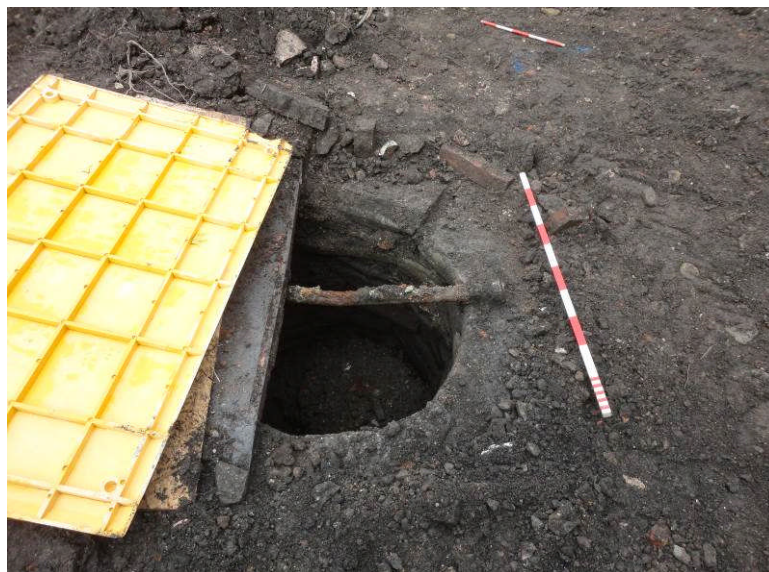
Photo 14: The stone-lined well in the garden
