### A WATCHING BRIEF ON THE INSTALLATION OF NEW PATH FURNITURE ON

## OFFA'S DYKE AT VRON FARM, TREFONEN, SHROPSHIRE, 2017

H R HANNAFORD MCIfA

A report for

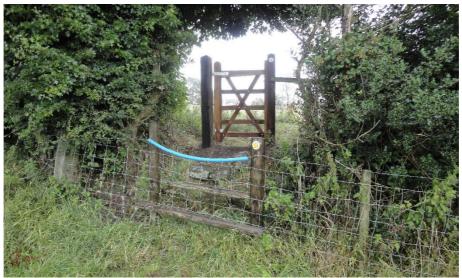
Photo 1: The old "stile" at Vron Farm before removal, looking NE

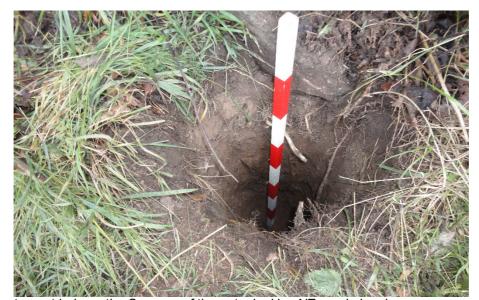
Photo 2: The gate post hole on the S corner of the gate, looking NE; scale bar 1m

postholes, 0.4m x 0.3m in plan (one 0.85m deep and one 0.65m deep) were excavated for corner and strainer posts, and three postholes to 0.3m in diameter and between 0.5m and 0.9m deep were dug for the remaining gate posts.

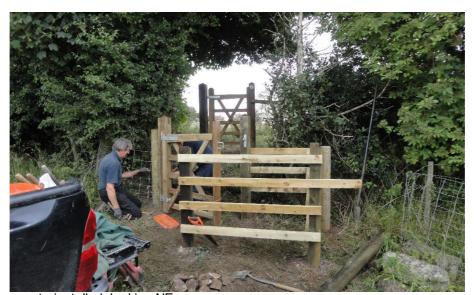
Photo 3: The new gate installed, looking NE
