***Archaeological Investigations at  
Rectory Wood, Church Stretton,  
Shropshire, 2009***

Archaeology Service Report Number 267  
© Shropshire County Council  
June 2009

A report for the  
**Rectory Wood Heritage Project,**  
Outdoor Recreation Service,  
Community Services,  
Shropshire Council

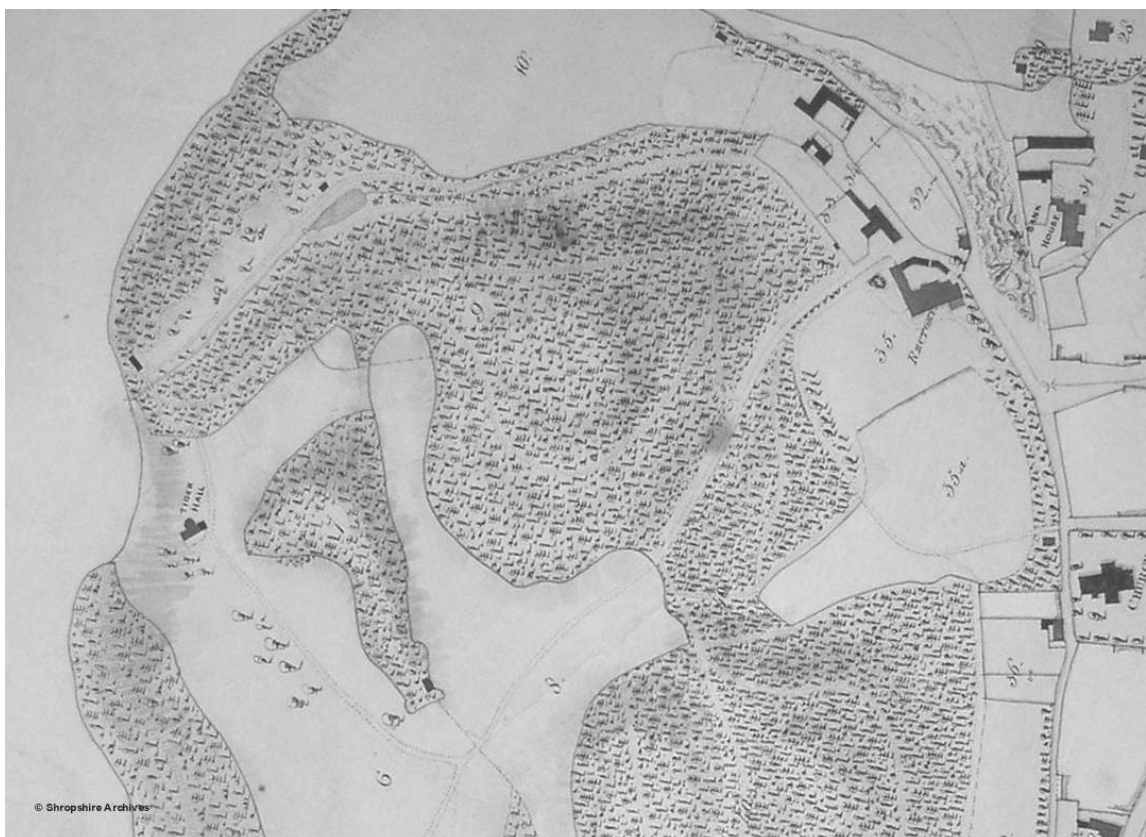
Figure 5b: Extract from 1834 map showing the study area (SA P67/F/1/1)

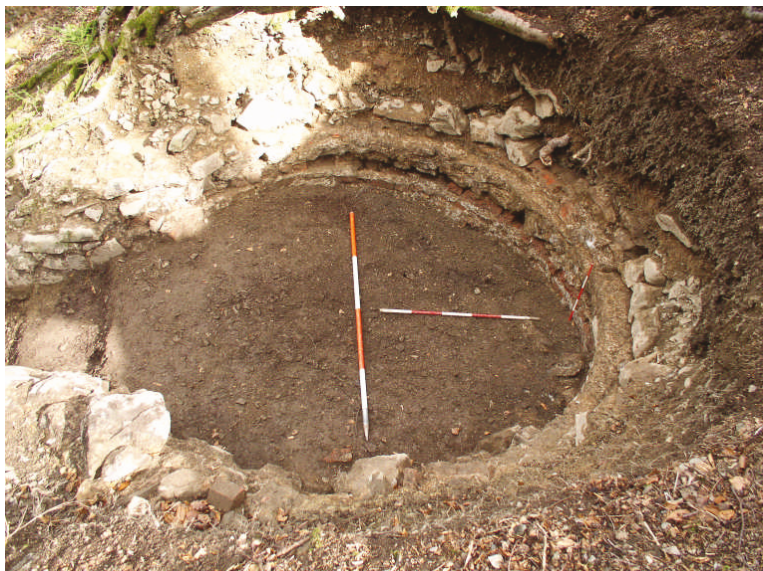
Photo 1: The chamber of the icehouse

The core of the chamber was filled with loosely packed stone and brick rubble (35) that almost certainly represented the collapsed roof of the structure. This deposit filled the chamber to within 0.8m of the top of the wall; it was not excavated. The top of the wall of the chamber was covered by a steeply sloping deposit of grey silty loam with small stone chippings (8 & 9), that appeared to have washed into the sides of the top of the chamber from the hillside above. The remainder of the top of the chamber was filled with a dark greyish brown humic loam (10) topsoil, and a peaty layer of humic soil composed of composted leaf mould (7). The side walls of the entrance passage were truncated and sloped down in line with the hillside from the top of the chamber to the edge of the former path along the hillside. The leaf-mould (1) and topsoil (2) were cleared from the top of the side walls (3 & 4) and top and front of the wing walls (25 & 26). The fills of the entrance passage were sampled and seen to consist of a stony dark grey silty loam (5) with some large stone fragments and brick; at the north end of the passageway this deposit (6) contained less brick and stone.

The ice house in Rectory Wood appears to survive in reasonable condition. It is likely to have had a circular, barrel-vaulted chamber. The structure survived to a height of 2.5m above the level of the former path, which itself was about 2m above the level of the pool. This would allow for a depth below the path of up to another 1.5m construction, with a drain beneath running into the pool. The roof of the structure has clearly collapsed, filling the chamber, and the top of the entrance passage has been truncated in line with the slope of the hillside. However, it is likely that the main body of the icehouse survives in the hillside. The only clue to the dating of the ice-house was in the bricks of the lining of the chamber, which were 18<sup>th</sup>-century in date. The form of the ice-house would also fit with this period.

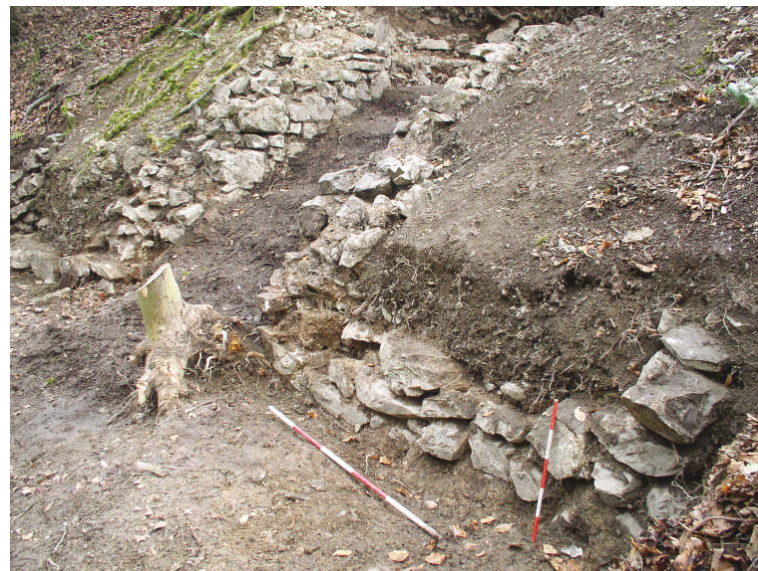
Photo 2: The entrance passage and wing wall of the icehouse

The remains of the ice-house consisted of a circular chamber approximately 3.6m in diameter with an inner diameter of 3m (Fig. 3). The chamber was cut into the bedrock (39) on the hillside overlooking the yew-ringed pool. The chamber (36) of the ice-house was constructed of random-coursed Longmyndian sandstone rubble masonry bonded in buff lime mortar, with an inner lining of red brick. The space between the chamber and the cut in the bedrock was packed with a brown clay (37) which presumably provided a degree of waterproofing and insulation for the chamber. The chamber was entered by way of an entrance passage 2.6m long and 1.1m wide (internally) that led back from a (now dis-used) path on the lower hill slope. The walls of the entrance passage (3 & 4) were also built of random-coursed Longmyndian sandstone rubble. The outer ends of the passage walls turned outwards to form wing-walls (25 & 26) which revetted the upslope side of the path to either side of the entrance passage.

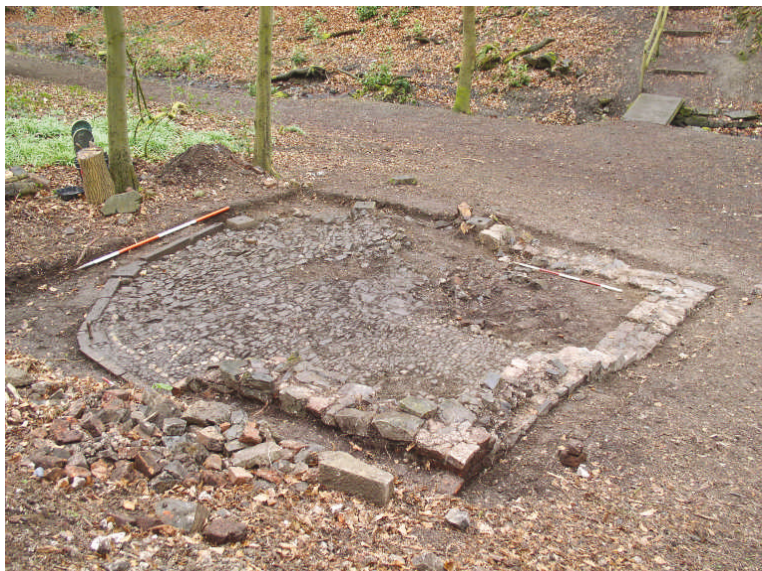
Photo 3: The summerhouse

The nature of the structure at the northwestern edge of the site identified by the 2004 field survey (Hannaford, 2004) was uncertain, though it appeared to have been sited to give a view down the valley towards the yew-ringed pool and pump-house (or gothic folly) (Phibbs, 2009). The trial revealed the foundations and floor of a D-shaped building, and these were sufficient to identify the structure as a summer house. The cartographic evidence suggests a date for the construction of the summerhouse of between 1767 and 1834. The mosaic letters I M or J M recorded by the excavation suggest that the summer house was built by John Mainwaring as part of his development of the garden. The brick fragments used in the walls of the summer house were of interest as they were of dimensions that indicated a 17<sup>th</sup>-century date. They had clearly been re-used, and were similar to the bricks used in the lower courses of the site boundary wall on Church Street. There were no finds of tile or slate, and it is likely that the upper part and roof of the summer house were of timber. As surmised, the summerhouse would have given a view along down the stream valley towards the yew-ringed pool and the pump house. The 1834 plan shows that during Pemberton's time this stretch of the brook was open ground (possible lawn, as suggested by Phibbs) with a few clumps of planting, though the pump house itself was within trees and probably obscured from view. Some thinning of the cherry-laurel, rhododendron, and other scrub and saplings that have grown here might partially open up this view again.

The remains of the summer house would be vulnerable to erosion if left exposed: the pebble and cobble floor is bedded on buried soil directly over the natural gravelly subsoil, and the end walls of the structure appear to have only slight foundations of a couple of courses depth. The mortar bonding the walls is not especially hard either. In fact the southwestern corner of the building had been damaged by its proximity to the path running through this part of the site. The excavations were backfilled to the top of the walls, recovering the floor, and protecting the walls, but allowing the partial outline of the structure to be visible.

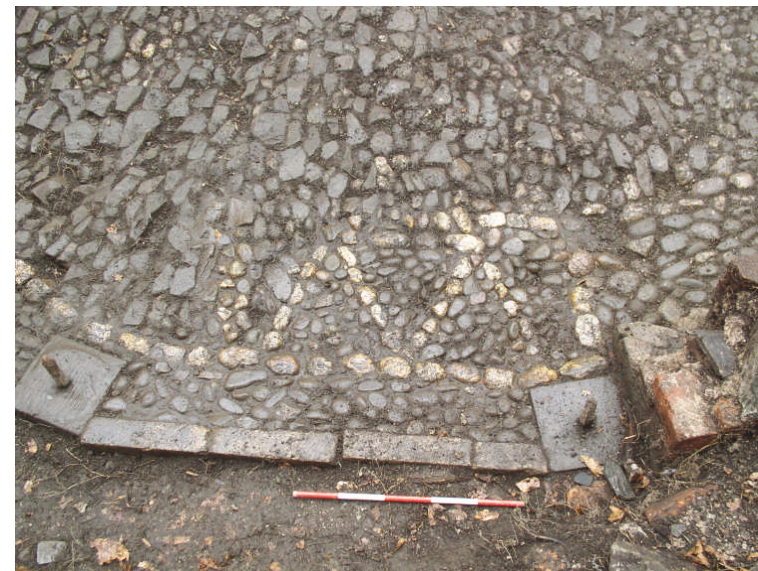
Photo 4: The mosaic "M" in the floor of the summerhouse

On the inside of the walls of the D-shaped structure, the topsoil was of a depth of as little as 0.05m up to 0.65m. Immediately beneath the topsoil was a pebble and cobble floor surface (18). This floor did not survive in the western corner of the structure, where it had been worn away, as well as being cut through by a large oval pit (32). The southeast, east, and northeast edges of the floor were kerbed in buff brick or stones. The edges on the south and southwest sides were of cobbles. The floor was not uniform. In the northwest half of the structure, enclosed by the walls, the surviving floor was of rounded pebbles. In the southeast half of the structure the floor comprised a mixture of pebbles, cobbles and rounded stones. Incorporated into the floor at the northeast edge of the structure was a mosaic of pebbles, with the letter "M" in a rectangular border picked out in white pebbles. The "M" was preceded by what appeared to be another letter, either an "I" or a "J", but the mosaic had been damaged here. The pebbles were bedded in dark grey humic loam, and this lay directly over the natural subsoil (34) of dark brown silty sand and grit.
