**ARCHAEOLOGICAL BUILDING RECORDING AT
THE FORMER FIRTH RIXSON WORKS, SHEFFIELD
ROAD, ROTHERHAM, SOUTH YORKSHIRE**

BUILDING ANALYSIS REPORT

Report Number 2011/34 May 2011

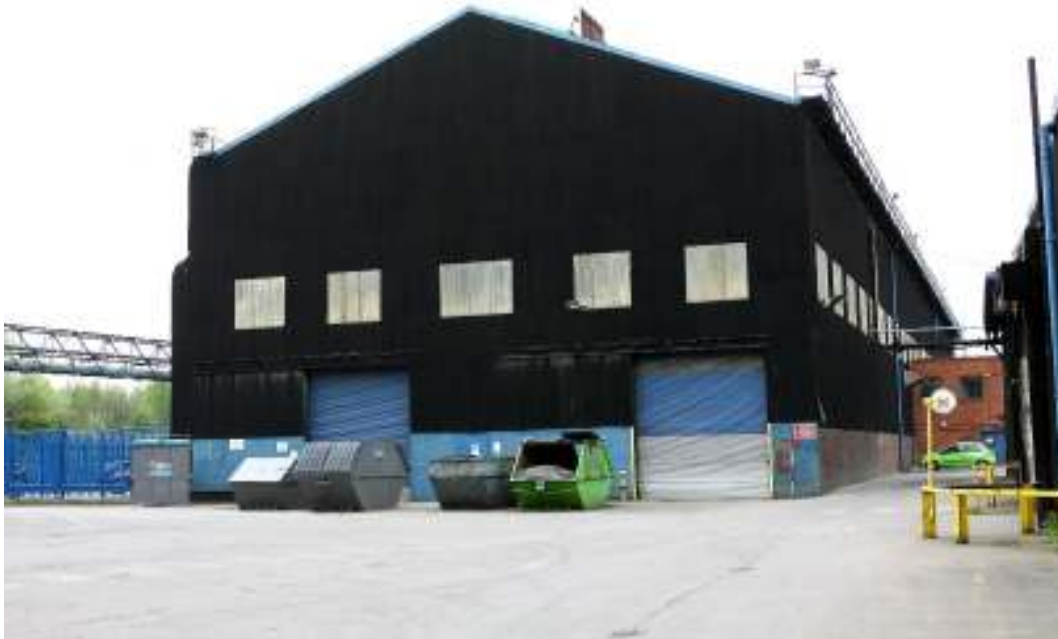
Plate 2: West gable of Building A (A1), viewpoint 65

The building is a large, single-storey works with two interconnecting ranges of different lengths, the longer range being to the south (A1). The works building has a steel frame with brick walls up to 2m in height surmounted by corrugated metal cladding (Plates 2-4). Steel lattice column girders support a travelling crane in the southern workshop A1 (Plates 5 and 7). The narrower northern workshop A2 does not have a travelling crane, but there is a large overhead pipe carried on the girders around the north and east walls. The pipe continues out of the building to the west, carried on a steel gantry and linking with the works building to the west, outside the development area (Plate 3).

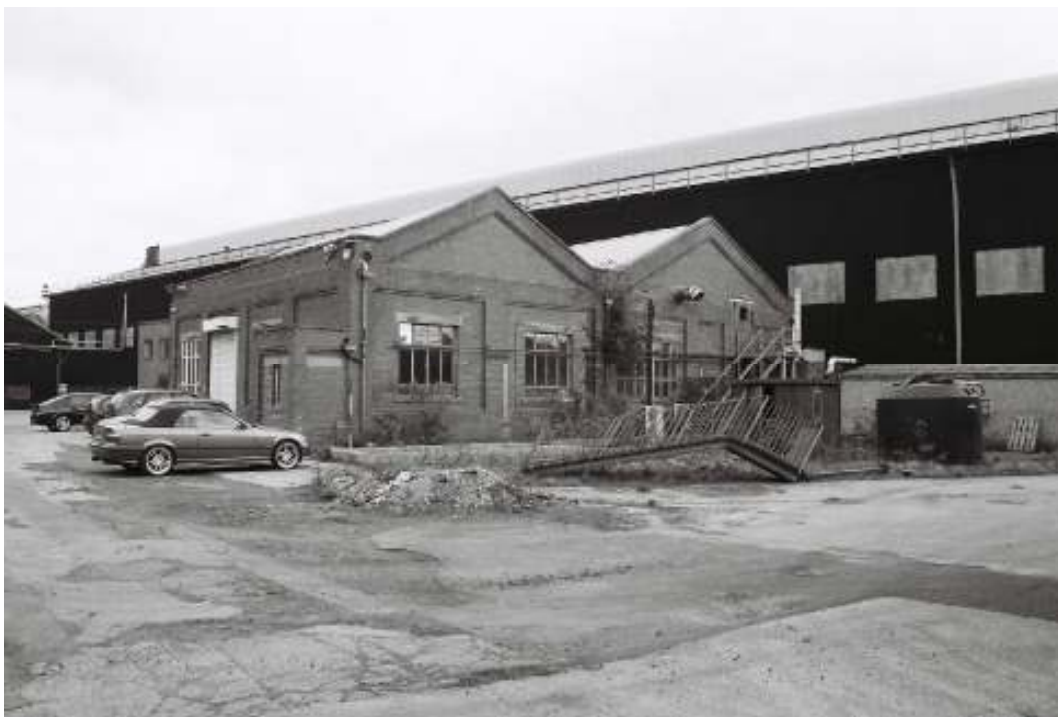
Plate 9: East elevation of Building B, viewpoint 68

The two upper storey rooms are located over rooms B4-B7. Room B8, at the west end, was labelled 'Reception', and room B9 was accessed through a door in the west wall of B8. Both rooms were of similar dimensions, with a curving ceiling that is a segment of the original arched ceiling of the canteen depicted on the 1941 sections of the building (Figure 12). The height of the rooms accordingly varies, becoming very low at the northern end, where there are short rectangular windows (Plate 14). There is a fire exit door at the east end, with a metal staircase leading down the exterior over the former boiler room. An air raid shelter was shown to the east of the building in 1941; this may be associated with a small brick shed (not accessed for the survey) and low concrete structures visible on the ground (Plate 9).

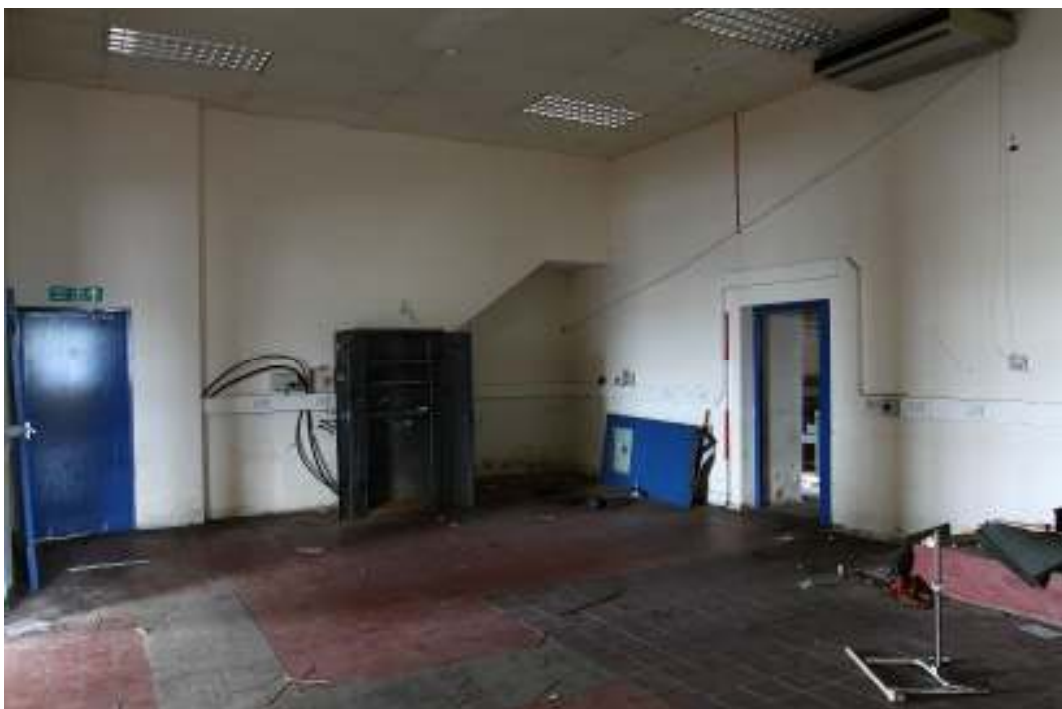
Plate 11: Room B2, viewpoint 10

Several modern alterations have been undertaken on the building, probably in association with its conversion into a test centre. A roller shutter door was inserted within one of the former window bays on the south elevation (Plate 8). A corridor (B10) was added on the western side of the building through the insertion of a breeze block partition wall, reducing the size of rooms B1 and B2. The corridor has doors into B1 and B2, and a staircase at the northern end leading to two inserted upper storey rooms. Apart from the insertion of the corridor, room B1 retains its original layout, though the height has been reduced through the insertion of a suspended ceiling at a level below the top of the windows (Plate 10). The former kitchen has been divided into two rooms, the larger B2, which is windowless, and a narrow room B3 on the east side. Both rooms have suspended ceilings and tiled floors (Plate 11).

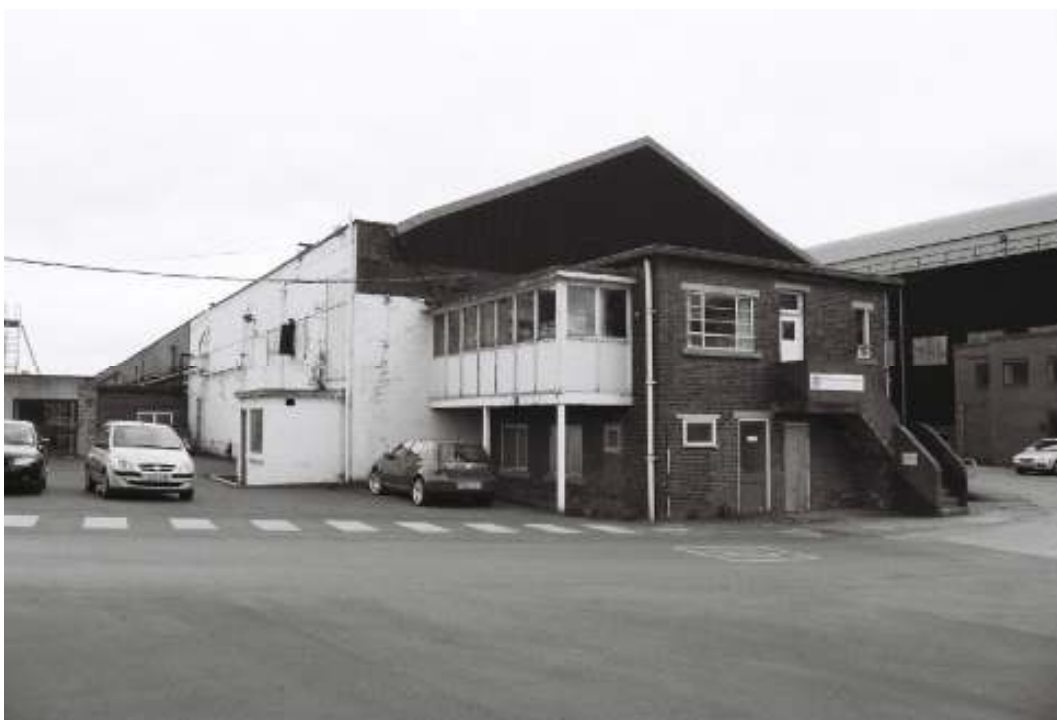
Plate 15: Exterior of Building C, east gable, viewpoint 73

Building C (centred on SK 41720 91902) was shown on the 1966 plan as a cold rolling mill (C2) and spring shop (C3), with an attached range to the south housing the annealing plant (C1). The building occupies the footprint of structures shown in 1905 and 1923, and represents the earliest surviving part of the works. The building was extended to the east between 1923 and 1955. There are plans of an extension to the cold rolling plant dating to 1955, which appear to relate to the western end of C2 (Figure 13). Part of the building was still in use by Firth Rixson at the time of the site visit, at the east end of C2, and this area was not accessed for the survey. All machinery had been stripped out of the accessible areas of the works prior to the survey. Externally, the building is clad in corrugated metal (Plates 16-17). There is a two-storey brick structure at the east end, with a flat roof (Plate 15). This was not accessed for the survey.

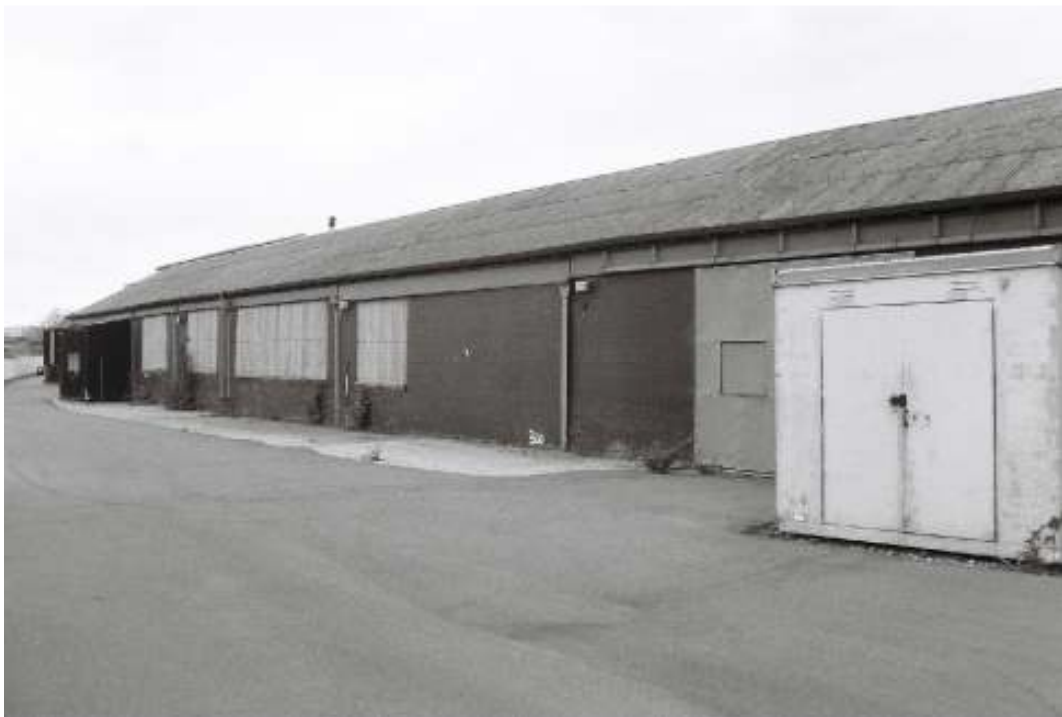
Plate 18: Exterior of Building C, south elevation of C1, viewpoint 76

sliding door on the north side (Plate 21), leading into a narrow yard area between C1 and C2. The south wall is of brick construction with metal cladding to the exterior (Plate 18); the north wall appears to be a steel frame with metal cladding and some areas of breeze block construction. The roof is supported on the top of the walls, and has steel composite trusses. Within the west end of the building is a small two-storey engineers' office unit of breeze-block construction.

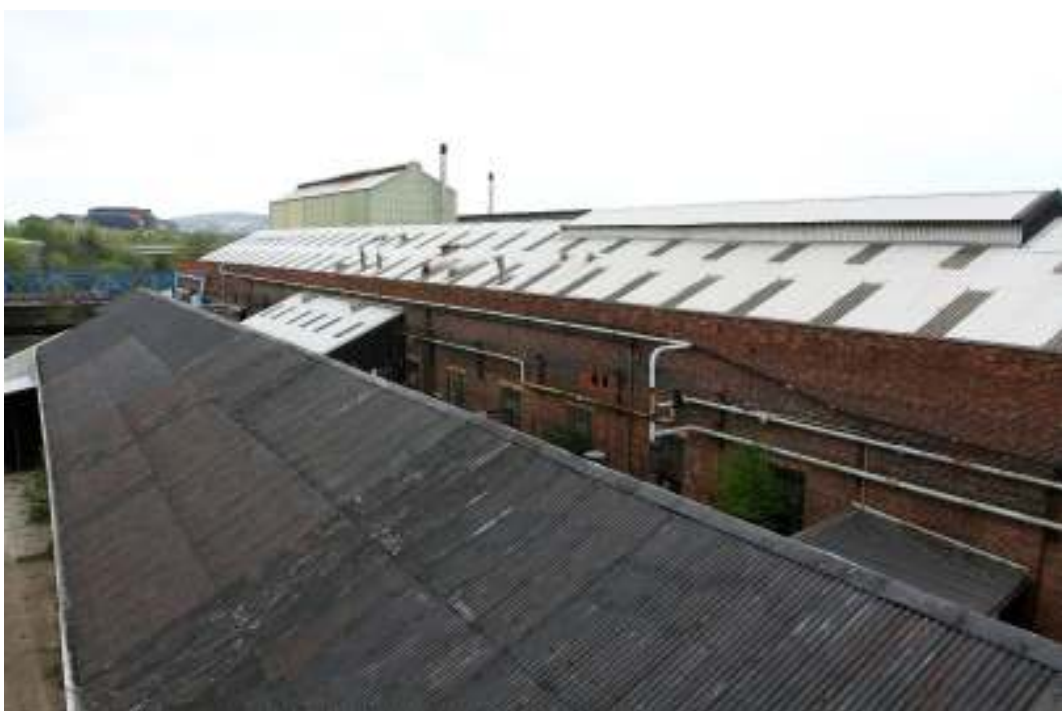
Plate 19: View over roofs of C1 (left) and C2, and south elevation of C2, viewpoint 37

Room C2 has brick walls with rectangular 10-paned metal-framed windows in the south wall (Plate 22). The windows have central opening sections of six panes. The walls feature protruding steel columns which support the riveted steel overhead crane track (Plates 23-24). Integrated into these columns are narrower, taller girders set into the walls which support the roof. Steel lattice girders run along the top of the brickwork, below the roof. There are two blocked entrances on the south wall, to the east of the western corridor leading to C1, infilled with breeze blocks (Plate 25). The lintels for these entrances appear to be of wood rather than stone, and the base is three brick courses above the current floor level. There are steel rails set into the concrete floor along the northeast side of the workshop, set c.5m apart and presumably related to former machinery (Plate 22). The crane track supports two overhead cranes. The roof is pitched, with composite steel trusses. There are skylights all along the roof, which appears from plans to have originally had a hot-working vent. Only a small section of this survives in the current roof (Plate 19).

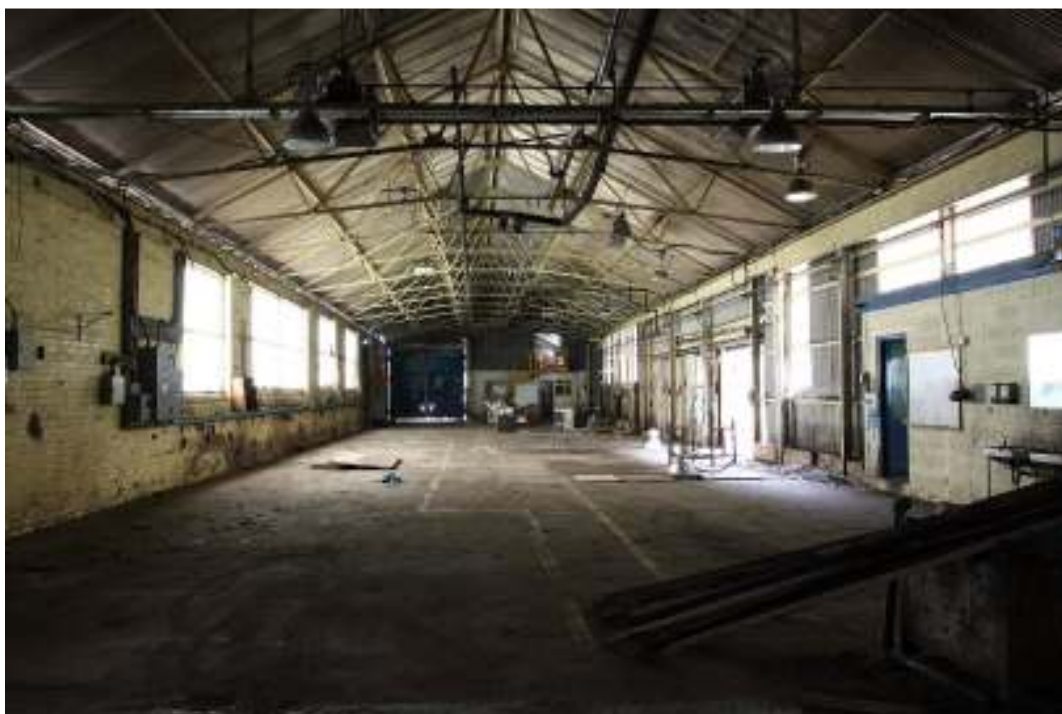
Plate 20: Interior of room C1, viewpoint 50

The former annealing plant, room C1, is a roughly rectangular range, connected to C2 by two wide corridors, the eastern one of which has been blocked with brickwork. The main room is a rectangular workshop, with a pitched roof and windows in the south wall (Plate 20). There is a

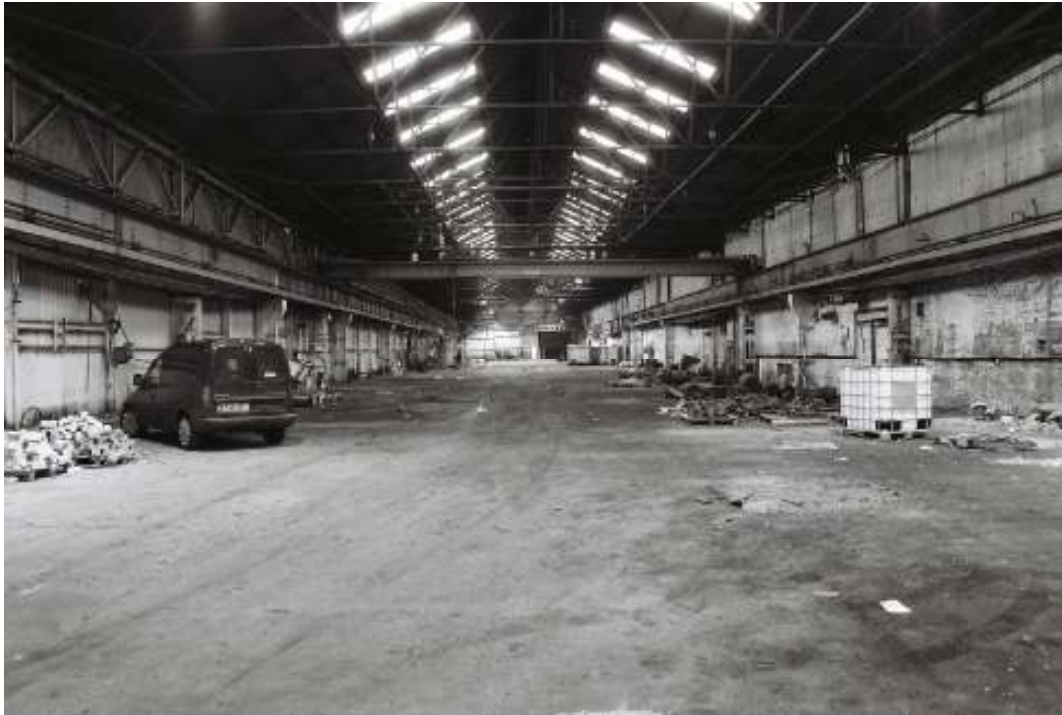
Plate 26: View of room C3, viewpoint 56

Room C3 is in a similar style to C2, though it has no windows in the walls and the north wall has no surviving brickwork (Plate 26). This wall is of steel frame construction with corrugated metal cladding. Both walls feature the same steel columns and lattice girders as room C2, supporting the overhead crane track and the steel composite roof trusses (Plates 27-29). There are a series of small square and rectangular holes in the wall between rooms C2 and C3, which may relate to former power transmission (Plate 30). The roof is pitched, with skylights and ventilation holes. It is unclear if this roof originally featured a hot-working vent. At the west end of the building is a brick-built single-storey structure, partially inserted into the main workshop, with a raised floor level. This houses a medical station (Plate 16). A stairwell is located adjacent to the medical station, leading down to a cellar room. This was not accessed for the survey due to health and safety considerations, but appeared from a cursory inspection to contain electrical switches. The stairs are set within a sloping concrete superstructure.

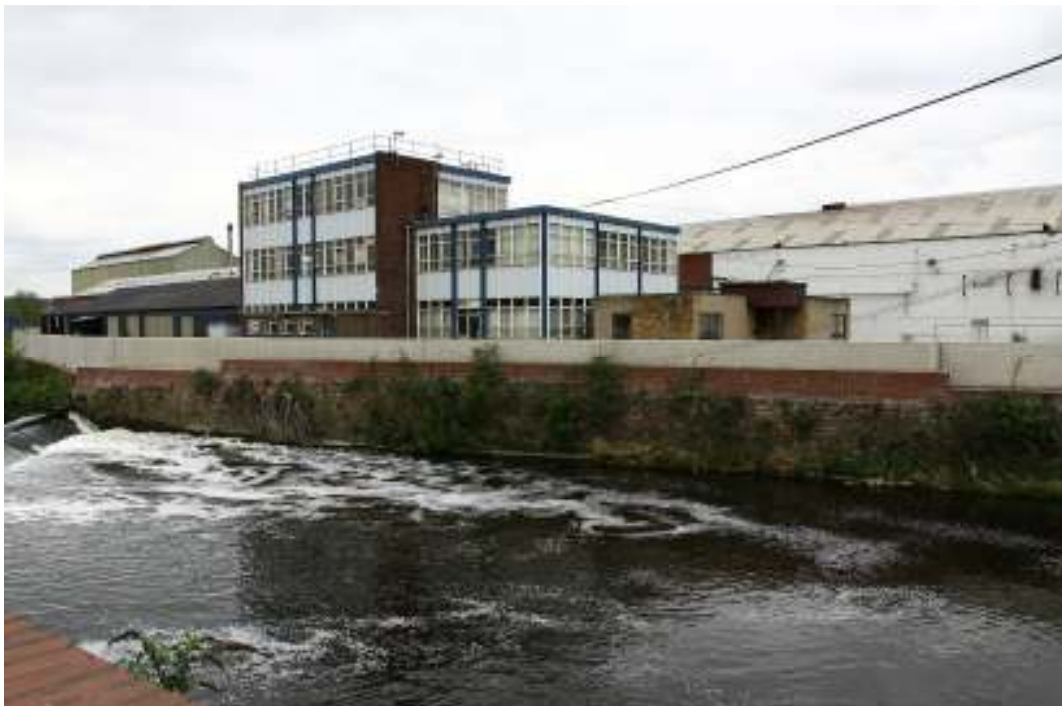
Plate 31: Exterior of Building D, viewpoint 93

The three-storey block is of brick construction, with glazed and panelled sides and a flat roof (Plate 31). The ground floor is accessed via a lobby on the south side, with a freestanding concrete staircase to the east of the entrance leading to the two upper storeys. The stairs have terrazzo surfacing and metal handrails. A boiler room is located to the north of the stairs. To

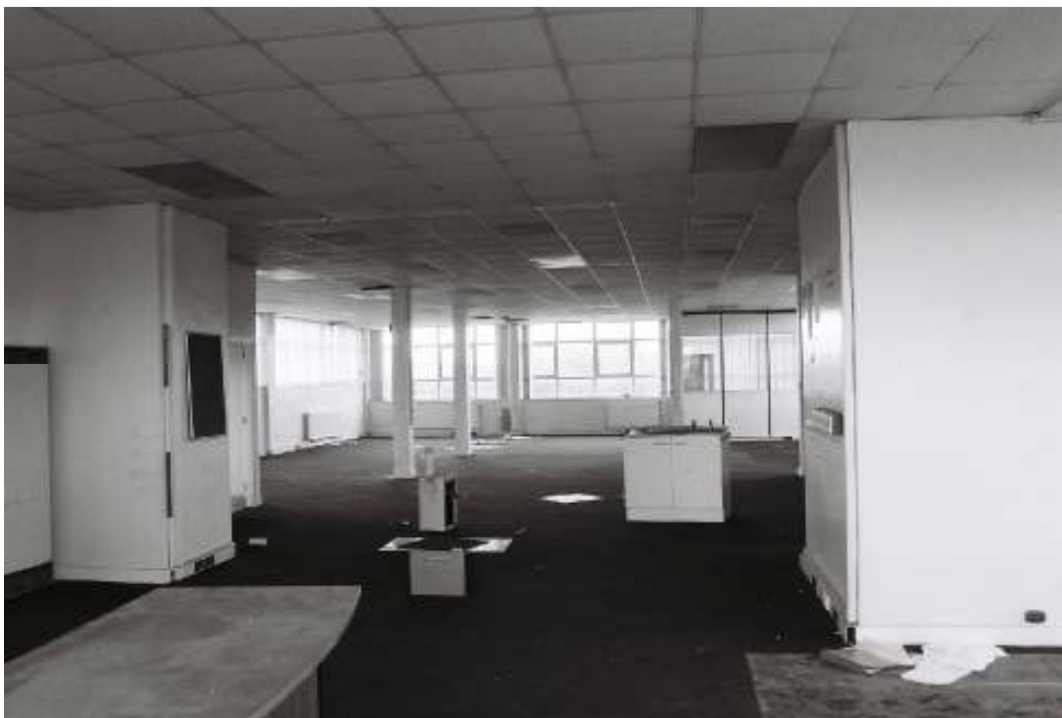
Plate 35: View of first floor open-plan office, Building D, viewpoint 32

The first floor houses a large open-plan office (Plate 35), with a meeting room at the southeast corner formed by glazed partition walls, and WCs at the north side of the office. The second floor has a small office to the west of the stairs, which opens onto two linked larger offices on the north side of the building. The smaller room may have been a secretary's office, with the larger rooms possibly being for senior managers.

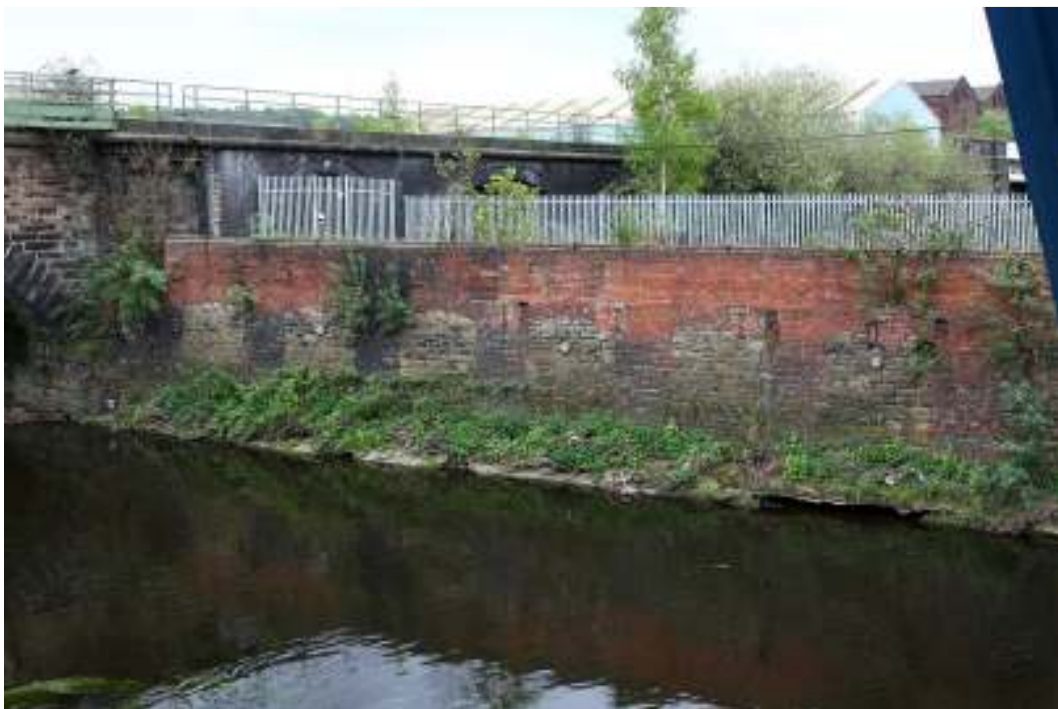
Plate 37: Blocked arches in retaining wall on south bank of River Don, viewpoint 91

To the east of the road bridge, the wall is predominantly of brick construction (Plate 37). The brickwork appears to be of late 19th- or early 20th-century date. There are at least seven blocked openings within this wall, infilled with stone. The openings have arched heads, formed by three rows of header-set bricks, and are likely to have been windows. Alternate windows have a small circular feature set into the centre of the stone infilling, which may represent blocked drainage or venting features. A series of iron or steel I-beams have been inserted into

the wall within brickwork settings, slighting the former windows. The I-beams have been cut flush with the wall. This wall clearly relates to a former building, probably associated with the Phoenix Bessemer Steelworks. A rectangular building was shown in this location on the 1905 OS map, but not on the 1892 map. This may have been the single-storey structure shown on the undated engraving of the works (Plate 1). In 1966, it was shown adjacent to the test house, but it is not clear from the plan if it was part of the test house or disused.
