ARCHAEOLOGICAL EVALUATION AT LAND OFF CHARLES STREET, SHEFFIELD

ARCHAEOLOGICAL EVALUATION REPORT

Report Number 2011/46 September 2011

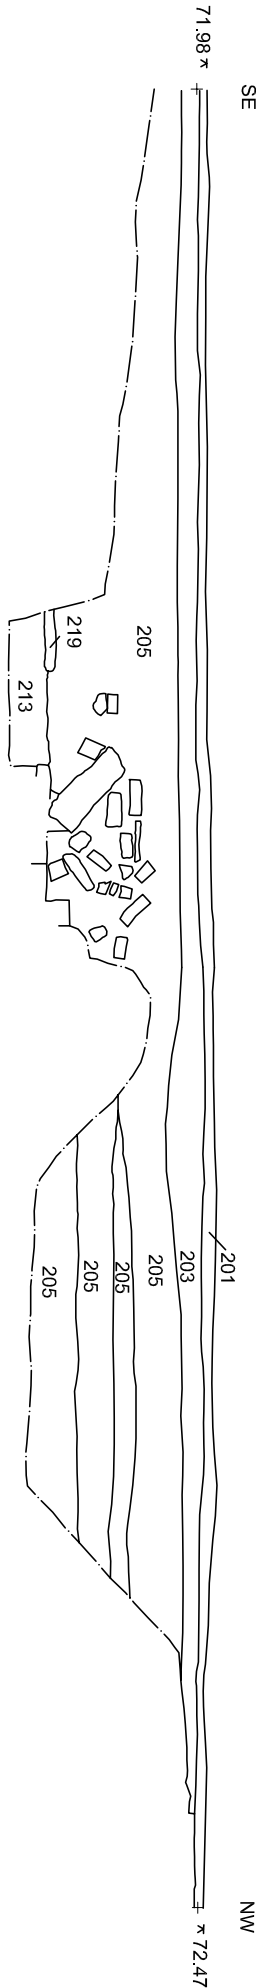
Section 8 - north-east facing section of Trench 2

----- Depth below surface after final machine excavation in trench 2

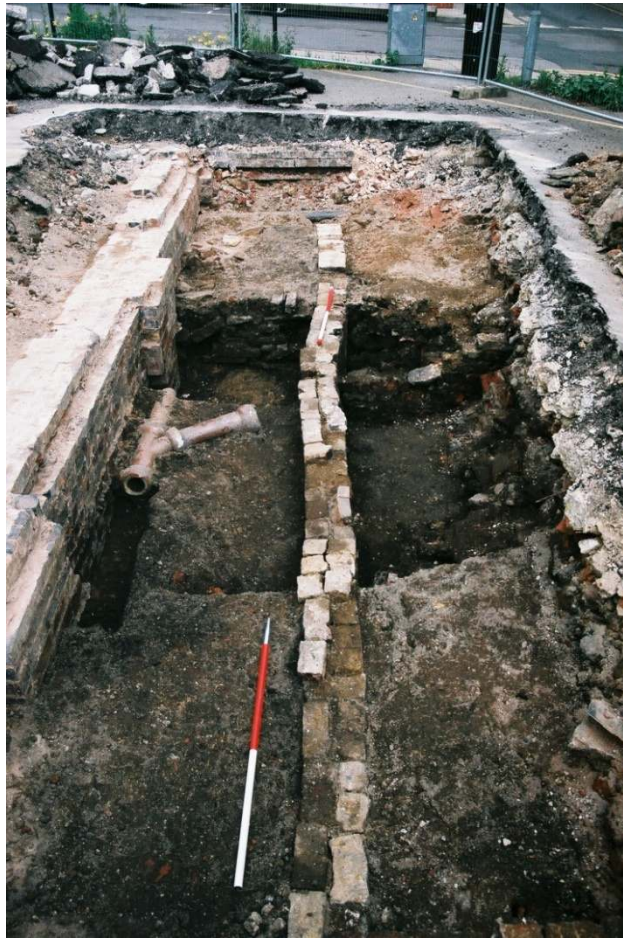
Plate 1: View northeast along Trench 1, showing wall 110 (centre) and wall 105 (left)

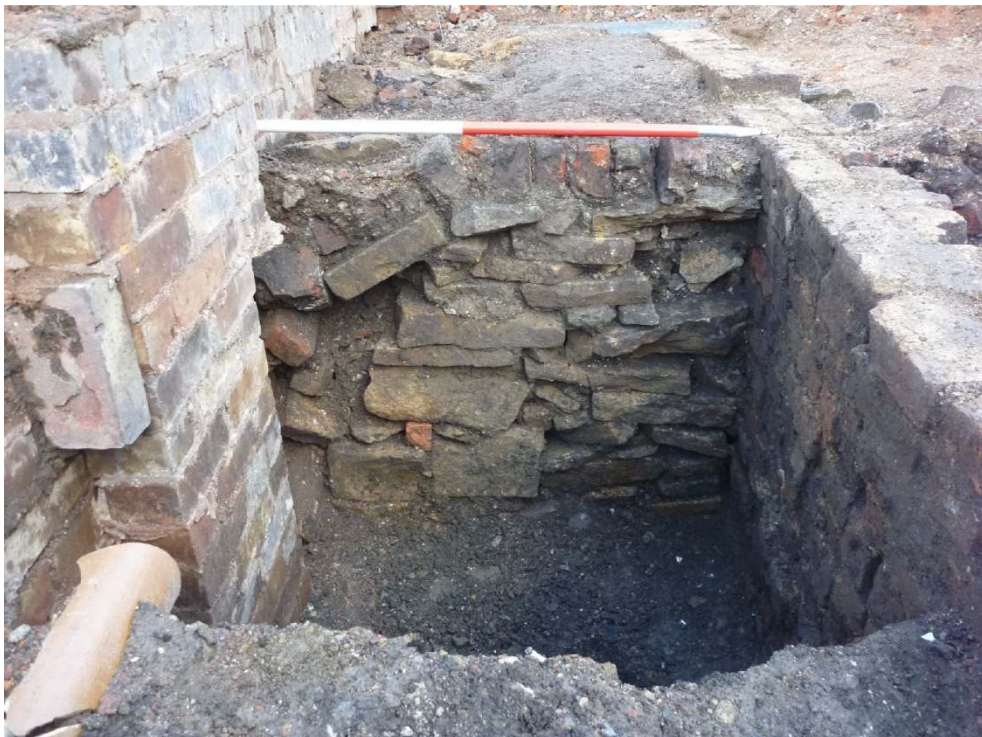
A stone-built wall, 123, was encountered to the north of wall 110. The relationship of these walls was difficult to establish; wall 123 appeared to butt against 110, but the foundation trench for 110 cut through the redeposited natural (126) that appeared to lie against 123, suggesting 110 is later and may have cut through the earlier stone wall. The northwest end of 123 was cut by the foundation trench for modern wall 105, so only a 0.8m length of the wall survived (Plate 2). A sondage was excavated adjacent to 123, but the base of the wall was not reached. The wall was constructed with irregular coursing, with hints of a rubble core between two rows of larger stones. It was topped by a single row of bricks laid on their heads, and may have been the southwest exterior wall of a cellar. A grey-brown gritty silt rubble deposit (127) was located to the northeast of this wall, west of wall 110, possibly the cellar fill. A structure was shown in this location on the 1851 OS map, depicted on the 1896 Goad fire insurance plan as two single-storey buildings, possibly sheds or outshots to the rear of no.114 Charles Street.

Plate 2: Elevation of wall 123, with wall 105 to left and brick wall 110 to right, viewed facing northeast

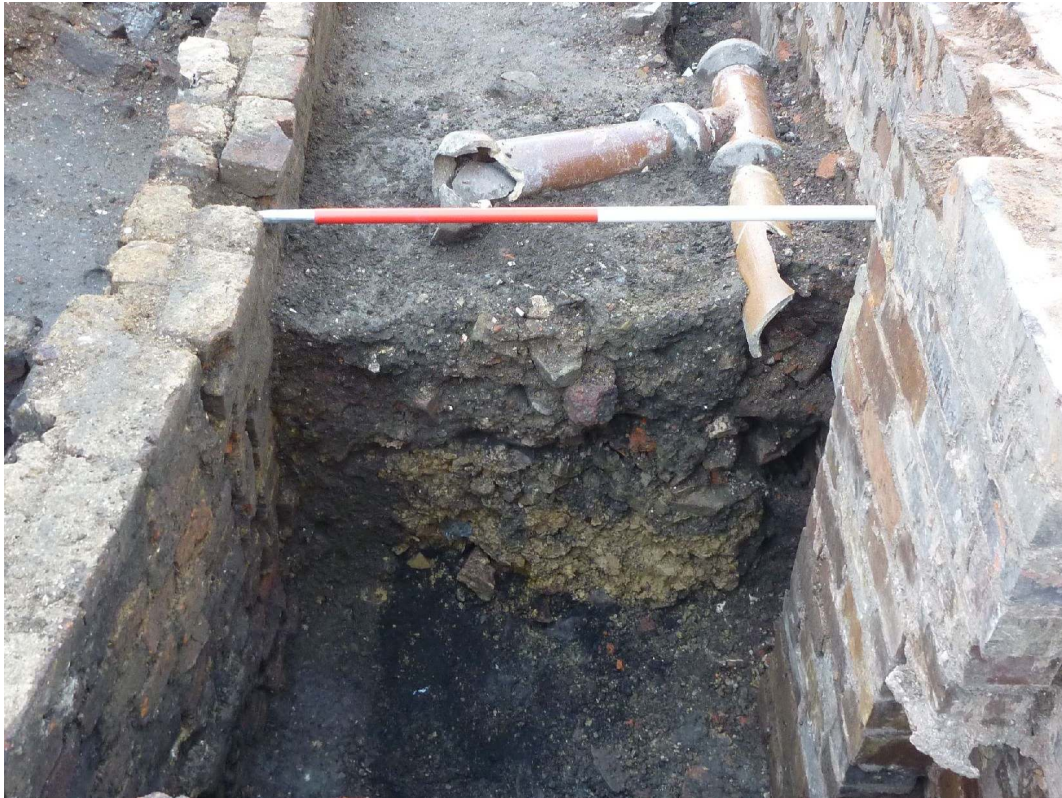
The upper deposit, 111, was a reddish-brown soil with a high rubble content. This was cut by trench 130 for a ceramic water/drain pipe, 118. The pipe ran parallel with the rear wall of the houses (110), at just under 1m distance from the wall. The cut was only visible in section (Figure 7; Plate 3), and had been truncated by the foundation trench for modern wall 105. The pipe trench was filled by a dark grey sandy loam with rubble inclusions (129). The pipe had been damaged by the construction of 105, and clearly related to the 19th-century houses rather than the 20th-century works. The pipe was of ceramic construction, with a junction visible in the exposed part, which headed east towards the wall 110. It is likely that this represents water or drainage supply to the houses, and was probably a late 19th-century addition.

Plate 3: Section of yard deposits in Trench 1, and pipe 118, viewed facing southwest

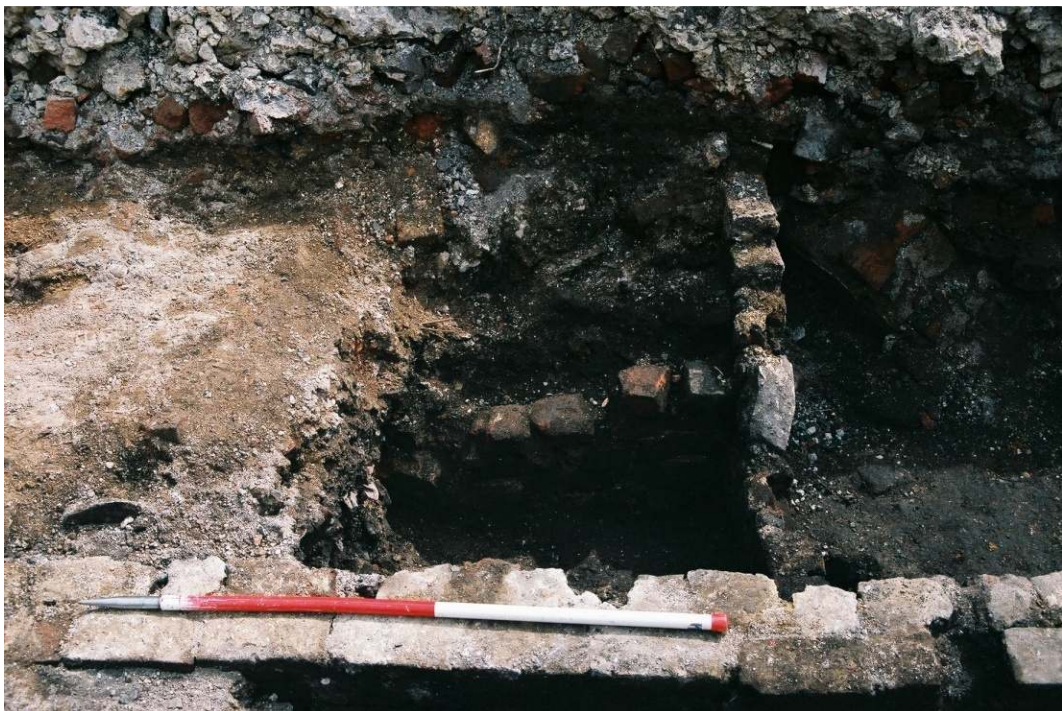
Two single-skin brick walls were bonded to the south side of the external wall 110. These walls, 115 and 116, were interpreted as dividing walls for the cellars associated with the terraced houses. They were constructed of handmade brick, and butted against the rear wall, partially tied in to the upper courses. Plaster was visible on the southwest face of wall 116. Walls 115 and 116 were 3.45m apart, indicating the width of the former houses. Two cellars were investigated, one between walls 115 and 116, the other to the northeast of wall 115. Sondages were excavated into the cellar fills; due to the narrow area of the cellars exposed in the trench, it was not possible to excavate to the floor level. A further cellar fill, 120, was located to the southwest of wall 116. This was not investigated, as only a very small segment of this cellar was exposed in the trench.

Plate 4: Trench 1, detail of walls 115 and 119, wall 110 in foreground, viewed facing southeast

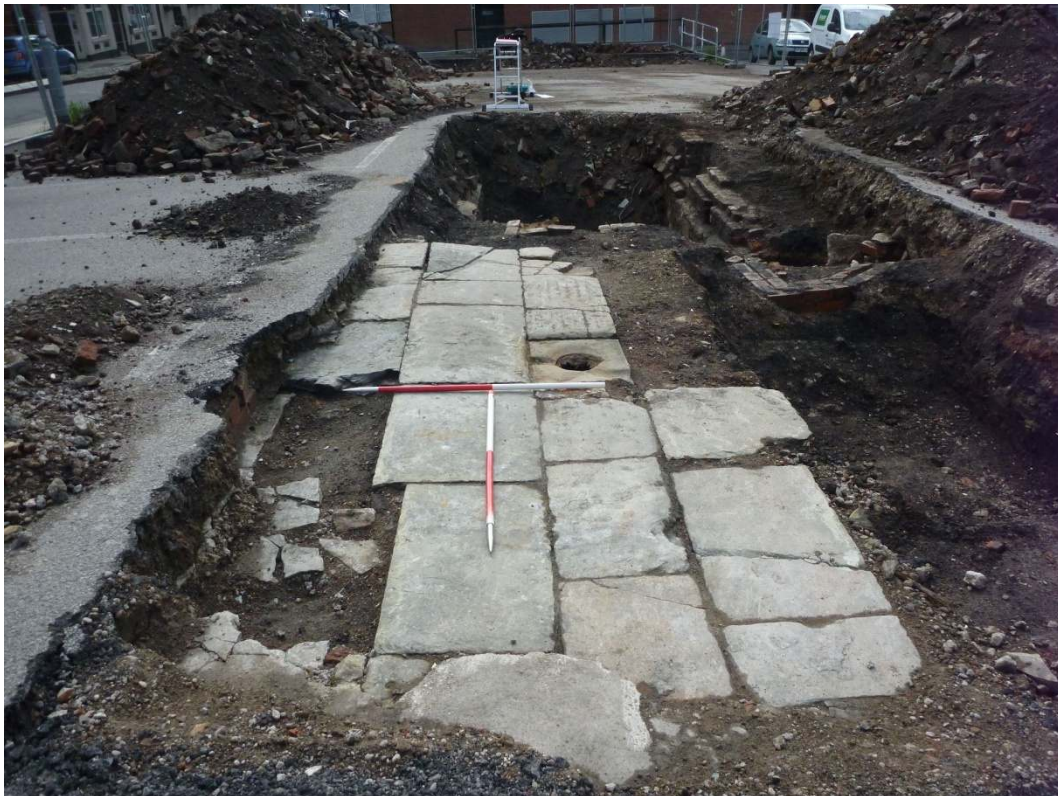
Plate 5: Trench 2, stone flag surface 204, viewed facing southeast

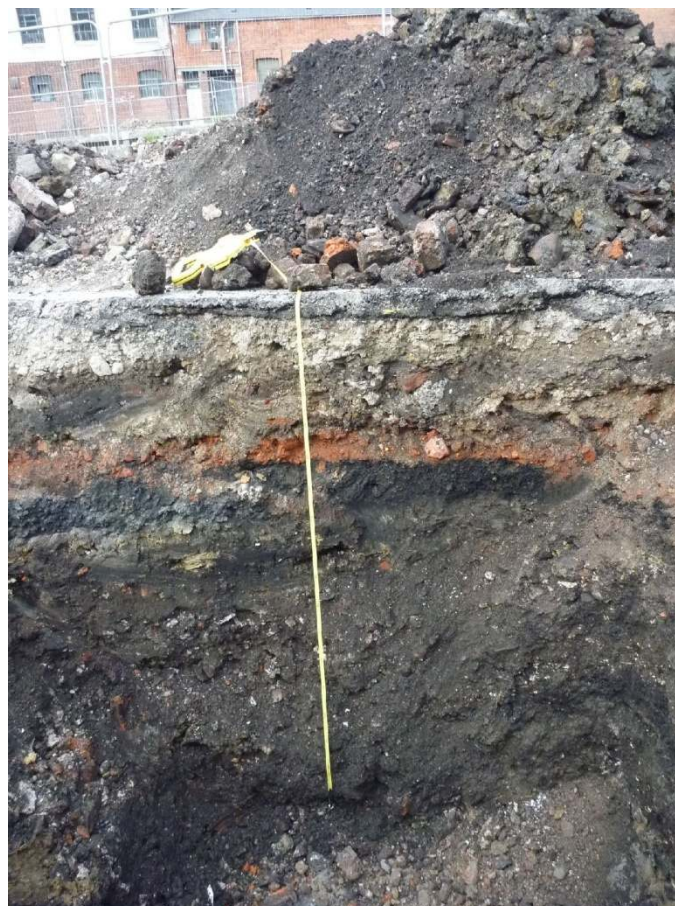
The flags were sitting on made ground, 205, which comprised a series of dumping or levelling layers including rubble, brick rubble, clay lenses and gravelly material. At the northwest corner of the trench, these made ground layers continued down to 1.8m below the tarmac surface, where a yellow-grey clay was encountered, possibly the natural bedrock (Plate 6). This was revealed in a machine-excavated sondage. To the southwest of the flagged surface, the made ground 205 surrounded an irregularly-shaped brick-built feature, 206. This feature was constructed of frogged, machine-made red bricks, and had two parallel sides running at a diagonal angle from the north end of the feature, forming a narrow chamber (Plate 7). The structure was quite poorly built, with awkward joins between the north end and the diagonal walls. Structure 206 was a maximum of six brick courses in height, and the south ends of the sides were stepped, apparently truncated. The feature was half-sectioned, revealing a concrete base with a narrow linear hollow along its centre, suggestive of a pipe trench or drainage channel. The concrete was overlain by a thin, sticky, green-brown deposit. The purpose of the feature was unclear; it is tentatively interpreted as being related to 20th-century sanitary arrangements. It was filled by a brick rubble deposit with a high proportion of whole or nearly-whole bricks, which was interpreted as part of dumping layers 205. The bulk of the finds recovered from layer 205 came from within and around this feature, and included a relatively large quantity of ceramic sherds, mainly domestic forms of 19th- to 20th-century date, as well as 19th- to 20th-century bottle and window glass.

Plate 6: Trench 2, section of made ground deposits 205, viewed facing southwest

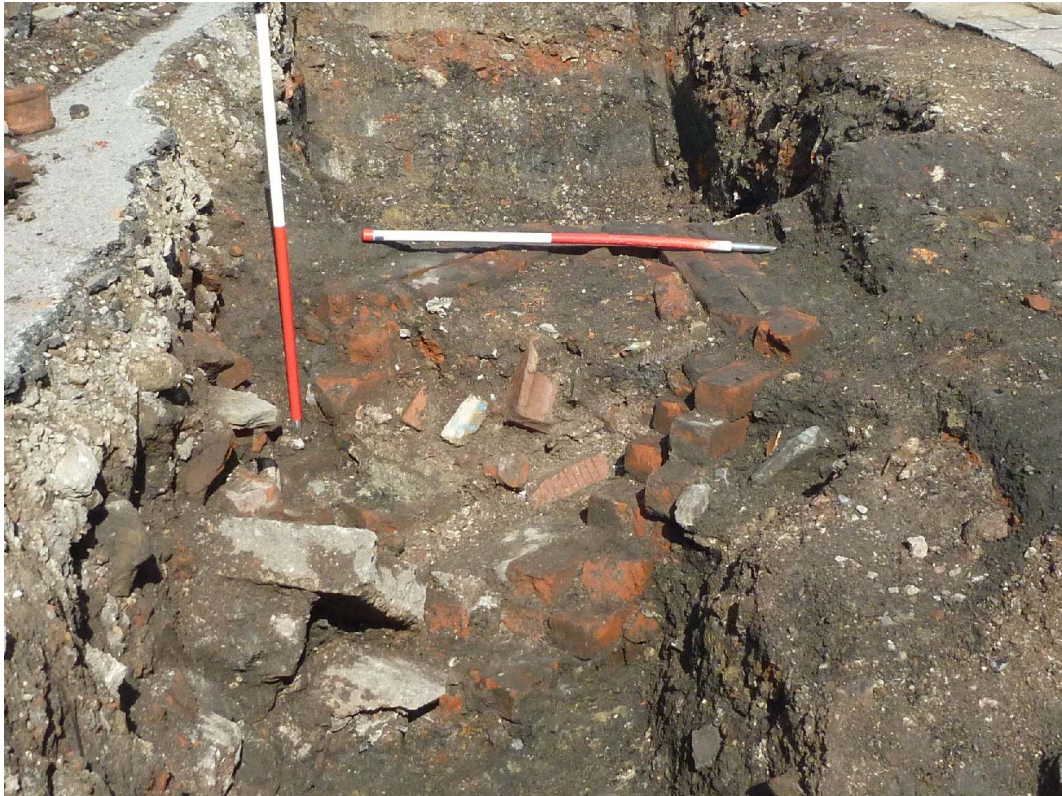
Plate 7: Brick structure 206, viewed facing northwest

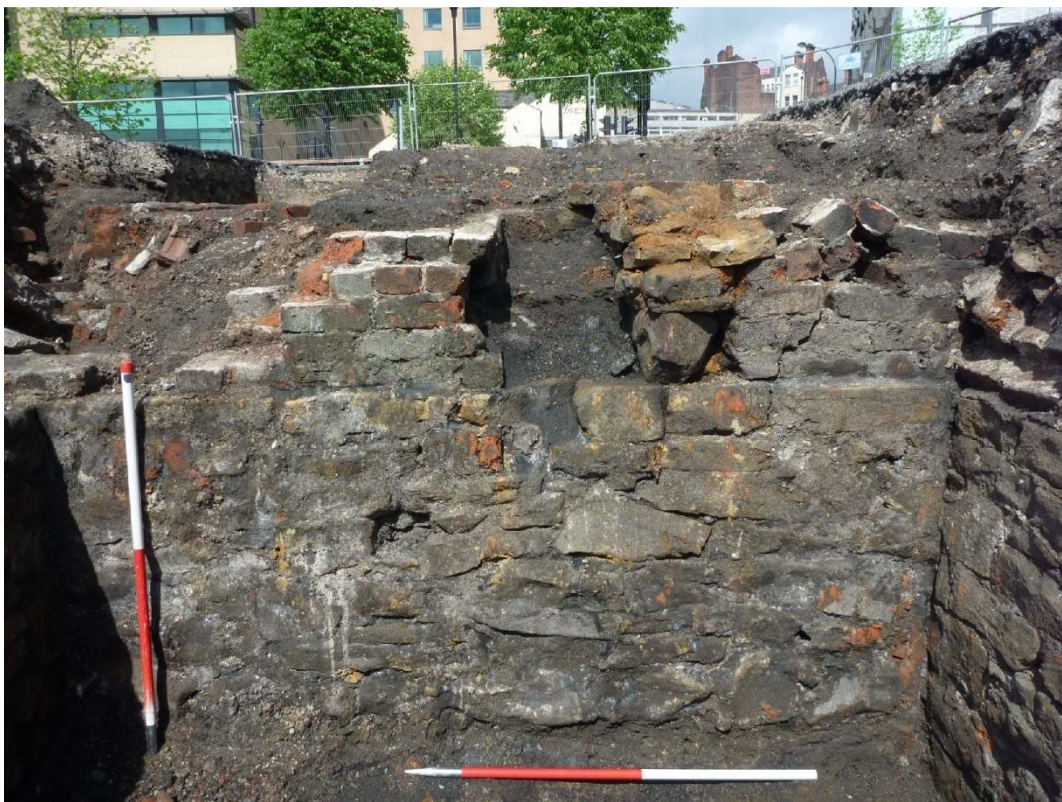
Plate 8: Northwest cellar wall 208, with coal chute 209 above, viewed facing northwest

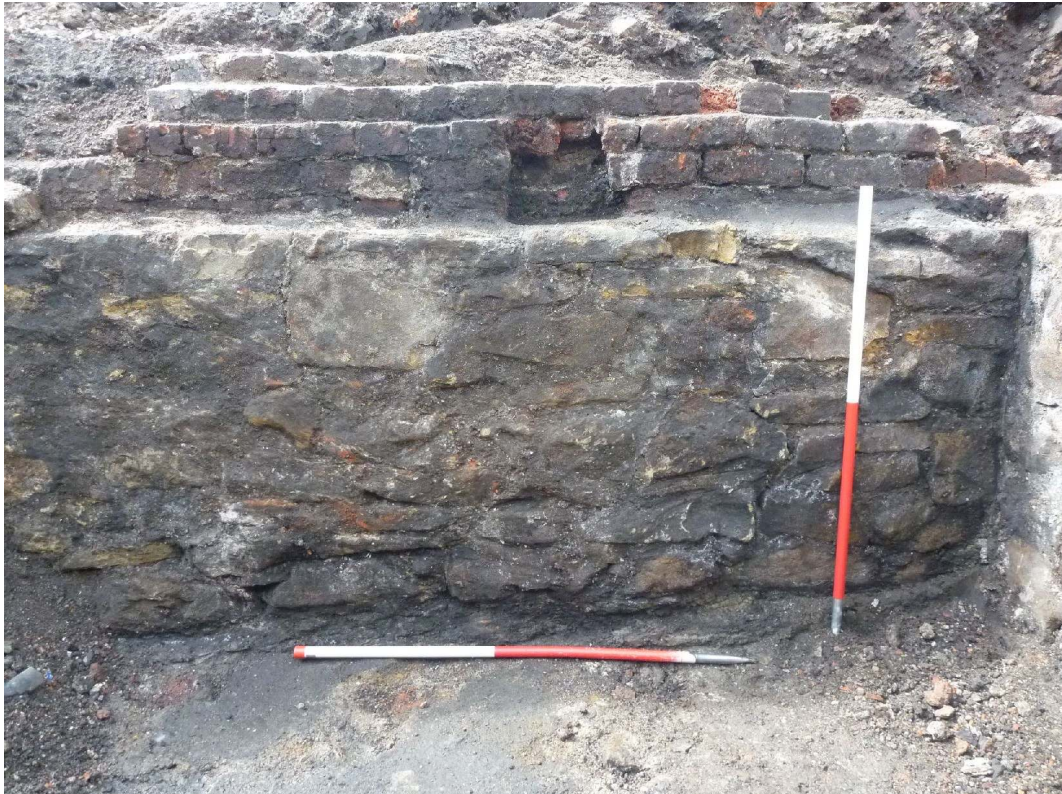
On top of the northeast and southwest cellar walls were the remnants of springers for a vaulted brick ceiling (207). On the southwest wall this was topped by unfrogged brick wall (216), which presumably formed the main fabric of the building (Plate 9). Within the northwest wall were the remains of a structure interpreted as a coal chute, a rectangular compartment extending to the northwest of the cellar, constructed of handmade red brick (209). The interior of the compartment contained coal dust (217), which sloped downwards towards the cellar and could also be seen in patches on wall 208 below the coal chute. The coal chute appeared to have been altered at some point, with stone blocking (214) reducing it to half its original width. The 1851 and 1896 maps suggest that the coal chute would have been accessed from the yard to the rear of no.100 Charles Street, which could be reached via a cart passage between nos.100-102. No remains of the passageway survived within the trench, with the flagged surface 204 having been removed in this area.

Plate 9: Trench 2, southwest wall of cellar (208), with overlying brick wall 216

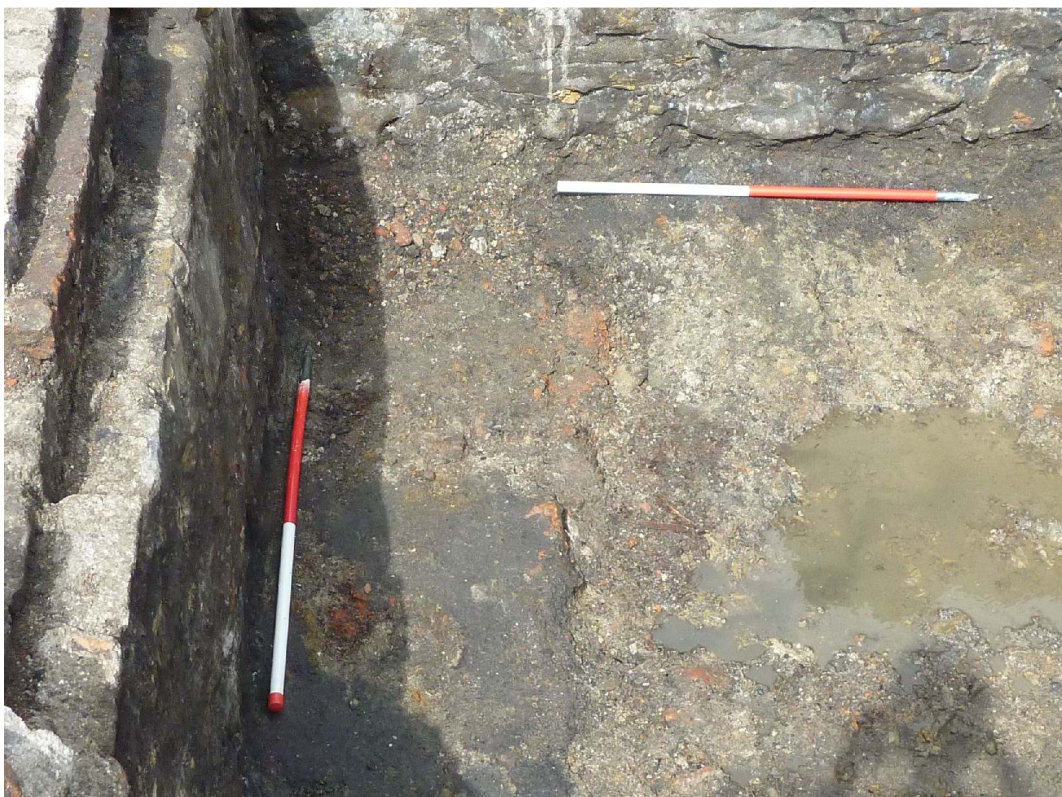
The cellar appears to have had an earth floor, with the clay bedrock at the base (211) being stained with coal dust indicating that it was exposed during the cellar's use. Patches of mortar (212) overlay the clay, particularly at the southwest side of the cellar, suggesting there had been a later mortar floor (Plate 10). The cellar fill, 210, comprised a rubble deposit including sections of the cellar ceiling, suggesting that the backfilling coincided with the demolition of the building. The fill contained industrial waste material, including bundles of steel wire and a grindstone.

Plate 10: Trench 2, floor 212 of cellar, viewed facing northwest

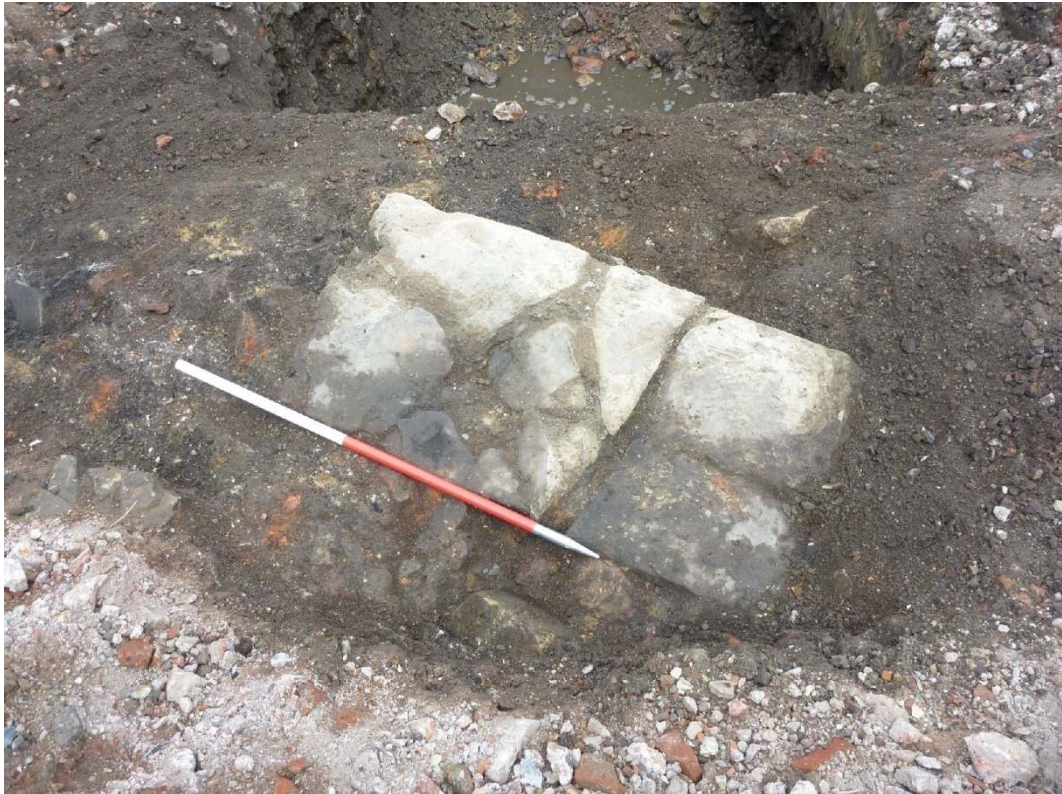
The upper layer of the trench comprised a dark brown sandy clay with frequent brick and stone fragments, representing crushed demolition rubble (301). This layer was c.50cm thick. In the southeast end of the trench, 301 overlay the remnants of a stone flag surface, 302. This comprised several large sandstone flagstones and unfrogged brick fragments set on a patchy bedding layer of lime mortar (Plate 11). The flagstones were aligned at an angle of c.45 degrees to the orientation of the streets and former buildings as shown on historic maps. No associated structural remains were noted, and only a small patch of the surface survived (1m by 2m), so its date and relationship to earlier works buildings are unclear. The surface overlay a dark brown, very compact sandy clay made ground deposit, 303.

Plate 11: Trench 3, remnant of surface 302, viewed facing northwest

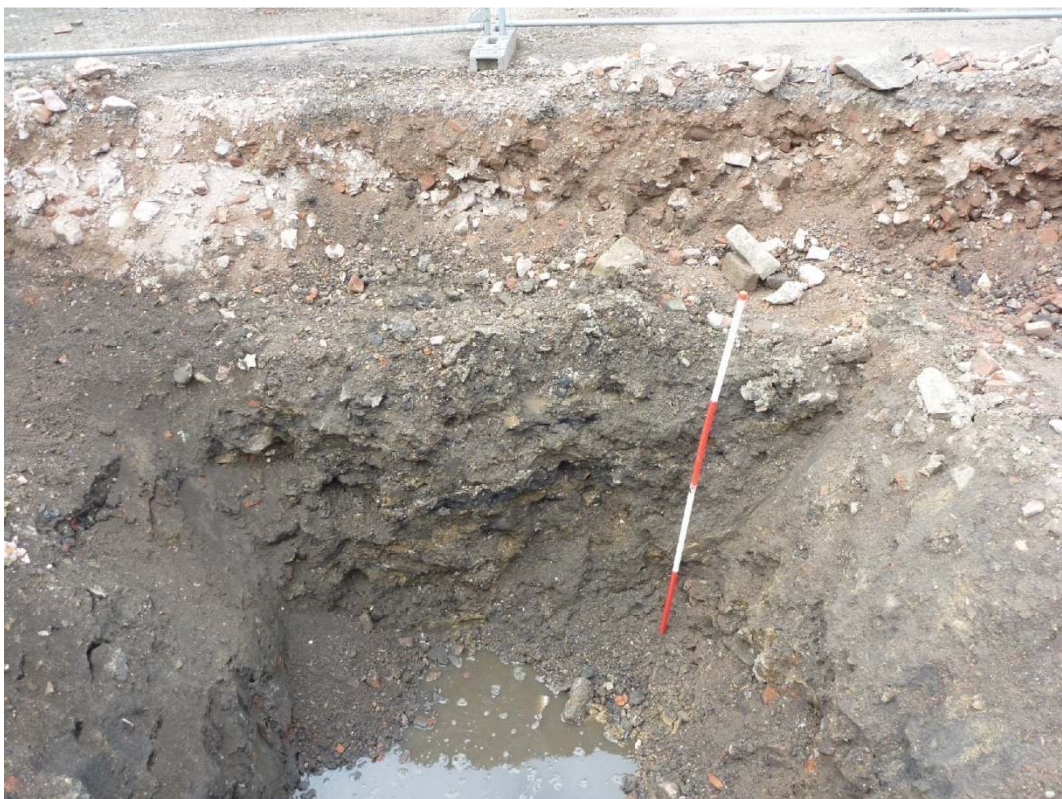
Deposit 303 comprised all the made ground deposits underlying 301, and was excavated by machine to a depth of 2.3m below the ground surface in the centre of the trench (Plate 12). No natural subsoil or bedrock layers were encountered within this trench. This part of the site is assumed to have been disturbed by the removal of foundations and cellarage associated with the former works buildings.

Plate 12: Trench 3, section through made ground 303, viewed facing northeast

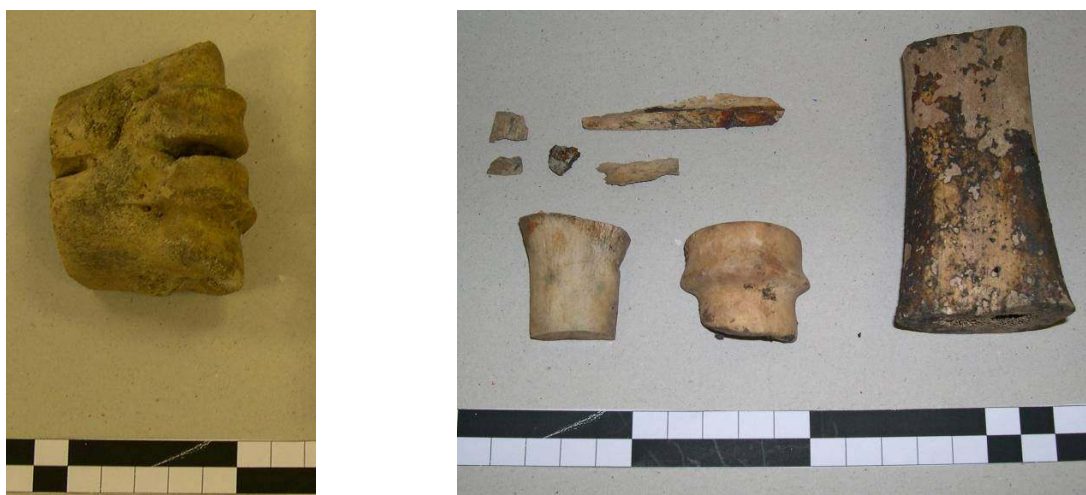
Figure 1. Left; ref 111/22, sawn end of a long bone. Right, ref 128/16, the shaft is sawn to the required length. Fragments from handle preparation.

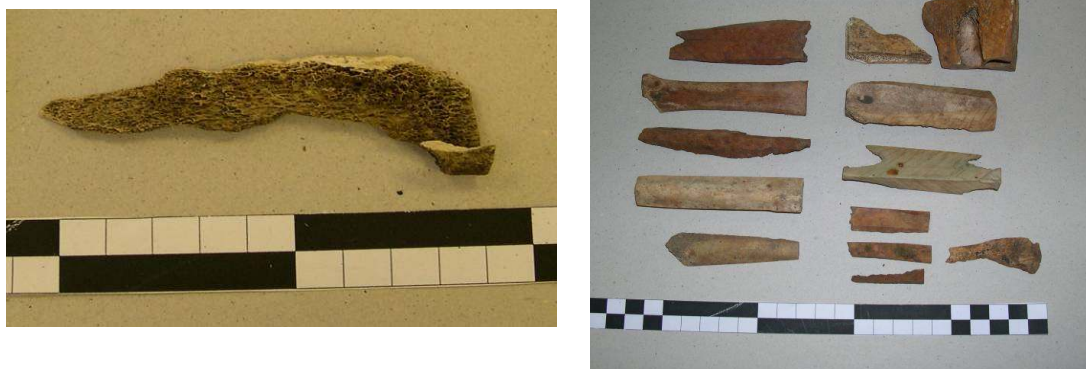
Figure 2. Left, ref 114/5 sawn bone, cross section suggests a rib. Right, ref 205/34, manufacturing waste; showing the square section from which 'quadrants' were removed.

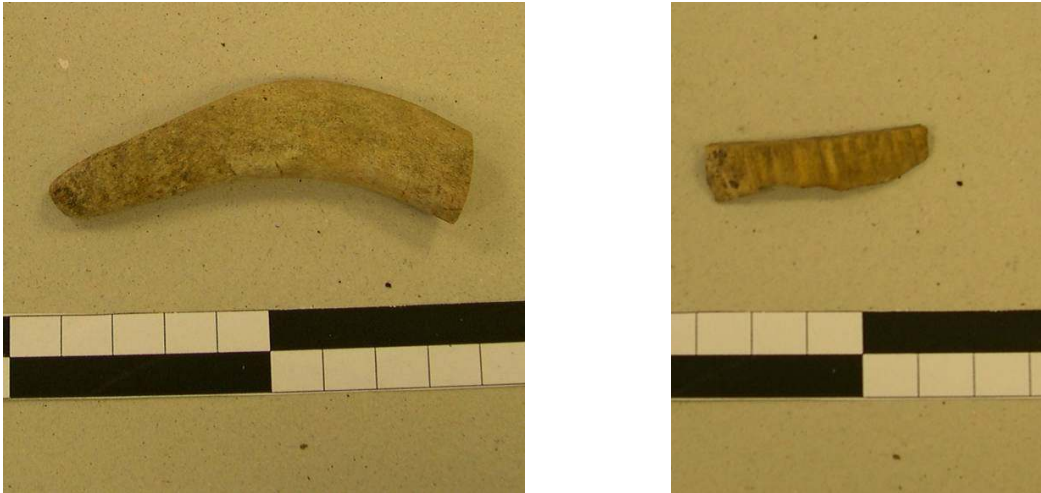
Figure 3, Left, ref 126/6, sawn antler tip. Right, ref 205/32 possibly stag antler or ivory.

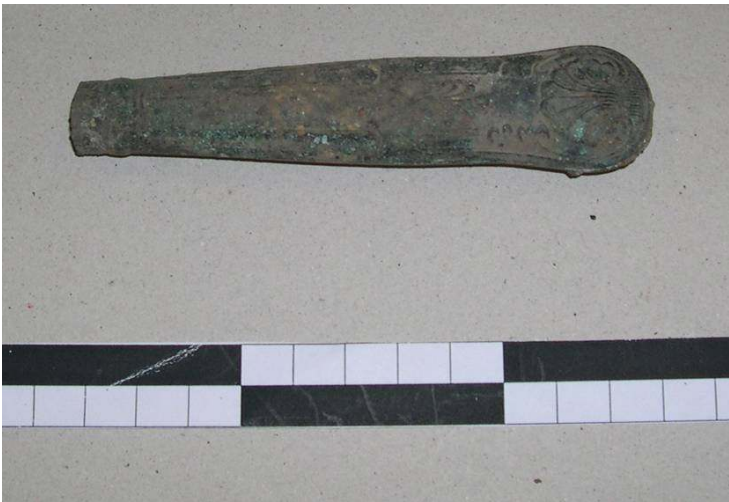
Figure 4. Ref 205/34, nickel silver, King's Pattern knife handle.
