**ARCHAEOLOGICAL INVESTIGATIONS AT THE MANOR
HOUSE, NORTH WINGFIELD**

WATCHING BRIEF REPORT

Report Number 2013/24 September 2013

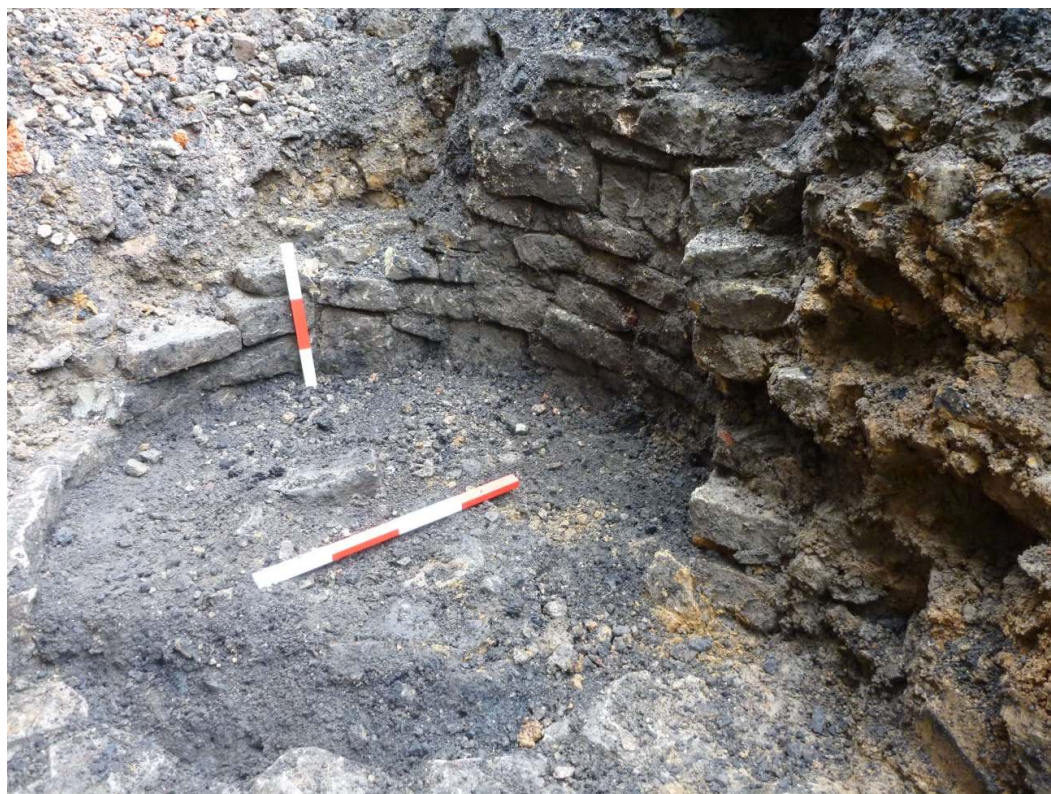
Plate 2: Well (context no.105) viewed from the south

A stone-lined well (105), oval in plan, was recorded in the southern part of the foundation trench. This was built from irregular, angular pieces of sandstone that survived to a height of 0.3m on its northern side. The well measured 1m in length and 0.9m in width, with a principally east-west alignment. Its better surviving northern side appeared to extend up to the base of the topsoil (100). The well was in-filled by a modern loose, brown silty material

(106) containing some stone rubble, pottery, glass and plastic. The well's construction and relationship to surrounding deposits suggests a c.19th-century date. It was not excavated, as the foundation would be able to bridge over the feature, a construction cut number [107] was assigned.

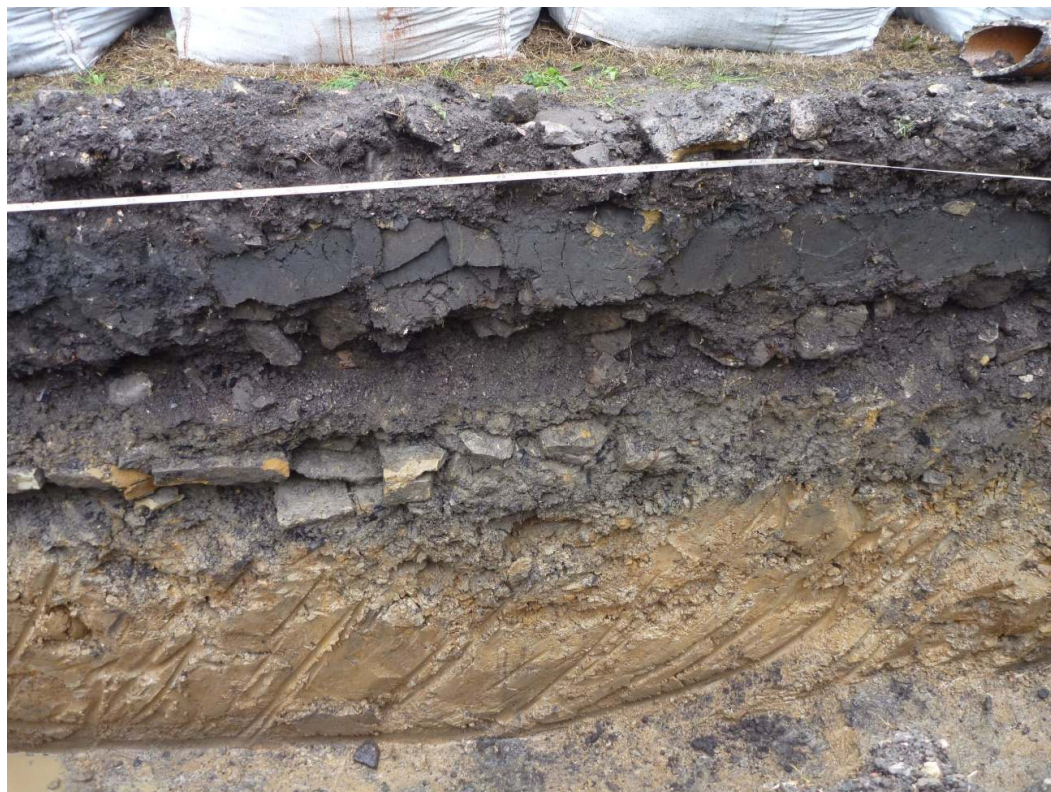
Plate 3: Stone built structure (context no.108) viewed from the north

A stone-built structure (108) was exposed in the north-facing section of the northern foundation trench. In some areas, it appeared to be a one course thick slab surface. In others, it appeared to be two or more courses thick and resembled a wall. The feature was entirely within subsoil deposit (101). Where it passed over cut feature [109], the stones appear to have sunk in to the fill of the earlier feature (110). No finds relating to this feature were recovered and a date cannot be established.

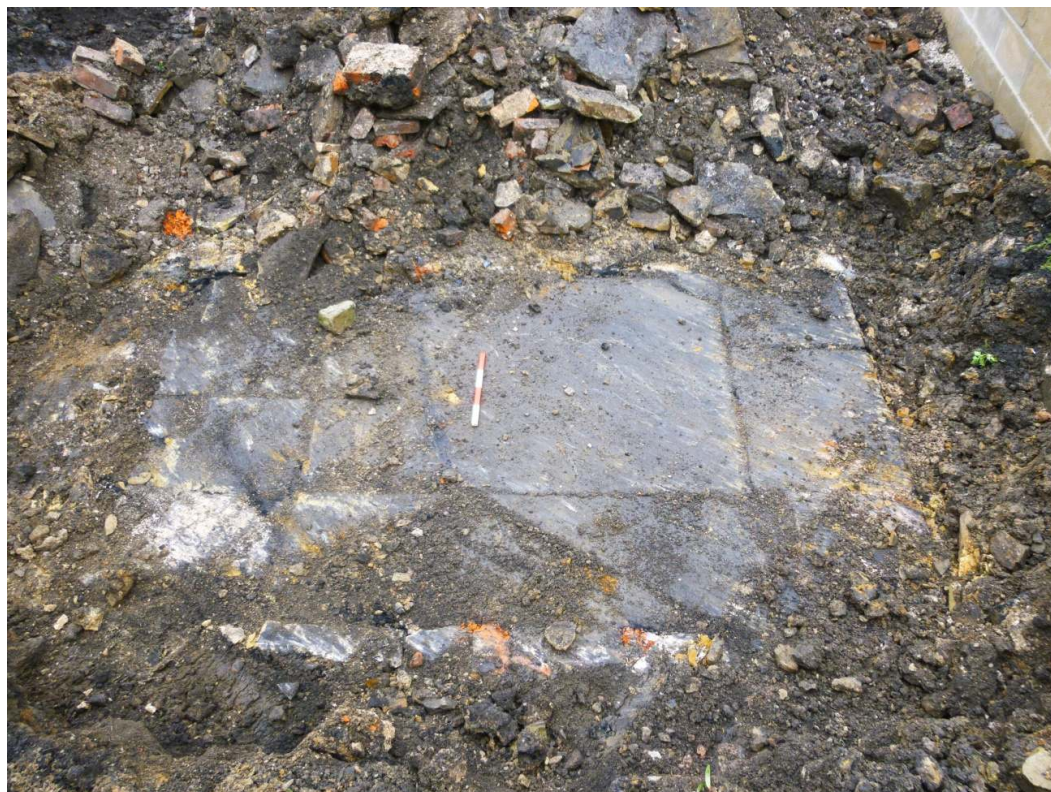
Plate 4: Flagstone surface (context no.115) viewed from the west

A stone wall foundation (114) and associated flagstone floor (115) was exposed in the eastern part of the foundation trench. The wall formed the corner of a structure, revealed 0.1m below the ground level, with arms aligned north-south and east-west. It was built from sandstone fragments with dressed exterior faces and was bonded with a lime-based mortar. Overall the walls measured 3.1m north-south, 3.2m east-west and 0.55m thick. The base of the wall was 0.65m below the ground surface.

The flagstone floor (115), exposed 0.55m below the surface, was keyed-in to the internal faces of the wall. The average flagstone measured approximately 0.8m in length by 0.6m in width and up to 0.18m thick. The floor was also bonded with a lime mortar. The structure was bedded on a silty clay containing small coal fragments up to 0.05m thick. The western edge of the floor was bounded by the remains of a red brick wall bonded with lime mortar. The structure does not appear to have survived to its full extent as the walls become rubble and indistinct at both ends. This feature is probably the surviving part of a c.19th- to c.20th-century outbuilding, mostly destroyed by later activity.
