**ARCHAEOLOGICAL INVESTIGATIONS AT CHARLES  
STREET, SHEFFIELD**

*ARCHAEOLOGICAL REPORT*

Report Number 2014/46    December 2014

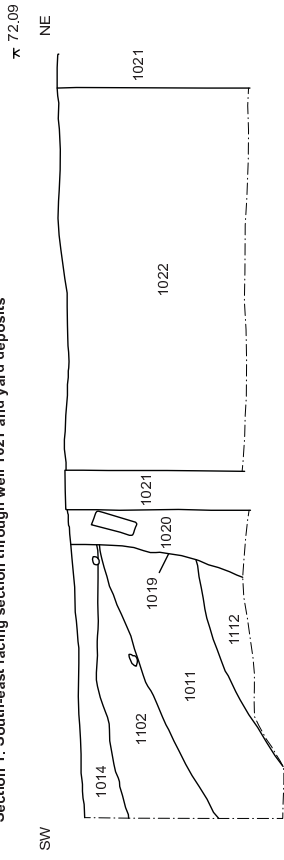
Section 1: South-east facing section through well 1021 and yard deposits

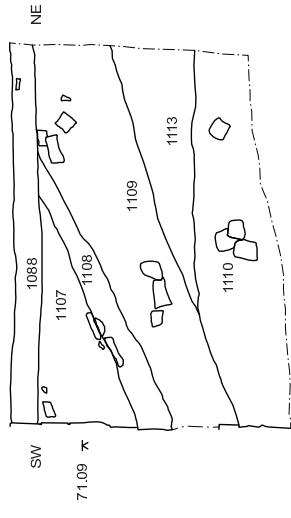
Section 2: South-east facing section through the backfill of Cellar F

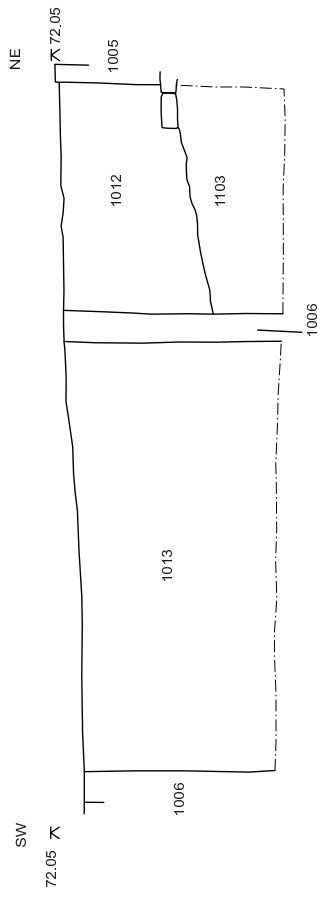
Section 4: South-west facing section of well 1006

rendered with grey cement. The structure and depth of 1006 suggests that it was probably a well that had been backfilled in the late 19<sup>th</sup> or early 20<sup>th</sup> century. The post-demolition fill of the well was a loose dark grey sandy deposit containing frequent clinker, black ash and occasional brick and mortar fragments (1013). This deposit was excavated to a depth of approximately 1m, but the base of the fill and the well were beyond a safe and practical excavation depth. The well fill contained transfer printed 19<sup>th</sup>-century pottery, late 19<sup>th</sup>- to early 20<sup>th</sup>-century glass, three late 18<sup>th</sup>-century pipe bowls, some unworked animal bone and a lump of iron clinker slag.

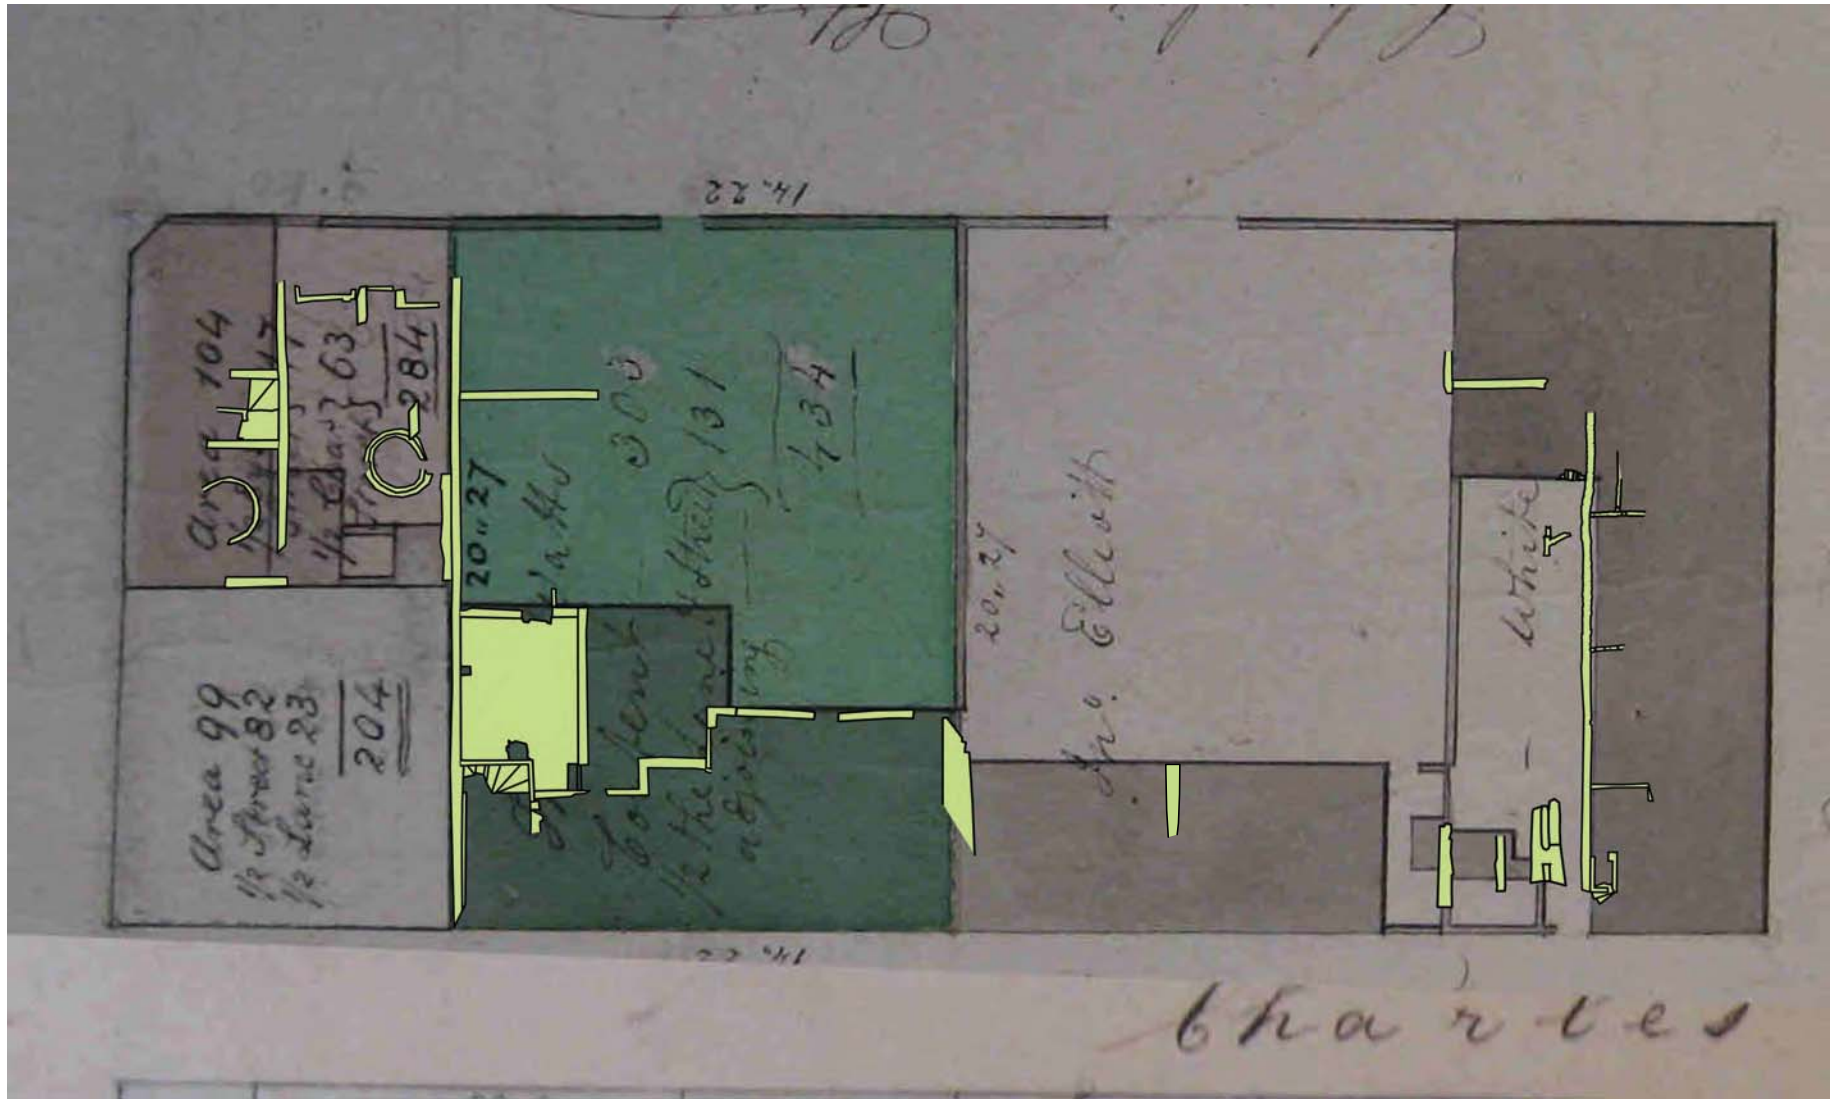
Figure 8. Phase 1 structures over a 1819 map

At the extreme south-western end of the site, the back wall (1139) of a row of terraced houses fronting onto Eyre Lane was recorded (Figure 4). These were present on the 1819 map (Figure 8) and likely to be contemporaneous with the Phase 1 structures observed in the north-western end of the site. The cellars fronting onto Eyre Lane displayed some signs of later modification. A possible yard deposit (111) related to these cellars produced 24 clay pipe fragments, eight of which dated between 1800 and 1900 and sixteen of which dated between 1830 to 1860. The fill (125) of foundation cut [124] for the main back wall (1139) of this row of cellars contained two clay pipe stem fragments, dating between 1780 and 1900. These dates fit with the belief that these structures were amongst the earliest phase of development on the site and were in constant use for over 100 years until their demolition in the mid-twentieth century.

An outhouse structure related to the houses fronting onto Eyre Lane is clearly visible on the 1819 map (Figure 8). Several walls were observed in this location (Figure 4), but most of them seem to be later (Phase 3), likely replacing part of the earlier structure that is represented on the 1819 map. However, two of the walls (1188) and (1215) appeared of an earlier construction than the internal walls and floor surface, and may be all that remain from the original structure. A nearby drain (1176) and associated wall (1177) have also been tentatively

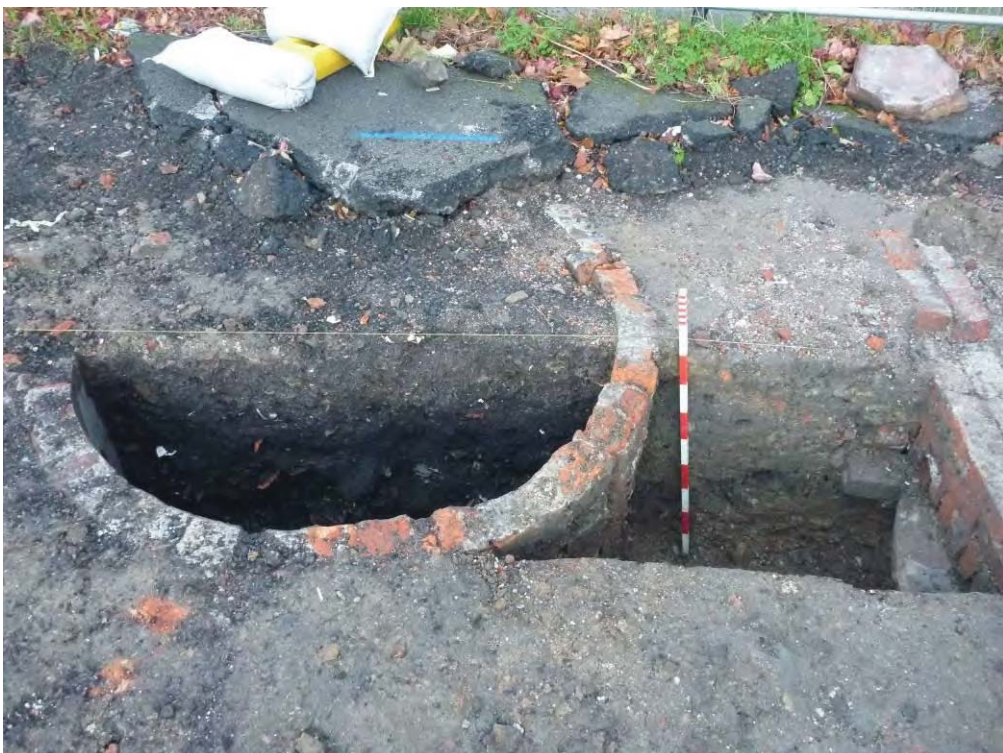
Plate 2: South-west facing elevation of investigative slot dug through well 1006

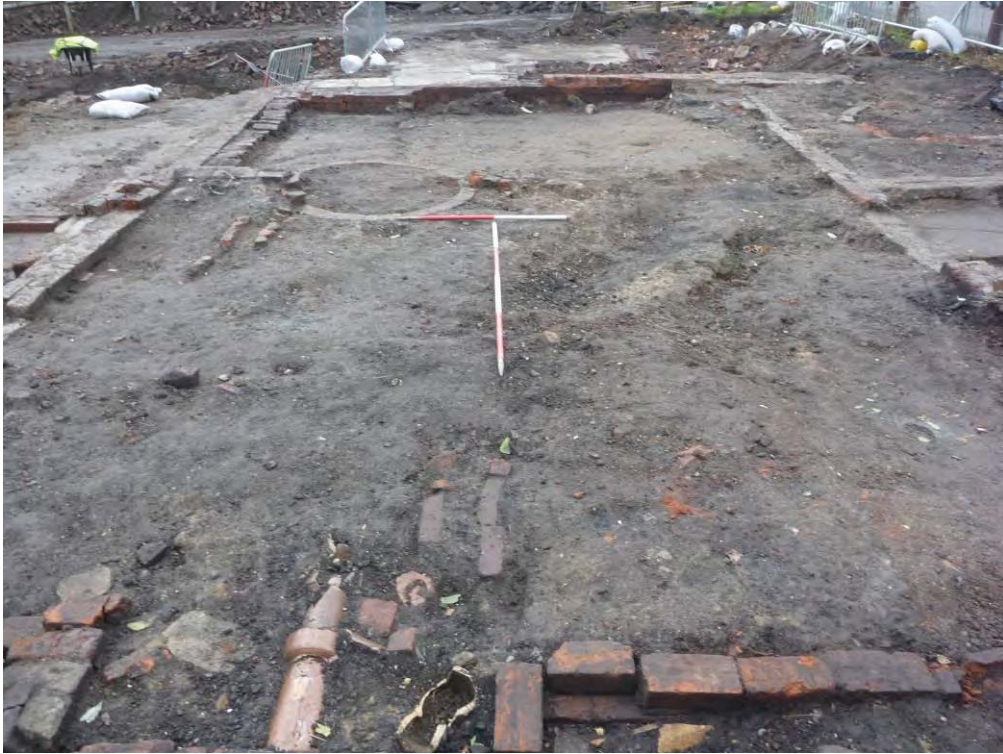
**Plate 3: Yard containing well 1021, amongst other features, viewed from the north-east**

The yard (Plate 3) was bounded on all sides by walls (1003, 1009, 1018 and 1029). The discontinuous wall 1029 on the north-eastern side was not excavated due to its proximity to the trench edge. The surviving sections of wall 1029 were all constructed from handmade red bricks and were a single brick wide. A number of ceramic service pipes had been cut through the wall. These services replaced culverts 1027 and 1028 that were also located in the yard. The culverts were built from reused handmade red bricks which measured up to 230mm long, 110mm wide and 80mm thick. These culverts may relate to well 1021, although no direct relationship could be established. It is possible that this relationship was removed by the construction of walls 1024 and 1101 that were built over the well after it had been infilled with deposit 1022. These walls may relate to a ceramic drain, 1026, located adjacent to wall 1101. They were built from partial, reused handmade bricks of poor quality. The well itself (Plates 4 and 5) was built from similar bricks bonded with a light grey lime mortar. Its internal face was rendered with grey cement, similar to well 1006. Its fill, 1022, was a loose, dark grey brown, sandy silt containing frequent fragments of clinker, brick, mortar and occasional pieces of slag. The fill was excavated to a depth of 1m, which did not reveal the base. Other finds within this

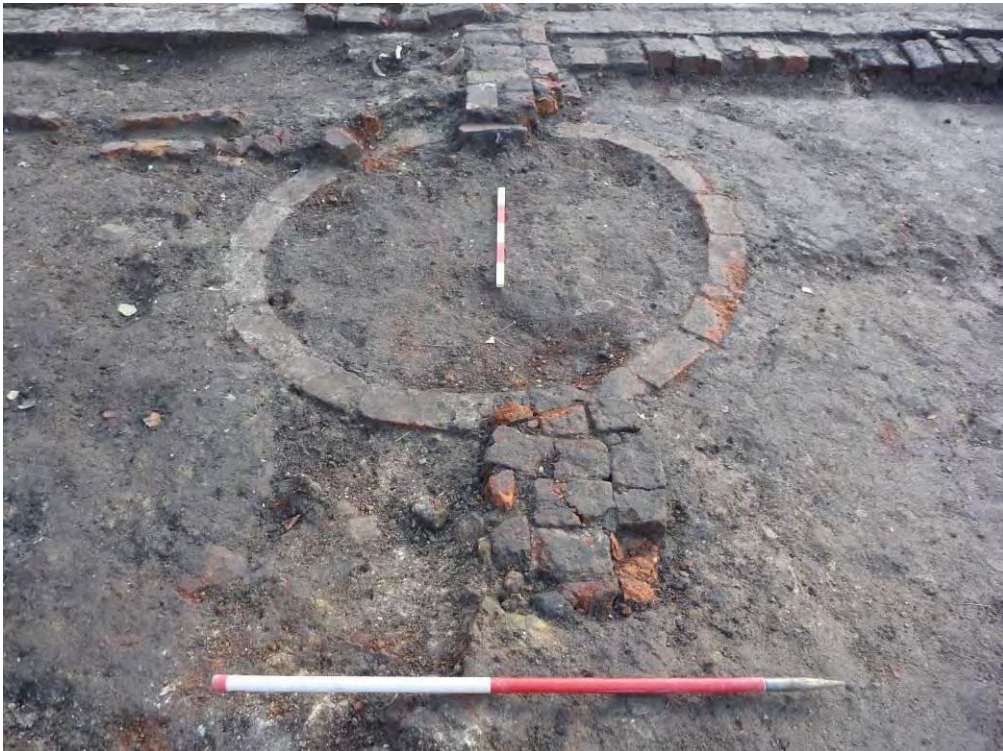
**Plate 4: Well 1021, pre-excitation, viewed from the north-west**

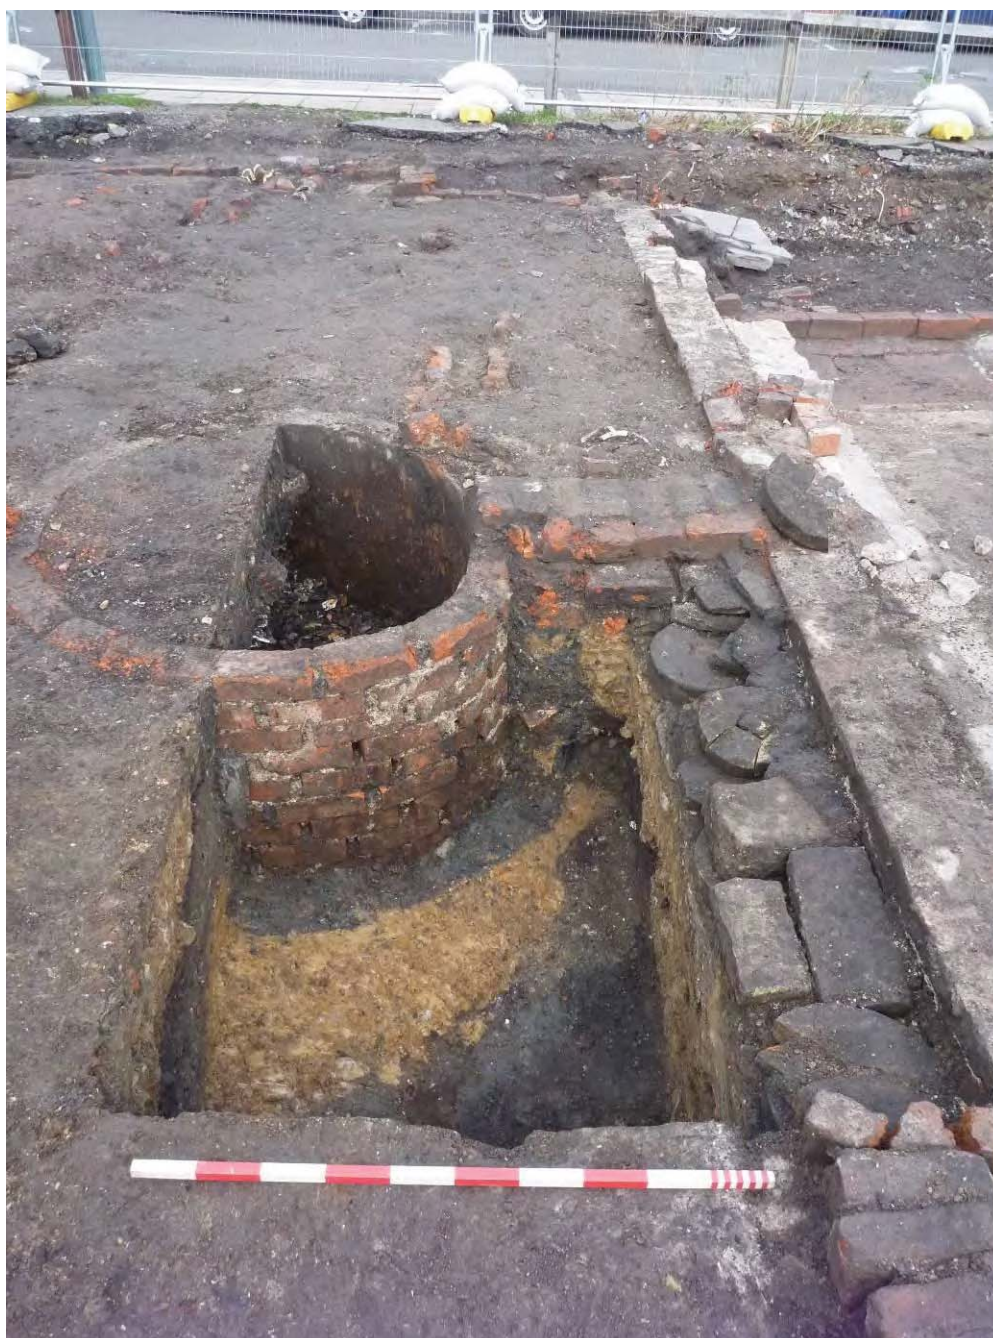
**Plate 5: Well 1021 and associated deposits, post-excitation, viewed from the south-west**

Outside the well, to the south-west, a sondage was excavated to establish the sequence of deposits and possible surfaces in the yard and their relationships to the well. Contemporary to the well was wall repair 1017. This was built up against wall 1018 on the same north-east to south-west alignment, and constructed from reused handmade bricks laid as headers on base or on edge. It was built on a foundation of rough sandstone pieces and reused grindstone fragments. Overall it measured 2.89m long, 0.22m wide, and 0.35m deep, so was probably not a load-bearing structure. Both wall 1017 and well 1021 were constructed in cuts that were excavated through the uppermost surviving yard deposit 1014. This was a firm mid brown silty clay with frequent mortar flecks and occasional small brick and mortar fragments. Beneath this were two dump deposits. The upper deposit, 1102, was a compact, yellow-brown sandy clay, overlying 1111, a friable, dark grey-brown sandy silt, that was deposited on top of the natural clay 1112 and built up against wall 1018. All of these yard deposits contained pottery dating from the late 18<sup>th</sup> and 19<sup>th</sup> centuries as well as some unworked shell and early 20<sup>th</sup>-century glass. This appears to indicate that the yard had been in continual use from the late 18<sup>th</sup> century through to the 20<sup>th</sup> century. The boundary wall 1018, forming part of a boundary line extending north-east to south-west across the entire site, had a second sondage excavated through it further north-east (Plate 6). This revealed a similar sequence of dump deposits (1154-1156), again containing late 18<sup>th</sup> to 19<sup>th</sup> century pottery, beneath the uppermost yard deposit 1014 and overlying the natural clay.

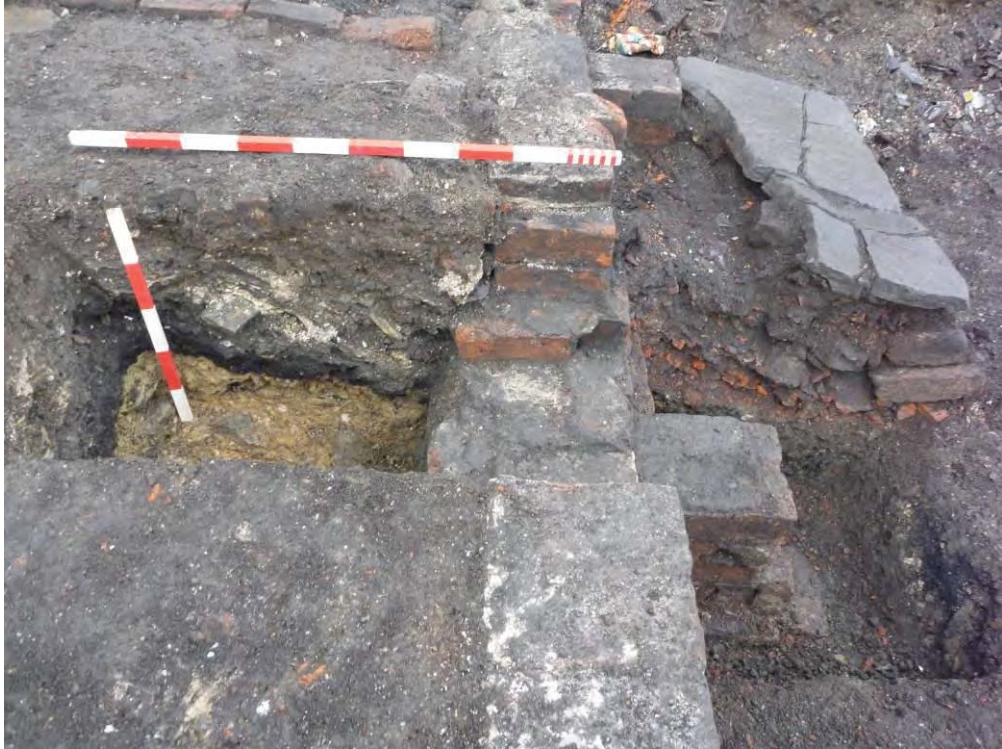
**Plate 6: Investigative slot dug through wall 1018 viewed from the south-west**

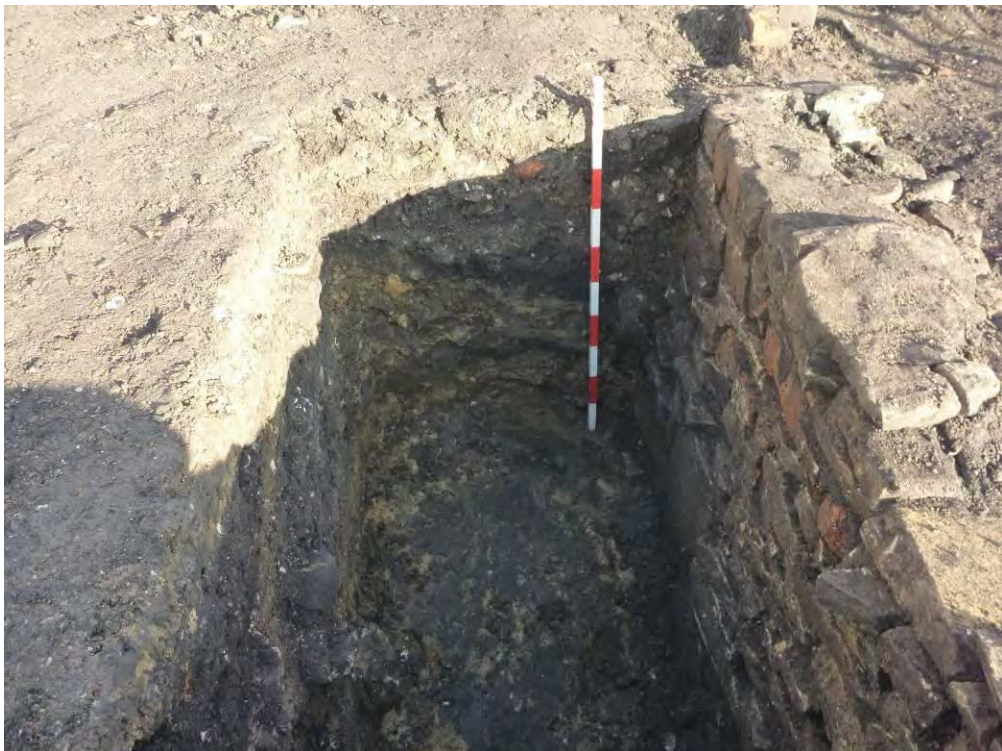
**Plate 7: Investigative slot dug adjacent to wall 1085, viewed from the south-west**

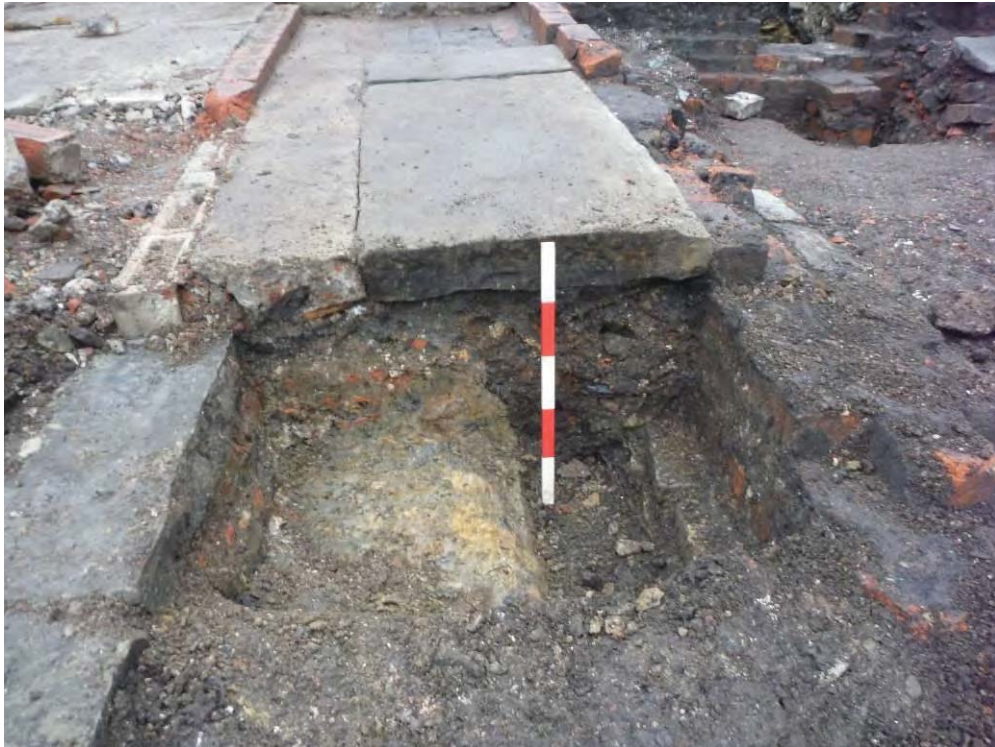
**Plate 8: Investigative slot dug through surface 1034 viewed from the south-east**

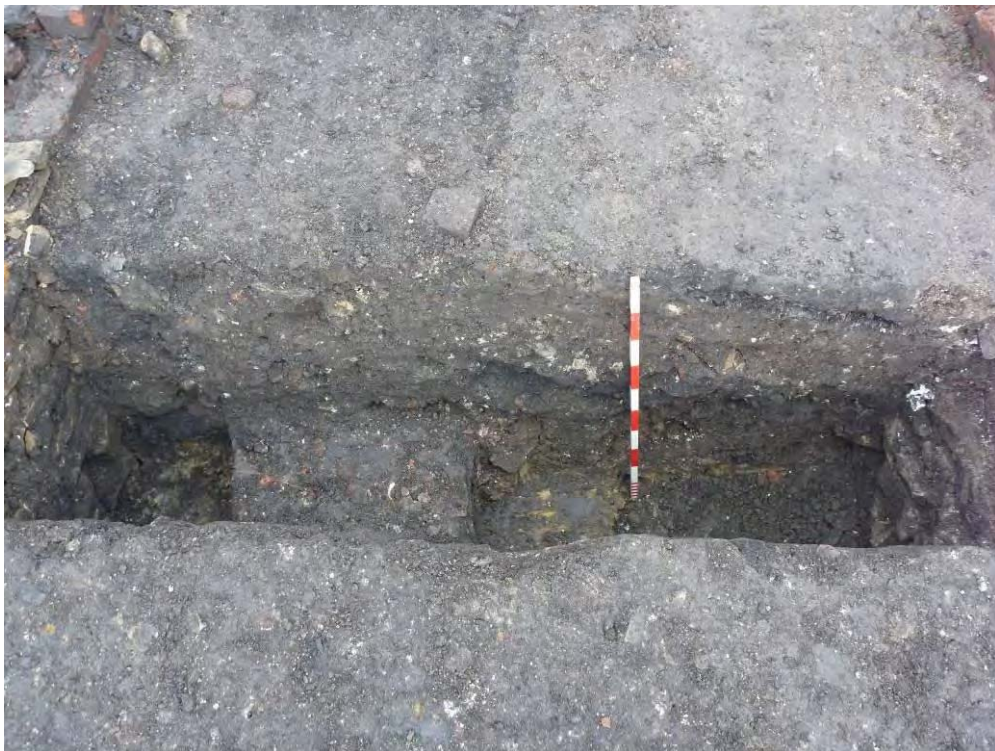
**Plate 9: Investigative slot dug between to walls 1085 and 1087, viewed from the south-west**

was made from stone slabs, machine-made bricks and concrete and post-dated remnants of a sandstone slab yard surface, 1037, which was also exposed in evaluation trench 2 (context number 204). A sondage was dug through the stone slabs of the ginnel surface (Plate 8), revealing that it was built on top of a levelling deposit 1080, a friable, dark brown sandy silt containing frequent brick and sandstone fragments. This overlay a fragmented brick surface, 1081, which in turn overlay the foundation cut and fill for the construction of cellar wall 1084 (1218 and 1217). The construction cut had been excavated through an earlier compacted grey clay and mortar deposit 1082 probably a former surface overlying natural clay 1153. Deposit 1082 contained a number of sherds of 18<sup>th</sup> and 19<sup>th</sup> century pottery including a sherd from a blue feathered edge, scallop rim, white earthenware plate and a sherd from an earthenware pancheon. This sequence of deposits and features appear to relate to the surfaces of a cart passage between walls 1085 and 1087, enabling access from the northern yard to Charles Street.

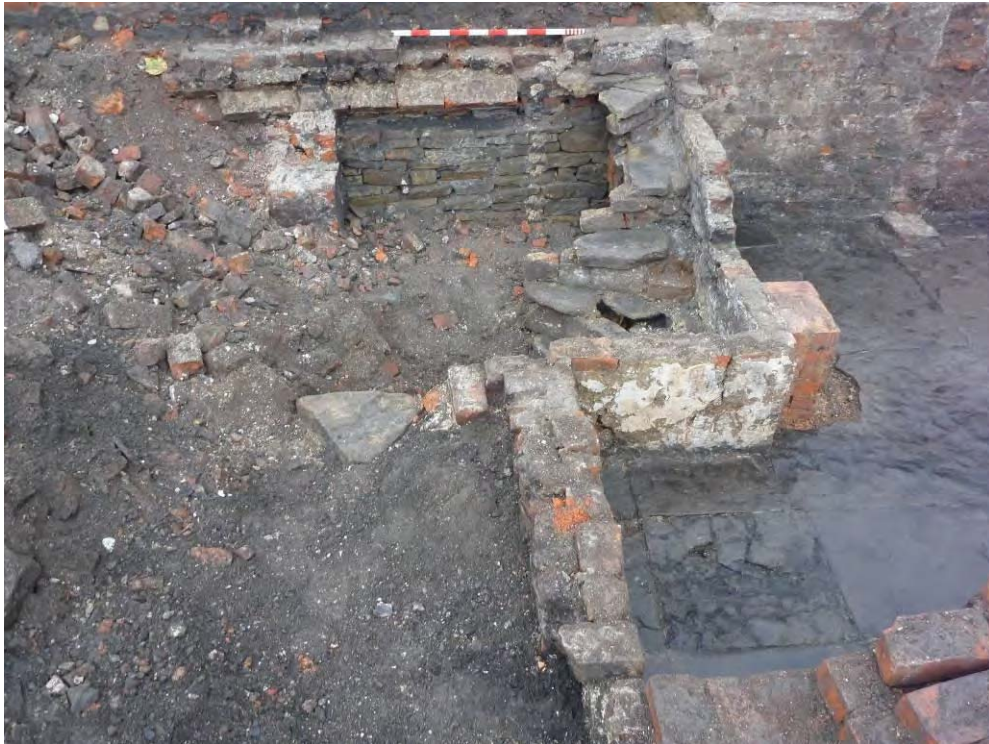
**Plate 10: Cellar C viewed from the south-east**

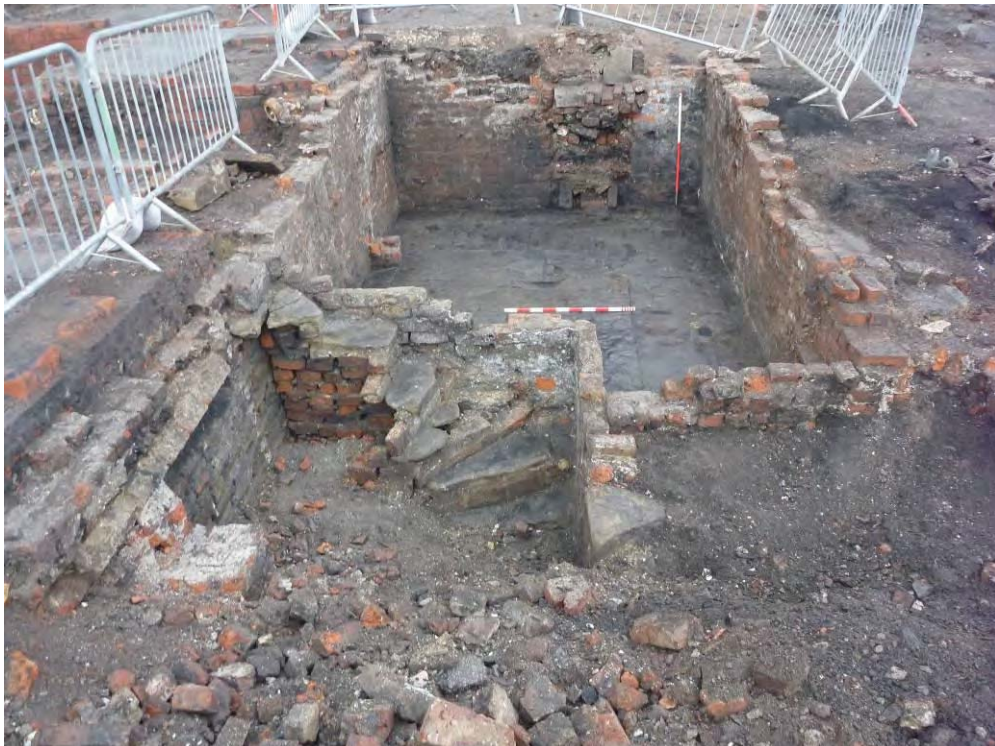
**Plate 11: Cellar B viewed from the south-west**

The demolition infill of the larger Cellar B was completely excavated (Plate 11). The majority of this material (1042) was brick rubble and mortar, presumably from the demolition of the overlying structure. Finds included an early 20<sup>th</sup>-century ceramic ornament, two glass bottles dating 1888-1897 and numerous metal objects. Beneath the rubble was a worn sandstone slab

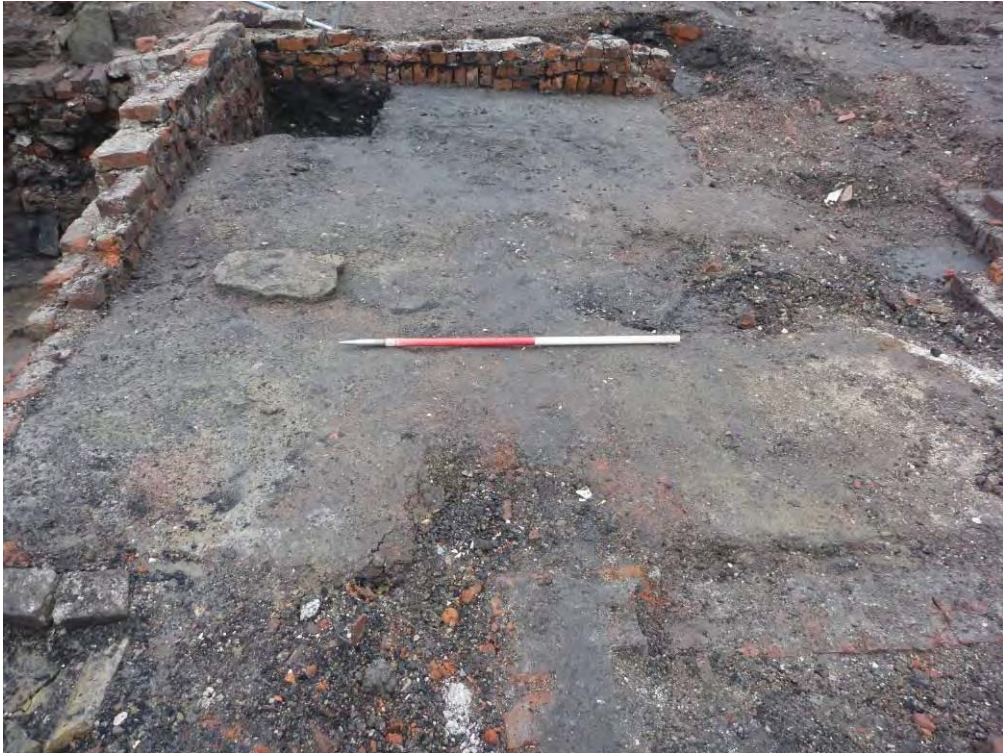
**Plate 12: Yard surface 1165 viewed from the south-west**

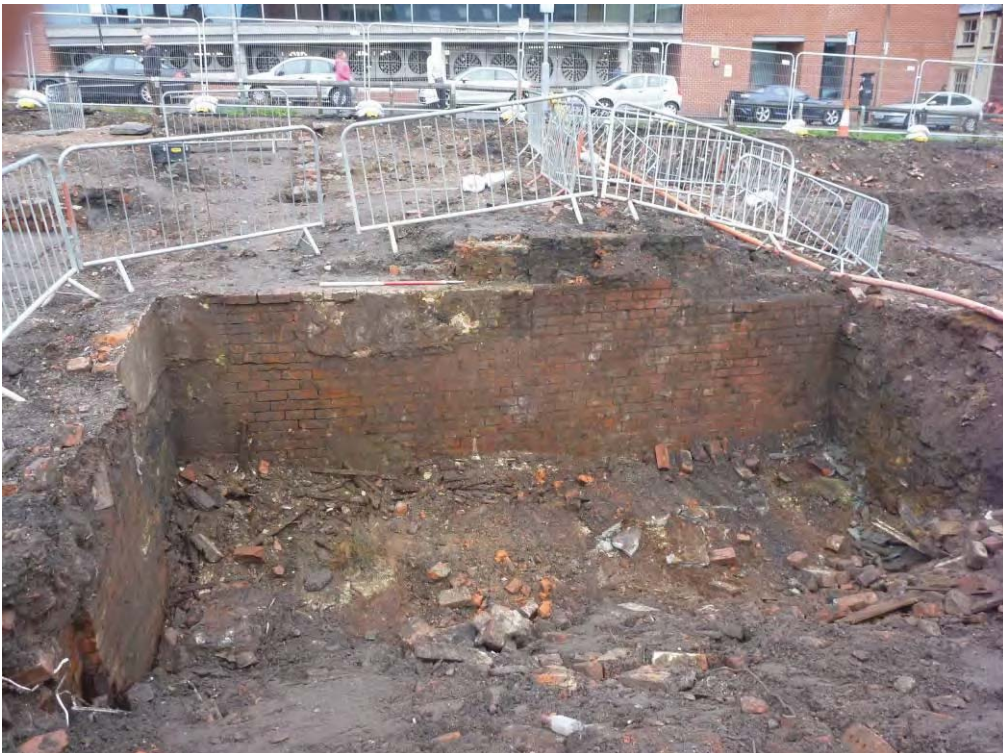
**Plate 13: Cellar D, prior to removal of wall 1092, viewed from the south-west**

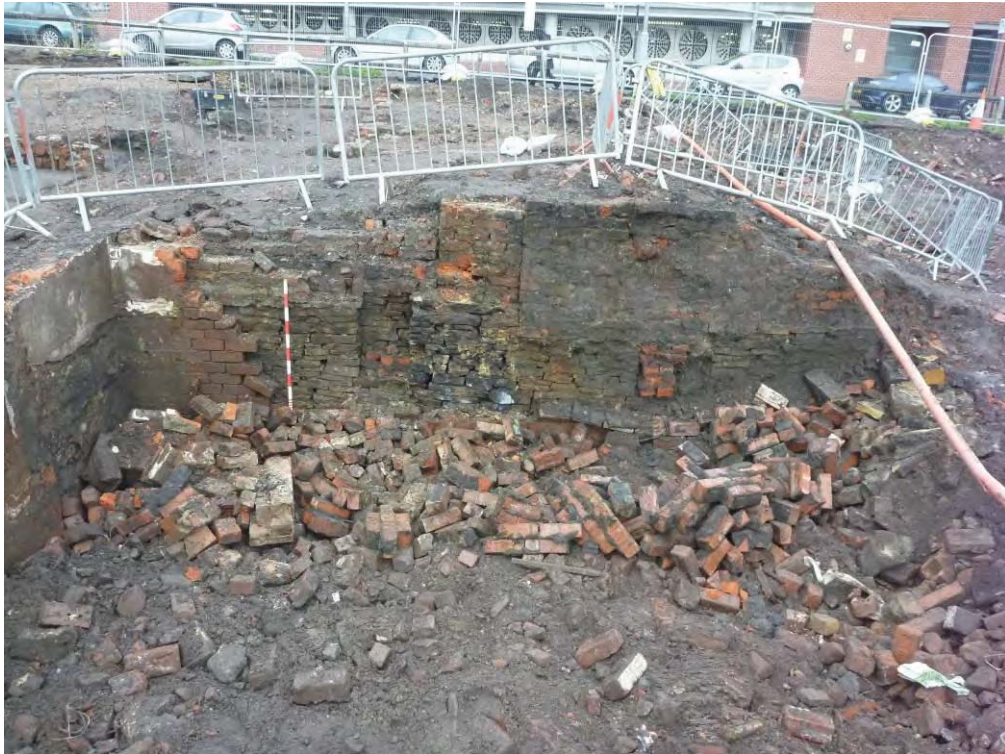
**Plate 14: Cellar D, after removal of wall 1092, viewed from the south-west**

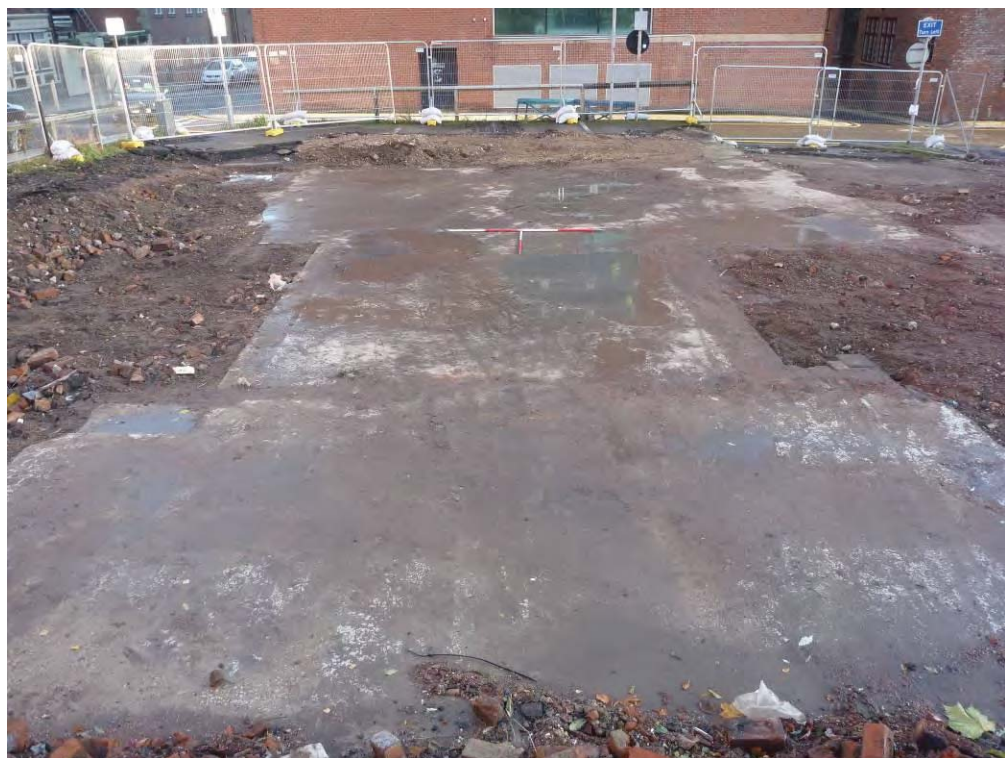
**Plate 15: Concrete surface 1067 viewed from the north-west prior to removal during machine strip**

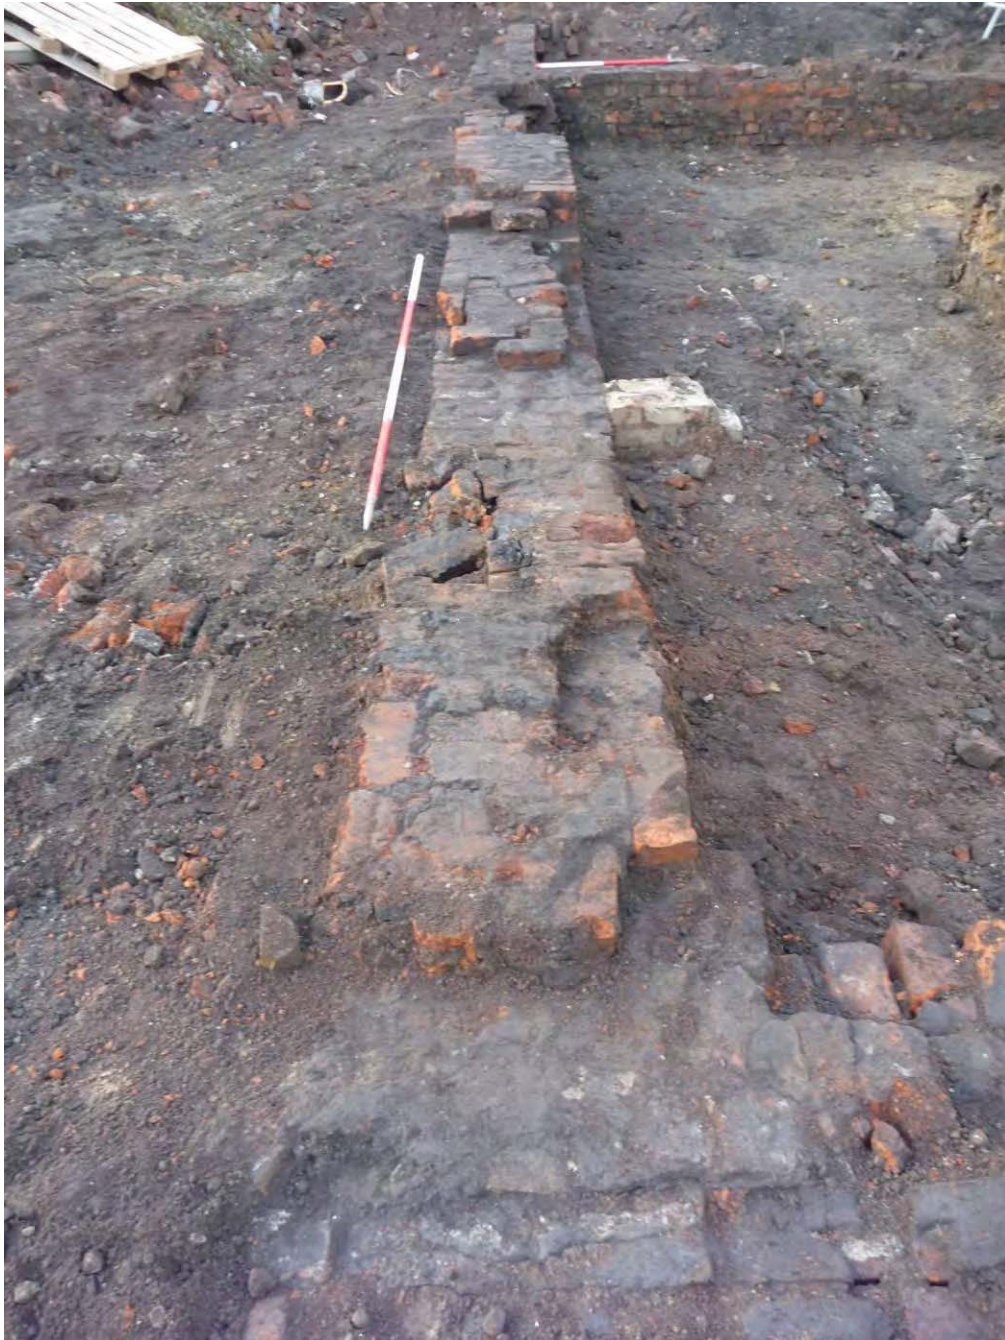
**Plate 16: Works wall 1119 viewed from the south-west**

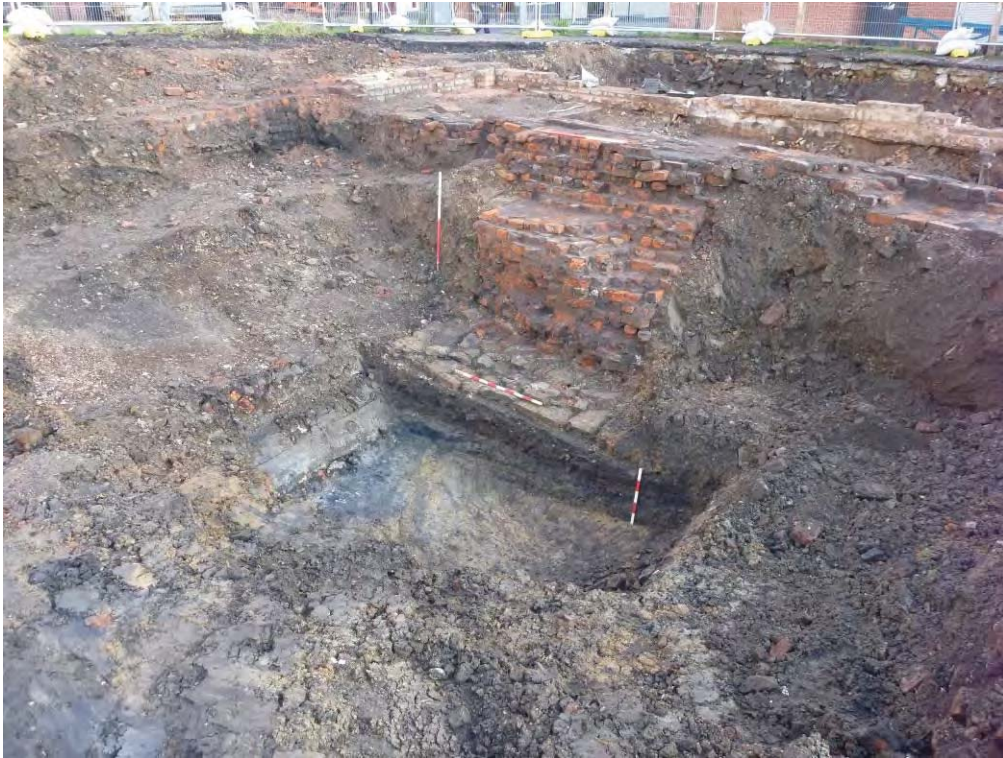
**Plate 17: Brick and stone machine base 1130 viewed from the west**

Within the works and butting against the south-eastern wall 1121 was a large brick structure, 1130, possibly a machine or furnace base. There was a patch of heat damaged bricks on top of this structure but this was localised and overall its size and strength suggest it supported a substantial structure. The surviving remains stood 19 courses high on top of a foundation of sandstone and bricks (Plate 17). Its total dimensions were 3m long, 2.2m wide and 2m high. It was built from similar bricks to the rest of the works walls and was bonded with the same type of dark ashy mortar. On top of this made ground were fragmented bits of possible brick surface (1131 and 1132) and services (1124 and 1186). Other than these isolated features nothing other than levelling deposits filled the space within the outer walls of the works. A machine-excavated slot established that the machine base foundation overlay a foundation of churned up soil and redeposited natural, 1223, on top of natural clay 1224. This foundation

During the archaeological investigations, a large base (1130) (Figure 4) was identified within the yard of the Canada Works, approximately where the furnaces are located on the 1896 map (Figure 11). The base is had 2m deep foundations and butted up against the south-eastern wall (1119). The bedding layer (1223) beneath the base contained two clay pipe bowl fragments and four stems. The bowls probably date to the late 18<sup>th</sup>/early 19<sup>th</sup> century. One of the four

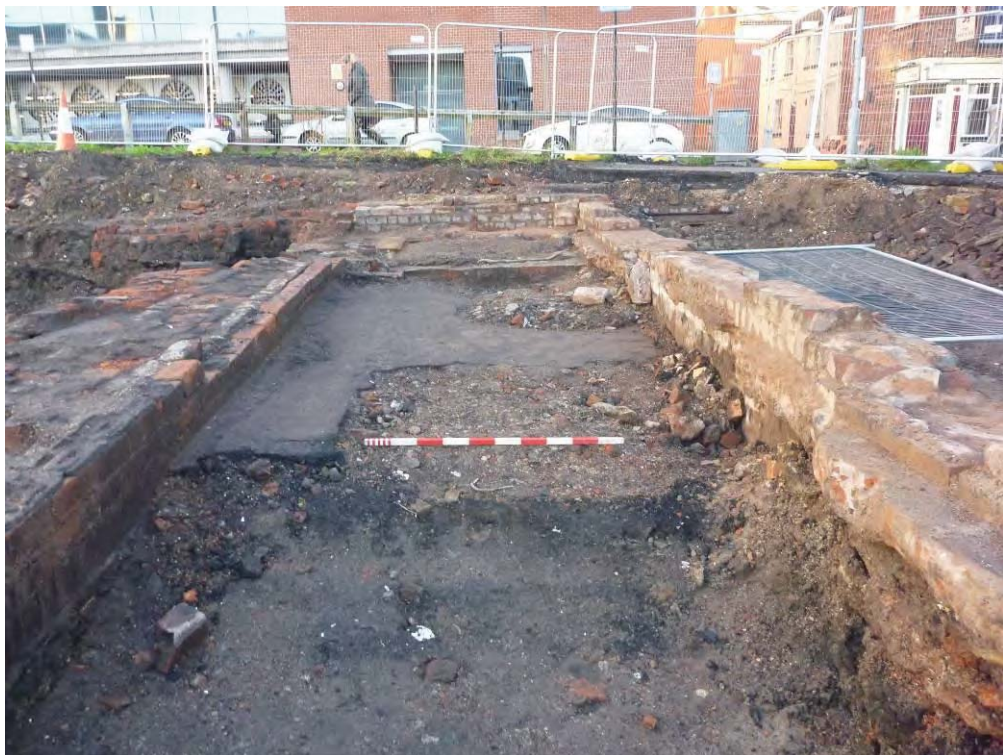
**Plate 18: Yard space between walls 1121 and 1138 viewed from the south-west**

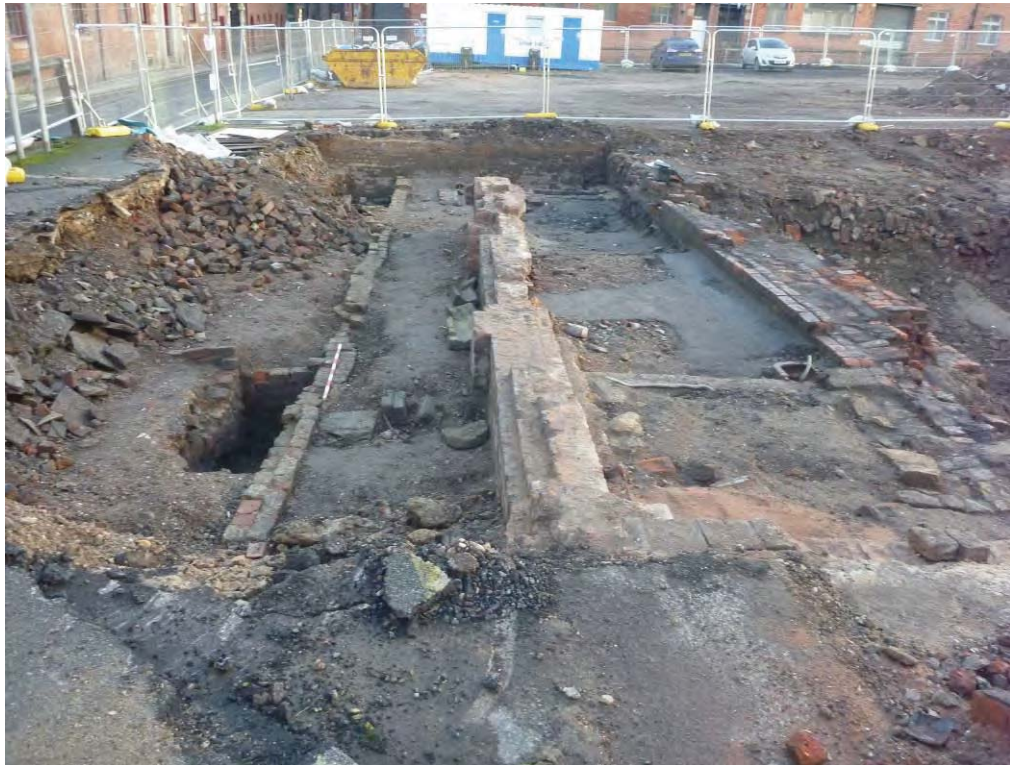
Plate 19: Eyre Lane cellars rear wall 1139 and modern wall 1138 viewed from the north-east

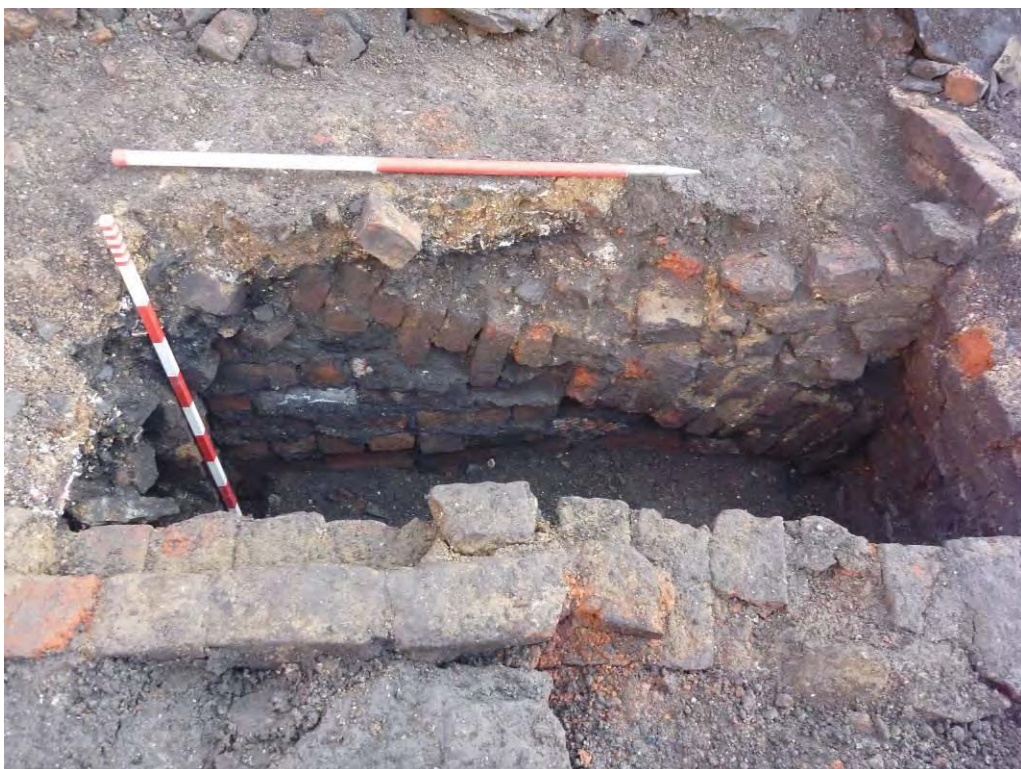
Plate 20: Blocked up vaulting within slot dug in north-eastern Eyre Lane cellar, viewed from the north-west

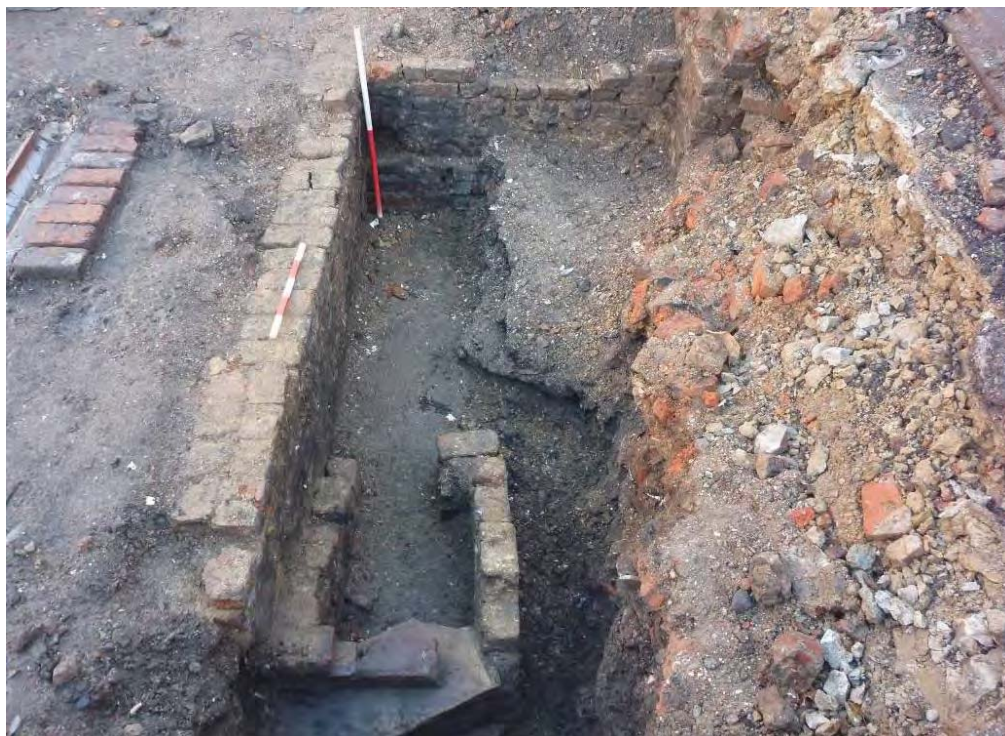
**Plate 21: Slot dug in to south-western Eyre Lane cellar viewed from the south-west**

The sondage in the south-western cellar (Plate 21) identified a damaged stone stairway (1220) and a short section of north-east to south-west aligned wall (1196) at the edge of excavation. The purpose of this wall was unclear but it may have formed part of an internal division within the cellar, in addition to supporting the stairs. Again, it was not possible to reach the base of the cellar due to safety concerns.

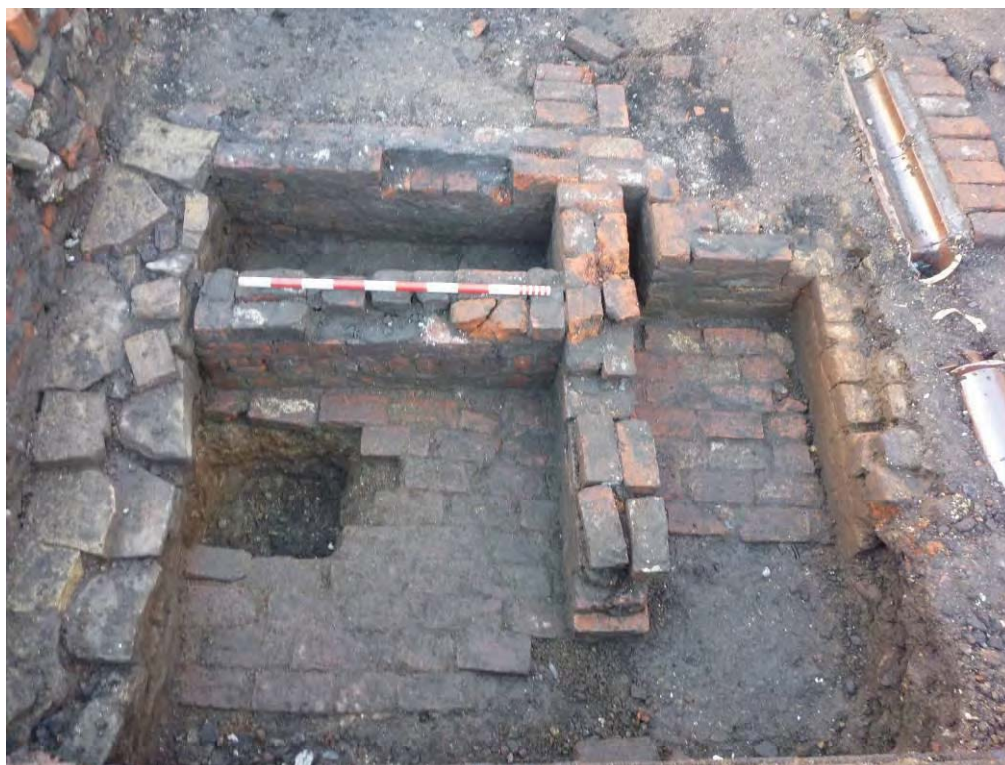
**Plate 22: Brick and stone structure, possibly an outhouse, viewed from the south-west**
