**ARCHAEOLOGICAL WATCHING BRIEF AT THE SQUARE,
RETFORD, NOTTINGHAMSHIRE**

ARCHAEOLOGICAL WATCHING BRIEF REPORT

Report Number 2014/35 October 2014

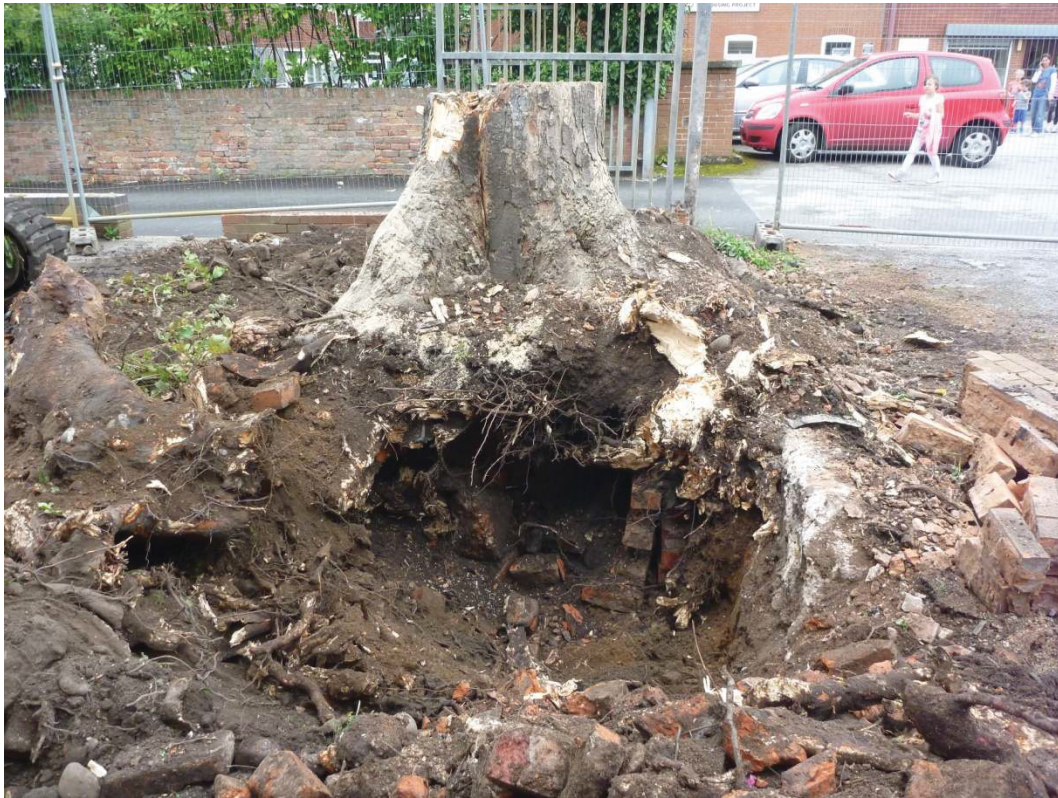
Plate 1: Working shot of tree root and manhole during removal

The first stage of monitored groundworks consisted of the removal of a root system of a substantial tree which had been growing in the Site's north-west corner. The roots penetrated the ground over a considerable distance and excavation to a depth of 1.2m area, over an area of 5.3m x 3.6m, was necessary to remove the root ball in its entirety. Upon extraction, it became apparent that the sycamore roots had penetrated an underlying engineer inspection chamber associated with a redundant drainage system (Plate 1). The deposit impacted upon by tree growth was ascribed the context number [1000]. This was a mixed backfill deposit, containing inclusions of 19th- and 20th-century brick rubble fragments in a dark brown silty sand matrix. One base fragment of a 19th-century stoneware bottle was recovered from this context during monitoring.

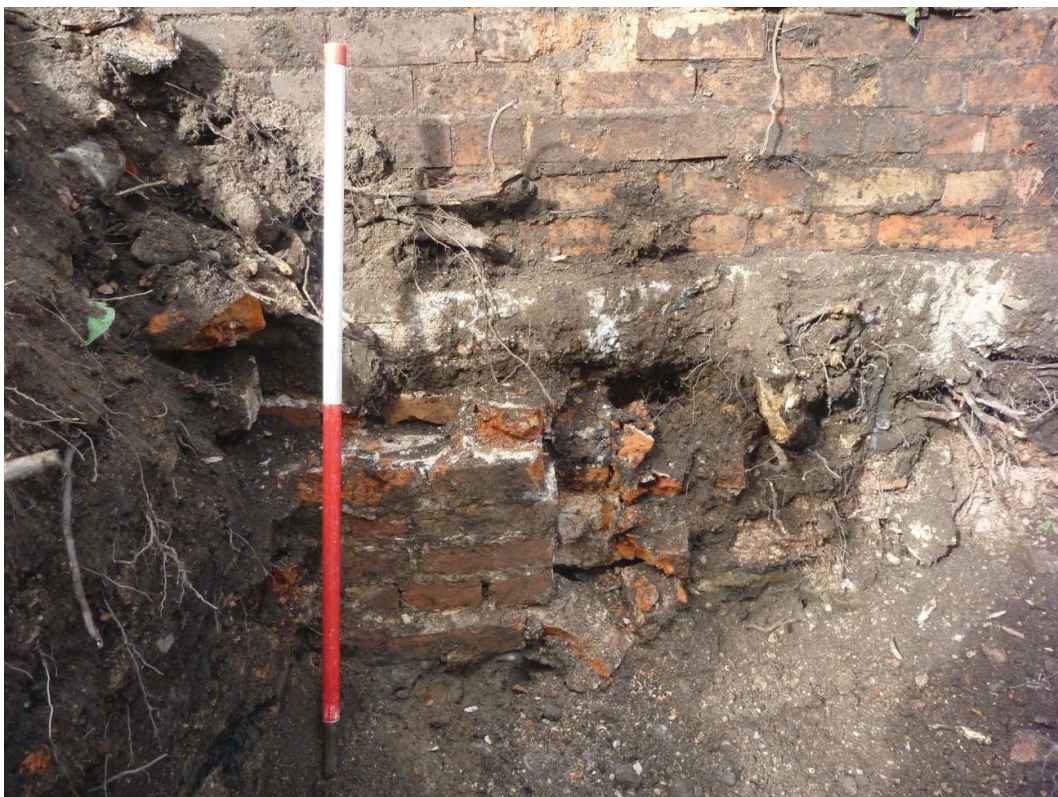
Plate 2: Structure [1003] below modern structure [1001]. Viewed facing west, 1m scale.

The excavation of foundation trenches exposed predominantly modern features. In the north-west corner the structures observed comprised post medieval and modern walling. A modern red brick wall [1001] served as the west boundary wall between the Site and an access road immediately to the west. The base of the concrete foundation for wall [1001] was bonded directly on top of the truncated remains of an 18th- to 19th-century wall [1003] (Plate 2). This feature shared the same north-south orientation as [1001]. Its foundation had been constructed directly on top of natural gravel deposits [1008]. The wall was two courses in width and was stretcher-built, with red bricks measuring 23.5 x 12 x 6cm. Its vertical extent measured 0.5m. Structure [1003] was interpreted as an earlier boundary wall.

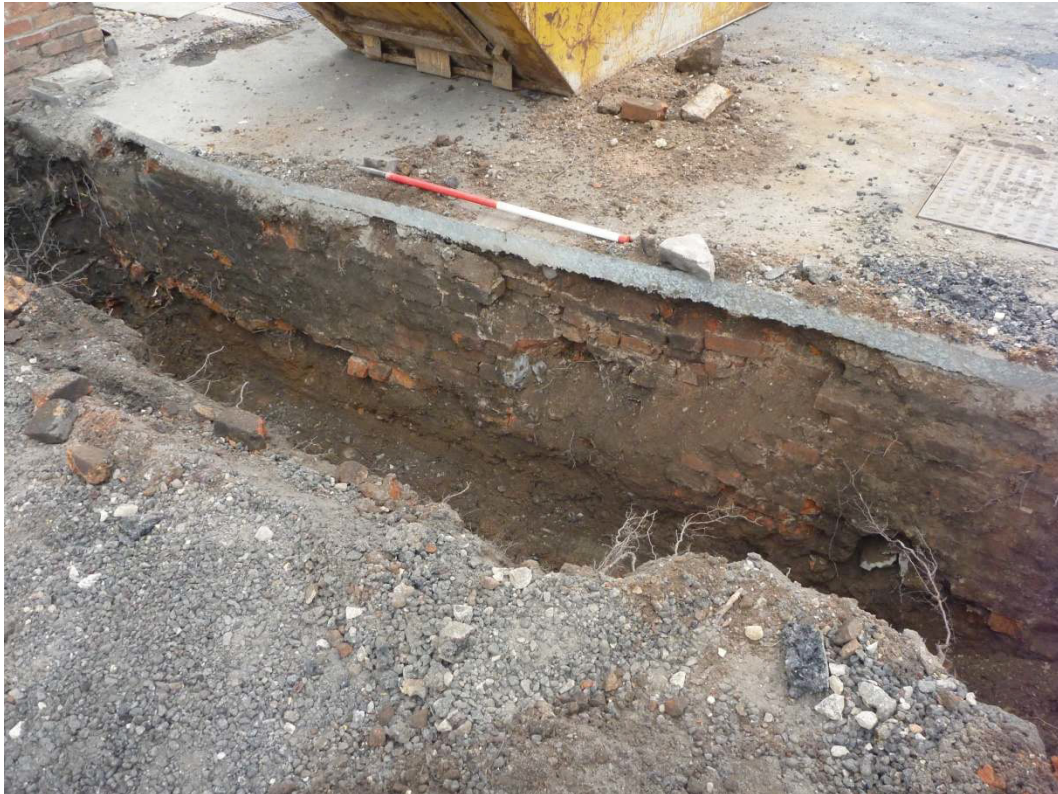
Plate 3: Structure [1005] in north-facing section of south foundation. Viewed facing south-east. 1m scale.

Excavation of the south foundation trench exposed a red brick wall [1005] (Plate 3), similar in construction to [1004]. Structure [1005] was visible in the entirety of the north-facing section of the south foundation trench. Eight courses of stretcher-built brickwork were visible in section, supported by header-built foundation course. The absence of a more substantial spreading foundation suggests that, rather than the foundation for a building, [1005] was the south boundary wall of a yard associated with the property.

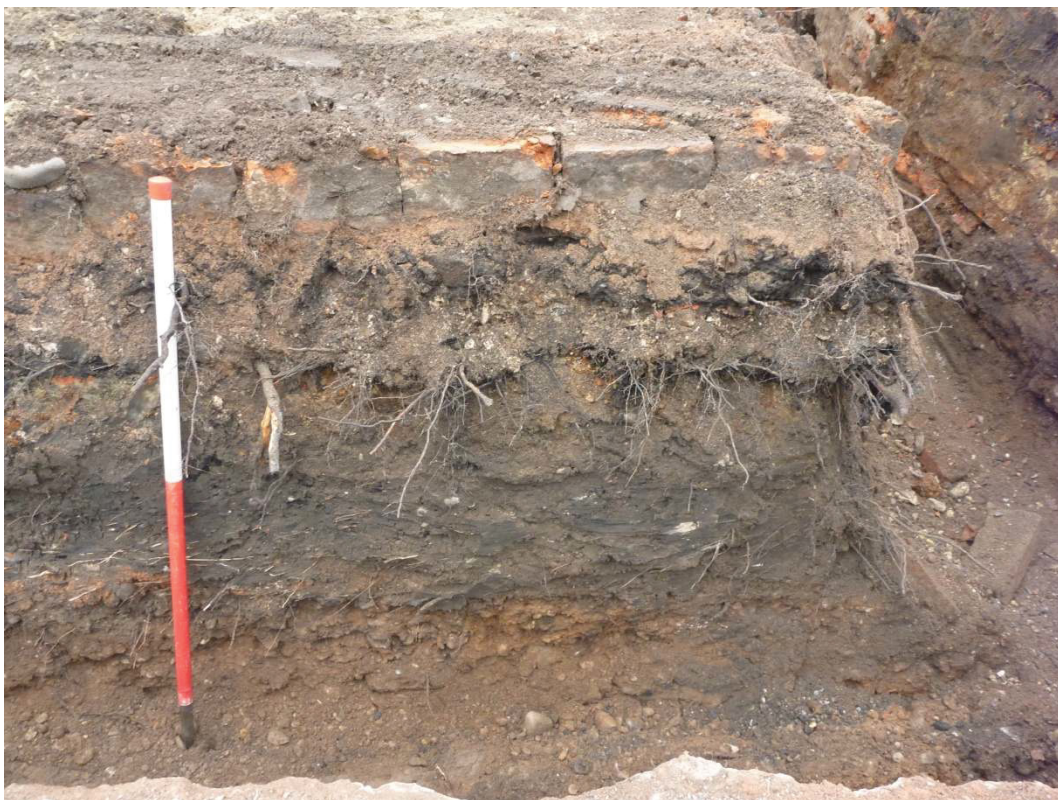
Plate 4: Subsoil [1007], sealed by yard surface [1006]. Viewed facing east. 1m scale.

The interpretation of [1005] as the boundary wall for a yard was supported by the presence of red brick surface [1006] (Plate 4). This feature was observed in section at various points along the foundation trenches, sealed beneath the bedding material for the tarmac car park surface. Structure [1006] comprised a single layer of 19th-century red brick, laid on edge, and was interpreted as a 19th-century yard surface.

The excavation of the west foundation trench impacted upon a buried soil [1007]. This deposit was sealed beneath the bedding layer for yard surface [1006] and was directly on top of the natural gravel and sand deposits. Deposit [1007] was 0.6 to 0.7m in depth and comprised a grey-brown silty sand, with occasional inclusions of small rounded pebbles and occasional charcoal flecks. A single sherd of pancheon rim, most likely 18th- to 19th-century in origin, was recovered during excavation. In the absence of any more definitive evidence, deposit [1007] was interpreted as a post-medieval subsoil. However, a single sherd, does not provide the most secure dating for this soil horizon or how long it took to develop.
