**ARCHAEOLOGICAL ASSESSMENT AT WORTLEY TIN
MILL, WORTLEY, BARNSLEY, SOUTH YORKSHIRE**

ARCHAEOLOGICAL ASSESSMENT REPORT

Report Number 2014/37 January 2015

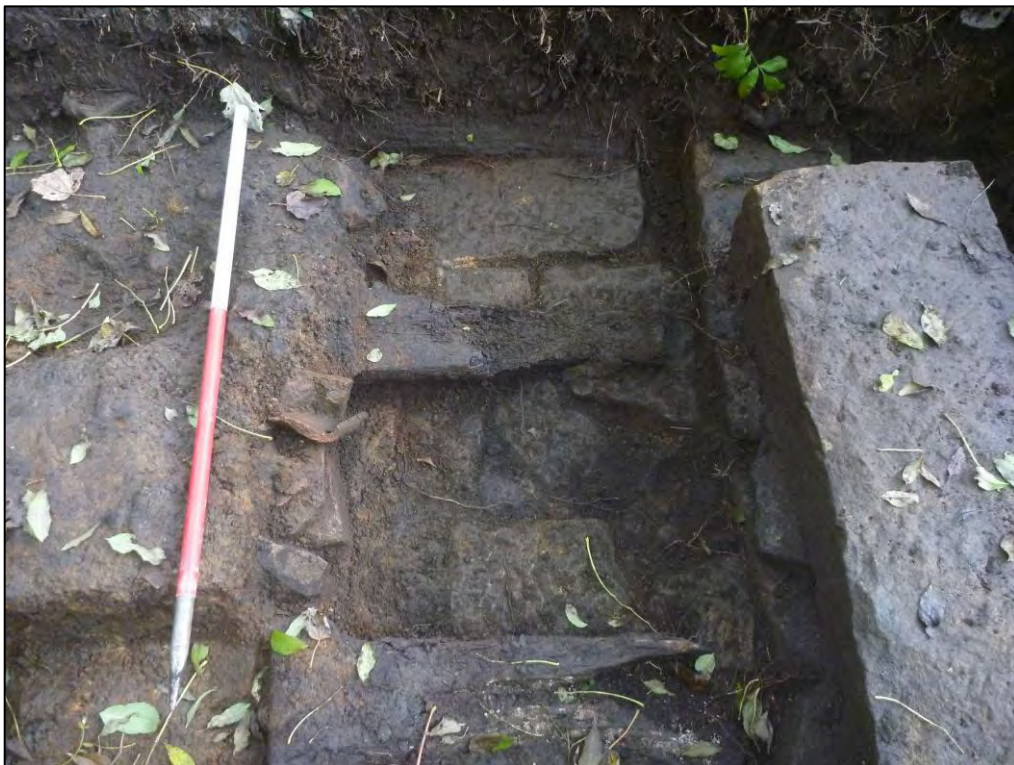
Plate 4: Floor surface (105) with timber planks (124) overlying stone foundation layer (136) in the centre, with wall (129) on the left. Trench 1, looking east. Scale 1m.

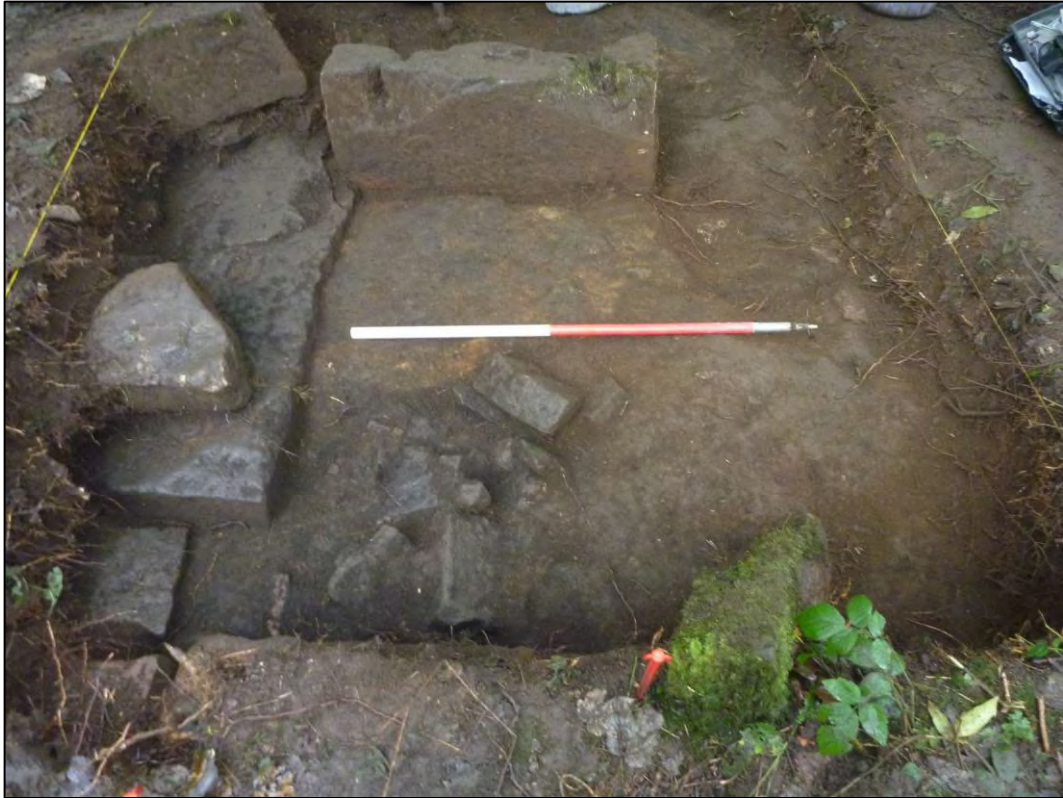
Plate 5: Southern end of Trench 1, looking north, showing upright slab (112), possible machine base (113) and surface (105). Trench 1. Scale 1m.

Slab (113) (Plate 5) was observed within the western edge of the trench, measuring 1.28m long by 0.44m wide (not fully exposed in width), with a thickness of 0.18m. Two fragments of heavily corroded iron were adhered to the stone, possibly the remnants of machine fittings, and a small, shallow rectangular socket hole was cut into the surface of the stone. At the northern end

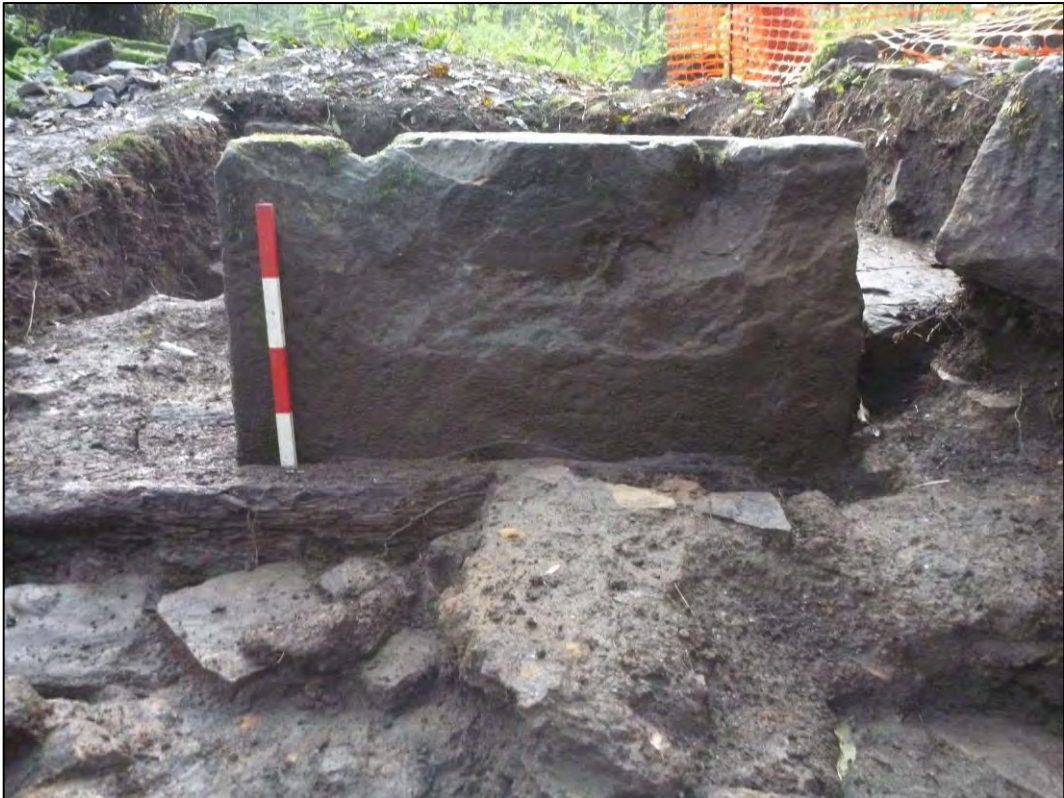
Plate 7: Upright slab (112) and abutting timber (116), looking south, Trench 1. Scale 0.40m

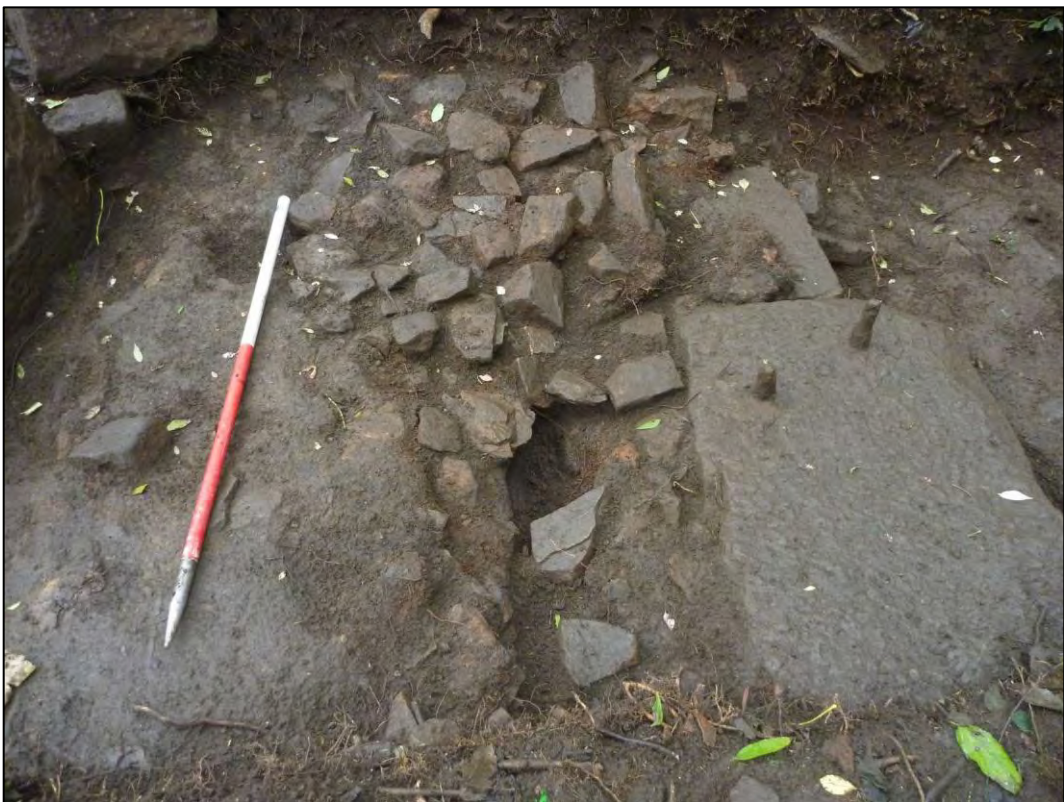
Plate 8: Timber-lined and rubble-capped drain [118] and partially exposed wheel base and axle (121), looking west. Trench 1. Scale 1m.

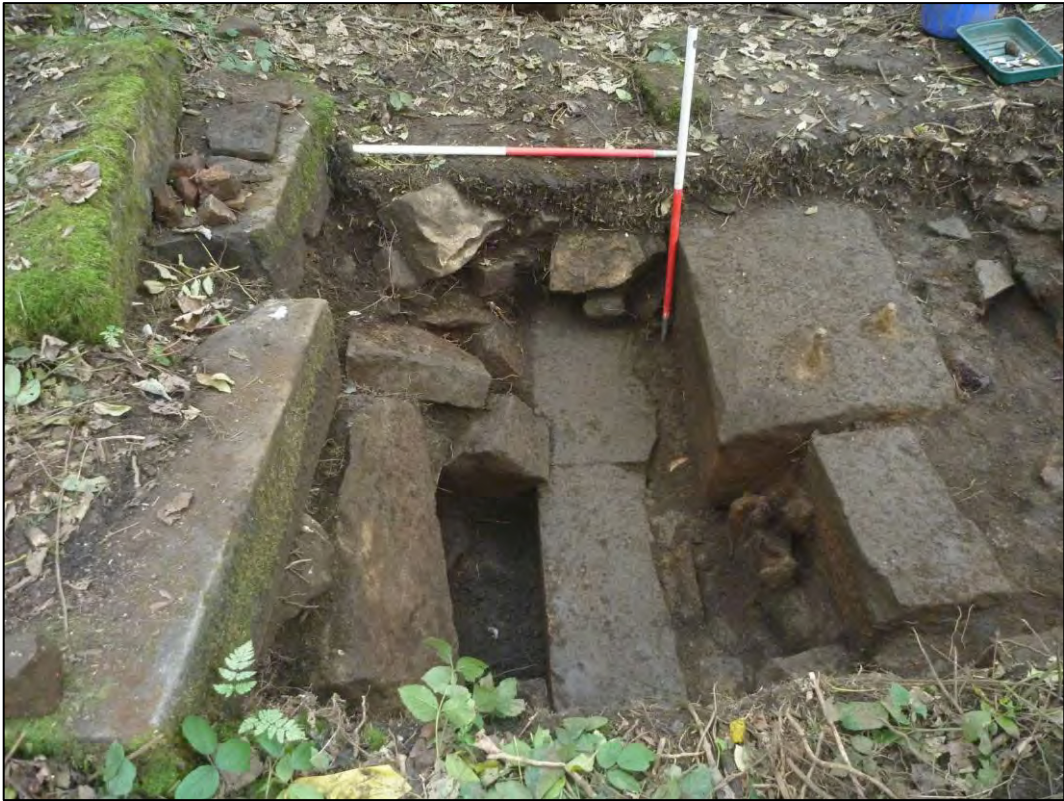
Plate 9. Partially exposed wheel base and axel (121) on the right, and wheel pit wall (130) on the left, looking east. Trench 1. Scales 1m.

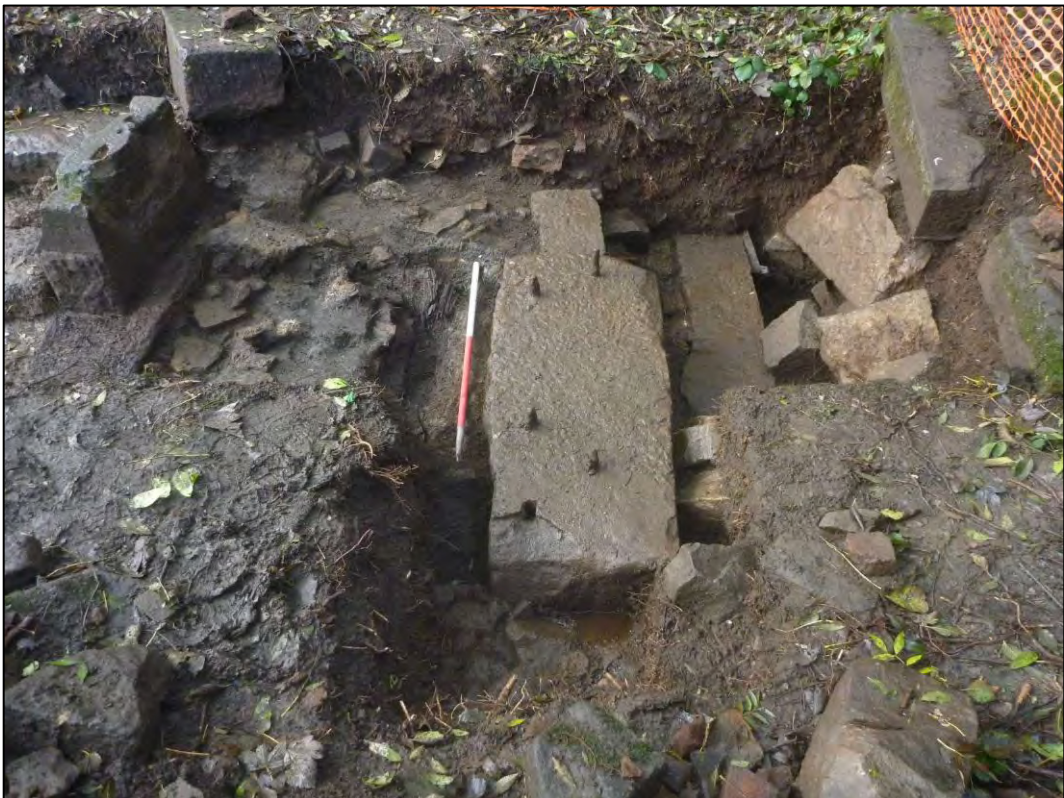
Plate 10. Fully exposed wheel axle (121). Trench 1, looking west. Scale 1m.

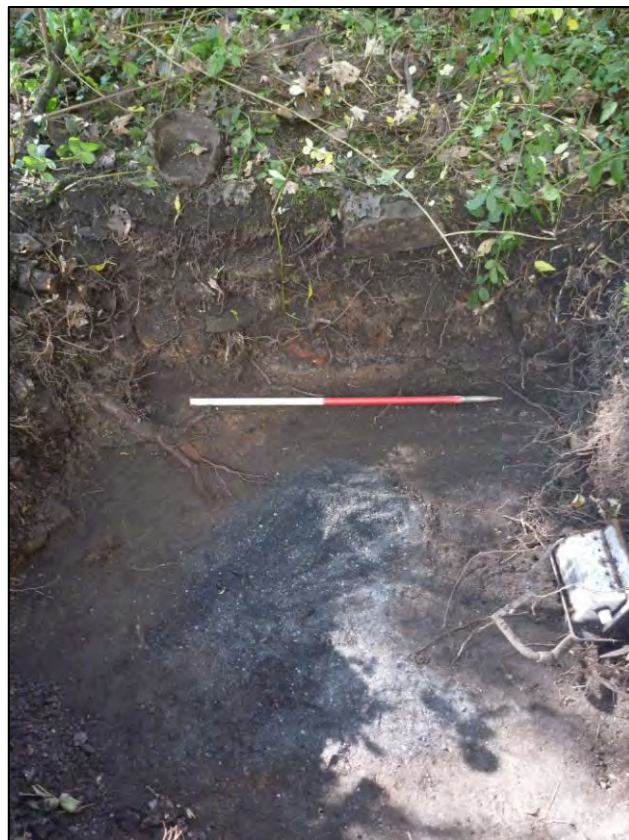
Plate 12: Trench 2, mid-excavation, showing the deposit of metal scale (205) at the base of the trench and twentieth century debris in the topsoil (201) protruding from the section edge on the right hand side. Looking west. Scale 1m.

In the centre of the trench, immediately underlying (203) and located to the north of the three dump deposits discussed above, was a small deposit comprised entirely of metallic flakes (205) (Plate 12), measuring approximately 1m by 0.50m, with a thickness of 0.08m. These flakes were directly comparable with the metallic flakes observed in surface (105) in Trench 1, hence it seems highly likely that deposit (205) represents a dump of waste material from the mill.

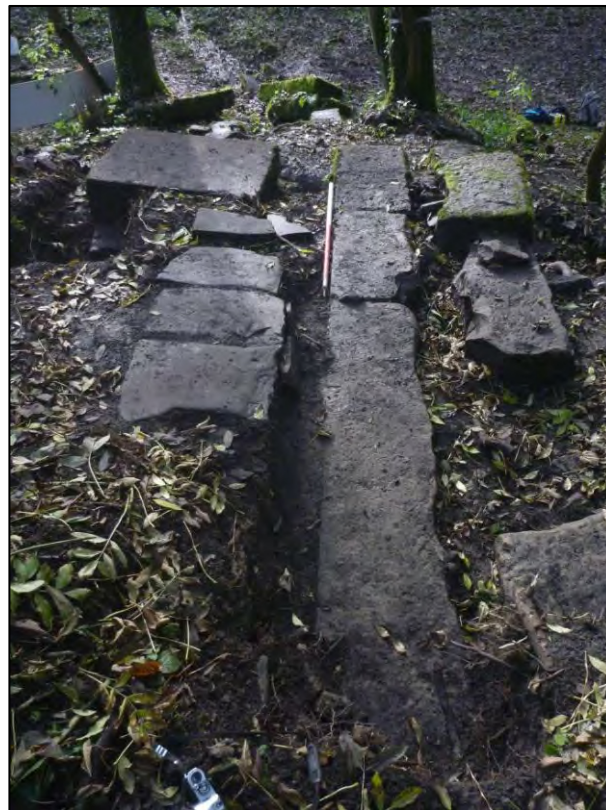
Plate 18: Wall (406) in the centre, with discontinuous wall (408) to the right and stone flags (407) to the left. The large square capping stone (409) of the culvert can be seen beyond flags (407). Trench 4, looking south. Scale 1m

A discontinuous north-south aligned wall (408) (Plate 18) was present approximately 0.20m to the west of wall (406), running directly parallel to it. As with wall (406), (408) was constructed from large ashlar blocks, with two courses visible, and each course measuring between 0.35m and 0.40m in thickness. At least one stone appeared to be missing from the wall, which terminated at the southern end but continued to the north beyond the confines of the trench. An east to west aligned wall (415) was present at the southern end of wall (408), running out from the base of it, exposed for approximately 0.10m and continuing to the west beyond the confines of the trench.

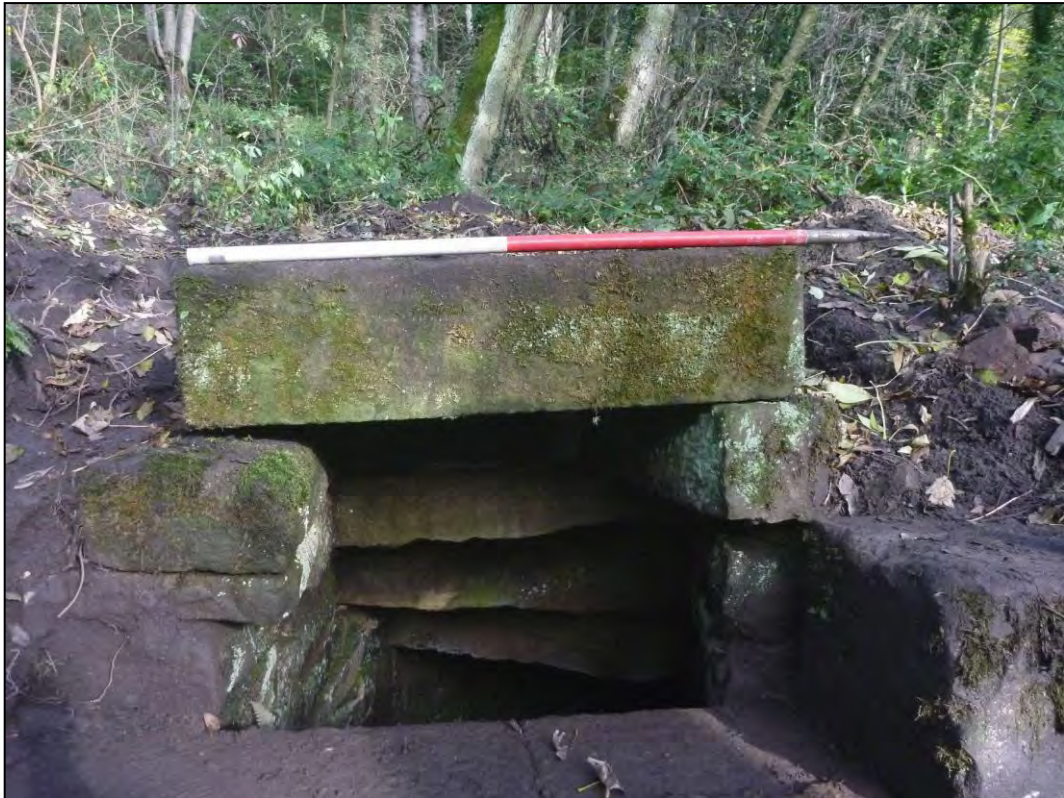
Plate 19: Capping stone (409) laid upon the walls (411) of the culvert, with lower wall (410) visible at the bottom of the picture. Trench 4, looking north. Scale 1m.

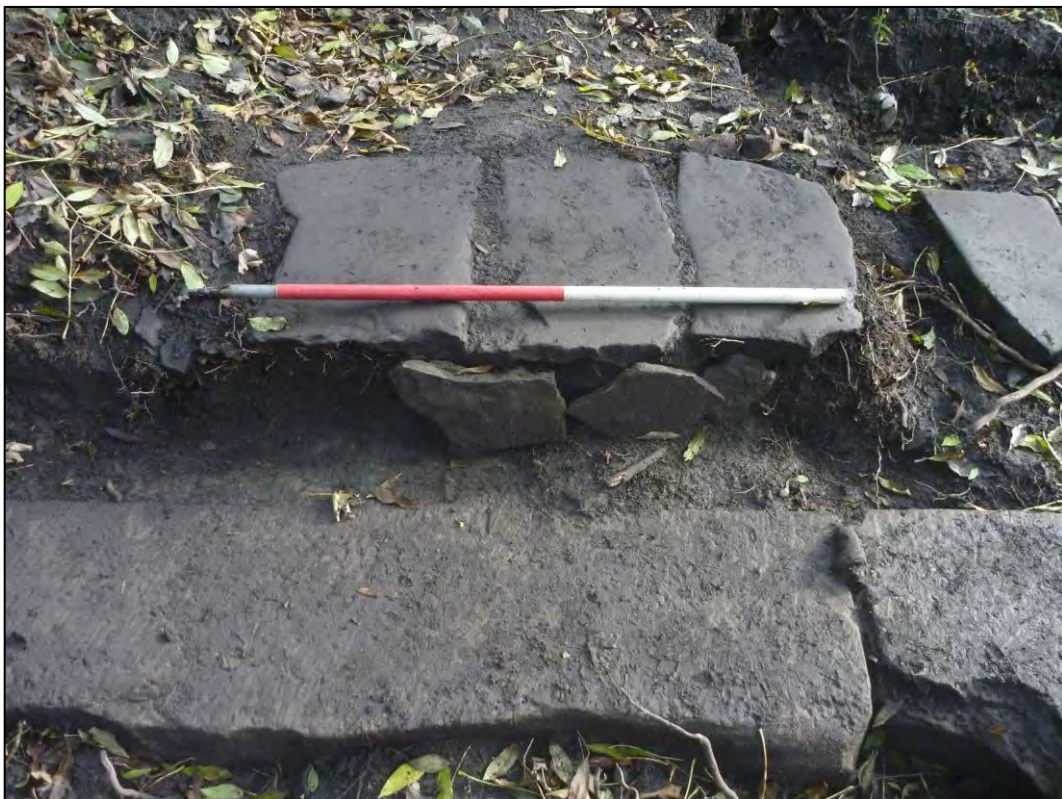
Plate 20: Flags (407) with north-south aligned wall (406) at the bottom of the picture. Trench 4, looking east. Scale 1m.

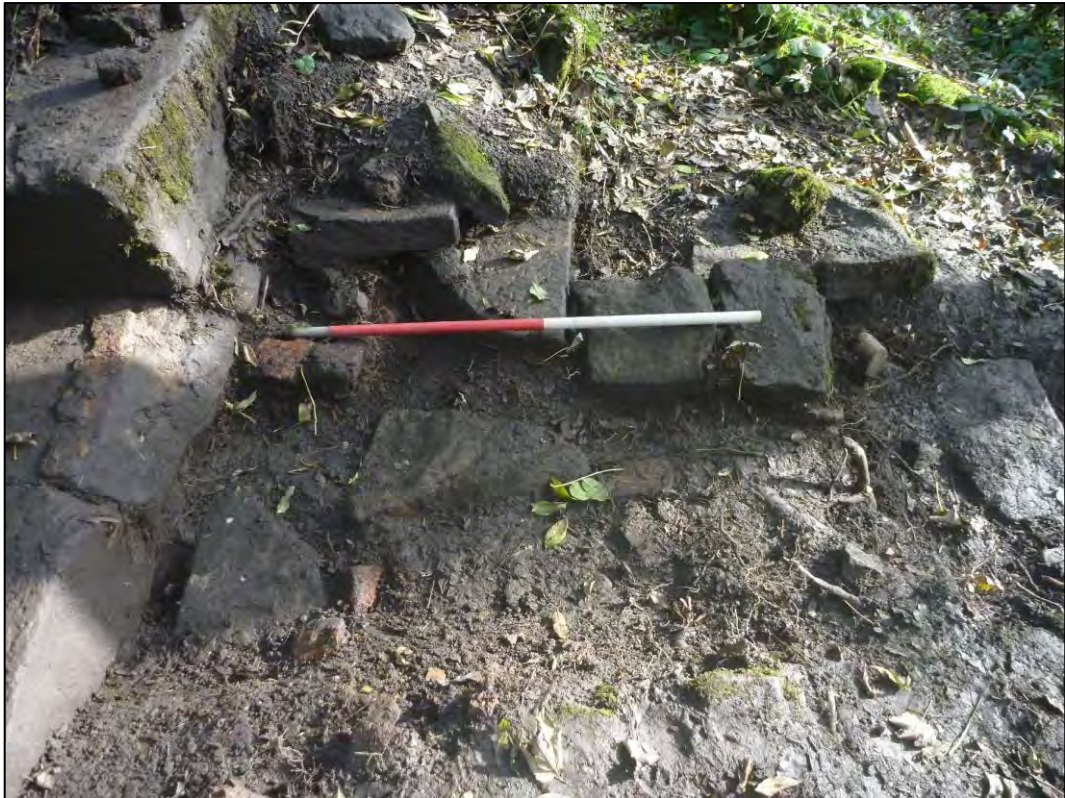
Plate 21: Wall (412), Trench 4, looking east. Scale 1m.

The southern end of the trench contained few structural remains in comparison to the northern end. A possible discontinuous wall (412) (Plate 21) was observed abutting wall (410), aligned north-south and comprising roughly cut stones, measuring 1.50m in length. Only one course was visible and it was unclear whether further courses continued beyond the base of the trench. The wall was built on a slope, dropping north to south from wall (410). To the west of the wall, immediately below the topsoil (401), dark brown clay-silt (404) (Plate 21) was present, with frequent inclusions of brick and stone rubble. It seems likely that this deposit represents deliberate backfilling after the construction of the culvert. At the very southern end of the trench, a lower opening for the culvert was evident in partially exposed stone block (413), which was almost identical to (409). A single stone (413), aligned east west and measuring 0.5m by 0.35m was present in-between wall (412) and capping (414); it did not appear to belong to either of these structures and may represent an east to west aligned wall that has been removed.

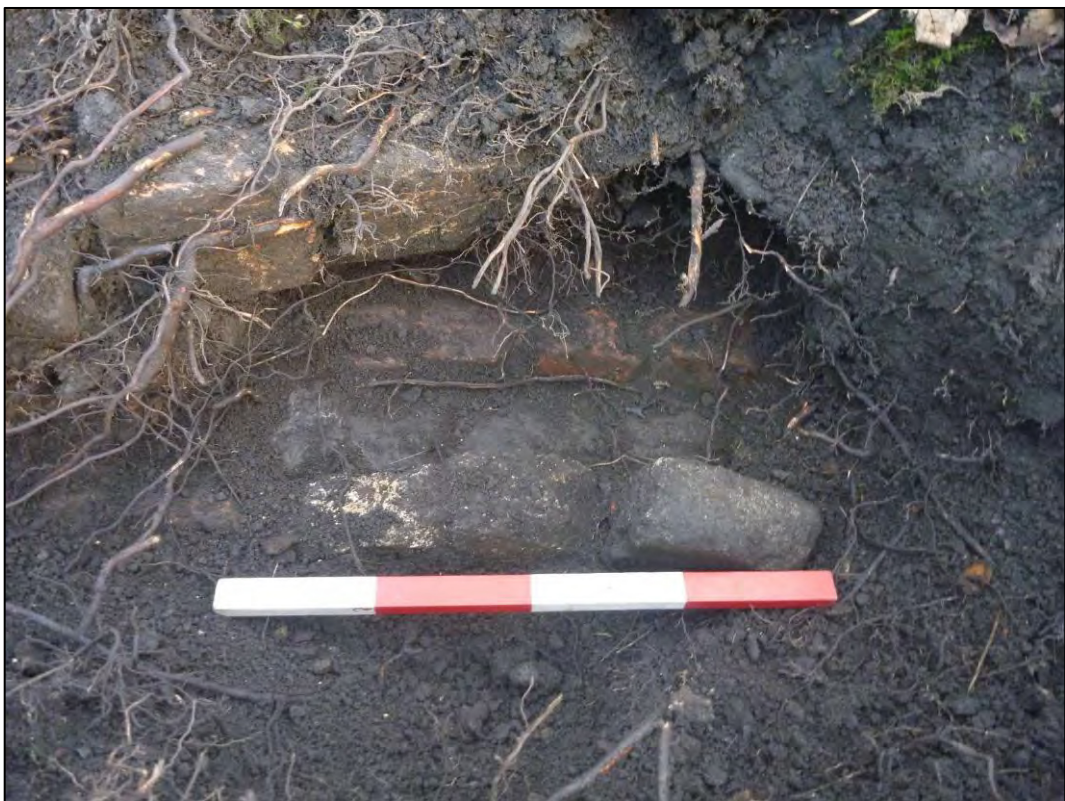
Plate 22: Trench 5, showing detail of brick wall (502) and brick lined drain (503). Scale 0.40m

Immediately beneath the topsoil, a roughly east to west aligned brick wall was observed (502). The full extent of the wall was not exposed, hence the true dimensions are unknown. Two courses were visible although no mortar or bond was observed. The wall was constructed directly over what appeared to be a small brick-lined drain, slightly offset from the wall, with the

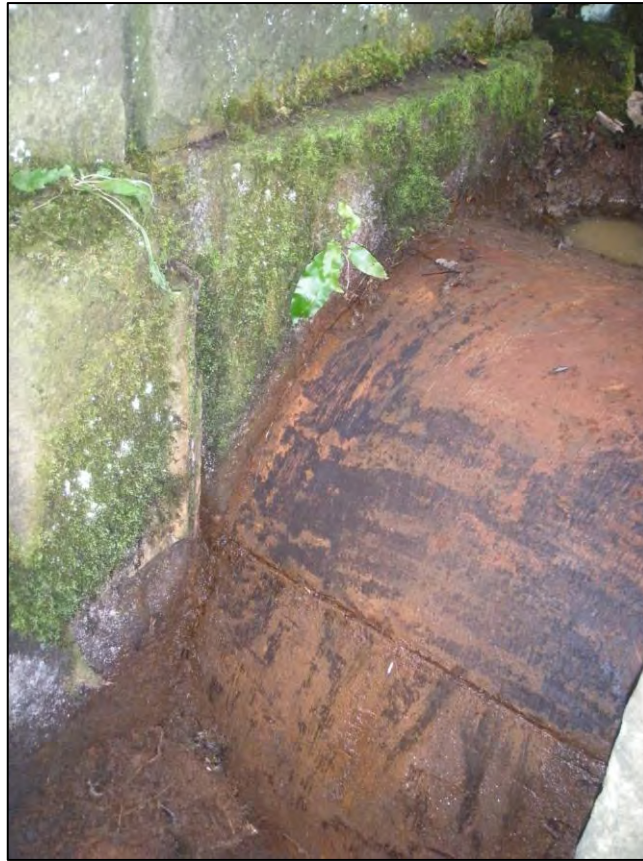
Plate 23: Curved stones within the wheel pit associated with Trench 1

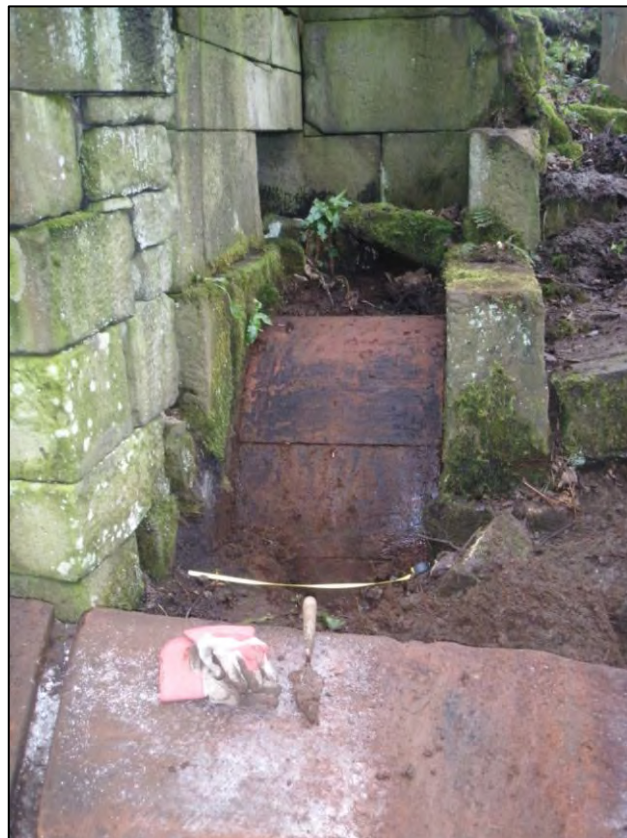
Plate 24: Curved stones within the wheel pit associated with Trench 1

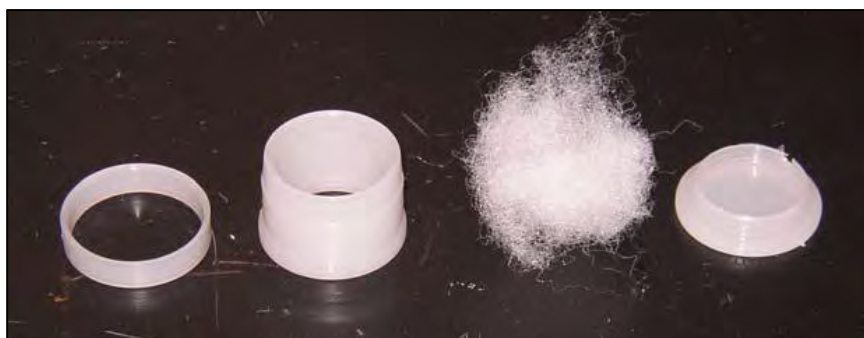
Plate 26: Sample cup components

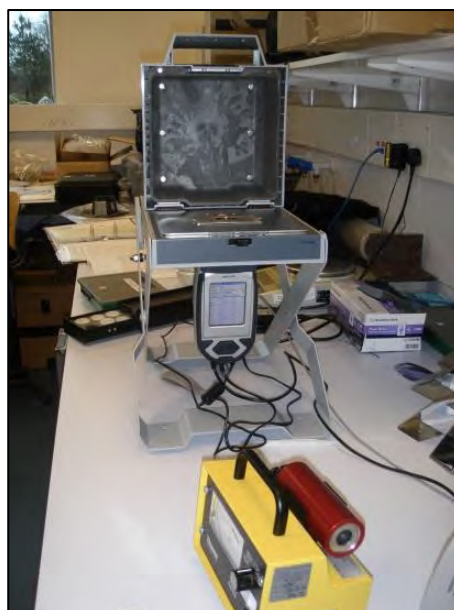
Plate 27: Nitron pXRF

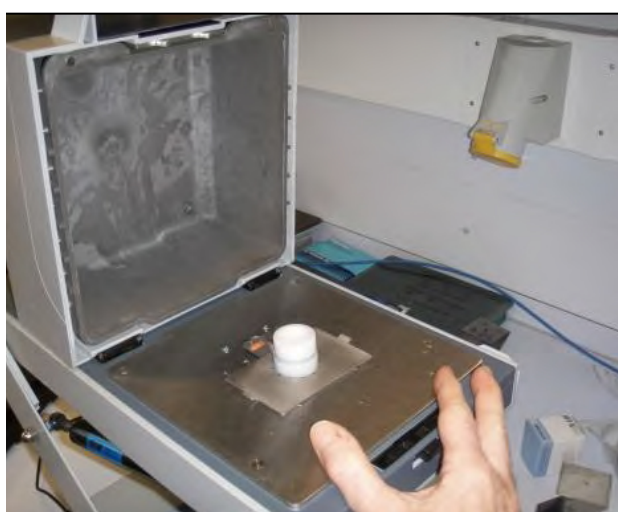
Plate 28: Presentation of sample to p XRF
