**ARCHAEOLOGICAL INVESTIGATIONS AT CANONS
ASHBY, NORTHAMPTONSHIRE**

*WALKOVER SURVEY AND
PALAEOENVIRONMENTAL SAMPLING REPORT*

Report Number 2014/43 November 2014

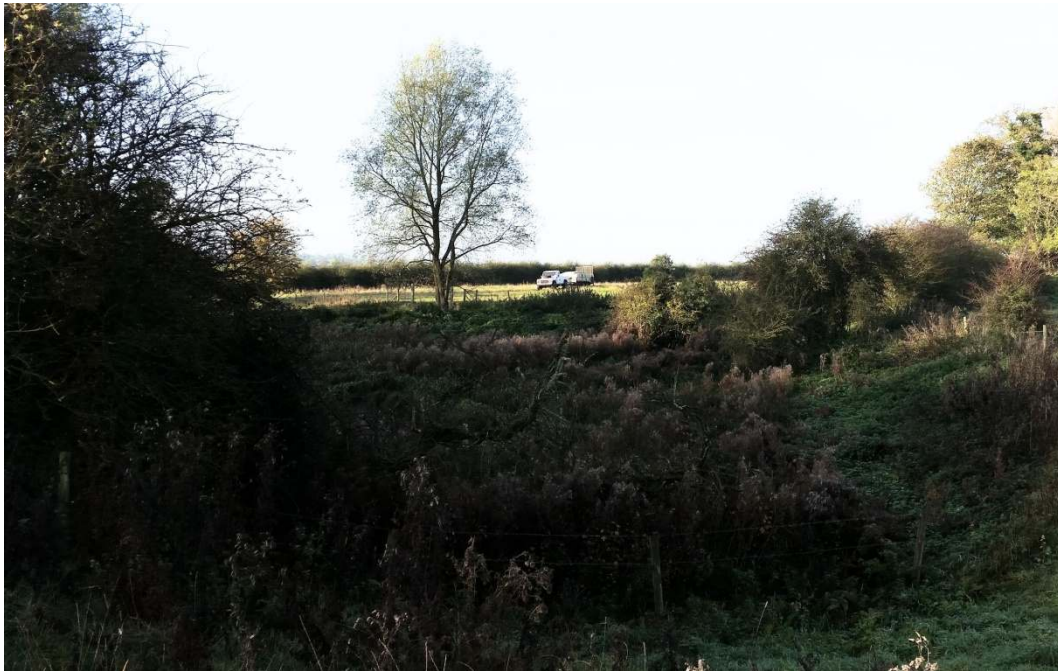
The site lies within the boundary of the scheduled monument: Canons Ashby Priory and Village (Heritage List ID: 1000488) and encompasses an area of 0.7ha, bounded by hedging and fencing on all four sides. The site comprises two ponds, which are likely to have their origins as fishponds that served the Augustinian priory. The northernmost pond still holds water and was subject to some vegetation clearance work and de-silting sometime in the early 2000s, with the southerly pond made up of boggy ground. A third pond once existed, but is now only present as a slight depression in the landscape to the south of the existing ponds, part of an agricultural landscape that is regularly ploughed. The existing two ponds are currently obscured by emergent aquatic plants, with the area surrounding the ponds comprising a mosaic of rank grassland, nettles, brambles and other tall ruderals typical of disturbed and nutrient-rich ground conditions (Plate 1).

Plate 1: General view of Pond 1, looking south-west

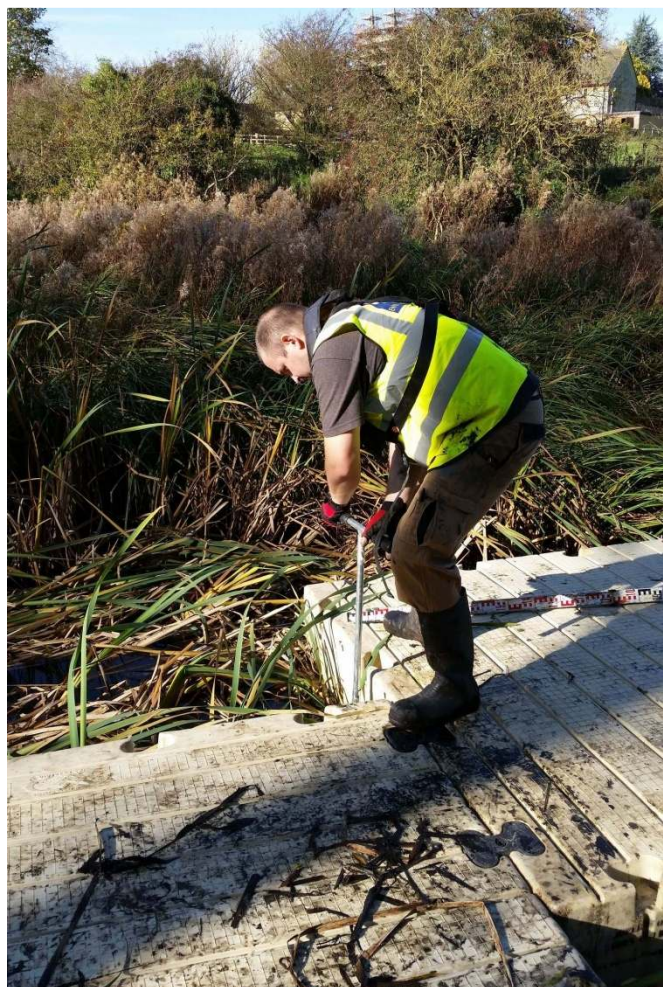
The extraction and collection of sediment samples was overseen by agb Environmental. A 'Dutch' auger was used to collect the samples (Plate 2), which were retained by agb Environmental for contamination analysis. Sub-samples were collected for palaeoenvironmental purposes at increments ranging between 0.5m and 1m, depending on the amount of sediment collected, or where a sediment change occurred. A sediment log was maintained for each auger location and the depth of all samples was recorded.

Plate 2: Core sampling off the pontoon at Pond 1

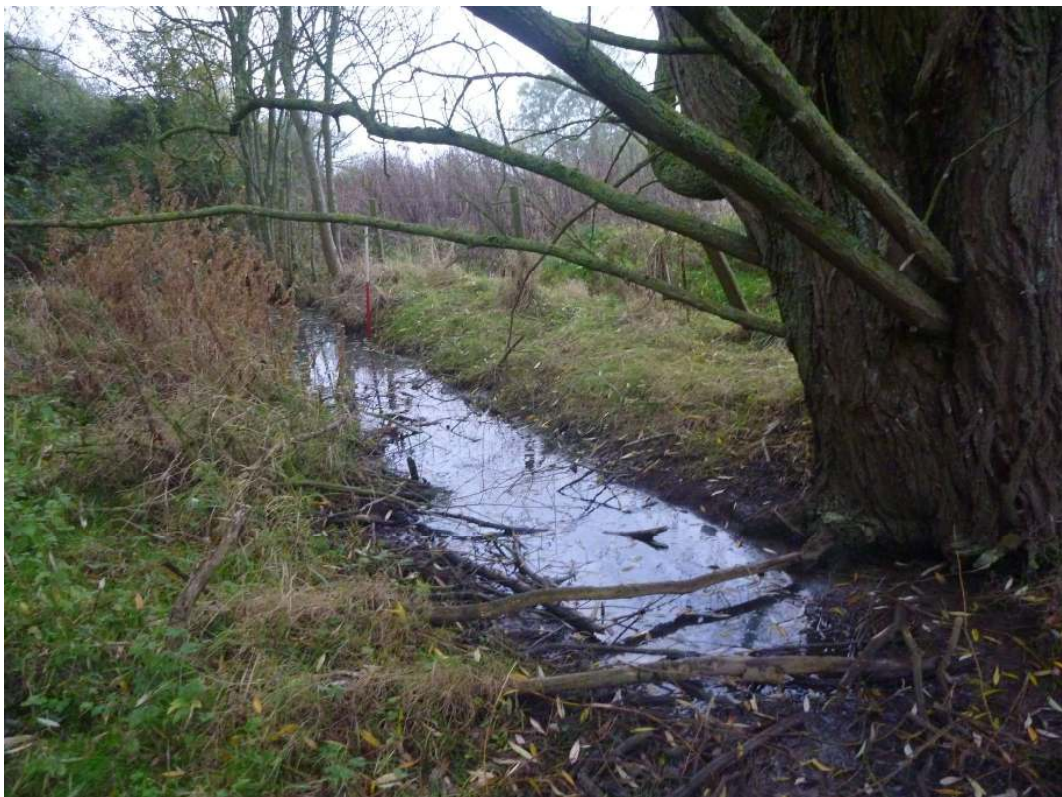
Plate 4: Possible outflow leat C005 from pond C003, viewed facing south-east

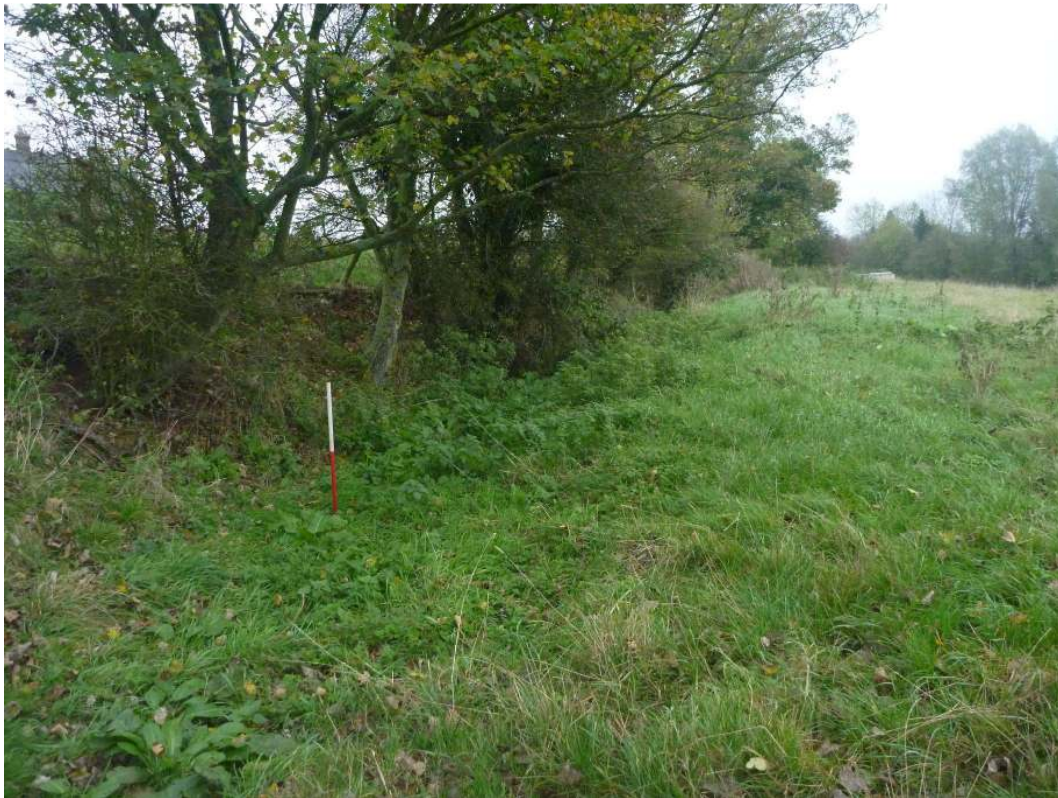
Plate 5: Southern arm of moat C015, showing vegetation growth, viewed facing north-east

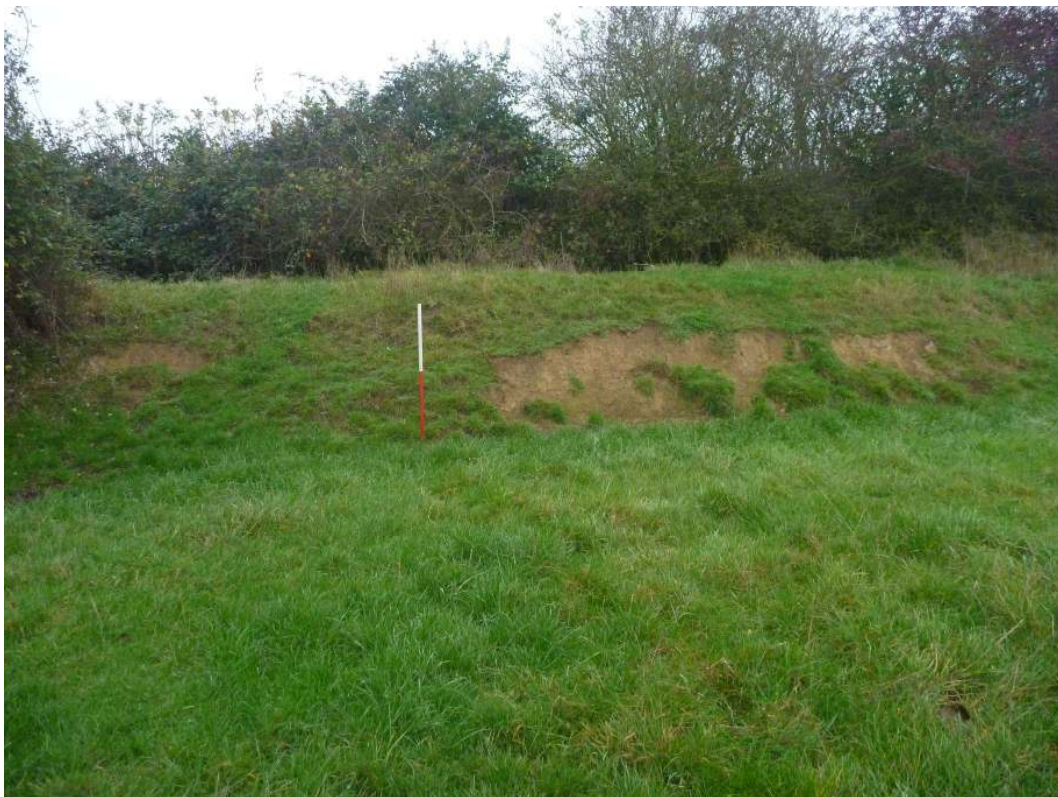
The Canon's Walk has suffered from erosion along its northern and eastern banks within the northern field, probably due to animal erosion from stock, as well as from animal burrows (Plate 6). There are also numerous burrows within the bank to the east of the stew ponds, where trees growing along the top of the bank are also likely to have caused damage to the structure (Plate 7). At the north-east corner of the walk animal and vehicular passage into the adjacent field have worn the bank away, and it is much less prominent in this area.

Plate 6: Northern bank of the Canon's Walk C004, showing erosion scars, viewed facing north

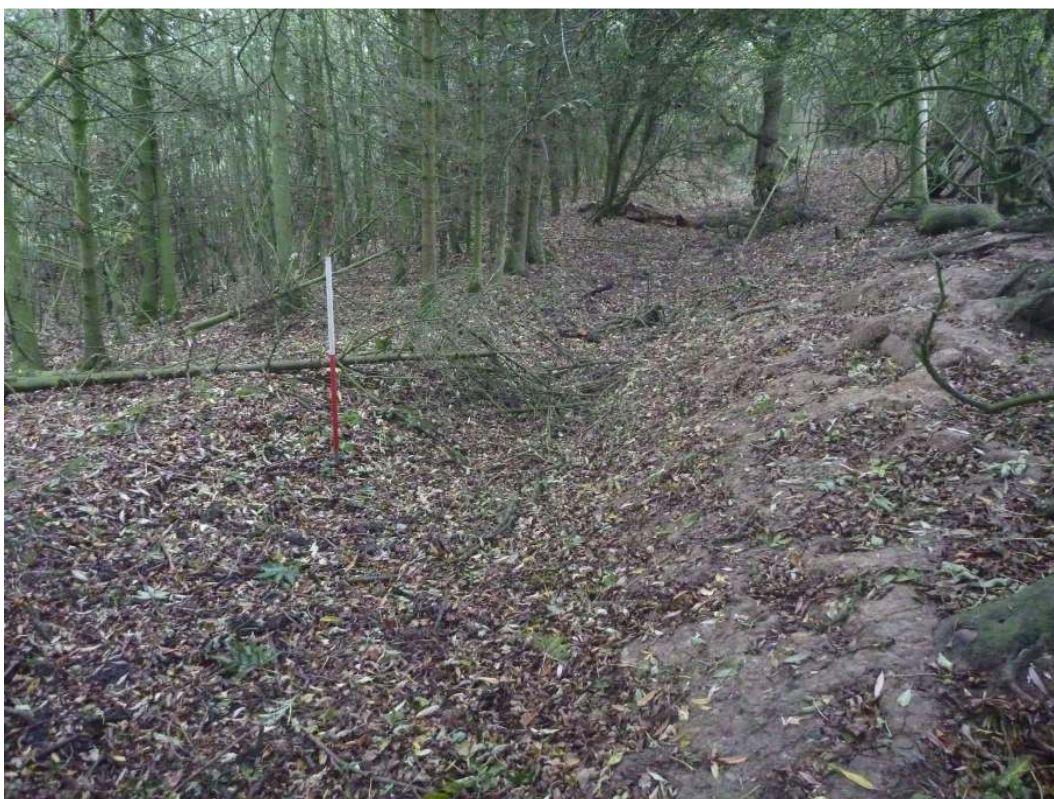
Plate 7: Eastern bank of the Canon's Walk C004 (on left) and ditch C007, showing animal burrow erosion and modern tree growth, viewed facing north

Feature ID	Feature name	Feature type	Description	Condition	NGR	Historic map
C004	Canon's Walk, Canon's Ashby	Walk - Earthwork bank	An earthen bank formerly forming a roughly rectangular walkway leading from the walled garden (C011) in the north, around the fish ponds (C002-003) at the south east, and originally heading back northwards towards the moat (C015). It is likely to have been constructed as part of the Tudor gardens on the former priory site. The northern and eastern sections of the walk survive as earthworks, whilst the southern and western parts of the circuit have been levelled. The full course of the walk is shown on the RCHME survey plan. Where it survives, the bank varies between 0.80m and 1.5m in height. In places it has a clearly defined level top, but parallel with the middle stew pond (C003) it becomes broader, wider and less defined. Along the northern stretch, the bank is overgrown with hawthorn and brambles, and on the eastern stretch adjacent to the stew ponds it is covered with young trees and shrubs. There is erosion on the bank, which in part seems to derive from cattle poaching, and rabbit burrows are visible in places along the eastern bank. Within the northern field, the bank has a slight ditch on the south and west sides, though this is not visible adjacent to the stew ponds further south. There is a more substantial ditch to the east and north (feature C007). The junction of the north-south and east-west banks at the northeast corner of the walk has been eroded and worn by animal and vehicular passage between two fields, and the bank is substantially lower in this area; the ditch is barely visible at this point also.	Average	SP 57982 50444	1884 OS map

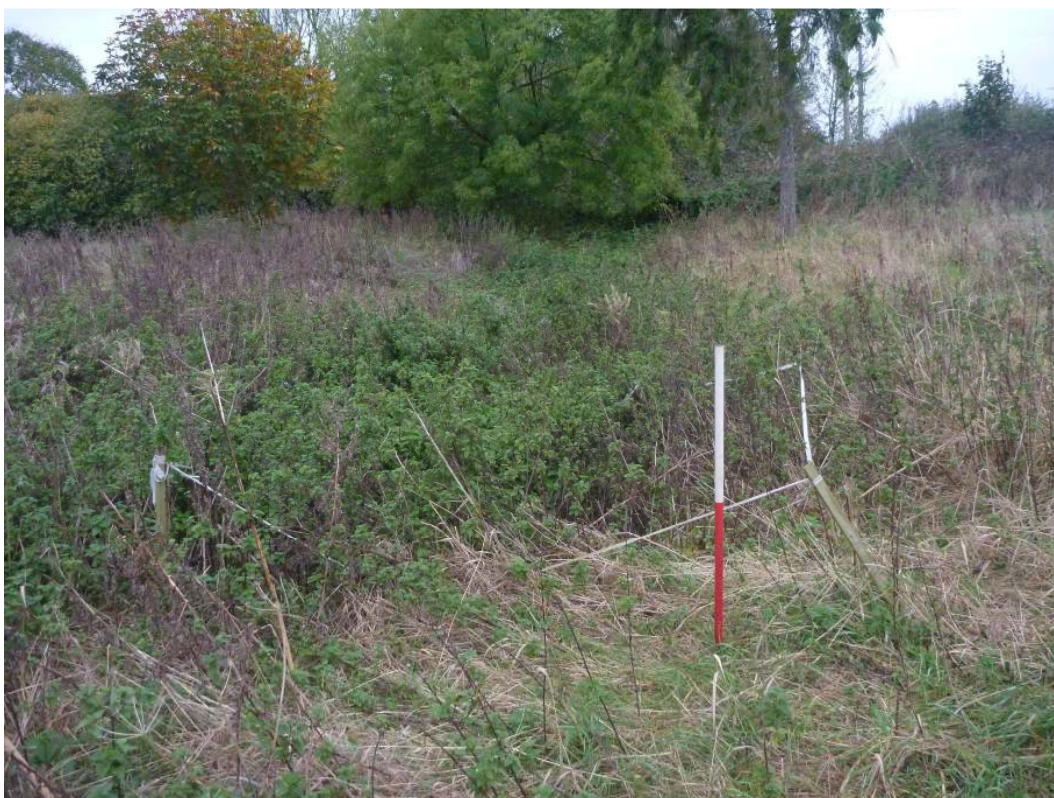
Plate 8: Linear ditch C013 forming east side of monastic precinct, viewed facing north

Feature ID	Feature name	Feature type	Description	Condition	NGR	Historic map
C013	Ditch east of priory site, Canon's Ashby	Ditch	A linear ditch or hollow to the east of the priory site and overgrown with nettles and brambles. The vegetation makes it difficult to see, but the southern end looks a bit wider than is depicted on the RCHME survey, and it is possible to trace the line of the edges of the feature as slight earthworks up to the northern wall of the walled garden (C011). The feature is c.8-10m wide at the top, 2-3m wide at the base and c.1m deep. There is a sunken hollow in one area, which may be a recent investigation pit. No water is visible within the feature. The feature is on a similar alignment to that of the infilled stretch of moat to the south (C009), and it is possible that it represents a continuation of the moat around the eastern side of the priory precinct, or a feeder channel from the Norwell (C025) to the moat. The feature is not shown on historic maps, but there is a field boundary in a similar location on the 1884 OS map.	Poor	SP 57873 50531	None

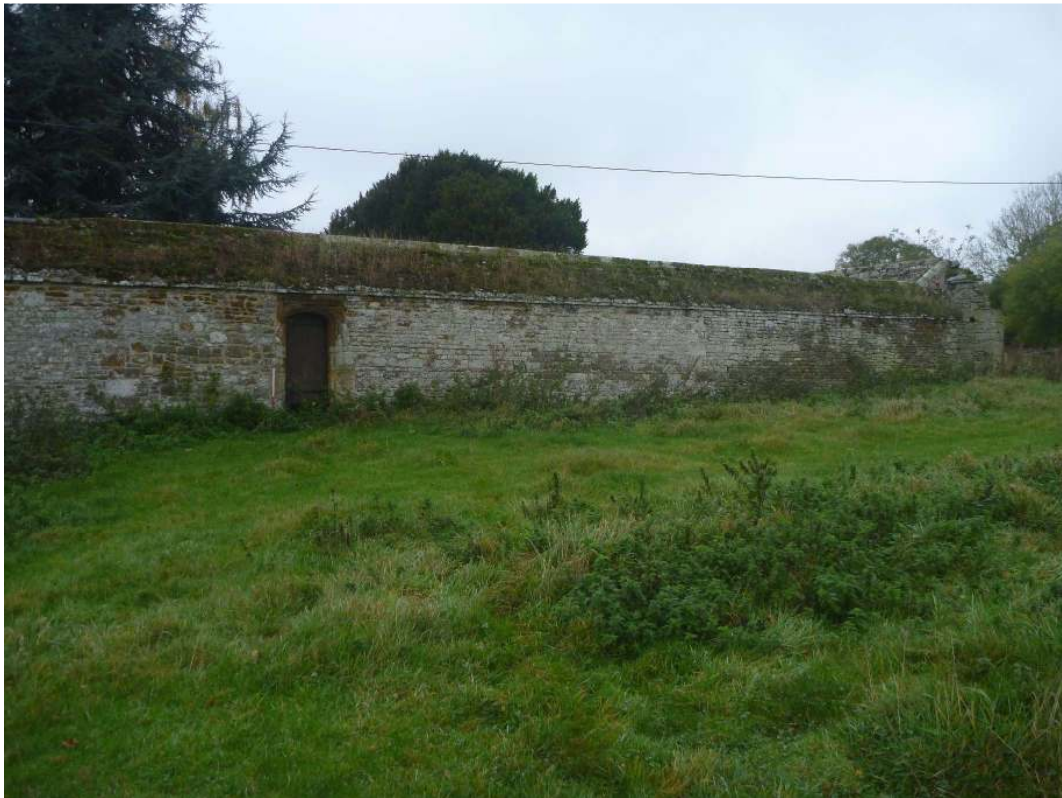
Plate 9: Eastern wall of the walled garden (C011), showing gateway, with scarp C010 in foreground, viewed facing north-west

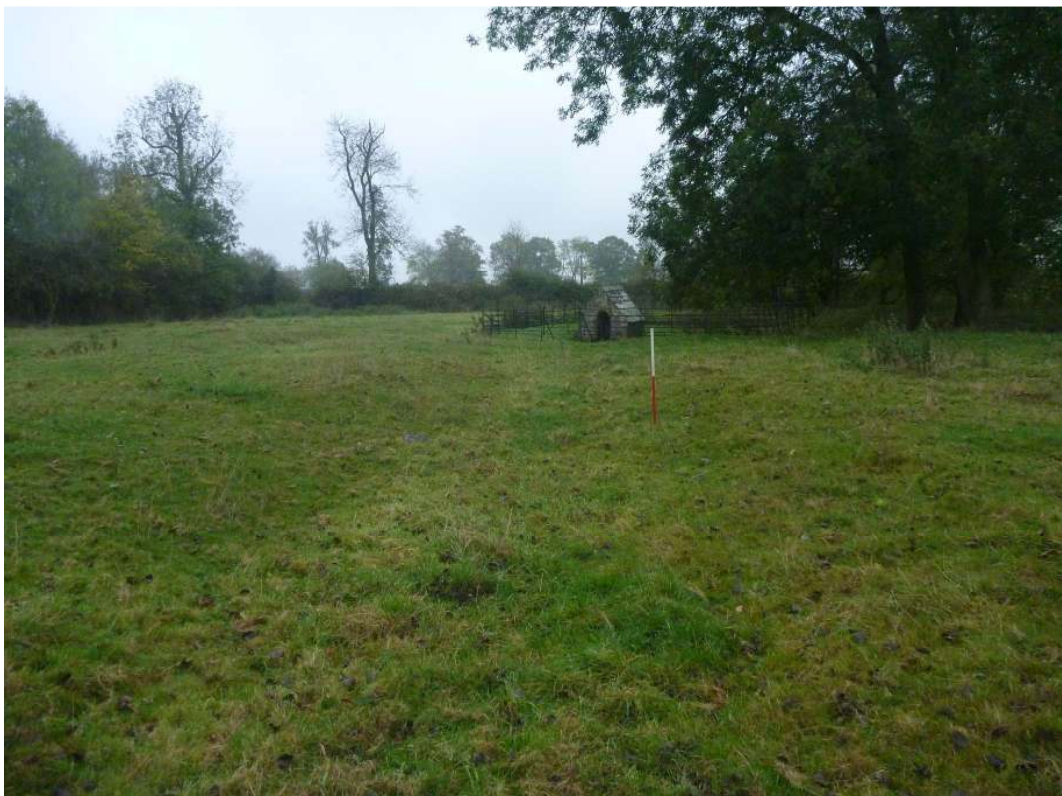
Plate 10: Linear hollow C023 on probable pipeline route, viewed facing east towards Norwell
