**ARCHAEOLOGICAL INVESTIGATIONS AT RADFORD  
STREET, SHEFFIELD**

***ARCHAEOLOGICAL MITIGATION REPORT***

Report Number 2015/35    February 2016

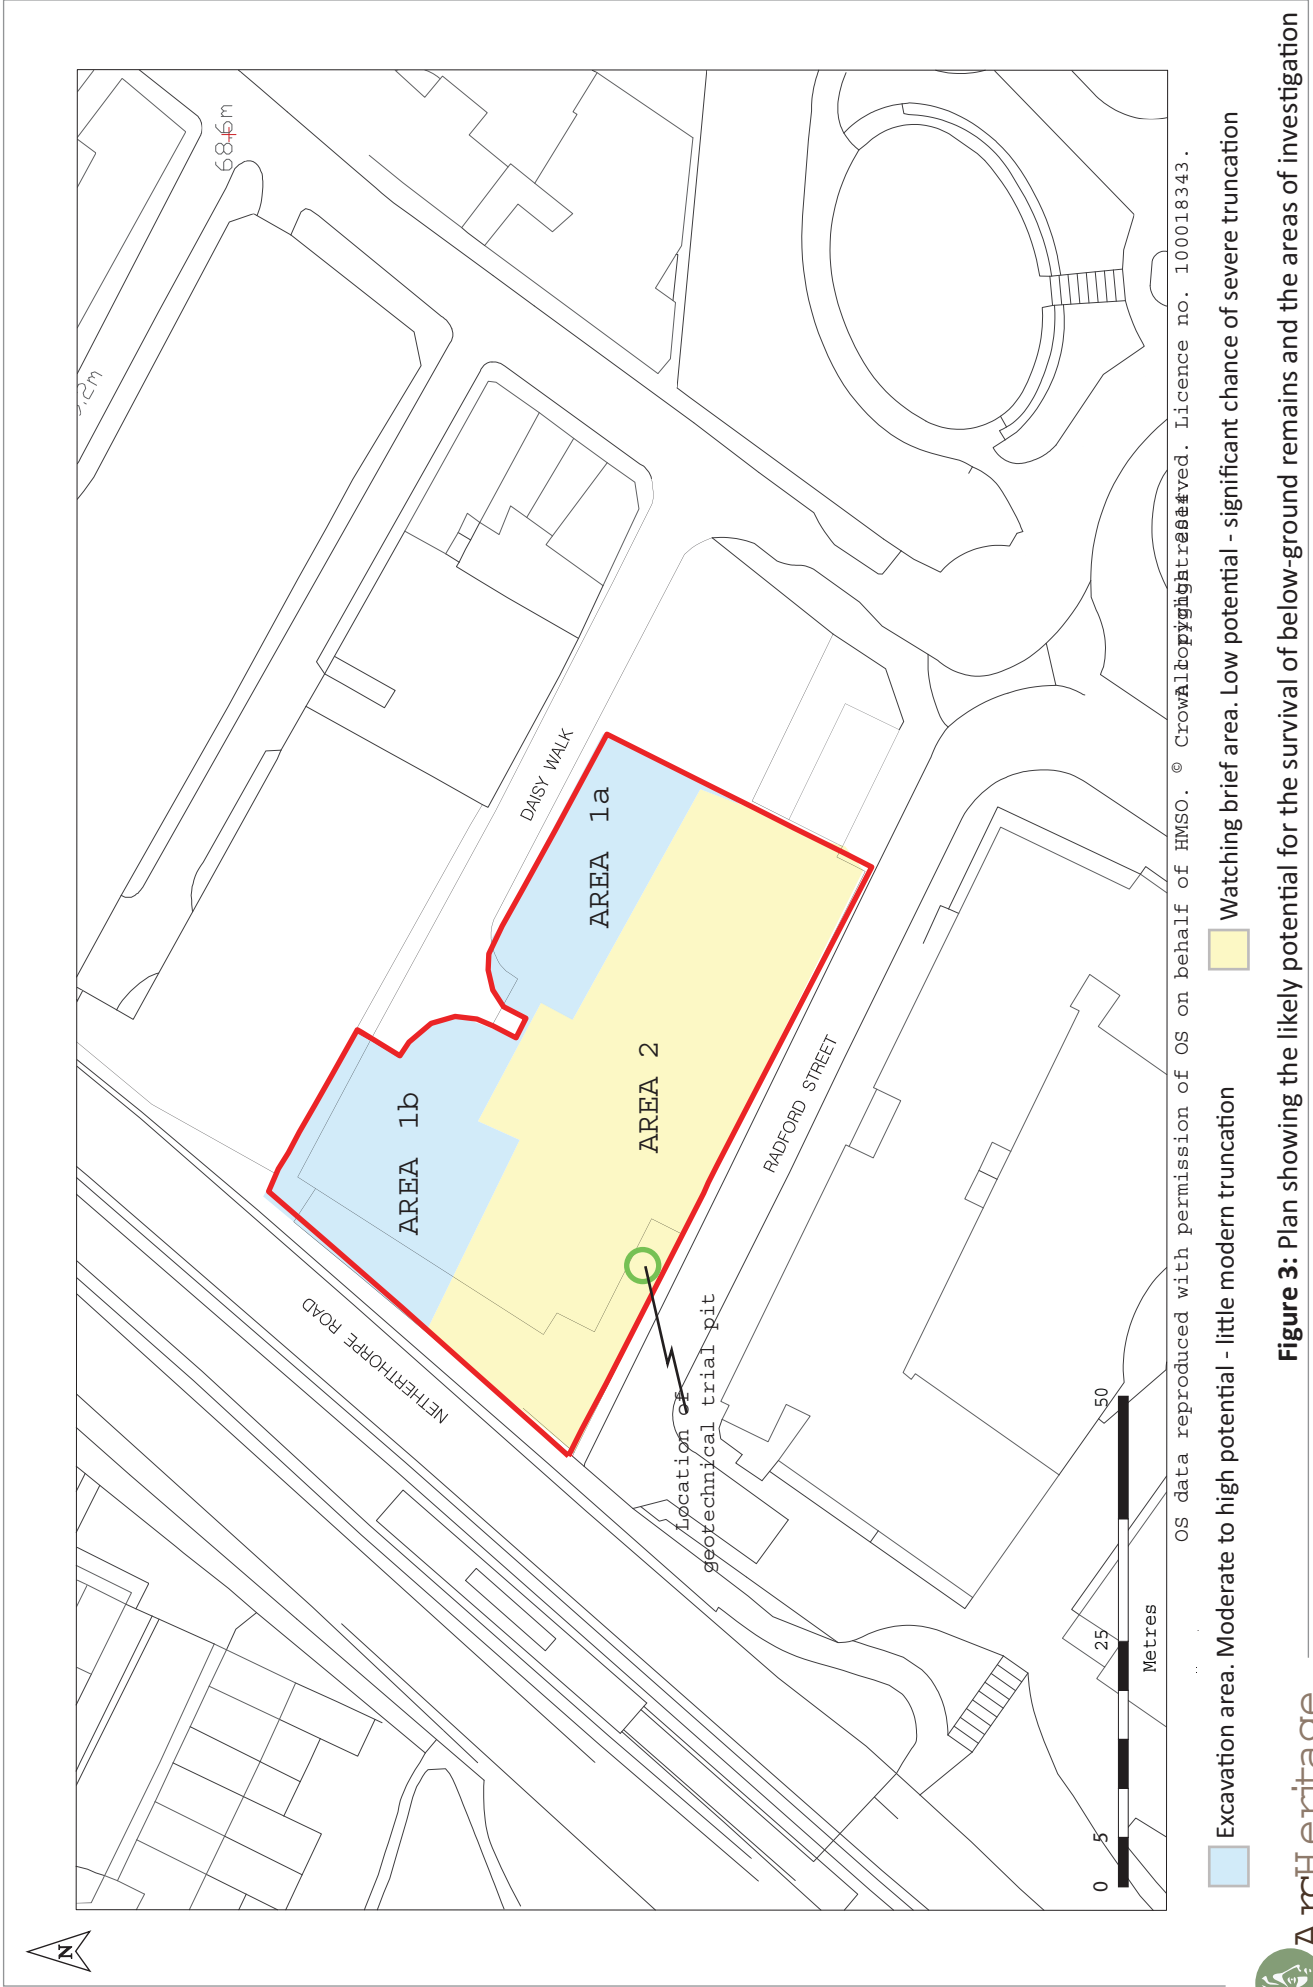
**Figure 3:** Plan showing the likely potential for the survival of below-ground remains and the areas of investigation

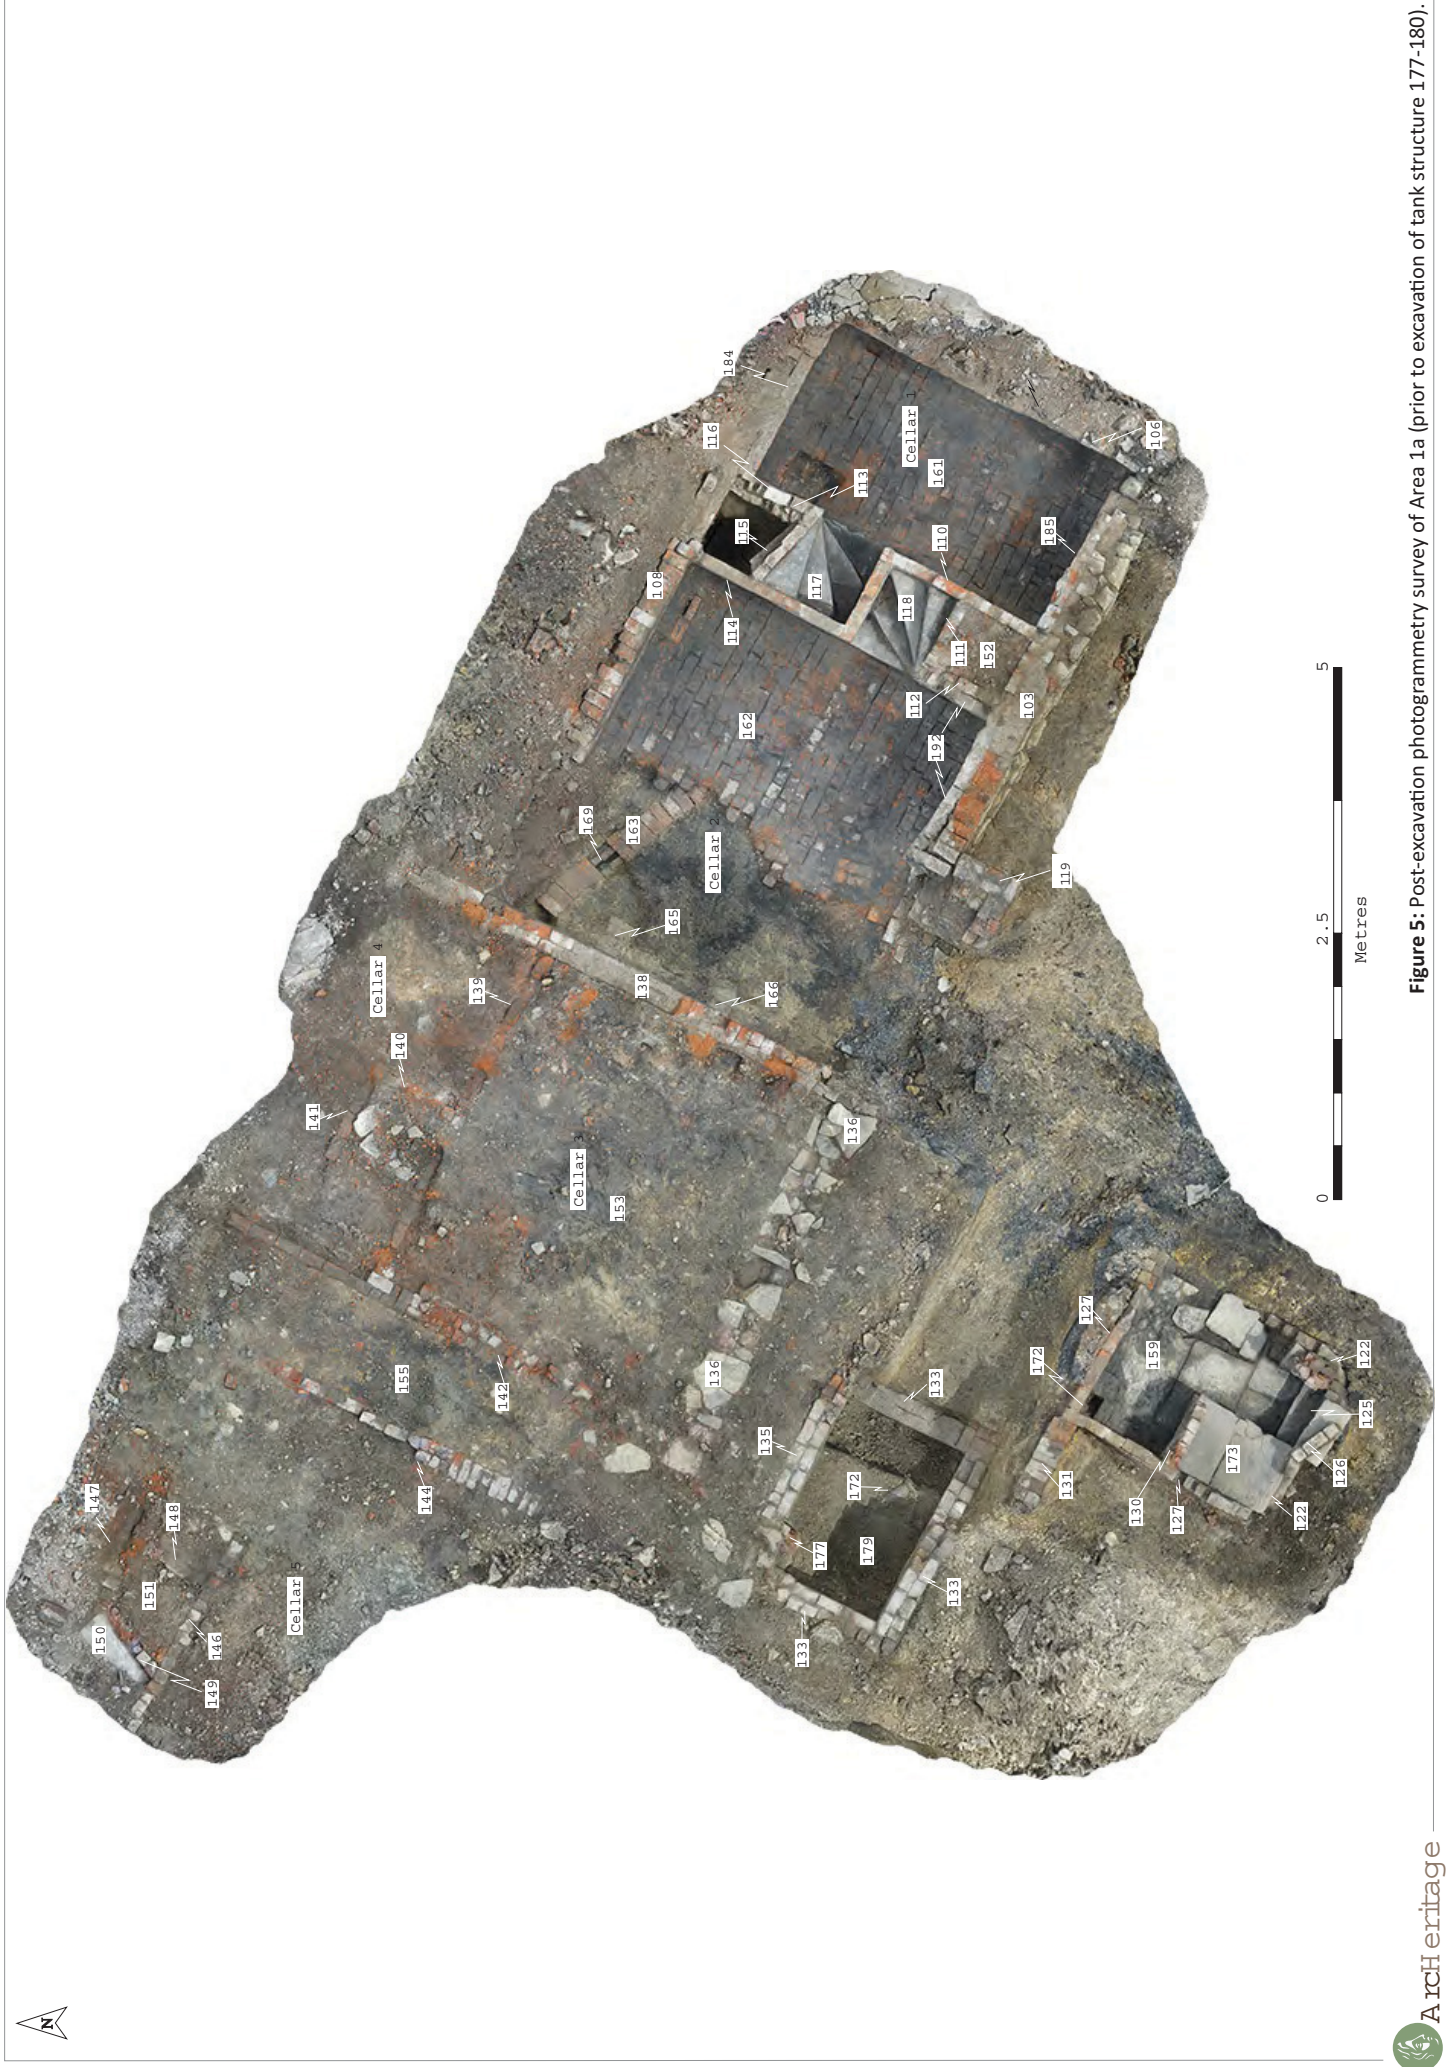
Figure 5: Post-excavation photogrammetry survey of Area 1a (prior to excavation of tank structure 177-180).

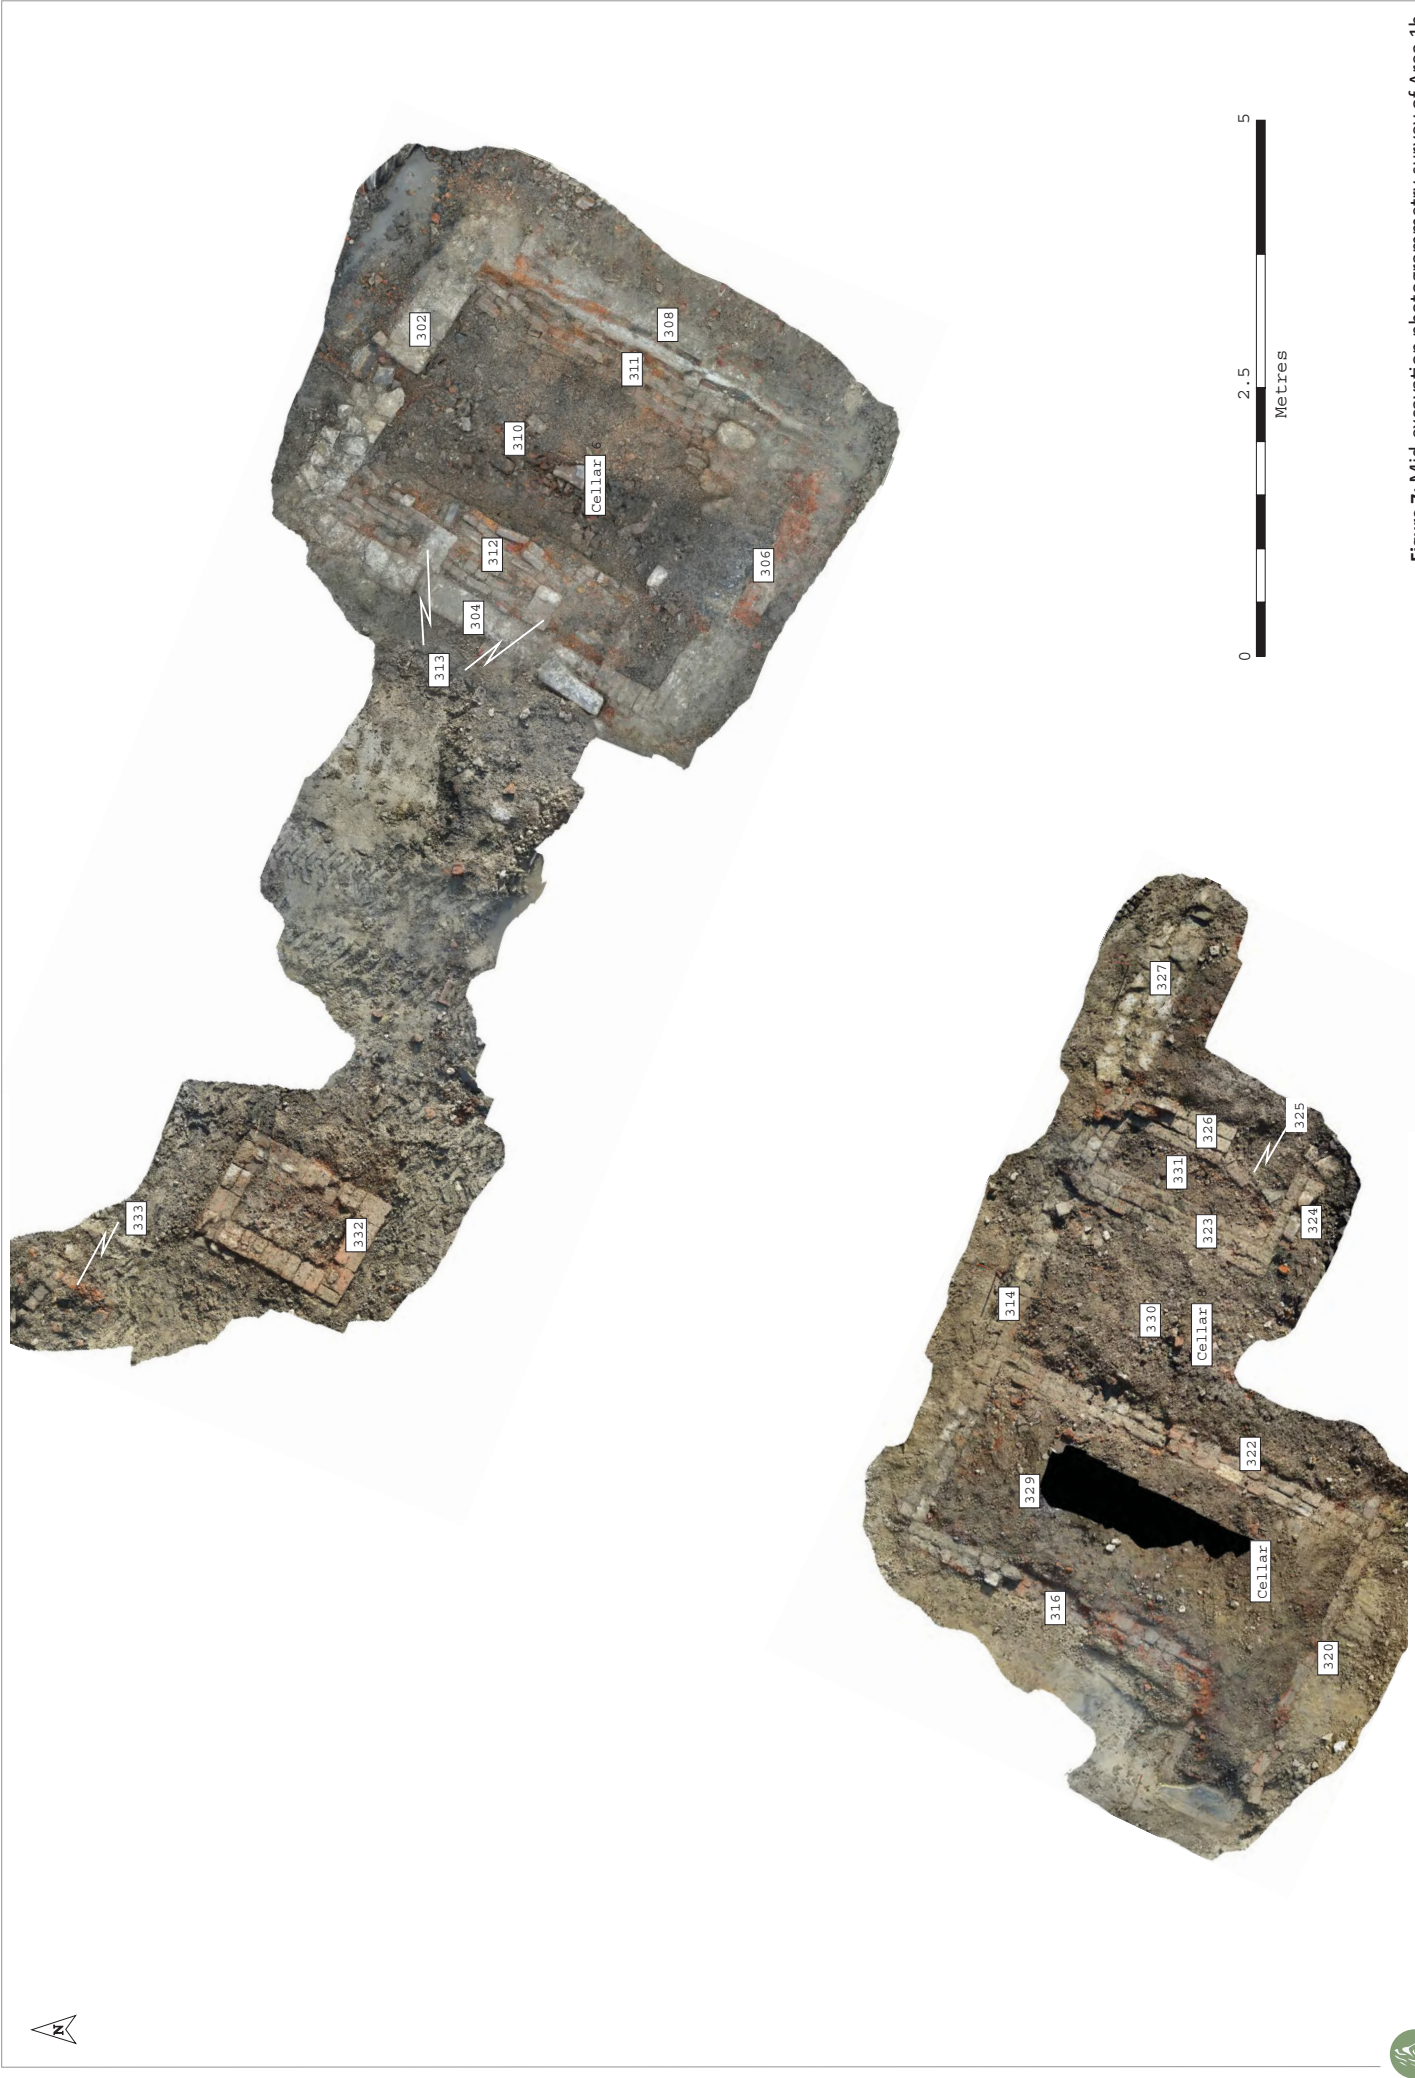
Figure 7: Mid-excavation photogrammetry survey of Area 1b.

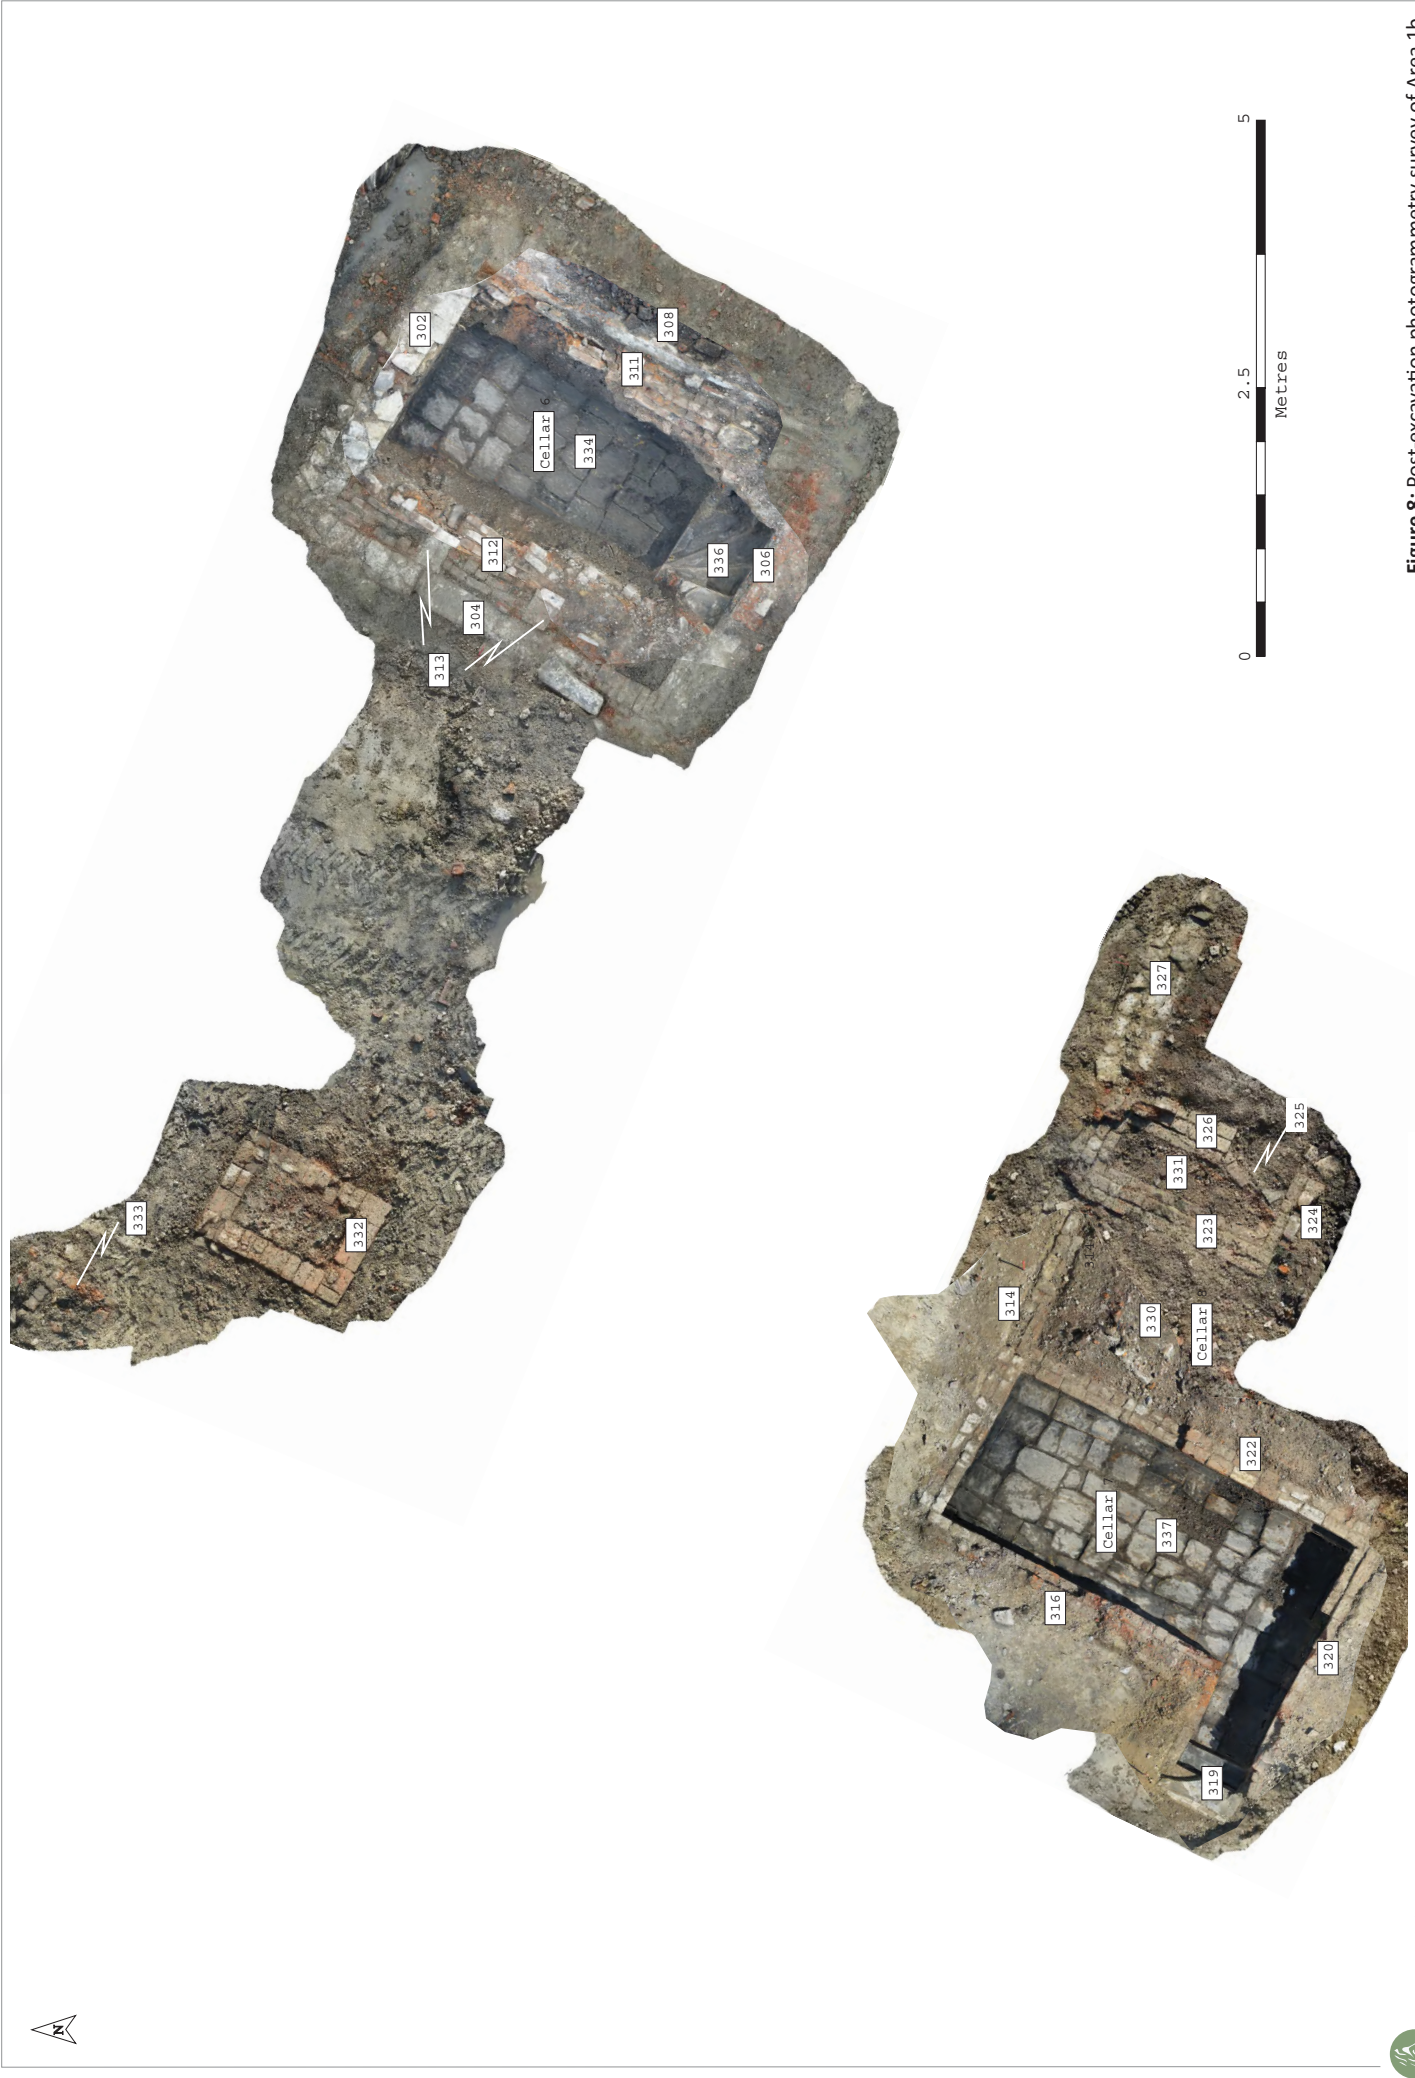
Figure 8: Post-excavation photogrammetry survey of Area 1b.

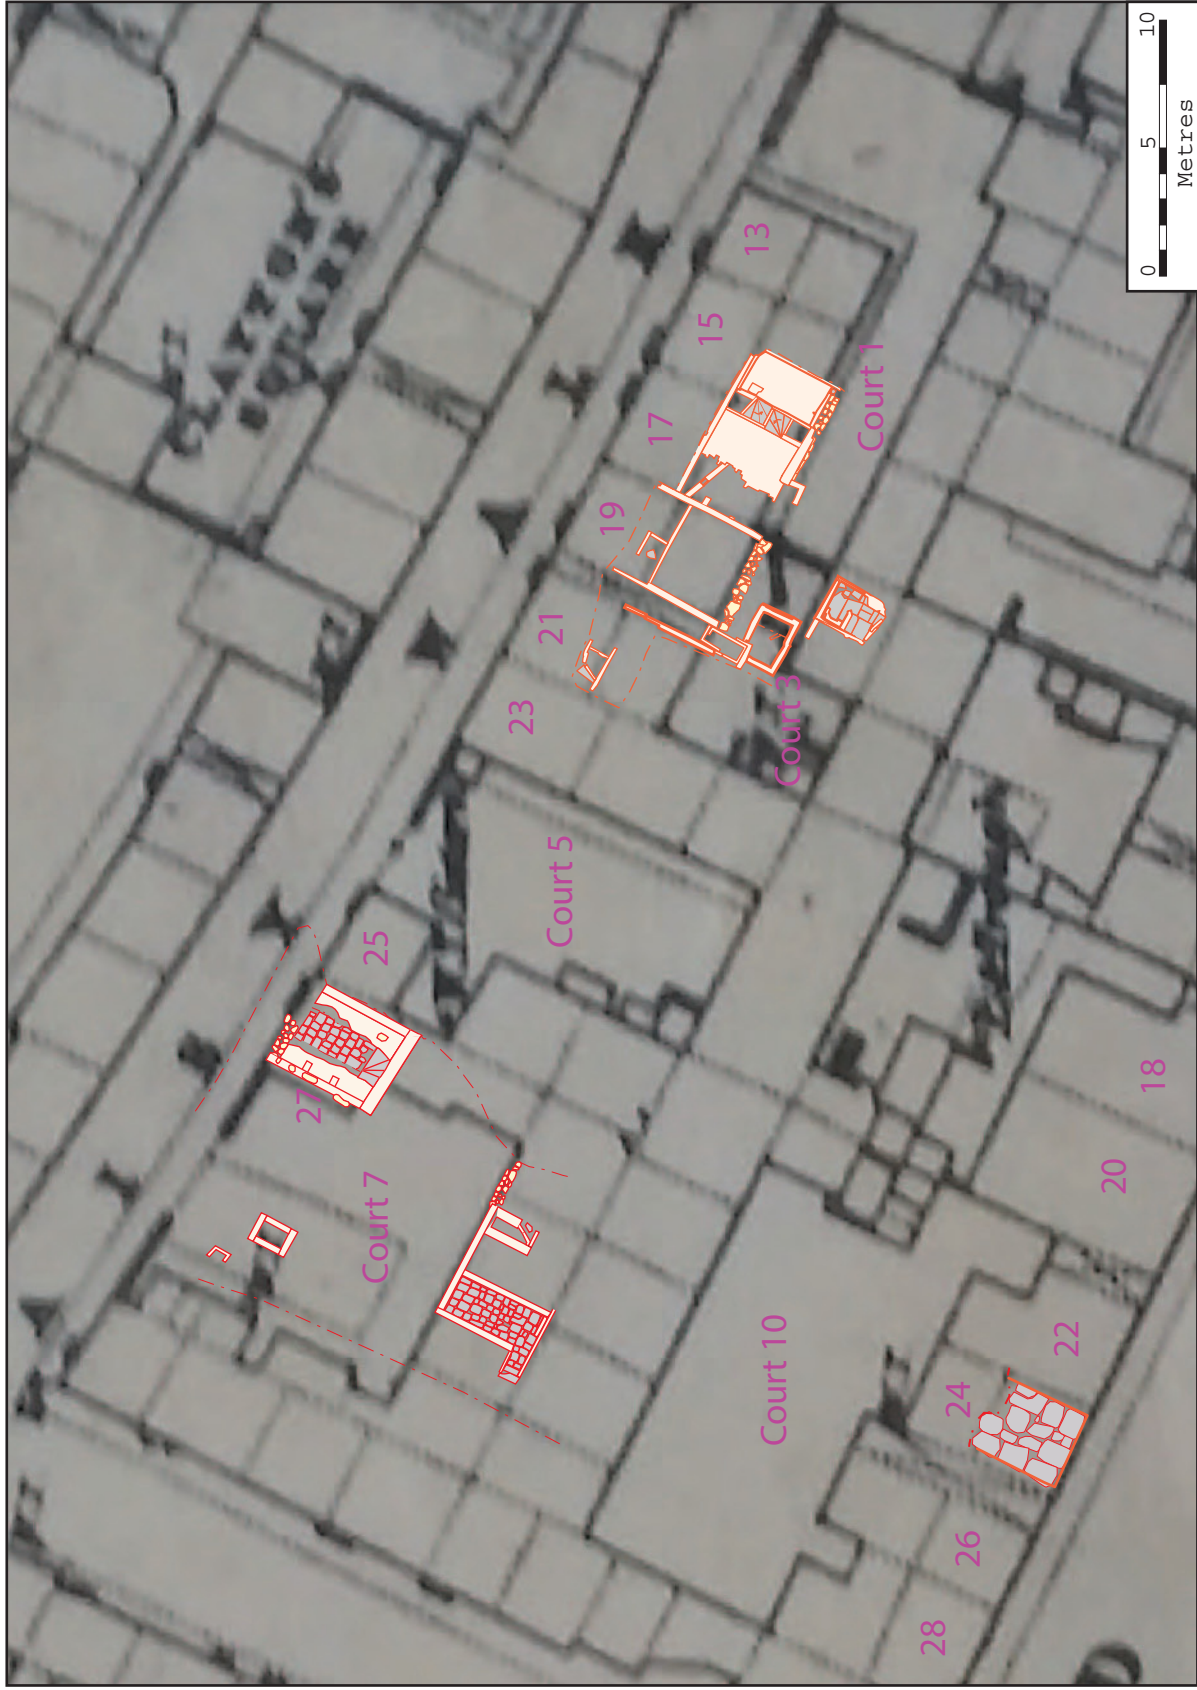
Figure 9: Plan of the excavated features in Areas 1 and 2 over the 1851 OS map, with probable property numbers shown in pink.

The remains uncovered in Area 1a are likely to relate to a row of back-to back housing that fronted onto Daisy Walk (Figures 9-11). The cellars recorded during this excavation all appear to represent standard half width cellars (with one half belonging to the front house and one half to the back). Full width cellars were not uncommon, and were often used as small workshops and communal coal stores, although no evidence for this was observed during the excavations.

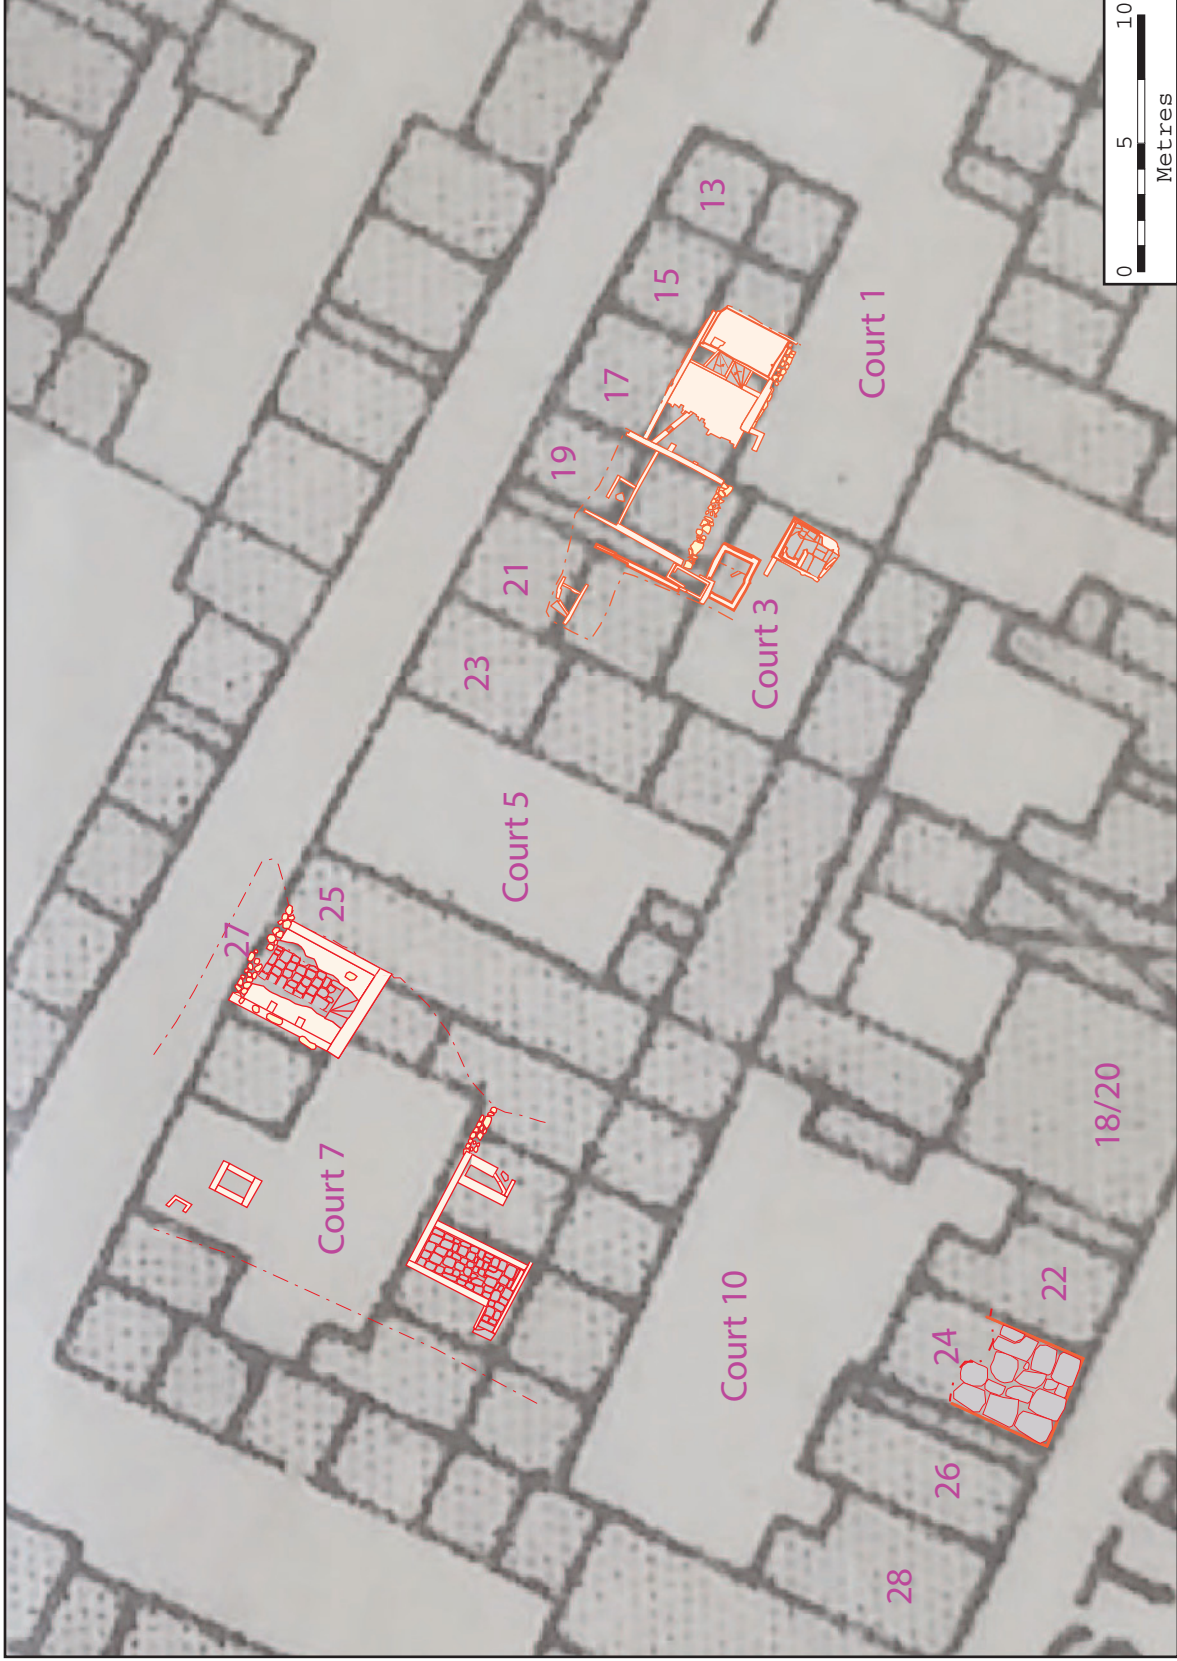
**Figure 11:** Plan of the excavated features in Areas 1 and 2 over the 1923 OS map, with probable property numbers shown in pink.

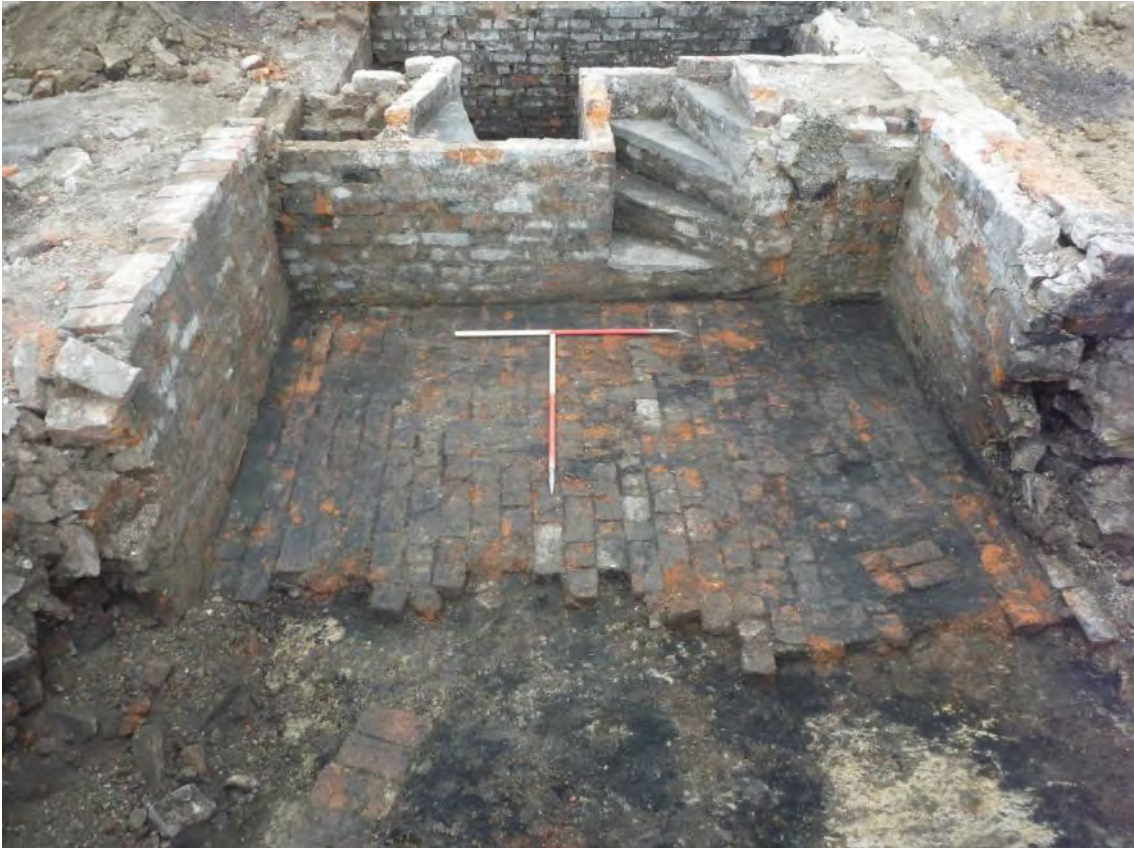
**Plate 6: Stairs 117 (Cellar 1, left) and 118 (Cellar 2, right). Looking south-west. Scale 1m.**

Cellar 2 was immediately adjacent to Cellar 1, partitioned by staircase structures (117) (Cellar 1) and (118) (Cellar 2) and associated walls (110-116). The staircase (118) in Cellar 2 was identical in construction to that in Cellar 1, and entered the room in the south-eastern corner. The two north-west to south-east aligned walls (103 and 108) are continuations from those observed in Cellar 1, with north-east to south-west aligned wall (138) forming an internal partition wall with Cellar 3 to the north-west. Unlike Cellar 1, Cellar 2 displayed no clear evidence of phasing, and no internal modifications were observed as in Cellar 1. A brick floor (162) was present, extremely similar to floor (161) in Cellar 1. Floor (162) (Plate 5) comprised a single course of plain red bricks, with the underlying coal and clinker bedding (180) acting as a bonding material between the bricks. Some signs of repair were evident within the floor in the south-western corner, with a handful of bricks laid against the arrangement of the rest of the floor. The brick floor (162) abutted the walls (103, 108, 112 and 114) of the cellar, suggesting that the floor was laid after the walls were built, although is likely to be contemporary with the construction of the walls.

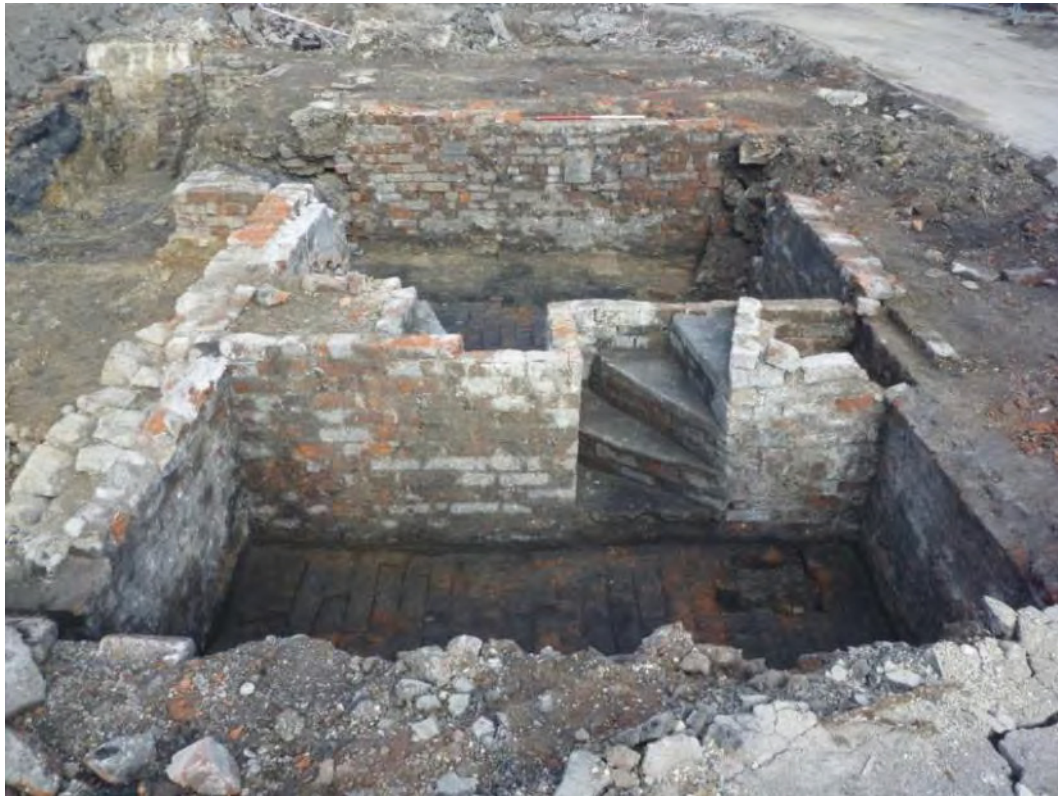
**Plate 9: Cellar 1, looking north-west. The internal skin walls of the cellar can be observed in this photograph, with wall 184 to the right and wall 185 to the left. Scale 1m.**

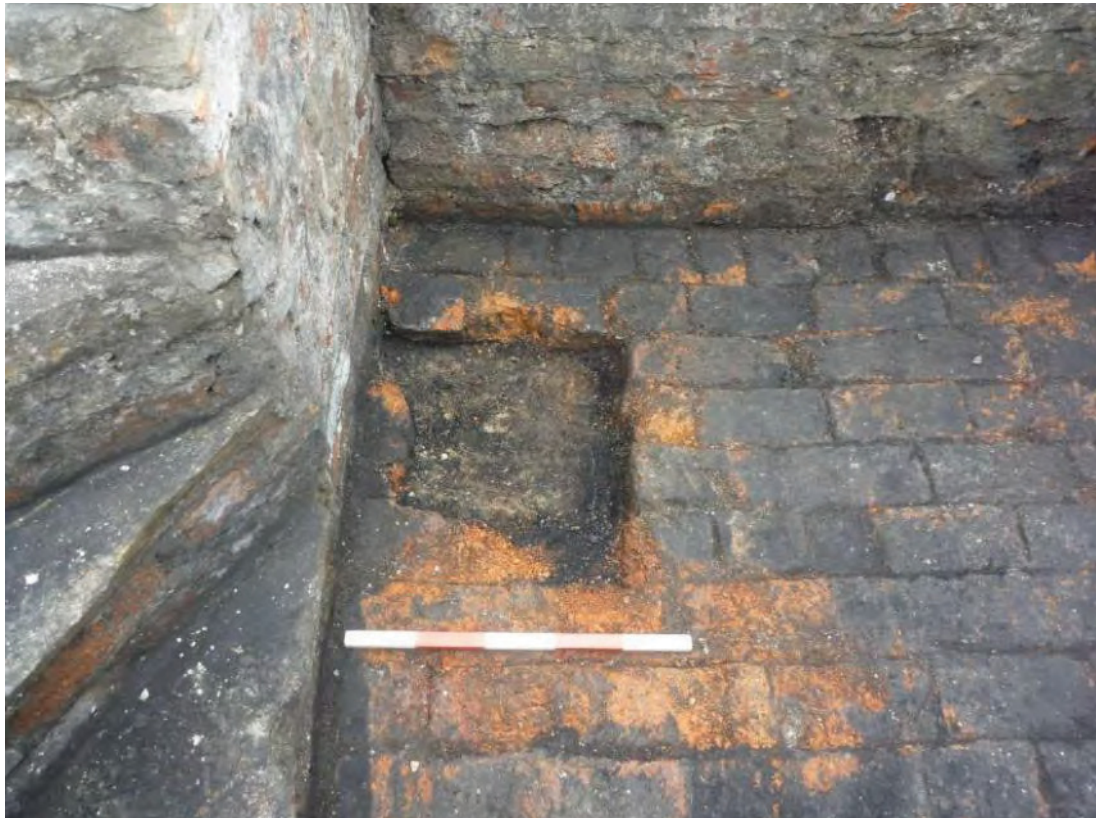
**Plate 10: Sondage in brick floor 161 of Cellar 1, showing underlying bedding deposit (182) over the natural geology. Scale 0.5m.**

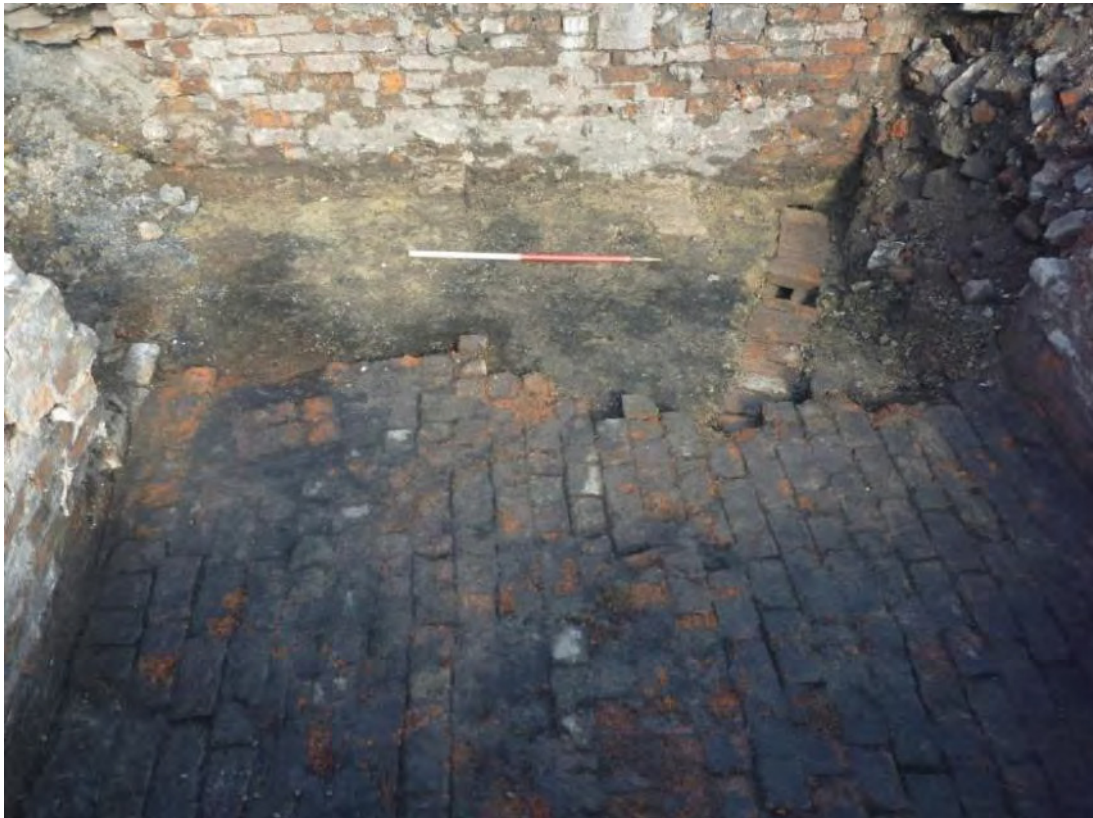
**Plate 11: Truncation in Cellar 2, showing damage to the brick floor (162) and walls (103, 108, 119 and 192). Drain (163) and possible fireplace (164 and 165) can also be observed. Looking north-west. Scale 1m.**

Later truncation activity (Plate 11) has severely disturbed the remains in Cellar 2, with the entire north-western extent of walls (103) and (119), the upper courses of wall (108) and the north-western half of floor (162) completely removed. The nature of the truncation suggests it may have been caused during the initial demolition of the site in the 1930s, or by later

groundworks associated with the construction of the St Phillip's Social Club, but a definitive cause could not be established.

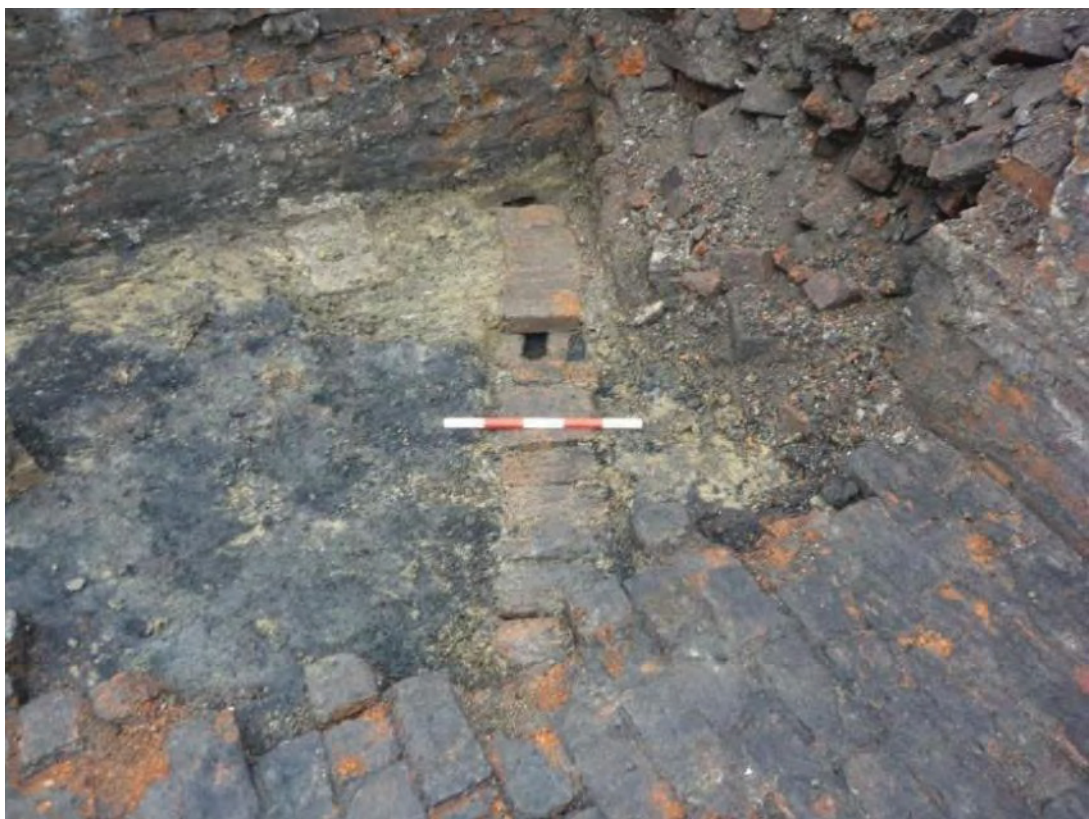
**Plate 12: Drain (163) in Cellar 2. Looking north. Scale 0.5m.**

Beneath the floor (162) in Cellar 2, a brick-built drain was present (163) (Plate 12), aligned roughly north-west to south-east, sloping downwards towards the north-west. The drain was cut [164] into the natural geology (193), comprising a channel formed out of plain red-bricks, laid on their long edge, capped with similar bricks in a single row. The channel width varied from 0.06–0.08m and ran under wall (138). The bricks used to construct drain (163) were markedly different to other bricks observed within the site, with a shallow central notch, suggesting that all of these bricks were made within the same mould. The drain was filled with very soft and smooth dark brown grey clay (169), presumably a natural build up of deposits which accumulated during the time the drain was in use. No finds were recovered from the drain fill. Two rows of bricks, (165 and 166) (Plate 13), were also present beneath floor (162) in Cellar 2, butting up to wall (138). The northern most of these structures, (165), comprised a single row of 4 red bricks in header formation, laid on their long edge with thick light grey lime mortar. The southern-most row of bricks, (166), was 1m away from (165), comprising only a single brick, although cut [168] suggests that at least two more bricks would have been present. Both of these rows of bricks could be traced up the face of wall (138), which was slightly scarred with what appears to have been extensions of (165 and 166), which the scarring suggests would have been partially keyed into wall (138). The location and relative dimensions of (165 and 166) suggests they may represent the location of a fireplace, or a bench or worktop structure. The entire internal area of Cellar 2 measured 3.6m by 3.2m. The excavated backfill (154) within Cellar 2 contained pottery and metallic artefacts (Appendix 3 and 5), with abundant brick rubble.

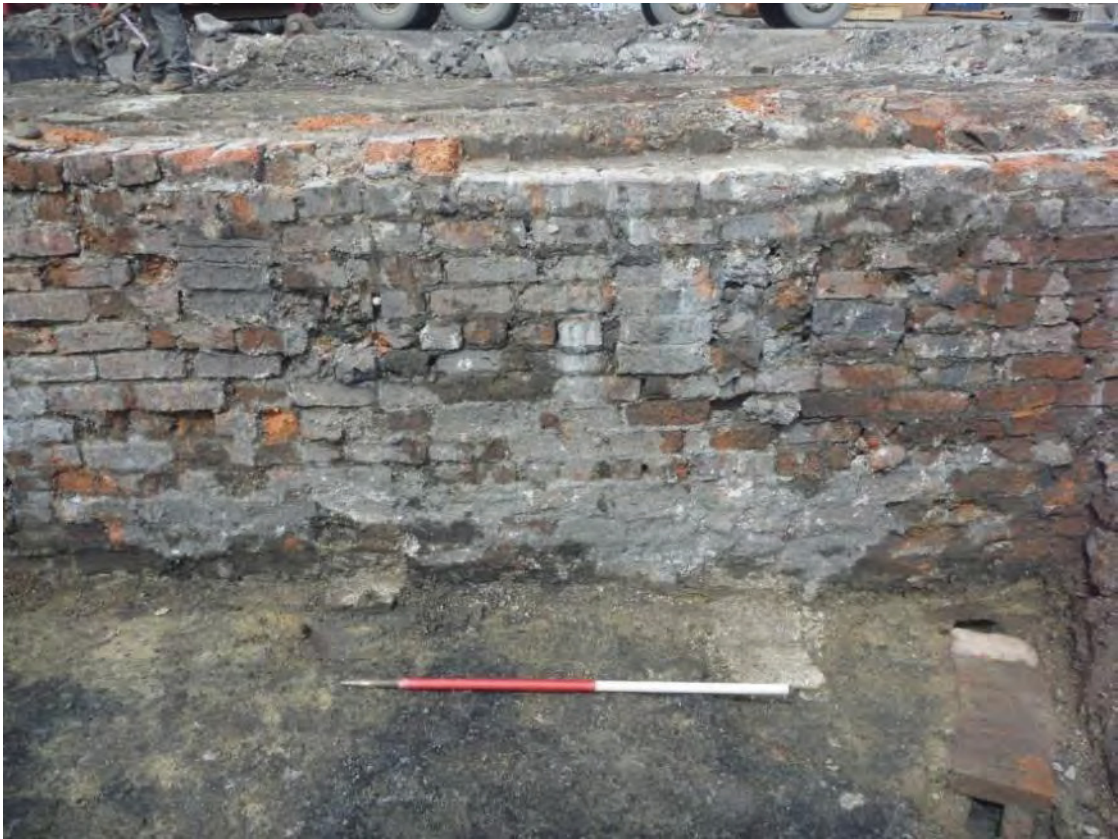
**Plate 13: Possible foundations of a fireplace (165 and 166) and drain (163) in Cellar 2. Looking north-west. Scale 1m.**
