**ARCHAEOLOGICAL INVESTIGATIONS AT RADFORD  
STREET, SHEFFIELD**

***ARCHAEOLOGICAL MITIGATION REPORT***

Report Number 2015/35    February 2016

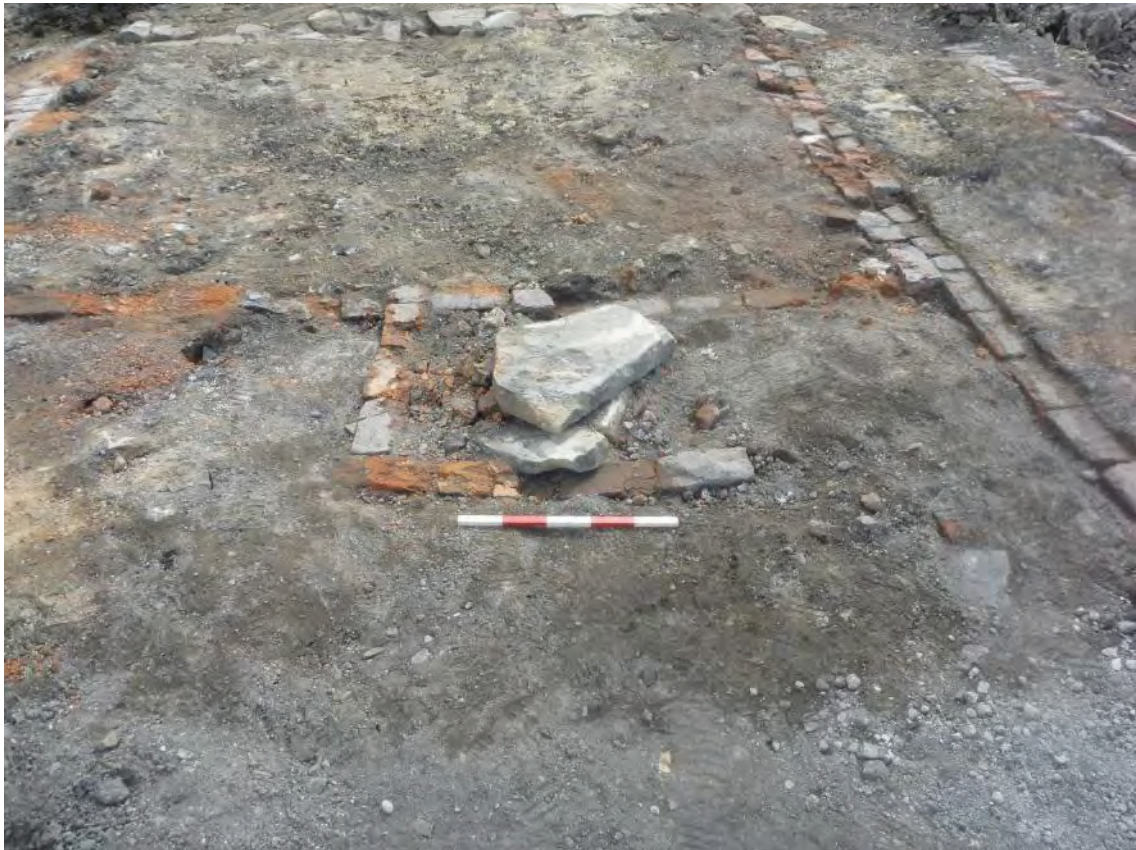
**Plate 15: Probable stairway 140 and 141 in Cellar 4. Looking south-east. Scale 0.5m.**

Cellar 4 (Plate 15) also remained unexcavated, the majority of it extending beyond the north-eastern limit of excavation. A probable staircase (140 and 141) was observed, which would have acted as a staircase for either Cellar 3 or 4, presumably with a corresponding staircase for the other cellar adjacent to it, which was not revealed during excavation.

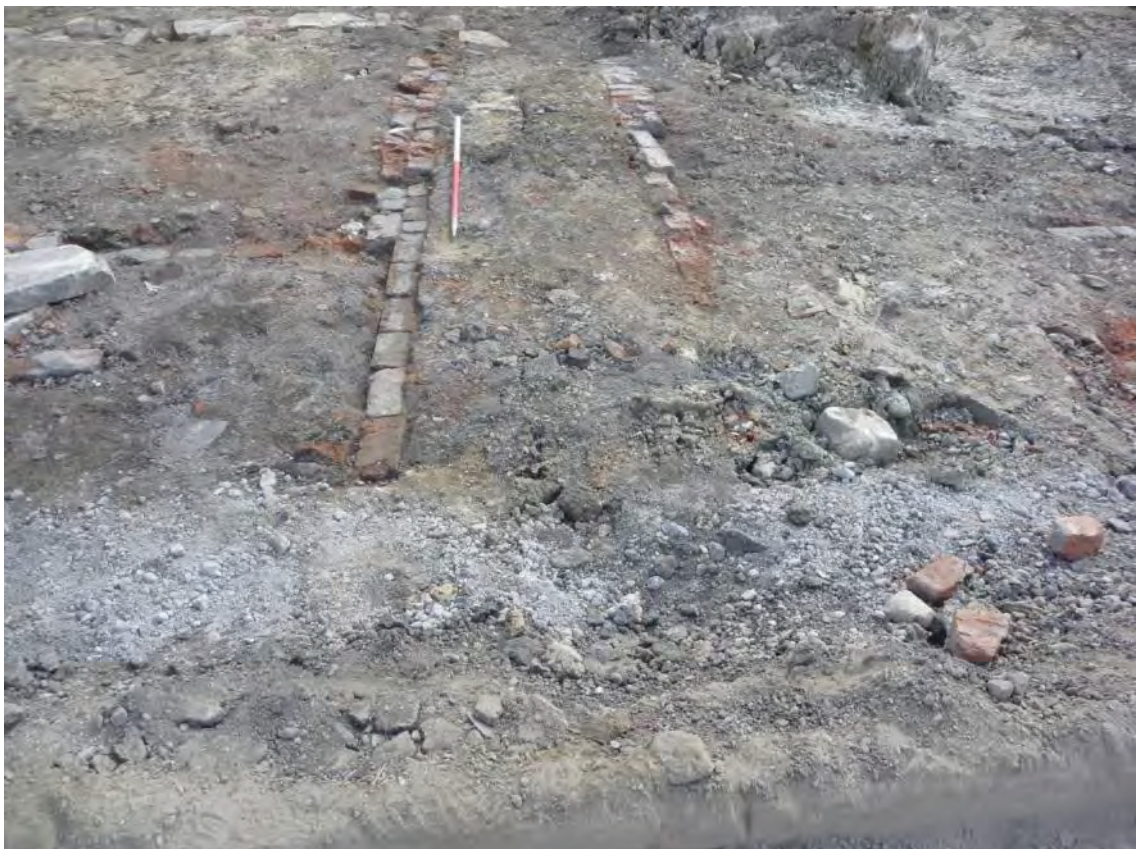
**Plate 16: Alley walls (142) and (144). Looking south-west. Scale 1m.**

Wall (142) comprised the north-eastern to south-western wall of Cellar 3 and 4 appears to have been an external wall, forming an alley way with wall (144) (Plate 16). Unlike external back walls (103) and (136), these external walls were not very different from the internal partition walls, comprising plain red bricks bonded with grey lime mortar, between one and two courses thick. The construction of both these walls was somewhat varied and mixed, suggesting either extensive modification or repair, or indicating that not a great deal of care was taken during construction. The width of the alley way measured approximately 0.90m. The surface of the alleyway was not observed, as backfill (155) was not fully excavated. The backfill (155) comprised firm mid-yellowish brown silty clay, with frequent inclusions of CBM, together with pottery and clay pipe (Appendix 3 and 4). A further staircase and cellar structure (Cellar 5) (Plate 17) was present to the north-west of the alleyway, with the staircase (150) on the same north-western to south-eastern alignment as that observed between Cellar 3 and 4. The backfill (151) of Cellar 5 remained unexcavated, although pottery, clay pipe and bone fragments was recovered from it (Appendices 3-5).

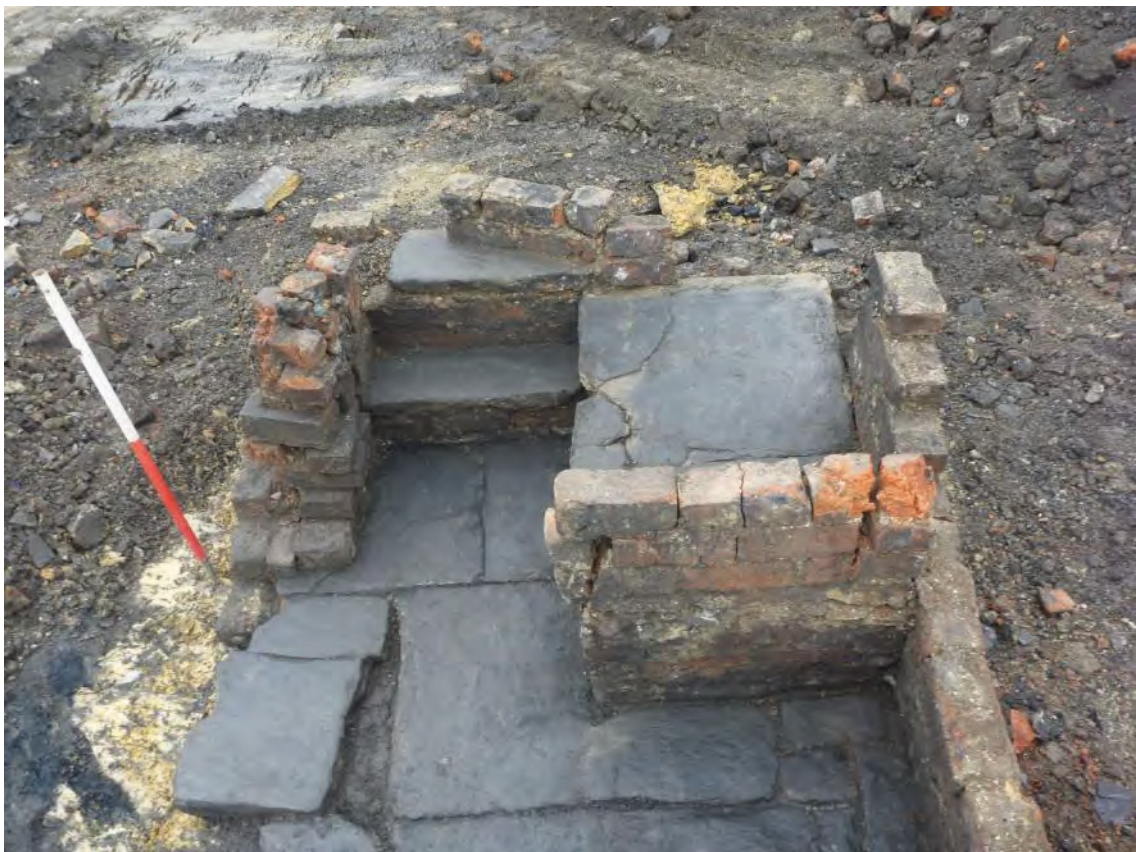
**Plate 20: Outhouse with stairs (125). Looking south-west. Scale 1m.**

Within the outhouse structure, the north-eastern space created by internal wall (130) measured approximately 1.50m by 0.82m, with the south-western space measuring approximately 1m by 0.84m. A possible staircase (125) (Plate 20) was present in the south-western space against wall (122). A single skin brick wall (126), slightly offset from wall (122), is likely to be part of the brick support for a staircase, suggesting it may have been curved or spiral, as with the staircases observed within the previous cellar structures. Only the two lower steps (125) remain, constructed out of two courses of plain red brick capped with a squared gritstone slab. A shelf or storage area was also present in the south-western compartment, with a gritstone slab shelf (173) (Plate 21), built into walls (130 and 122), approximately 0.38m above the floor (159). As excavated the shelf was formed of two slabs angled and sloping down towards the centre, although it appears that this is probably the result of structural

decline and the slabs were originally one large slab that had broken and slumped in its centre. The void created by these structures measured 0.77m by 0.72m with a height of 0.38m at the edges. Both compartments of the outhouse structure were flagged (159) with roughly squared gritstone slabs of varying size. The flags had clearly been laid around the walls, and did not run underneath them. An underlying coal and clinker bedding deposit (171) was present beneath the flags (Plate 22), from which a small fragment of clay pipe stem and a small fragment of pottery was recovered, directly related to the construction phase of the outhouse structure. The flagged floor (159) showed some signs of repair at the junction of the L-shaped wall (127), where plain red bricks were present instead of flags. In the floor (159) at the corner of wall (127) was a rectangular void measuring 0.25m by 0.17m, containing a ceramic drain (172) (Plate 23), from which five fragments of pottery (Appendix 3) were recovered from the mixed soft yellow clay and dark brown clay silt fill (160). The drain continued in a north-westerly direction. The red brick repair/modification to floor (159) around drain (172) suggests that the drain may have been a later addition to the structure. The excavated backfill (157) within the outhouse structure, contained within walls (122 and 127) contained frequent pottery, clay pipe, glass and other miscellaneous artefacts (Appendices 3-5), with frequent brick rubble.

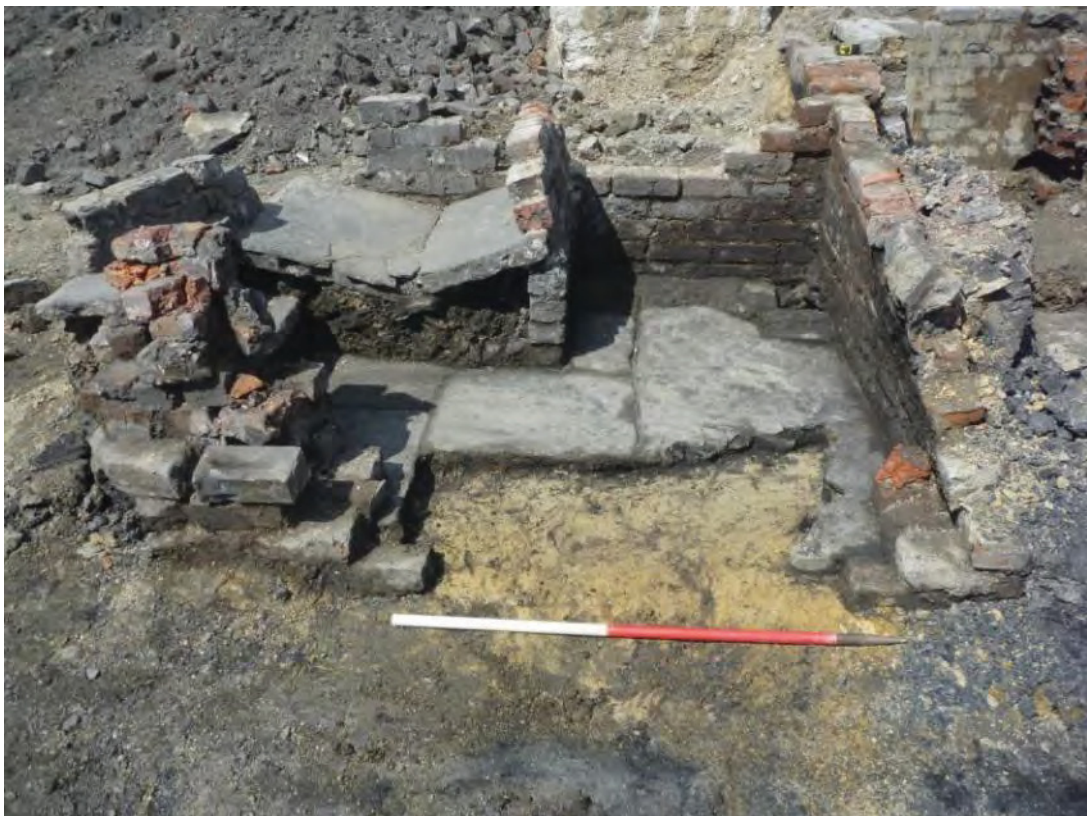
**Plate 22: Outhouse structure following the partial removal of flagged surface (159), showing a thin layer of bedding (171) upon the natural geology.**

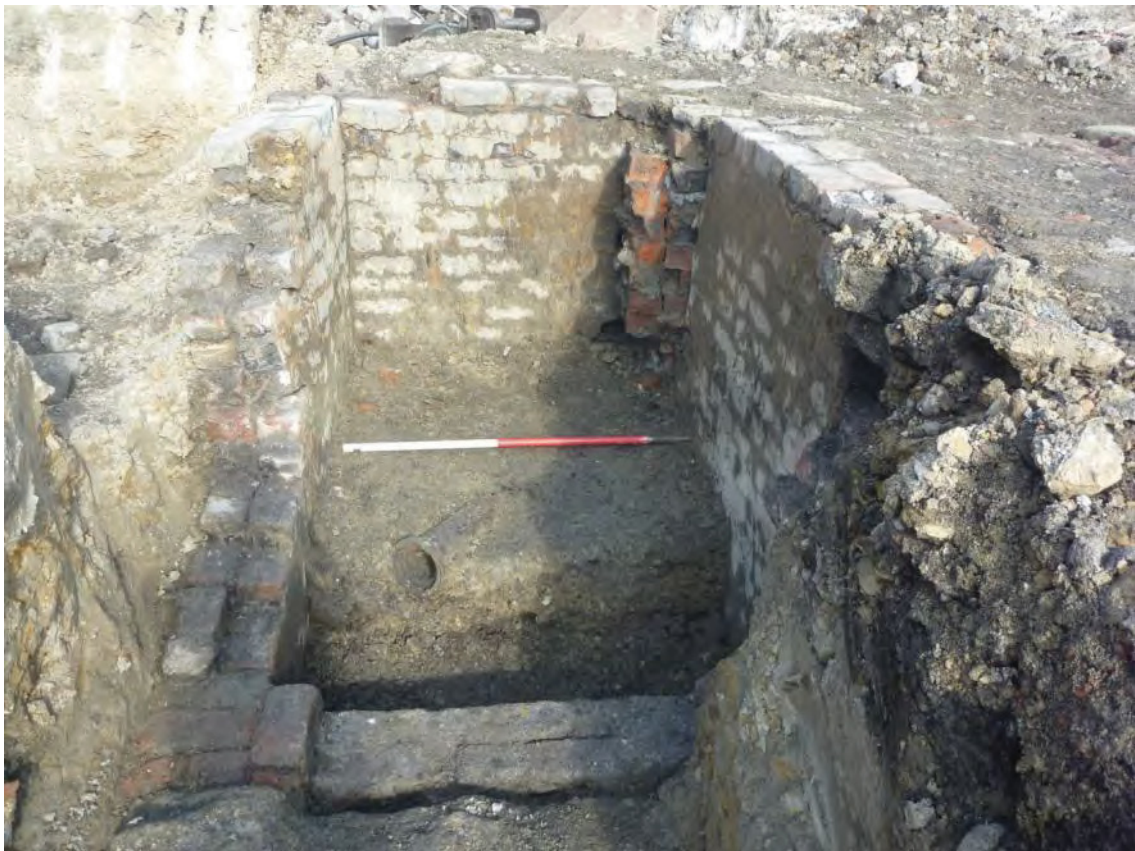
**Plate 24: Drain (172) within backfill (179) and walls (133 and 135), with later truncation from structure (177). Looking north-west. Scale 1m.**

fill (179) demonstrated that drain pipe (172) ran into and beneath this structure. Although the pipe was damaged where it met with (177) it is unclear whether this damage was caused by the insertion of (177). The later structure (177, 187-190) took the form of a north-east to south-west aligned rectangular red-brick structure, measuring internally 1.5m by 0.64m. The structure appeared to have later modifications (188, 190), and was squeezed into the gap created by alleyway walls (142 and 144) (Plates 26-27). The structure was roughly made, and it is possible it may be a manhole or some other structure associated with services. The backfill (186) of the structure contained fragments of drain pipe, pottery and glass fragments (Appendix 3 and 5).

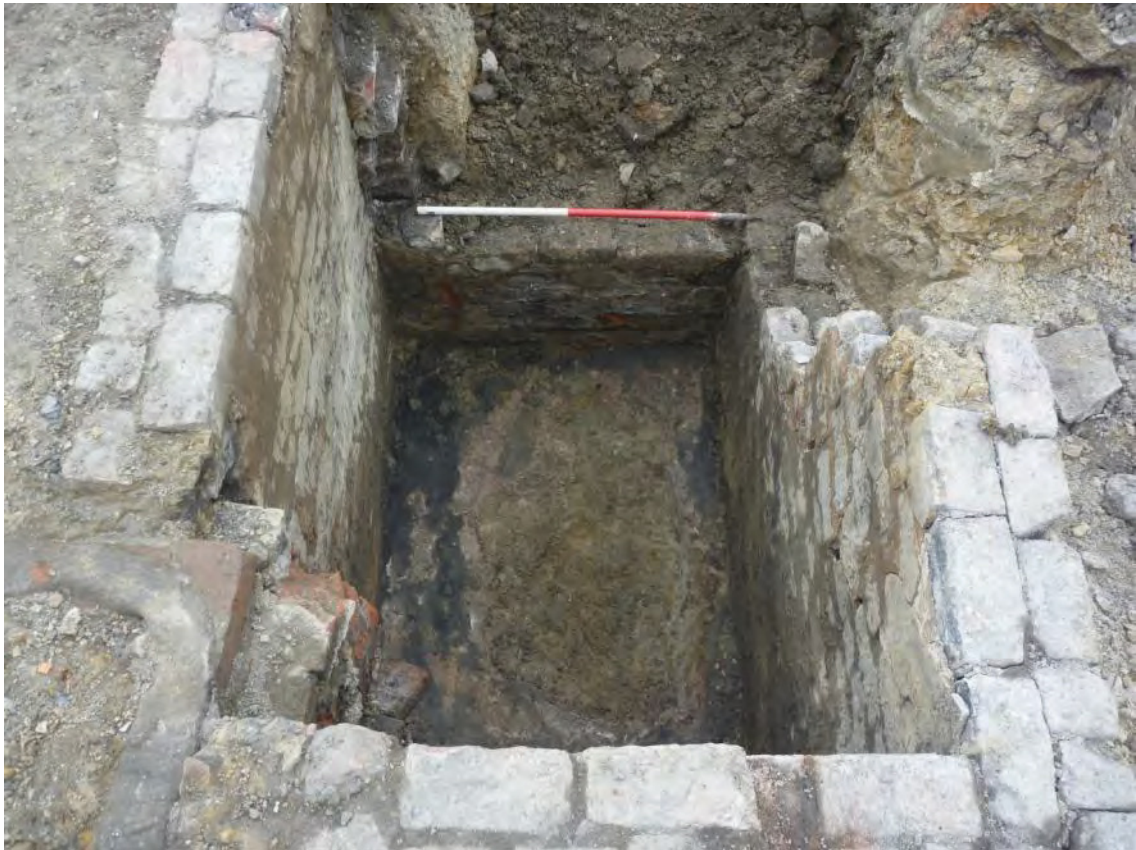
**Plate 25: Tank (133) and (135) with rendered surface (191). Looking south-east. Scale 1m.**

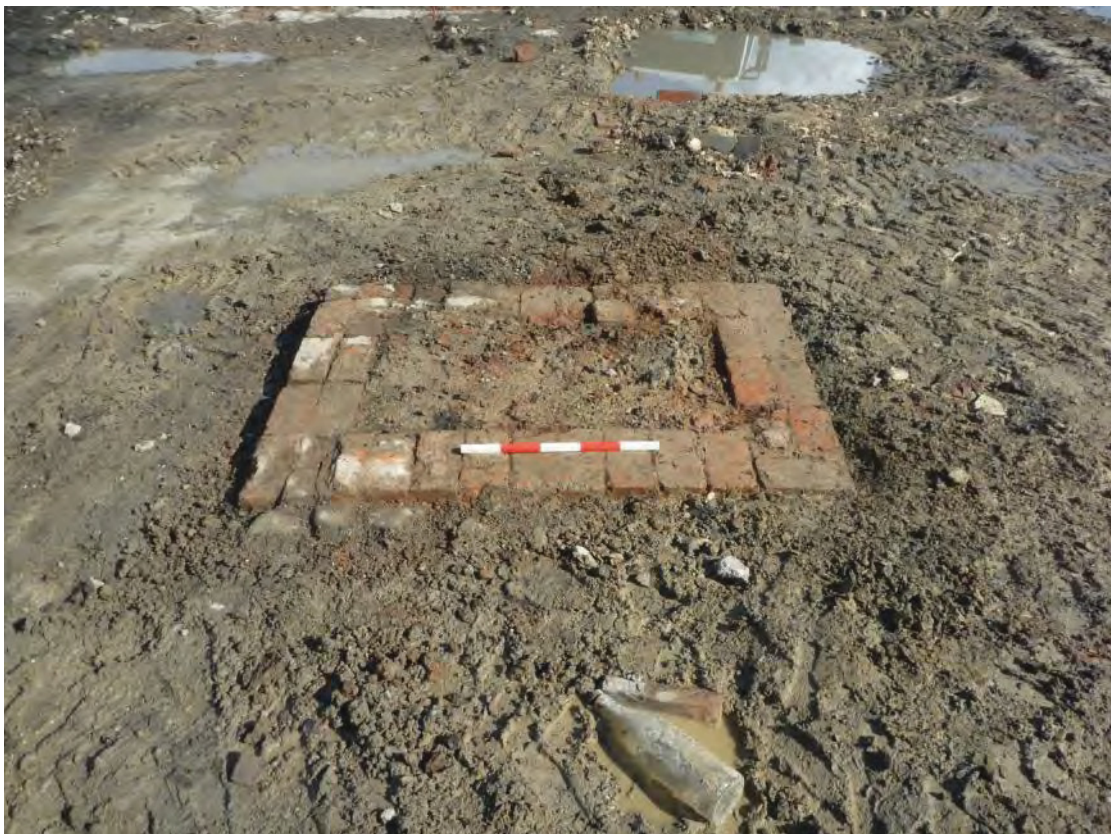
**Plate 32: Manhole structure 332. Scale 0.5m. Looking south-east**

The structural remains were all fairly similar across the site, comprising plain red-brick bonded with lime mortar. The only instance of later machine-made brick was observed in the manhole structure (332) in Area 1b. All of the surfaces comprised either plain red brick, or squared gritstone flags.

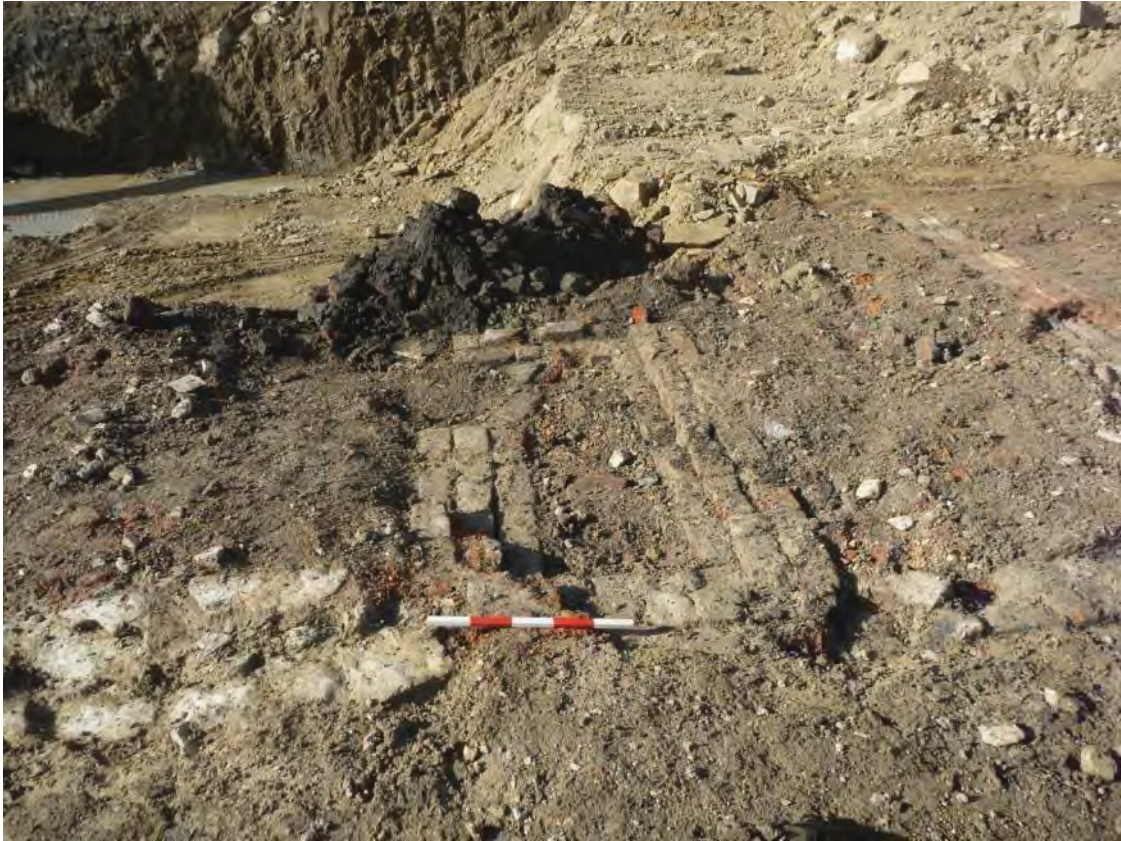
**Plate 35: Possible staircase structure 323-326, and brick wall 314 and stone-built back wall 327. Scale 0.5m. Looking south-west.**

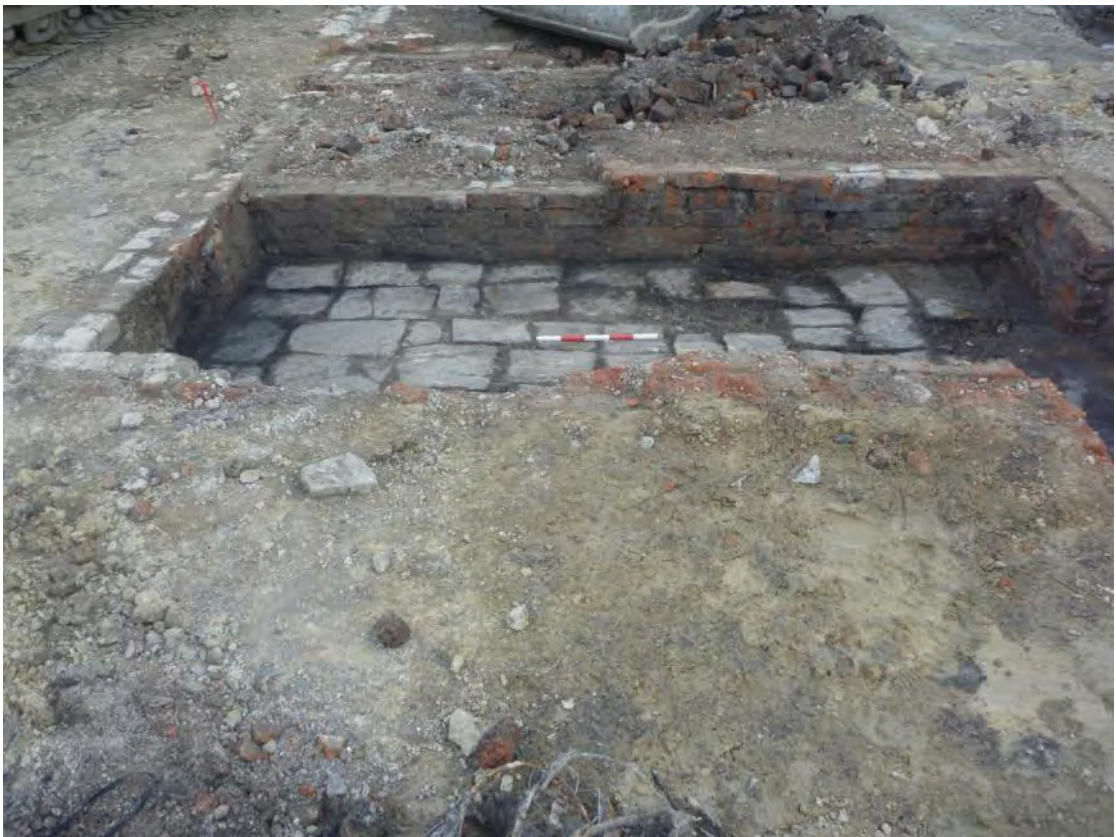
**Plate 36: Cellar 7. Scale 0.5m. Facing south-east.**

Cellar 7 (Plates 35-38) was situated at the north-western end of back wall (314), and was roughly rectangular in shape, with a recess in the south-western corner where the staircase (319) enters the room. The stairs (319) (Plates 38-39) were constructed out of red-bricks with squared gritstone flag steps. Unlike the staircases observed within the other cellars across the site, stairs (319) showed no evidence of being spiral.

The main walls of the Cellar 7 (314, 316, 320, 322) were all of similar red-brick construction, with grey lime mortar bonding. The floor (337) comprised squared gritstone flags bonded with brown clayey sand (340), with traces of coal within the gaps between the flags. The excavated backfill (329) of Cellar 7 comprised mid-brown grey clayey sand, with frequent inclusions of brick. A degraded metal bucket was found within the backfill (329) of Cellar 7, together with fragments of pottery (Appendix 3), bone and glass (Appendix 5). The maximum internal dimensions of Cellar 7 measured approximately 3.66m by 2.36m.
