# Archaeological watching-brief at the Church of St John the Baptist, Adel, Leeds

ArcHeritage Report 2015/59  
December 2015

Project Name	Church of St John the Baptist, Adel, Leeds
Report Title	375
Report status	Final
ArcHeritage Project No.	375
Type of Project	Watching Brief
Client	Adel St. John The Baptist Parish Church Council
NGR	SE2746540230
OASIS Identifier	archerit1-235374
Author	Toby Kendall and Laura Strafford
Illustrations	Toby Kendall and Laura Strafford
Editor	Glyn Davies
Report Number and Date	2015/59 22 <sup>nd</sup> December 2015
Version and filename	Version 1

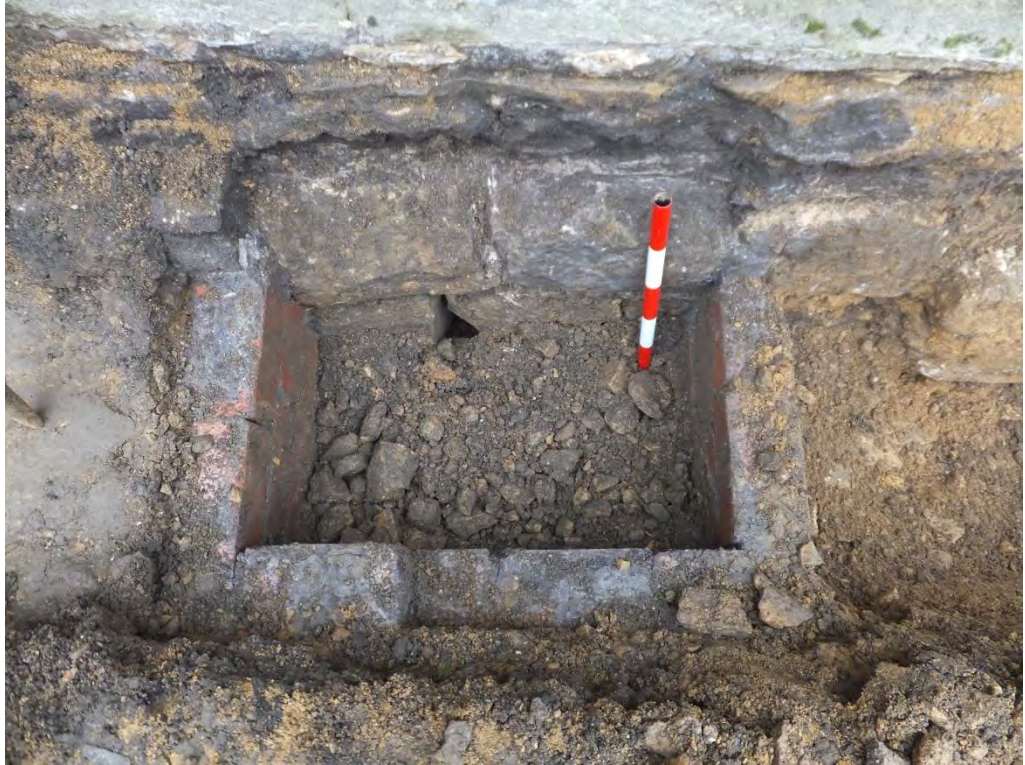
On the east side of the vestry, a brick-lined duct (1003) measuring 940mm north to south and 400mm east to west was visible, built up to the side of the vestry footings. The duct was a single brick thick and extended down beyond the limit of the excavations. The duct appears to extend down the side of the vestry basement, indicated by a blocked up hole, in line with the duct, which was located just above the floor level inside the basement. This was bonded with a grey cement mortar and is clearly an addition to the original build of the vestry. The engineering bricks used in the duct appeared the same as, and are probably contemporary with, bricks seen beneath the steps leading down into the basement. The duct had been backfilled with loose sandstone rubble (1009). The uppermost bricks of the structure had subsequently been disturbed during the laying of the modern path around the vestry.

Plate 1: Duct 1003 & 1009 on the eastern side of the trench. Looking west, scale 0.5m.

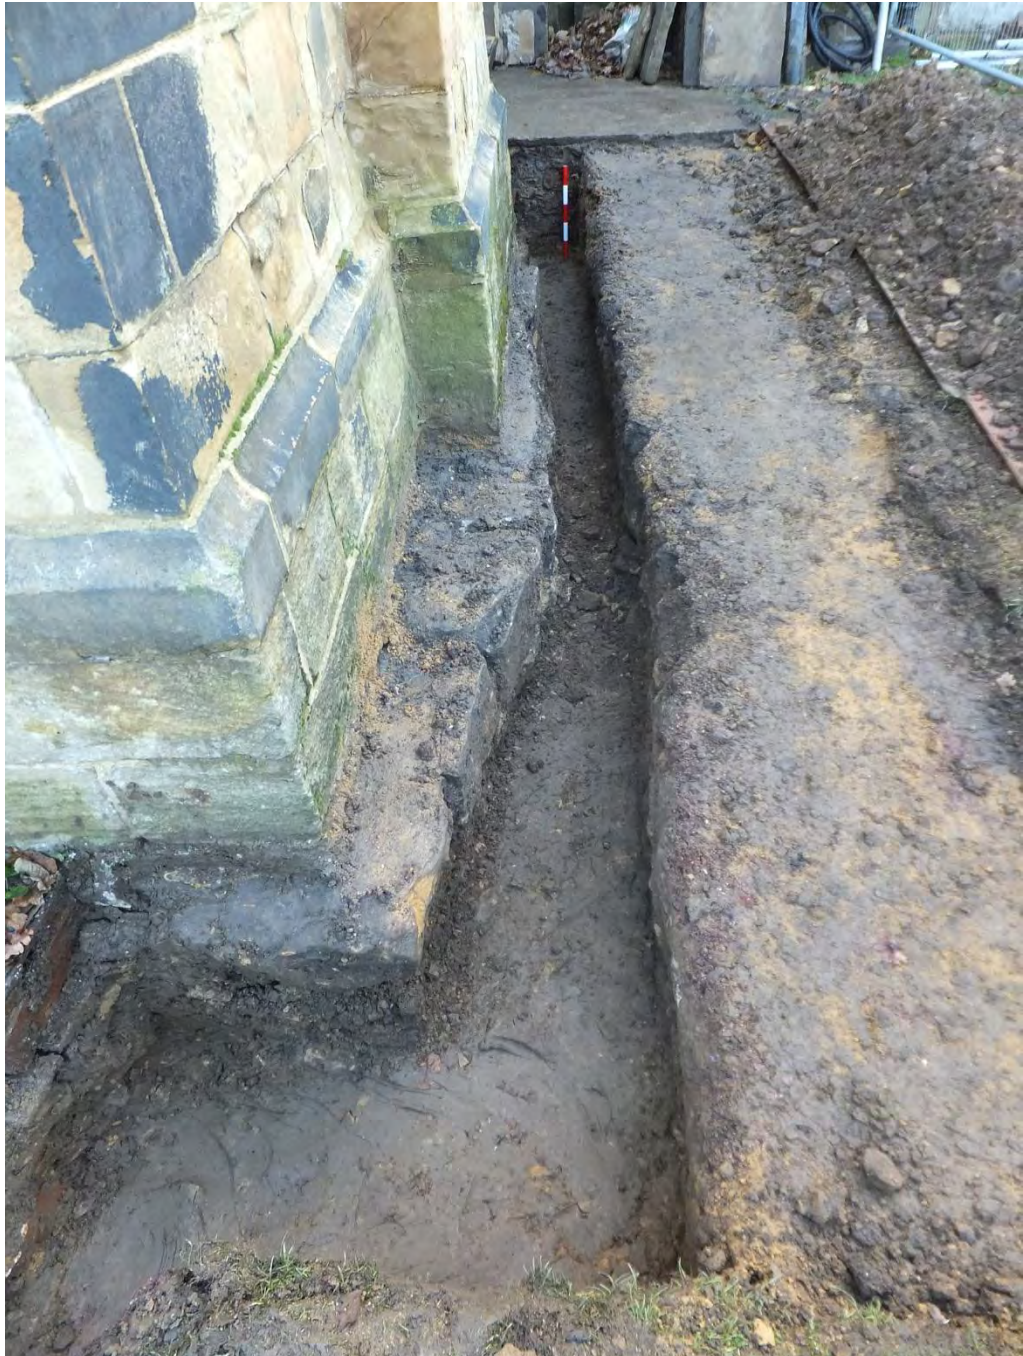
Plate 2: West side of the trench, looking south. Scale 0.5m.

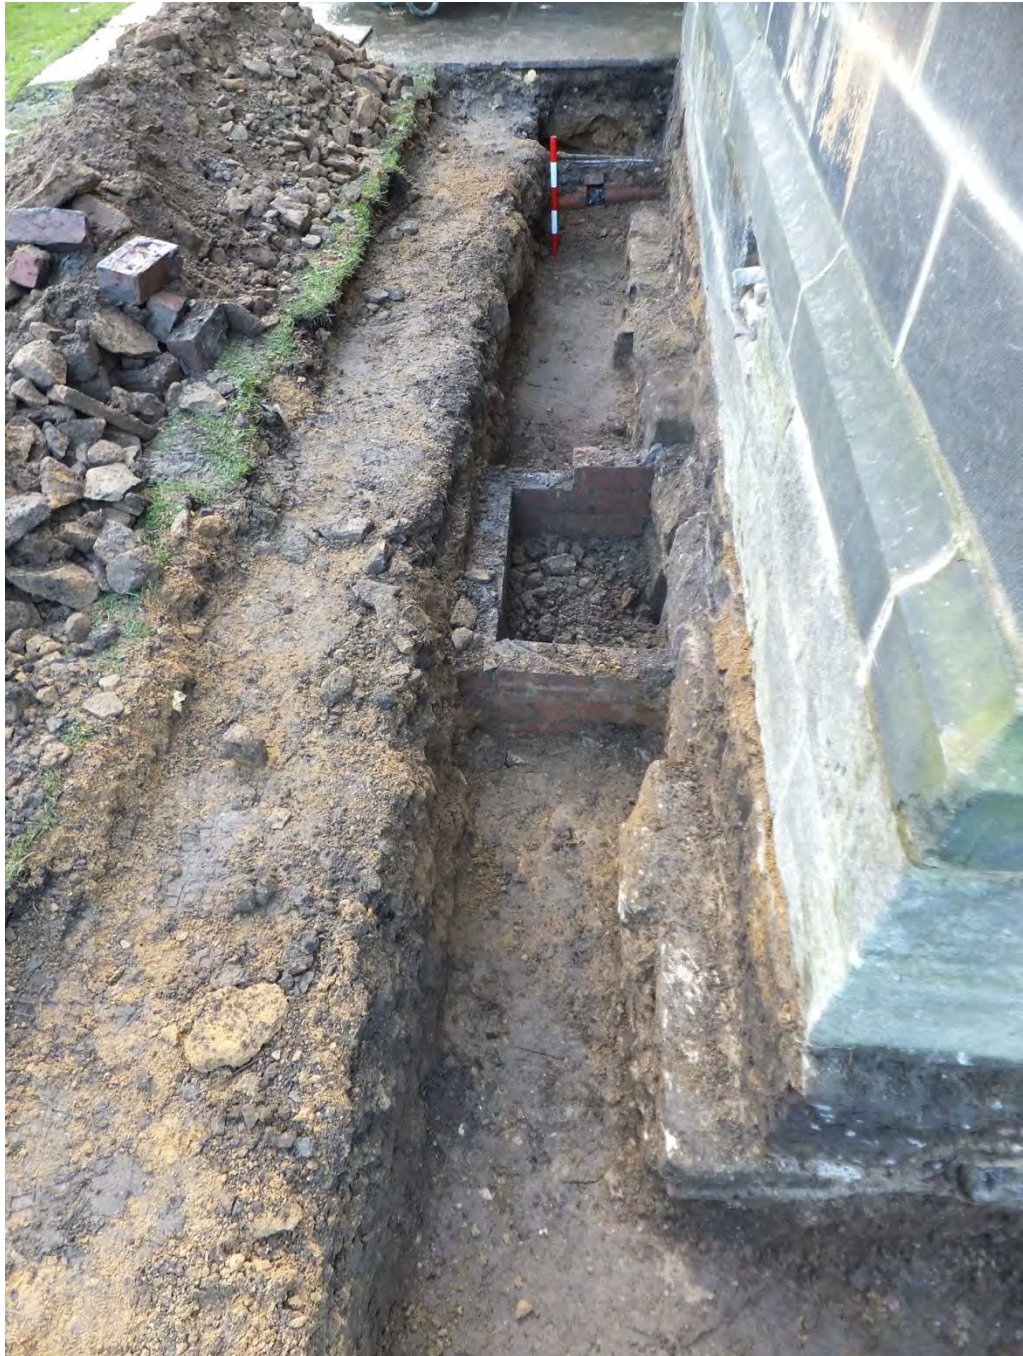
Plate 3: East side of the trench, looking south, showing duct 1003 & 1009. Scale 0.5m.

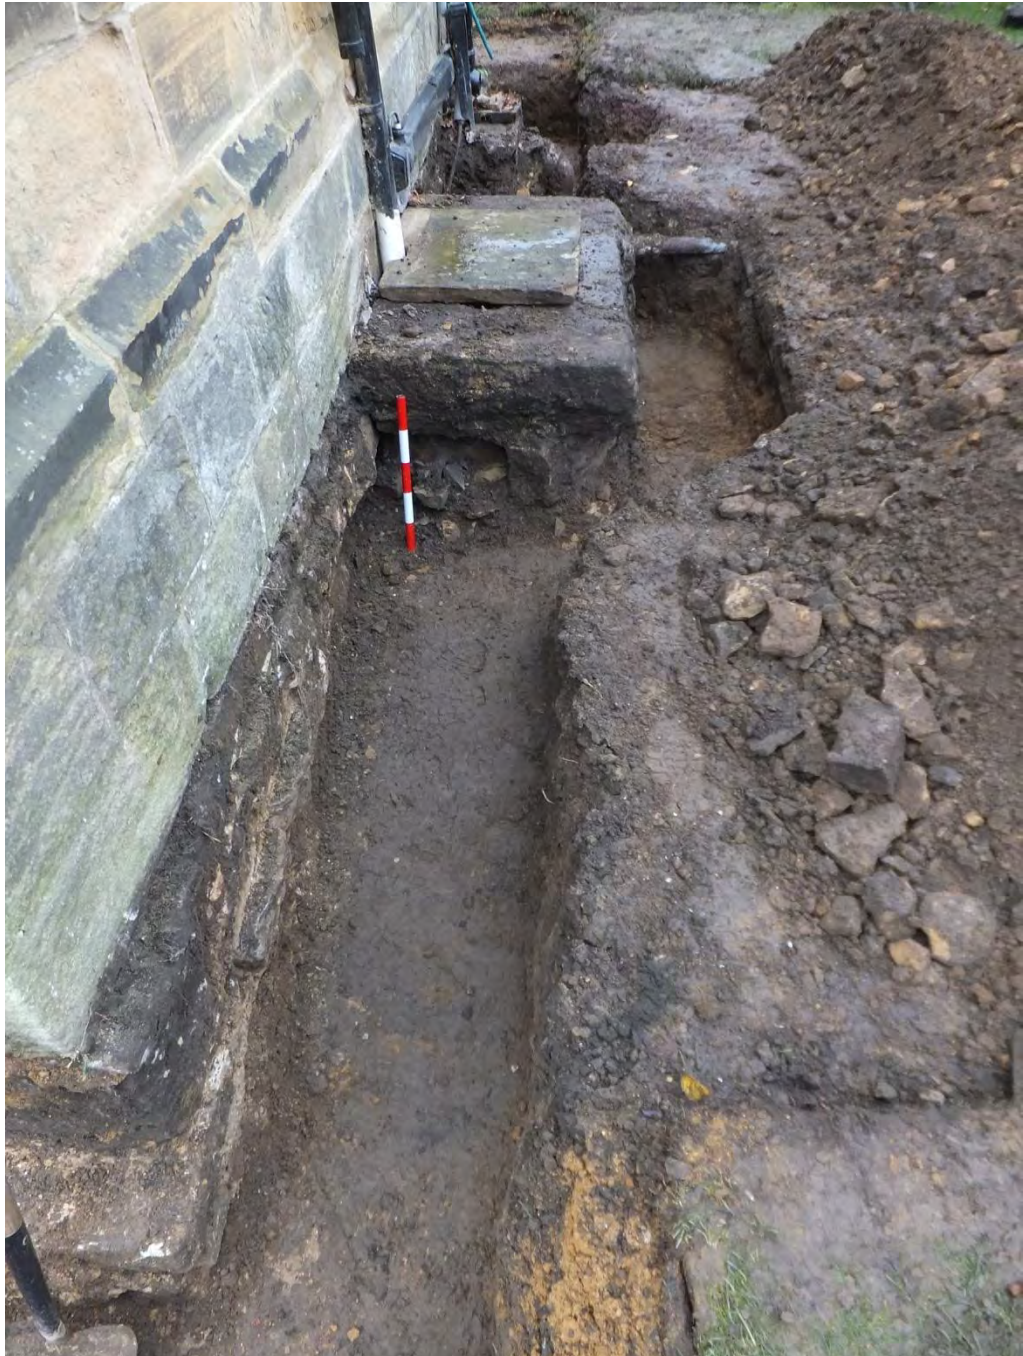
A coal chute (1008) was located on the north side of the vestry which connected to the vestry basement, and this appeared to be broadly contemporaneous with main vestry structure. The coal chute, which was built of stone with a large stone slab capping it, remains *in-situ*. To the west of the coal chute was a drain system (1007) comprising salt-glazed pipework. The nature of the pipework suggests that it dates from 1848 onwards, making it a later addition to the 1830's vestry.

Plate 4: North end of the trench, looking west, showing coal chute (1008). Scale 0.5m.

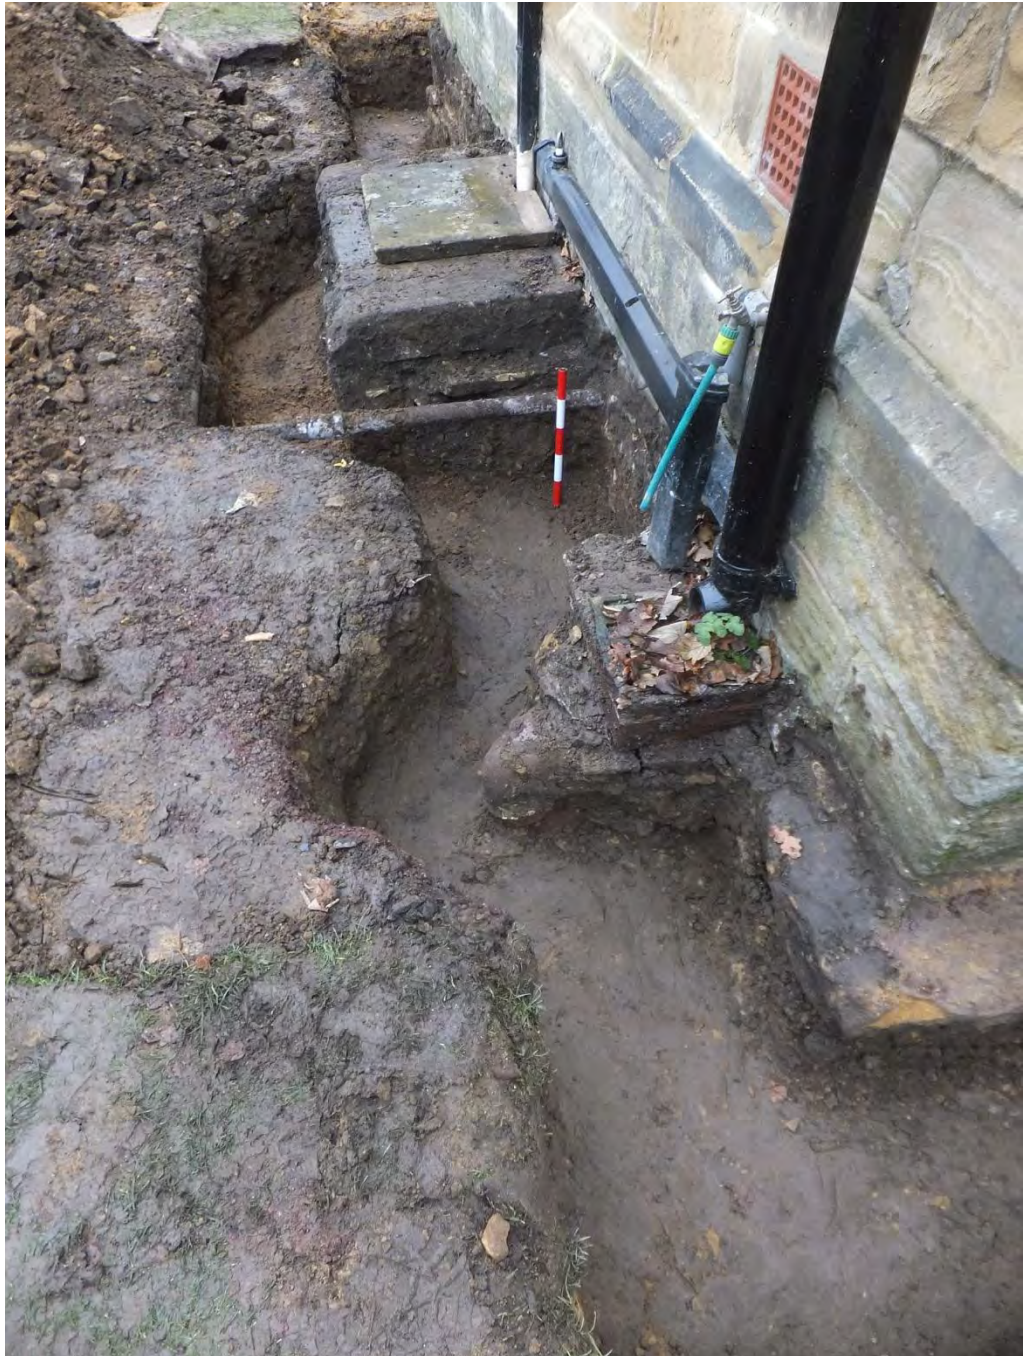
Plate 5: North end of the trench, looking east, showing coal chute (1008). Scale 0.5m.
