Church Street, Thorne,
South Yorkshire
Building Recording and Watching Brief
ArcHeritage
March 2016

**Archaeological Building Recording and Watching Brief at Church Street,
Thorne, South Yorkshire**

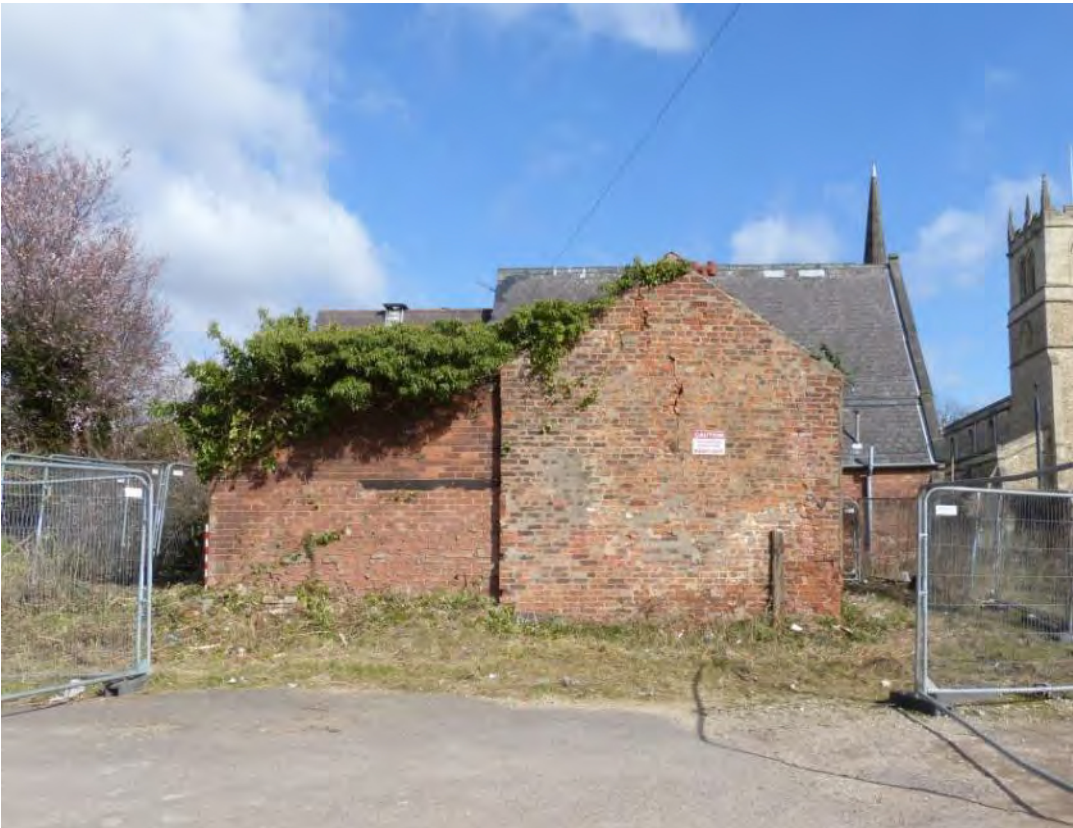
Two principal construction phases were evident on the exterior of the building (**Plate 1**), with one wall in the later phase also having been subjected to an element of rebuilding. Constructed from handmade bricks (**Plate 2**), the southern half of the building formed the earliest phase and appears to date from the mid-19th century. No features were shown at this location on the 1825 Thorne enclosure map, when the site formed part of a yard associated with buildings that stood along the Church Street frontage. By the time of the 1840 Thorne tithe map, a building had been constructed within the footprint of the southern half of the existing building. Rectangular and square features shown along the south elevation in 1840 remained extant at the time of the 1932 Ordnance Survey map, which suggests that the 19th-century building survived at that date. Given the use of handmade bricks, the southern half of the standing building is likely to be the remains of the structure that was shown on the 1840 tithe map.

The west elevation of the first phase was 4.5m in length (**Plate 1**). The brickwork had not been laid in a typical bond, with courses of headers and stretchers at irregular intervals. Several substantial cracks were present in the exposed brickwork of the west elevation. Isolated patches of thin cement render had been applied to this area, perhaps to obscure further cracks or to cover weathered or decayed bricks. Several sections of this cement patching had also been scoured to resemble brickwork. A single modern airbrick had been inserted into the gable, while the remnant of a wooden post was affixed to the wall, 1.73m, from the building's south-west corner. This feature's former function is unknown. Due to the construction of the building's second phase, no scarring was visible at the location of a square feature that had been shown at the building's original north-west corner on the 1840 tithe map and the 1892

Plate 1: Western elevation of the building, with the earliest phase (southern half) on the left, and the more recent phase (northern half) on the right. Scale 1m.

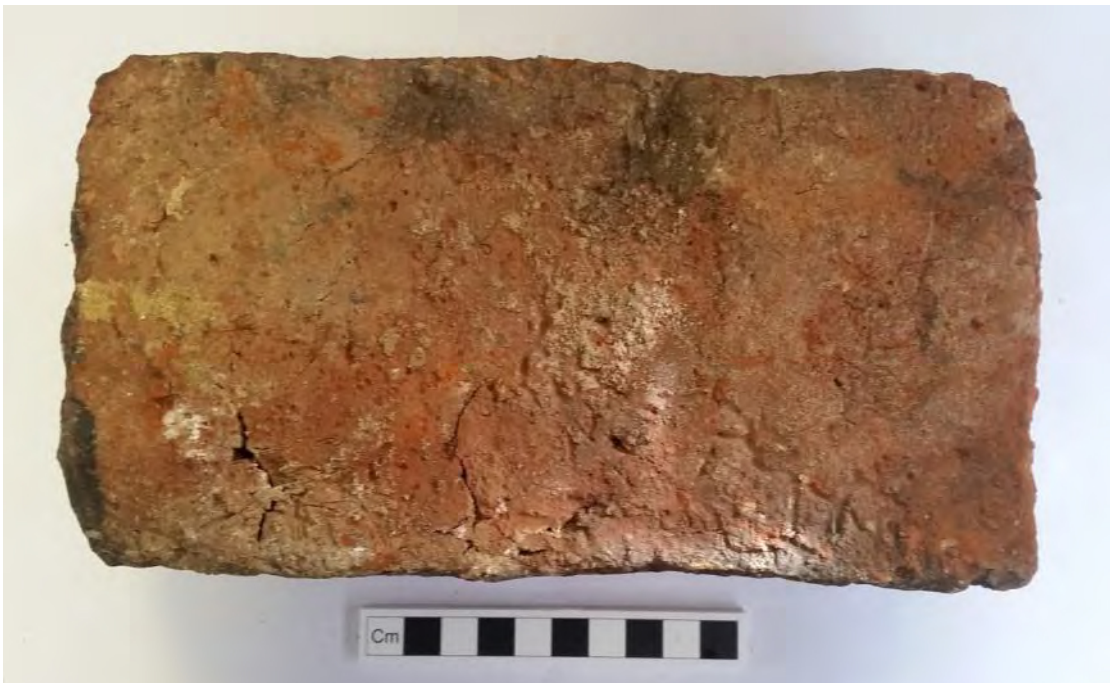
Plate 2: Example of the bricks used in the construction of the southern half of the building (Phase 1). Scale 10cm (1cm increments).

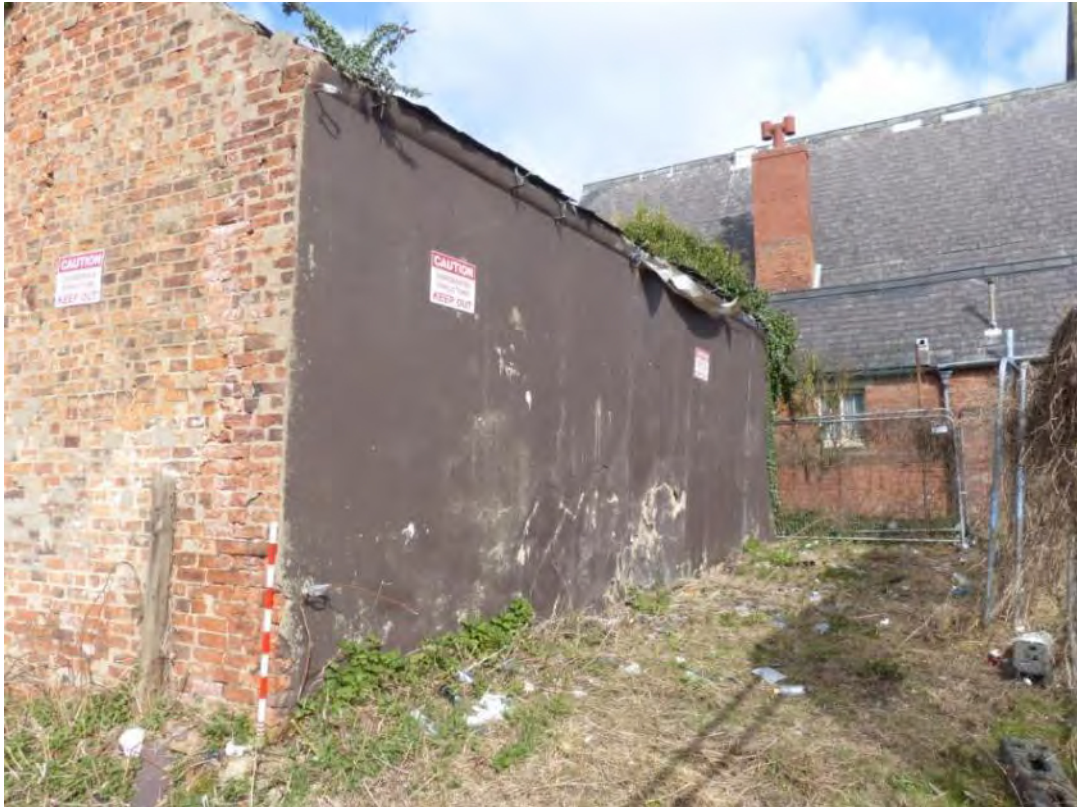
The south elevation of the first phase was 9.4m in length. A cement render, approximately 2.5cm in thickness, was present on this face. Having once been painted brown, this material was damaged with large cracks and small areas of missing render revealing the brickwork beneath (**Plate 3**). While neither doors nor windows were present in the south elevation, it is not known if such features were present but had been blocked and obscured by the render. The latter has also concealed any scars from the demolished rectangular and square features that were shown along this elevation between 1840 and 1938. Several brackets that formerly supported a downpipe and guttering remain in place.

Plate 3: Southern half of the building, showing cement render on the southern elevation. Scale 1m.

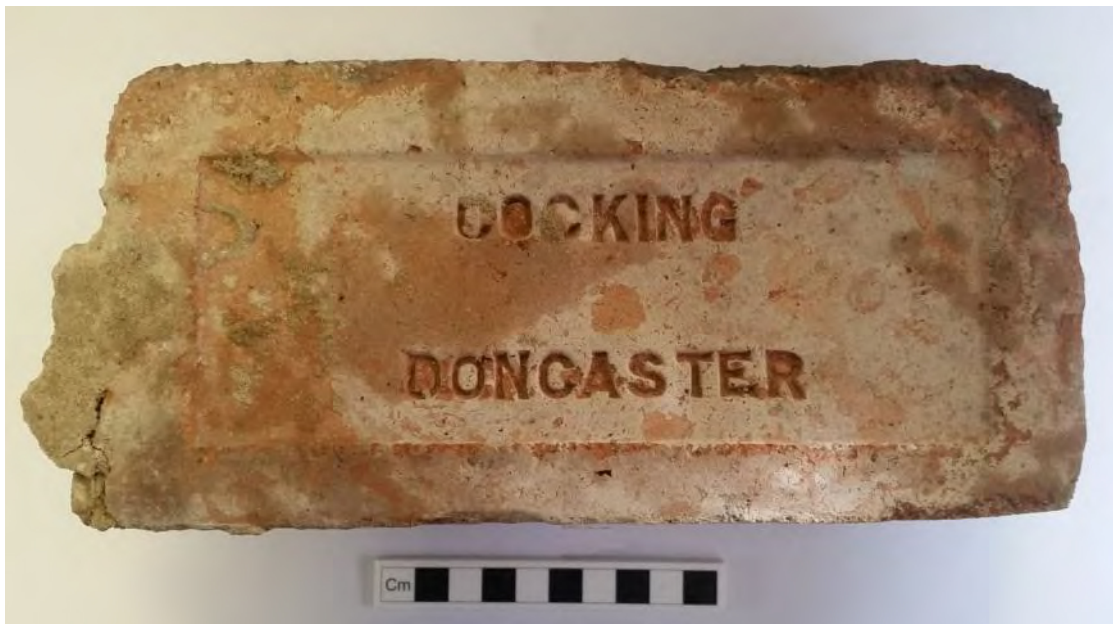
The northern part of the building forms the later phase and appears to date from the mid-20th century, constructed from machine-made bricks laid in stretcher bond (**Plate 4 and 5**). None of the historic maps label the building and its function during this period is unknown. A doorway was situated at the building's north-east corner, with three windows in the north elevation. These features were secured by exterior-grade hardboard sheeting and no details of lintels, sills, glass, frames or the door were visible. Given the size of the respective security boards, the easternmost window appeared to be smaller than the others. While dense vegetation obscured much of the north elevation, the area around the latter window was relatively free from vegetation and a small area of flashing was visible between the window and the roof. A vent/extractor unit, secured by a metal grill is present between the two larger windows.

The northern half of the building was constructed from machine-made red brick, each brick bearing the name 'COCKING DONCASTER' (**Plate 4**). The northern half of the building was sub-divided internally into numerous different spaces. The largest space (Room 2) was devoid of any fixtures or fittings (**Plates 10, 11, 13 and 16**). The décor was identical to that observed with Room 1, with red and grey lino tiles, and flaking pale blue wallpaper. At the north-eastern end of the room was a kitchen (Room 3) with a built-in cupboard, shelves, a stainless steel sink, and a stand-alone cooker (**Plates 11-15**). A window was present in the eastern elevation of the kitchen, over the sink. The lower two thirds of the wide opening from the kitchen (Room 3) into Room 2 was partitioned, and may have acted as a kind of serving hatch. The only door access into the kitchen was from Room 1. Two toilets were also present at the north-eastern end of the northern half of the building (**Plates 11-13**). Only one of these appeared to be accessible from the inside of the building (Room 4), with the smaller toilet having an external door only (Room 5).

Plate 4: Example of the bricks used in the construction of the northern half of the building (Phase 2). Scale 10cm (1cm increments).

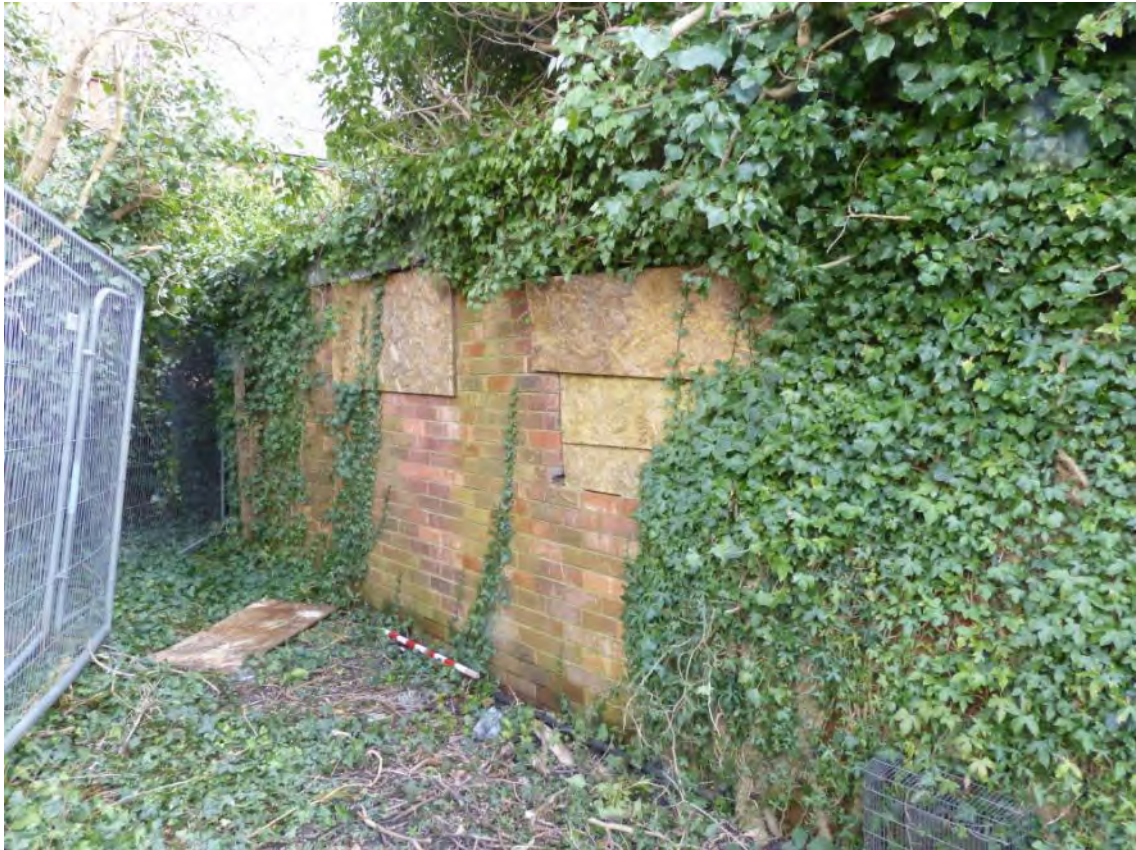
Plate 5: Northern elevation of the building. Scale 1m.

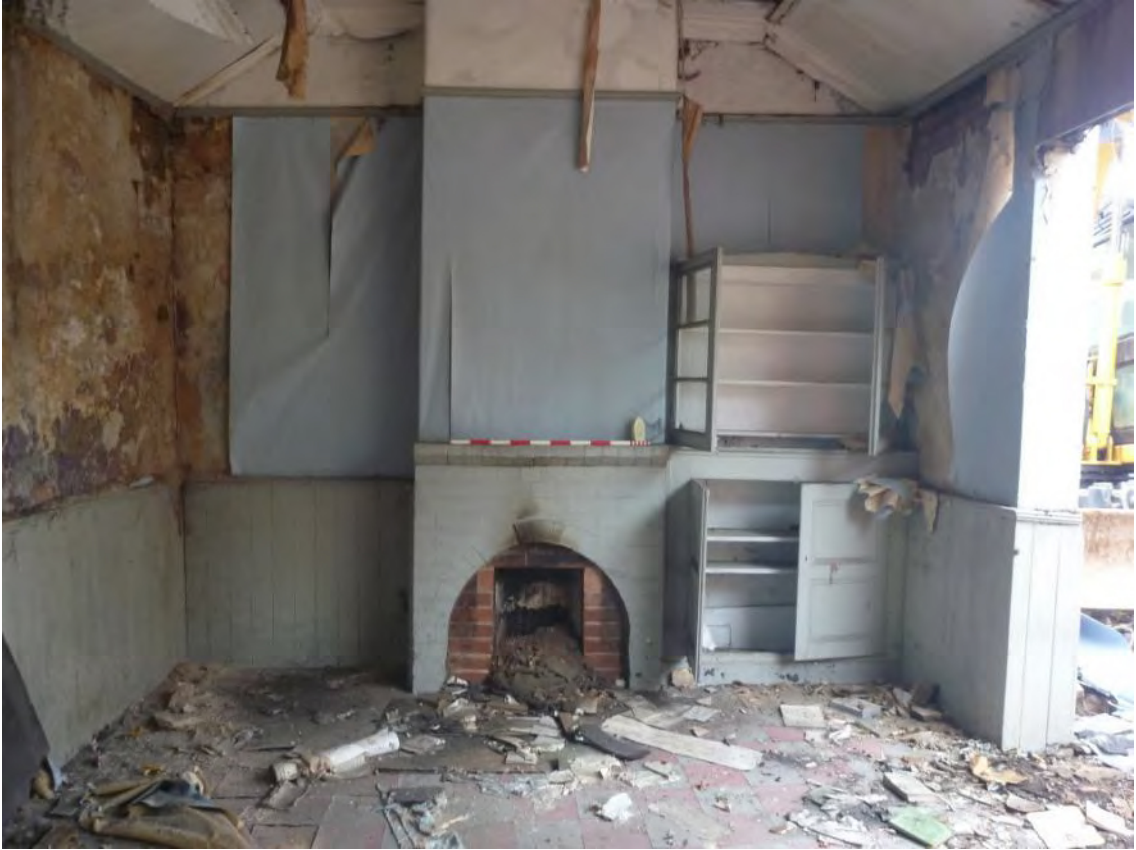
Plate 7: Fireplace and built-in cupboards in the southern half of the building (Room 1). Looking south-west. Scale 1m.

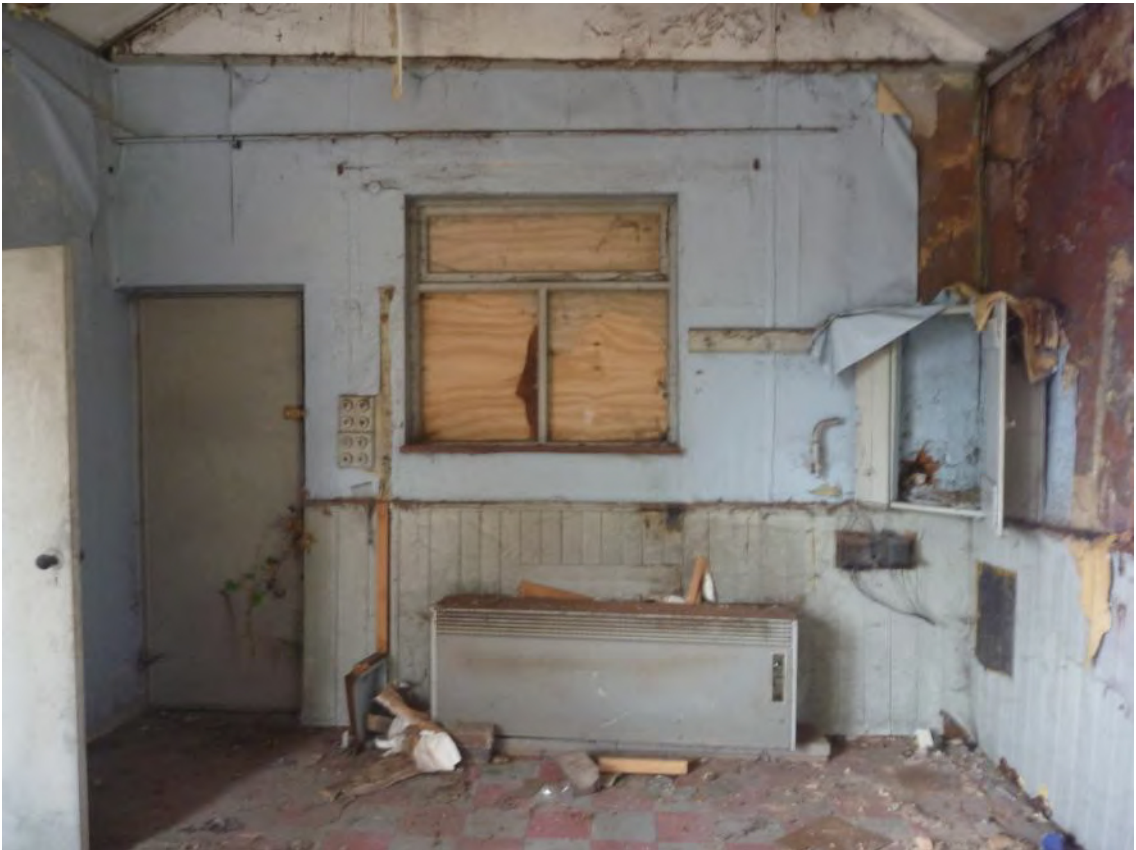
Plate 8: Southern half of the building(Room 1), looking north-east.

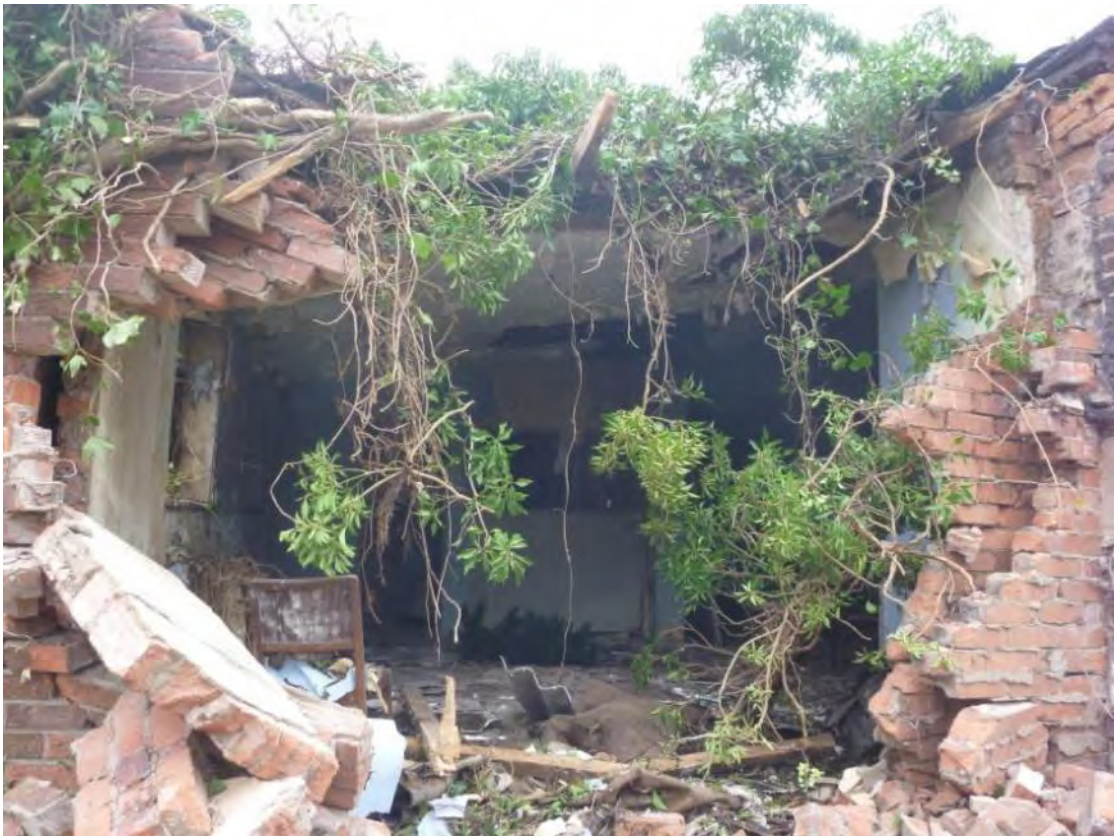
Plate 10: Initial removal of the western exterior wall in the northern half of the building (Room 2). Looking north-east

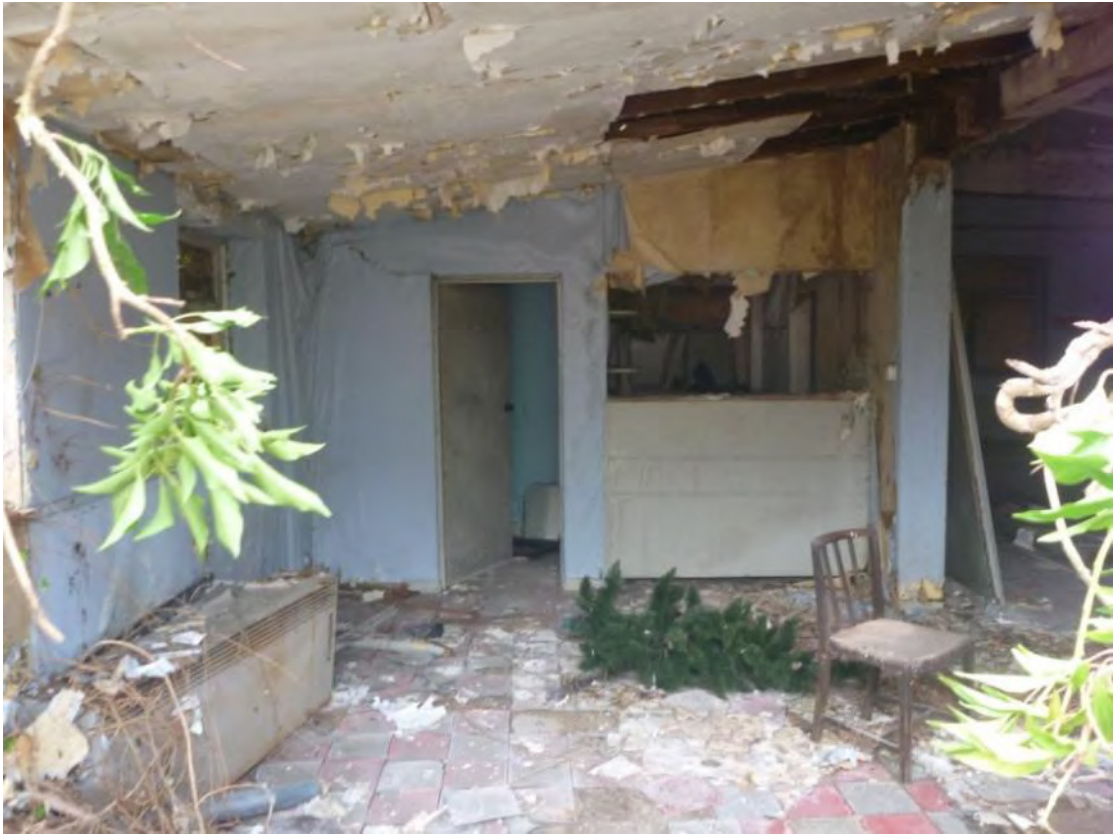
Plate 11: Northern half of the building (Room 2), looking north-east towards a kitchen (left) (Room 3) and toilets (right) (Rooms 4 and 5).

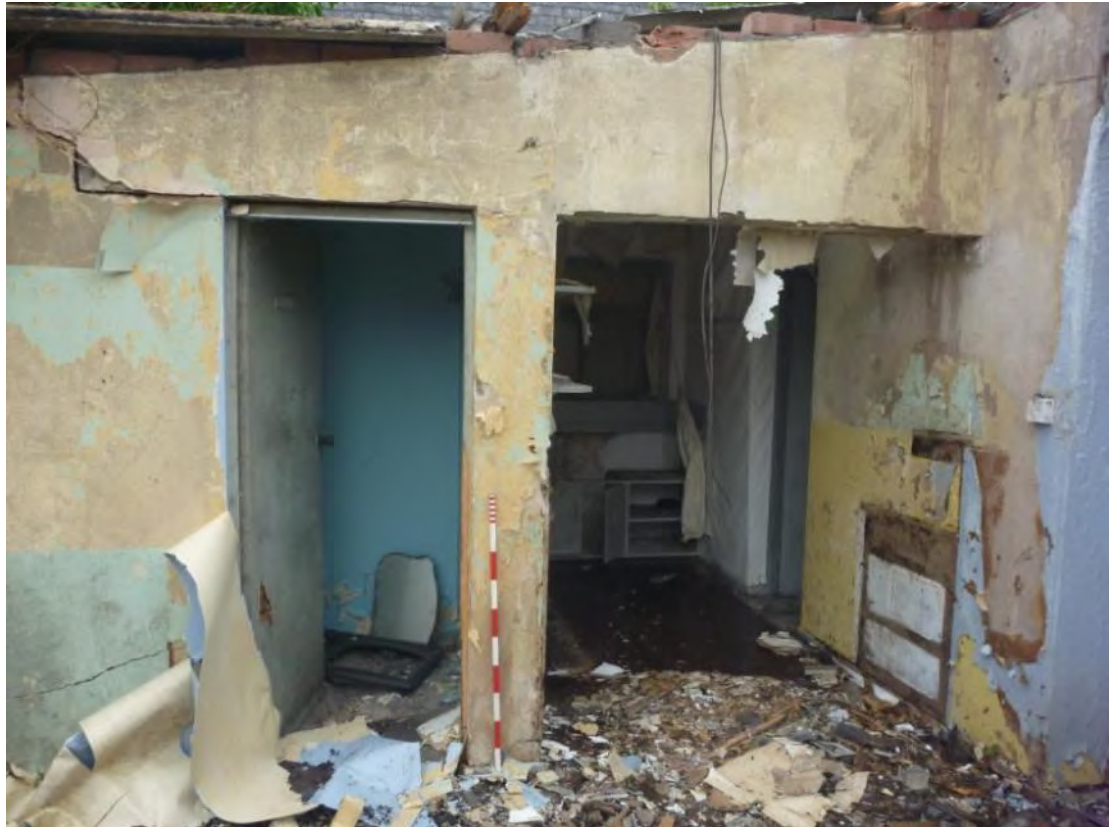
Plate 12: Northern half of the building (Room 2), looking north-east towards a kitchen (left) (Room 3) and toilets (right) (Rooms 4 and 5). Scale 1m.

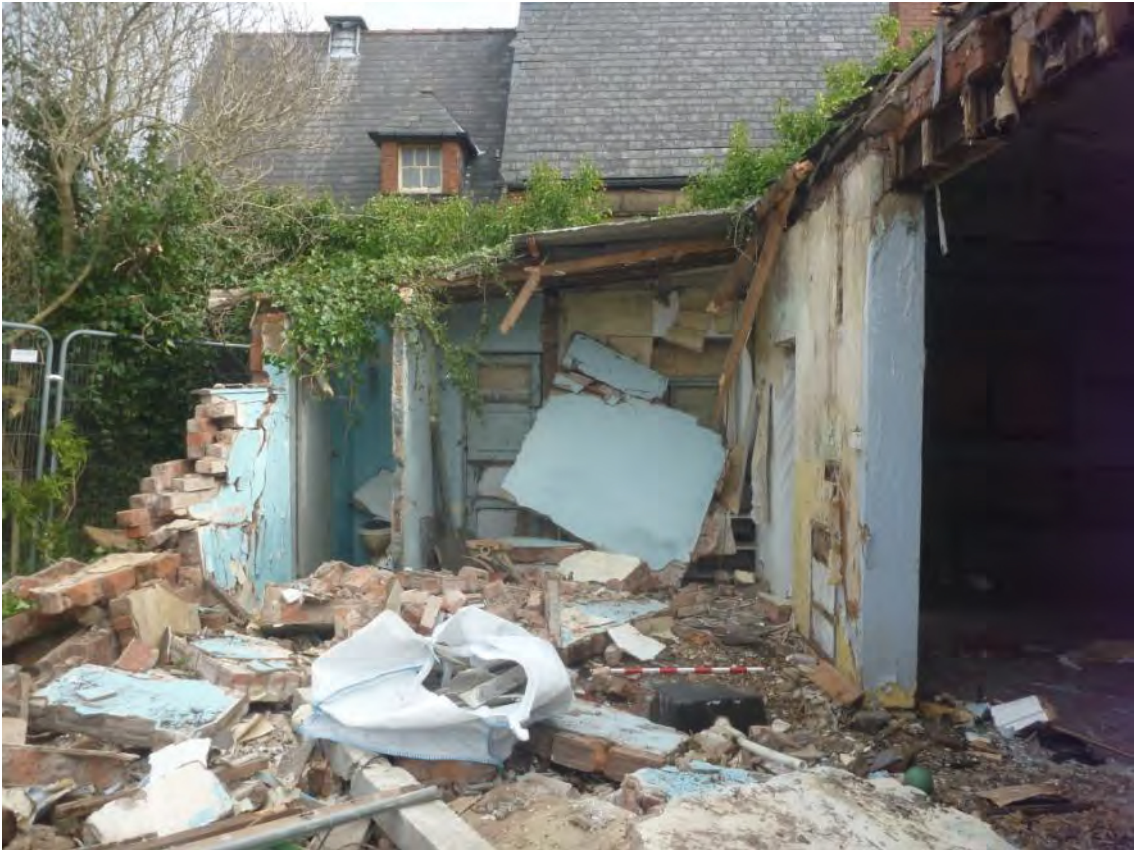
Plate 13: Northern half of the building (Room 2), looking north-east towards a kitchen (left) (Room 3) and toilets (right) (Rooms 4 and 5). Scale 1m.

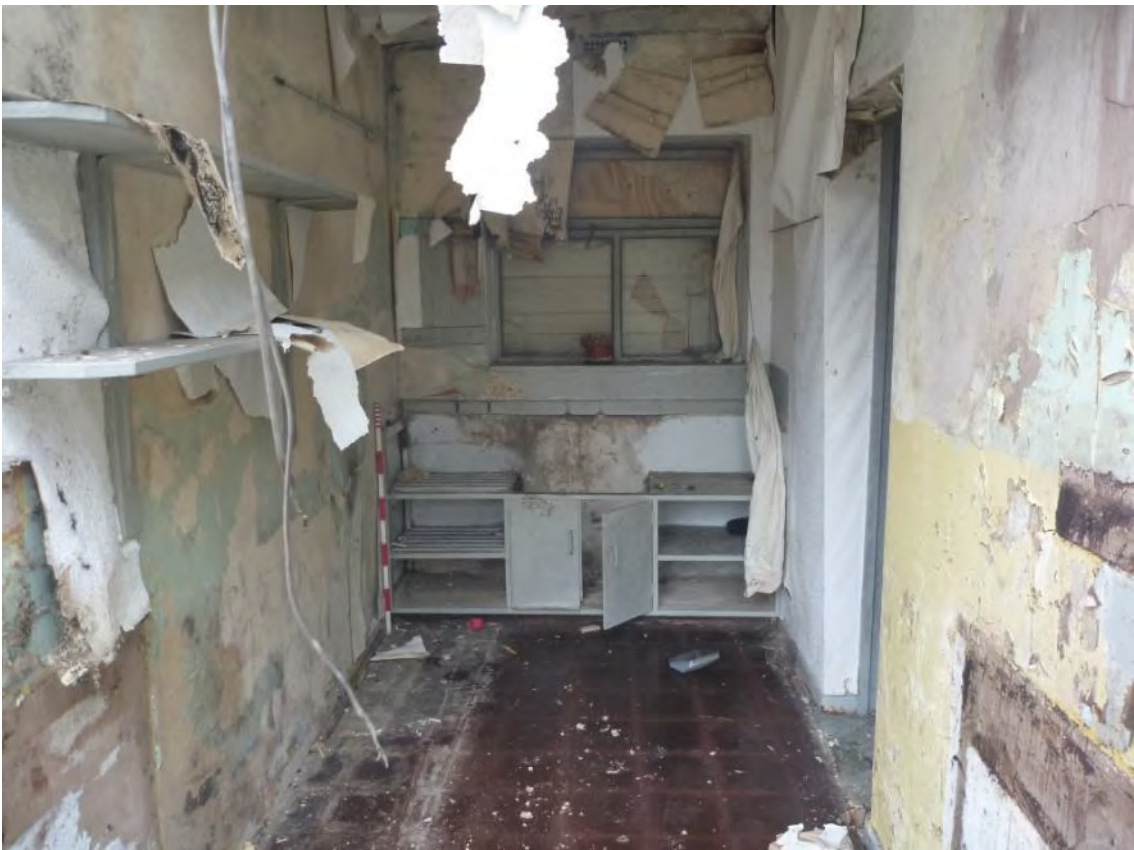
Plate 14: Kitchen (Room 3) in the northern half of the building. Looking north-east. Scale 1m.

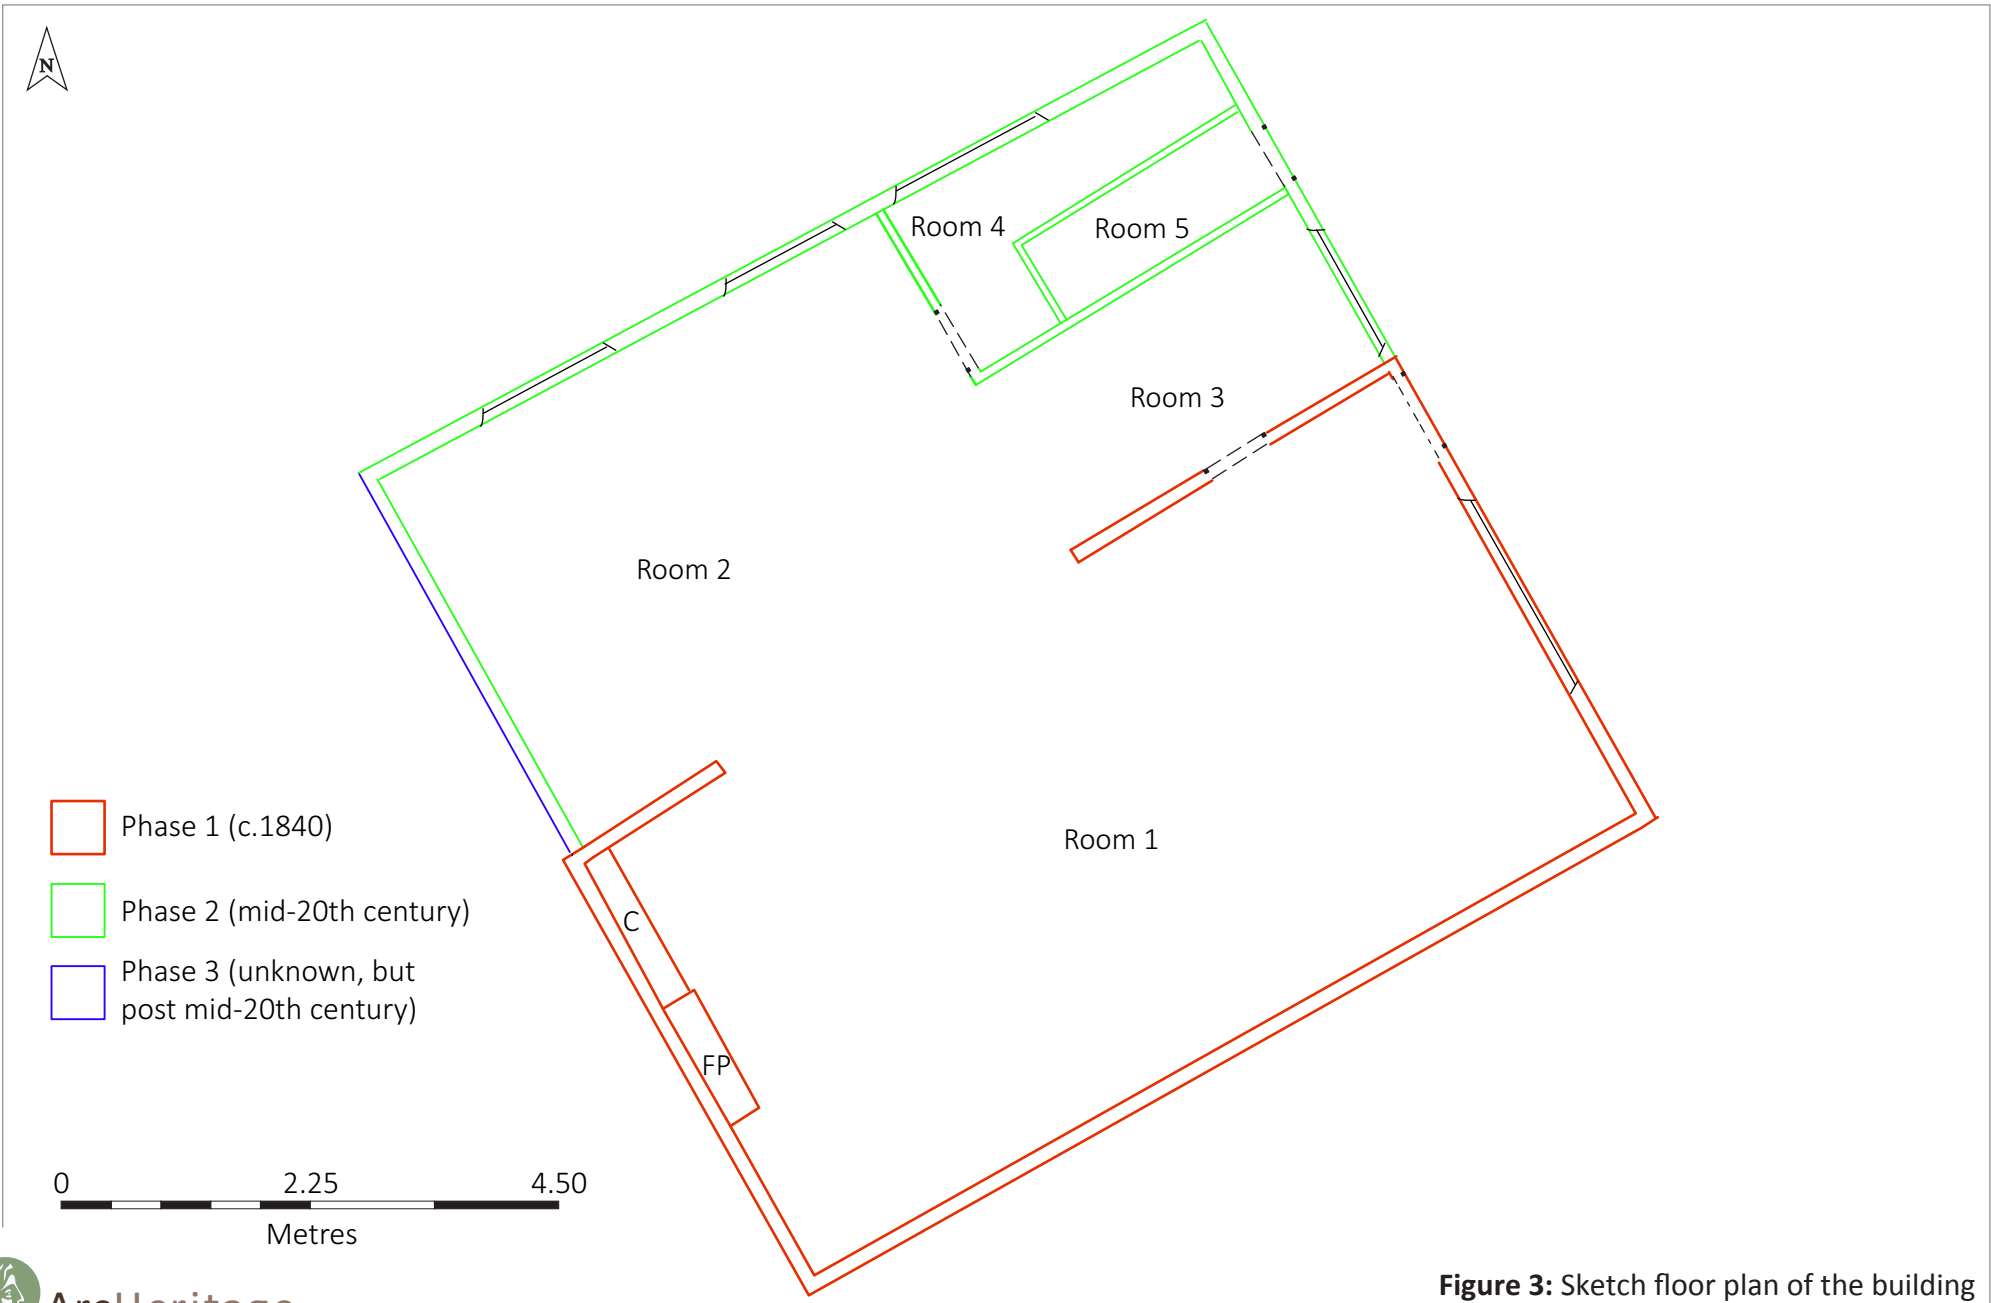
Figure 3: Sketch floor plan of the building

The watching brief identified the general layout of the building, together with the most recent function of each room. A sketch floor plan is shown in Figure 3. Due to the nature of the works and the risk associated with entering the building, some of the measurements taken are approximate, and the floor plan must be seen as a guide only rather than an accurate measured drawing. For ease of description, the internal rooms have been numbered 1 to 5, as illustrated in Figure 3.
