Stoneywell, Charnwood
Archaeological Landscape Survey Report
for the National Trust

ArcHeritage June 2016
OASIS reference: archerit1-248399

Stoneywell, Charnwood: Archaeological Landscape Survey

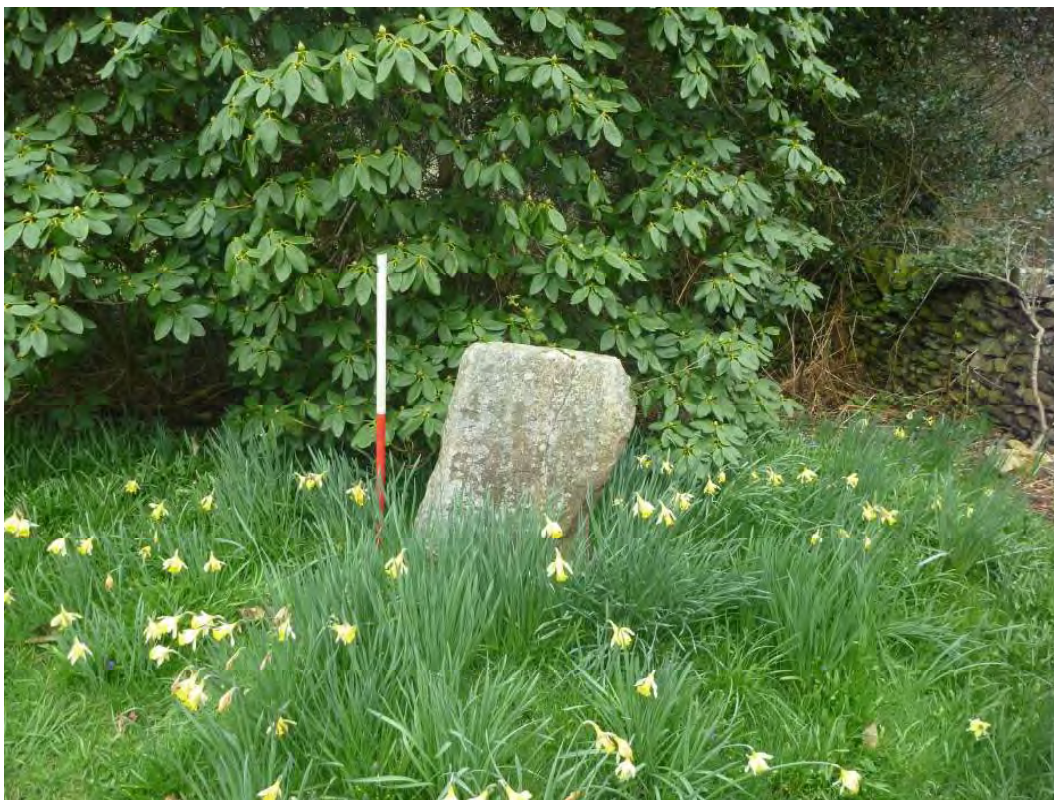
Plate 1: 'Mere stone', feature 102, viewed facing southeast

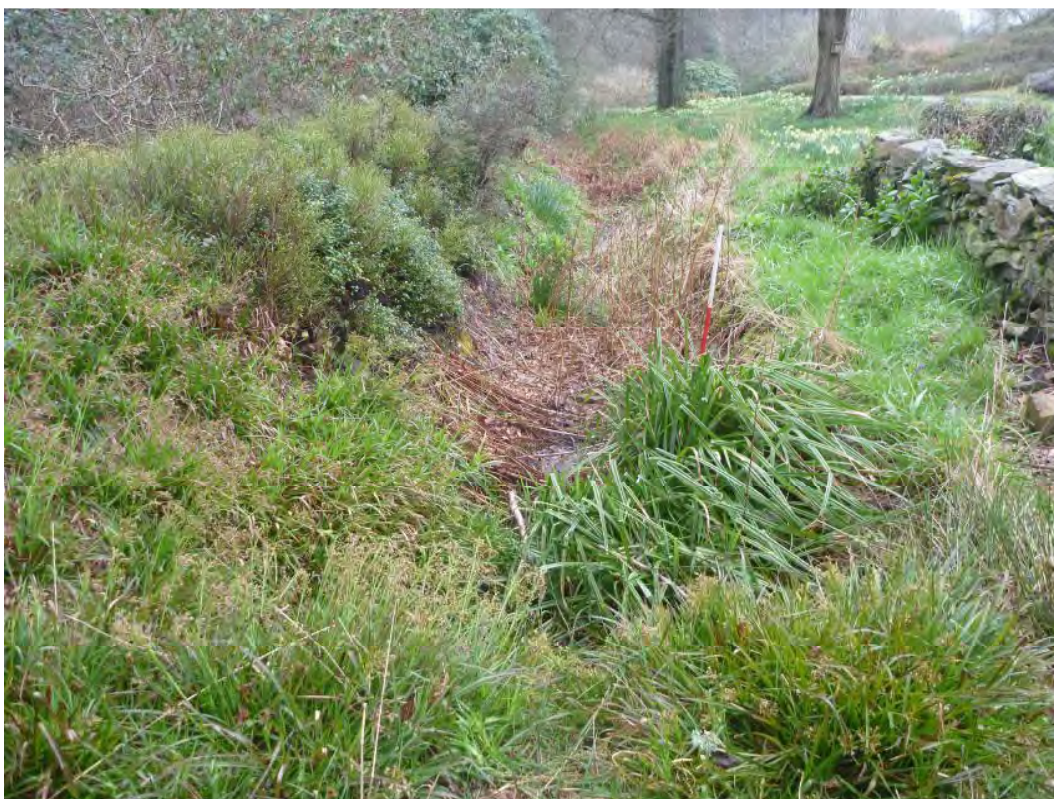
The bank and ditch boundaries (105 and 106) mentioned in Section 5.1 are important features associated with the wood. They are likely to mark the edge of land enclosed in the medieval or early post-medieval period, and may have been constructed to prevent wild and stock animals on the commons entering the enclosure. These features are considered to be of regional significance (see plate 2). The bank and ditch are both in a reasonable condition, though potential threats include an active badger sett close to the bank within the wood and the roots of trees along the edge of the wood. Tree falls in this area would have the potential to damage the bank if roots pull material out of it.

Plate 2: Woodland boundary bank and ditch, feature 105, viewed facing southeast

<p>should take care not to disturb or damage the earthworks and any sub-surface deposits associated with the bank and ditch. The condition of ditch 106 in the roadside verge north of the site boundary should also be monitored, though it is likely to be outside the National Trust's area of ownership.</p>
Animal management	<p>Monitor the locations of badger setts and establish whether any burrowing activities are threatening significant archaeological features. This is particularly a potential issue with the boundary bank and ditch (feature 105) along the edge of Stoneywell Wood. Historic England's guidance on dealing with badger setts should be consulted where necessary (English Heritage 2014).</p> <p>An extensive rabbit warren was noted in the triangular area at the northwest corner of Stoneywell Wood, in a heavily vegetated area that is difficult to access. No features of archaeological interest were noted in this area, though vegetation may have obscured any earthworks.</p>

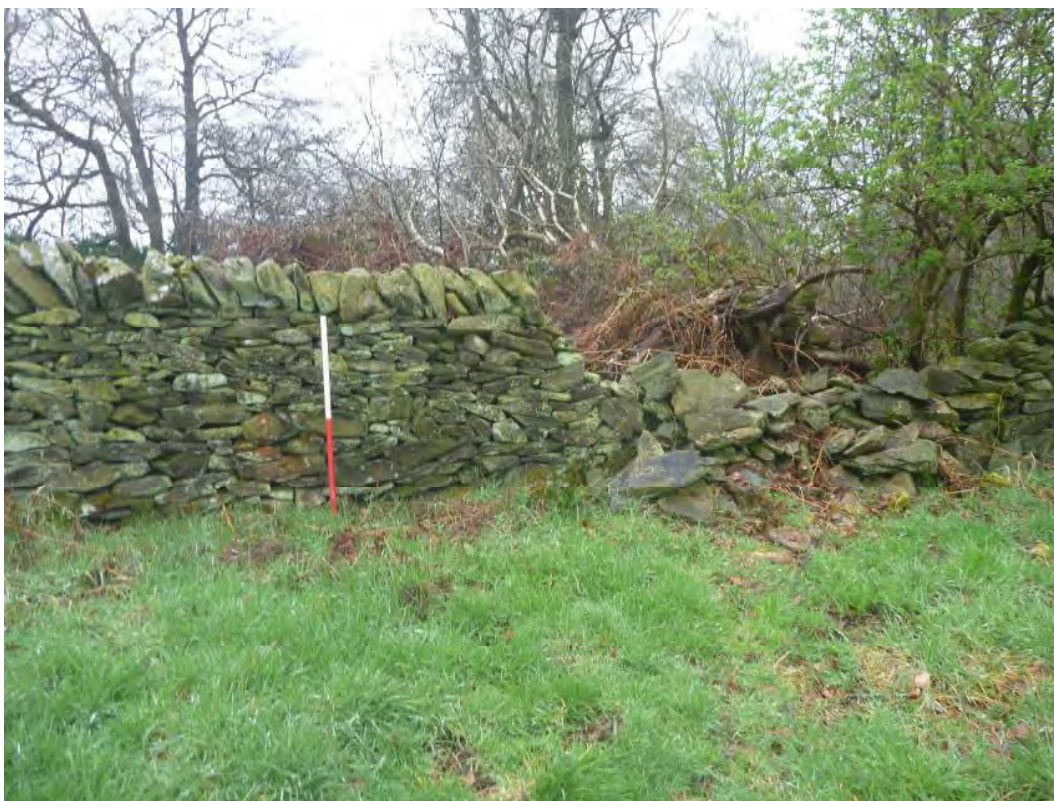
All the boundaries of Rocky Field (201-204) had been laid out on their current position by the time of an 1866 sale plan for Hammercliffe Farm. This indicated that the five narrow plots allotted to John Pares had been laid out as two larger, consolidated plots, one of which, on the higher, stony ground, was used as woodland. The diagonal boundary between the two fields appears to follow the ridge of Chitterman Hill. These boundaries have not been altered since this period, though it is likely that they have been repaired or rebuilt over time. The walls around Rocky Field are mainly in a poor to average condition, with some sections of collapse, at least one associated with a fallen tree from Rocky Plantation (plate 3).

Plate 3: Boundary wall 202 in Rocky Field, damaged by falling tree

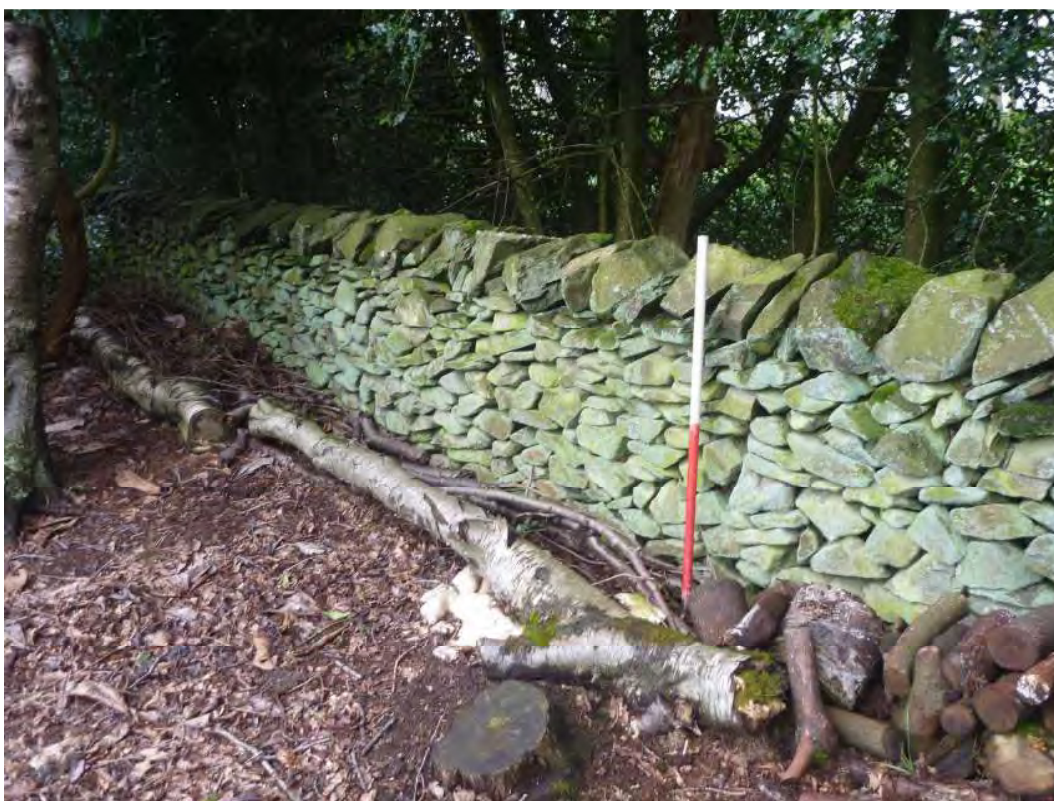
Plate 4: Boundary wall 209 at the northern side of Stoneywell Cottage grounds

ID	Boundary type	Location	Description	Condition	Period	NGR
209	Drystone wall	Stoneywell Cottage	The boundary wall to the northwest of the Stoneywell gardens is of drystone construction, up to 1m high. It is in an average condition, with some poorer sections. The wall crosses the boundary ditch (106) at its northeast end, terminating at the associated bank.	Fair	c.1899	SK 49744 11844
210	Wooden fence	Stoneywell Wood	The boundary around Stoneywell Wood is a rough wooden post and rail fence, in good condition. At the northwest end of the wood, a substantial boundary ditch and bank (feature 107) is probably the more ancient boundary of the wood, just outside the fenced area.	Good	Recent	SK 49738 12100
211	Wooden fence	Stoneywell Wood	The boundary on the north side of a triangle of land west of the northwest corner of Stoneywell Wood is a wooden post and rail fence in a reasonable condition.	Good	Recent	SK 49601 12139

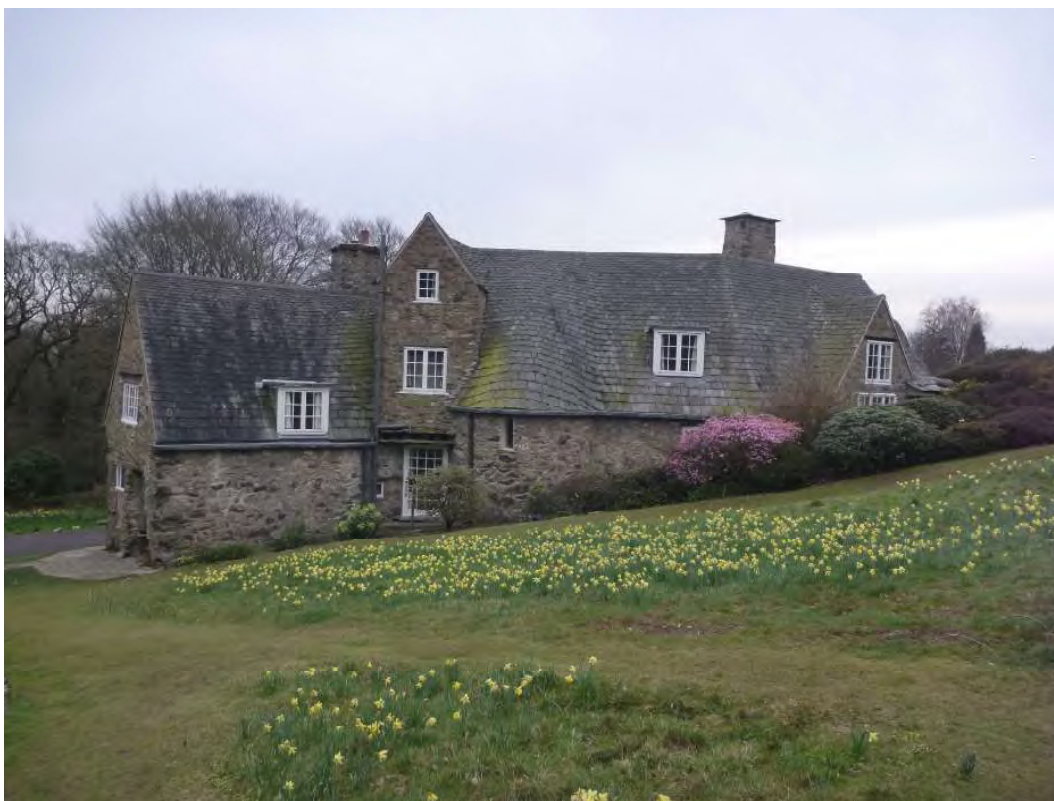
Stoneywell Cottage (feature 124) is a grade II* listed building. It is a fine example of an Arts and Crafts influenced cottage, with an irregular, curving plan designed to fit around the foot of the rocky outcrop at the edge of Chitterman Hill (plate 5). The natural outcropping rock was used as foundations where possible, and the changes in level accommodated by varying floor heights. The walls are of stone local to the site, including unworked boulders and stones from the former drystone field walls, in a rubble construction with mortar render. Slate has been used for the door lintels and window sills and lintels, including a large slab over the front door with the date 1899 and initial 'G' carved on it (plate 6). There are two substantial chimney stacks, the largest to the south end, at the highest point of the building, in a stepped style with slate string line and capping (plate 7). The roof is currently of local Swithland slate, which replaced the original thatched roof following a fire in 1939. The house is a mixture of 1½ and 2 storeys, with dormer windows in the roof, several of which are triangular in shape.

Plate 5: Western elevation of Stoneywell Cottage, viewed facing east

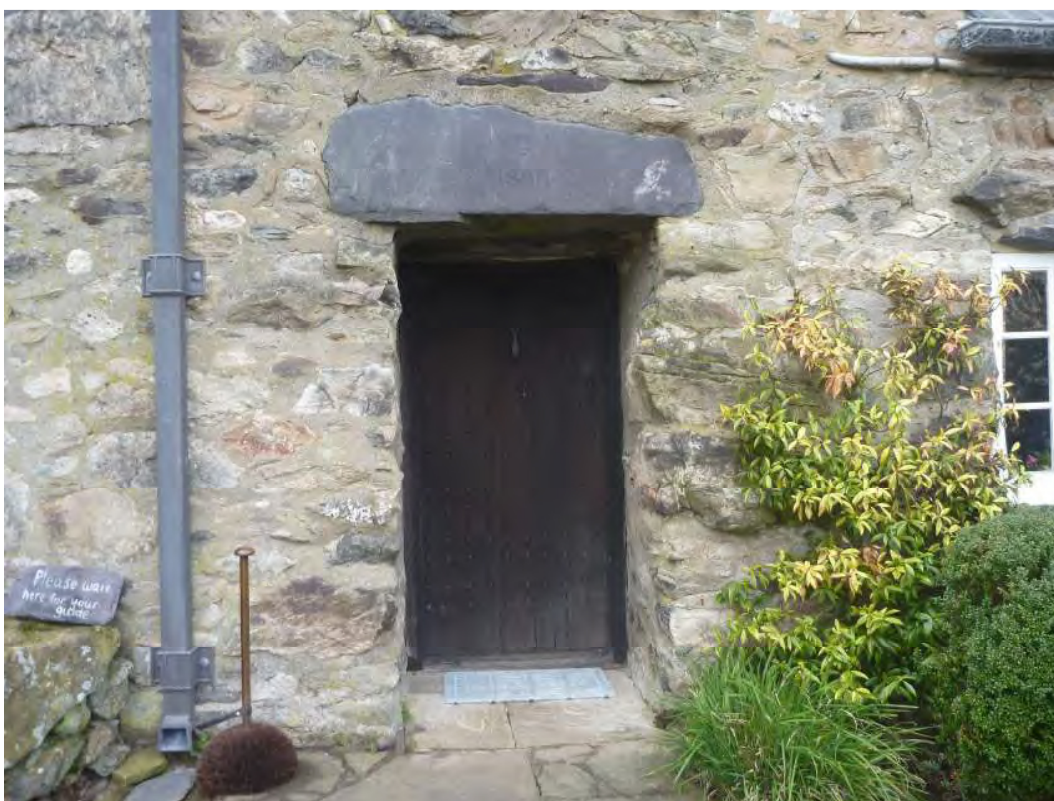
Plate 6: Main doorway to Stoneywell Cottage, showing datestone, viewed facing west

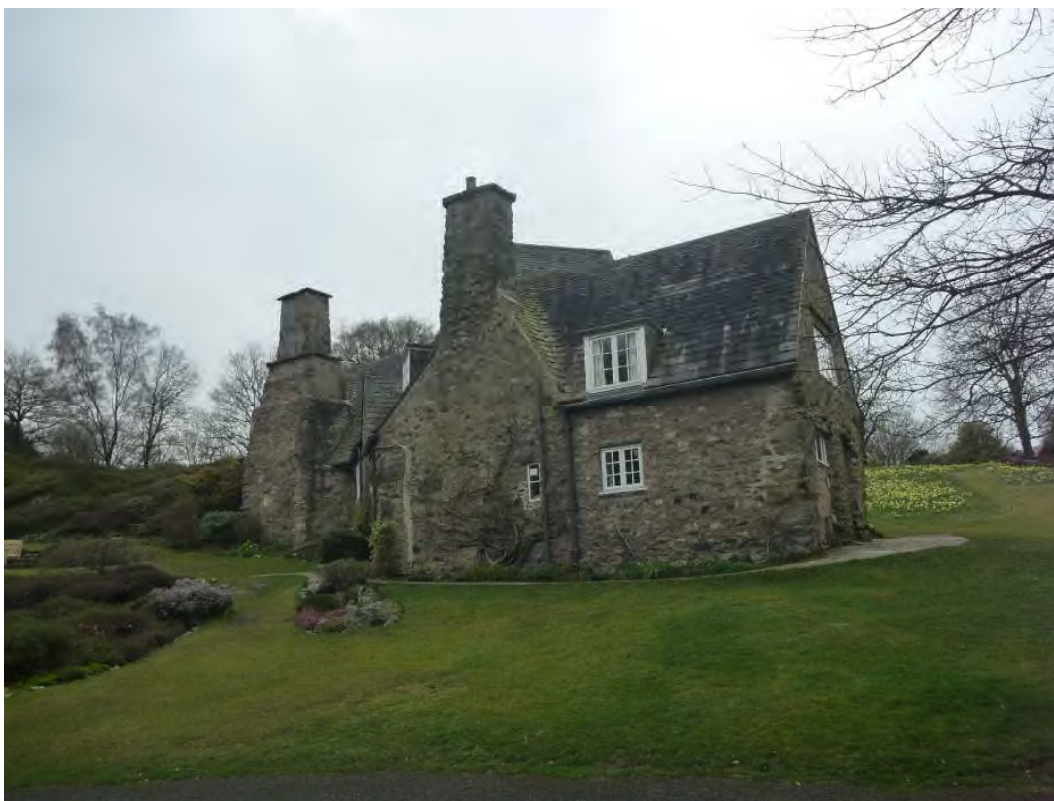
Plate 7: Eastern elevation of Stoneywell Cottage, viewed facing northwest

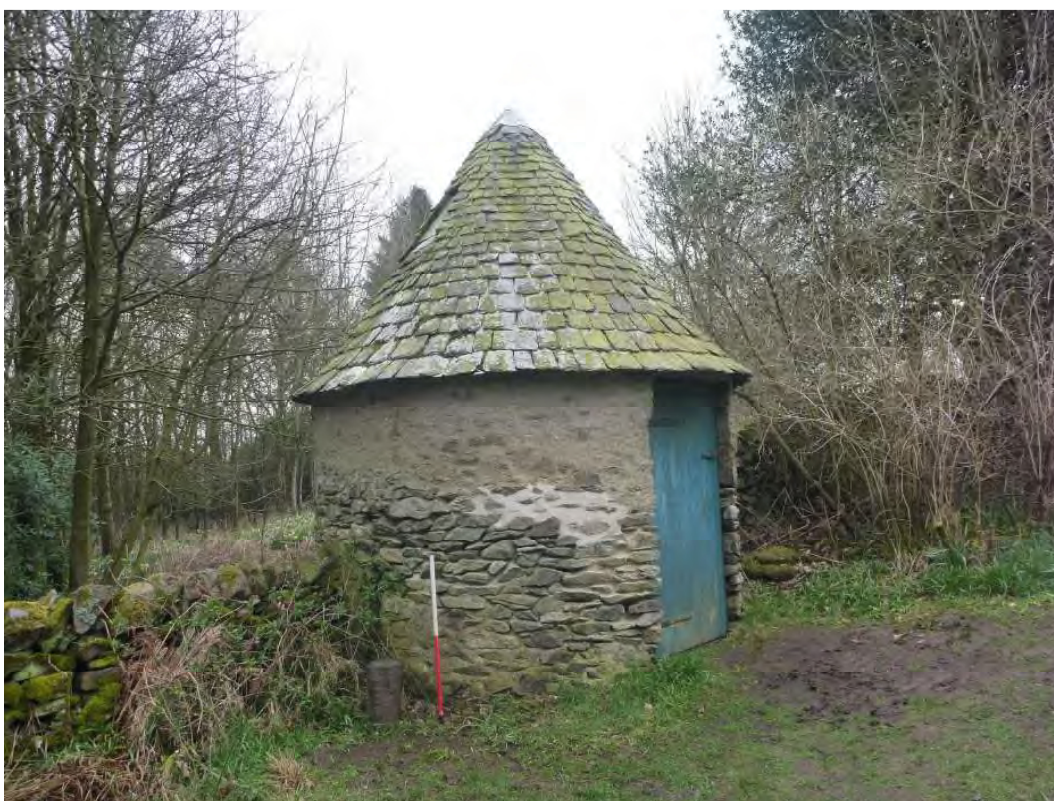
Plate 8: Pump house (feature 103) and wall 205, viewed facing southwest

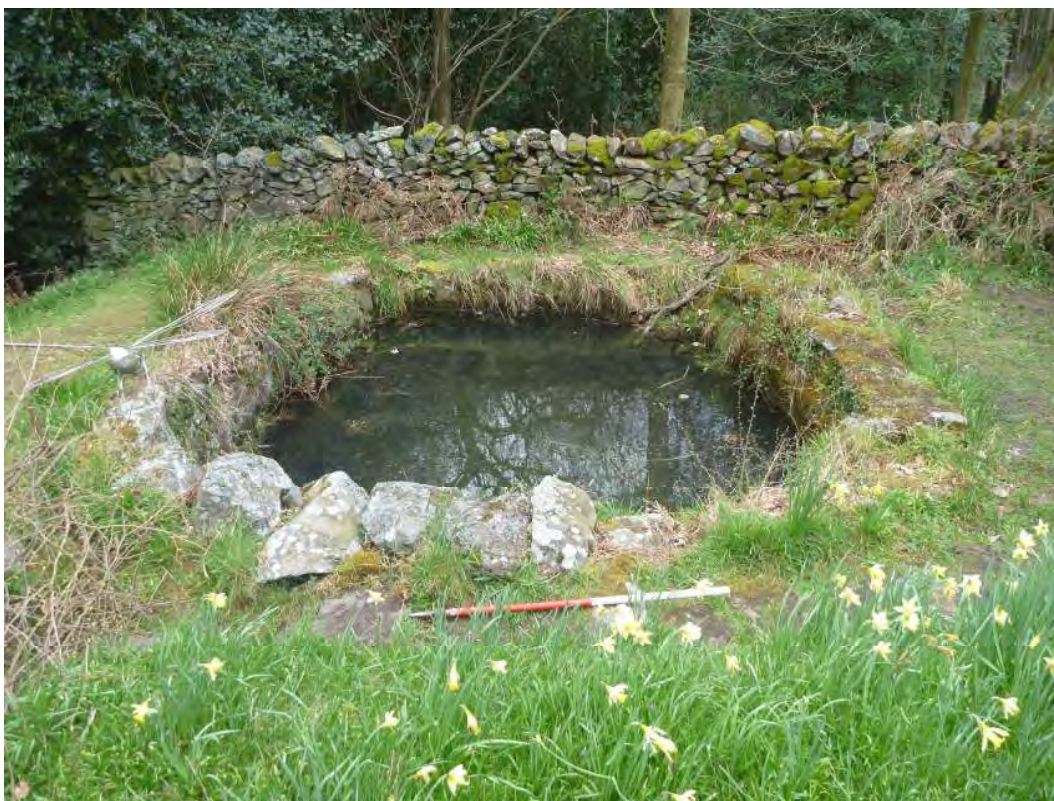
The pond is currently fenced off and the water low and fairly stagnant, but it is in generally reasonable condition. There is a substantial amount of vegetation growth both within the pond and on the walls, including brambles, and a tree stands near the southwest corner. The brambles obscure the walls and these and the tree roots could have the potential to damage the stonework.

Plate 9: Pond 104 adjacent to pump house, viewed facing southeast

Mon ID	NT SMR	Related ref	Mon type	NGR	Description	Designation/ significance	Period	Condition	Threats
104	68757		Pond	SK 49872 11741	A square pond adjacent to the pump house and probably associated with it. It is c.3m square, with a low stone wall around the edge, and concrete rendering on the interior (unclear if this is over stone or a completely concrete lining). A ceramic overflow pipe is visible in the northeast corner, but the southeast corner, closest to the pump house, is obscured by vegetation so it is not clear if there is a pipe running to it. The surrounding stone wall protrudes only slightly above ground level. The pond is quite deep, c.1.5m.	Regional (group value)	Post-medieval	Good	Some vegetation growth which could affect the wall integrity.
105	68758		Boundary ditch	SK 49790 11844	A substantial boundary ditch aligned northwest to southeast and running along the southwest side of Stoneywell Wood. It varies in width and depth along its length, but is on average 1.8-2m wide at the top and 0.5m wide at the base, with a U-shaped profile and relatively flat base. The ditch is c.0.5-0.7m deep, with a stony bank on the northeast side. In the southern end there is some puddled water, suggesting it may function as a drainage ditch, but it is most likely a boundary, probably a pre-Parliamentary enclosure boundary of the woodland. It is on the line of the boundary shown on the 1796 map.	Regional	Medieval to post-medieval	Good	Vegetation, mainly along the bank, including trees which could impact on the bank; a recent badger sett is very close to the bank at SK 49718 11967.

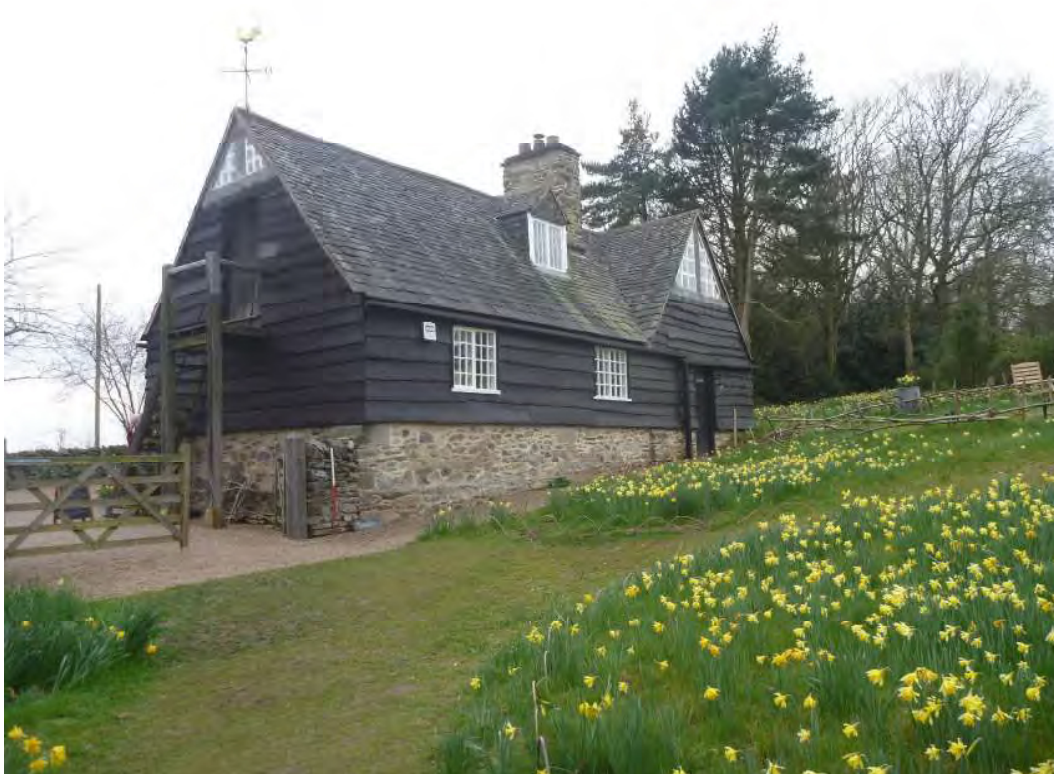
The coach house and stable block (feature 125) on the western side of the grounds were built in 1902, and first shown on the 1929 map. These buildings are grade II listed on the grounds of group value. The walls are of granite and slate rubble construction, with rustic weatherboarding on the upper two thirds of the exterior walls. The building is in a L-shaped arrangement, with the longer northern range housing the stables and currently the toilets. This range has small triangular dormer windows in the roof on the side facing onto the yard, and larger triangular windows on the northern elevation. The stable still contains a loose box and stall, and a hand-pump, with a stone flagged floor. The shorter eastern range housed the coach house and possibly accommodation for a coachman. There is a taking-in door at first floor height, possibly for a hayloft, accessed via an external wooden staircase (plate 10). To the rear of this range is the current tea room, which houses a circular oven or copper.

Plate 10: Northeast elevation of coach house (feature 125), viewed facing west

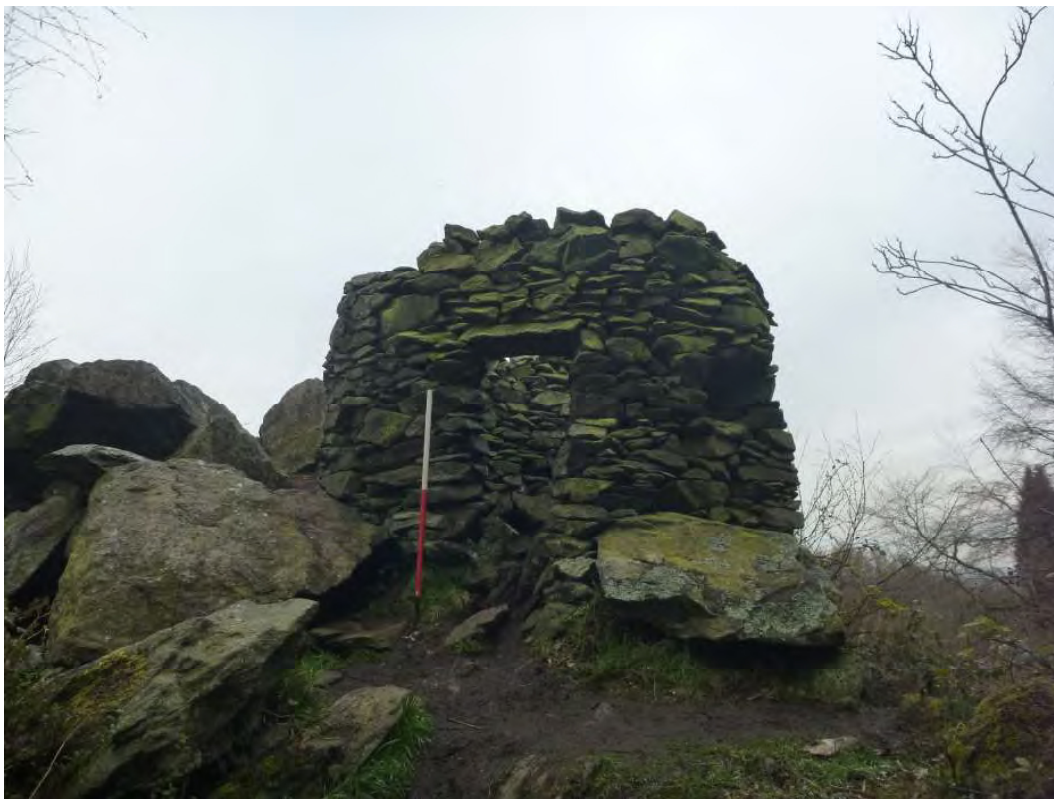
Plate 11: 'Tower' fort, feature 117, viewed facing east

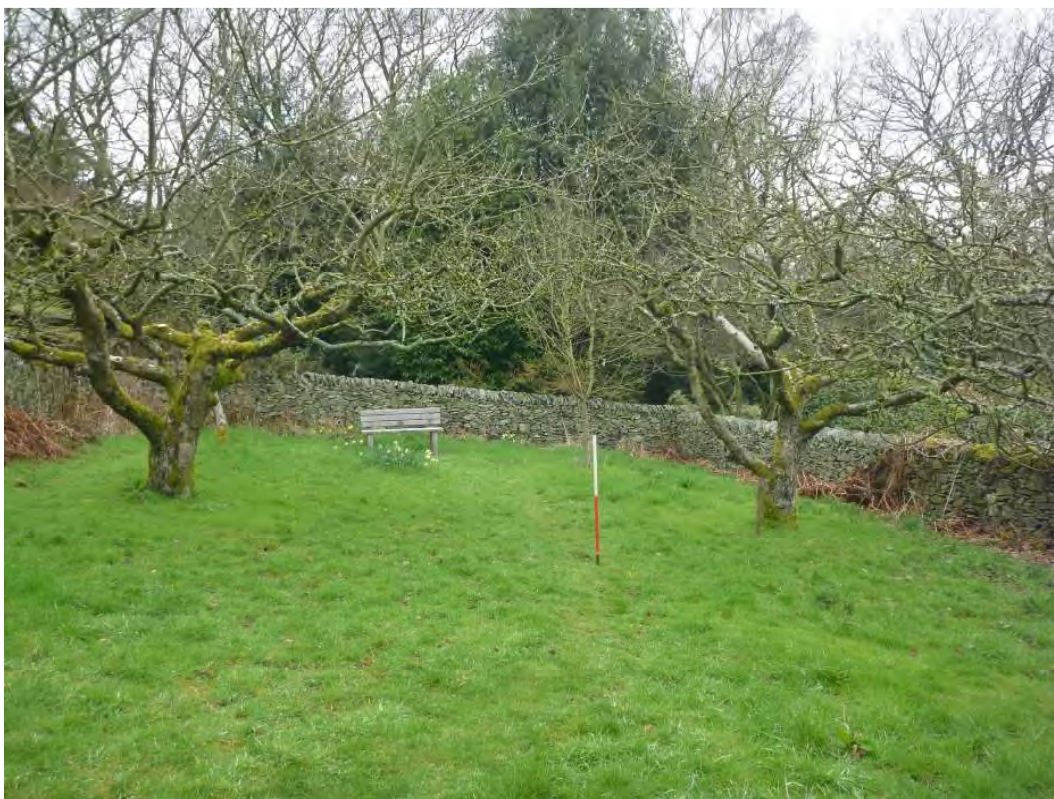
Plate 12: Walled orchard (feature 119), viewed facing northwest

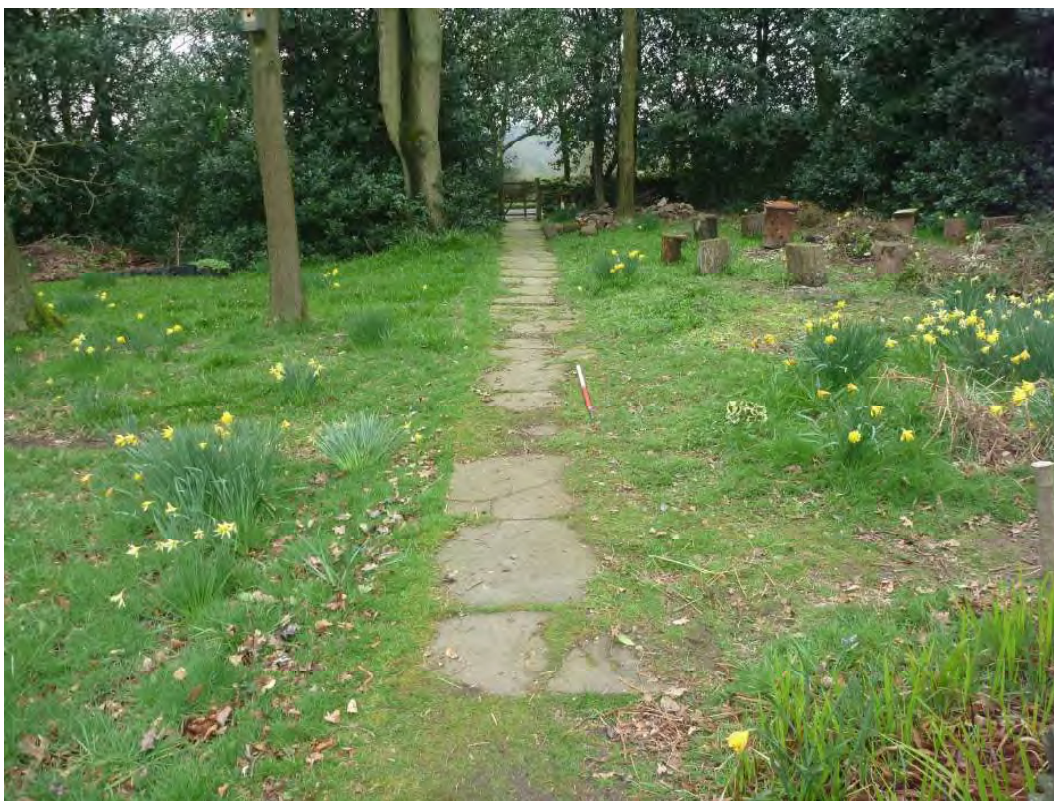
Plate 13: Flagged footpath, feature 122, viewed facing southwest

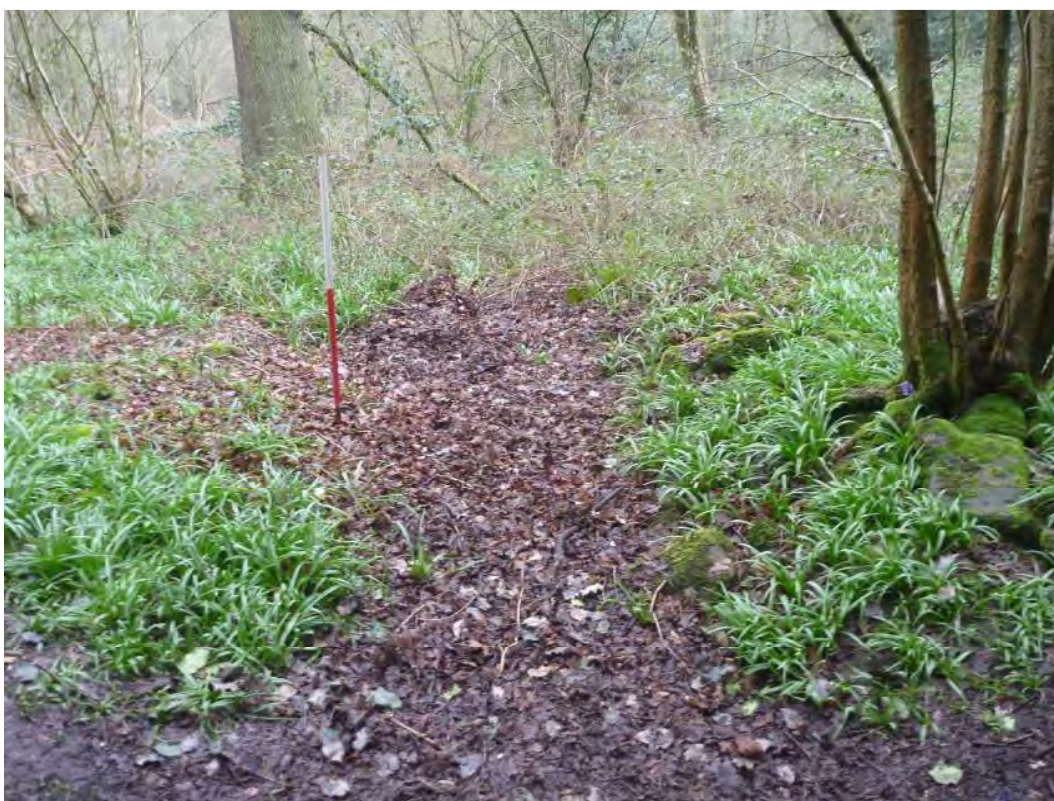
Plate 14: Linear ditch 107, viewed facing northeast

Mon ID	NT SMR	Related ref	Mon type	NGR	Description	Designation/ significance	Period	Condition	Threats
107	68760		Linear ditch	SK 49685 12113	A linear ditch aligned east to west within the wood, running from the boundary ditch 105 at the west downslope and out of the survey area to the east. It is up to 1.5m wide at the top and fairly shallow at the western end, c.0.3m deep, becoming more substantial as it runs downslope to the east, up to 0.5m deep. It appears to be for drainage, although may also form a compartment boundary within the wood. In places it is densely overgrown, particularly with brambles, and some trees are along the edge. In places a bank is visible to the north, 0.8m high and 0.3m wide.	Local	Post-medieval	Fair	Vegetation, including trees, may impact on the earthworks.
108	68761		Stone row	SK 49718 12003	A short stretch of linear stony bank near to a boggy, damp area with recent tree management activity. It is aligned northwest-southeast, and only visible for 2.5m in length. It is 0.5m wide and 0.2m high, slightly earth covered. It may be an old tree throw, but there is no associated hollow. One tree stump is set within the feature. Possibly the remains of a short length of walling, but with no clear function.	Local	Unknown	Fair	Vegetation could impact on the feature but no immediate threat is visible.

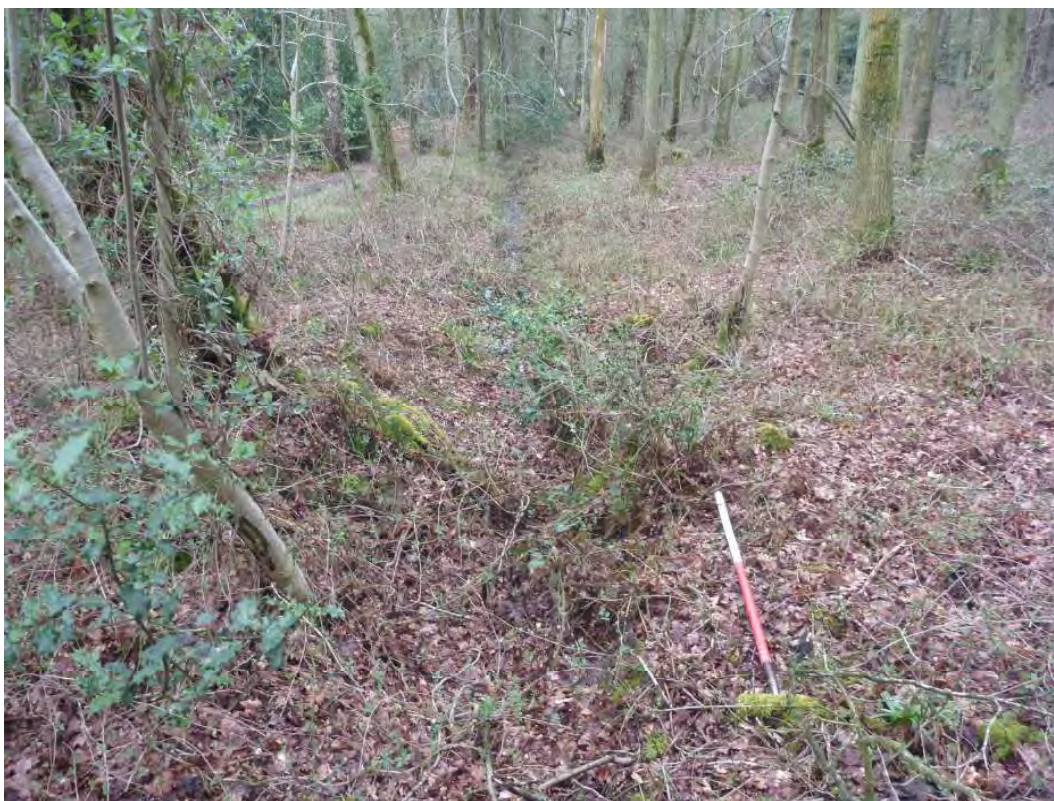
Plate 15: Drainage ditch 112, viewed facing southeast

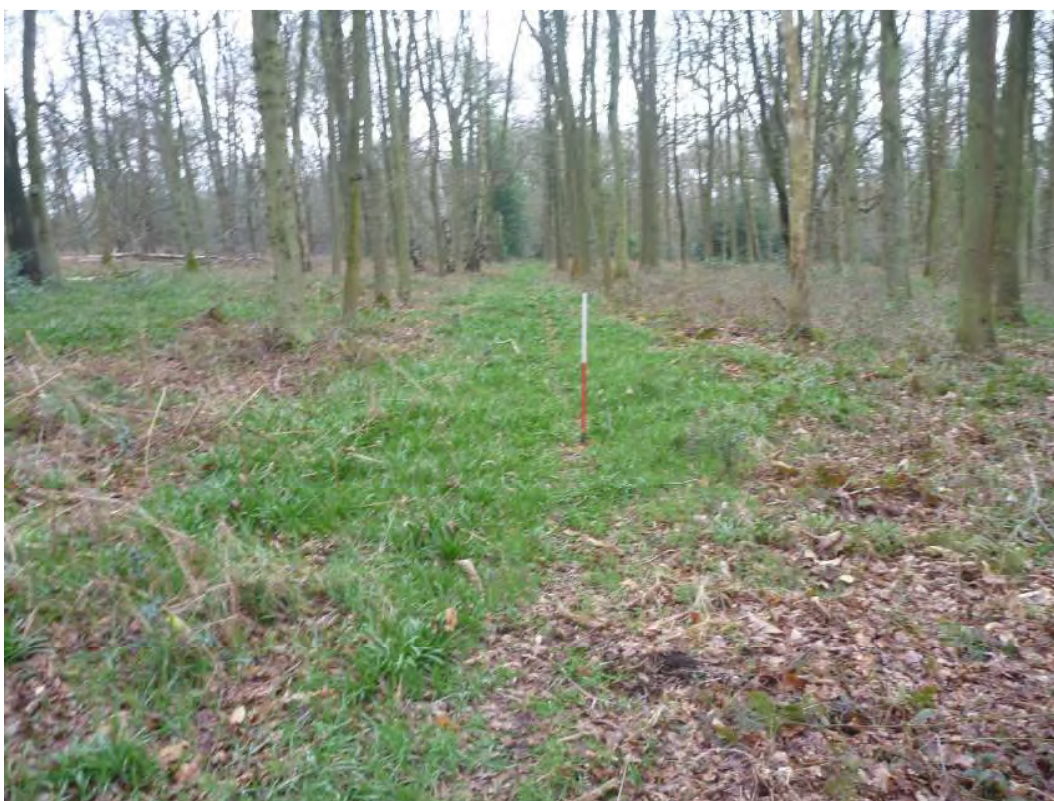
Plate 16: Abandoned footpath 111, viewed facing northwest

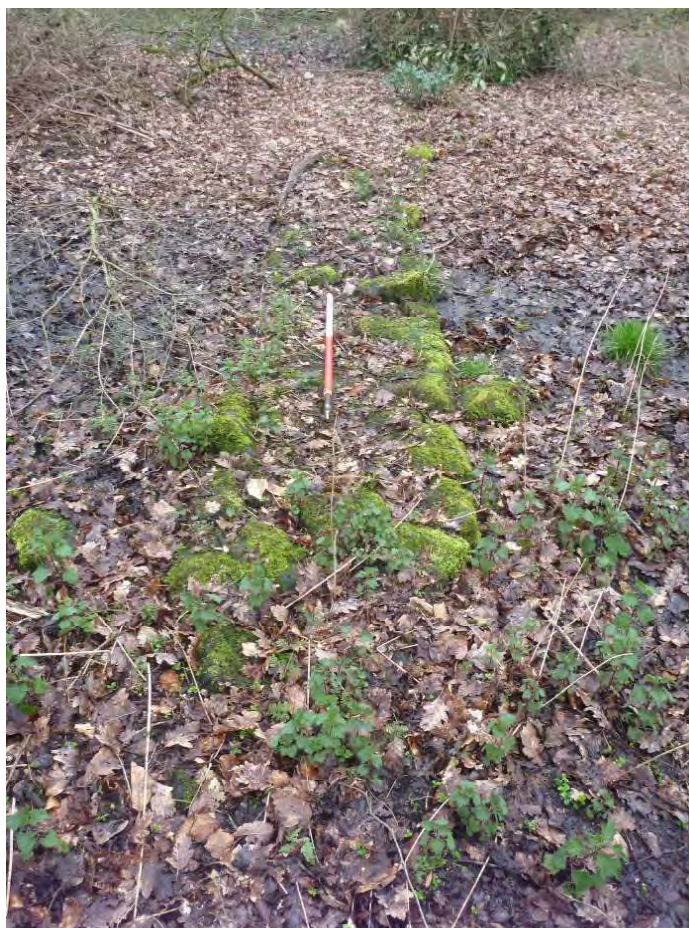
Plate 17: 'Bridge' structure 110, viewed facing southeast

Mon ID	NT SMR	Related ref	Mon type	NGR	Description	Designation/ significance	Period	Condition	Threats
110	68763		Bridge	SK 49750 12005	A possible small bridge or causeway in a damp, boggy area. It is c.3m long, 0.65m wide, aligned roughly northwest-southeast. It is mainly one stone wide. It is quite mossy, suggesting it is not a recent feature. It may be associated with a former pathway through the wood (feature 111).	Local	Post-medieval	Fair	Vegetation could impact on the feature but no immediate threat is visible. The boggy nature of the ground suggests the feature is at risk of being lost to mud.
111	68764		Pathway	SK 49794 11923	A former pathway, now mainly disused, visible as a clear, level area mainly aligned southeast to northwest through the southern and central part of the wood. The southern end curves round to the west, to the entrance to the wood from Stoneywell Cottage, indicating that it is likely to be a former woodland walk from the cottage. There is no visible evidence of construction, but it has remained clear up to the edge of the boggy ground to the north. The bridge feature 110 may be associated with it, but the feature could not be followed in denser bracken and bramble vegetation to the northwest.	Local	Modern	Fair	The pathway is currently clear at the southern end, but could be threatened by encroachment of bramble and bracken, as well as by sapling trees.

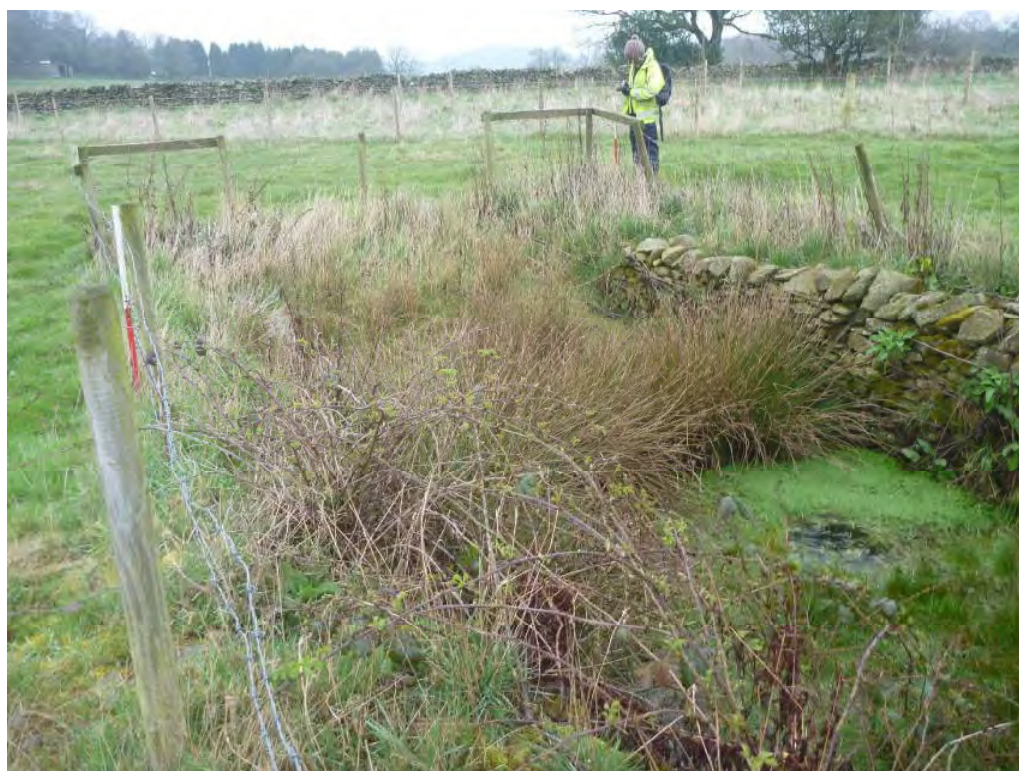
Plate 18: Possible cart pond 101, viewed facing east

Mon ID	NT SMR	Related ref	Mon type	NGR	Description	Designation/significance	Period	Condition	Threats
101	68754		Pond (field pond, possible cart wash)	SK 49324 12025	A rectangular, stone-lined pond within the Rough, approximately 10m x 5m in extent, and a visible depth of 1.2m. Three sides have drystone revetment, with the fourth, north-east side having a grassed ramp down to the pond, suggesting it was built to water livestock, or may have been a cart wash. It was not noted whether the grass obscures a cobbled or flagged ramp and base. The pond still holds water, but is fenced off. Vegetation growth inside obscures the wall in places, including brambles.	Regional/ Local depending on purpose	Post- medieval	Good	Vegetation could impact on stonework and increase the likelihood of the pond silting up.
102	68755		Marker stone	SK 49851 11728	A marker stone, set upright close to the bend of the drive leading to Stoneywell Cottage. It is 0.7m tall, 0.5m wide and 0.1m broad, with relatively straight faces. There are no obvious markings on the stone. It is likely to be a parish boundary marker, or 'mere stone', as shown on the 1796 map of the area. Possibly known as the 'Pilgrim Stone', according to local volunteers.	Regional	Medieval to post- medieval	Good	None

Forestry and vegetation management	<p>It would be desirable to control the extensive brambles and bracken within the woodland, to avoid obscuring and potentially damaging archaeological features.</p> <p>Any forestry works within Stoneywell Wood should aim to avoid damage to features identified in the survey.</p> <p>Wherever possible, the route of the historic pathway should be maintained free of shrubs and trees. It would be beneficial to incorporate this into the visitor experience. Some works may be needed in the 'lost' section to demarcate the path more clearly.</p>
Further research	<p>Further documentary research on the history of Stoneywell Wood could have the potential to clarify the period when it was enclosed from common land, and therefore the approximate date of the surviving boundary ditch.</p> <p>It was not possible to find any information relating to the laying out and design of the gardens at Stoneywell Cottage during the desk-based research. Further research may reveal more information on the design principles, as well as the extent of formal planning, as the grounds seem to have been modified over time.</p> <p>Due to the problems with utilising GPS recording within the wooded areas, it is recommended that future surveys utilise a Total Station to more accurately locate features.</p> <p>Archaeological evaluation of the nature of the base and ramp of the pond in Rocky Field would assist in determining whether it functioned as a cart wash.</p>
