Ilam Park, Staffordshire: Archaeological Evaluation

ArcHeritage Report 2017/12
February 2017

**Ilam Park, Staffordshire
Archaeological Evaluation**

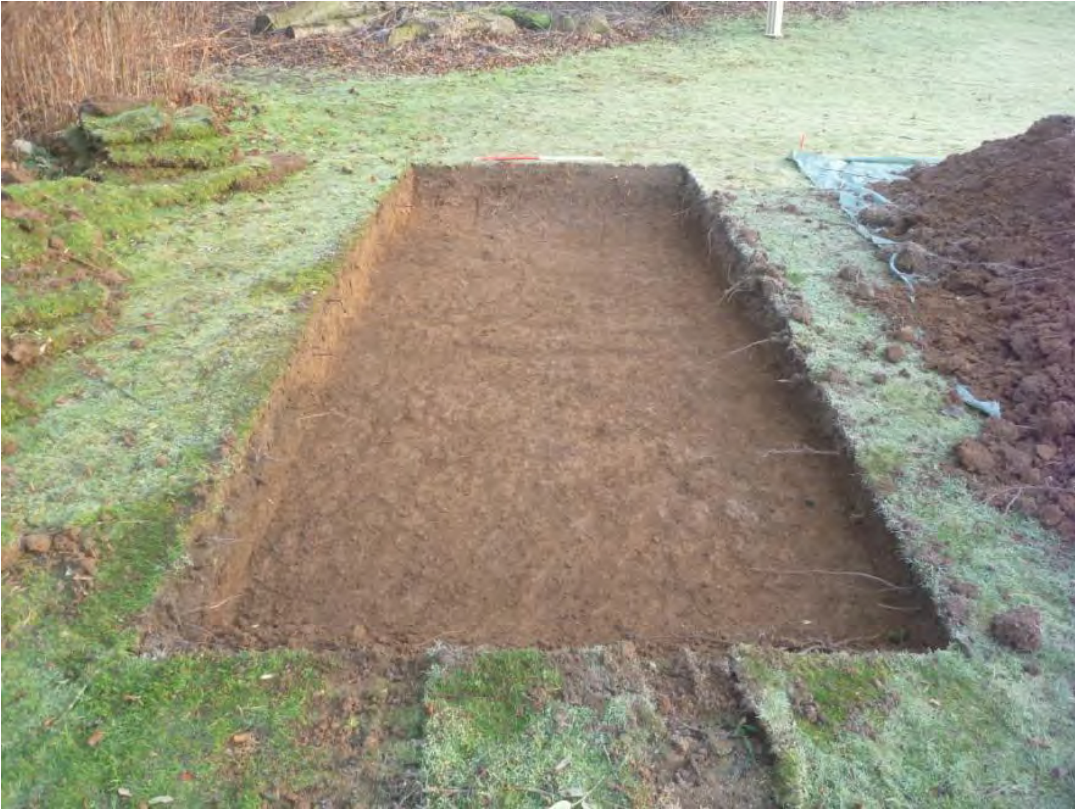
Plate 1: Trench 1, looking north-east. Scale 1m.

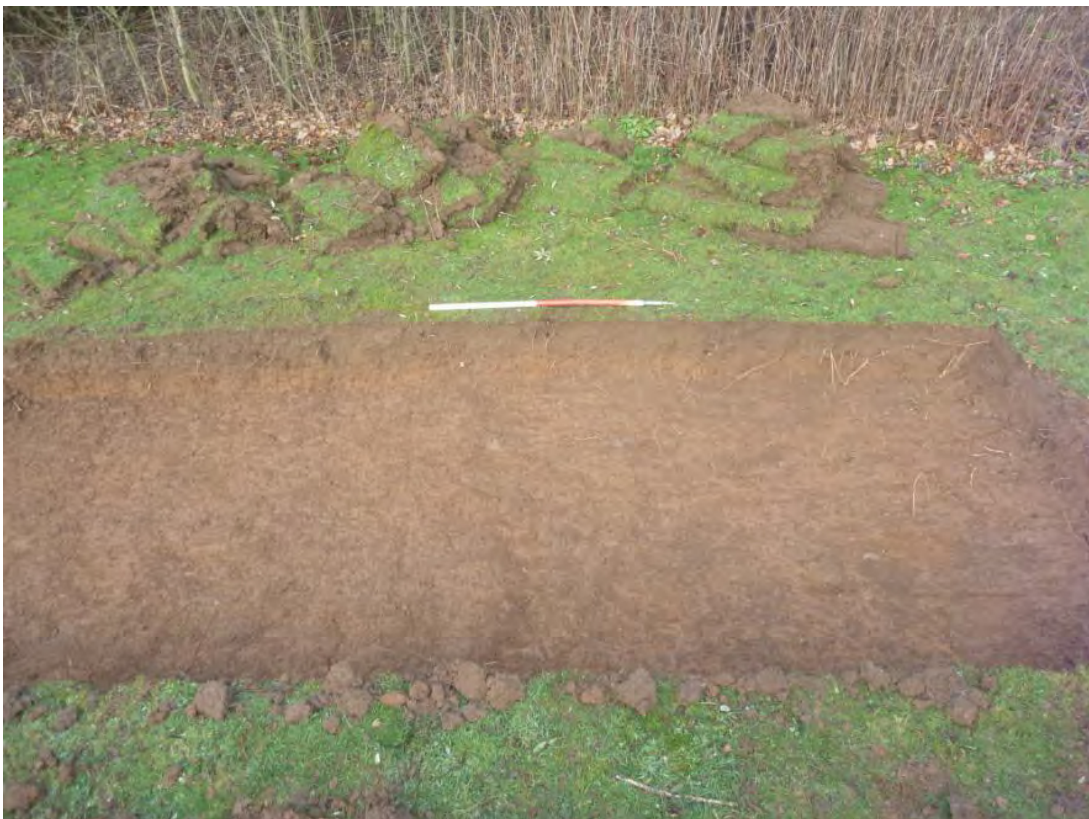
Plate 2: Representative section of Trench 1, showing topsoil (101) and subsoil (102). Looking north-west, scale 1m.

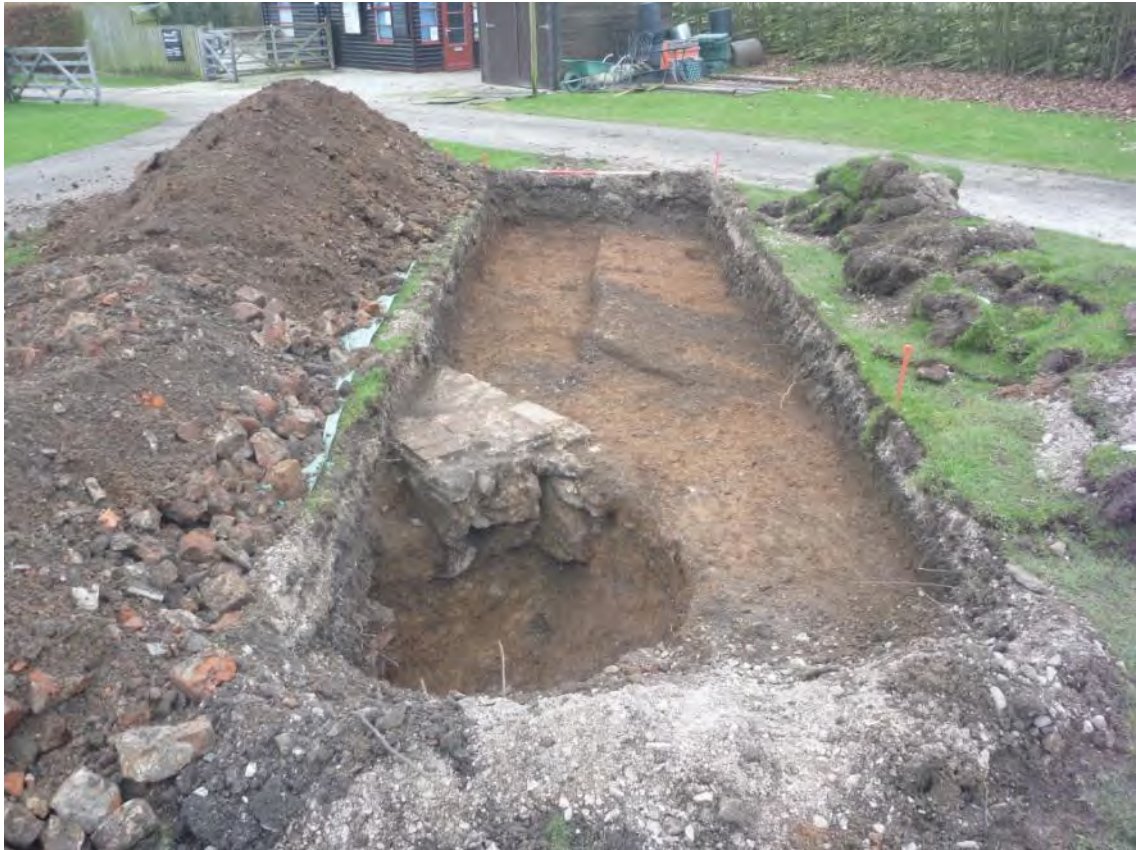
Plate 3: Trench 2, showing truncated wall (203) and hedge line (206). Looking south-west, scale 1m.

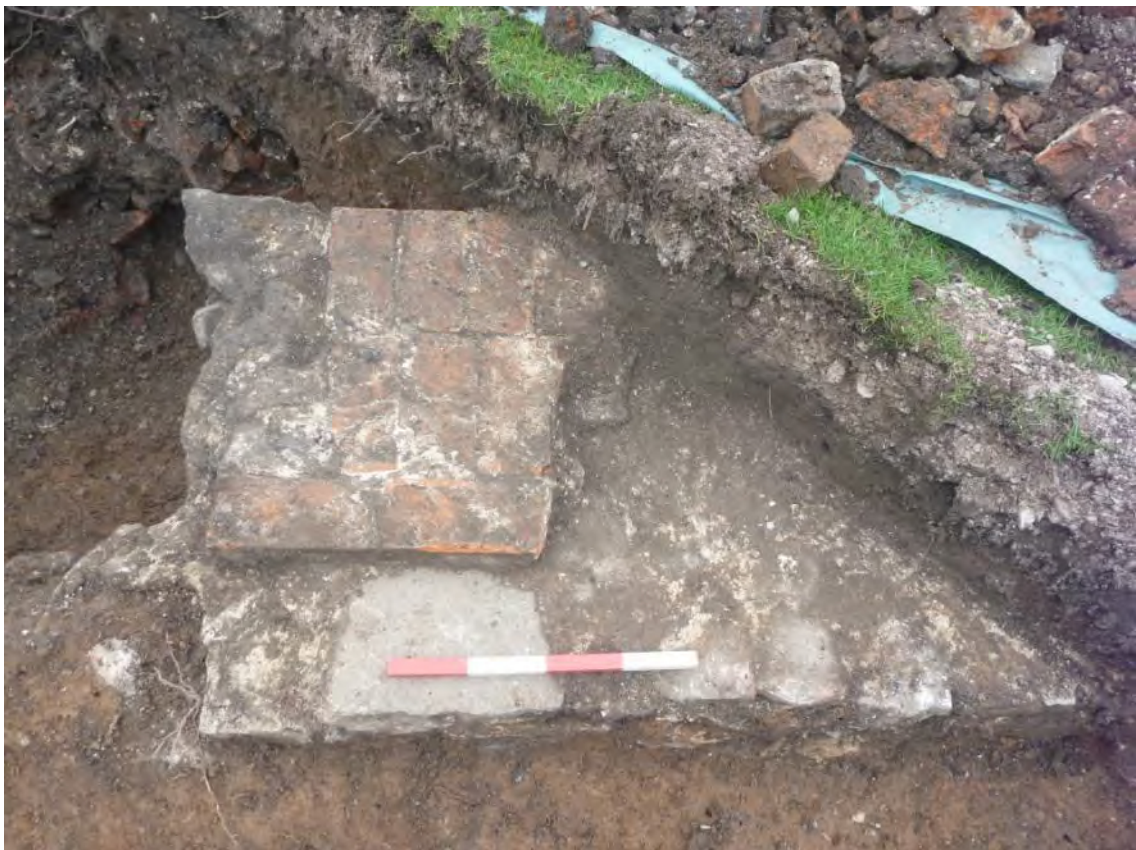
A short section of wall (203) (Plate 3-6), aligned north-west to south-east, was present at the north-eastern end of the trench. The wall was constructed out of roughly squared limestone blocks, with a small rectangular area of bricks on the upper surface (Plate 4). Heavy lime mortar was adhered to the structure. The wall was visible for a length of 1.35m, with the south-eastern end continuing beyond the limit of excavation into the eastern edge of the trench. The north-western end of the wall appeared to be truncated (Plate 5), at the location where it is likely to have once joined with a return wall, visible as a parch mark in the grass (Plate 6), heading north-east (part of which is recorded as (306) in Trench 3 and (504) in Trench 5). The wall (203) was cut into subsoil (207), and penetrated the subsoil for a maximum depth of 0.52m. The lowest course of stones, laid well into the subsoil, were more coarsely-shaped than those towards the upper courses.

Plate 4: Wall (203), Trench 2. Scale 0.40m

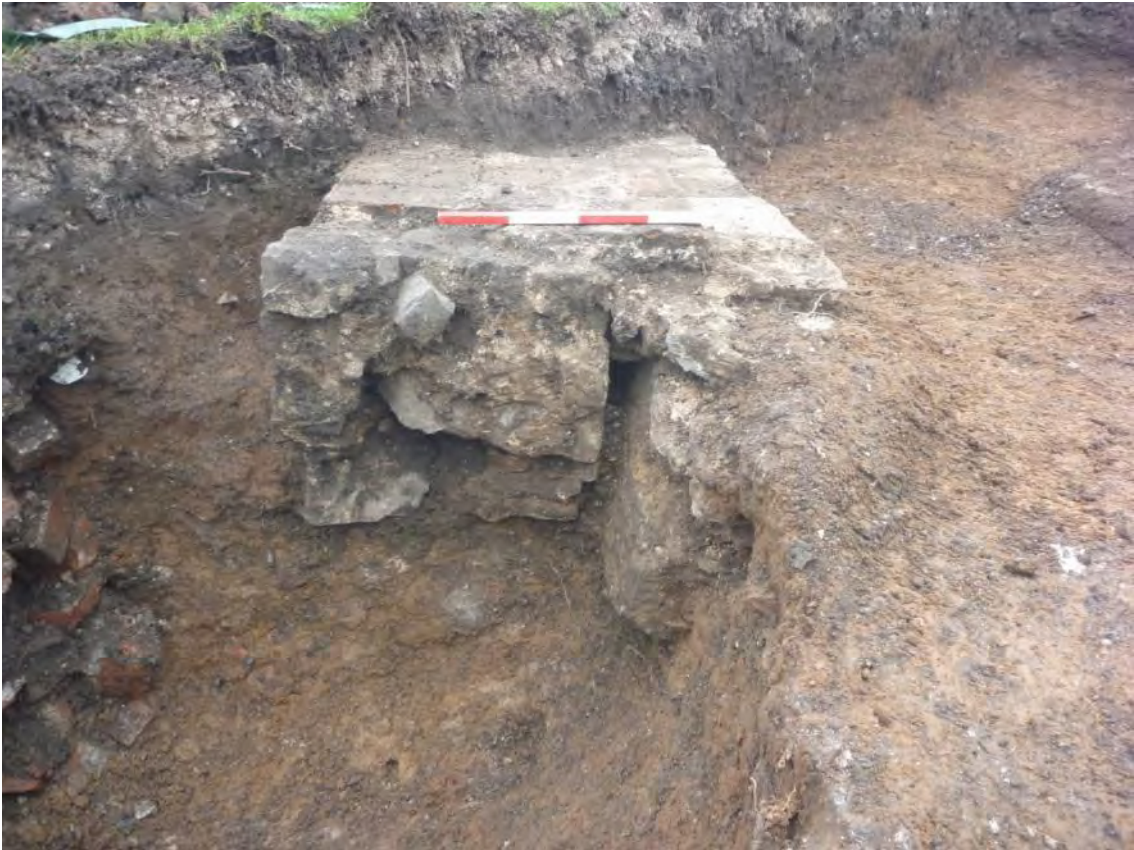
The truncated alignment of wall (203) in Trench 2 at the junction with the north-eastern return is evidence of deliberate disturbance. The location of this wall fits well with the 1839 Cobb map (Figure 9) where the main garden boundary wall is depicted. All of the wall remains identified during the evaluation had been reduced to ground level, some of which were just visible within the grass, but some of which were completely buried. The reason for the truncation of the corner of the wall is unclear. The stones of the wall have been removed and then backfilled with abundant bricks, limestone blocks and pottery fragments. The pottery predominantly dates from the late 19th to early 20th century, with very few 18th century examples, which corresponds well with the garden depicted on the Cobb map; by the OS map of 1881, the garden is no longer represented on maps, hence it must be assumed that it had been removed by this point.

Plate 5: Truncated wall (203), Trench 2. Looking south-east, scale 0.40m.

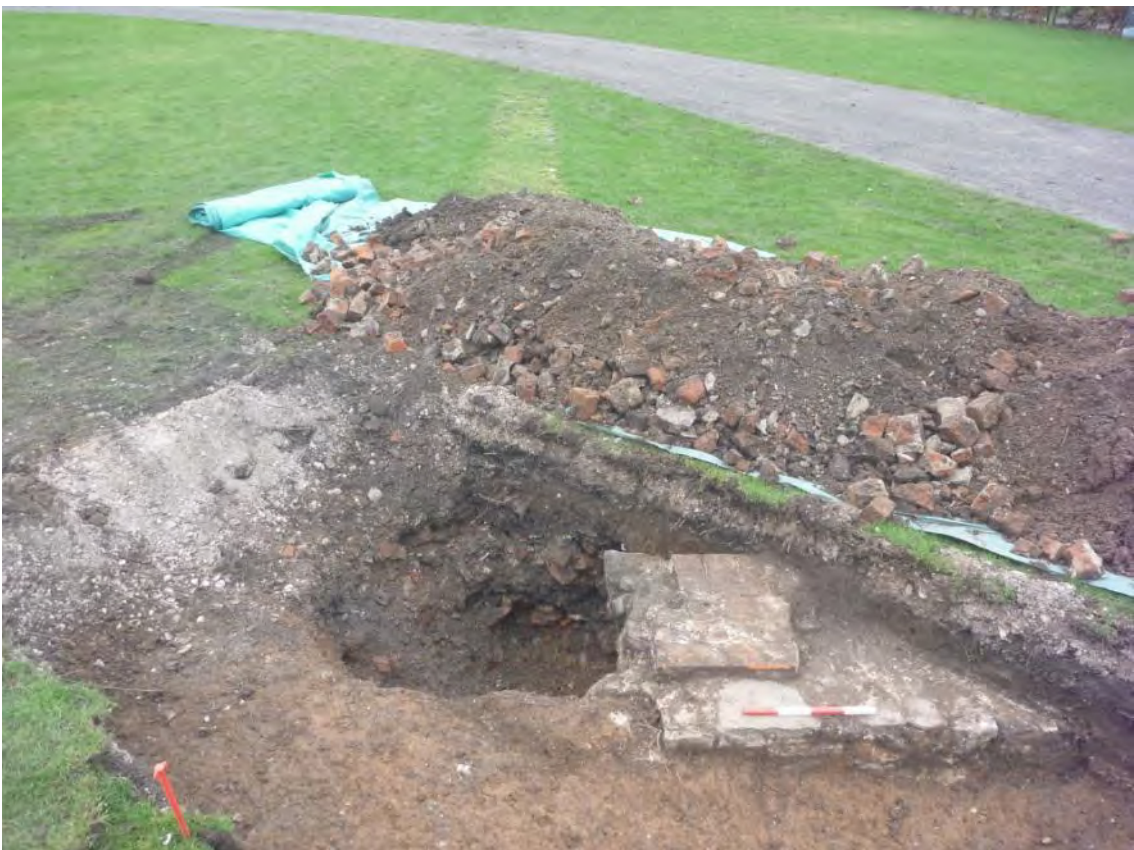
Where the wall (203) had been truncated, a very rubble-rich deposit (204) was present, contained within the construction cut [208] for wall (203), presumably used as a backfill after the wall (203) had been robbed out. The deposit comprised mixed grey clay silt with abundant fragmented brick and limestone blocks, very frequent late 19th and 20th century pottery fragments, and less frequent charcoal, glass and clay pipe fragments. An assessment of the ceramics is detailed in Appendix 3 and other finds in Appendix 4.

Plate 6: Truncated wall (203) with the backfill deposit (204) visible in the section. The trajectory of the return wall is visible in the grass, heading north-east. Looking north-east, scale 0.40m

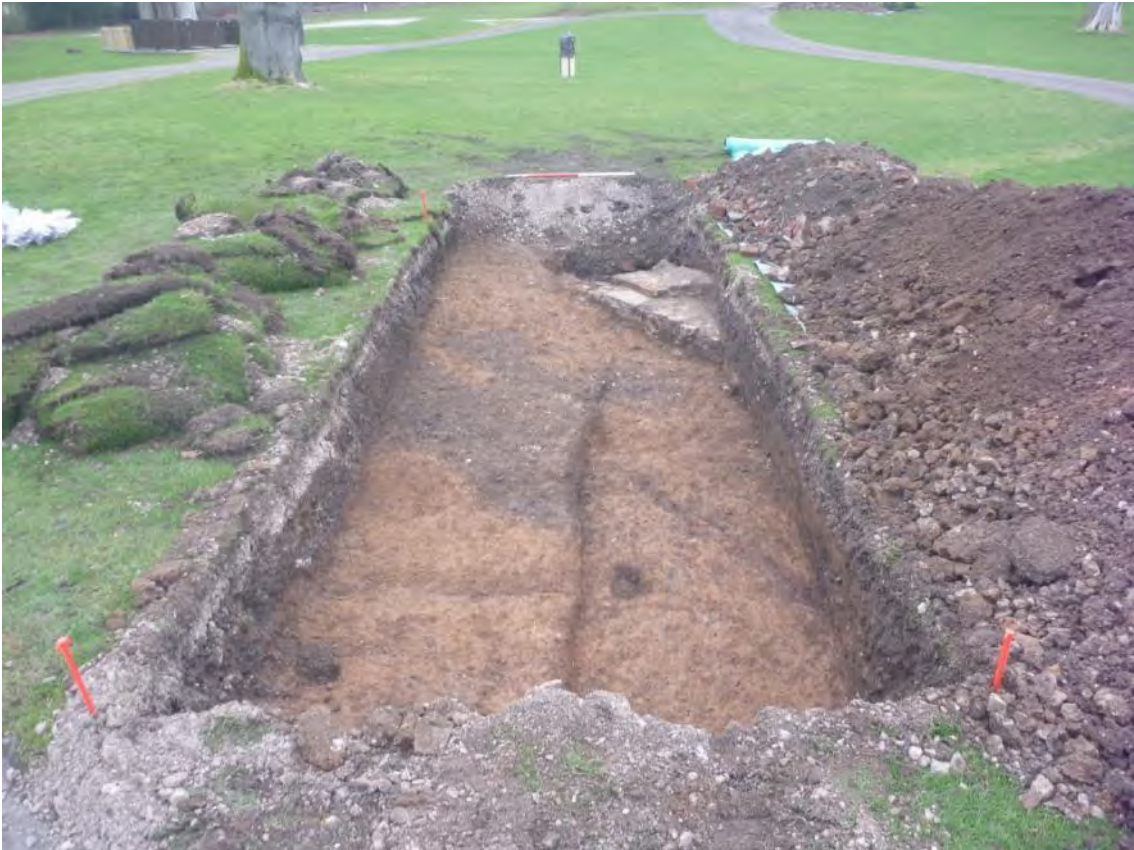
Towards the south-western end of the trench was an irregular linear feature (206) (Plate 7) comprising mottled dark grey clayey silt with frequent small fragments of charcoal and brick. Frequent fragments of degraded wood were also present, which were mostly thin and linear, likely to be remnants of roots. The feature was aligned roughly north-west to south-east, on a similar alignment to wall (203), although slightly off-set. The feature measured approximately 2m in width, with an undulating depth of between 0.04 and 0.22m. The irregular form of the feature, and the inclusions of degraded root suggest that this is a former hedge.

The linear (206) in Trench 2, filled with a mottled silty deposit with degraded wood fragments, was aligned on roughly the same orientation as the wall (204), but slightly off-set. This is likely to be the remains of a hedge. Due to its slightly off-set alignment with the wall, it seems unlikely that these two features are contemporary, with the hedge perhaps installed after the demolition of the wall, to retain a boundary.

Plate 7: Trench 2, showing root disturbance from hedge (206) in the foreground. Looking north-east, scale 1m.

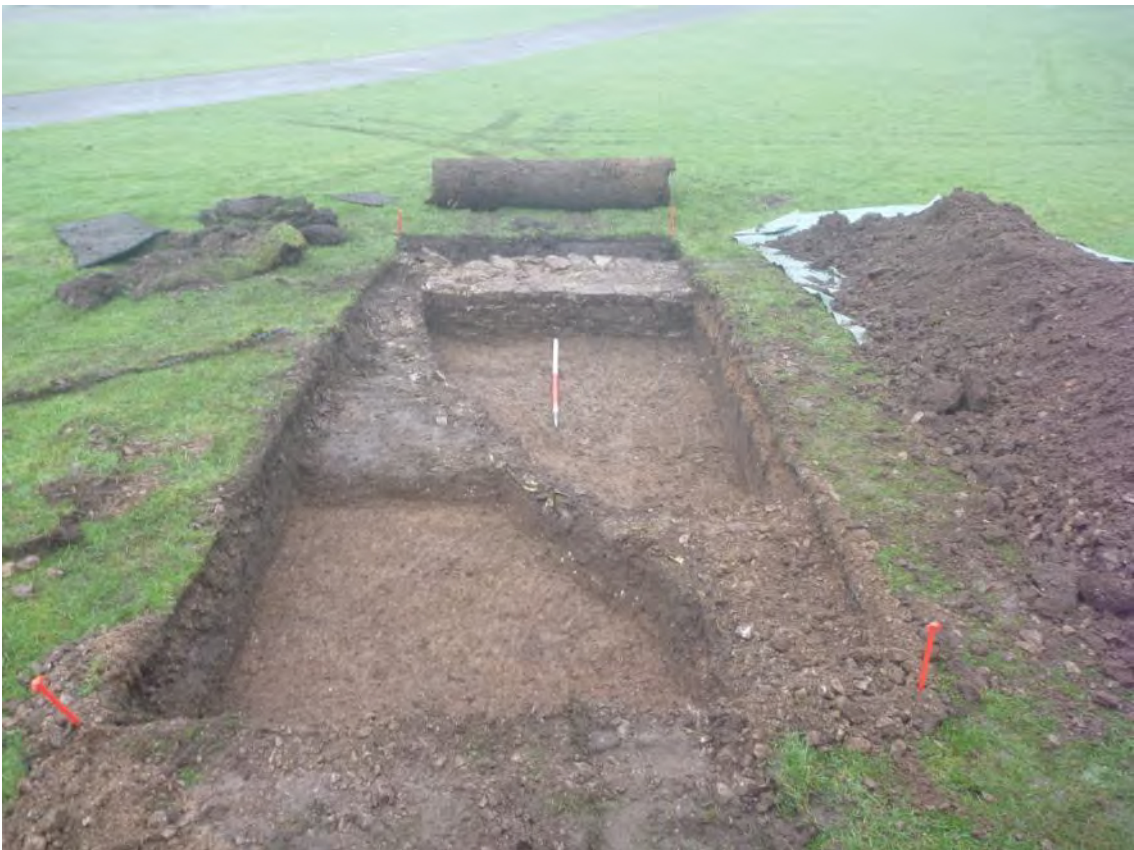
Plate 8: Trench 3, with wall (306) visible at the far end of the trench. Looking north-west, scale 1m.

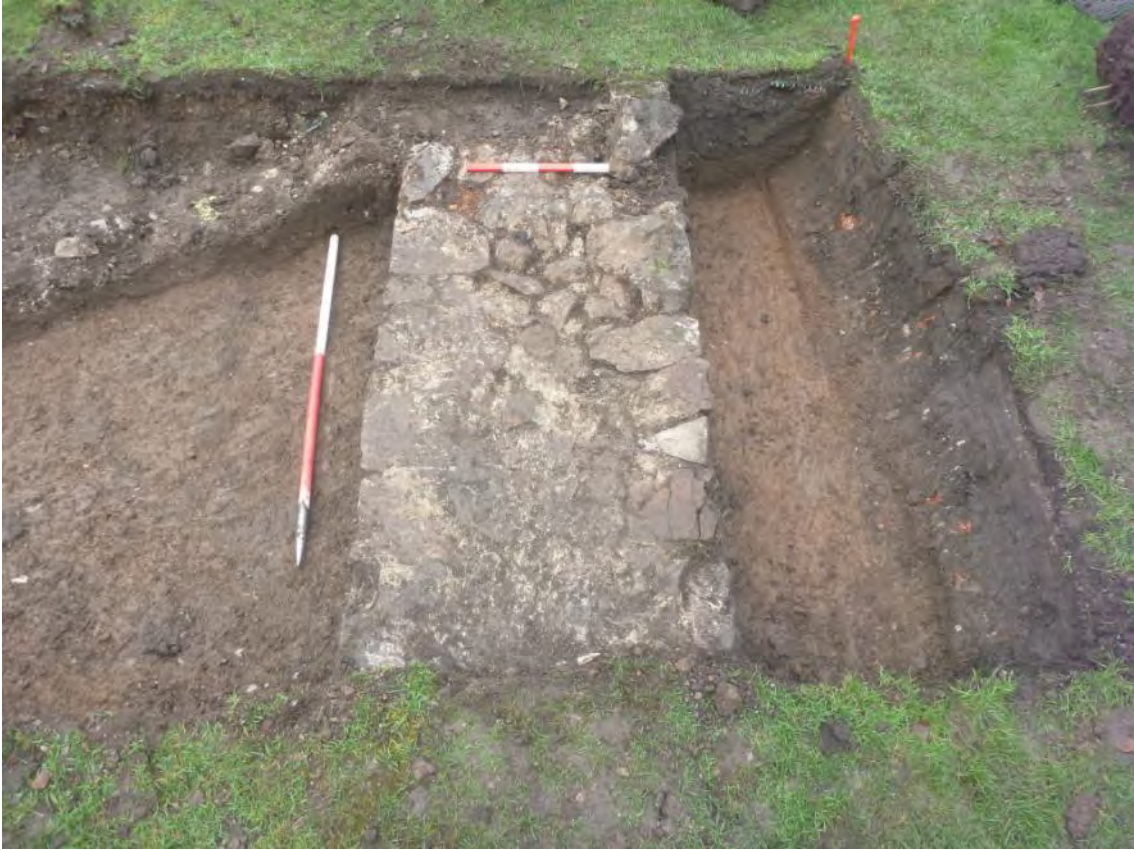
A north-east to south-west aligned stone wall (306) (Plates 9-11) was present at the north-western end of the trench. A sondage was excavated against the northern elevation of the wall, which determined that the wall had a maximum height of 1.3m, penetrating the subsoil for a total depth of 0.95m from the upper surface of the subsoil (309). The wall was exposed for a maximum of 11 courses, with stones which were very variable in size and shape, comprising limestone blocks, no larger than 0.3m in length, and bonded with white lime mortar. The core of the wall was rubble, with the outer faces containing more neatly dressed stones. No clear cut was observed for the wall, suggesting that it was trench-built. The south-western corner of the wall was truncated by the electrical pipe [304]/(305).

Plate 9: Plan view of wall (306), Trench 3. Looking south-west, scale 1m.

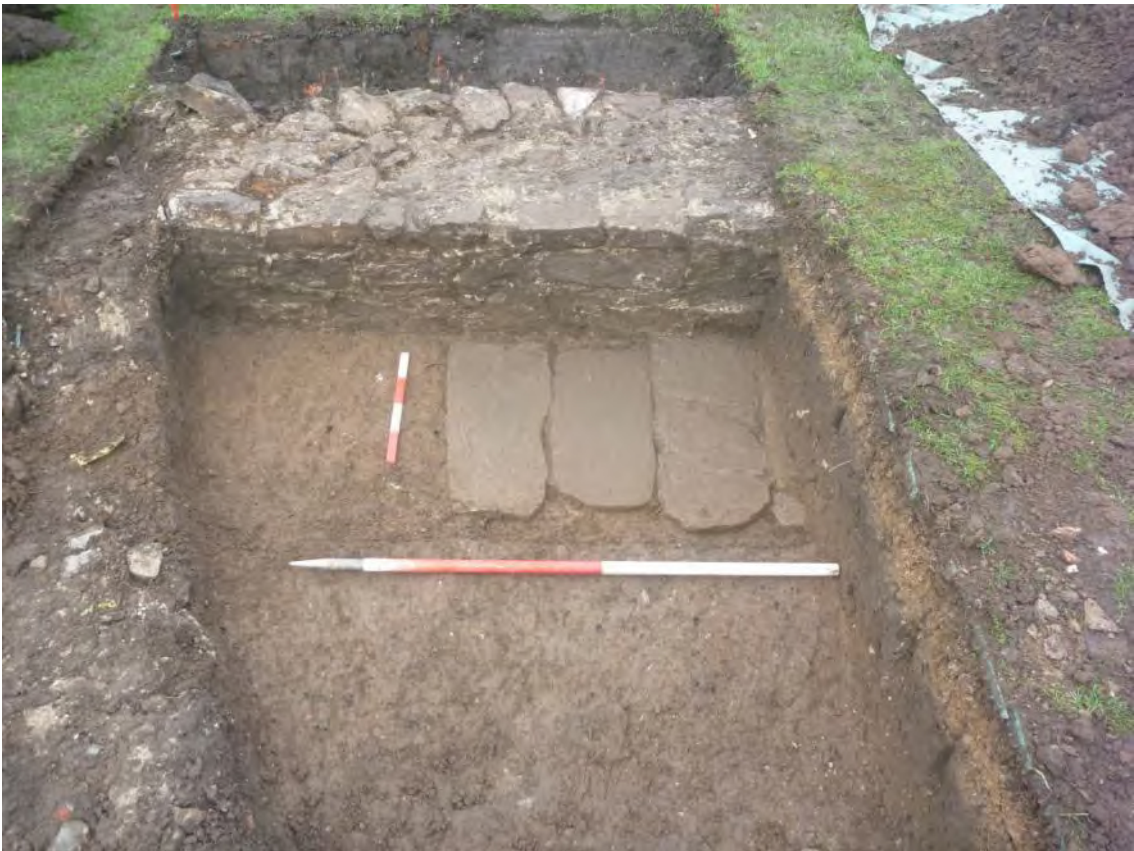
Four stone slabs (307) (Plate 10) were observed to be embedded into the subsoil (309), butting up to the south face of wall (306). The stones themselves were oblong, measuring on average 0.6x0.2m, forming a narrow surface or pathway, aligned north-east to south-west, identical to the wall (306). The stones (307) continued into the eastern trench edge, and terminated approximately halfway across the trench, covering a total area of 0.8m by 0.6m. It could not be determined whether the stones originally terminated at this point, but the proximity of electrical cable [304]/(305) may indicate that the feature (307) has been truncated by this later activity.

Plate 10: Wall (306) and surface (307), Trench 3. Looking north-west, scales 1m and 0.40m.

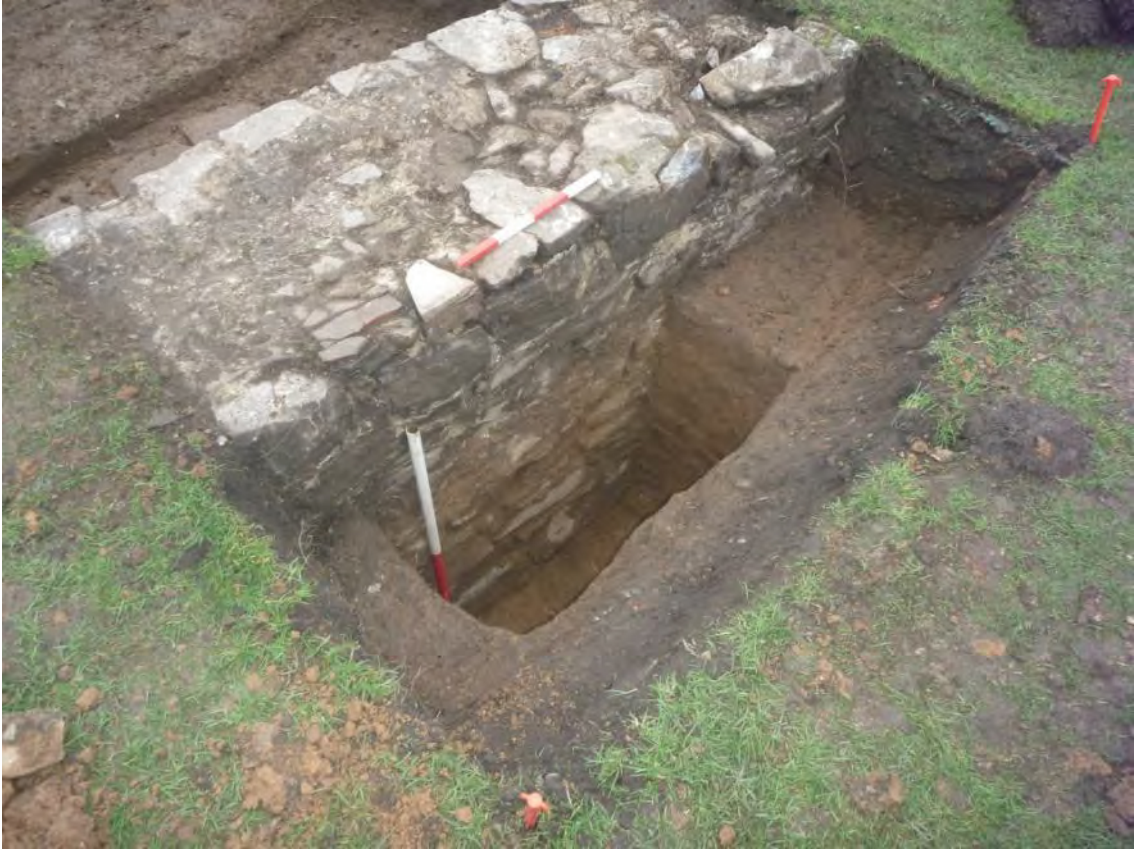
Wall (306) in Trench 3 forms part of the return alignment of the garden boundary wall (203) in Trench 2, with the wall (504) in Trench 5 also forming part of the same wall (Figures 9 and 10). The wall survived below ground in good condition, constructed out of limestone blocks and bonded with lime mortar. The foundation of the wall (306) penetrated almost 1m in depth from the upper surface of the subsoil, in contrast with the wall (203) in Trench 2, which was cut approximately 0.52m into the subsoil. This difference in foundation depth of these walls may be explained by the raise in ground level between Trench 2 and Trench 3. The limestone slab surface (307), which butted up against the southern edge of the wall (306), may represent the remains of a path which would have run around the inside perimeter of the garden boundary wall, and is a good indication for the original ground level of the kitchen garden. The surface extended into the eastern trench edge, although it terminated before reaching the western trench edge. There was no clear indication whether this was the original point at which the surface terminated, although it seems unlikely; it is possible that the surface has been truncated by the later insertion of electrical cable [304]/(305).

Plate 11: Wall (306), Trench 3, showing depth of foundations. Looking south, scales 1m and 0.40m.

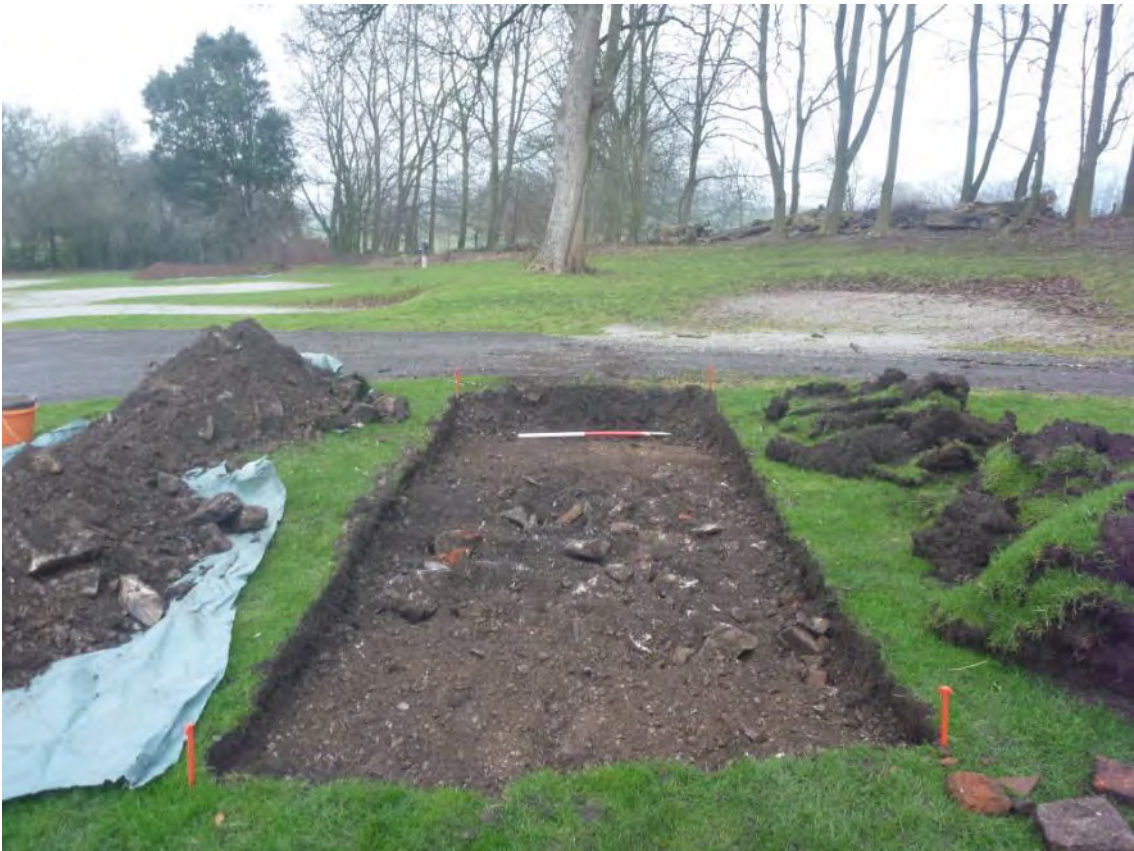
Plate 12: Trench 4, showing demolition backfill (403). Looking north-west, scale 1m.

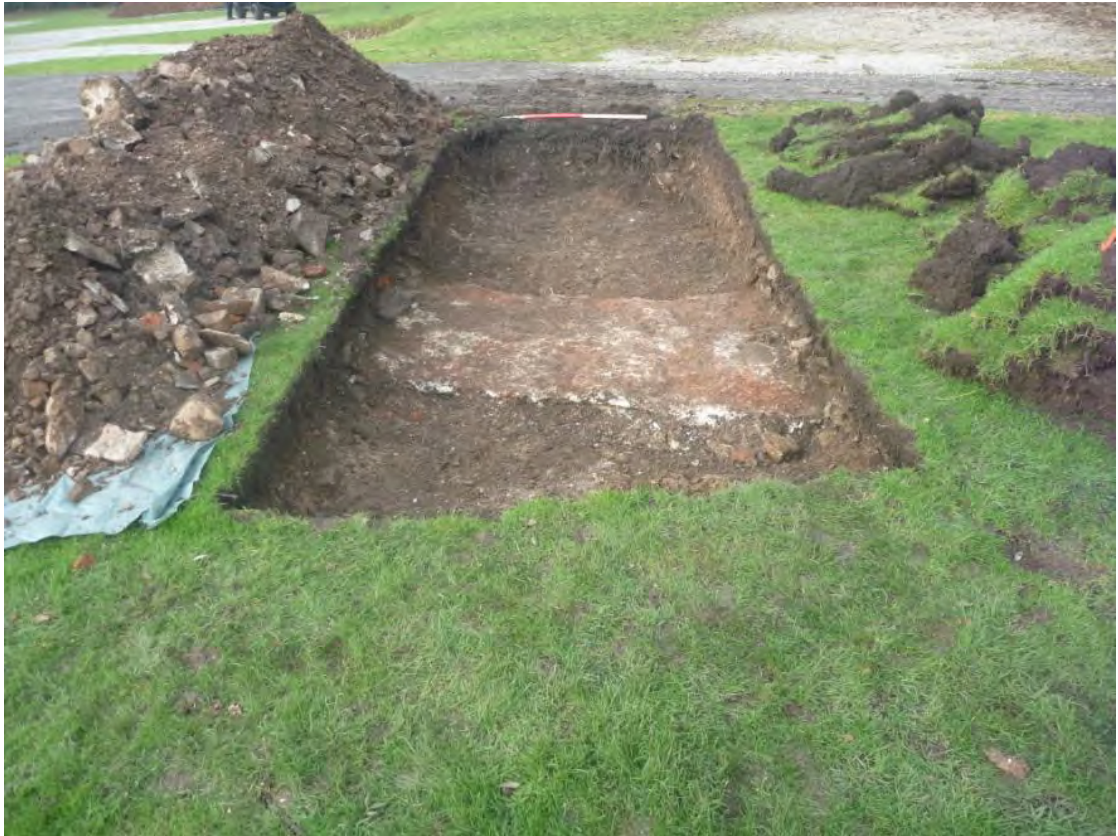
The remains in Trench 4 are difficult to interpret. Cut [405] appears to have been created for structure (404), and backfilled around the edges at the base with (406). Deposit (403) may be the demolished remains of an original structure, possibly a wall or path, which was built upon (404). Deposit (403) is now a rubble deposit which forms the upper fill of [405]. This structure (404), in contrast with the wall remains in Trench 2, 3 and 5, is crudely made. The single fragment of an 18th century earthenware bowl retrieved from backfill (403) is likely to be residual; a fragment of late 19th pottery found within the deposit (406) at the base of the cut

Plate 13: Trench 4 showing structure (404), following the removal of demolition deposit (403). Looking north-west, scale 1m.

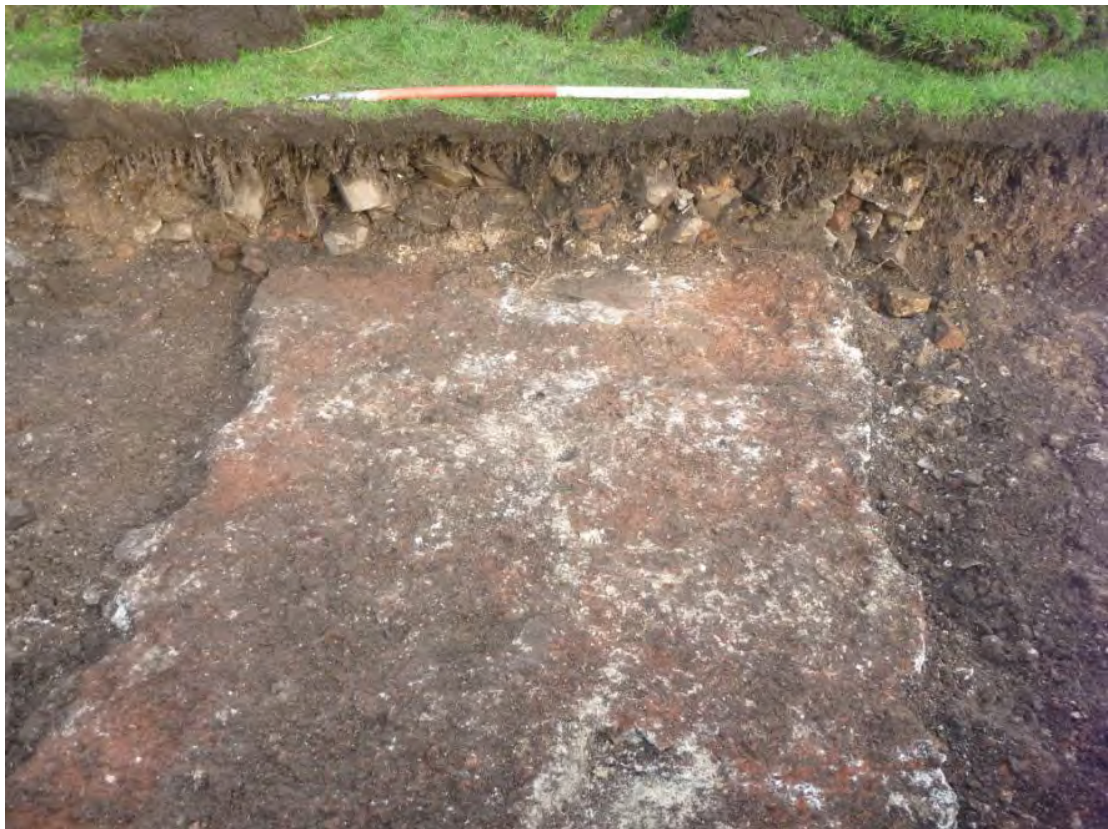
Cut [405] (Plate 14) began immediately beneath the topsoil (401), cutting through (402), and had relatively straight, steep sloping sides. A deposit comprising over 70% sub-angular limestone blocks and brick fragments (403) filled the cut [405]. Fragments of soft lime mortar were occasionally observed within the deposit (403), which was fairly loose with no structure to the limestone and brick inclusions within it. At the base of (403) was a structure (404), comprising a thin layer of crushed brick and lime mortar, aligned north-west to south-east, with a maximum thickness of 0.08m. The structure measured 1.60m in width and continued in length into both the east and west section of the trench and beyond the limits of excavation. The structure appeared to be crudely made, perhaps a foundation base from which to build a wall or a path. Rubble backfill (403) may contain the remains of a structure. At the extreme edges of the structure (404), against the eastern and western section of the trench, one limestone block remained adhered to the crushed brick base at each edge (Plates 15), which may be all that remains *in situ* of the original structure.

Plate 14: Structure (404), Trench 4, showing the construction cut [405] and demolition backfill (403) in section. Looking north-east, scale 1m.

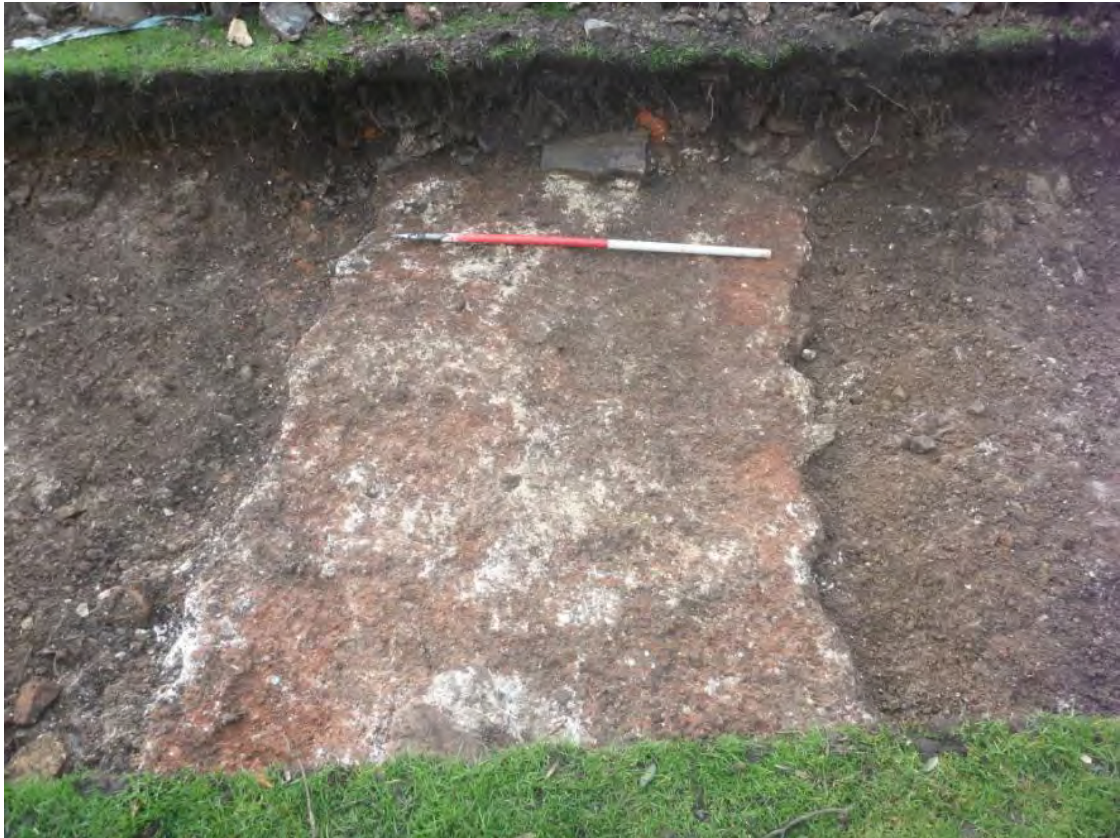
Plate 15: Structure 404, Trench 4. The roughly-shaped stone by the section edge may be the remnants of a wall built off (404). Looking south-west, scale 1m.

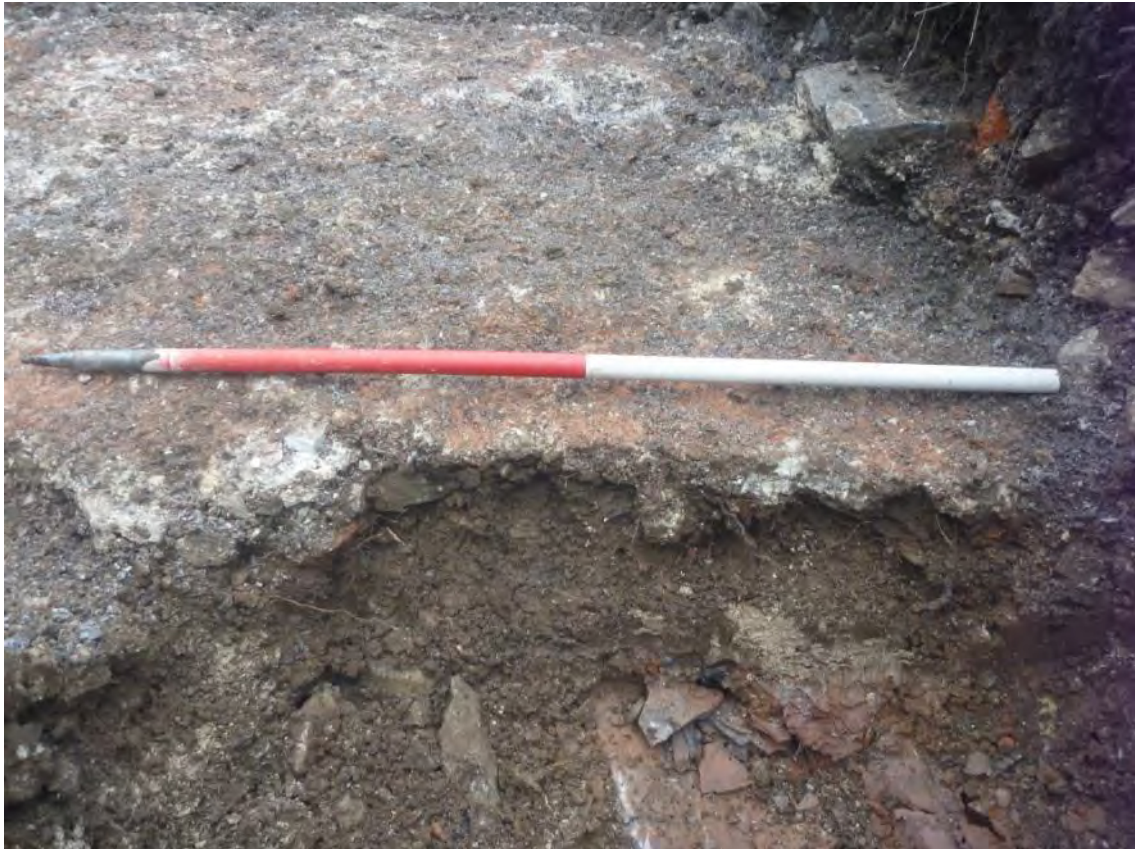
The cut [405] truncated subsoil deposit (407), a mid orange-brown silty clay. Frequent angular and sub-angular cobbles and pebbles of limestone, and occasional roots were present throughout the subsoil. The subsoil was present throughout the trench, with a maximum identified depth of 0.3m. The crushed brick structure (404) was built upon the truncated surface of the subsoil within cut [405] (Plate 16). Bedrock (408) was present immediately

Plate 16: Section through structure (404), Trench 4, showing its thickness. Looking south-east, scale 1m.

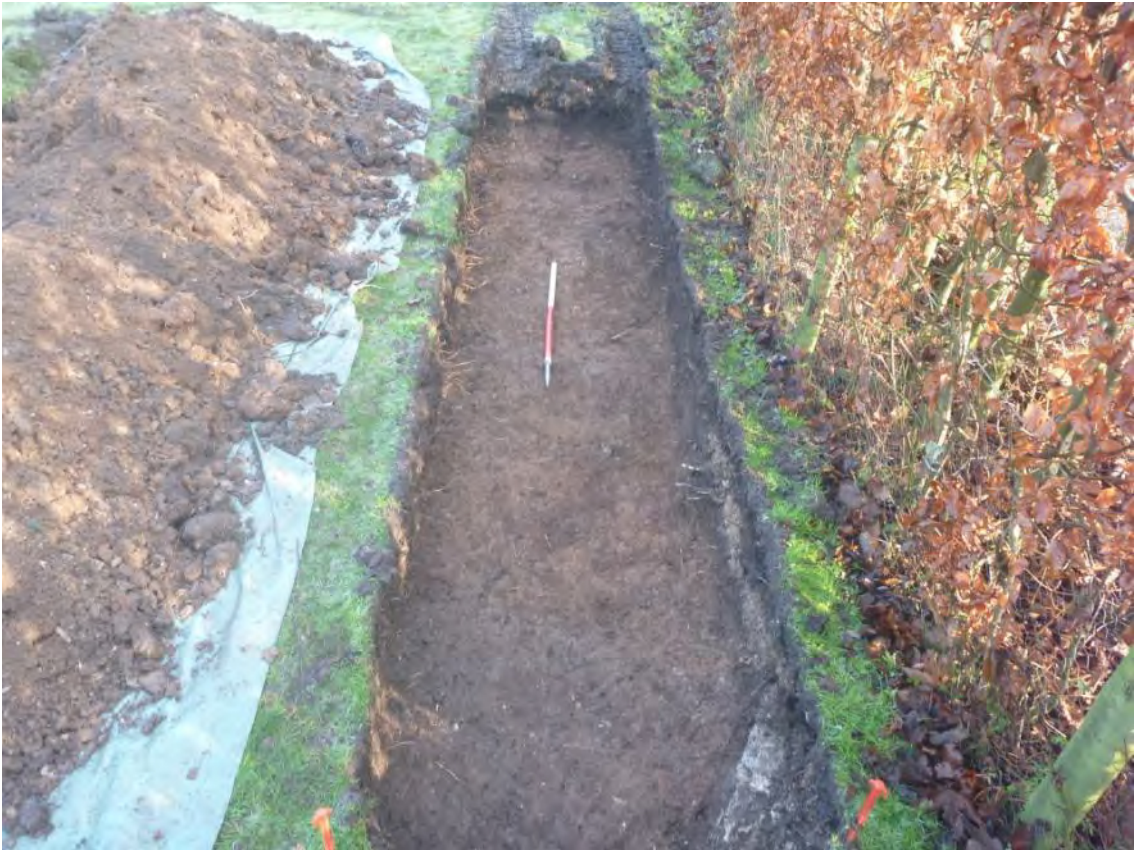
Plate 17: Trench 5, with wall (504) visible in the bottom right of the photograph. Looking north-east, Scale 1m.

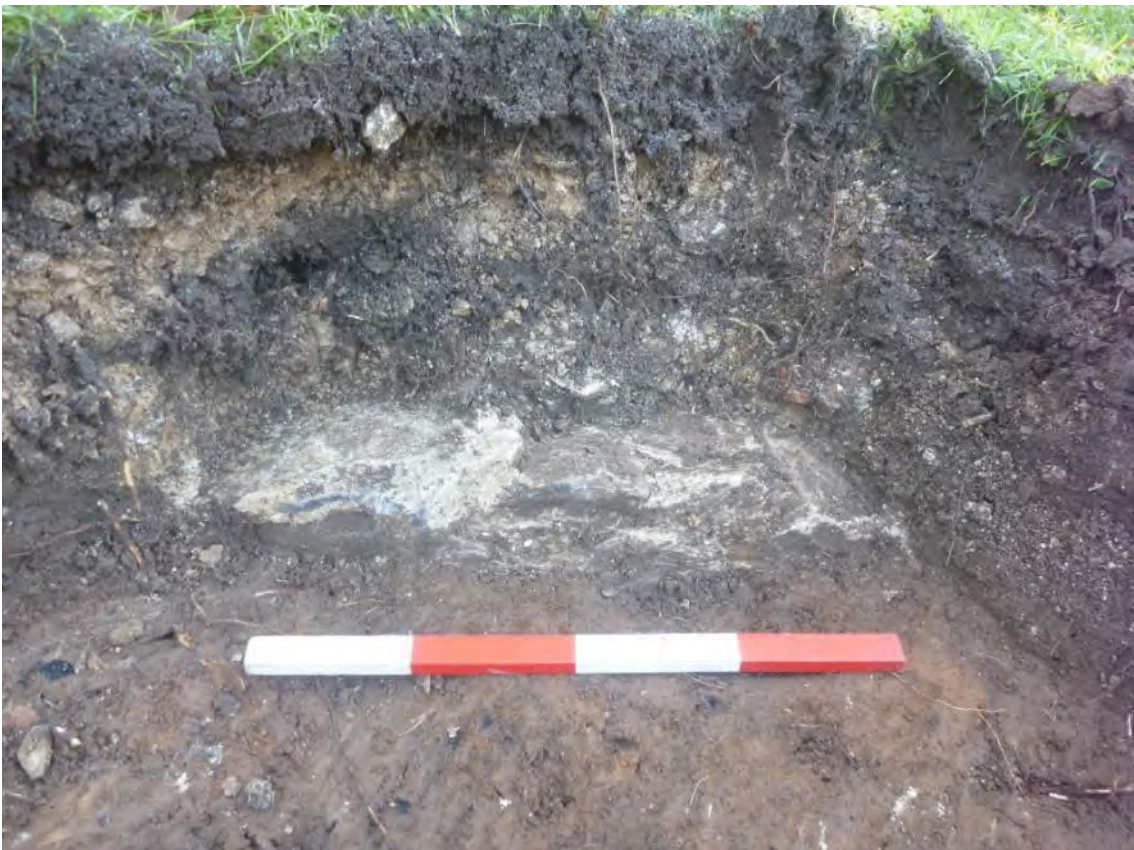
Within the extreme south-eastern corner of the trench was a short alignment of wall (504), (Plate 18) aligned north-east to south-west. The wall was visible for approximately 0.50m along its northern face, and was cut into the subsoil (503). The wall was exposed for a height of 0.1m, although it was not excavated to the foundation base. The wall was constructed out of limestone blocks bonded with white lime mortar.

Plate 18: Wall (504), Trench 5. Looking south-east, scale 0.40m.

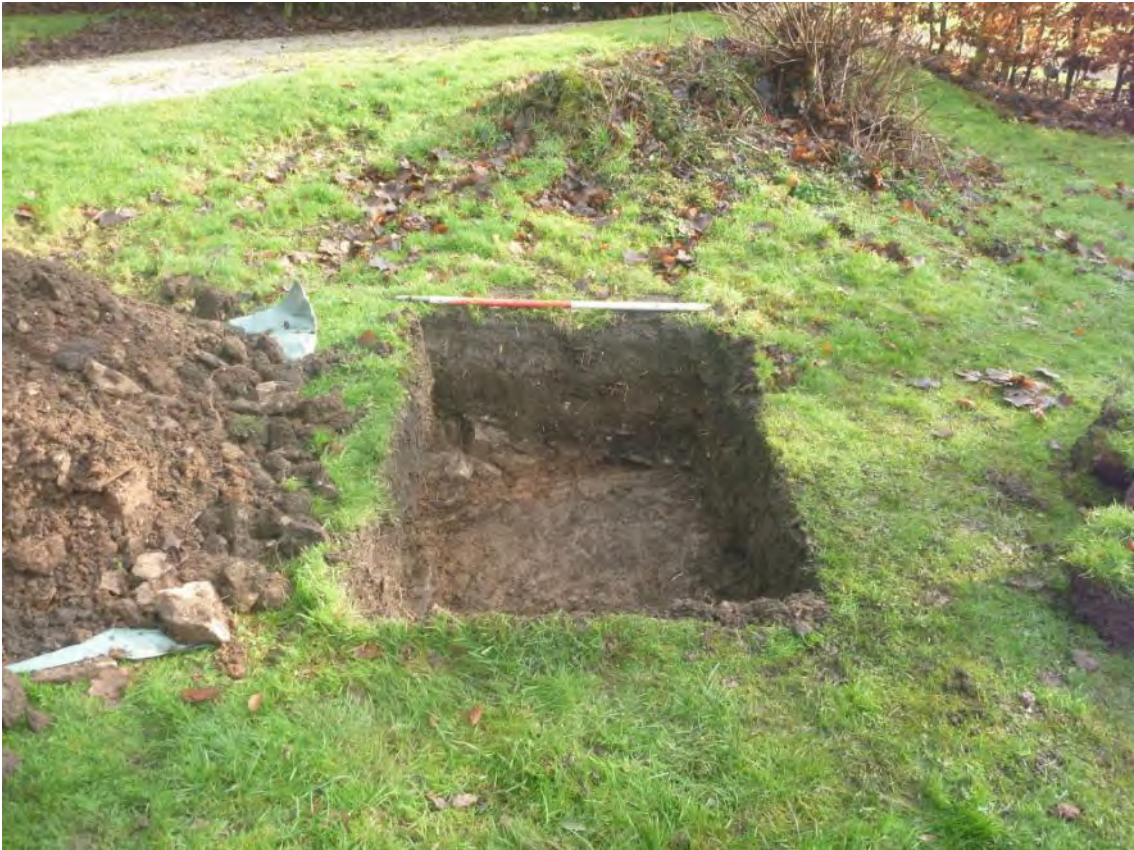
Plate 19: Trench 6, looking south-east. Scale 1m.

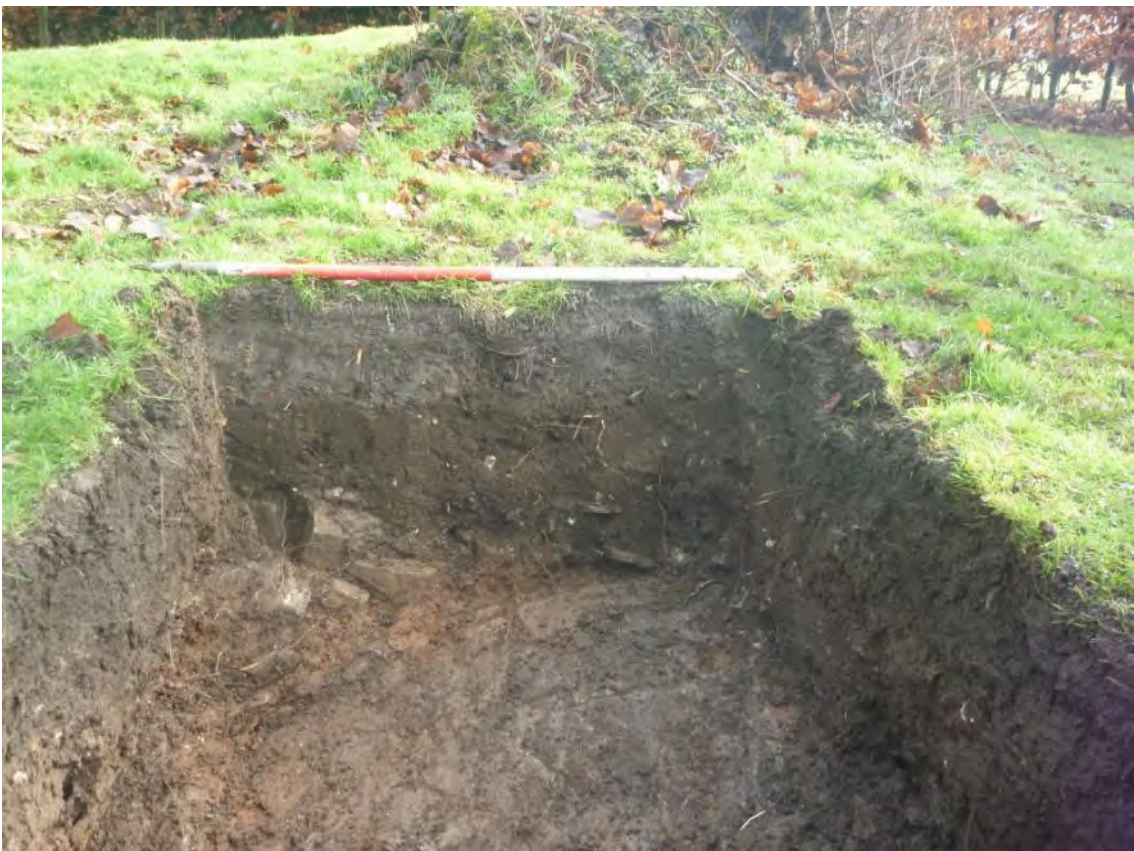
The topsoil (601) comprised very dark brown-grey silty clay with frequent roots and occasional sub-angular limestone and brick fragments. The topsoil was present throughout the trench with a maximum overall depth of 0.42m. Immediately beneath the topsoil (601) was a subsoil deposit (602) of mid orange-brown silty clay. Frequent angular and sub-angular cobbles and pebbles of limestone, and occasional roots were present throughout the subsoil. The subsoil was present throughout the trench, with a maximum depth of 0.2m. The bedrock (603) was present immediately beneath the subsoil (602), comprising solid, horizontally bedded limestone with very occasional pockets of mid-orange brown silty clay between the laminations of stones.

Plate 20: Representative section of Trench 6. Looking south-east, scale 1m.
