Ilam Park, Staffordshire: Archaeological Evaluation

ArcHeritage Report 2017/12
February 2017

**Ilam Park, Staffordshire
Archaeological Evaluation**

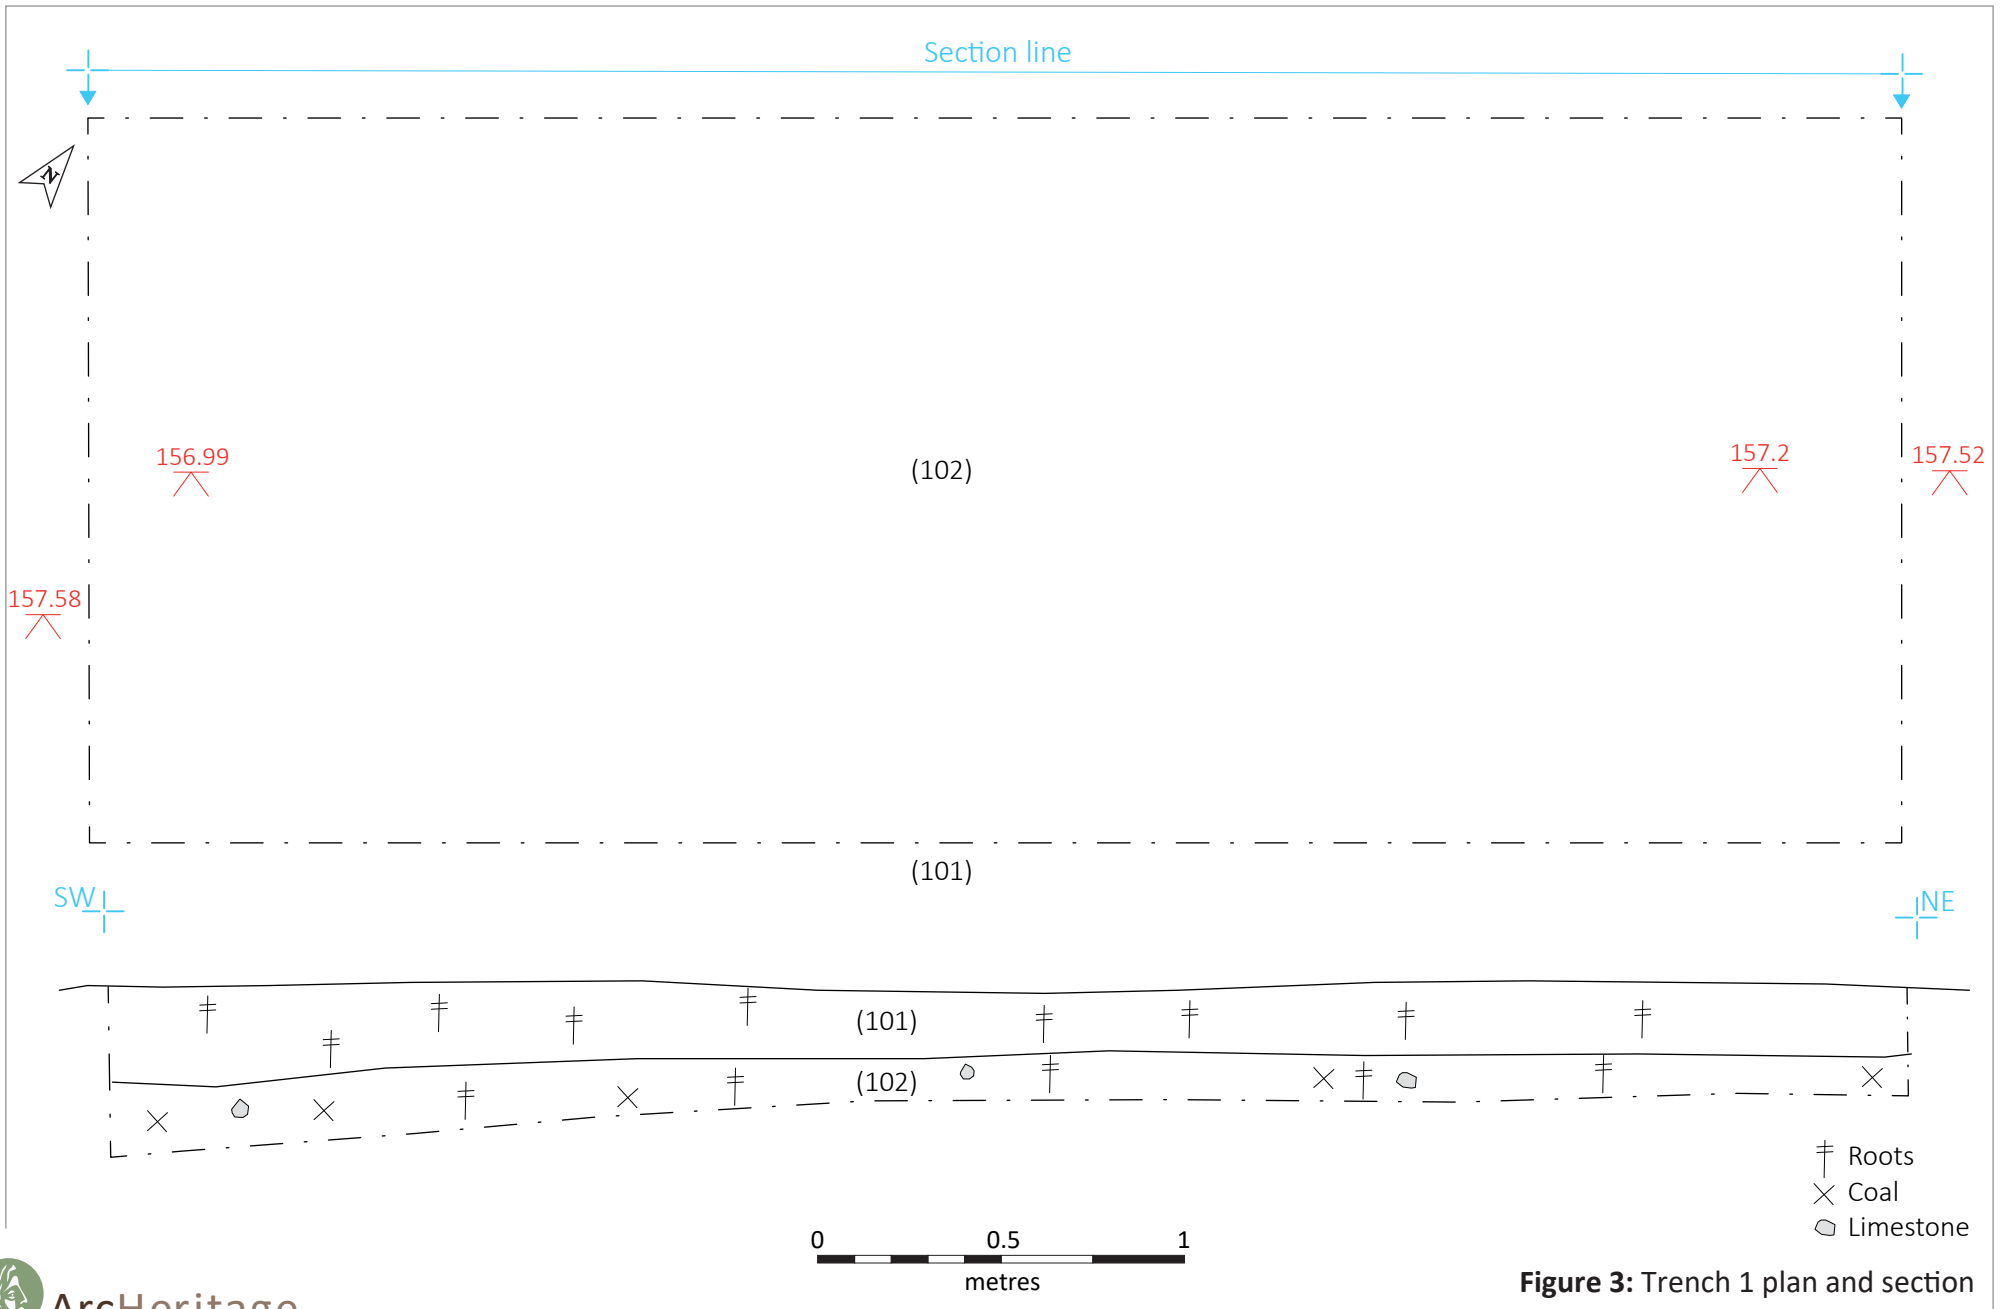
Figure 3: Trench 1 plan and section

Trench 1 (Plates 1-2; Figure 3) was located at the northern end of the site and was aligned north-east to south-west. The trench measured 5m in length by 2m in width and reached a maximum overall depth of 0.33m.

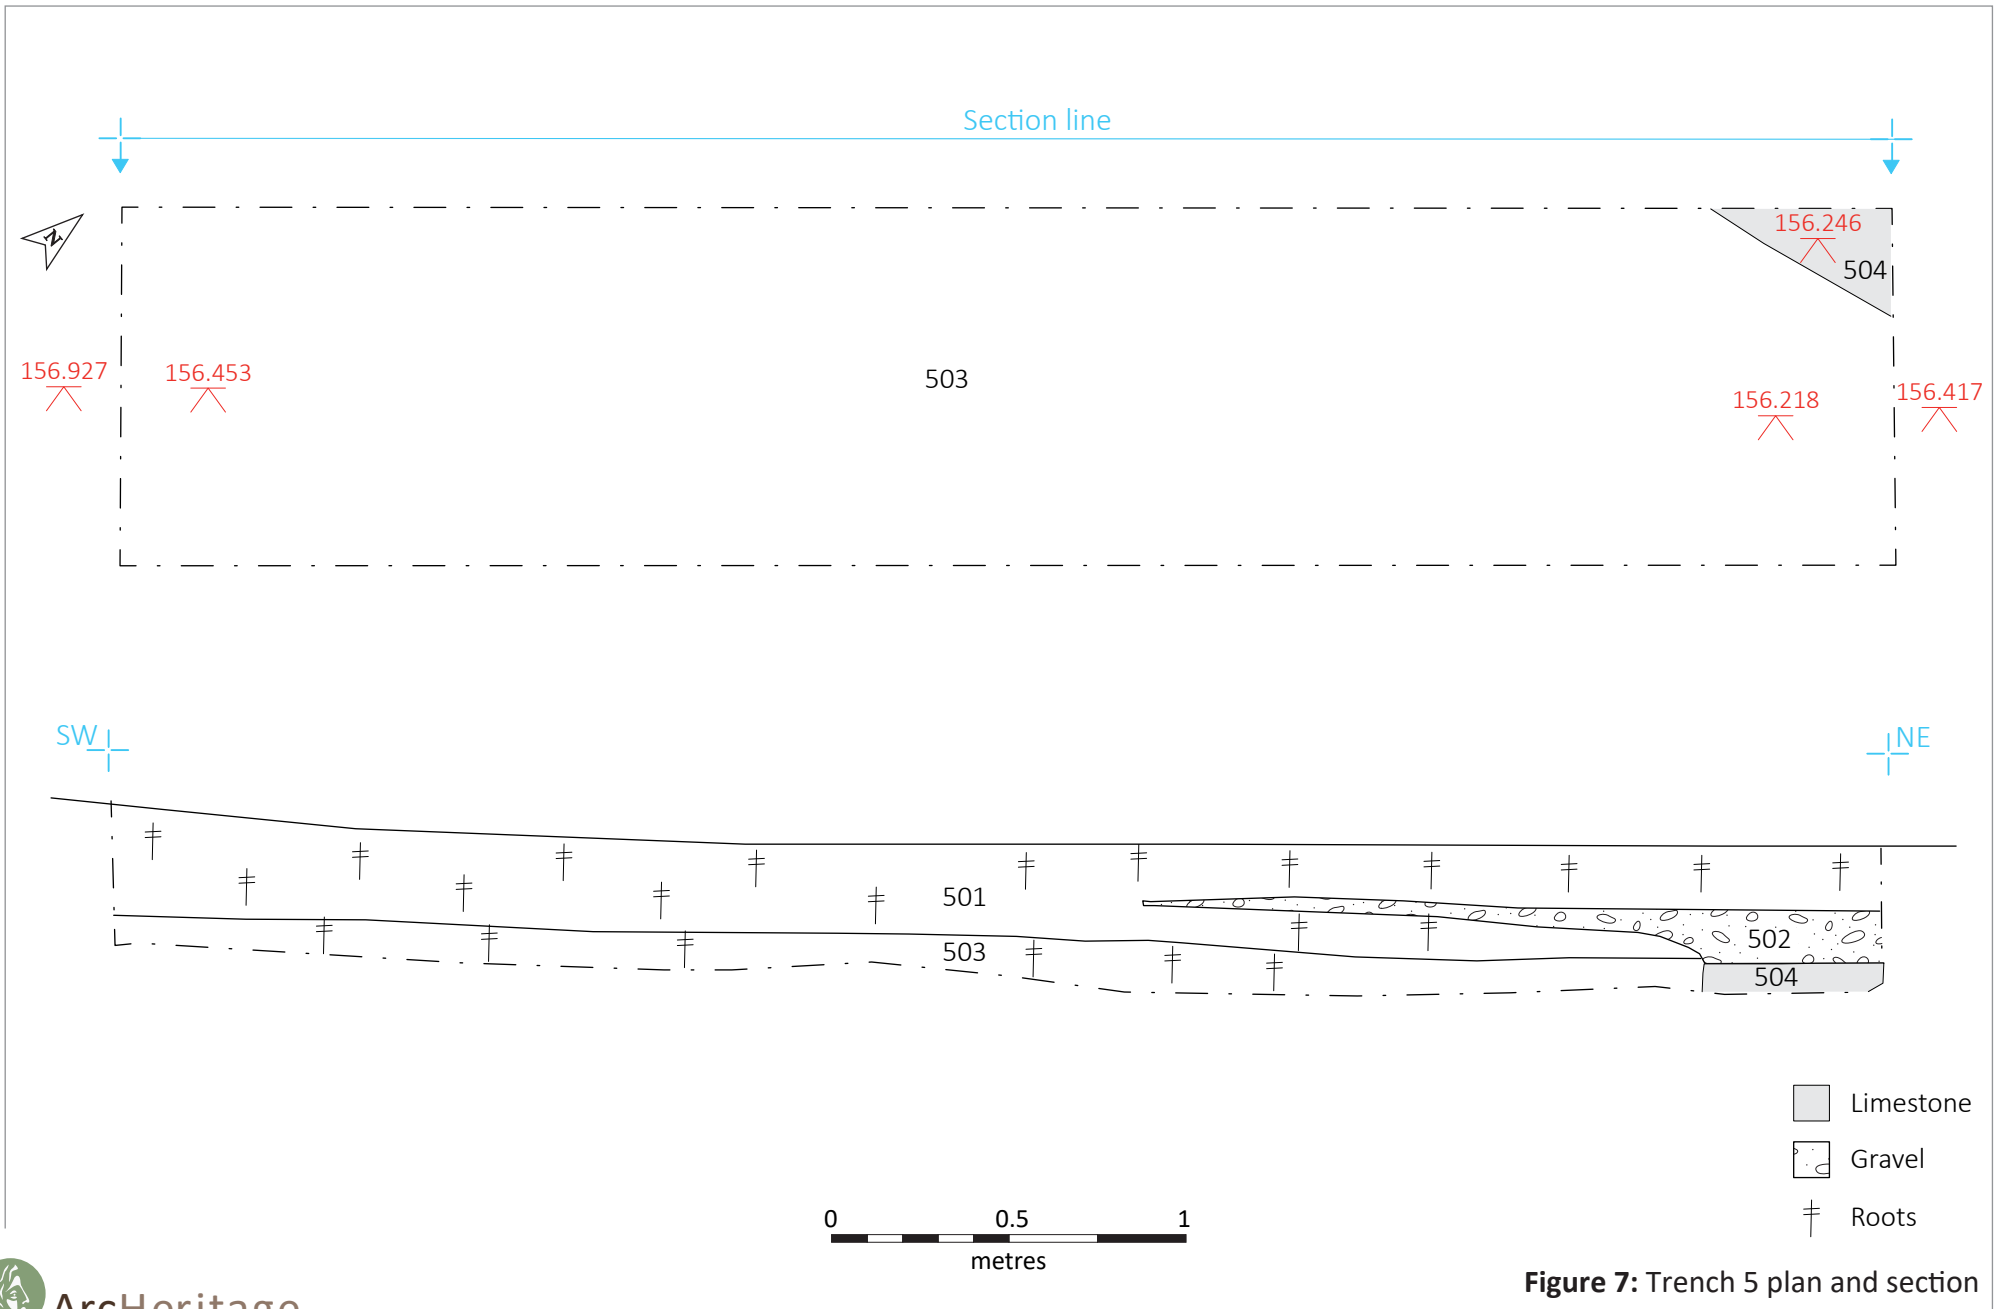
Figure 7: Trench 5 plan and section

Trench 5 (Plates 17-18; Figure 7) was located at the southern end of the site and was aligned north-east to south-west. The trench measured 5m in length by 1m in width and reached a uniform overall depth of 0.5m.

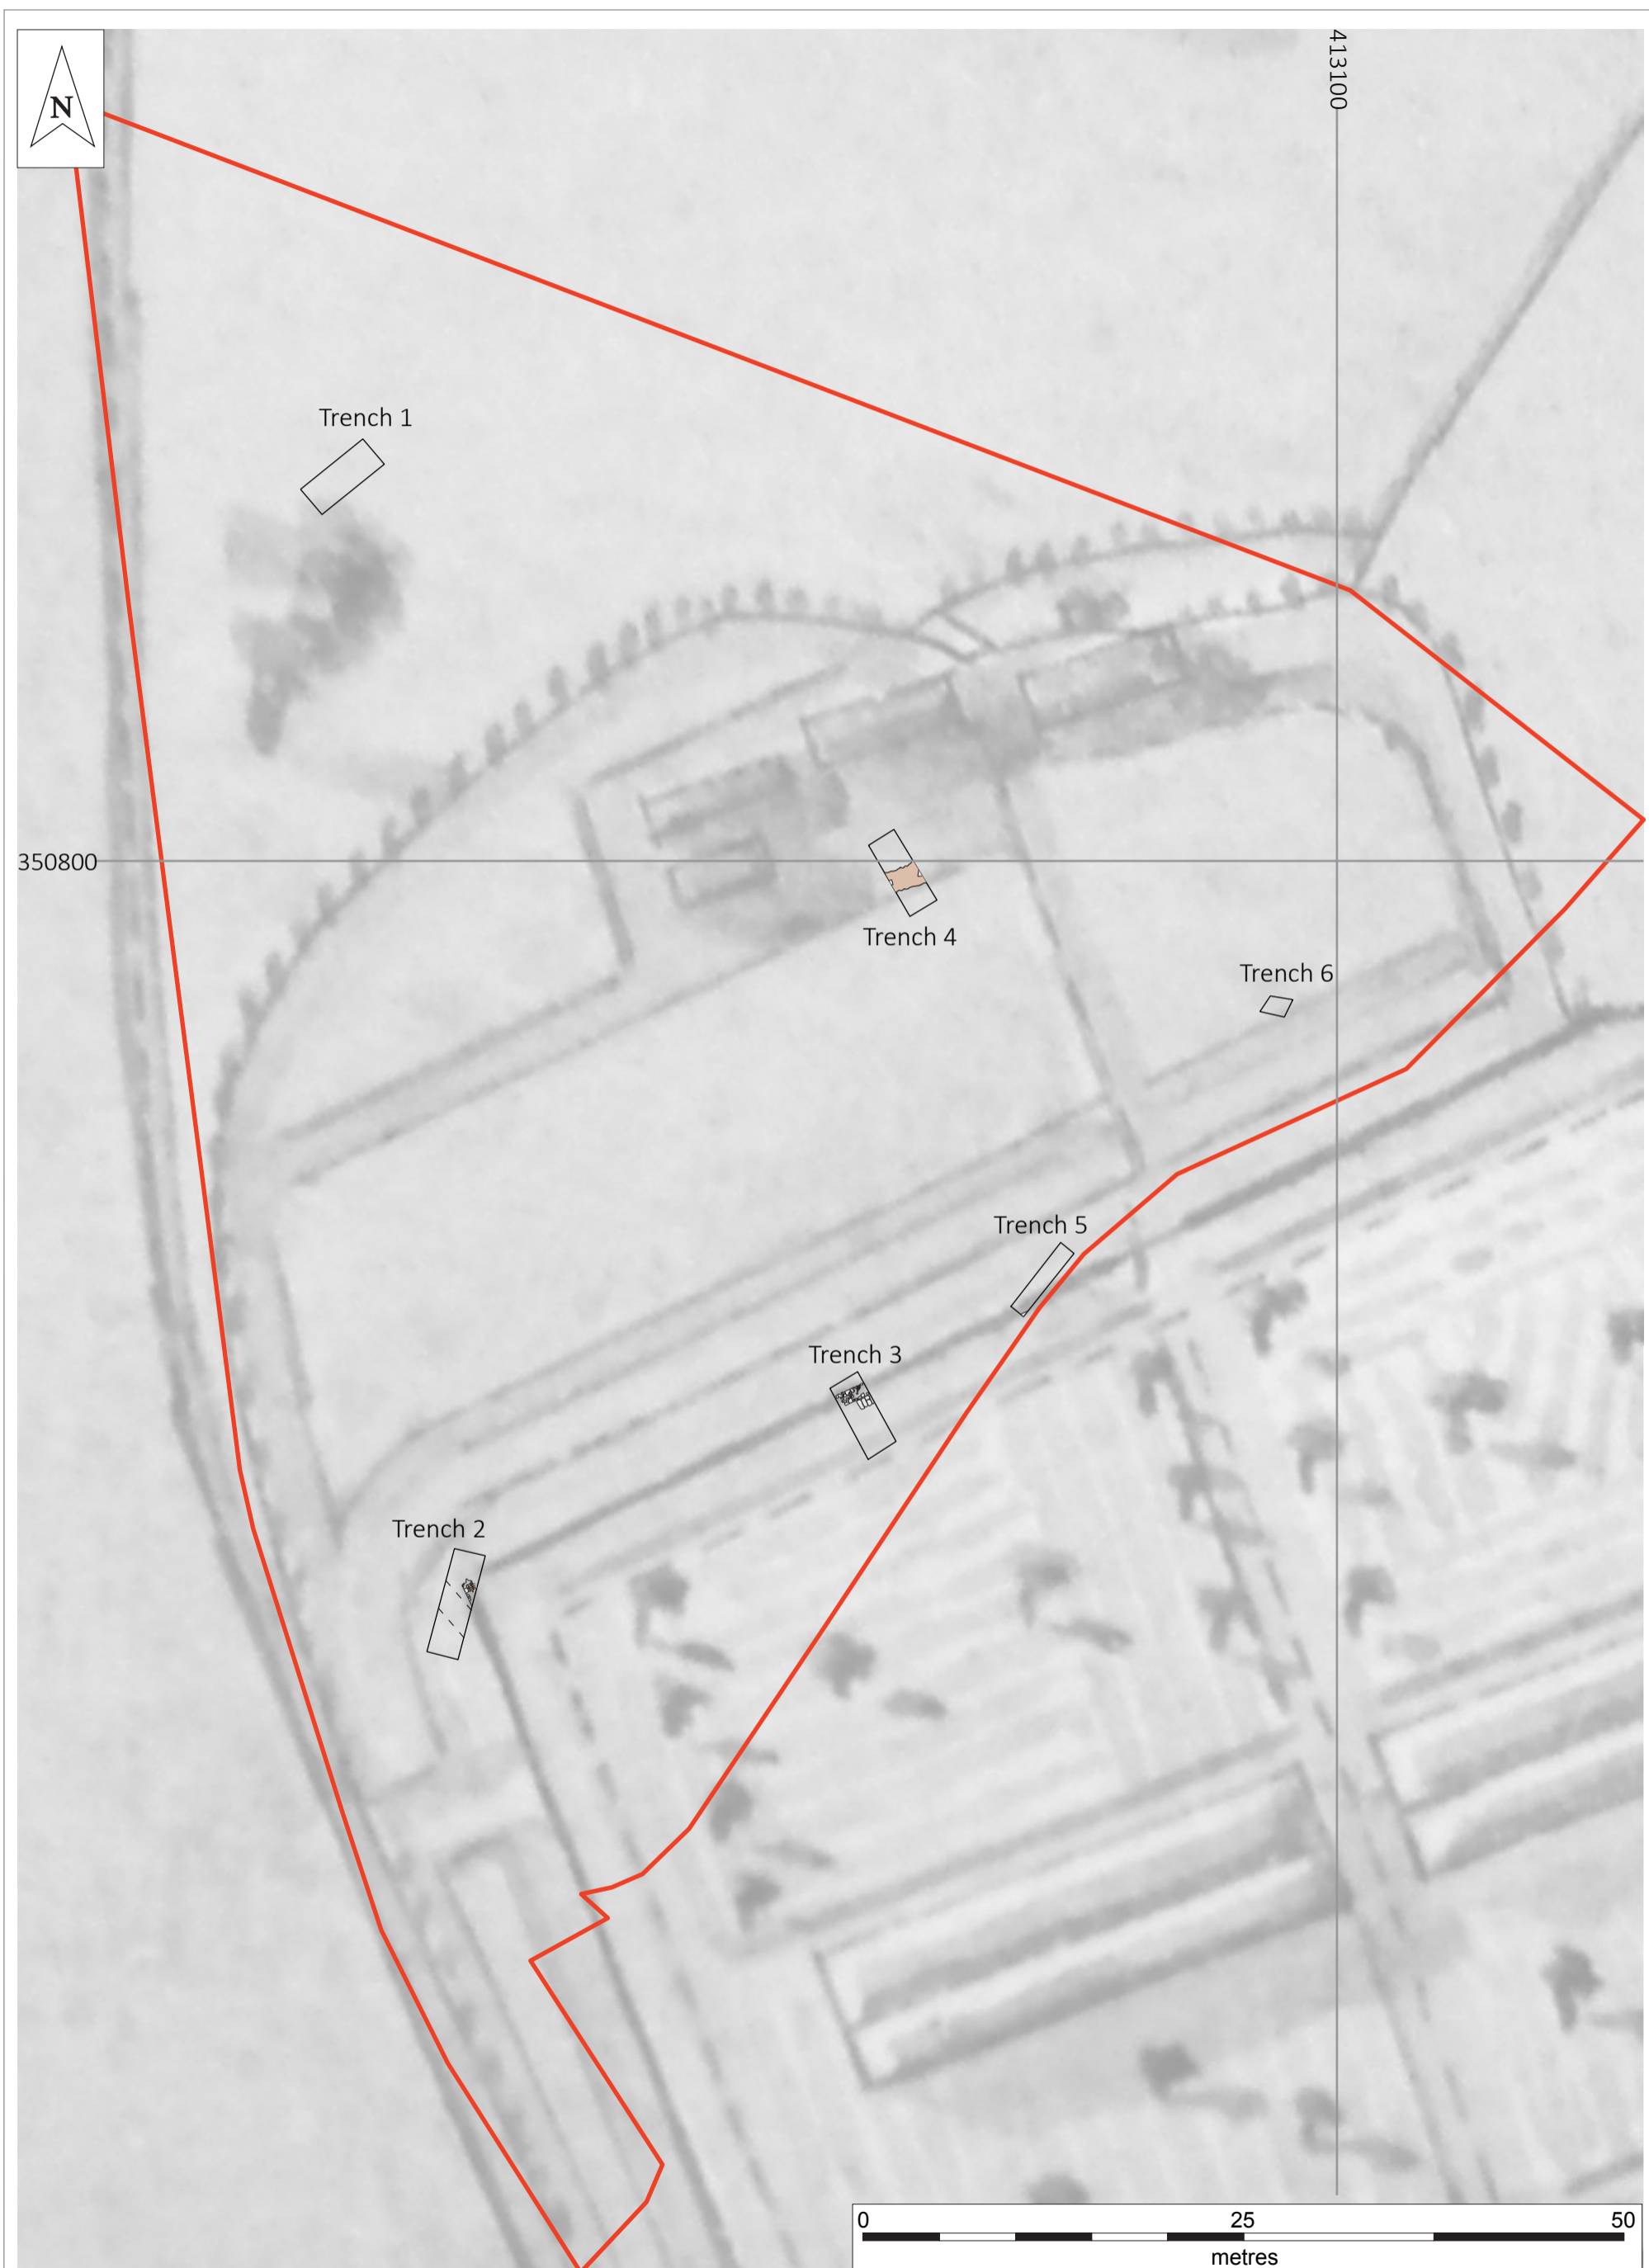
Figure 8: Trench 6 plan and section

Figure 8: Trench 6 plan and section

Trench 6 (Plates 19-20; Figure 8) was located at the western end of the site and measured 1m by 1m. Due to the presence of electricity cable hazard tape upon opening the trench, the trench was relocated to the south-east slightly. This resulted in a 1m by 1m trench with a 0.60m extension with a battered edge of at the north-western end of the trench, to protect the buried cable. The trench achieved a uniform overall depth of 0.55m.
