The Old Smithy,  
Commercial Road, Tideswell  
Historical Building Survey  
ArcHeritage 2017

**Old Smithy, Commercial Road, Tideswell:  
Historical Building Survey**

Project Name	Old Smithy, Tideswell
Report Title	Old Smithy, Commercial Road, Tideswell: Historical Building Survey
Report status	Final
ArcHeritage Project No.	882
Type of Project	Building recording
Client	Hartley Construction
NGR	SK 1534 7577
Planning reference	NP/DDD/0616/0579
OASIS identifier	archerit1-285796
Author	Richard Sheppard and Rowan May
Illustrations	Richard Sheppard and Rowan May
Editor	Anna Badcock
Report Number and Date	2017/40 25/05/17
Version and filename	V1: 882 Old Smithy report v1-2.docx

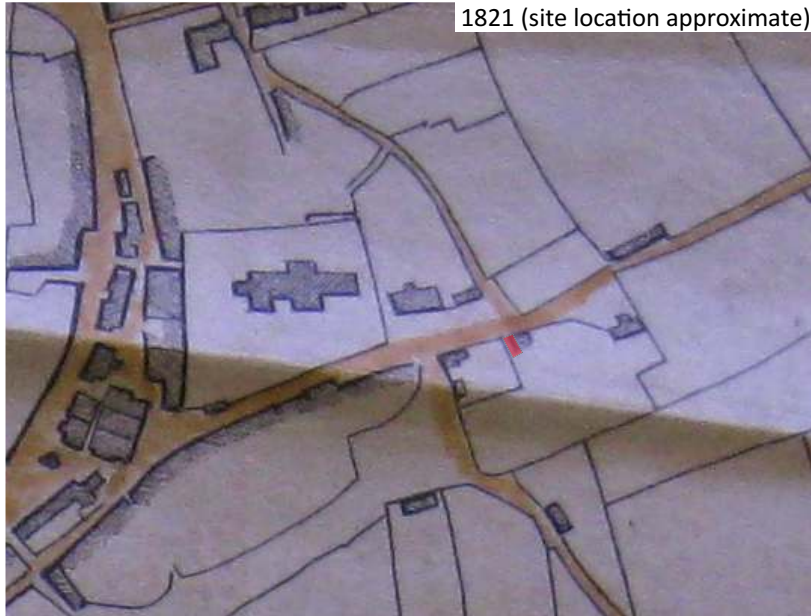
Figure 2: Historic mapping 1821-1922

A building is shown in its approximate location on the 1821 Tideswell Enclosure map. This map was the first to show the village in some detail and it appears that there were relatively few buildings then standing at the north-east end of Commercial Road. The section of the map shown in Figure 2 depicts the church to the northwest of the site and part the Cross Dagers

The First Edition 25 inch to 1 mile Ordnance Survey map of 1880 shows an almost fully developed street frontage, with the Old Smithy building and the present-day cottage to the east (Figure 2). The smithy building is shown as narrower than on later editions of the map and it seems that this may be due to the surveyor exaggerating the (still existing) gap between the building's west side and the neighbouring boundary; later maps actually fail to show this narrow gap.

The building is first indicated as a smithy on the 1922 Ordnance Survey map (Figure 2); however, records suggest that the building was first used as a smithy in the late 19<sup>th</sup> century, with both it and the cottage to the east appearing to have been associated with the Sellers family (also spelt Sellars). As late as the 1960s, the smithy was being used by blacksmith Joe Sellers (born c.1896), photographs of whom are shown here in Plates 2 and 3 (from Hill, 2007). He had followed the same trade as his father Leonard (born c.1870), who is listed as a blacksmith on Commercial Road in the censuses of 1891 and 1901. In the former, he is listed as living at the same abode as his father Joseph (born c.1834), a shoemaker, and his mother Mary. This is likely to have been the adjacent cottage, where the later Joe and his family are known to have lived. According to Hill (2007), Leonard Sellers learnt his trade from Fred Lomas, a blacksmith based at the Peacock Inn buildings on Queen Street. This is mistaken, for Leonard will have learnt his trade from Fred's father Robert Lomas (born c.1854), listed in 1891 as blacksmith and publican of the Peacock Inn, Ash Lane; the 1898 map shows a smithy that he is likely to have used. In 1891 Tideswell had six blacksmiths in all. In 1881, Lomas was living close-by on Church Street, and it is possible that he was then using the Commercial Road smithy that his apprentice Leonard Sellers later took over.

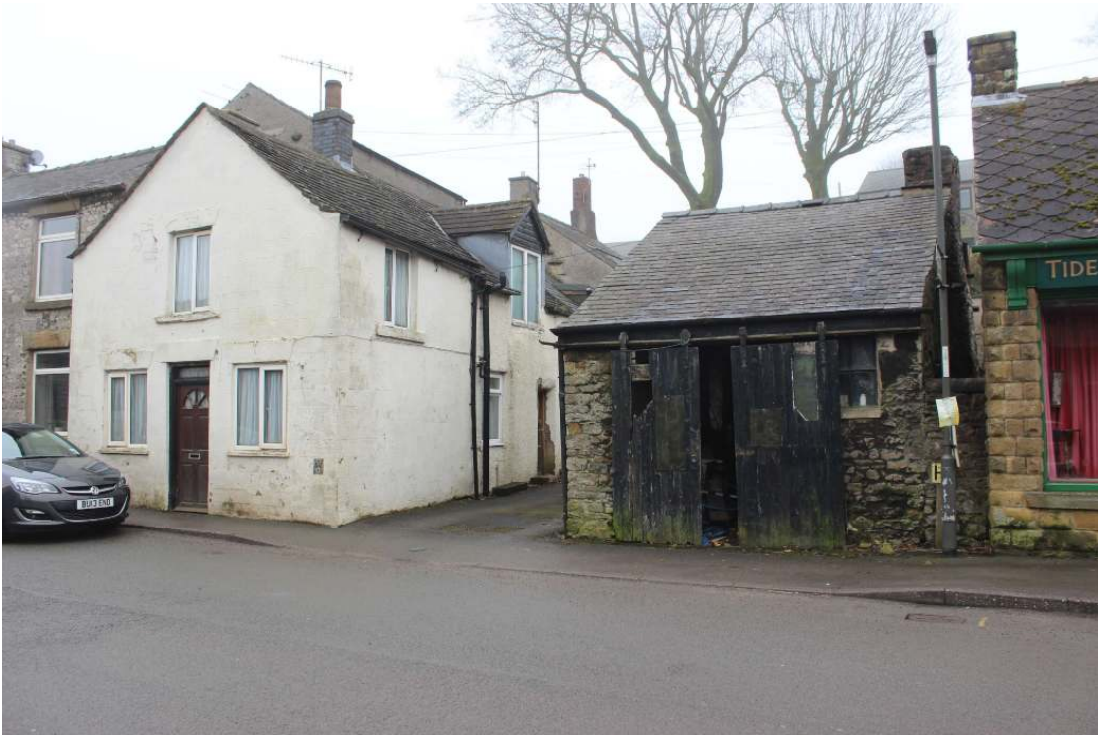
On the north street frontage there is a pair of sliding doors of differing width and a small window to the side (Plates 5 and 6). On the east side facing the cottage there are two wooden-framed windows. The first from the road, a 6-pane window, has been put into a former doorway, infilled below the window sill (Plate 7). The second 16-pane window appears to have replaced a shallower opening which may have housed shutters to help alter lighting and air flow to the hearth behind it. This is suggested by shoulders on the recessed side walling on the interior (Plate 13). The south side has a centrally-placed pair of 6-pane windows (Plates 8, 9), whilst the west side is an unbroken wall with a very rough exterior (Plate 10). The building has a very limited curtilage comprising a small yard area to the rear, the west part of which is raised, and to the side a narrow yard shared with the adjacent cottage.

Plate 5: Frontage of the former smithy and the owner's cottage on Commercial Road

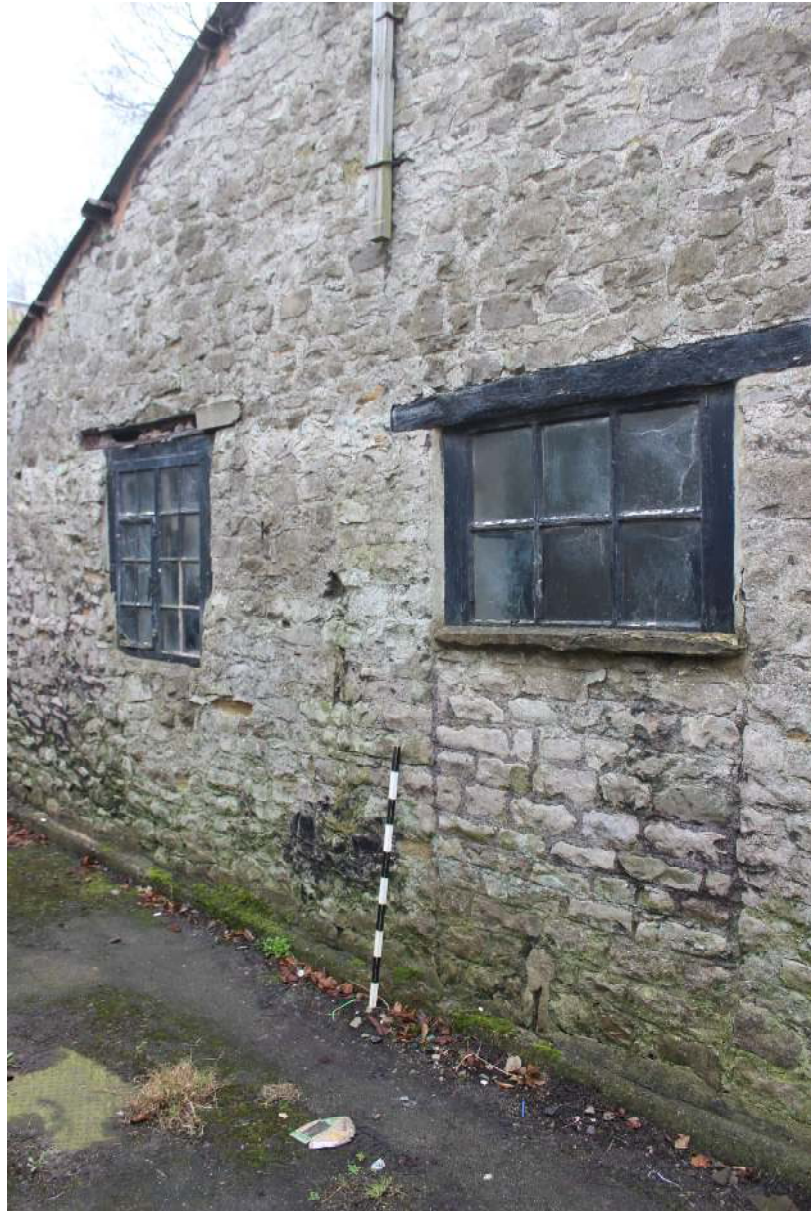
Plate 7: Enlarged window to left and, to right, a partly infilled former doorway in the east elevation

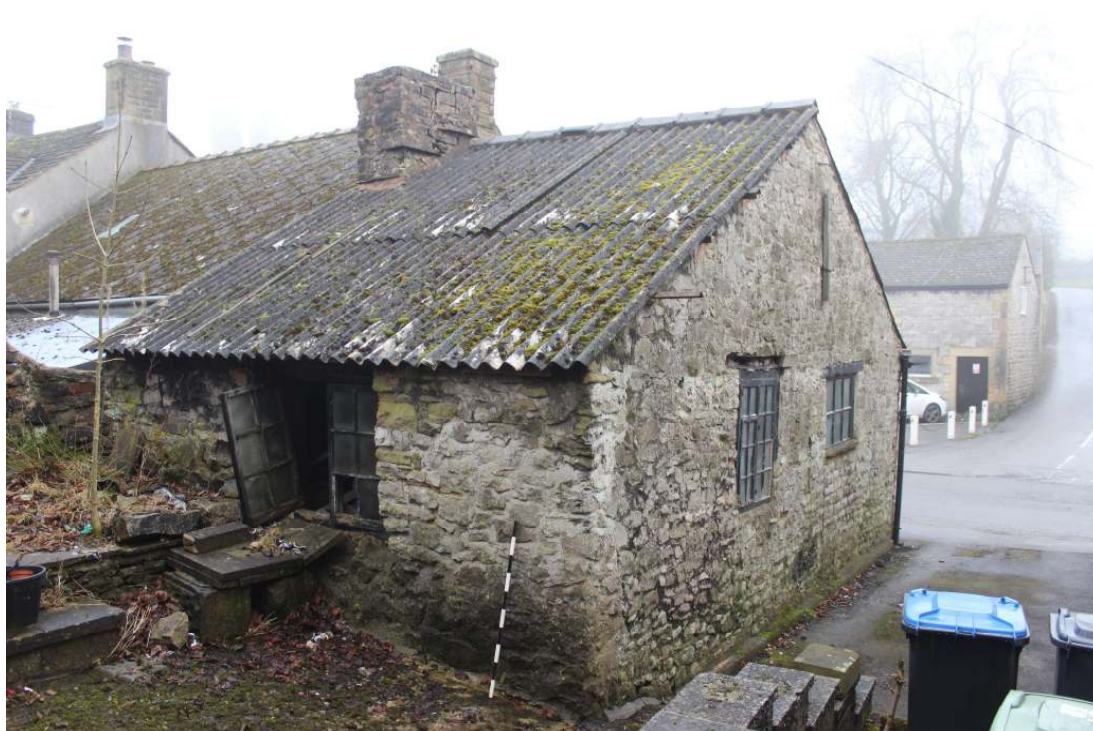
Plate 8: East and south sides, together with a view of the roof and chimney

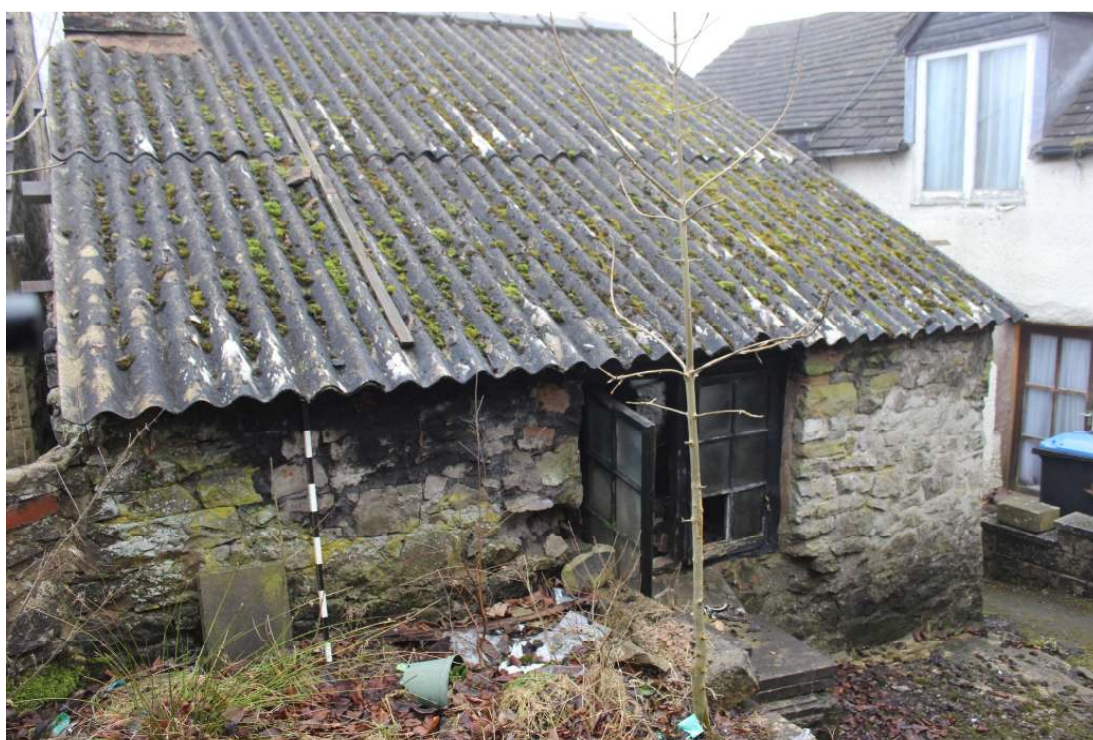
The original size of the hearth is similar to that found in Llawr-y-glyn Smithy (now re-erected at the Welsh Folk Museum), which is thought to have been capable of being used for the heaviest work such as the heating of tyres (Williams-Davies 1991, 22). A platform 45cm (1½ft) high is visible in the Tideswell smithy's rear yard on the south side of the building, next to the window (Plate 9). This is where tyreing may have taken place, with wagons entering the yard area from Church Lane. Two stone blocks by the window may have been used for this purpose.

Plate 9: South side with external raised platform in foreground

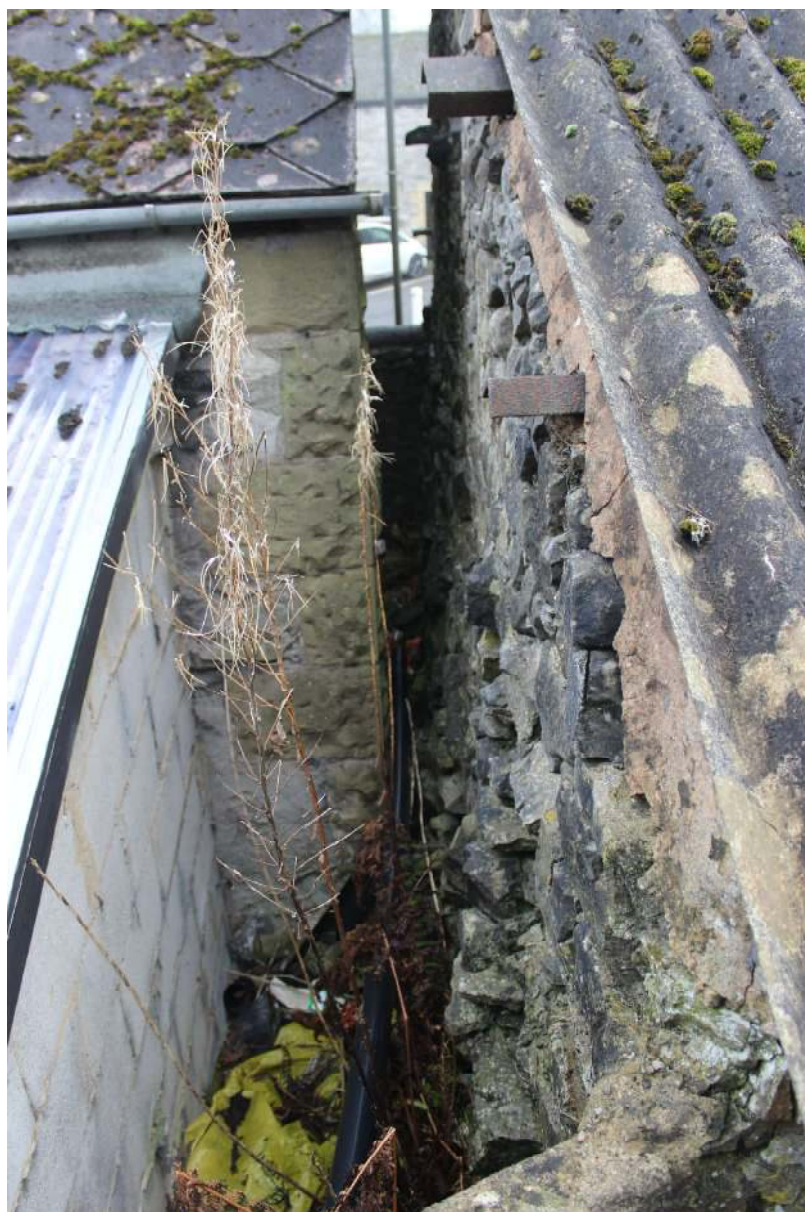
Plate 10: Roughly faced walling on the west side, with a narrow gap to the neighbouring property

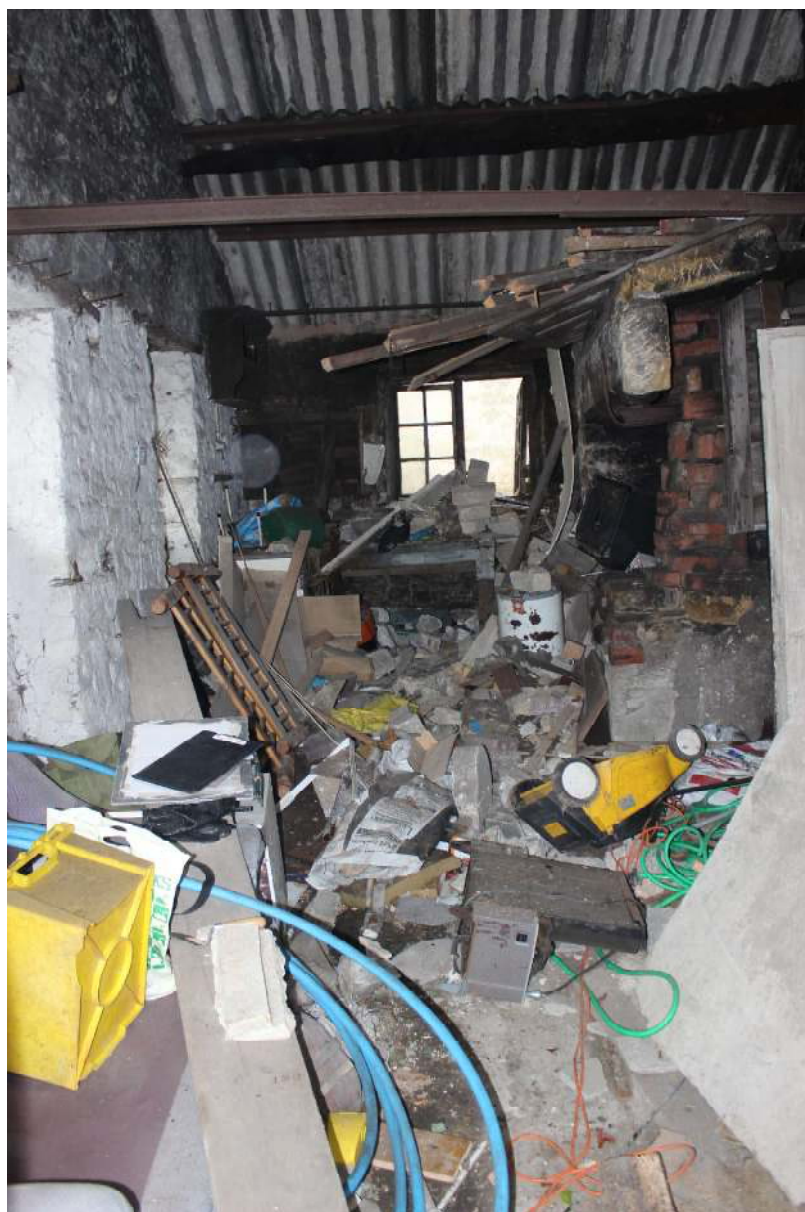
The site was visited on the 15<sup>th</sup> February 2017. The building was recorded by photography and measured drawings, within the constraints of being found to contain a quantity of discarded domestic and timber materials (Plate 11). Areas of the interior found to be inaccessible because of this are shown on the site plan (Figure 4). This report provides a detailed site plan at a scale of 1:50, together with modifications to the existing architect's long axis through-section and east elevation drawing (at the same scale).

Plate 11: The debris-filled interior of the former smithy, as found in February 2017

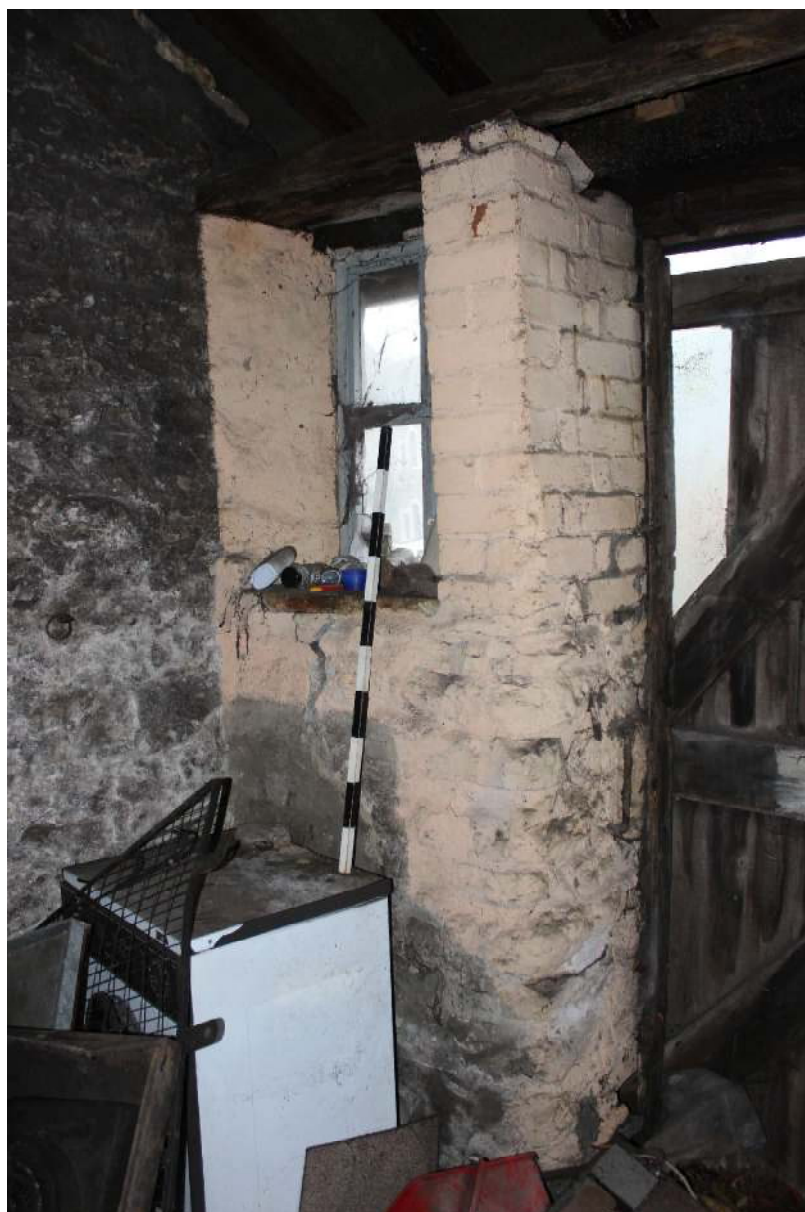
The Old Smithy is a single-storey structure of local limestone random rubble construction, with a small repair of brickwork on part of the north wall (Plate 12). It has a pitched roof with Welsh slates on the north side and corrugated iron on the south side. A stone chimney rises above the roof from the back wall (Plate 8). The building is of irregular plan and is set on a gentle slope, with the land rising more steeply behind the rear yard (see Figures 4 and 5). It is 8.2m (27ft) long and tapers from a width of 4.85m (16ft) at the south end to 4.25m (14ft) at the north end. The walls vary in thickness between 45-60cm (1½-2ft) and internally the building workspace averages a length roughly twice the width. A functional two-unit plan is reflected in the flooring; this is discussed further below.

Plate 12: Internal walling by main entrance

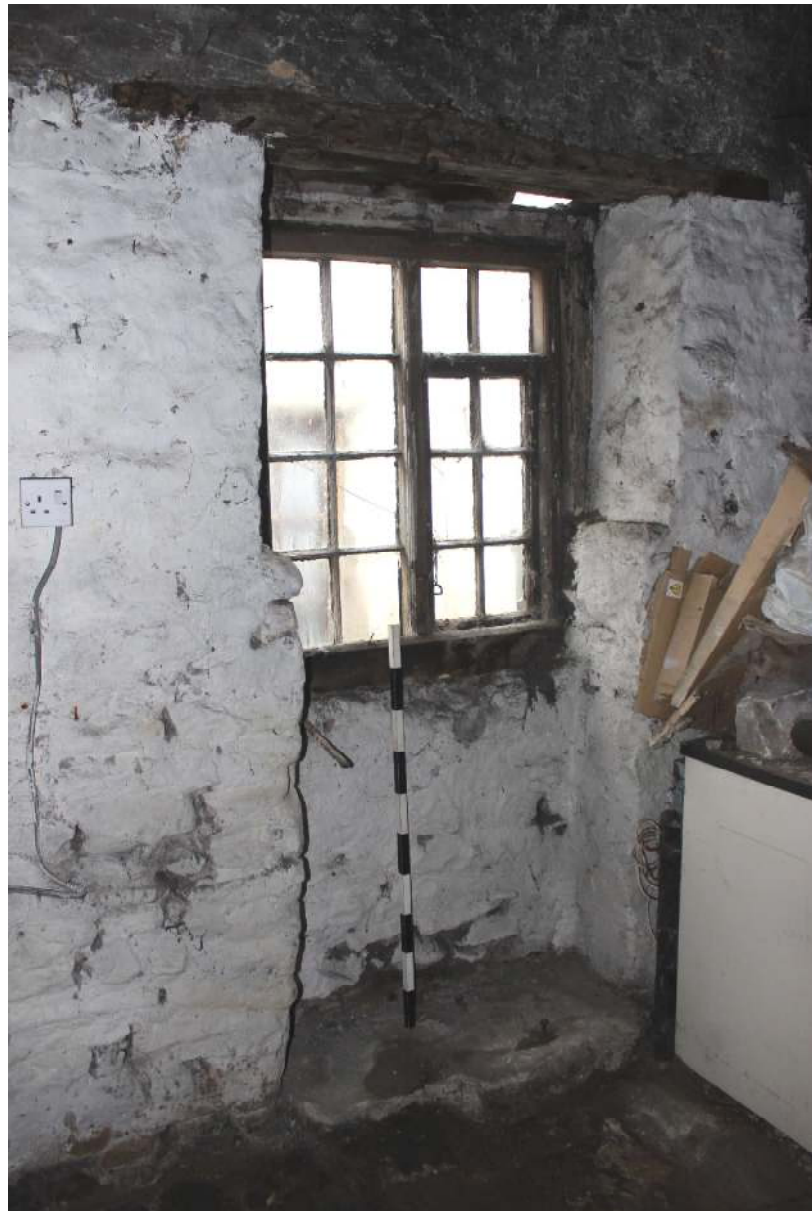
Plate 13: Recessed window opening with shoulders for former high window

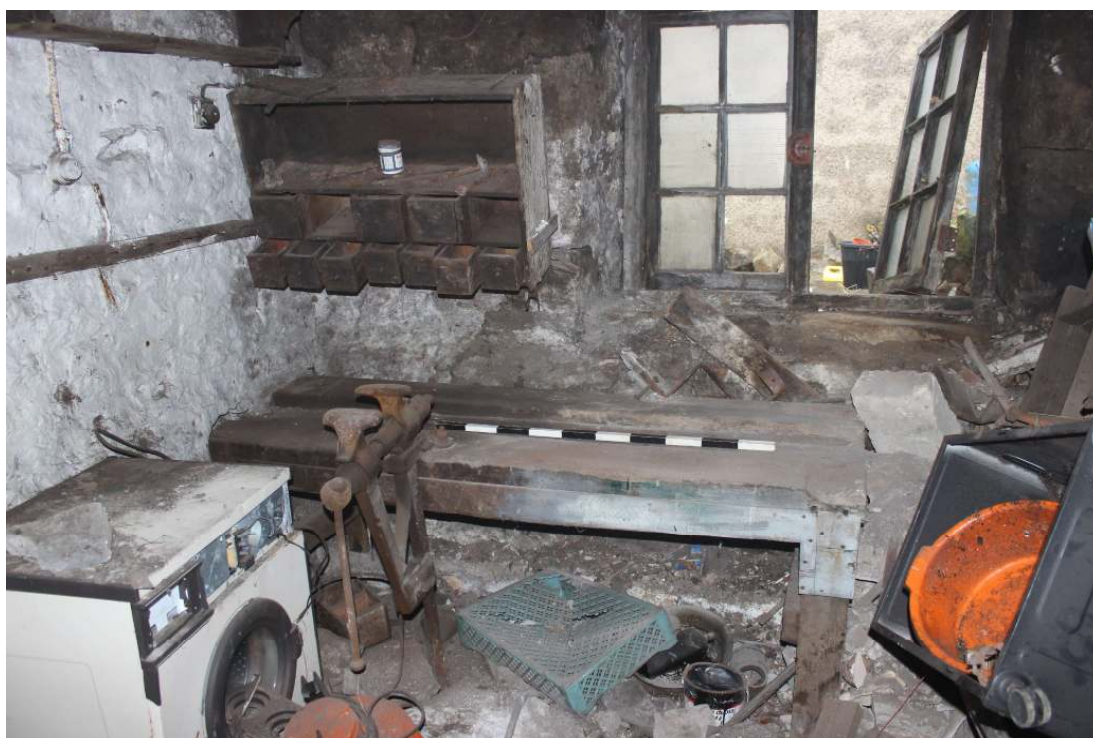
The interior of the building was found to still retain the blacksmith's hearth, a work-bench, some shelving and much of the flooring. The work-bench is 1.8m (6ft) long and still standing in the southeast corner with some shelving for tools and materials above and on the side wall (Plate 14). An attached vice has a leg to provide stability and allow for heavy work.

Plate 14: Work-bench with attached vice and shelving above

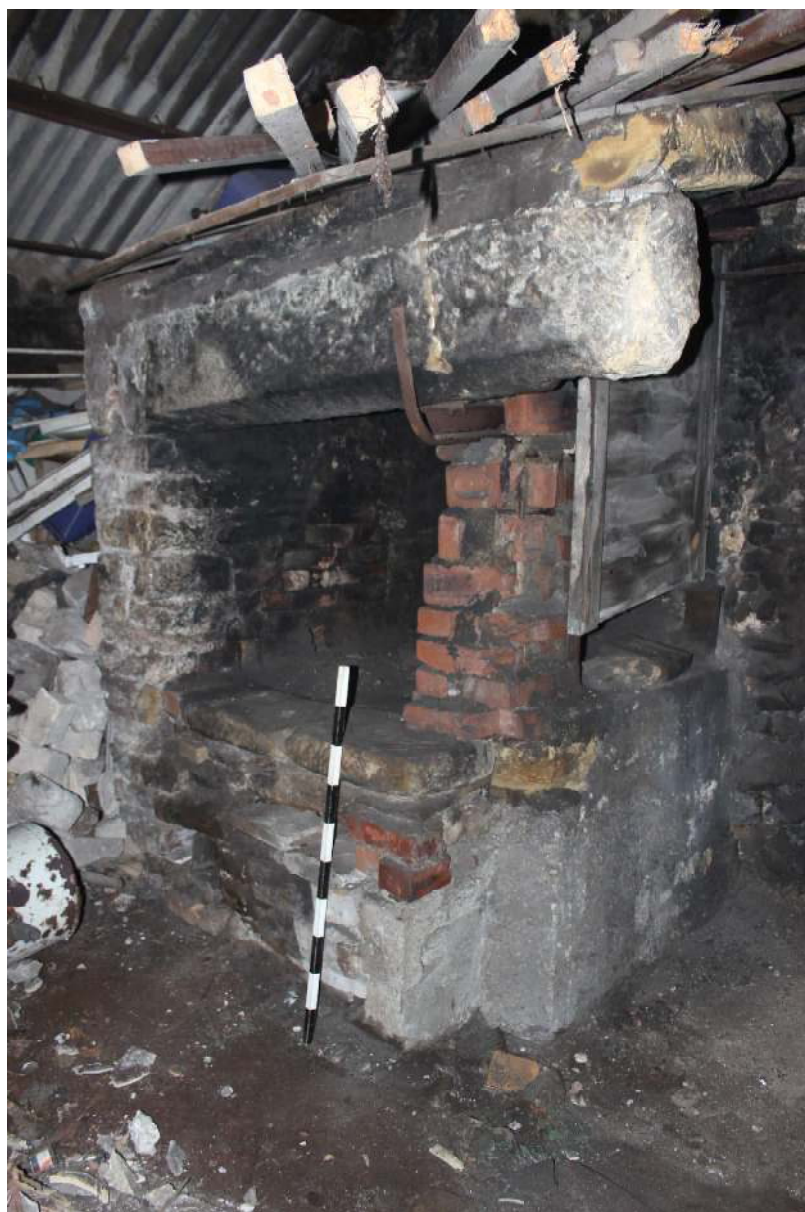
The single hearth projects out from the east wall and a flue rises behind it to a chimney above. The hearth is built from both stone and brick, with re-used architectural pieces framing the top and base of the opening (Plate 15). One of these re-used pieces appears to be the long lintel of a fireplace and it is possible these fragments came from a demolished nearby building. The hearth was originally longer, as shown by a dark stain on the west wall (Plate 16). With a width of 1.35m (4½ft), the length was reduced from 2.25m (7½ft) to 1.5m (5ft). The presence of a roughly-made brick pillar, along concrete and timber boarding at the sides, suggests that the north end of the hearth had probably collapsed. This had evidently occurred during the smithy's use, as in Plate 3 Joe Sellers can be seen standing beside the shortened hearth. A roughly-hewn opening in the back wall reinforces the impression that the hearth was not of the finest construction (Plate 17). It is not evident where the bellows would have been situated.

Plate 15: Hearth, showing reused stone lintel and support brickwork

As a redundant building, it is only fitting that it has now found a new use as a holiday let. The interior in particular will need to be redesigned for modern convenience. It is of interest that the hearth contains several architectural pieces, including what appears to be a long lintel to a fireplace. These pieces have evidently been recycled from elsewhere and it is possible that they came from either the nearby Cross Daggers public house, a 17<sup>th</sup>-century building that burnt down in 1937, or the King's Head Inn, demolished in 1958. It might be worth considering a further re-use of one or more of these pieces within the new interior.

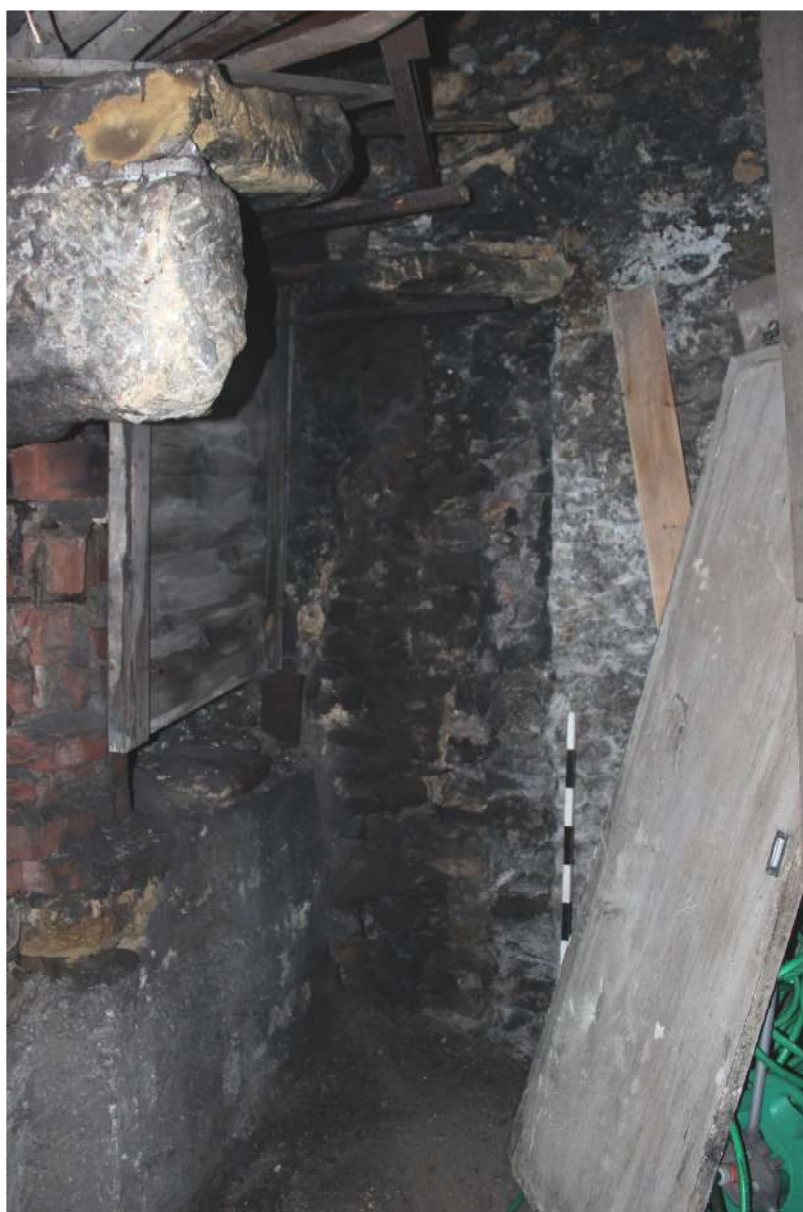
Plate 16: Dark stain on wall indicating the original extent of the hearth

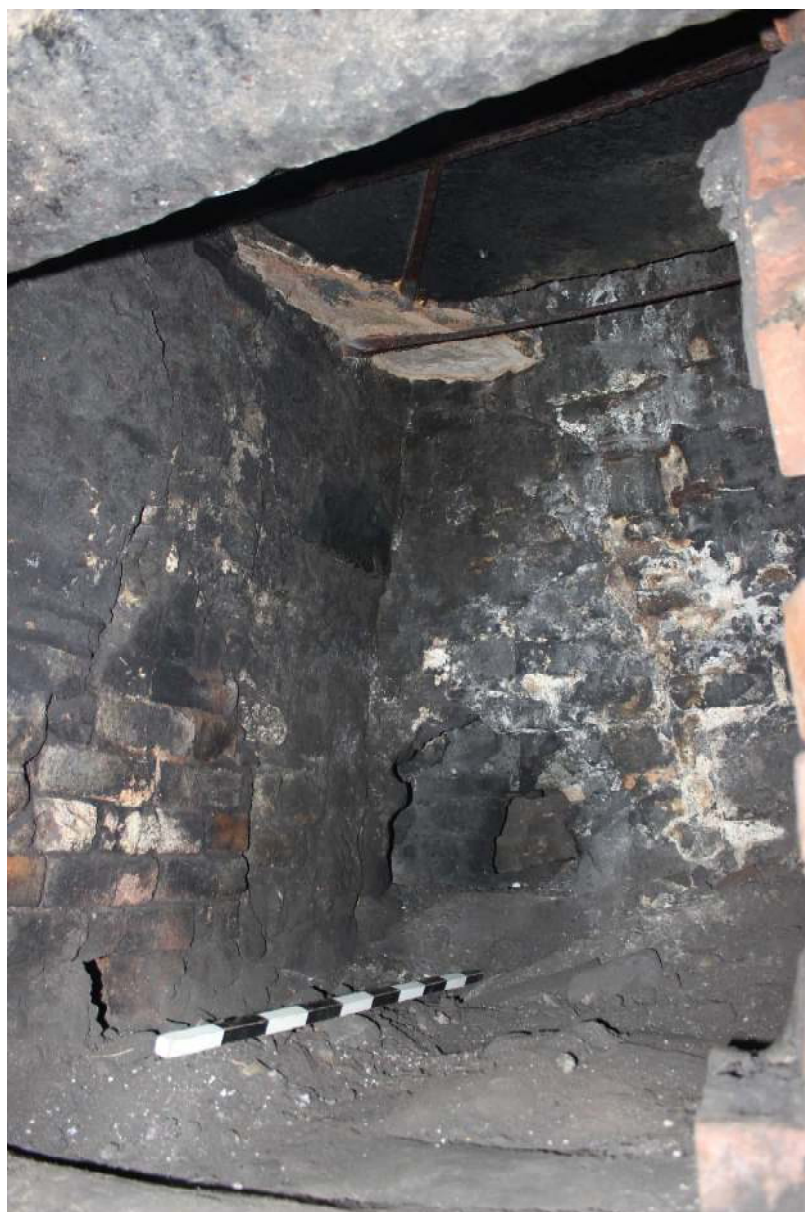
Plate 17: Inner view of hearth

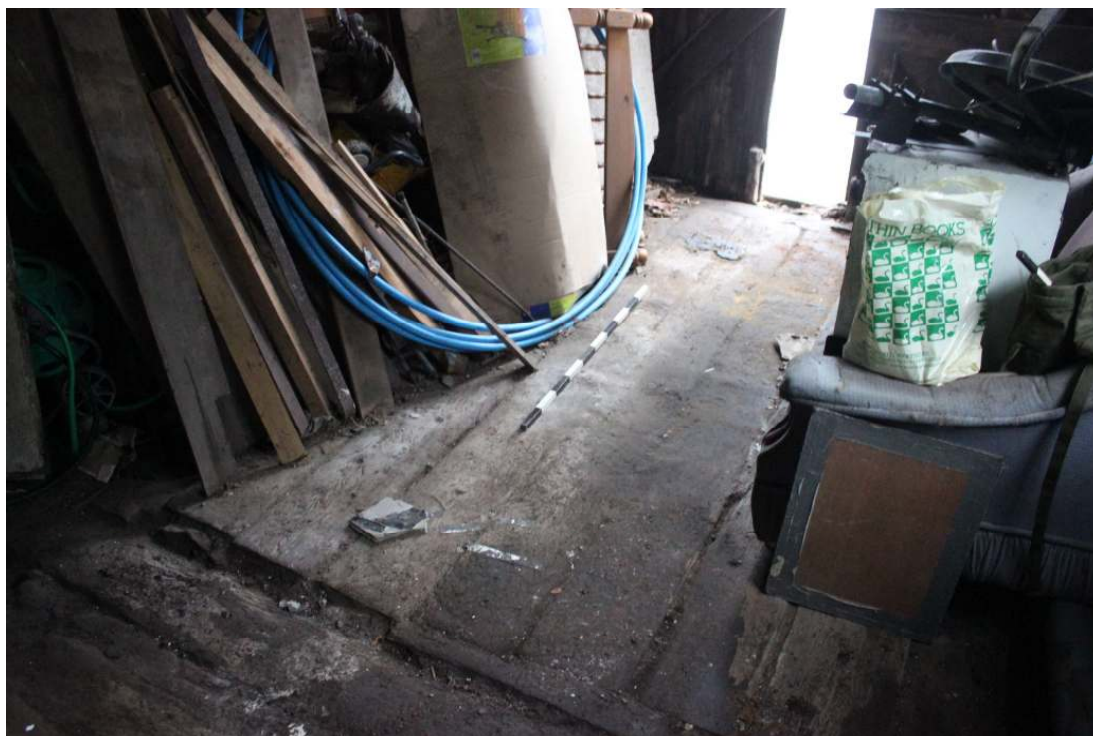
The area of the floor that could be cleared during the survey revealed two distinct spaces. The wide entrance on Commercial Road leads into a sloping wooden floor made up of 10 inch (25cm) wide planks (Plate 18). Long north-south running planks are flanked at both ends by east-west ones (see plan Figure 4). This was the shoeing bay, similar to one depicted in the artist's impression in Plate 4. It was not possible to see if tethering rings had been set into the west wall.

Plate 18: Sloping wooden flooring between the street entrance and the middle of the smithy

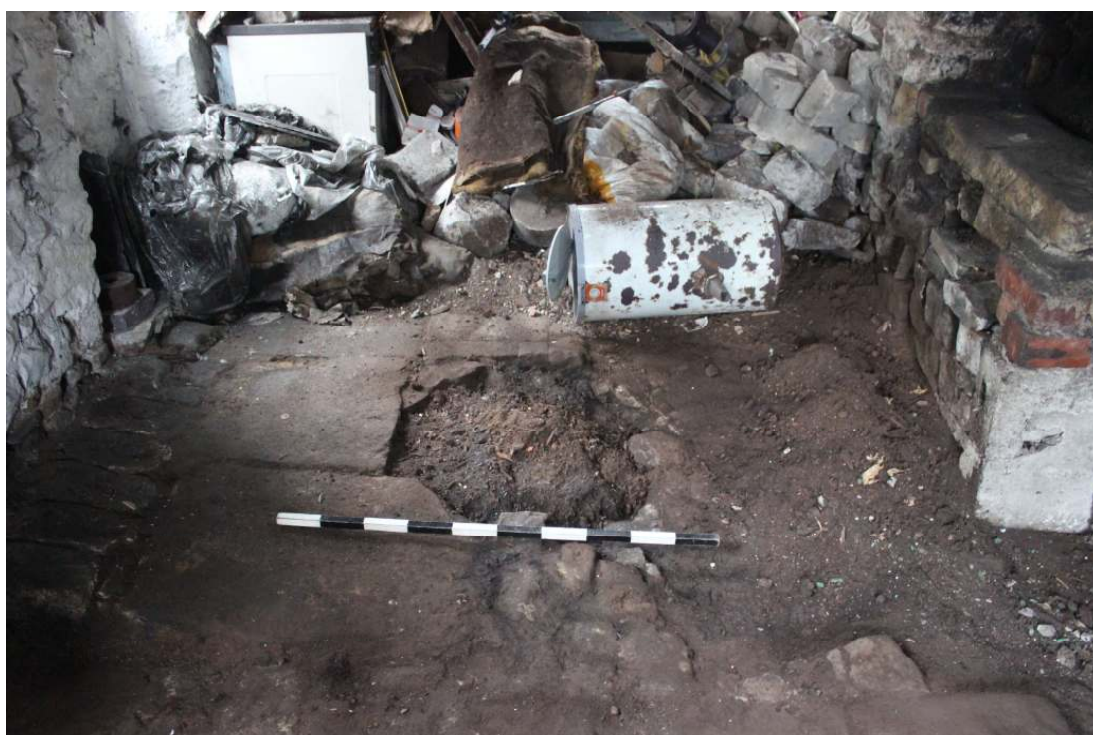
The timber floor occupies exactly half the length of the interior. It is slightly stepped at the south end where a higher stone floor starts (Figure 5). This is made up of rectangular flagstones which show serious signs of wear close to the hearth. The stone is completely missing from a roughly circular area (Plate 18) where the anvil can be seen in Plate 3. Anvils were usually set on a wooden stump (commonly of elm) to allow for a certain bounce (McDougall 2013, 17) and this would explain the resulting depression in the floor. Next to the east wall there is a line of six smaller but thicker stones which indicate a base for something, most likely to support a metal water trough for quenching hot metal (Plate 20).

Plate 19: Worn away part of the slab flooring near the hearth (to right) where the support block for the anvil had been set

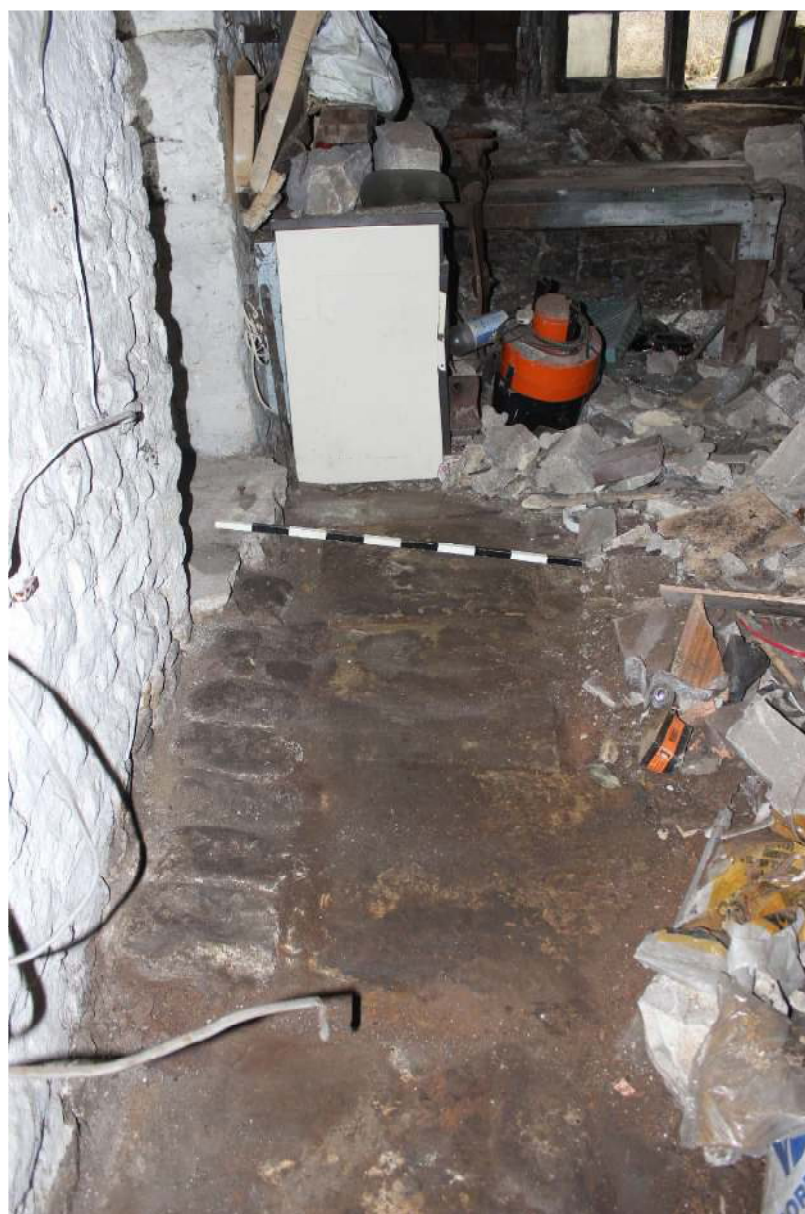
Plate 20: Line of hard stones set against east wall, probably the base for a water trough
