**HAZLEHURST FARM CRUCK BARN,  
HAZLEHURST LANE, SHEFFIELD**

*ARCHAEOLOGICAL BUILDING SURVEY*

Report Number 2015/37 July 2017

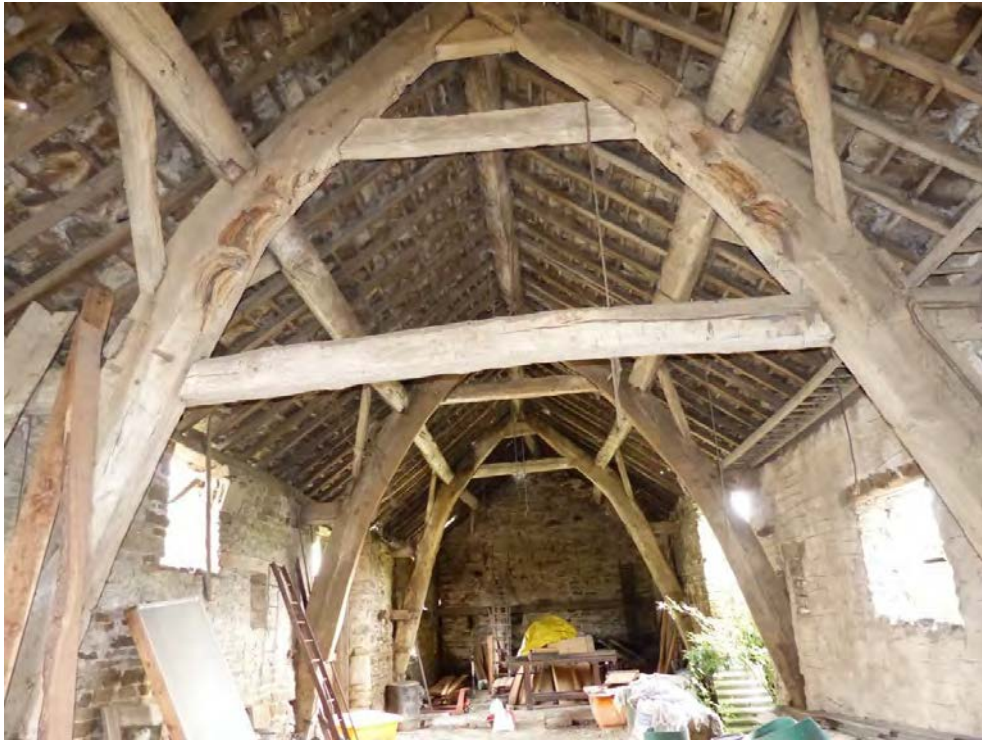
Plate 1: Crucks 2, 3 and 4 looking south

The timber-framed barn originally comprised a series of six oak crucks. Crucks 2, 3, and 4 are clearly visible in the main body of the barn (Plate 1). Cruck 1 is embedded in the north gable wall and Cruck 5 is embedded in a partition wall between Areas A and B (Bays 4 and 5) (Plates 2 and 3). The sixth cruck, now removed, was originally positioned in the location of the current south gable wall. The barn is positioned on a slope and the crucks are taller to the south than the north, to ensure that the roof line of the building is horizontal (DAS, 2012). The floor level is also stepped down from north to south. The building is around 152m (500ft) high, and is 5.75m (approx. 18ft) wide, and each bay measures 5.5m between cruck centres (approx. 18ft) (ibid).

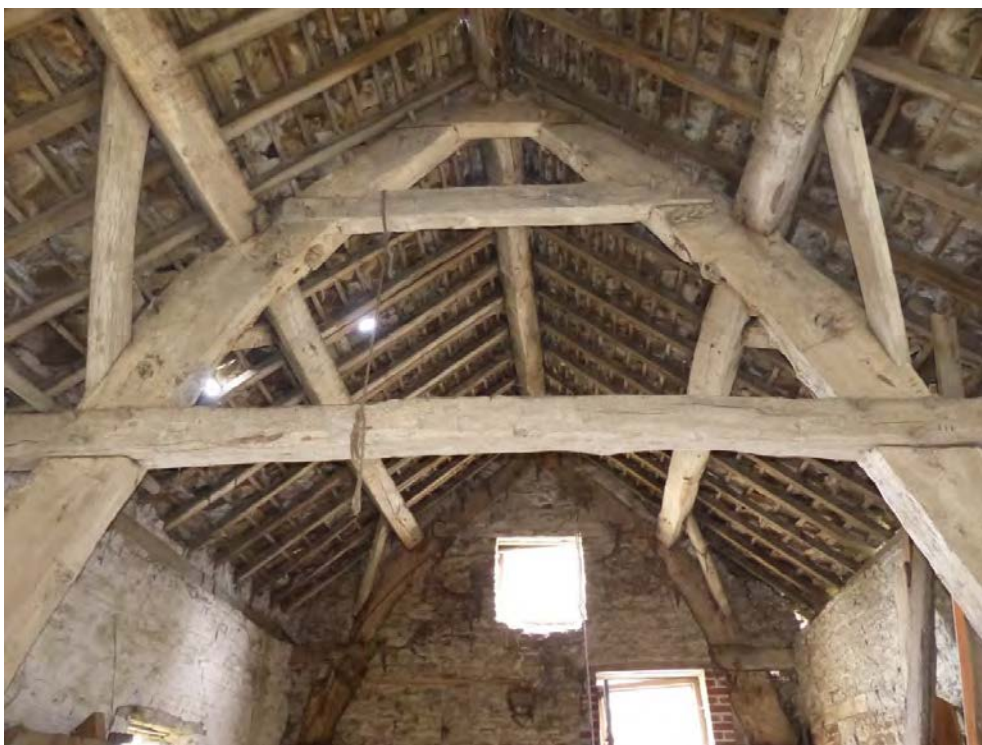
Plate 4: Cruck 2, looking north, detail of timber components

In the main, the crucks are in an excellent condition and comprise a pair of cruck blades, two collars, a tiebeam, and a wall post (Plate 4). Cruck 1 varies from the others and only has one collar. The central sections of the tiebeams in Crucks 1, 3 and 4 have been removed as part of later amendments (Plate 5). The wall posts are embedded within the stonework, though the west posts of Crucks 1 and 4 are visible where the stonework has become detached from the frame (Plate 6). Assembly marks (also known as carpenter's marks) are clearly visible on the upper face of the timbers that form Crucks 1-4. The Crucks are marked sequentially from north to south with the Roman numerals 'I', 'III', 'V', 'II' (Plate 7). The jointing methods used include halved lap joints, dovetail joints and mortice joints, generally pegged together with a series of three pegs.

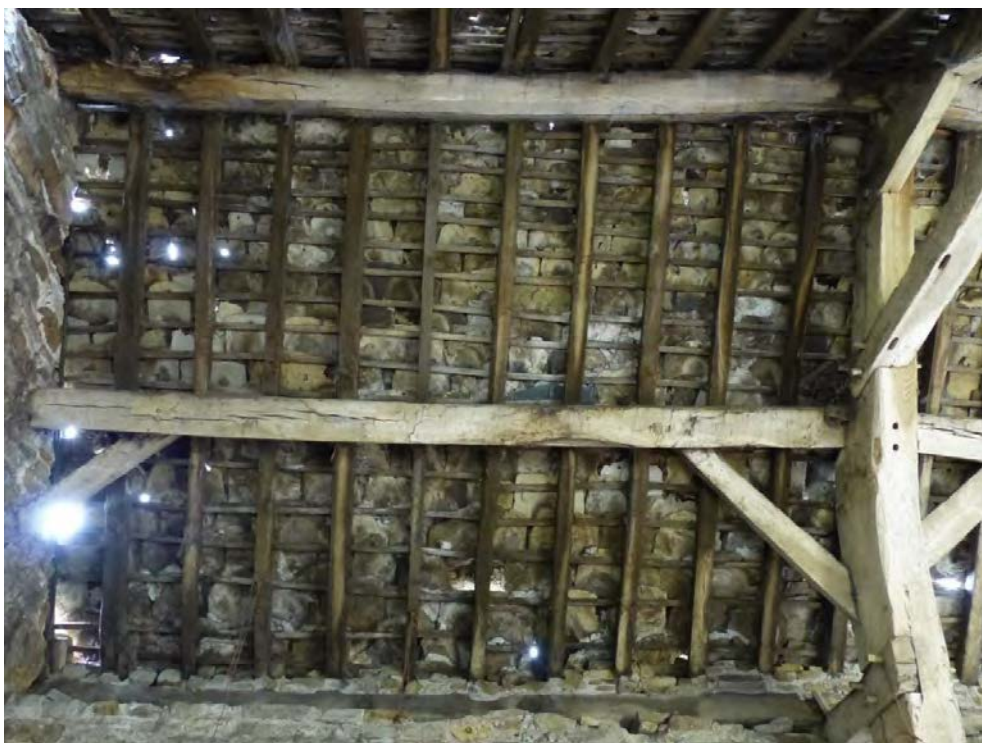
Plate 8: Detail of purlin in Bay 4, looking west

The cruck frames support a single purlin roof and the purlins are jointed into each of the cruck blades below the collar (Plate 8, see also Plate 4). The roof purlins comprise several separate timbers jointed together with scarf joints at intervals which coincide with the position of each

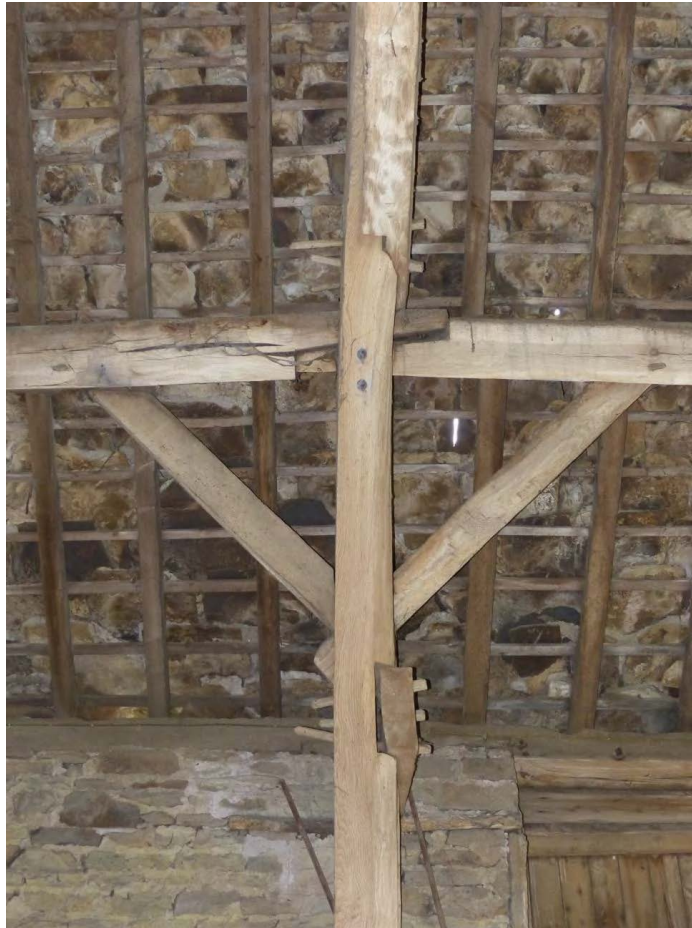
Plate 9: Cruck 4 looking west, detail of purlin and wind braces

cruck (Plate 9). A pair of curved windbraces extend from each cruck blade to the purlin. The ridge purlin appears to rest in the square-cut top of the cruck blades, and is formed out of a number of separate timbers jointed together with scarf joints (as shown in Plates 4 and 8). The barn is roofed with stone slates, although it is not an original roof; the slates hang on laths of sawn softwood rather than split oak (DAS, 2012).

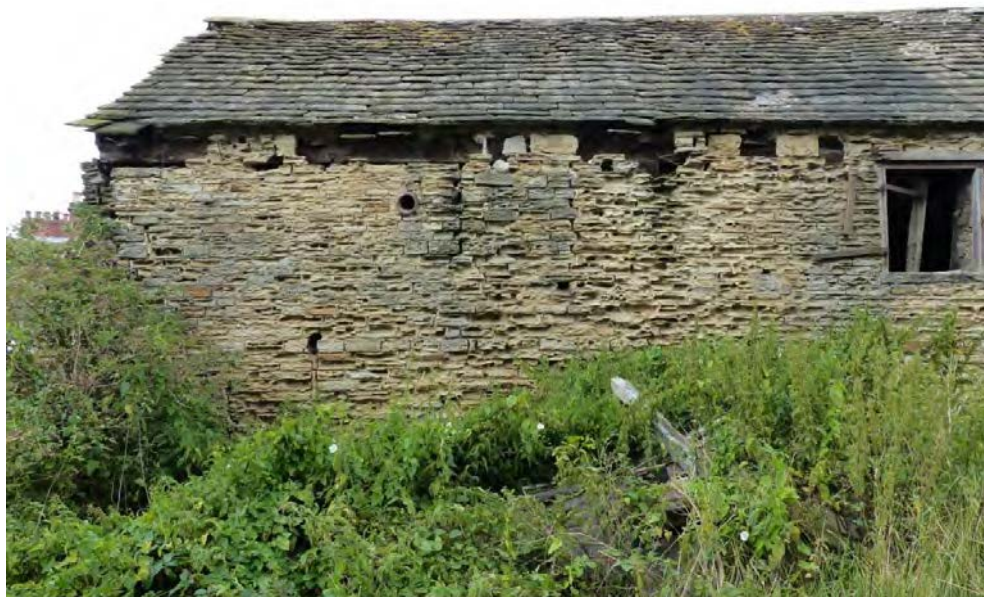
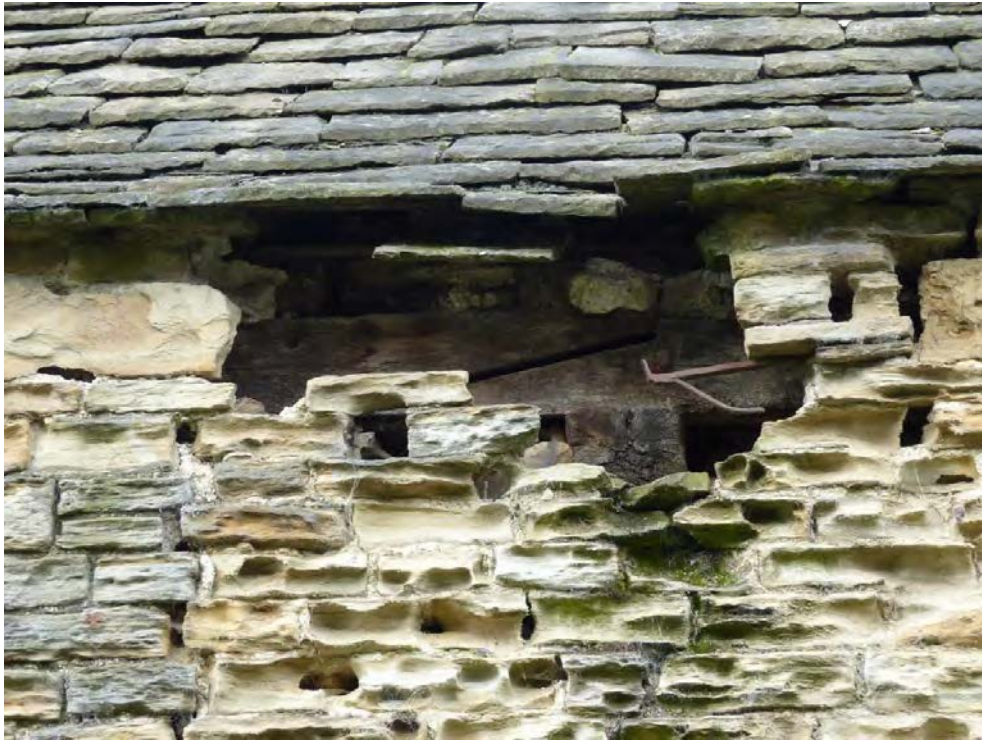
The wall plates appear to rest on the tiebeams (Plates 10 and 11). They are also formed out of several separate timbers jointed together with scarf joints at intervals which coincide with the position of each tiebeam.

Plate 10: Bay 5 looking west. Wall plate exposed behind stonework

Plate 11: Detail of wall plate and tie beam looking west (Cruck 5)

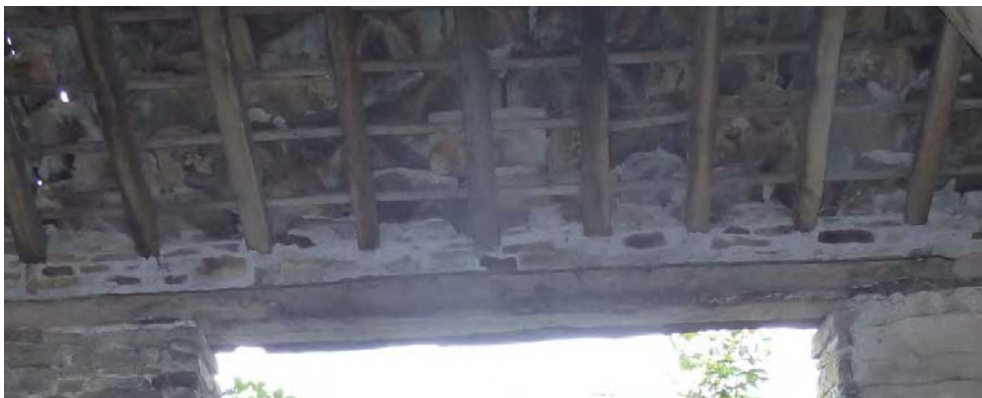
It is highly probable that the barn was originally used as threshing barn, with large opposing doors located in Bay 3, roughly in the same position as in the remodelled barn. Substantial oak brackets pegged into the wall plate of the west wall are evident either side of the door opening, along with hinges for original harr-hung doors and mortice holes for door frames (Plate 16).

Plate 16: The shaped brackets of the original harr-hung door (each with three oak pegs) can be seen in the wall plate above the opening (one to each side)

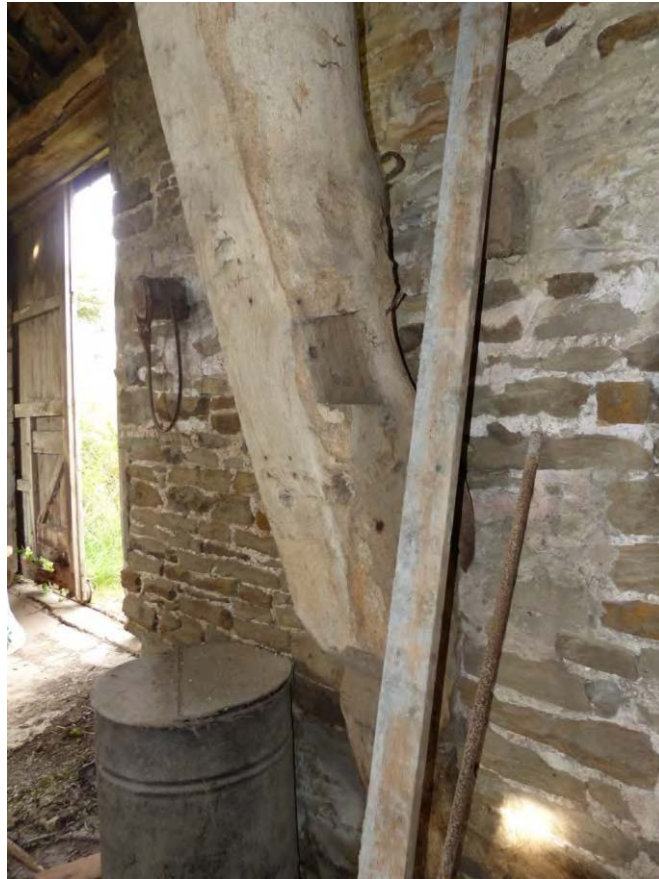
The bays to the south of the threshing floor were separated from the threshing area. In Cruck 4, empty mortice holes to the undersides of the collar and empty dovetail joints at the base of the cruck blades suggests that this cruck was originally closed and formed an internal partition wall (Plate 17).

Plate 17: Cruck 4 looking north-east and showing empty dovetail joint for a further horizontal timber

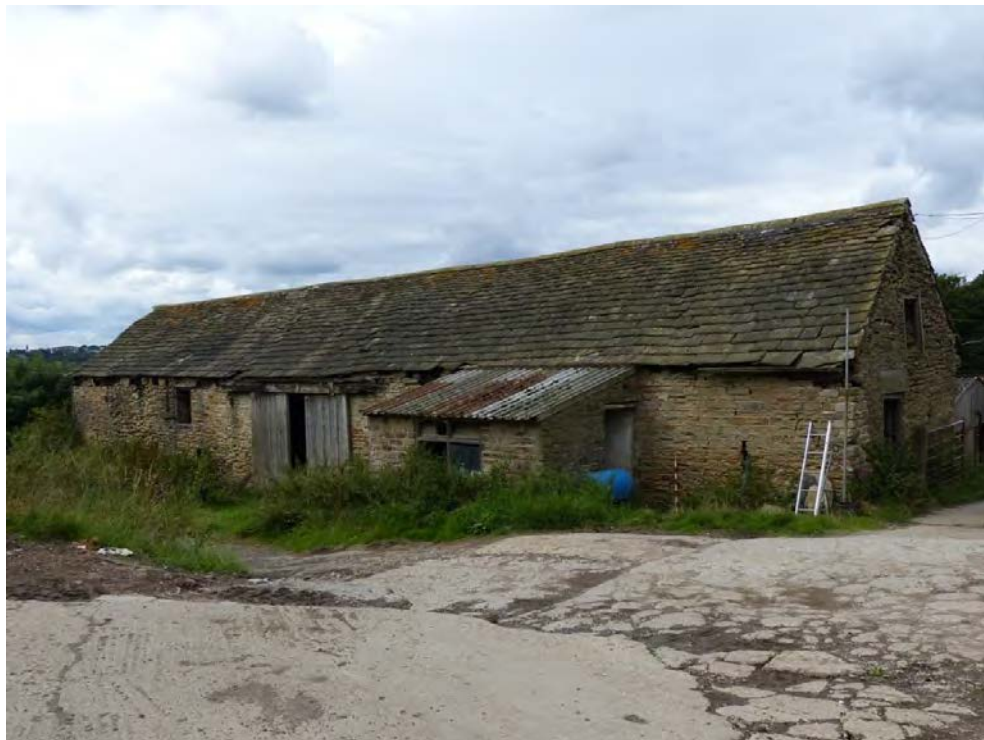
Plate 18: The Cruck Barn, looking south-west

The north and south gables and the east and west walls of the cruck barn have been replaced with coursed rubble stonework (Plate 18). It is likely that much of the original wall infill material was removed at this stage, although some of the original timbers were re-embedded in the stonework and re-used as lintels. The large openings for the threshing doors were retained within the remodelled barn. A single-storey outshot was constructed out of stonework on the west side of the building (Plate 19). Though the north wall and interior walls of the outshot abut up to the west wall of the barn, the stonework of the south wall of the outshot is coursed through the stonework of the south gable of the barn at roof height, suggesting that it was constructed as part of the same remodelling programme.

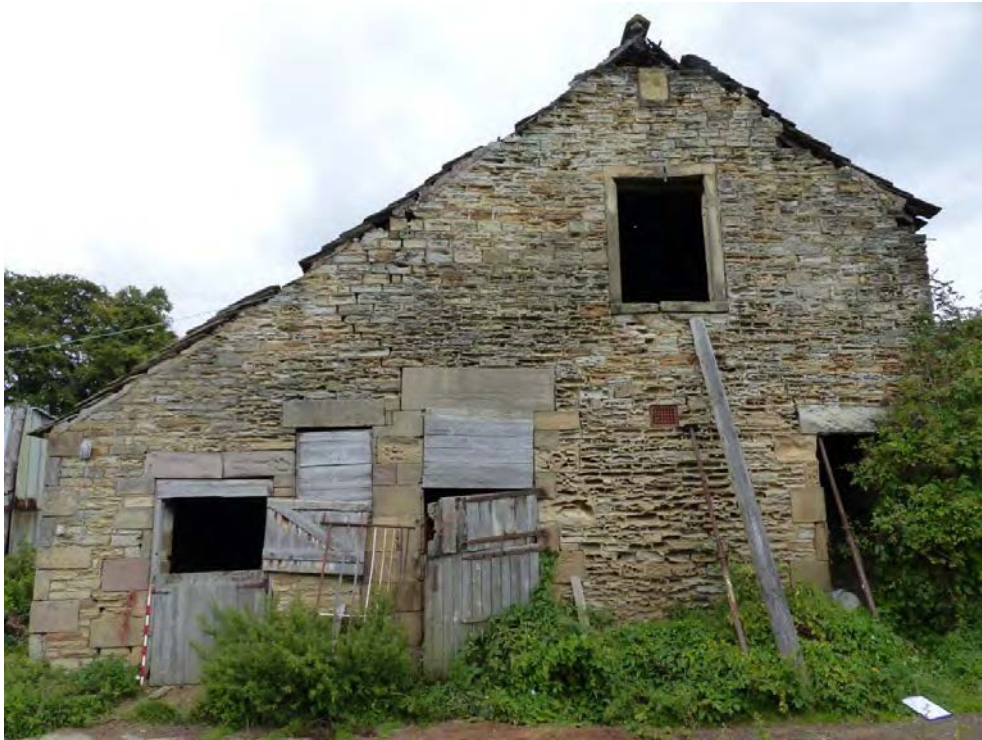
Plate 27: South gable looking north from right to left, the doorways give access to the staircase to Area F, Area B and Area C

There are three doorways to the south gable - two which lead into Bay 5 of the barn and a further doorway to the west, which leads into the outshot (Plate 27). A large window opening is positioned at eaves height and there is evidence of a further window (now blocked-up), in the outshot. The doorways have been dressed with masonry blocks, several of which appear to be replacements. A further small opening (now blocked up), directly below the ridge purlin, could be related to a pigeon loft.

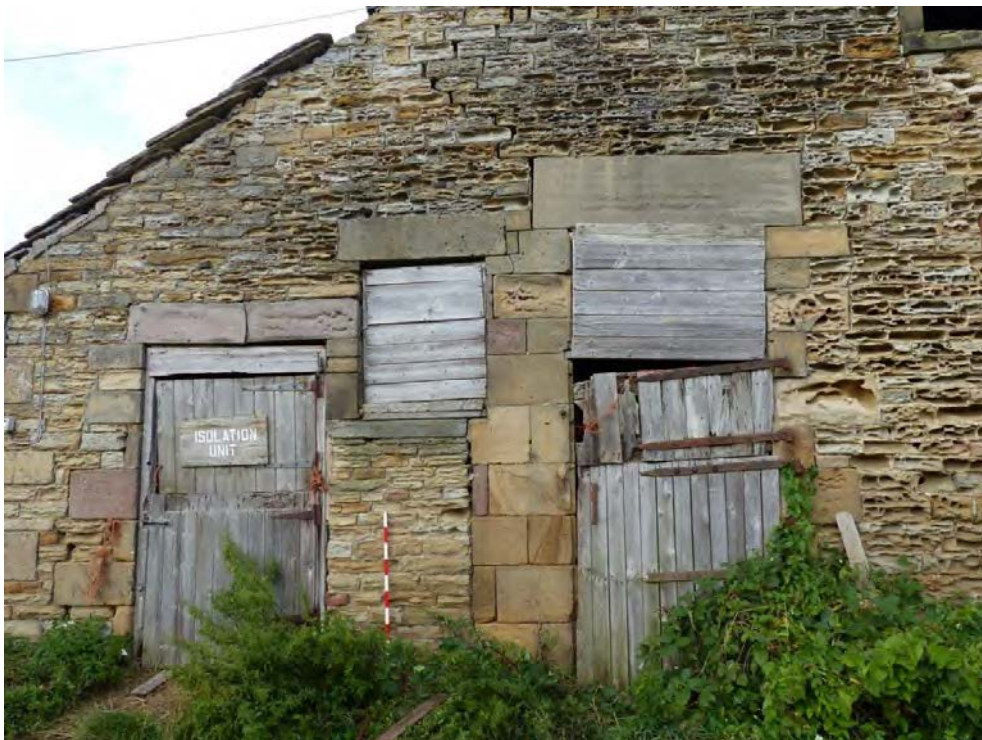
Plate 28: South gable looking north, detail of masonry blocks surrounding doorways and window

The removal of the cruck at this end of the building, coupled with the addition of the outshot and the doorway openings, may well be related to the structural issues in the stonework of the gable. The stonework of the south gable, and the south-east end of the east wall is badly weathered. The creation of a 'column' of masonry blocks to the left of the central doorway could be related to these issues (Plate 28).

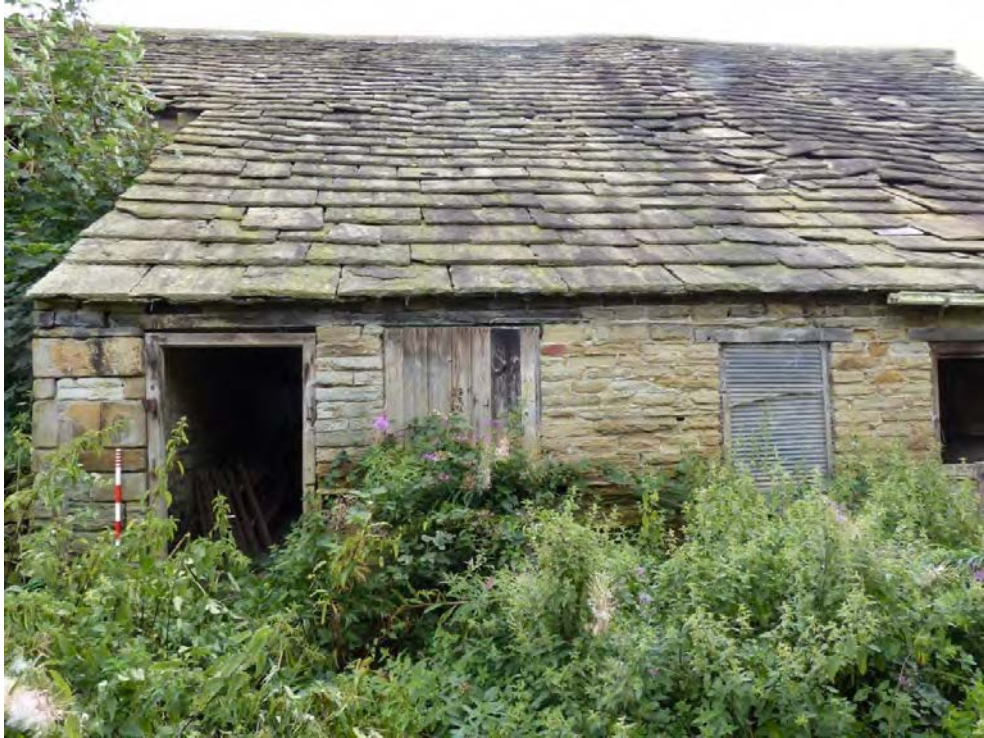
Plate 29: outshot Area E and D looking east

On the west elevation of the outshot there are two square-shaped window openings and two doorways. Quoin stones are positioned at the north-west and south-west corners of the outshot (Plate 29).

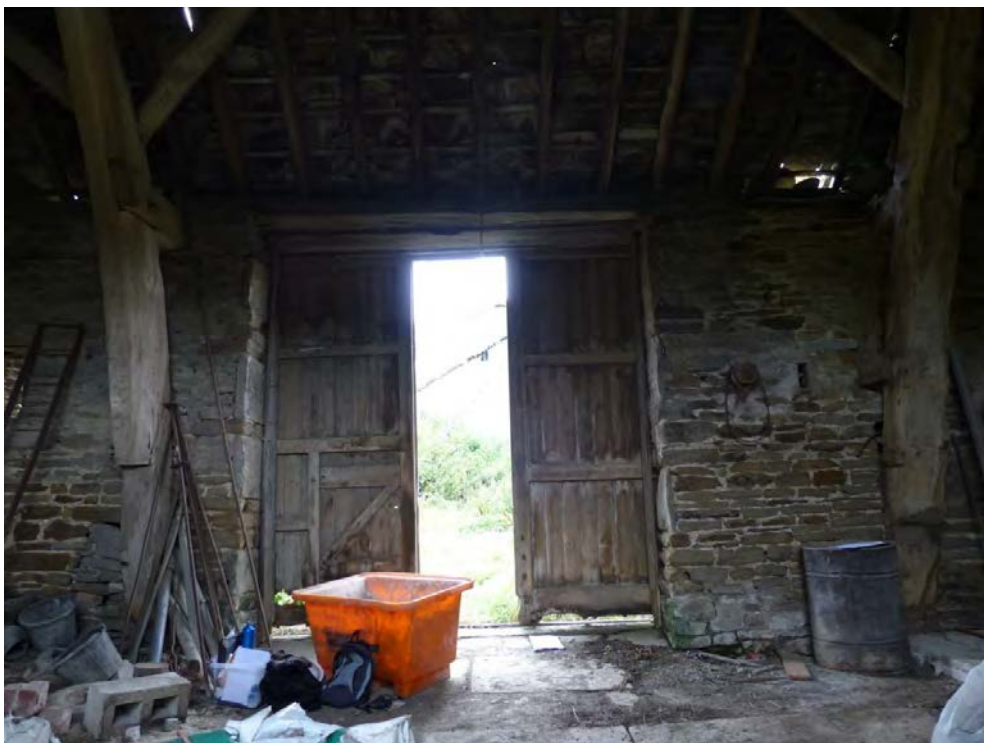
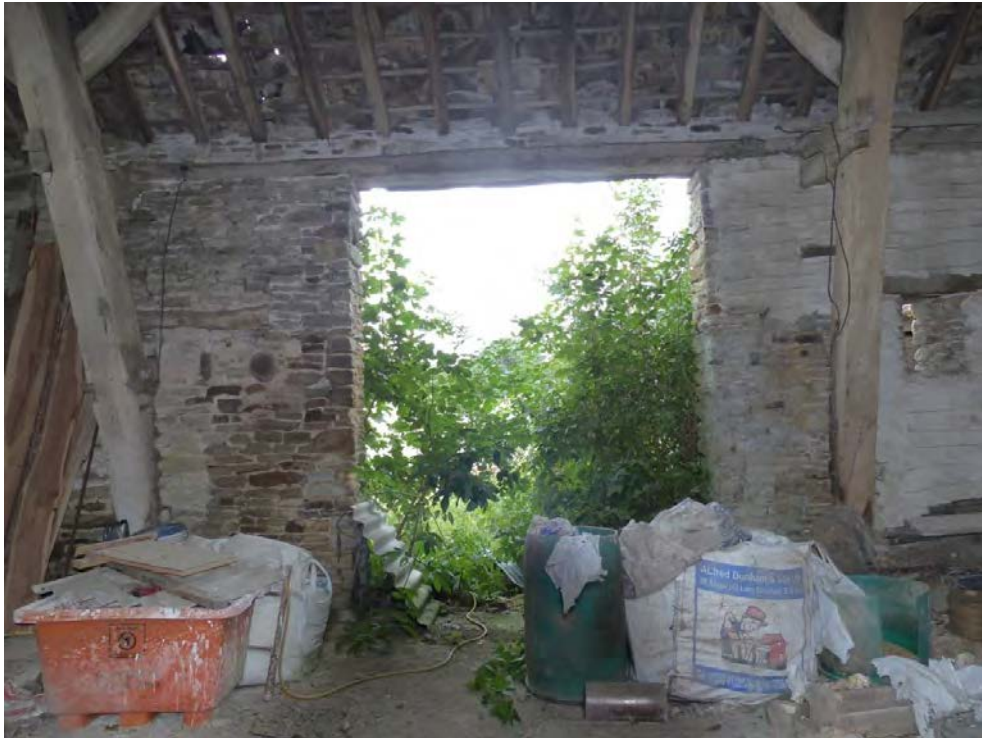
In Area A, a threshing floor of stone slabs is *in situ* between the threshing doors in Bay 3 (Plates 30 and 31). Bay 4 was made into two storeys and the remains of the floor joists are evident in the east and west walls (Plates 32 and 33). A doorway in the stonework of Cruck 5 (now blocked up) gave access to Bay 5.

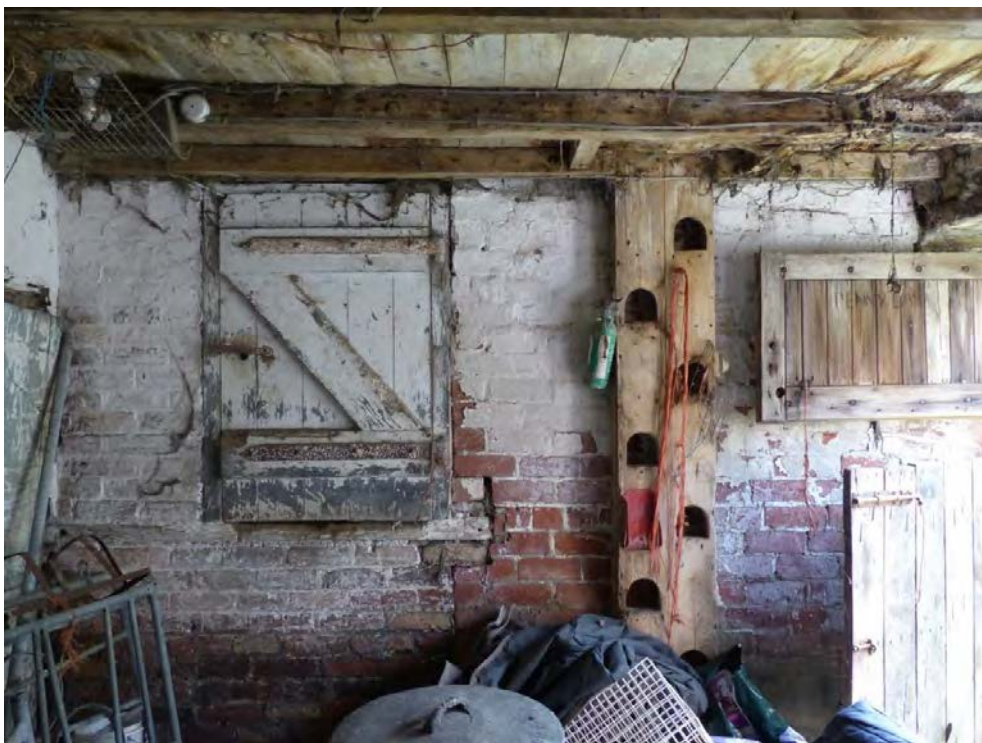
The outshot is divided into three compartments. Area D (plate 36) is divided from Area E (Plate 37) by an original partition wall constructed out of stone, whereas Area D (Plate 38) is divided from Area C (Plate 39) by a wall formed out of relatively modern machine-made bricks, suggesting that this was a later partition.

Plate 38: Area D looking south and showing brick internal wall

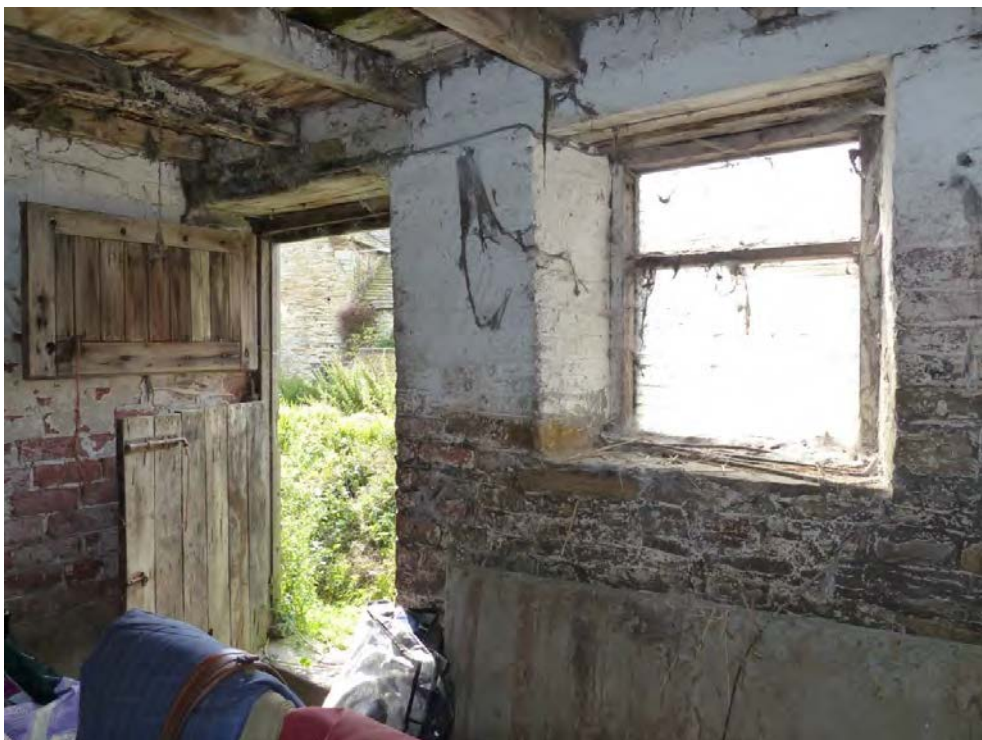
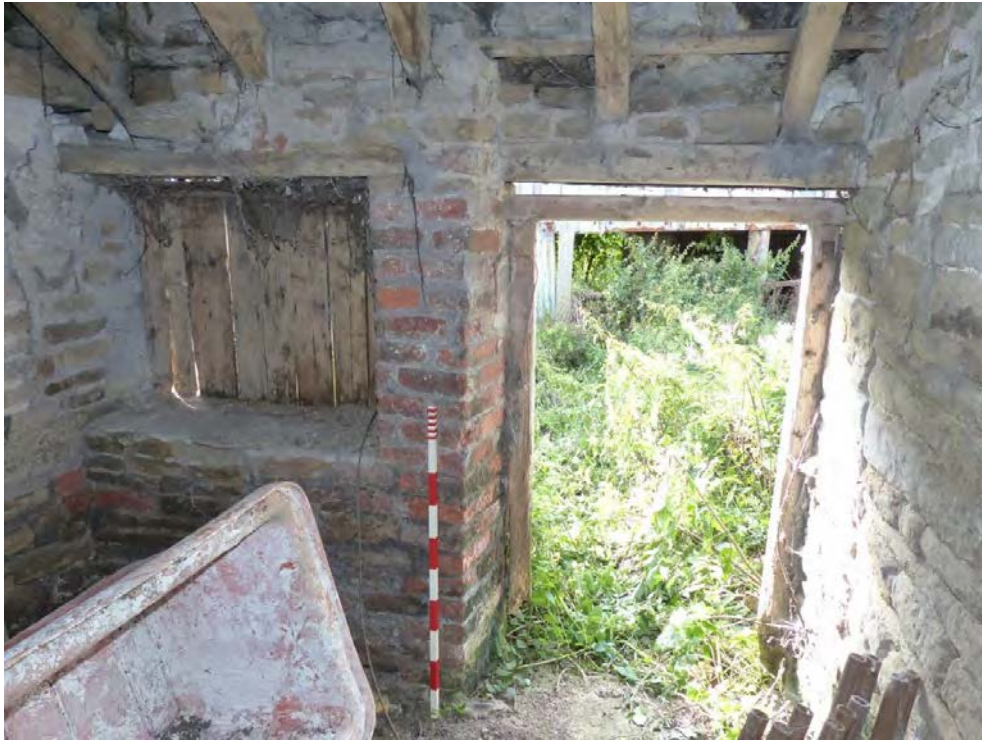
The external doorways and windows into Areas E and D are dressed with handmade bricks which are contemporary with the construction of the outshot (Plates 40 and 41). The walls of Areas D and E show signs of having been plastered.
