Derwentside Industrial Park, Belper,
Derbyshire
Archaeological Evaluation and Mitigation Report
ArcHeritage 2018

Derwentside Industrial Park, Belper, Derbyshire
Archaeological Evaluation and Mitigation

Project Name	Derwentside Industrial Park
Report Title	Derwentside Industrial Park, Belper, Derbyshire: Archaeological Evaluation and Mitigation
Report status	Final
ArcHeritage Project No.	1260
Type of Project	Evaluation
Client	Cawarden Company Ltd
Third Parties	Tapton Properties Ltd Westleigh Partnerships Ltd
NGR	SK 34975 46334
OASIS Identifier	archerit1-305791
Author	Laura Strafford and Richard Jackson
Illustrations	Laura Strafford
Editor	Glyn Davies
Report Number and Date	2017/80 January 2018
Version and filename	V2 1260 Derwentside eval report.docx

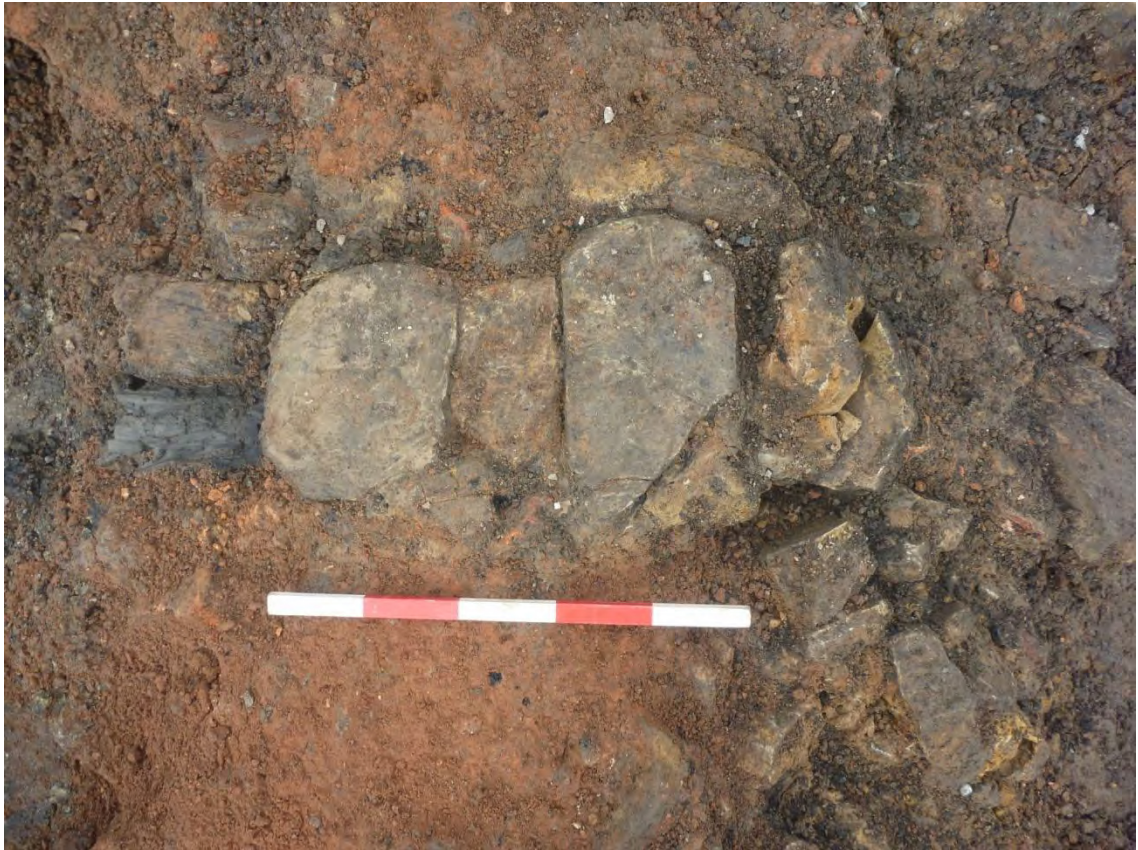
Plate 3: Detail of Structure (126) and deposit (127), Trench 1. Looking north-west, scale 0.5m

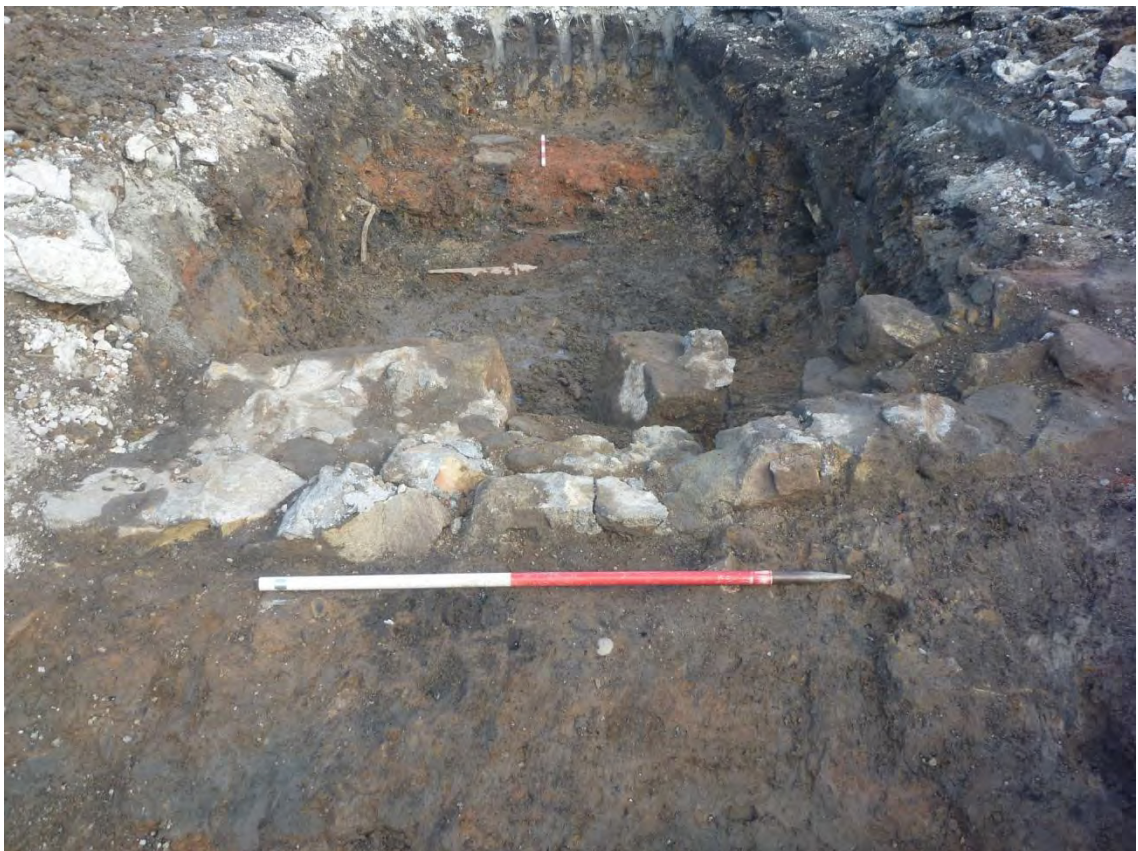
Plate 4: Wall (118), Trench 1. Looking north-east, scale 1m

presence of the thick made ground (125) throughout the base of Trench 1 suggests that this deposit was laid prior to building upon it in order to create a flat and stable base. Wall (118) and (132) is located over the main east to west alignment of the what appears to be the main building of the Iron Foundry, as marked on the 1891 OS map (Figure 8). Certainly the construction method and thickness of the wall as recorded during the excavations would be consistent with that of a main load-bearing wall. Structure (126) is located outside of the foundry building, and may be remnants of a yard surface. The compacted industrial waste feature (124) is located within the foundry building, although map evidence can suggest no more on the functionality of this building. The succession of deposits to the west of Wall (118) may represent a succession of deposits inside the building; the lowest deposit overlying the made-ground/levelling layer (125) was clean grey clay (121), possibly a sealing and insulation layer, overlain by a compact mixed orange clay layer, which may represent a surface. Immediately overlying this was thin black lens of clinker and cinder, likely waste from the foundry which has either been deliberately spread to create a surface, or has naturally accumulated during the life-span of the foundry.

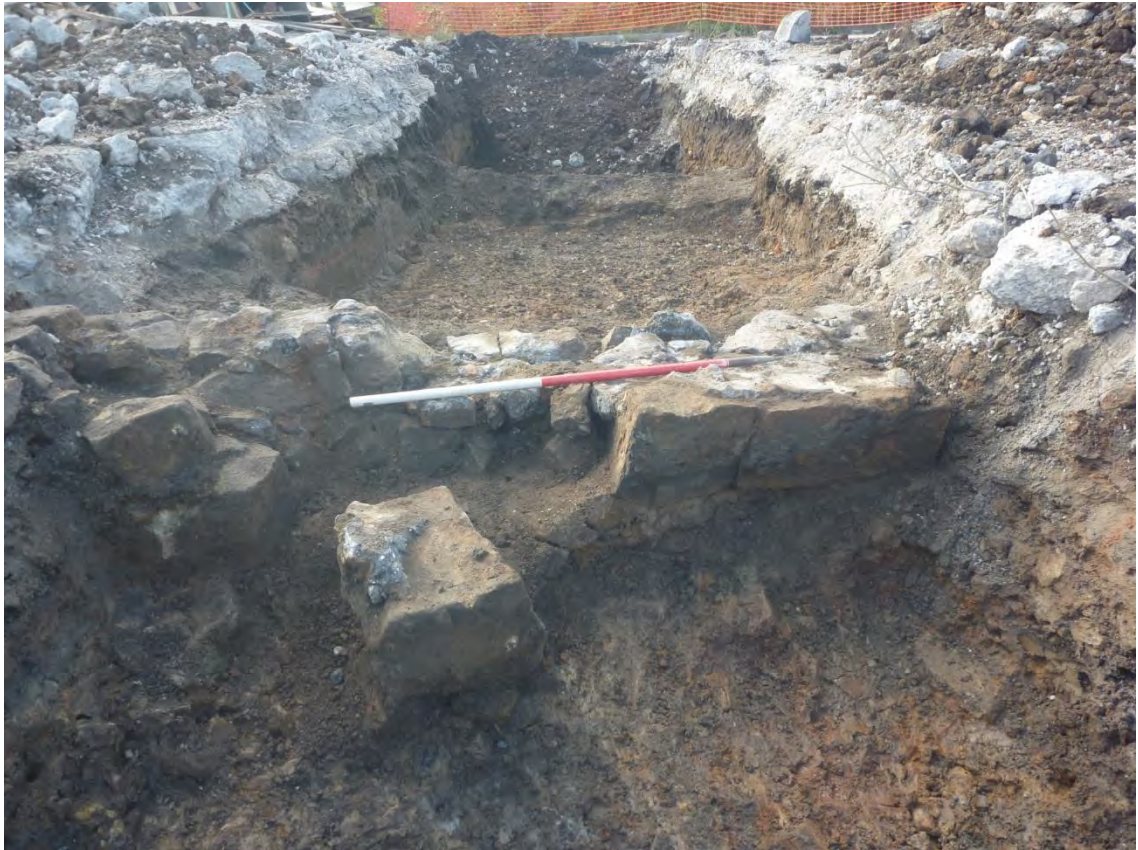
Plate 5: Wall (118), Trench 1. Looking south-west, scale 1m

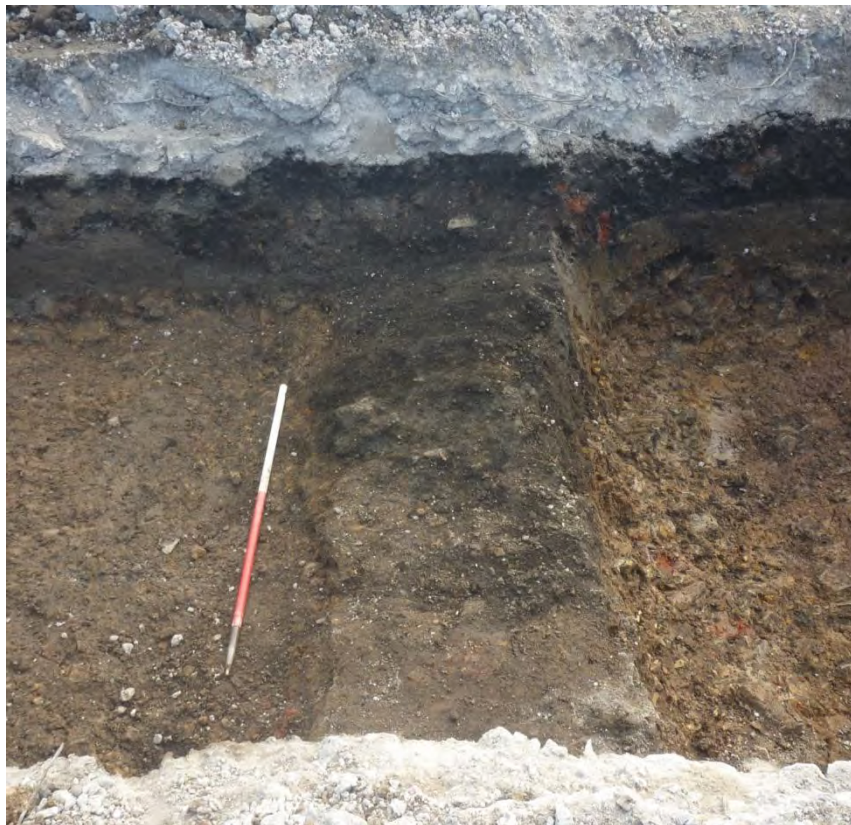
At the western end of the trench, a compact clinker deposit (124) (Plates 6 and 7) was located within a cut [123]. The cut was fairly irregular but clearly visible in section, with a vertical eastern edge and a gradually sloping flat edge. The base was slightly rounded. The single fill (124) was highly compacted, composed primarily of slag but with some clinker, coal and gritty sand. The deposit seemed to be made up entirely of foundry residue, and was so impacted that it was not possible to excavate with hand tools. The full extent of the feature was unclear, but exceeded 1.3m in width, with a surviving height of 0.28m.

Plate 6: Feature (124), Trench 1. Looking south-east, scale 1m

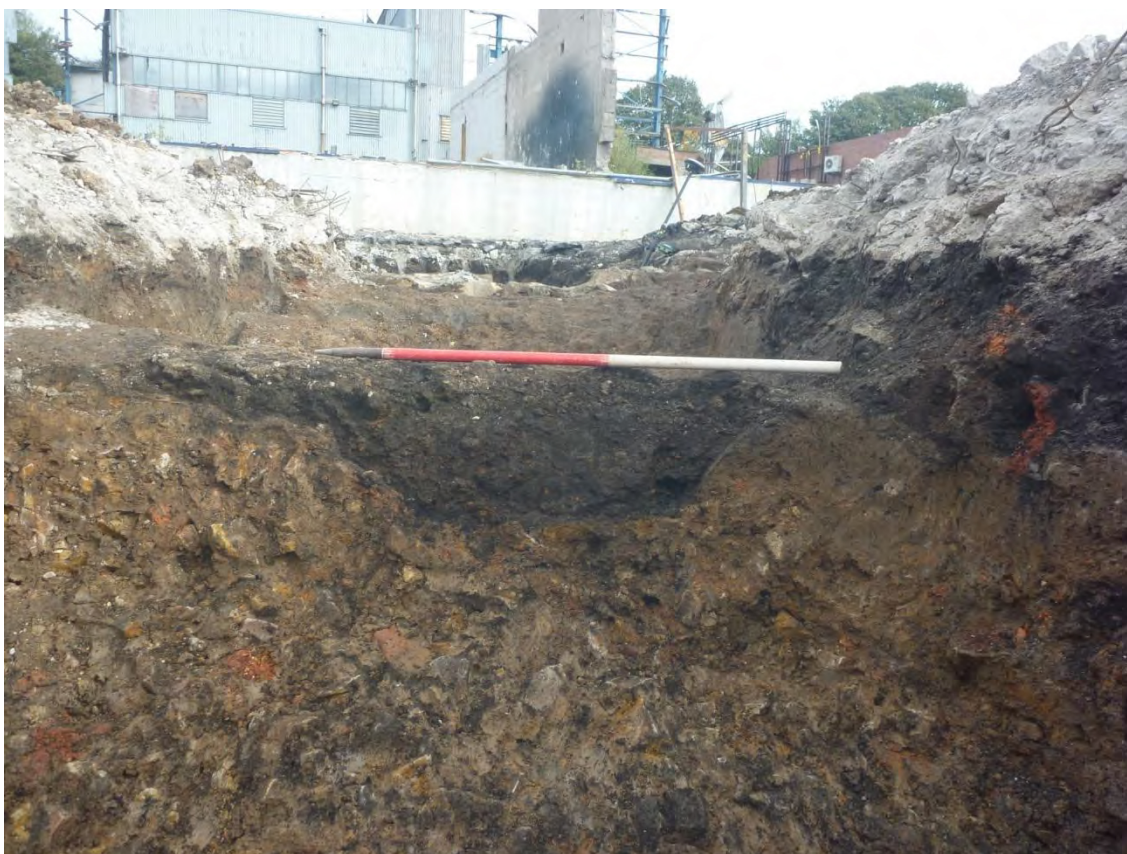
Plate 7: Feature (124), Trench 1. Looking north-east, scale 1m

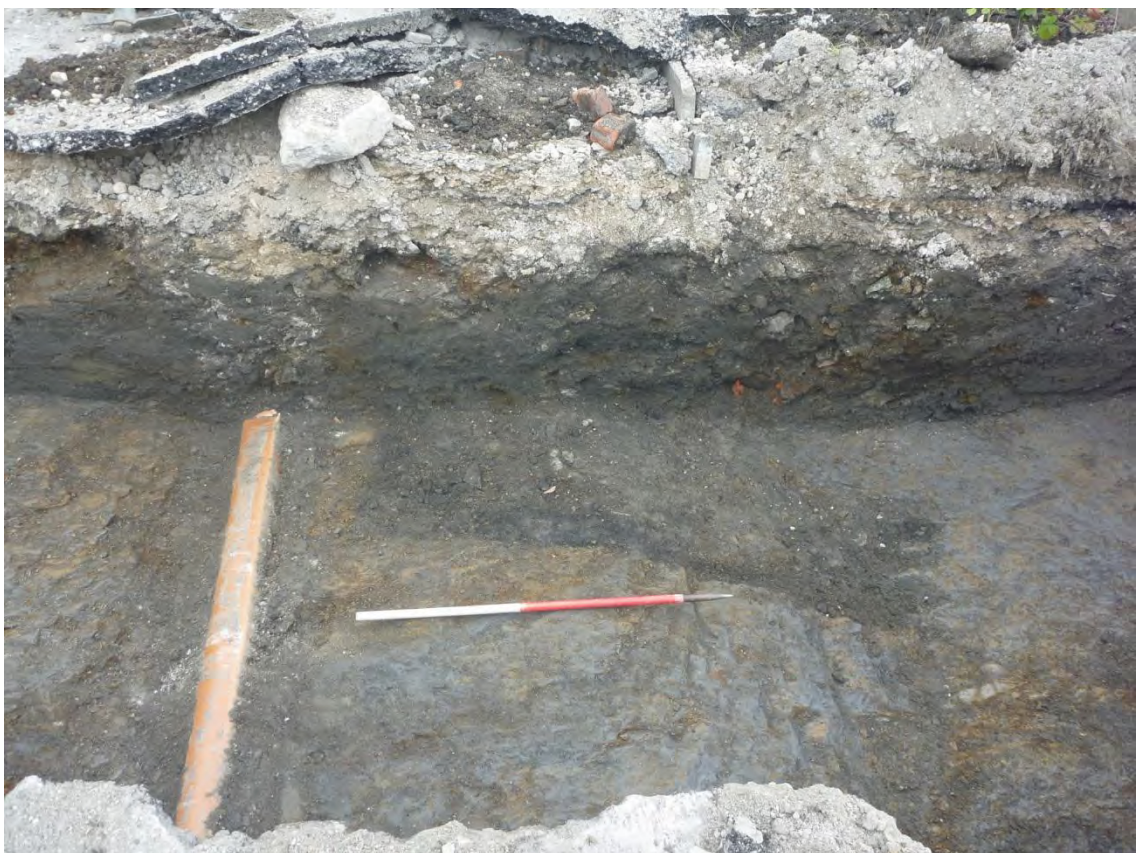
To the immediate south of the drain [206], a cut feature [208] was observed that cut through into the natural shale geology (210) (Plates 8-10). This measured a maximum of 2m in length by

0.7m in width, with very straight edges, with the exception of the southern edge which was irregular and jagged. The single fill (207) comprised very dark grey sandy silty clay, mottled with irregularly distributed inclusions of shale, occasional sub-angular limestone gravel and industrial waste. Very small fragments of asbestos were also observed within this fill, hence it was not excavated any further. The shape and dimensions of this feature suggest that it may be the scar of a toothed machine bucket.

Plate 10: Feature [208] and drain (204), Trench 2. Looking north-east, scale 1m

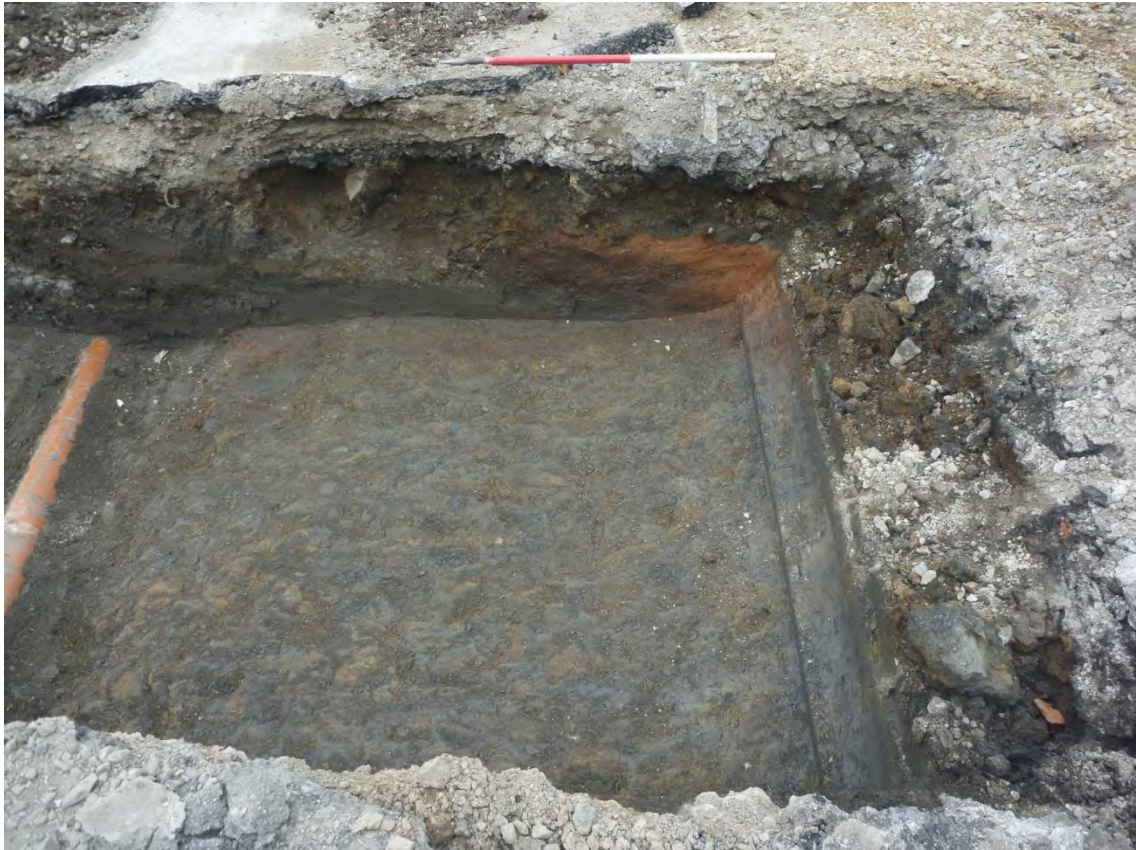
Plate 11: North-east facing section of Trench 2, showing variation in the natural geology (210), with a patch of brick earth that may have been quarried during the time the brick works operated on the site

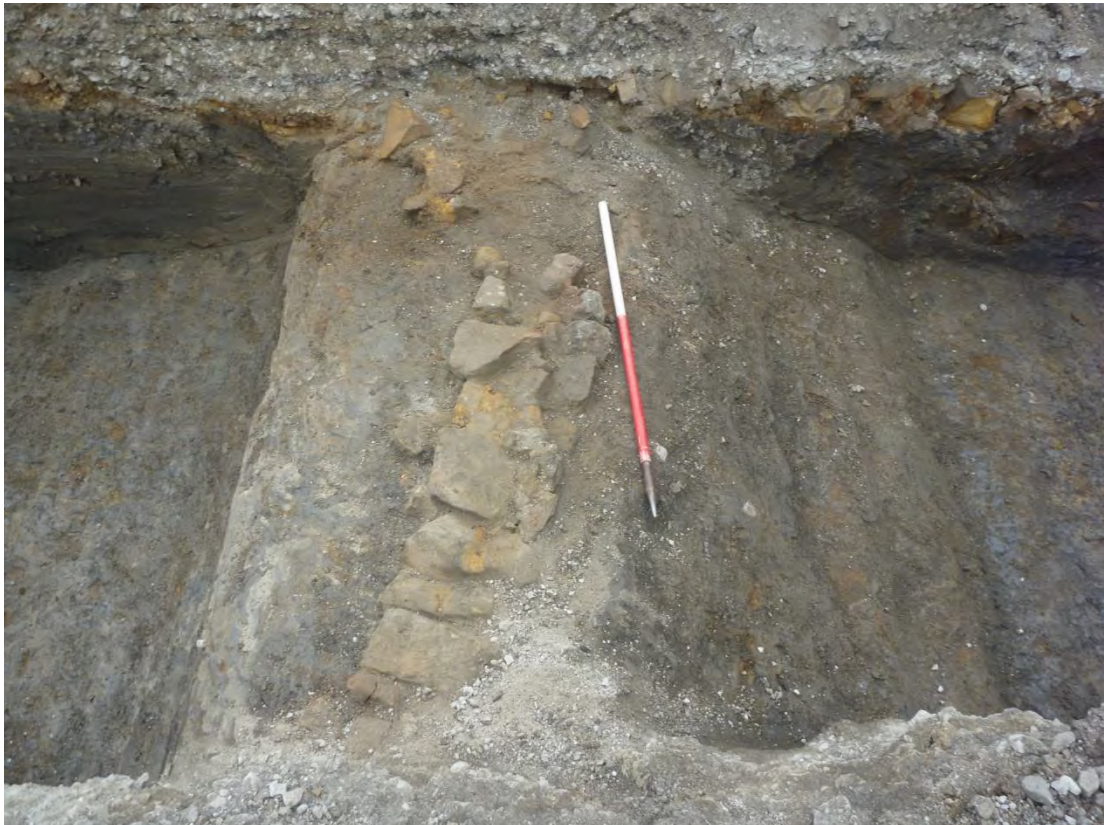
Plate 14: Structure (302), with possible Structure (310) shown in section, Trench 3. Looking north-west, scale 1m

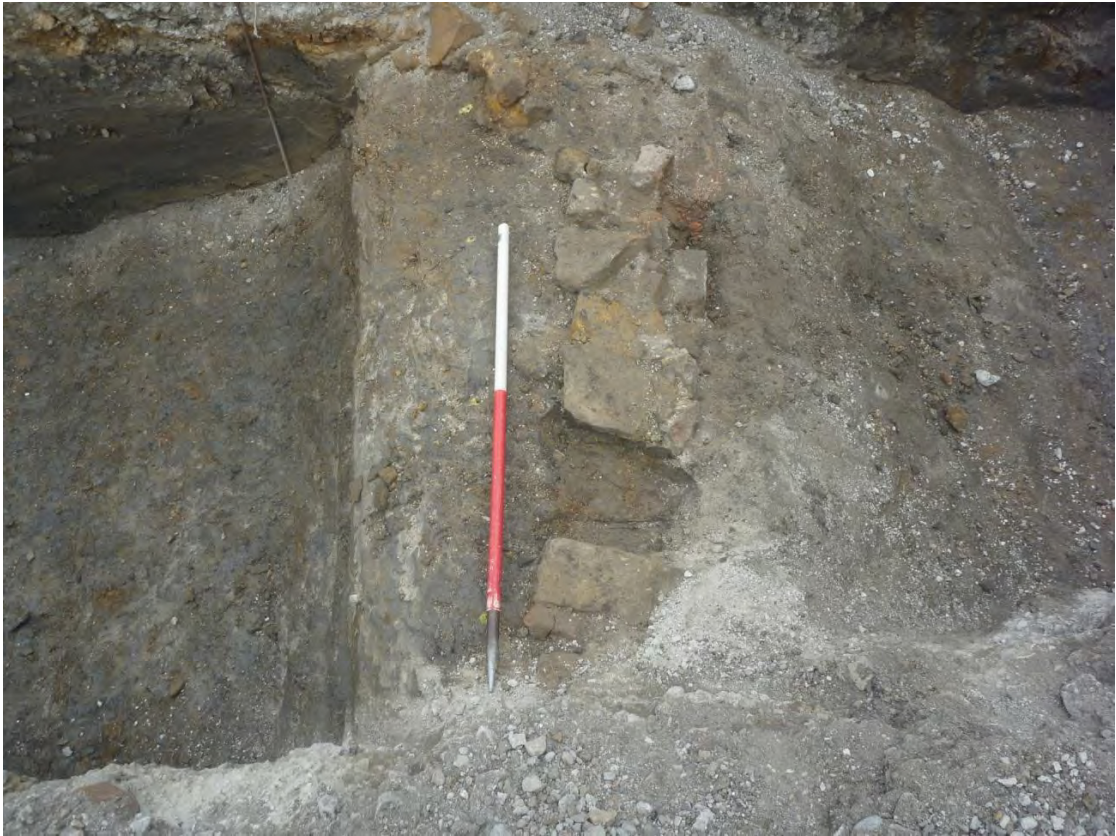
Plate 15: Structure (302), following removal of part of the structure, demonstrated that only a single course survives. Trench 3, looking north-west, scale 1m

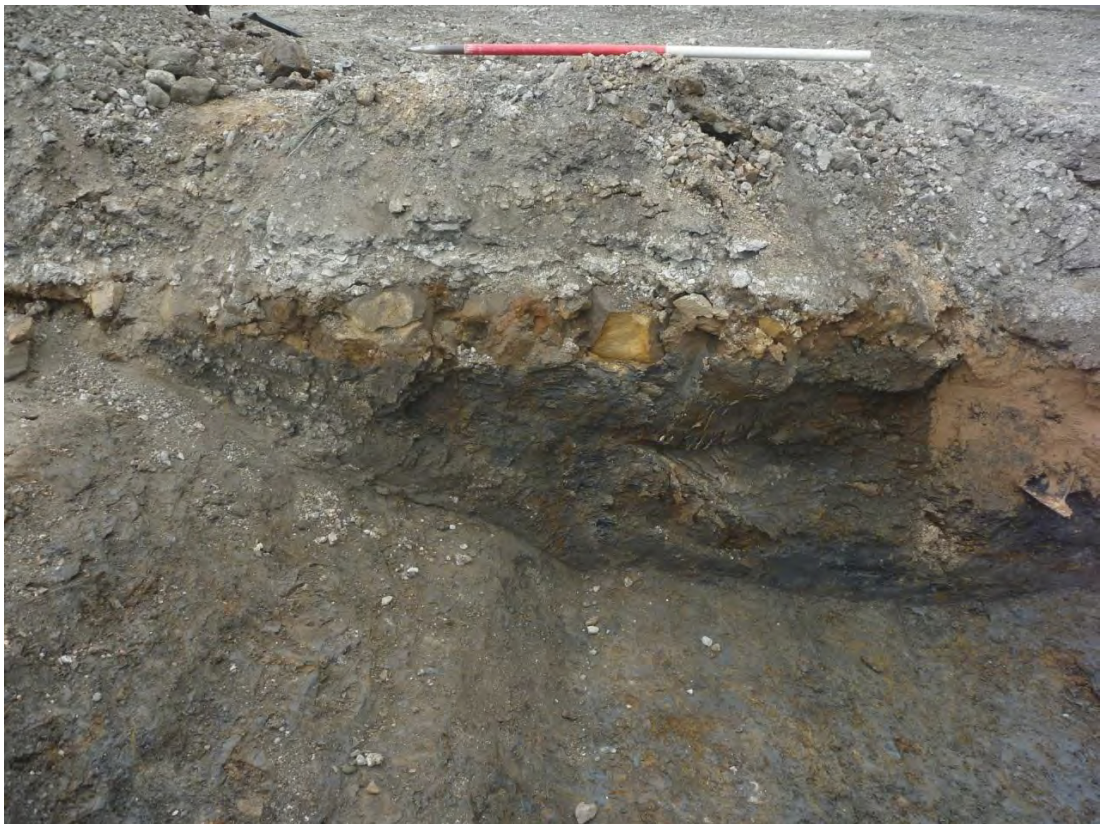
In the south-east facing section of the trench, a possible return for wall (302) was observed (Plate 16). The possible return (310) comprised sandstone blocks identical in size and shape those used in (302), within a clean plastic yellow clay matrix, possibly used as a grouting material as seen in (302). The sandstone blocks of (310) comprised a single course, and ran for 1.9m in length. The width of (310) could not be ascertained, as it continued beyond the limit of the trench. As with (302), structure (310) was placed with a shallow cut [311] within the

Plate 16: Possible Structure (310) shown in section, truncated by the cut [306] for recent plastic drain pipe (304). Looking north-west, scale 1m

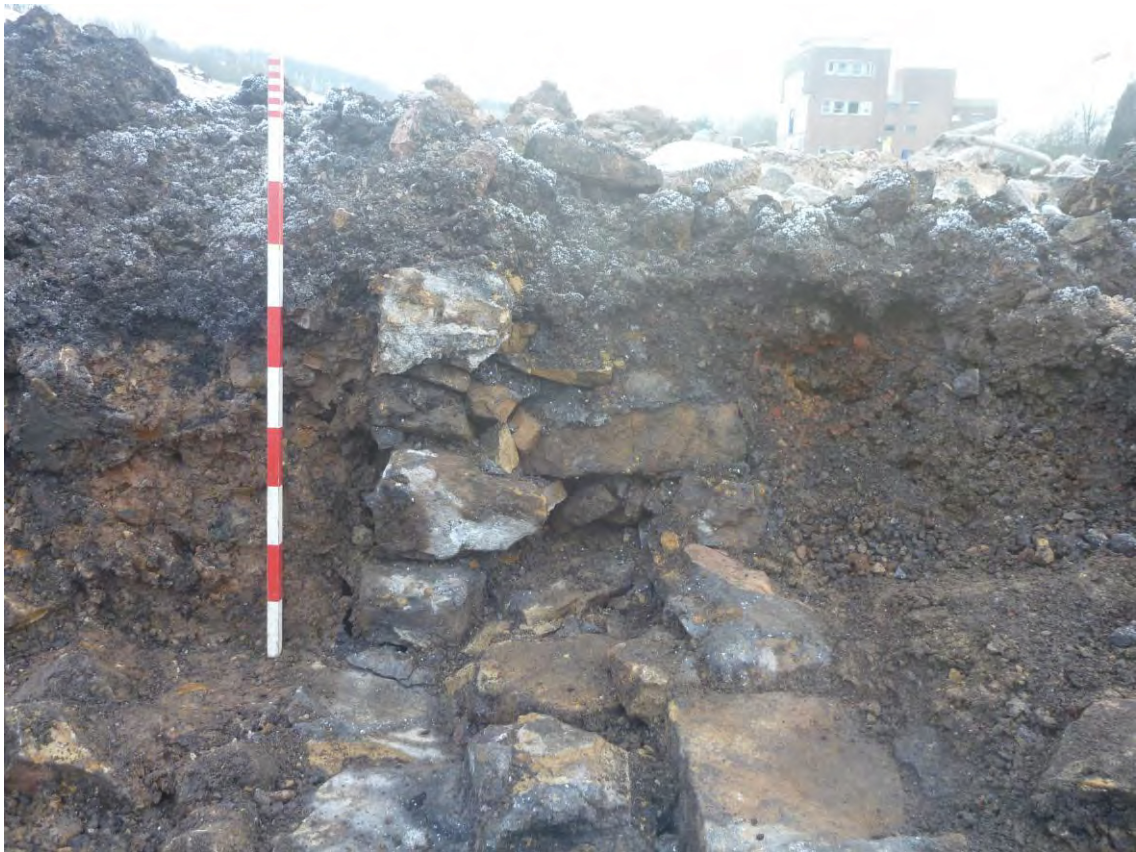
The watching brief was continued into the area formerly trenched and within the depth of remediation works undertaken, which was 0.5m in depth. Only one archaeological feature was identified. This was a truncated sandstone wall foundation (132) which was situated approximately six metres to the south-east of sandstone foundation (118) excavated in Trench 1. The structure had been heavily truncated by the installation of a heavy-duty electrical cable, surviving as a single foundation course for a linear extent of 1 metre (Figure 7). The structure was bonded with black ash mortar and constructed from roughly trimmed and faced sandstone constituents of varying irregular sizes, around a mixed core of larger constituents and rubble. The structure shared the same northwest-southeast orientation and alignment as structure (118) in Trench 1, and can reasonably be interpreted as a continuation of the same structure. It is worth noting that the deposits either side of (132) consisted of mixed sandstone rubble and clays to the northeast and mixed demolition rubble to the southwest.

Plate 17: Wall (132) within the watching brief area. Looking south-east, scale 1m

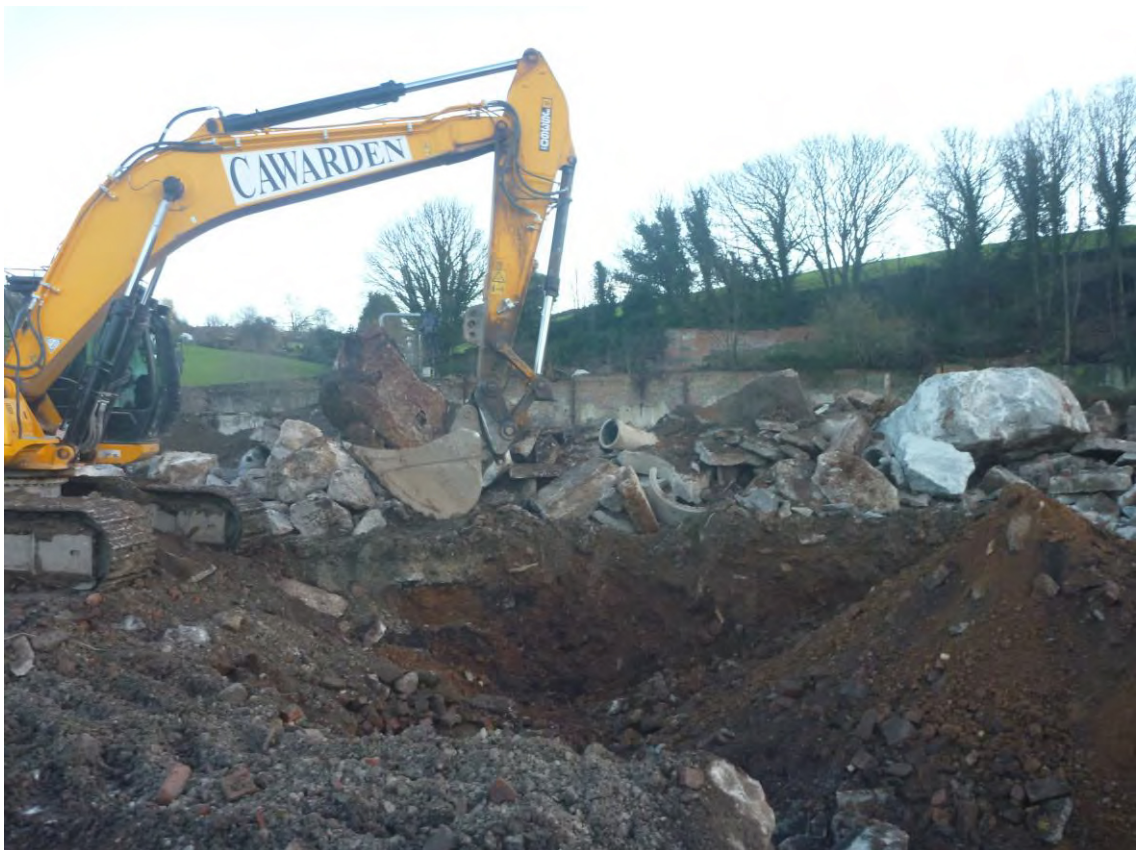
Plate 18: Working shot of the watching brief, showing an example of the concrete footings that were common throughout the area

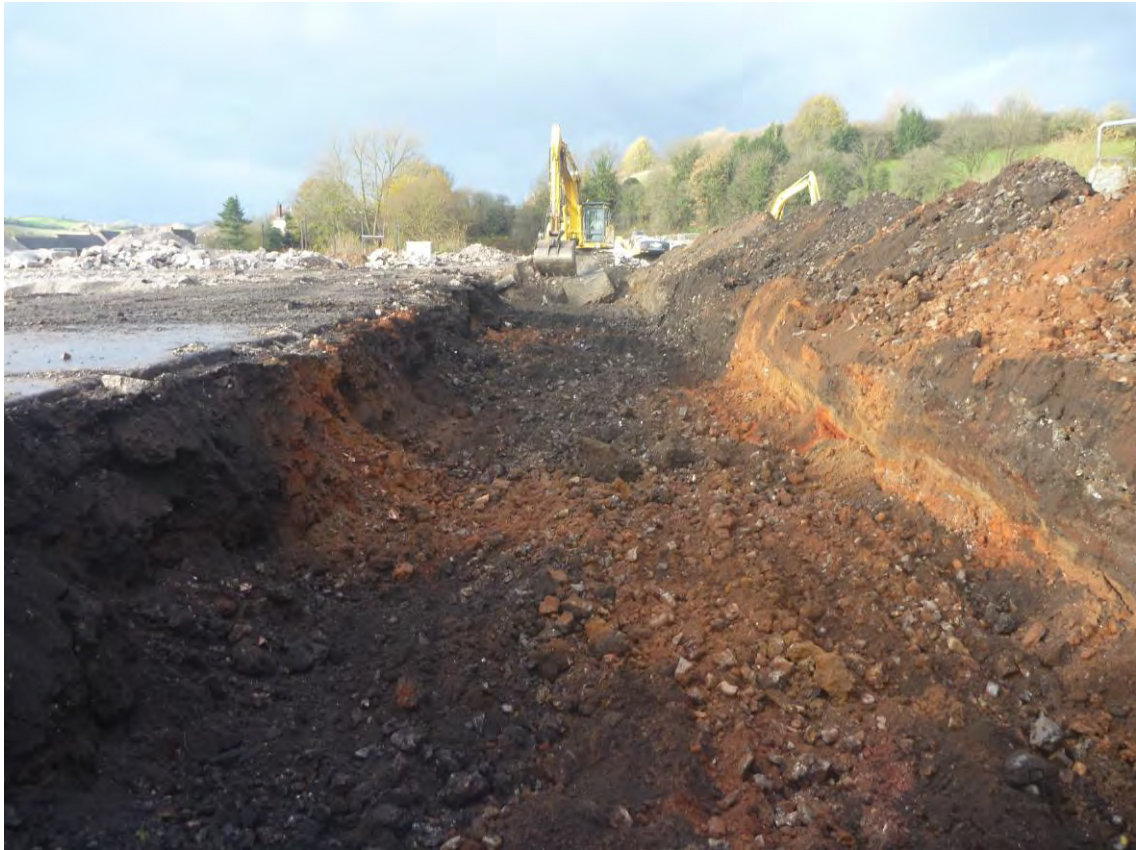
The general stratigraphic sequence observed in the main watching brief, to the south east of the area investigated via trenching, had concrete slab of 0.3m thickness overlying mixed foundry waste and rubble deposits (plate 19-20) that in turn overlay natural clays and shale bedrock. As the excavation progressed down-slope, the impact of remediation excavation on below ground deposits reduced considerably to slab lifting only and as such the stratigraphic sequence below was not observed.

Plate 19: Monitored remediation excavation of foundry waste, watching brief area. Looking north-west

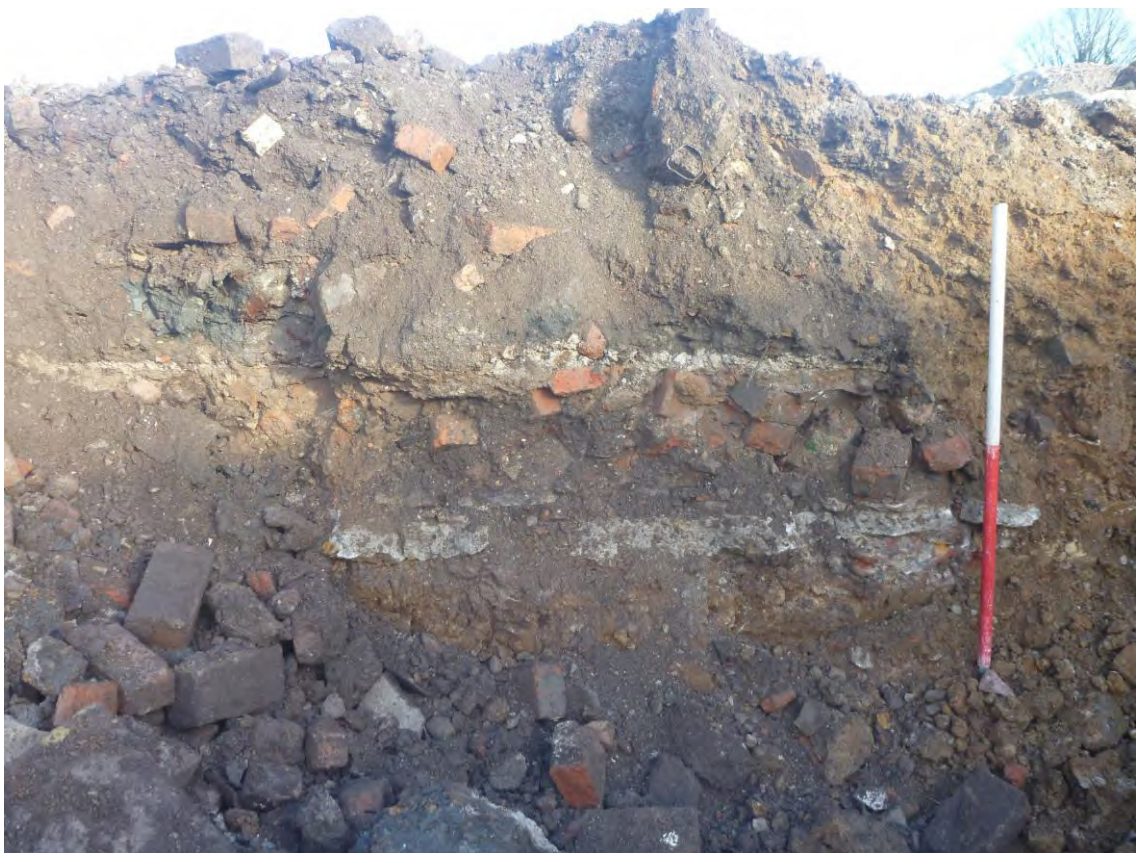
Plate 20: Example of truncated stratigraphic sequence, watching brief area. Looking north-east.
