Conisbrough Mill Piece, Conisbrough, South Yorkshire
Archaeological Walkover Survey and Excavation

Mill Piece, Conisbrough, South Yorkshire
Archaeological Survey and Excavation Report

Project Name	DVLP Site G: Conisbrough Mill Piece
Report Title	Mill Piece, Conisbrough, South Yorkshire: Archaeological Survey and Excavation Report
Report status	Final
ArcHeritage Project No.	663
Type of Project	Survey and Excavation
Client	DVLP
NGR	SK 51560 98762
Oasis ID	archerit1-306255
Author	Laura Strafford
Illustrations	Laura Strafford
Editor	Mark Stenton
Report Number and Date	2017/64 April 2019
Version and filename	V2 Conisbrough Mill Piece Excavation Report.docx

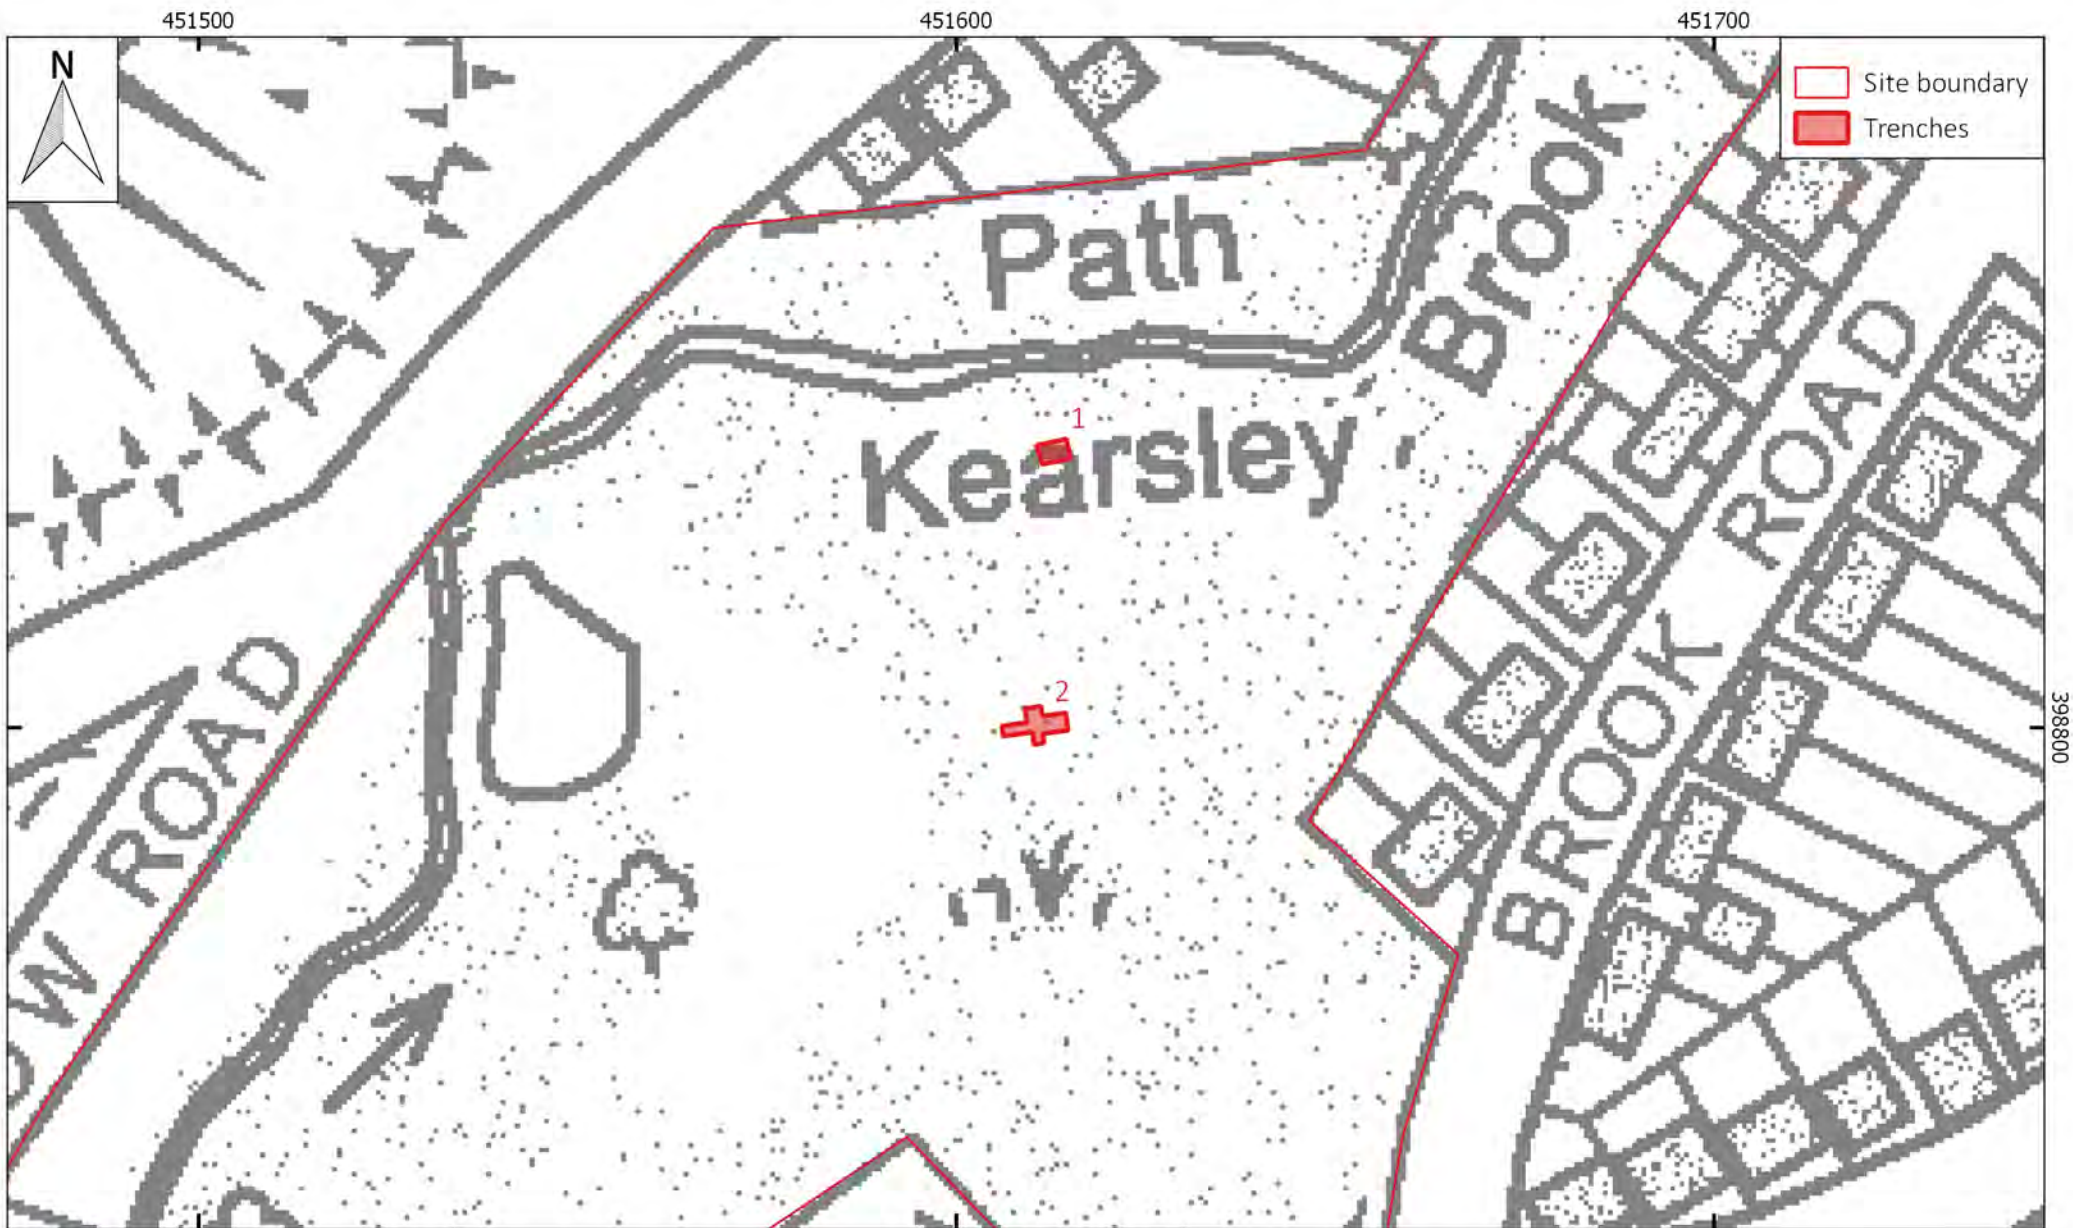
Figure 3: Trench location plan

Following the completion of the walkover survey and after discussions with volunteers, two trenches were opened: one in the location of Survey ID 2 (Trench 1) and another in the location of Survey ID 6 (Trench 2) (Figure 3). The features identified in these areas both demonstrated the potential for the survival of building remains.
