Castle Hill, Mexborough, South Yorkshire  
Archaeological test-pitting

ArcHeritage 2019

Project Name	DVLP Site B: Castle Hill
Report Title	Castle Hill, Mexborough, South Yorkshire: Archaeological Test-pitting
Report status	Final
ArcHeritage Project No.	663
Type of Project	Test-pitting
Client	DVLP
NGR	SK484999
OASIS Identifier	archerit1-306256
Author	Laura Strafford
Illustrations	Laura Strafford
Editor	Mark Stenton
Report Number and Date	2017/91 April 2019
Version and filename	V2 Castle Hill TP report V2.docx

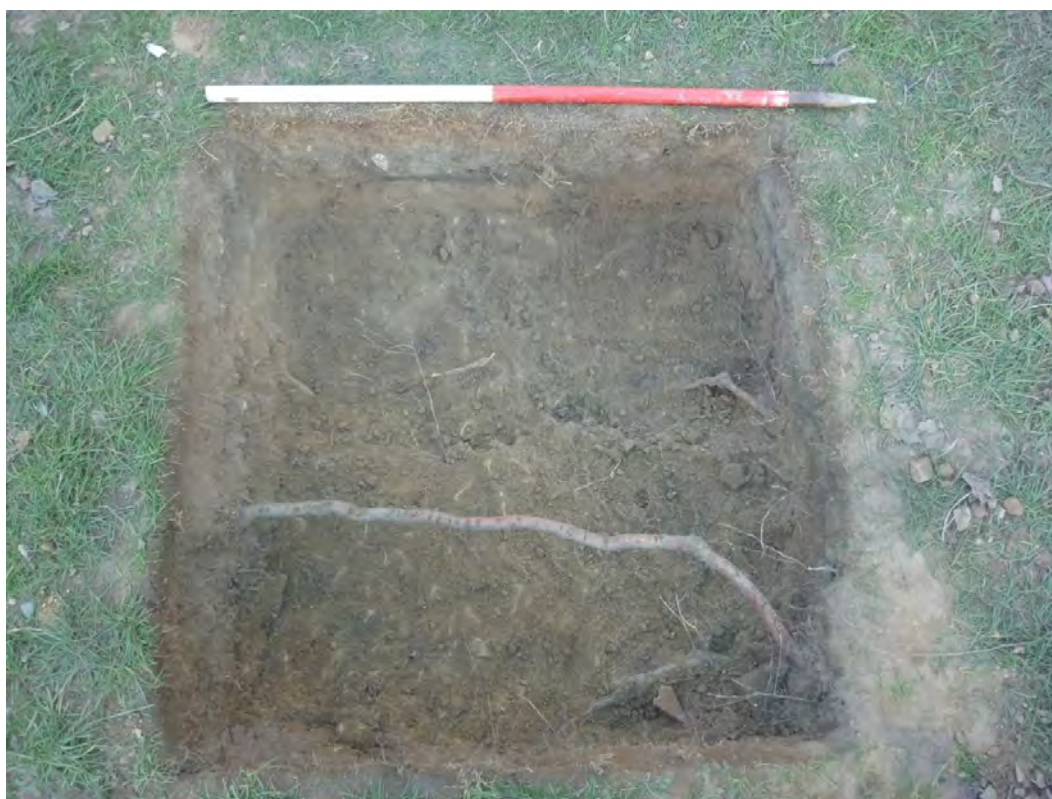
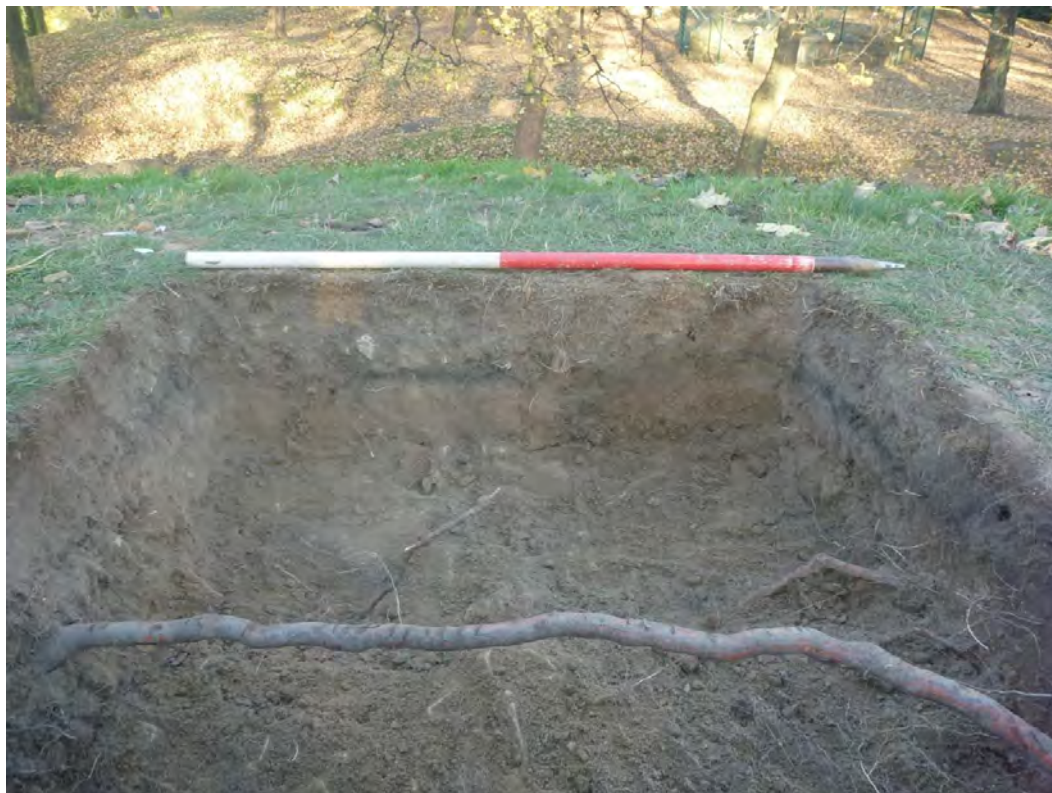
Test Pit 1 (Plates 1 and 2; Figure 3) was located on top of the motte. A thin line of turf in a silty matrix (101) directly overlay light brown-grey, fine, compact silt (102), which became very powdery upon excavation. Frequent roots and occasional sub-angular sandstone pebbles and cobbles were present throughout the deposit, which also contained pot and glass. This deposit (102) had a maximum thickness of 0.15m and directly overlay a lens of dark grey silt (103), which had a maximum thickness of 0.03m. The latter was present intermittently throughout the test pit. Directly beneath (103) was light brown-grey, fine, compact silt (104). While this was very similar to deposit (102), it contained a much higher concentration of sub-angular sandstone pebbles and cobbles, which made up approximately 50% of the deposit. Pottery was also recovered from this deposit. The depth of deposit (104) remains unknown, as it continued beyond the base of the test pit.

Plate 1: Test Pit 1. Looking north-east, scale 1m

Plate 2: Test Pit 1. South-west-facing section. Looking north-east, scale 1m

Nonetheless, these two test pits showed interesting differences, despite being located only 5m apart. Test Pit 2 contained only a single fill (201), which contained frequent sandstone boulders. In contrast, Test Pit 1 had a more defined stratigraphic sequence and, while it did contain sandstone inclusions, these were fewer and much smaller than those in Test Pit 2. It is possible that the sandstone boulders in Test Pit 2 may represent rubble/demolition from a structure which once stood on top of the motte. None of the stones were worked or faced, which suggests that they may be the remains of rough foundation courses.

The amount of 19<sup>th</sup> century artefacts recovered from Test Pit 1, some from the lower deposit (104), approximately 0.30m below the current ground surface, indicates that fairly recent activity has occurred upon the motte. This may have impacted any remains of an earlier structure. It should also be considered that the height of the motte has been reduced since any structure upon it was removed and that this may have removed all traces of any structure. The motte was found to currently stand at a maximum height of 7m.

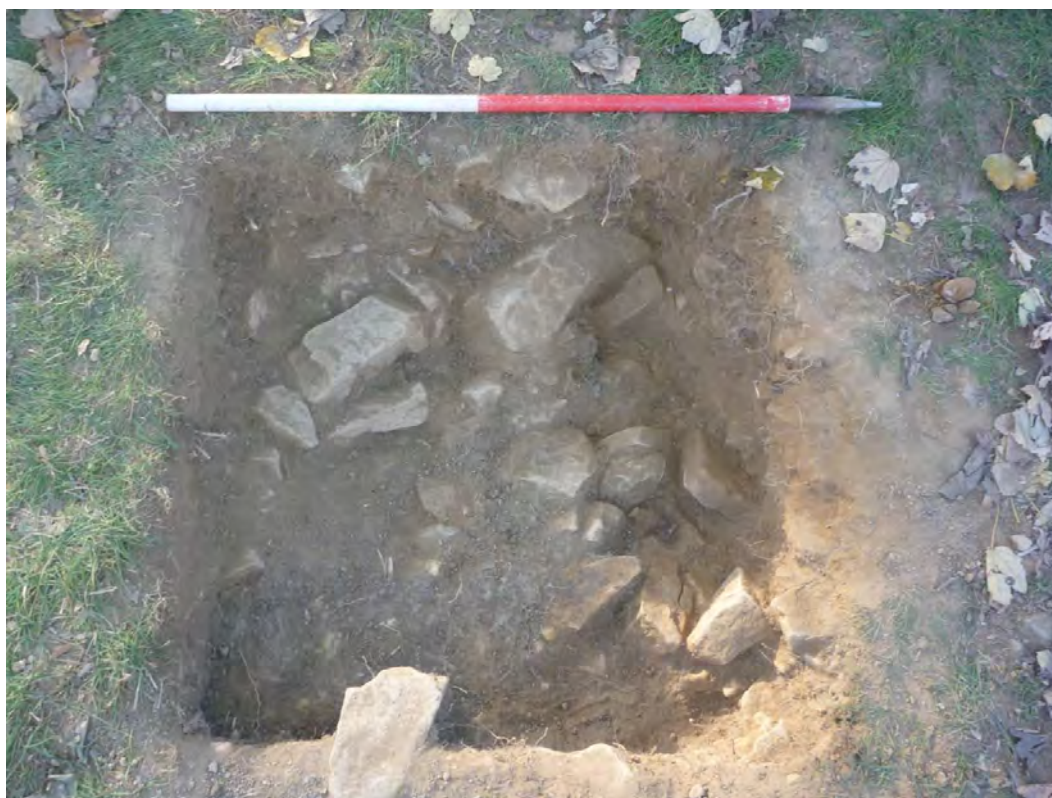
Test Pit 2 (Plates 3 and 4; Figure 4) was located on top of the motte, approximately 5m to the south-west of Test Pit 1. The test pit reached a maximum depth of 0.40m and contained only a single deposit (201). This comprised pale brown, silty-sandy clay with 40-50% angular and sub-angular sandstone inclusions, ranging in size from pebbles to boulders. Frequent roots were also present throughout the deposit. No archaeological features were observed within Test Pit 2 and no artefacts or other cultural material were recovered.

Plate 3: Test Pit 2. Looking south-west, scale 1m

Plate 4: Test Pit 2. South-east-facing section. Looking south-west, scale 1m

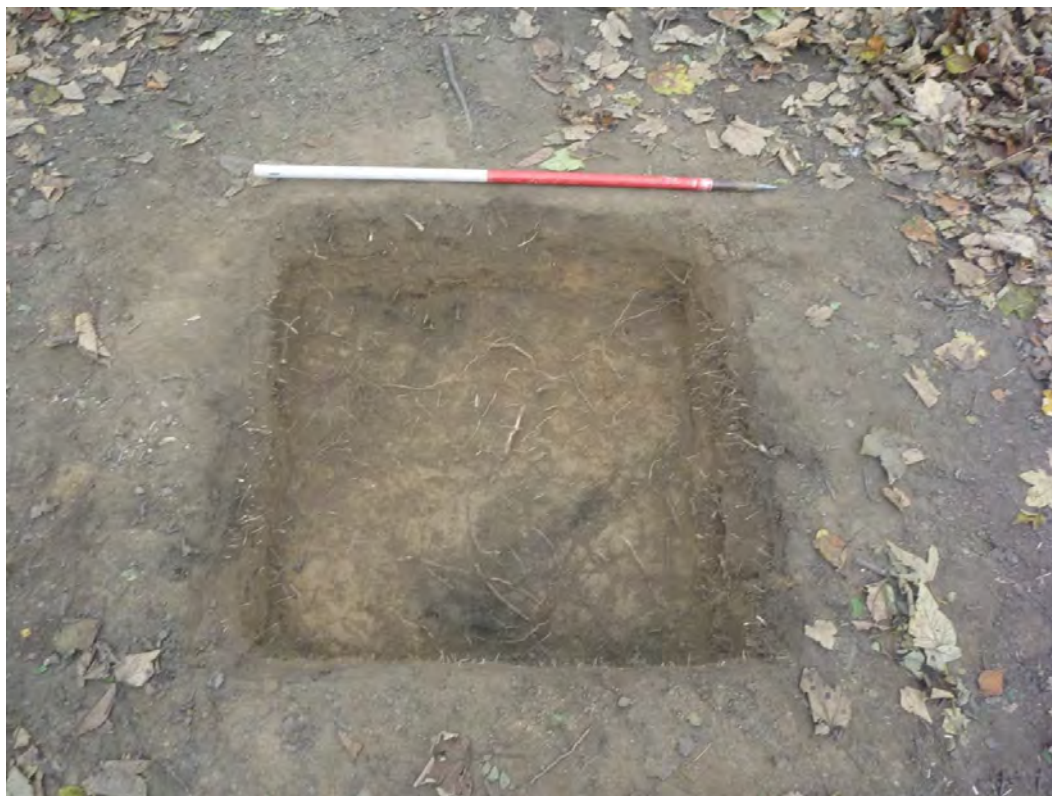
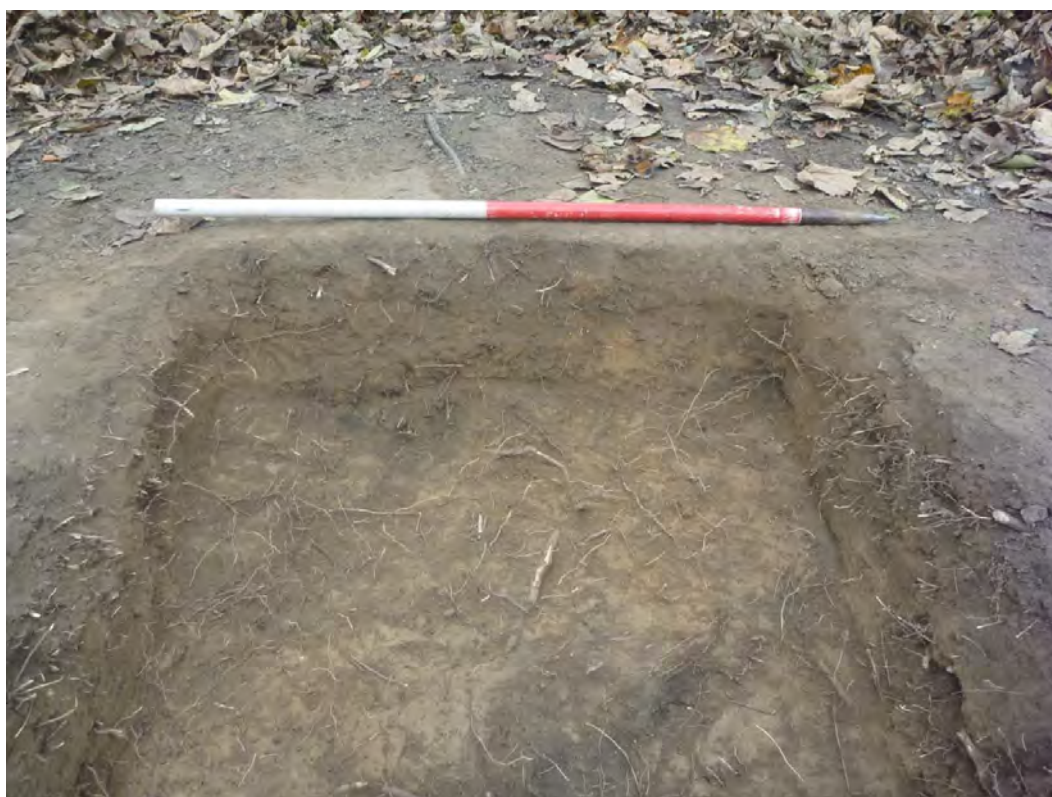
Test Pit 3 (Plates 5 and 6; Figure 5) was located within the bailey, to the south of the current bandstand. The test pit reached a maximum depth of 0.30m and contained a single deposit (301). This comprised mottled, pale to mid-brown silty-sandy clay that was very compact at the upper surface, but became friable with depth. Frequent tree roots and occasional sub-angular sandstone pebbles were present throughout the deposit. Occasional artefacts were scattered throughout (301), including pot, slag, glass sherds and two glass marbles.

Plate 5: Test Pit 3. Looking south-east, scale 1m

Plate 6: Test Pit 3. North-west-facing section. Looking south-east, scale 1m

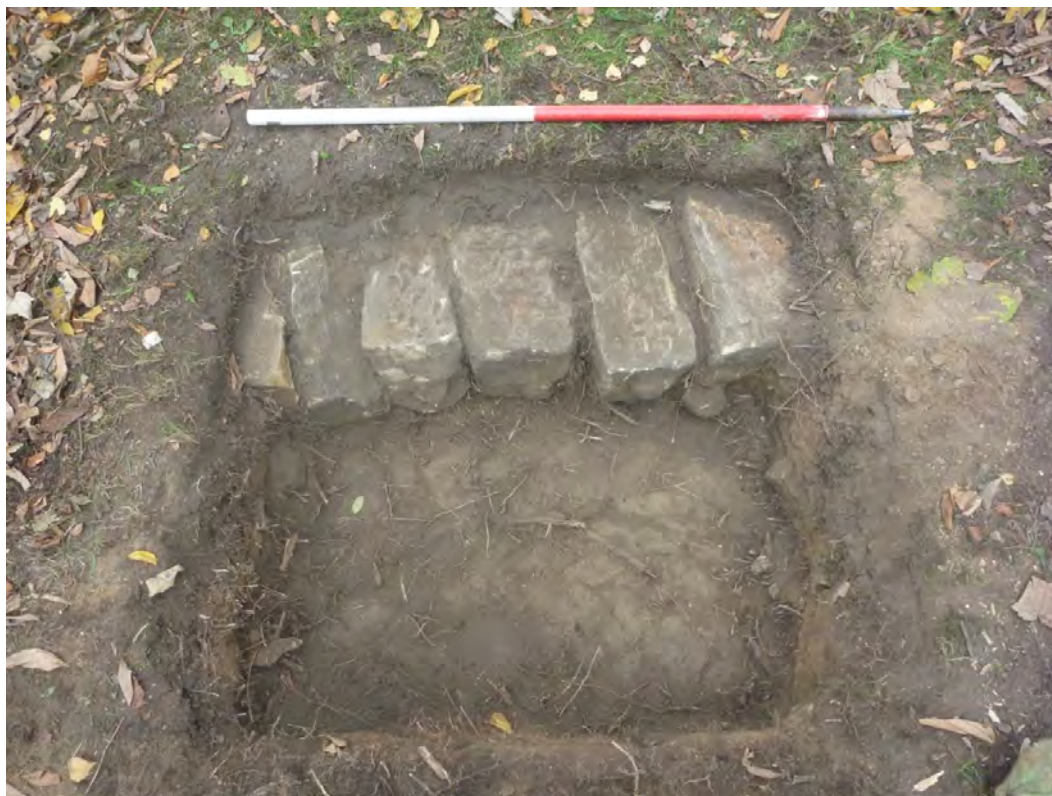
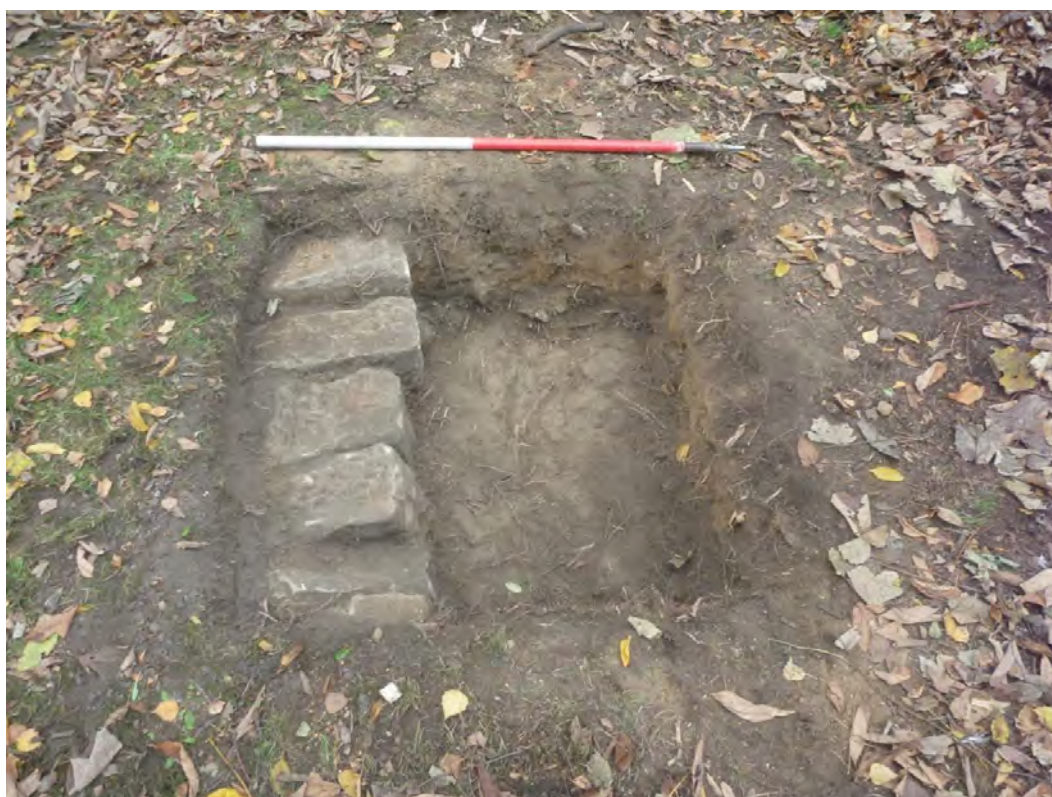
Test Pit 4 (Plates 7 and 8; Figure 6) was located within the bailey, to the north-east of the current bandstand. The topsoil (401) comprised dark brown, sandy silt with frequent roots and had a maximum depth of 0.10m. This directly overlay compacted pale brownish-yellow sandy clay subsoil (402), with occasional sub-angular sandstone inclusions. Directly beneath this was a similar deposit, but with a slightly higher clay content (403). This deposit contained a north-east to south-west aligned sandstone wall (406) that was present throughout the entirety of the test pit along its northern edge. No bonding material was observed between the stones, which were laid in stretcher formation. Each stone was between 0.15-0.20m in width, with the northern extent of the stone lengths extending beyond the northern confines of the test pit. The wall comprised a single course and was 0.30m in visible width and approximately 0.20m in thickness.

Immediately beneath deposit (403) was an intermittent layer of humic rich black clay silt (404), that contained frequent roots. This is likely to be material derived from root activity, being redeposited topsoil material transported by root action. At the base of the test pit was a dark brown, hard, compacted clay (405), which extended beyond the base of the test pit.

Plate 7: Test Pit 4. Looking north-west, scale 1m

Plate 8: Test Pit 4. Looking north-east, scale 1m

The wall in Test Pit 4 was very close to the modern ground surface. While no dating evidence was recovered in association with this wall, the small amount of the feature that was exposed within the test pit seemed likely to be related to the 19<sup>th</sup>- and 20<sup>th</sup>-century landscaping of the park.

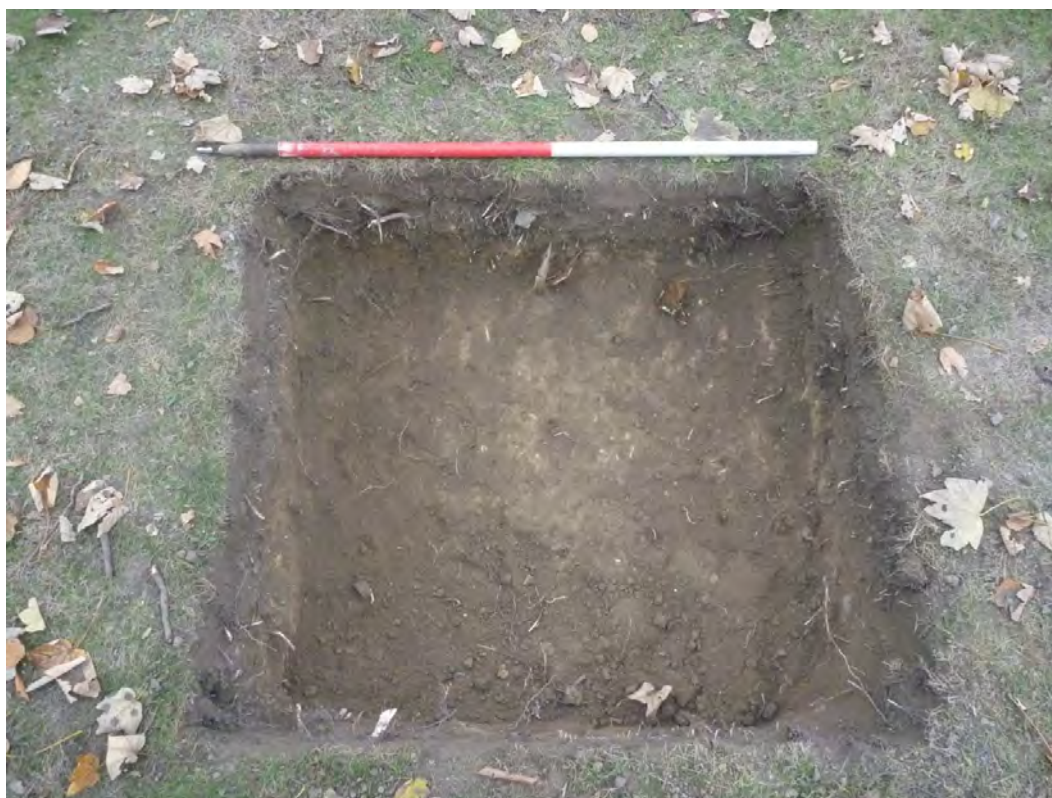
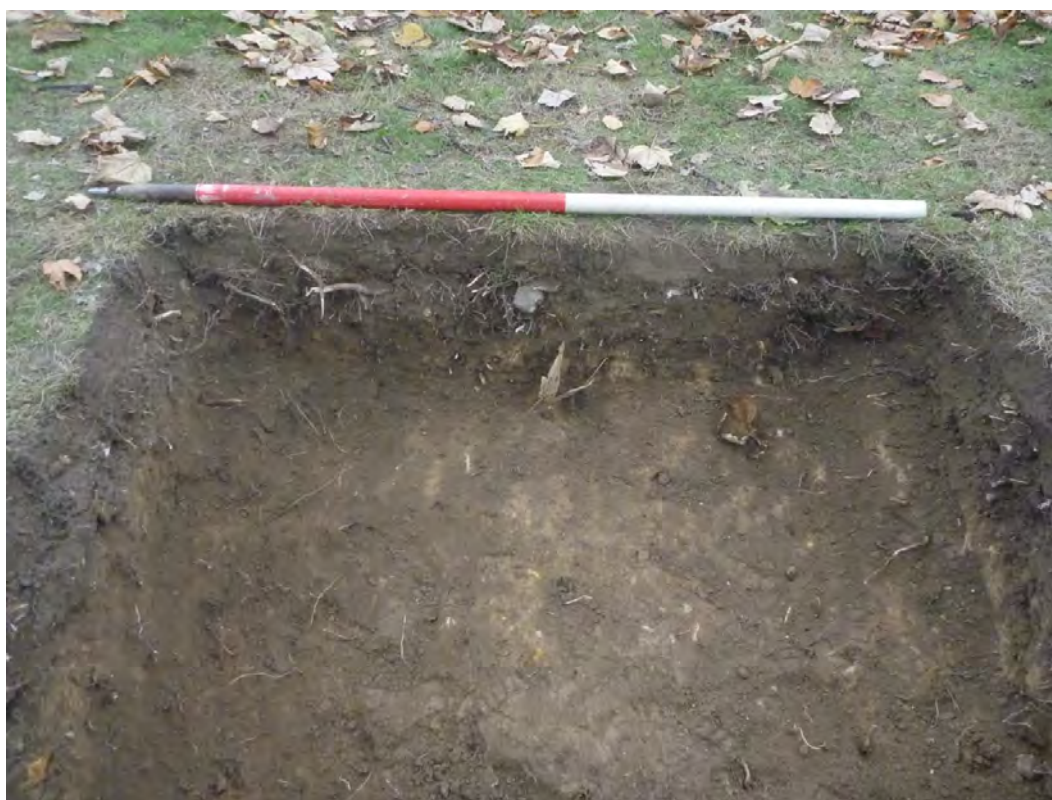
Test Pit 5 (Plates 9 and 10; Figure 7) was located within the 'crescent-shaped' earthwork, that has previously been described as the entrance to the motte. This feature had recent stone edging. A pathway appeared to have been cut through the earthwork.

The topsoil (501) comprised dark brown clay silt with frequent root activity, with a maximum thickness of 0.17m. This directly overlay very dry, mottled orange-brown sandy-silty clay (502), with occasional sub-angular sandstone inclusions and frequent root activity. Fragments of pottery were recovered from this deposit, including two fragments of saggar. Deposit (502) extended beyond the base of the test pit, which reached a maximum depth of 0.32m.

Plate 9: Test Pit 5. Looking south-east, scale 1m

Plate 10: Test Pit 5. North-west-facing section. Looking south-east, scale 1m

The fragmented and disorganised nature of the inclusions within deposit (502) in Test Pit 5 suggests that human agency was involved in the formation of the deposit. It is not clear if the pottery inclusions are dating evidence for the deposit itself or if these were later additions. Certainly, the edging and pathways throughout the earthwork indicate fairly substantial, modern disturbance.

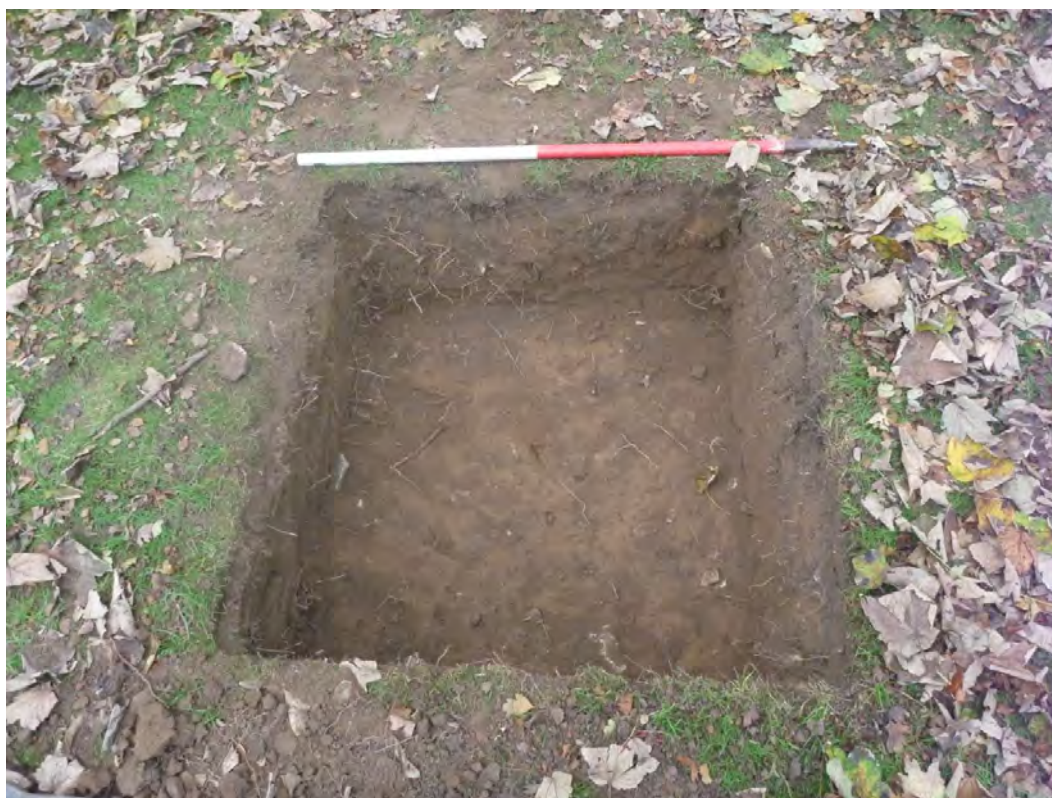
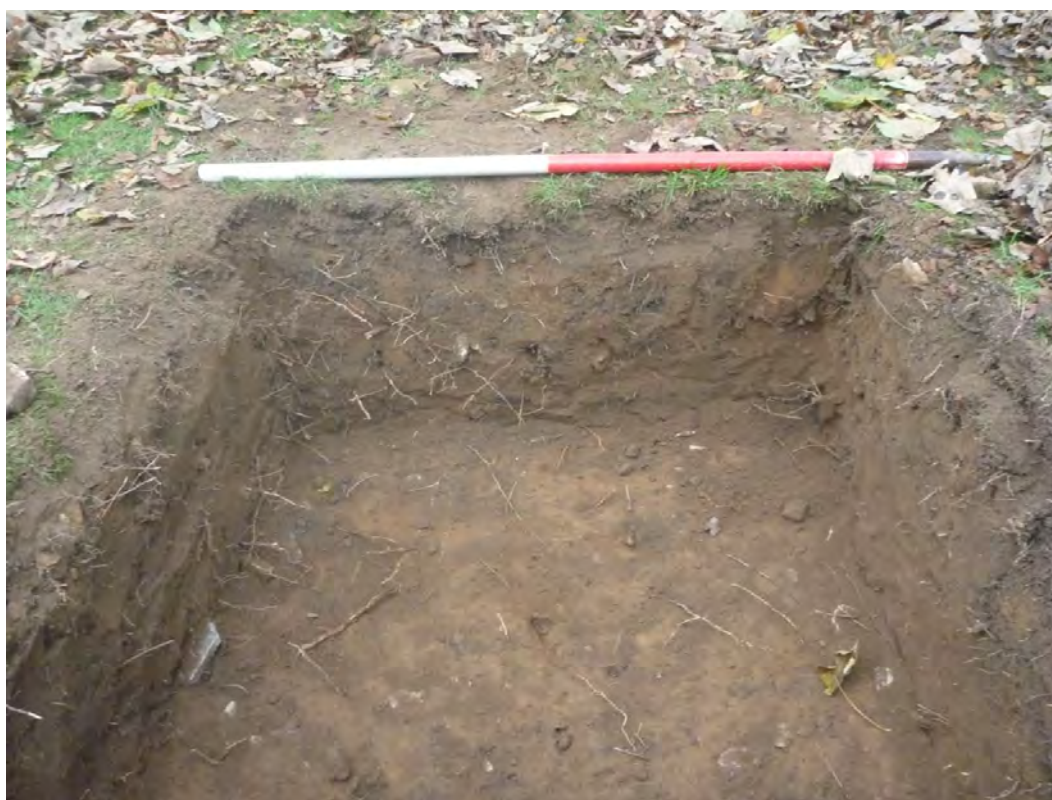
Test Pit 6 (Plates 11 and 12; Figure 8) was located at the base of the motte. The topsoil (601) comprised dark brown clay silt with frequent rootlets and a uniform thickness of 0.10m. Immediately underlying this was mottled pale and mid-orange brown dry sandy clay (602), with occasional inclusions of sub-angular sandstone pebbles. This deposit was excavated to a depth of 0.35-0.40m and continued beyond the base of the test pit. Occasional fragments of pottery were recovered from deposit (602), including some kiln furniture.

Plate 11: Test Pit 6. Looking north-west, scale 1m

Plate 12: Test Pit 6. South-east-facing section. Looking north-west, scale 1m

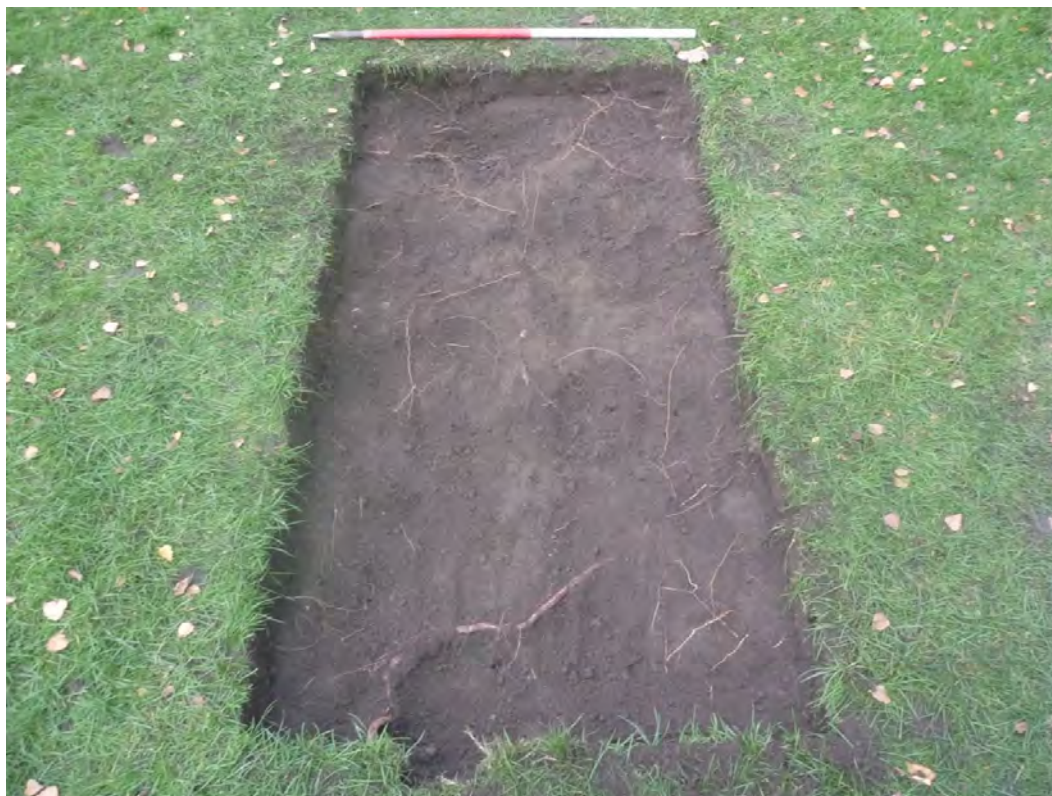
Test Pit 7 (Plates 13 and 14; Figure 9) was located within the grounds of New Pastures Primary School, immediately adjacent to the Scheduled site. This test pit measured 2x1m and was excavated by the pupils of the school. The topsoil (701) comprised mid-brown sandy silt with occasional inclusions of sub-angular sandstone pebbles. Various artefacts were recovered from the topsoil, including pottery, clay pipe stem, a plastic button and glass. The topsoil was excavated to a depth of 0.15m and continued beyond the base of the test pit.

Plate 13: Test Pit 7. Facing north. Scale 1m

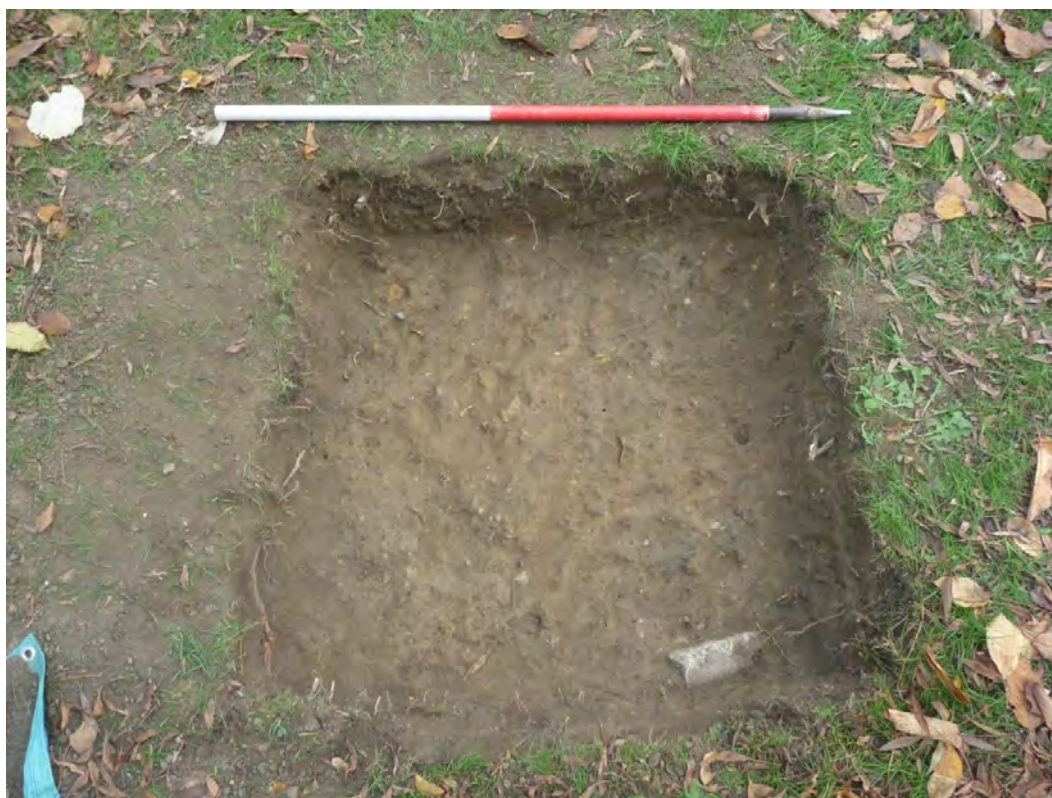
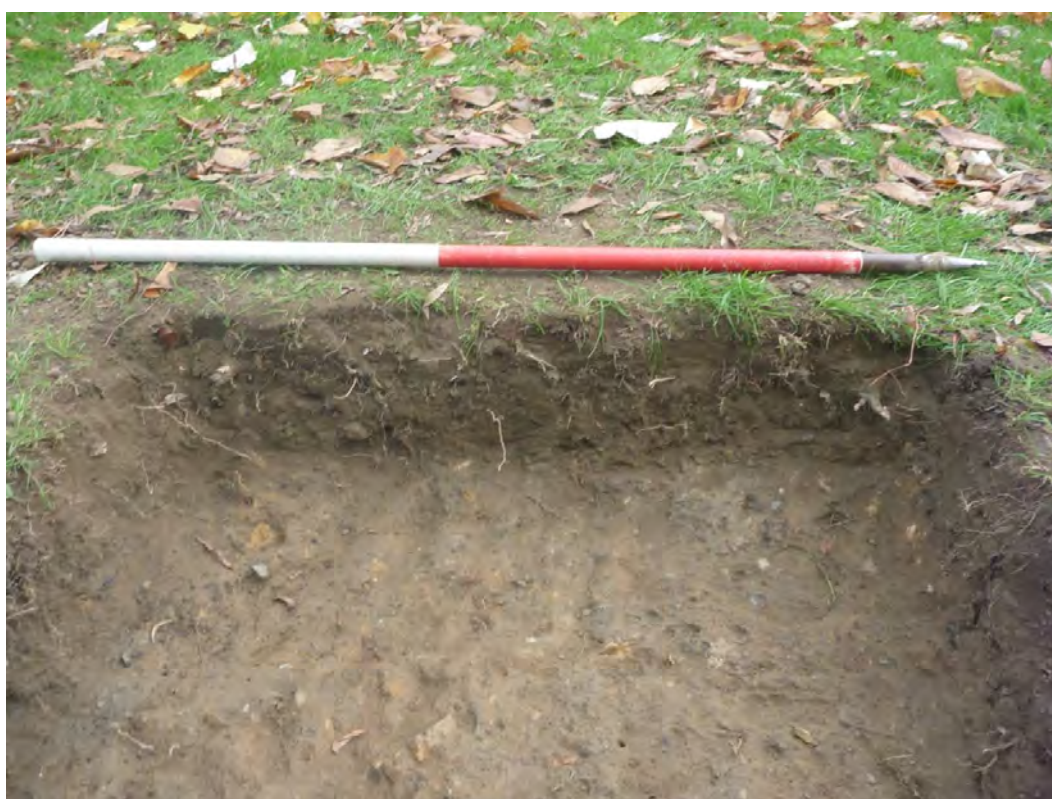
Test Pit 9 (Plates 17 and 18; Figure 11) was located in the recreation ground, to the immediate north of the Scheduled area. The topsoil (901) comprised dark brown silty clay, approximately 0.10m thick, with occasional roots. Immediately underlying this was light brown, compact silty clay (902), with occasional inclusions of crushed brick and slag. Pot, glass and charcoal were also present throughout this deposit, which extended beyond the base of the test pit.

Plate 15: Test Pit 9. Facing south-east, scale 1m

Plate 16: Test Pit 9. North-west-facing section. Facing south-east, scale 1m

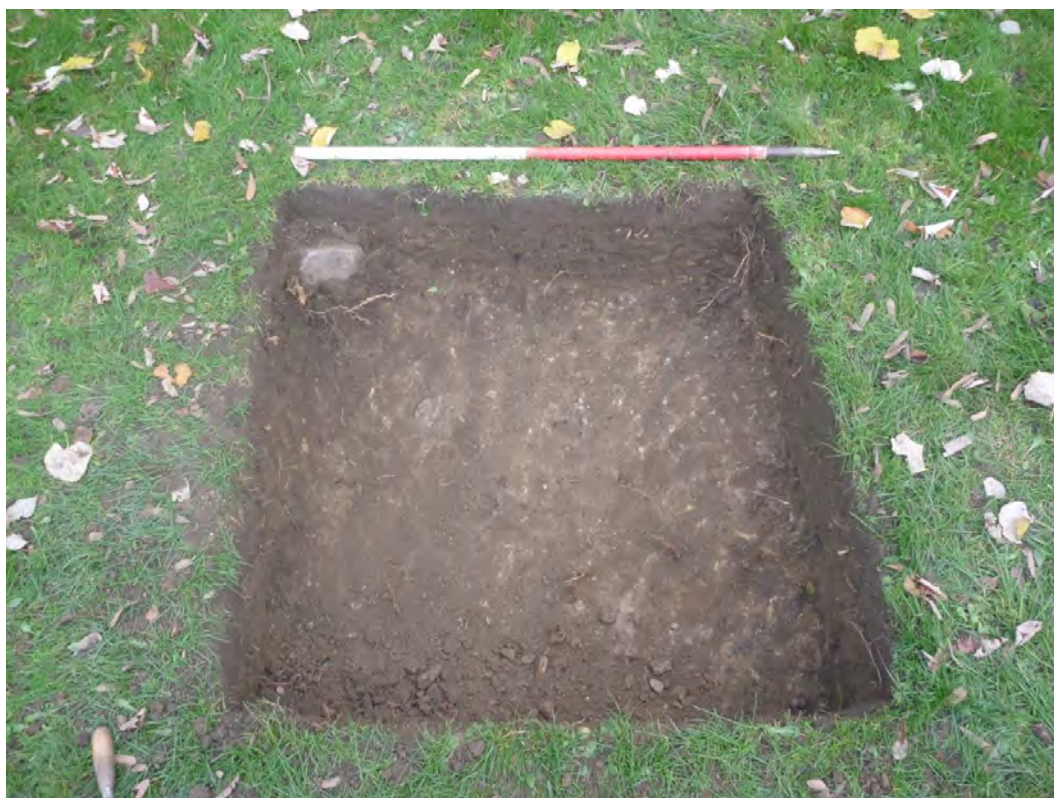
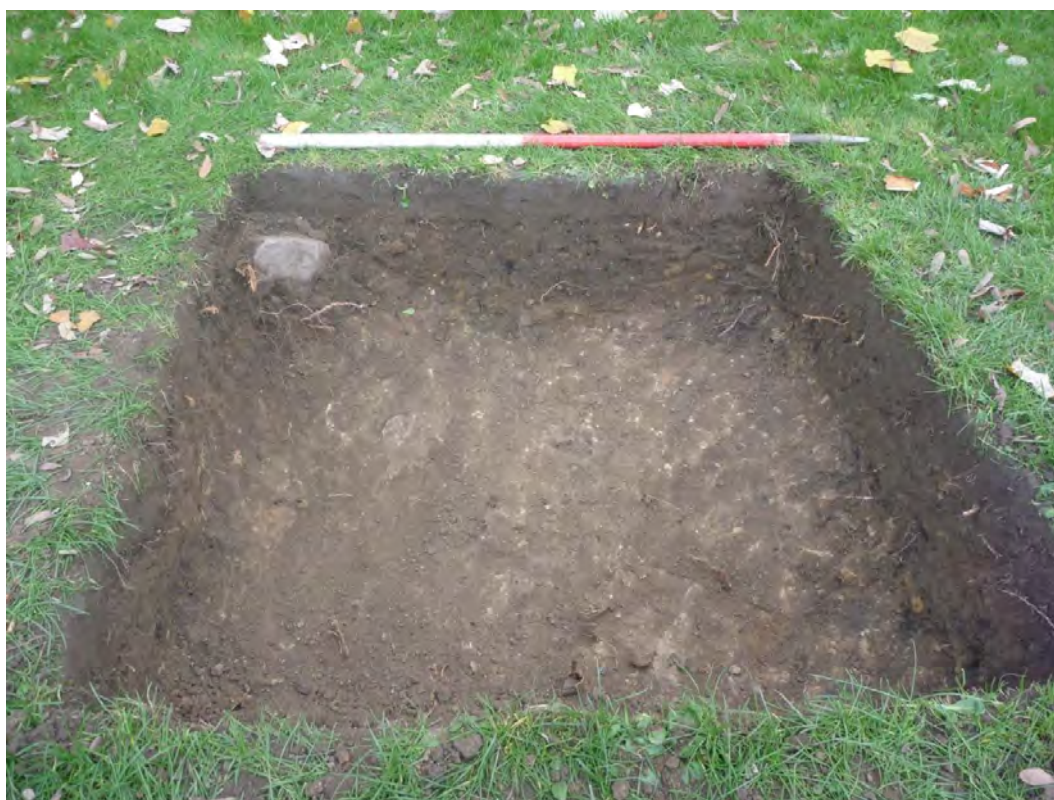
Test Pit 10 (Plates 19 and 20; Figure 12) was located in the recreation ground, to the immediate north of the Scheduled area. The topsoil (1001) comprised dark brown silty clay with occasional roots and an overall thickness of 0.10m. Immediately underlying this was dark brown silty clay (1002) with common sandstone sub-angular pebble inclusions. Pottery and glass were also recovered from this deposit, which had a maximum thickness of 0.18m. This directly overlay a compact, pale yellow silty sand (1003) with very frequent sandstone inclusions and occasional roots. One fragment of glass was recovered from this deposit. Deposit (1003) extended beyond the base of the test pit.

Plate 17: Test Pit 10. Facing south, scale 1m

Plate 18: Test Pit 10. North-facing section. Facing south, scale 1m

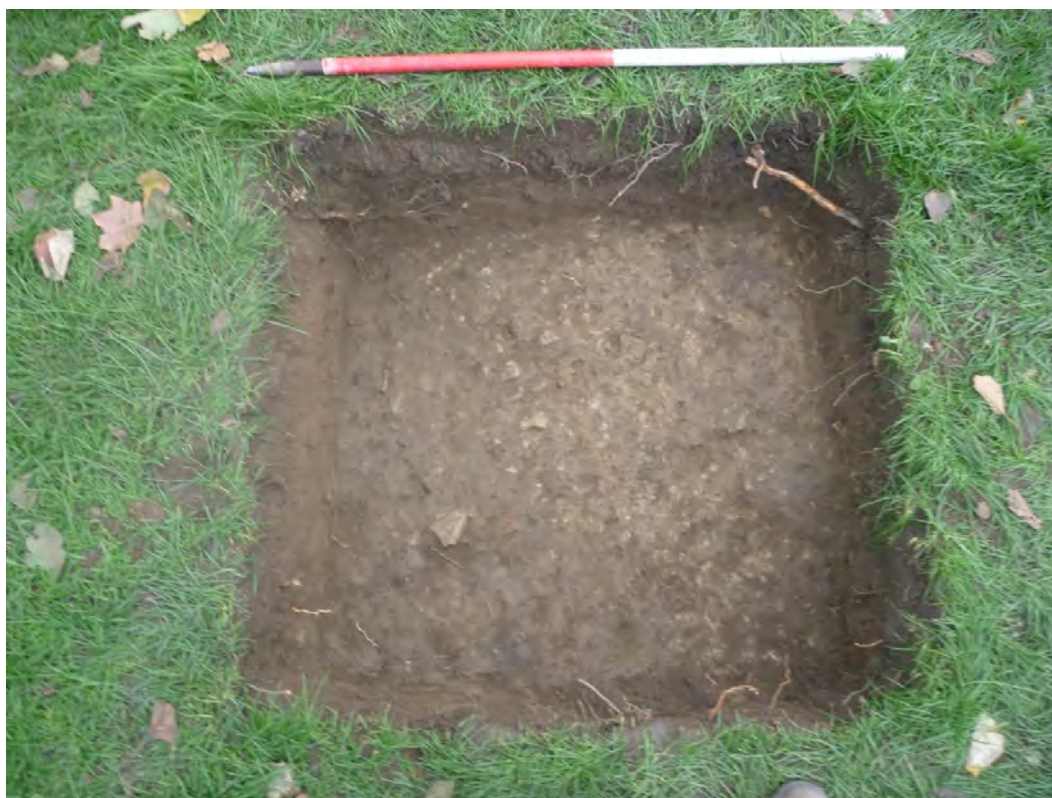
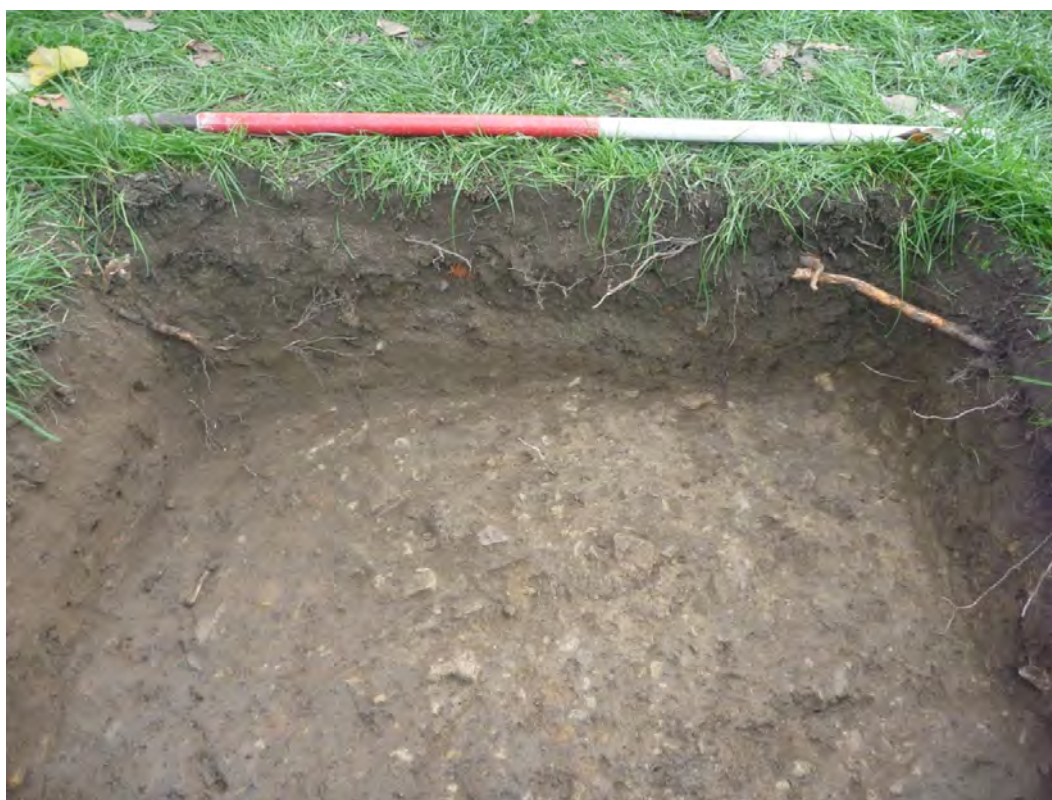
Test Pit 11 (Plates 21 and 22; Figure 13) was located in the recreation ground, to the immediate north of the Scheduled area. The topsoil (1101) comprised dark brown silt clay with occasional small pebbles and roots. The topsoil (1101) had a maximum thickness of 0.15m and contained

occasional pot fragments and one glass marble. Directly underlying the topsoil was light brown, compact silty clay (1102), containing frequent stone pebbles, brick fragments and pot. This deposit undulated gently, but had an average thickness of 0.10m. Directly underlying (1102) was pale orange compact silty clay with occasional sandstone inclusions (1103). Pottery fragments were recovered from this deposit. Deposit (1103) extended beyond the base of the test pit and its depth is unknown.

Plate 19: Test Pit 11. Facing north, scale 1m

Plate 20: Test Pit 11. South facing section. Looking north, scale 1m

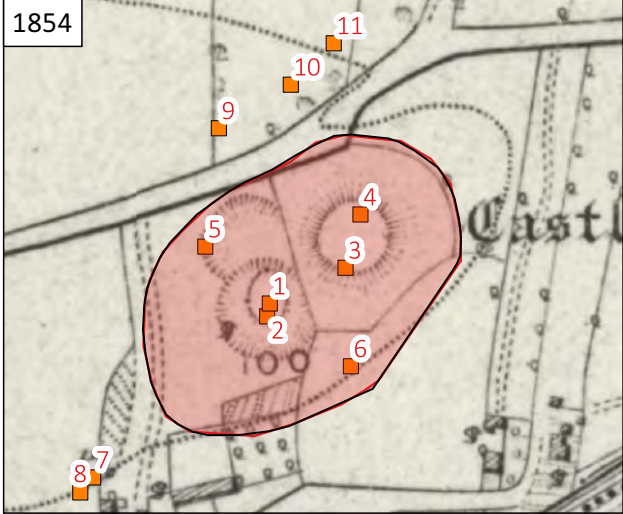
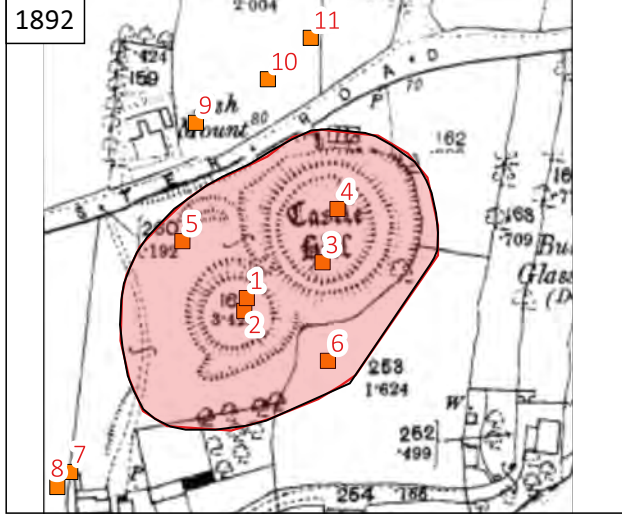
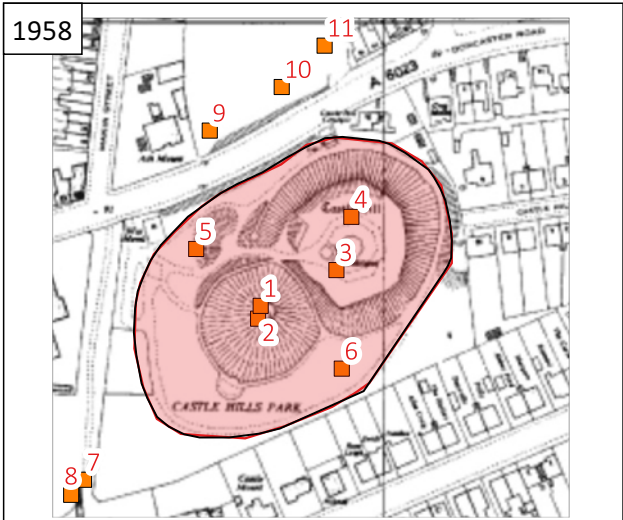
Figure 14: Historic maps of the site 1839-1967

The succession of historic maps covering the area (Figure 14) suggest that the earthworks have been much altered since 1839. It seems highly likely that earlier alterations had occurred in the period between the castle becoming disused and the 19<sup>th</sup> century. There is no known cartographic evidence to demonstrate these modifications.
