Hoyland Lowe Stand, Hoyland Historic Building Recording

Hoyland Lowe Stand, Hoyland Nether, South Yorkshire:
Level 2 Historic Building Survey

Project Name	Hoyland Lowe Stand Hoyland, South Yorkshire
ArcHeritage Project no.	663
Report status	Final
Type of Project	Historic Building Recording
Client	Dearne Valley Landscape Partnership
NHLE ID	1151093
OASIS ID	archerit1-323415
NGR	SE 363 009
Authors	Greg Laban
Illustrations	Greg Laban
Editor	Mark Stenton
Report Number and Date	2018/47 April 2019
Version and Filename	V2 Hoyland Lowe Stand report V2.docx

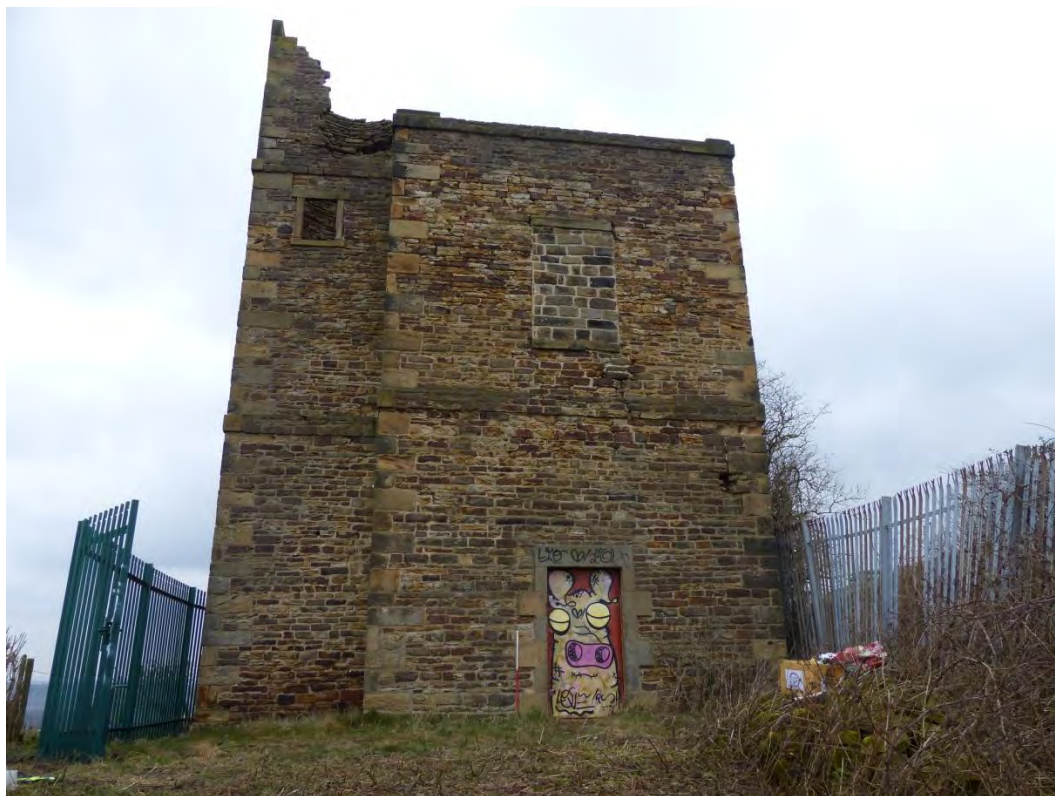
Plate 5: South elevation, looking north

The south elevation (Plate 5; Figure 7) features the main entrance door centred within the elevation. The door opening has ashlar stone block and start surrounds and a replacement modern iron door (Plate 6). Above the string course is a single centred window opening, now infilled with stone blocks. The window opening features a stone lintel and sill (Plate 7). Above the window is the string/eaves course that would have been located at the base of the parapet,

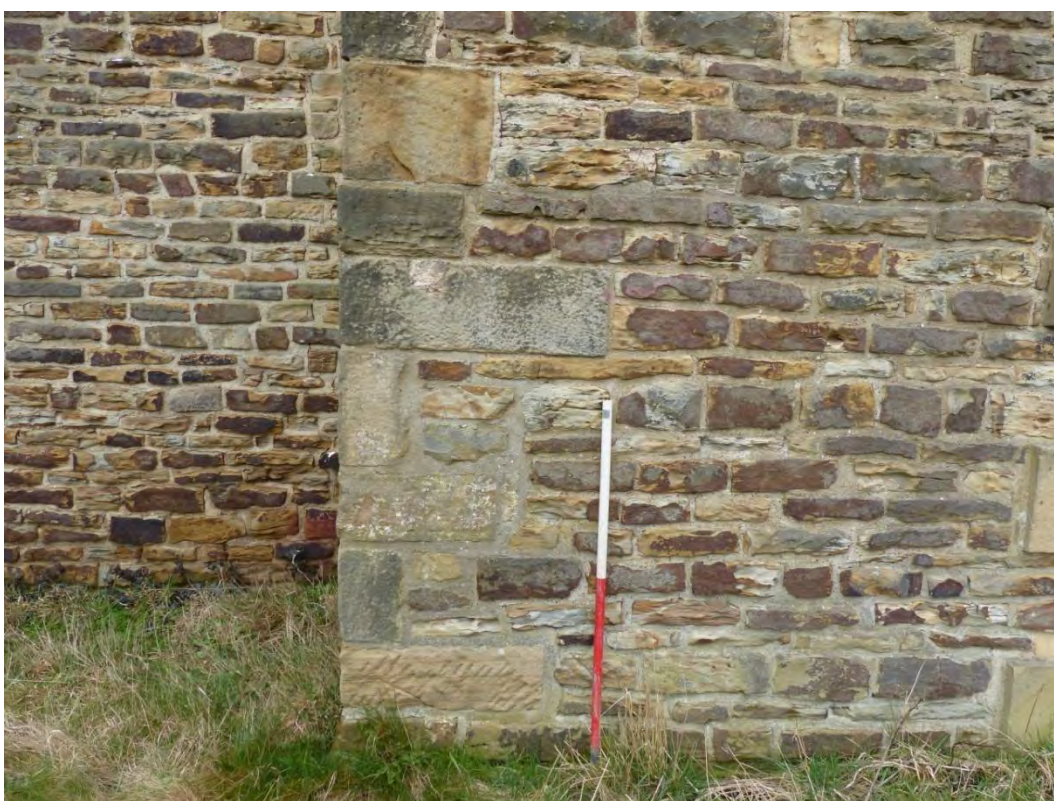
Plate 8: Detail view of quoins to south elevation, looking north

which is now removed. The edges of the elevation have ashlar block and start quoin stones (Plate 8).

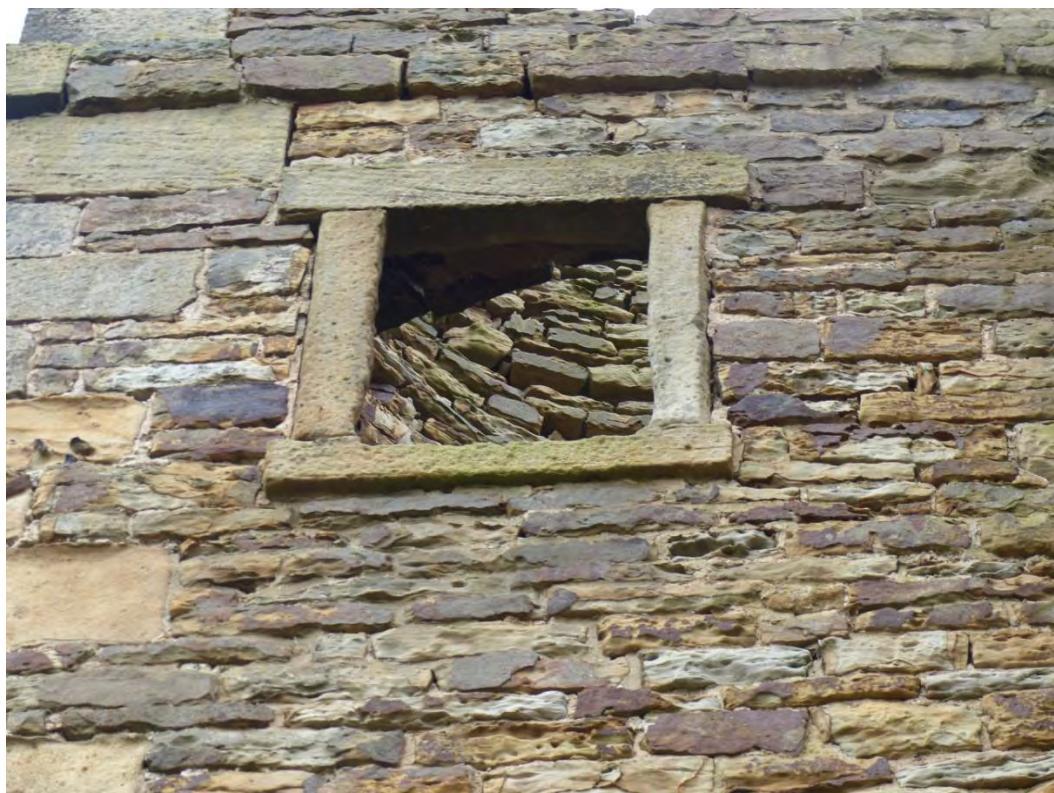
Plate 10: Detail of window to south elevation of stair turret, looking north

The south elevation of the stairwell block has quoins to the west end and a single window opening to the second stage; this is located to the top of the level and is slightly askew to the west (Plate 9). The window opening has a stone lintel, sill and surrounds (Plate 10). The third stage is partially in ruins.

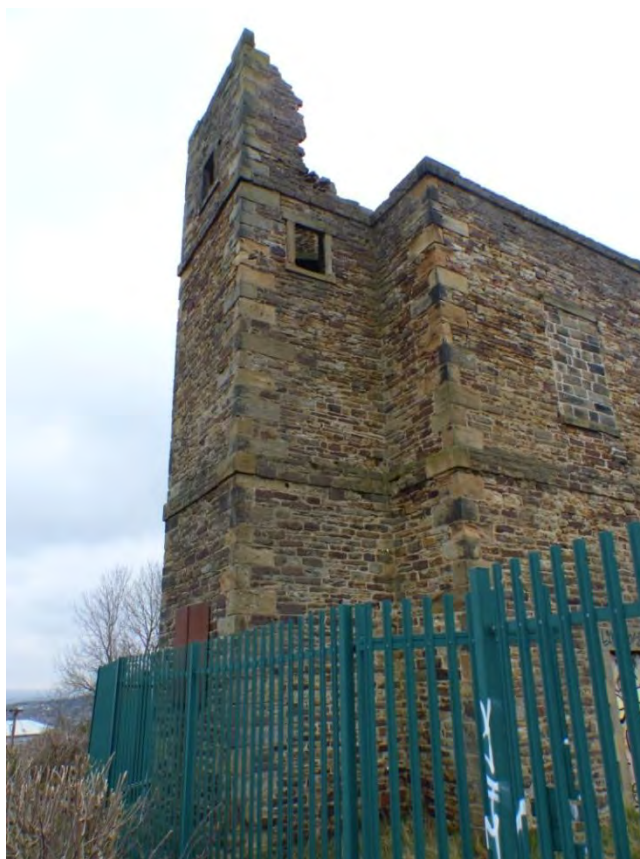
Plate 11: View of stair turret, looking north-east

The north elevation is comprised of the north facing elevation of the stairwell and two flanking ends of the main block (Plate 11). The stairwell has a single centred window opening to the first stage, now covered by iron sheeting. A second window opening is centrally located on the third stage with stone surrounds, lintel and sill.

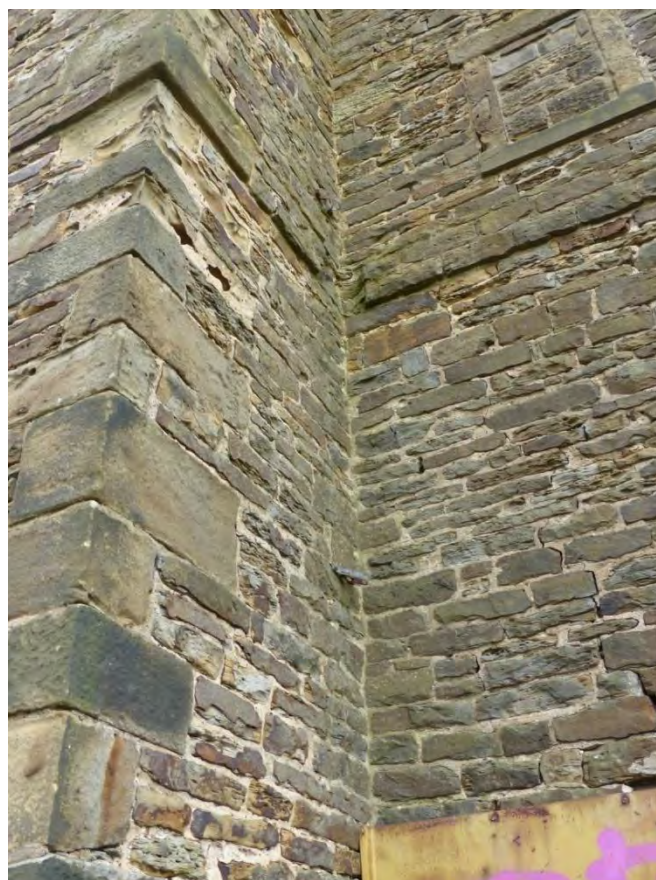
Plate 14: View of disused rainwater brackets to north elevation, looking south-east

The north elevation (Figure 8) is very similar to the south elevation, with the only differences including an area of collapse to the central opening that has been covered with iron sheeting (Plate 12). The sheeting partially covers what appears to be a central window opening that has been blocked with stone blocks up to the string course level. A centrally-located window to the second stage is similar to the south elevation, but this one retains stone surrounds as well as the stone sill and lintel. This window opening is also infilled with stone blocks. The north elevation of the stairwell block features a ground-floor door opening, now blocked by iron sheeting (Plate 13). Two metal brackets that once held rainwater goods were located on the east side of the north elevation (Plate 14).

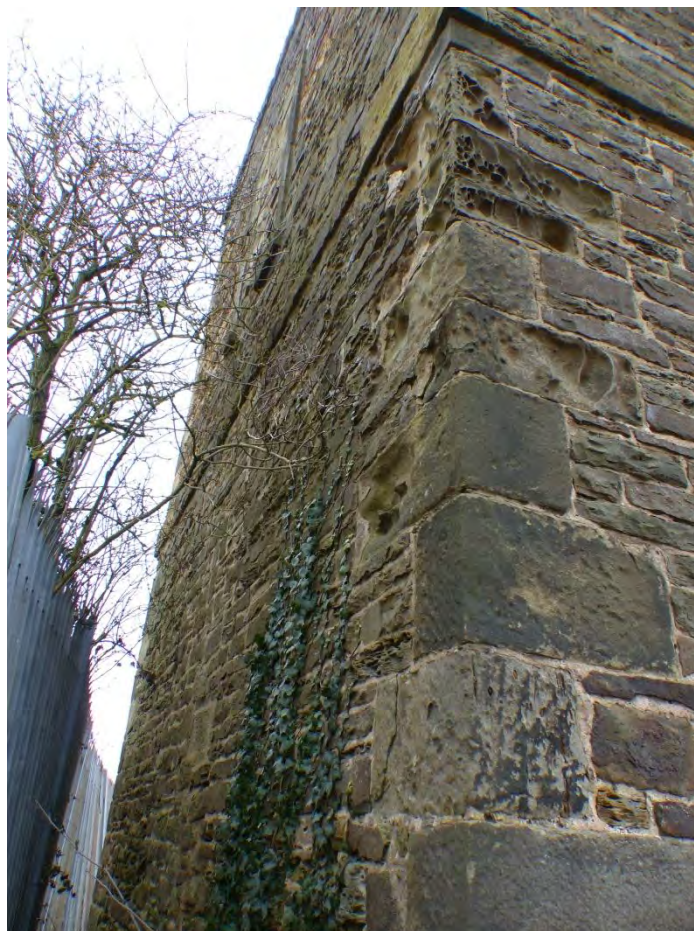
Plate 17: View of the east elevation, looking south-west

The east elevation (Plate 17) was difficult to survey as access was limited due to the current site fencing. The majority was visible, but it was not possible to take adequate photographs. The east elevation features a blocked window opening at the first stage level with very little remains of the opening visible, besides some straight joins, some differently cut stone blocks and more recent concrete mortar. The second stage features a similar window opening to the north and south elevations, with stone surrounds, lintel and sill, and filled with stone blocks.

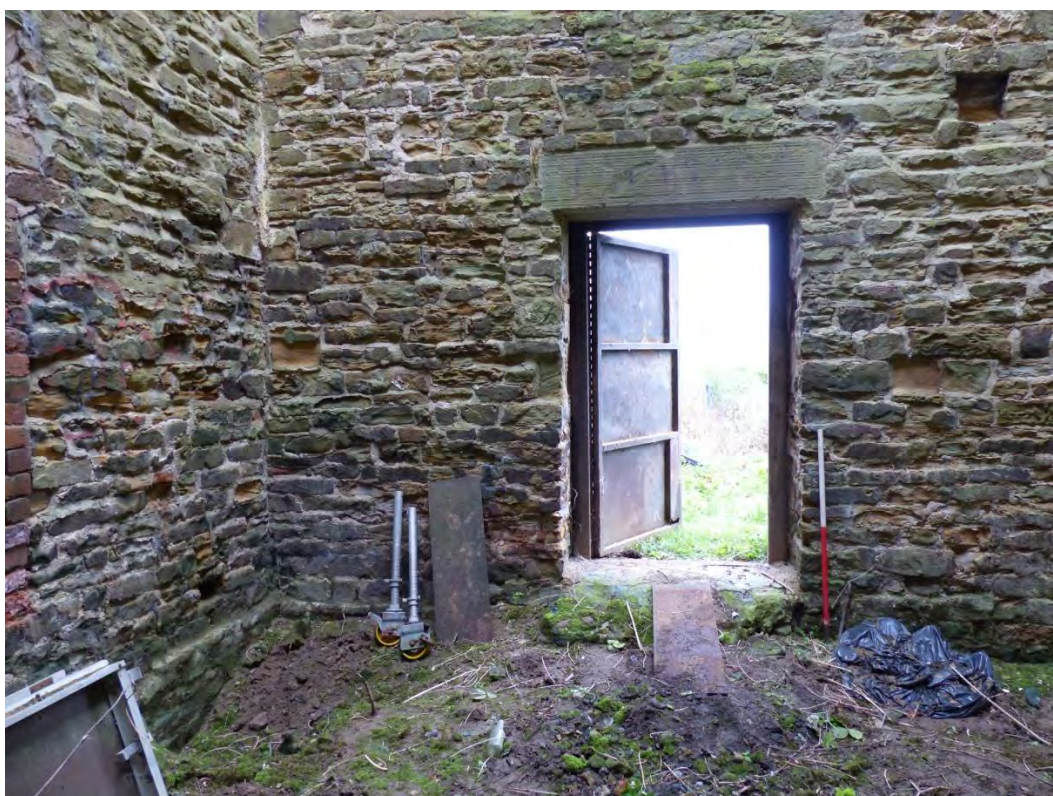
Plate 22: Door opening south interior wall, looking south

The ***south wall of the interior*** features the central door opening used for accessing the building (Plate 22). The opening now features a metal door and the interior has a modern concrete lintel above it. A square-headed window opening is located at the centre of the first floor elevation and is now blocked with stone and mortar, although a recess is visible (Plate 24). The window opening features brick voussoirs and a two-part stone sill. There are recesses in the stonework just below the door opening that likely would have held timber beams to help support the flooring here. Above the opening at the first-floor ceiling height are a number of openings for joists (Plate 25) that would have supported the observation deck/roof.

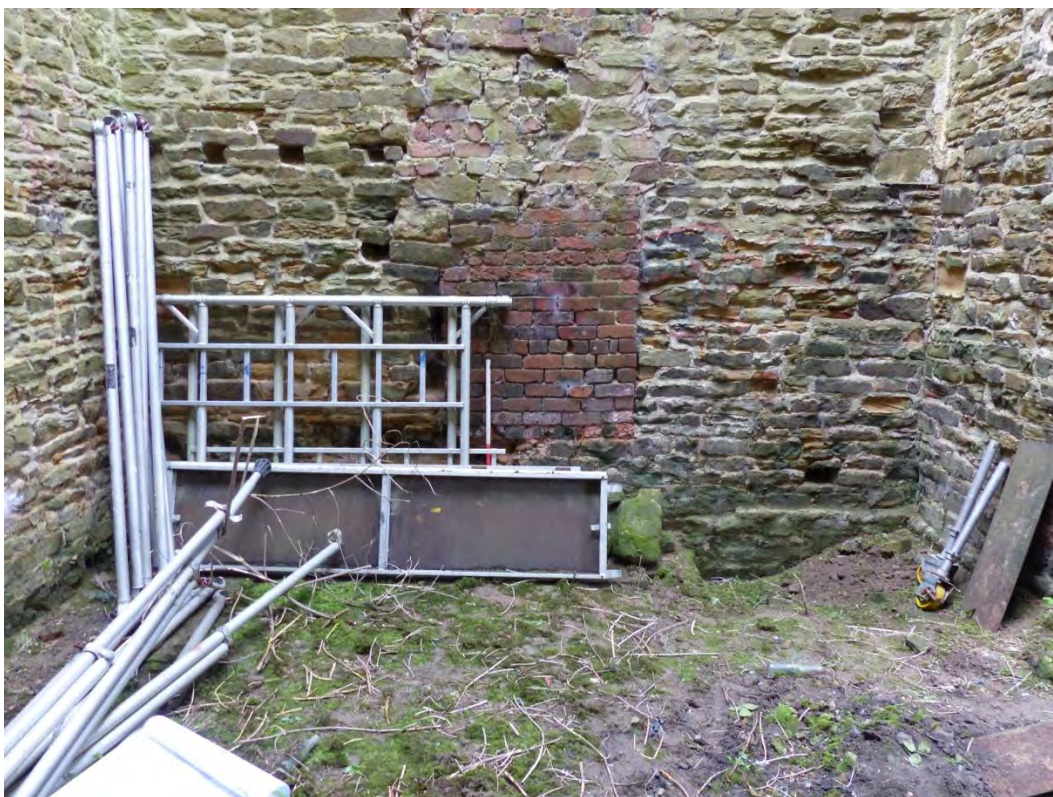
Plate 26: Lower portion of east wall interior, looking east

The ***east wall of the interior*** is composed in similar stone to the exterior. A central double window opening is blocked by red brick to the interior (Plate 26). It was originally two windows stacked on top of each other, which can be seen on a historic photograph of the building (Plate 4). Open mortises to the first floor would have held timber joists, whilst a slight lip would have helped to support the floorboards. The recessed window opening on the first floor is blocked

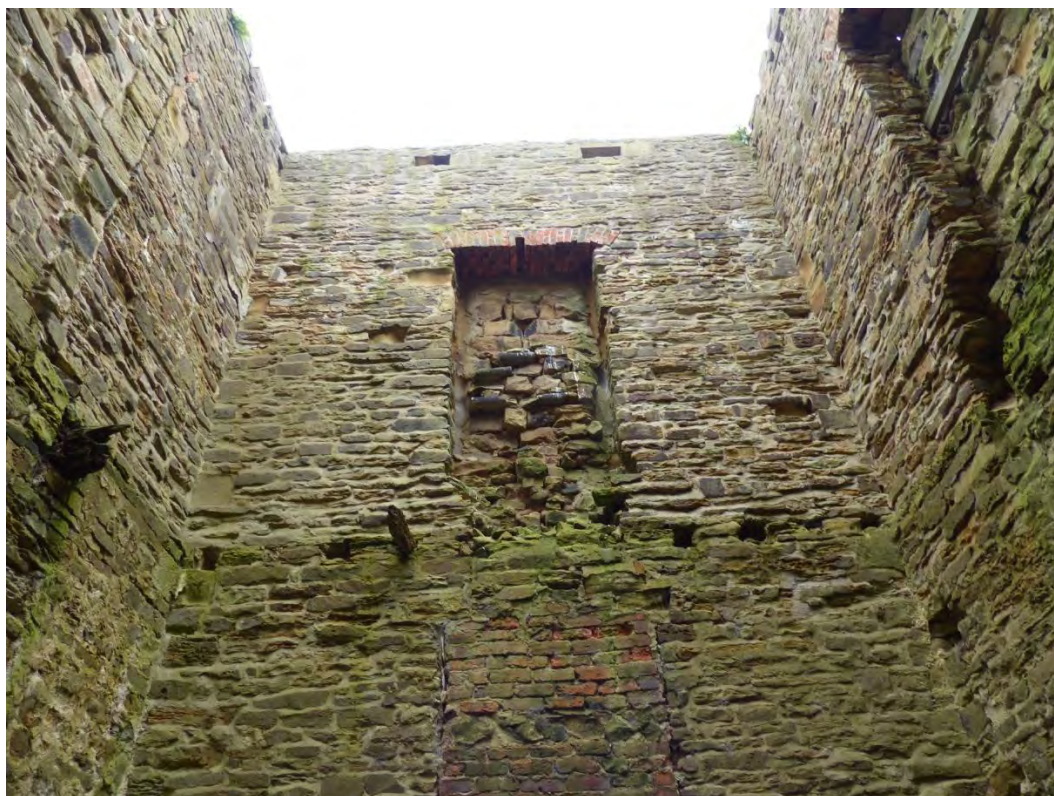
Plate 28: Upper portion of east wall interior, looking east

with stone and has brick voussoirs to interior (Plate 28). Two open mortises to the top of the wall would have supported beams for the roof.

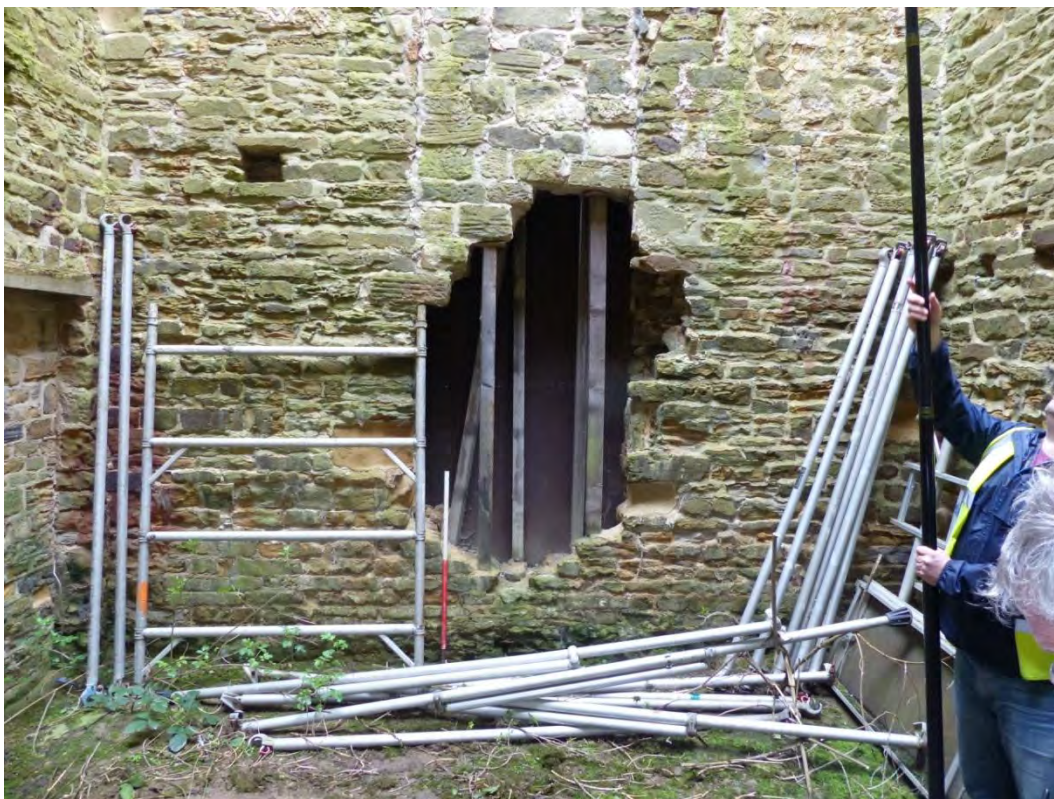
Plate 29: Lower portion of north wall interior, looking north

The *north elevation interior* is constructed of sandstone and pointed with sand and cement mortars. At first-floor level there is evidence of two timber joists which would have supported the first floor (Plate 30). The ceiling of the first floor has several openings to support the joists for the viewing platform/roof of the main block. The first floor window is blocked with stone. To the ground floor there is evidence of a window filled with sandstone blocks, but the base has collapsed creating a large gap in the stonework of the wall. The stonework has been propped with vertical timber beams and the hole is covered from the exterior with a metal sheet (Plate 29).

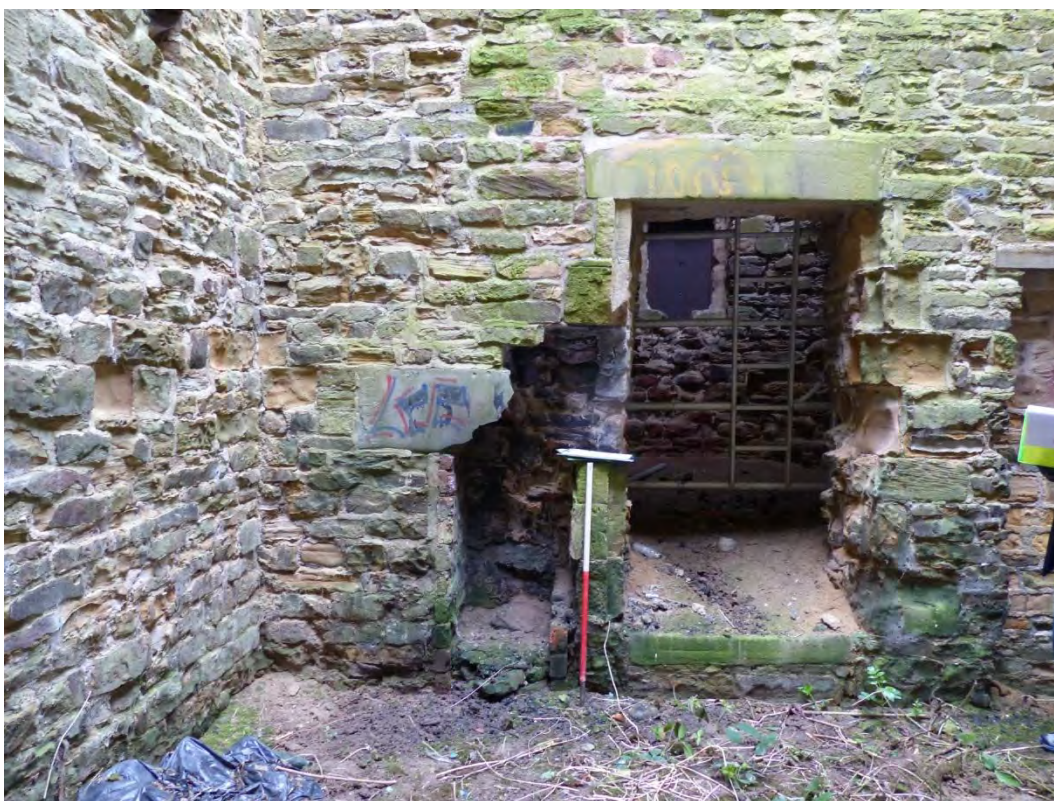
Plate 32: Lower portion of the west interior wall, looking west

The stairwell block is entered through an opening in the western interior elevation, with a step up through a square headed door opening (Plate 32). The interior of the stairwell block is circular to allow for a spiral stone staircase (Plate 36).

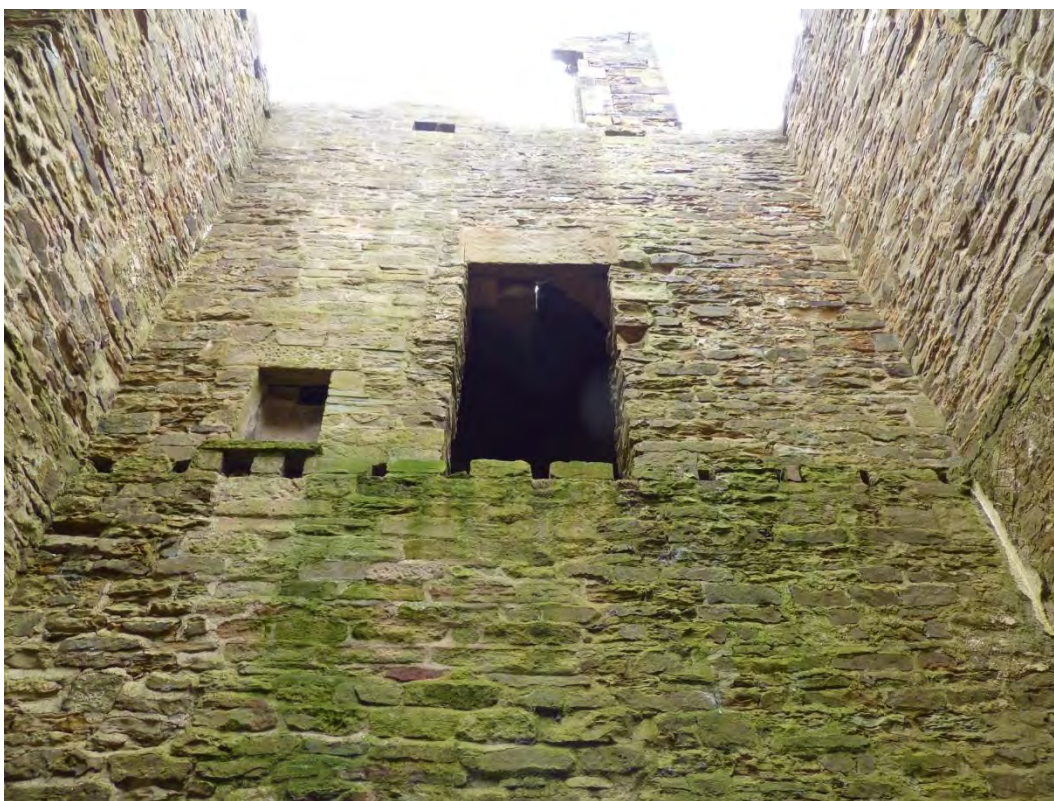
Plate 34: Upper portion of the west interior wall, looking west

The first floor reflects the ground floor with a central opening leading to the stairwell and a small fireplace just to her west of the door opening (Plate 34). However here there is no second door to the north. At first floor ceiling height there are two openings, likely for timber supports for the former roof/observation deck structure. Above these are the ruinous remains of the third stage of the stairwell block which feature what appears to be half a door opening, likely originally leading from the stairwell to the observation deck.

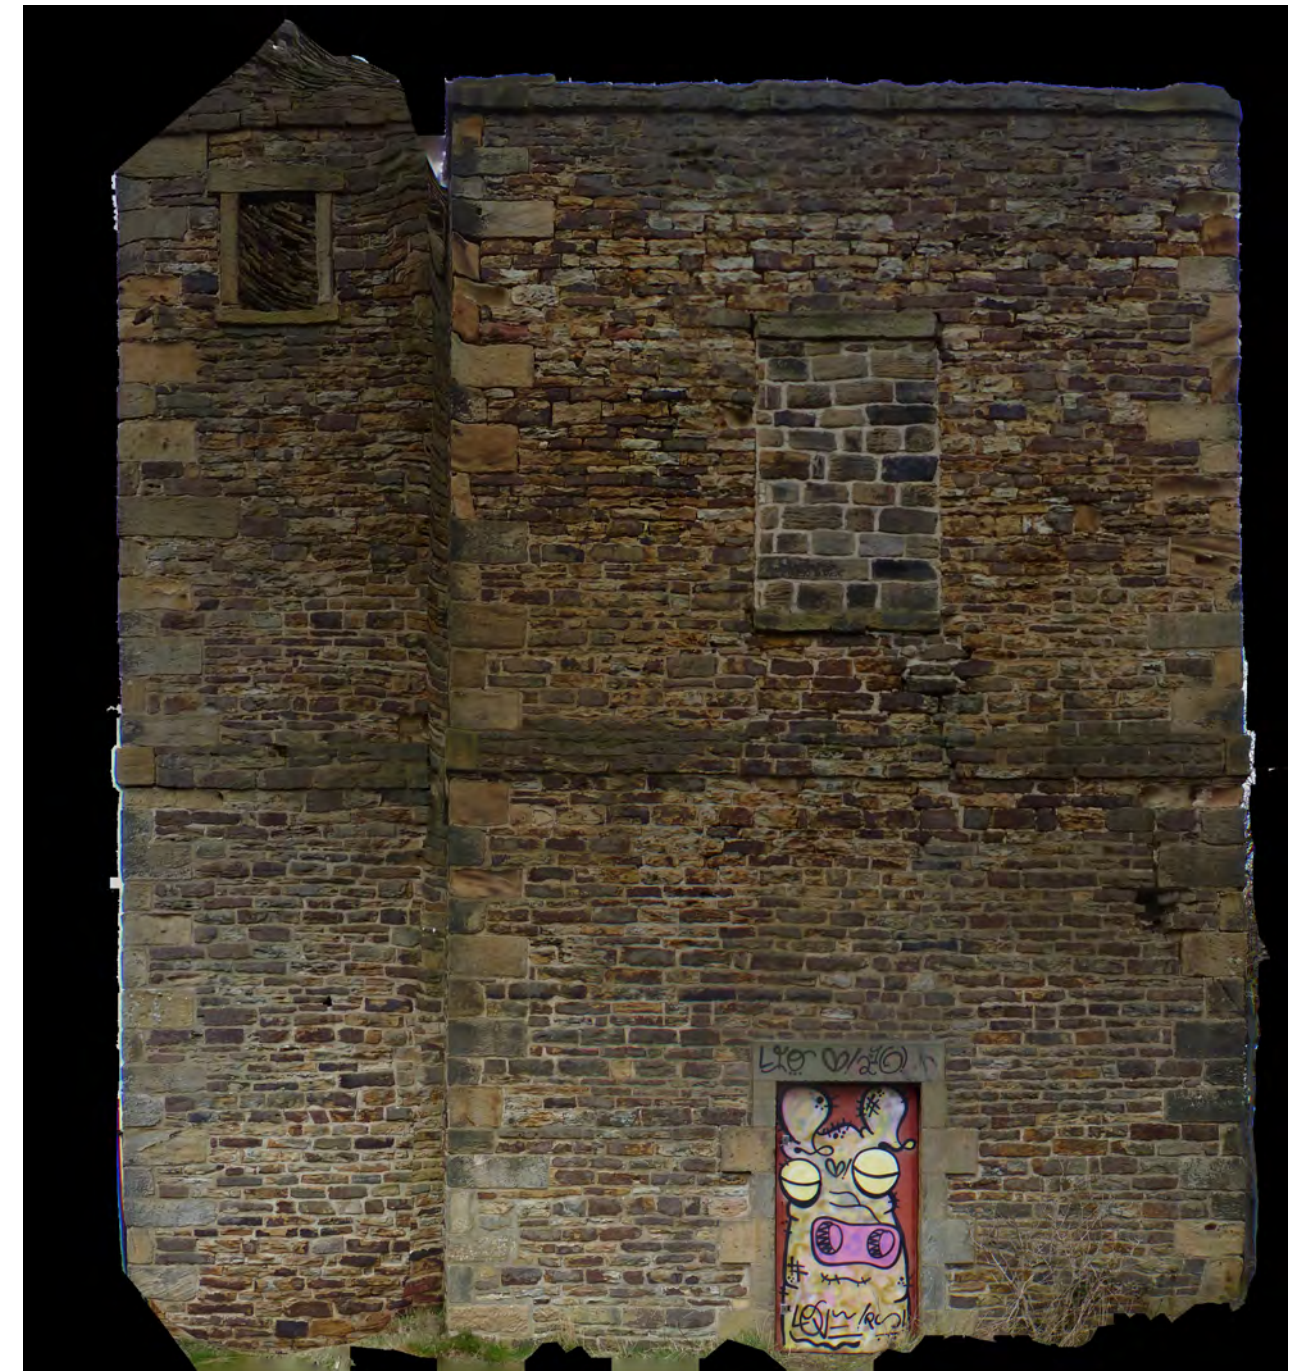
Figure 7: Rectified image and drawn south elevation of Hoyland Lowe Stand

however, it was possible to create photogrammetric elevations for the building's north and south elevations (Figures 7 and 8).
