Axe Head Barn, Upper Fold
Chapel-en-le-Frith, Derbyshire
Historic Building Record
ArcHeritage 2018

Axe head barn, Upper Fold
Chapel-en-le-Frith, Derbyshire
Level 2-3 Historic Building Recording

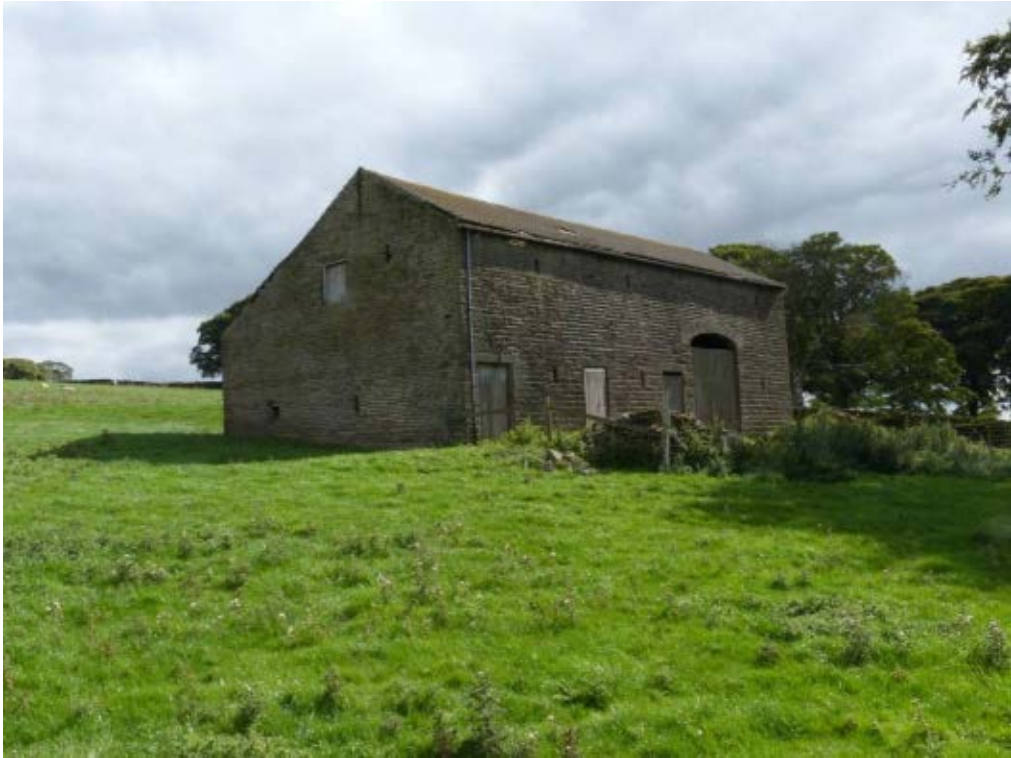
Plate 1: Axe Head Barn, looking south-east

The two storey barn is rectangular in shape and is orientated north-south (Plate 1). The principal elevation faces west and contains the main entrances to the building. The barn has a small lean-to at the north end of the east elevation. The building is built from coursed gritstone of varying quality and the pitched roof is clad in modern concrete tiles, apart from the lean-to which is clad with stone slate. Internally the barn is divided into five bays. The southern two bays comprise a threshing barn, open to the roof, while the northern three and the lean-to comprise cow-houses and the remains of a hayloft.

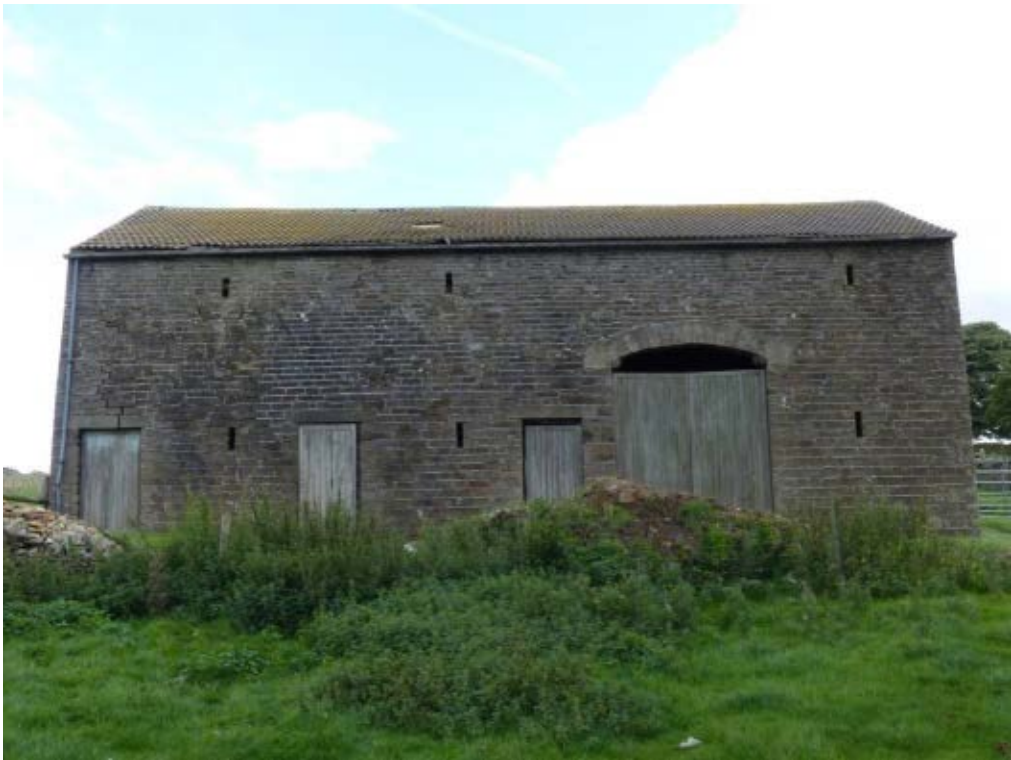
Plate 2: West elevation

The principal elevation, facing west, is given the most prominent architectural treatment with a façade of dressed gritstone (Plate 2). The elevation is punctuated by three doorways to its northern half and a larger double doorway to the southern half. The small doorways are topped with freestone lintels while the large doorway has a segmental arched head with finely cut voussoirs of the same stone (Plates 3 & 4). All the doorways feature voussoirs or lintels faced with margined broach-work, with that of the voussoirs radiating from the centre of the arch. All of the doorways feature modern plank doors. The façade also has six ventilation holes, three for each storey. The front of the cow house also features a strip of paving setts flanked by flagstones before the two outer doors (Plate 5).

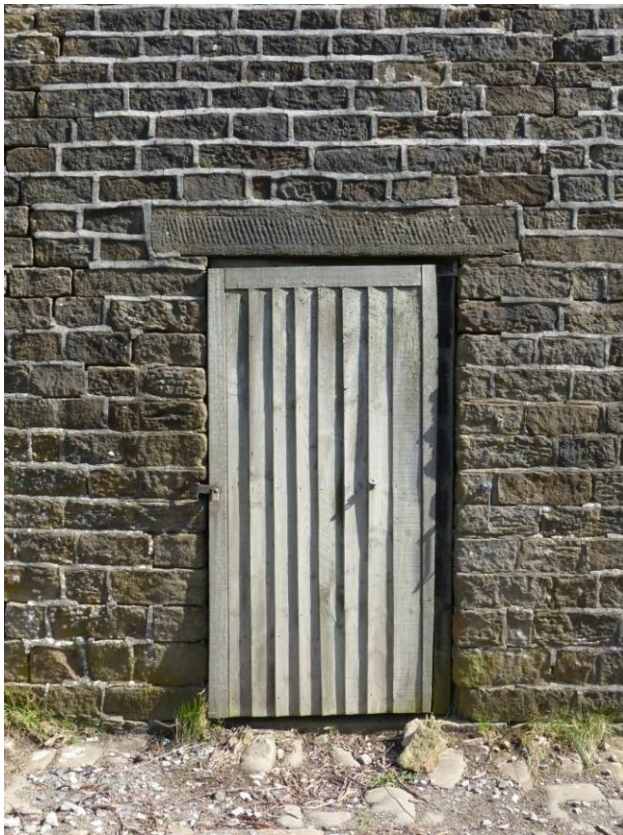
Plate 3: Main barn doorway, looking east

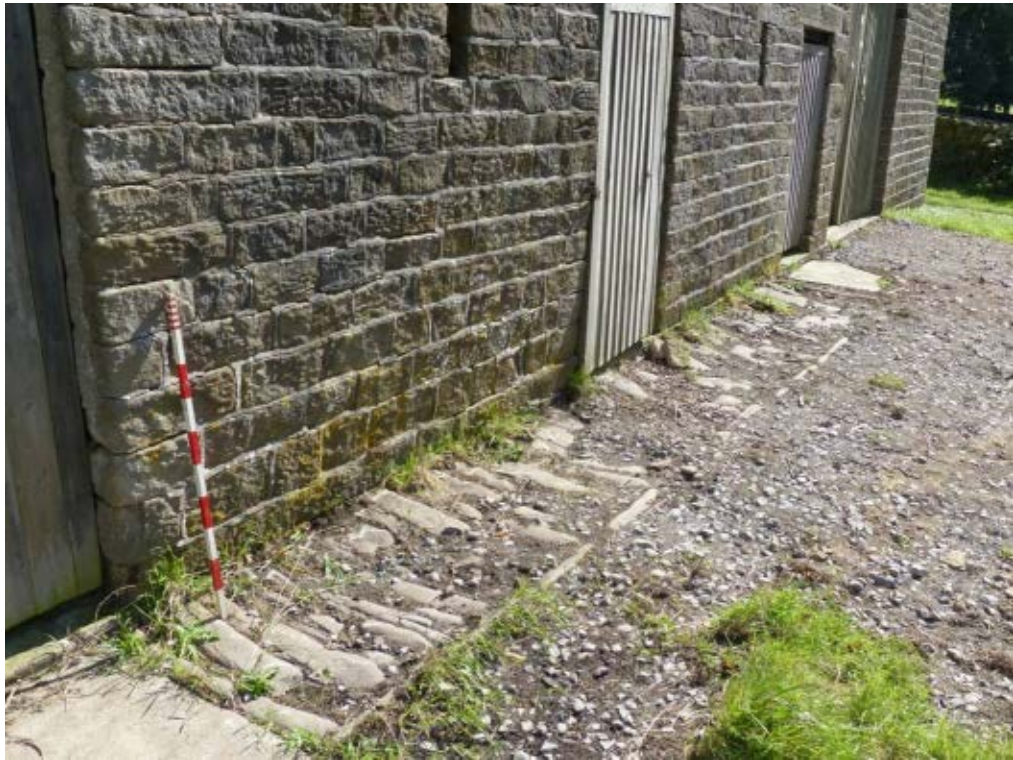
Plate 4: Central door to cow house, looking east

This arrangement indicates that the central door gave access to a central feeding passage, which also lead to the lean-to and presumably provided access to the hayloft. The two side doors therefore gave access to each individual half of the cow house. Each half also had its own muck hole and forking hole. The southern muck hole is still in situ but the northern opening, as mentioned above, has been blocked but is clearly visible from the inside (Plate 18).

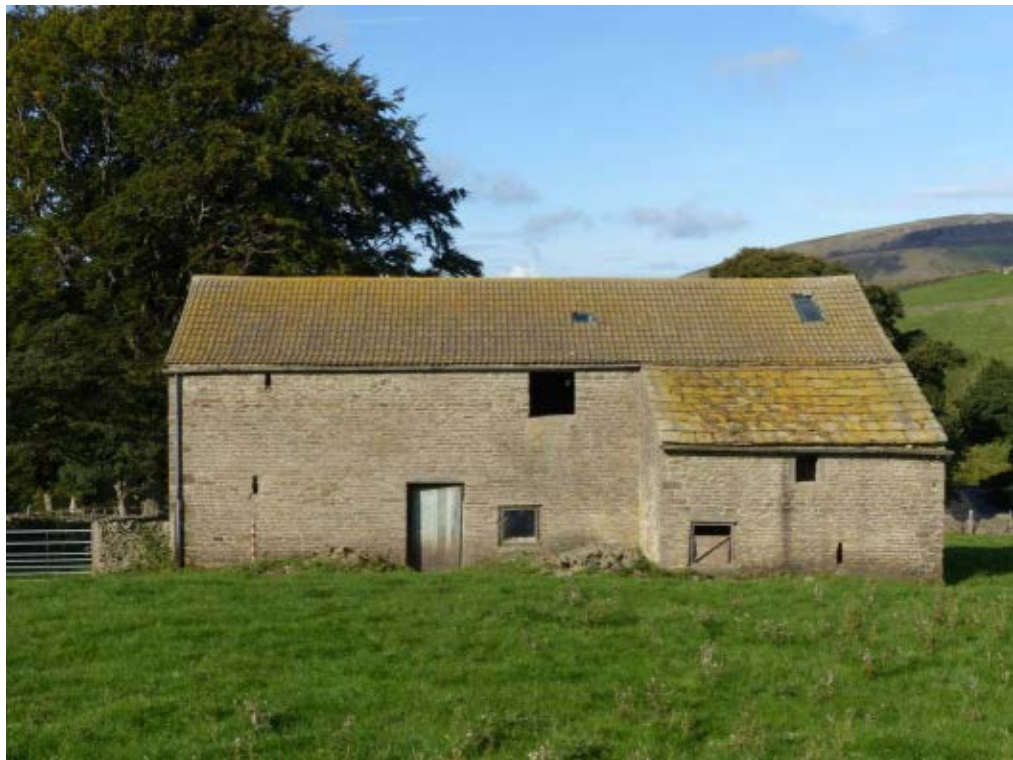
Plate 6: West elevation

The rear elevation faces east towards a pasture field (Plate 6). The elevation includes the lean-to which appears to be contemporary. The walls are constructed from coursed gritstone rubble, with larger blocks similar to the west elevation reserved for the quoins. The main wall has a small doorway leading into the barn topped with a wide lintel, finished in the same style as those of the west elevation. To the north of the doorway the barn has a ground and first floor opening, the muck and forking hole respectively. The ground floor opening was used to remove the manure from the cow house into a dung heap which could then be spread on the field in the spring. The forking hole was used for forking hay into the loft over the cows. The east wall of the lean-to also has a muck and forking hole, only smaller. The lintels and sill stones of the openings are crudely finished compared to the doorways, and use irregularly shaped stones (Plate 7). Interestingly, the lean-to's forking hole has monolithic jambs. The barn door itself is of modern plank construction and the muck holes have been glazed. The east elevation has a ventilation hole on each storey at its south end and a single ground floor ventilation hole in the wall of the lean-to.

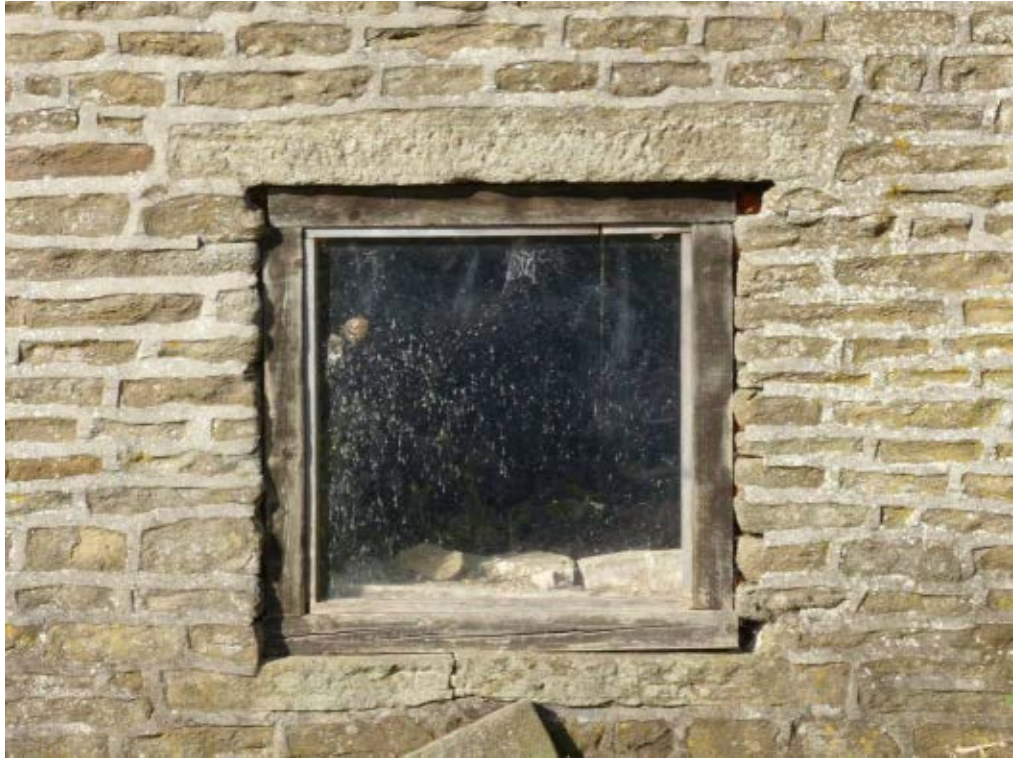
Plate 7: Muck hole in east wall of cow house with later glazing, facing west

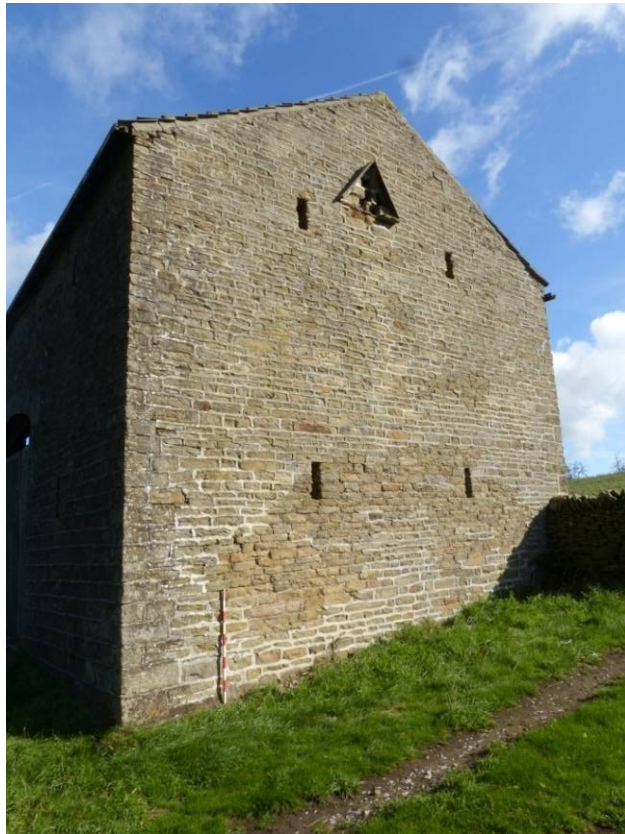
Plate 8: South elevation

The south elevation is constructed with stonework in the same style as the east (Plate 8). The façade is relatively blank, featuring two ventilation holes in each storey and a crude off-centre dovecote in the gable. The dovecote is formed of three stone slabs set in a triangular fashion into the barn's wall. The dovecot holes are simply gaps in the stonework separated by courses of thin stone slabs. The use of longitudinal stone blocks and the slabs set into the stonework suggests that either the dovecot is probably original to the building, or was inserted with great care.

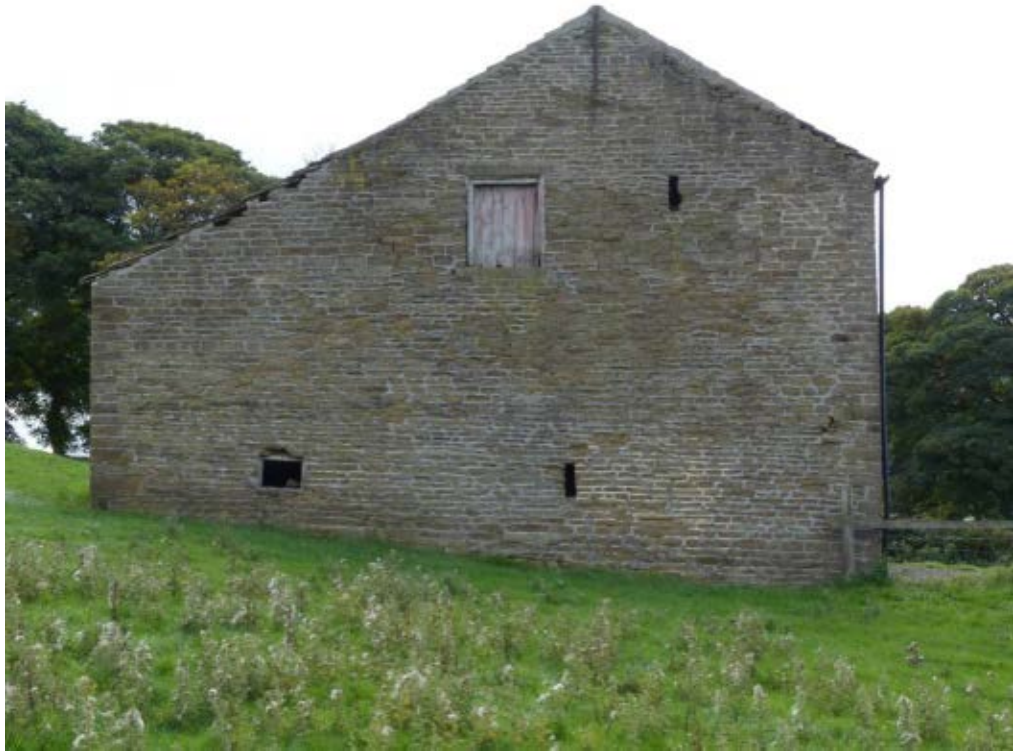
Plate 9: West elevation

The North elevation features a ventilation hole on each floor as well as a first floor forking hole and a small muck hole in the lean-to wall (Plate 9). A blocked opening that would have served as a further muck hole is evidenced by a remaining sill stone and a difference in the pointing

above it. The forking hole features a softwood plank and batten door which upon internal inspection is constructed with machine sawn wood and wrought iron strap hinges that were probably reused from an earlier door.

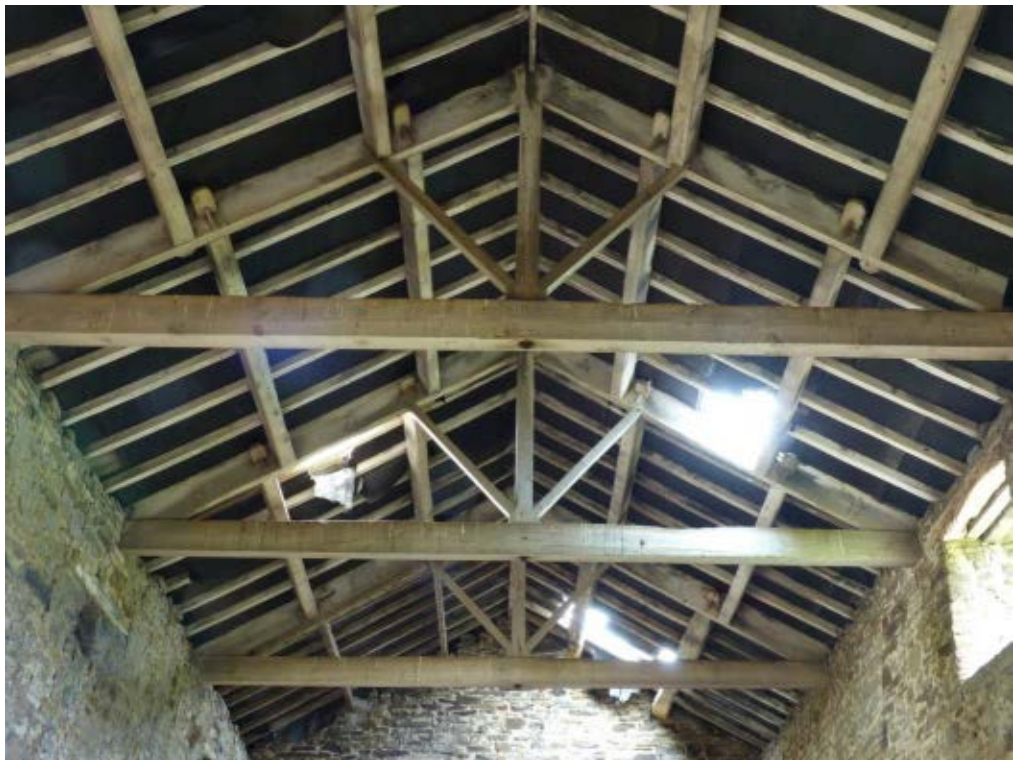
Plate 10: The roof, looking north

Internally the barn is divided into five bays by four king-post roof trusses (Plate 10). The roof is constructed principally from hand-sawn softwood. The tie beams rest directly in sockets in the wall, and lie on timber bearers with more substantial timber bearers a course below. The king posts are bolted to the tie beams and feature joggles supporting raking struts dovetailed into the principal rafters. The roof has two flights of butted side purlins with run out chamfers, attached to the principal rafters with through-tenons and face-keys. The purlins in the southernmost bay appear to be reused timber and those on the west side of the northern bay have been replaced. The purlins carry slender common rafters which meet at a ridge-piece. Each truss has clear carpenter's marks numbering the trusses I-III from south to north (Plate 11). The roof has had makeshift roof-lights inserted at various points with glass laid instead of roof tiles.

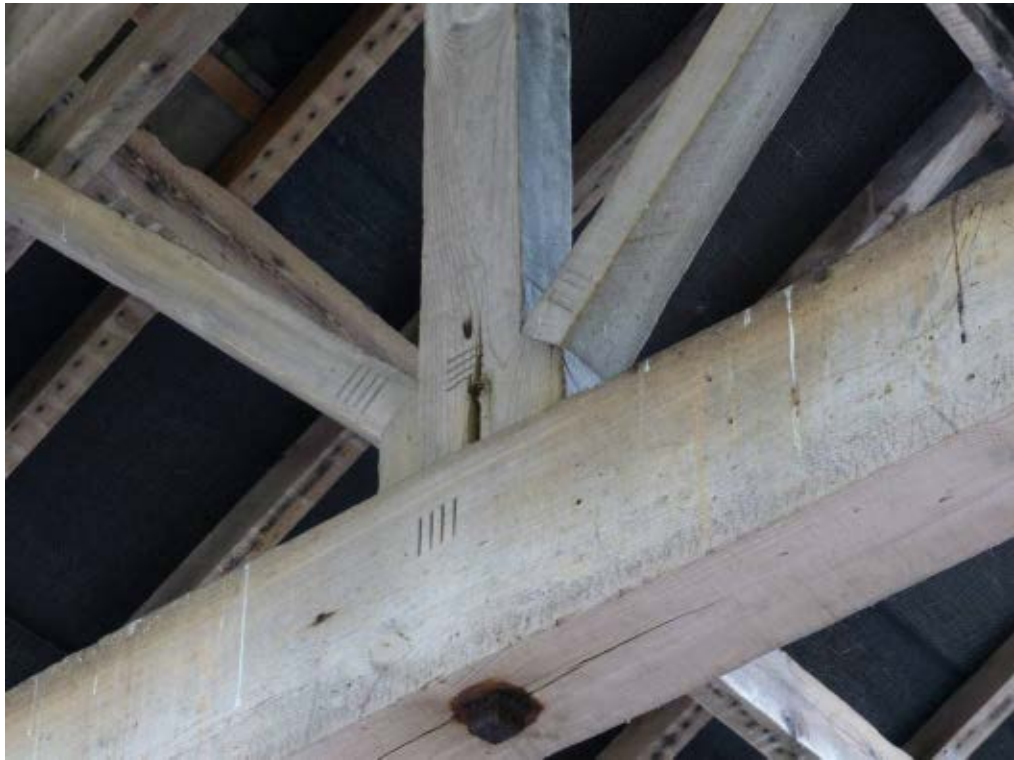
Plate 11: Carpenter's marks on truss III, facing north-west

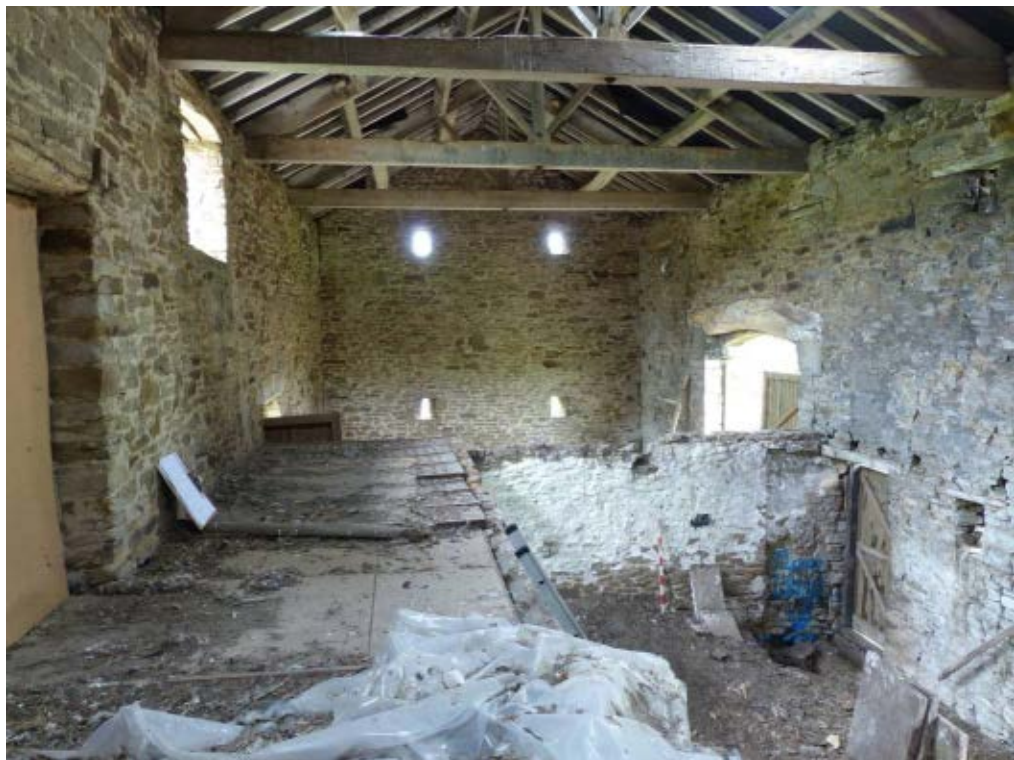
Plate 12: Interior of the barn, facing south

The interior is functionally divided into two parts by a stone wall rising a single storey in line with truss II (Plate 12). The southern two bays comprise a threshing barn whilst the northern three bays comprise a cow house and hayloft. The wall is of rubble construction with random sized blocks in a lime mortar. The wall is not bonded to the external walls of the barn but is probably original as it separates the two original functions of the barn and carries the hayloft floor.

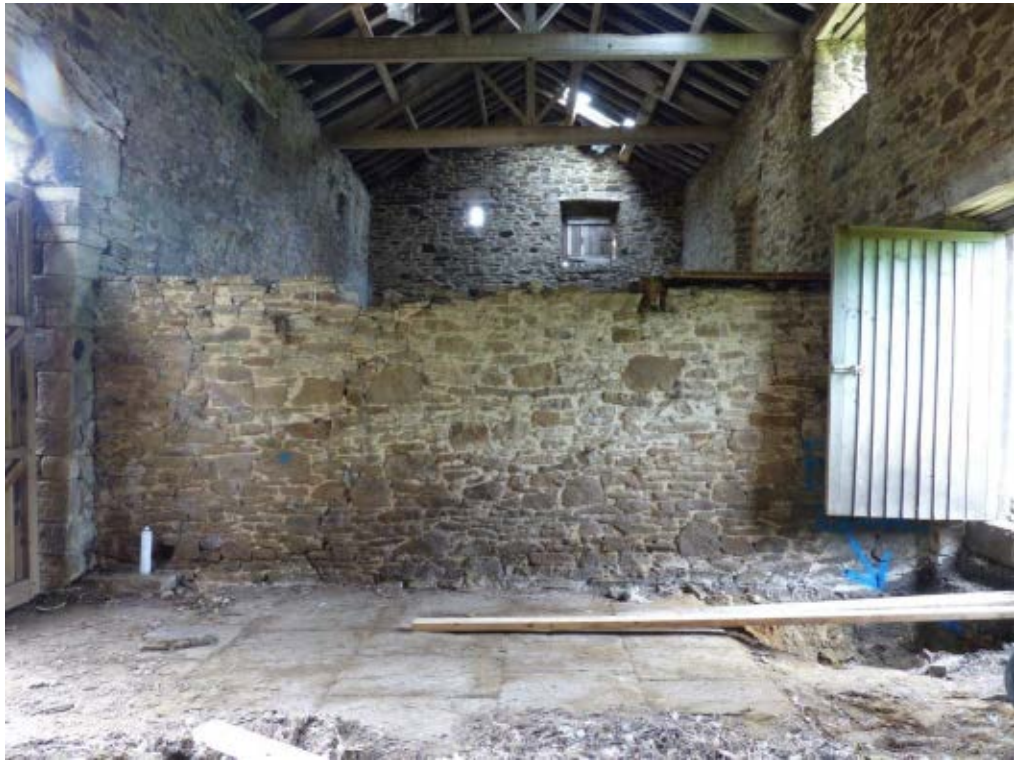
The southern two bays are relatively devoid of features but feature a tightly jointed flagstone floor between the front and rear barn doors which is presumably the original threshing floor (Plate 13). The tight joints between the flagstones would prevent grain falling between the stones while the cross-draft created by the two doors would facilitate threshing and winnowing, with the larger doorway facing westwards into the prevailing wind. The southernmost bay has a modern concrete floor and would have served as storage for unprocessed crops.

Plate 13: Flagstone threshing floor between the two barn doors, looking north

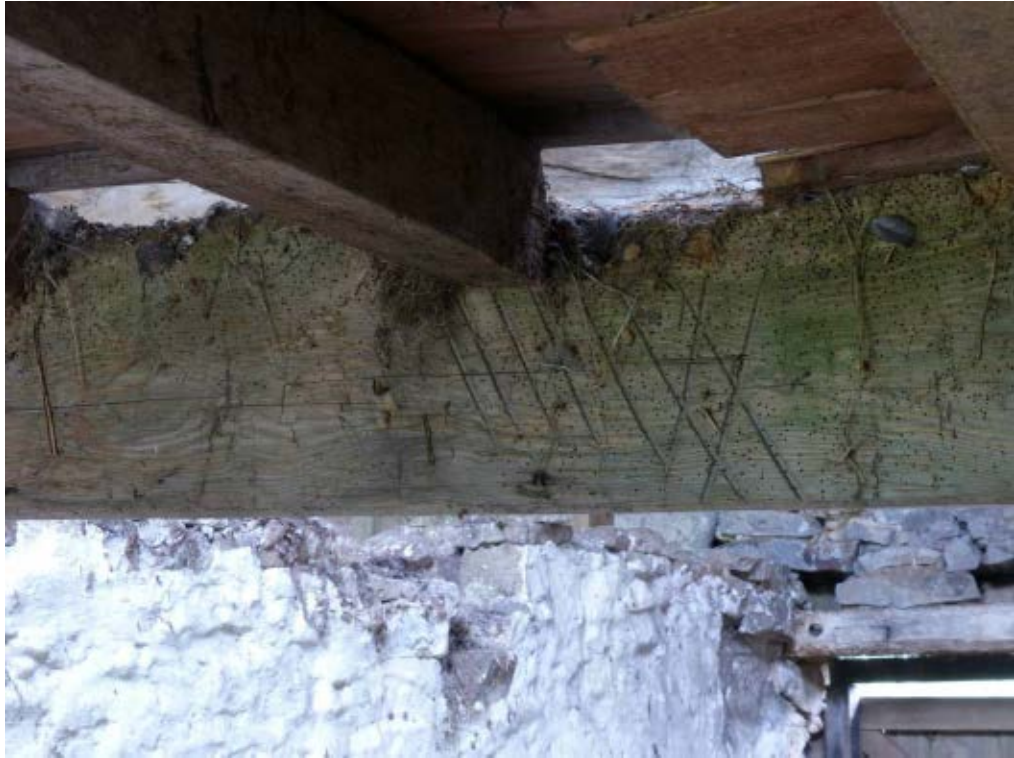
The remaining bridging beam has four redundant mortises in its soffit, most of which are obscured by the present posts. The mortises form two pairs and would have been for posts which would have supported the floor and formed part of the framing for timber stall dividers. It is likely that the arrangement was repeated on the missing bridging beam. Two stone slab dividers remain *in situ* in line with the presumed stall dividers and the remains of a stone wall (Plates 16 & 17). The slabs would have also acted as stall dividers, approximately one per metre, providing five dividers and six spaces for cattle. Assuming the arrangement was mirrored on the north side of the cow house, the main cow house would have accommodated twelve cows.

Plate 15: Interior of the cow house, merchant's marks on remaining hayloft bridging beam, facing west

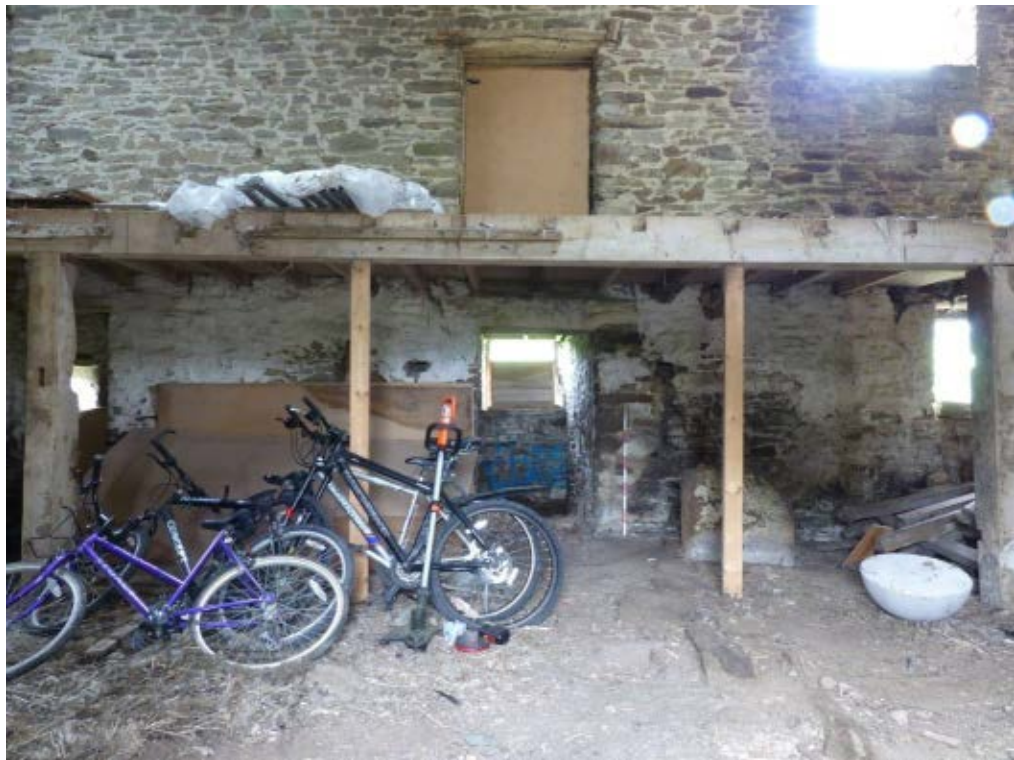
Plate 16: Interior of the cow house, the remains of a stone wall run from the bottom right of the photo, past an *in-situ* slab divider, looking east

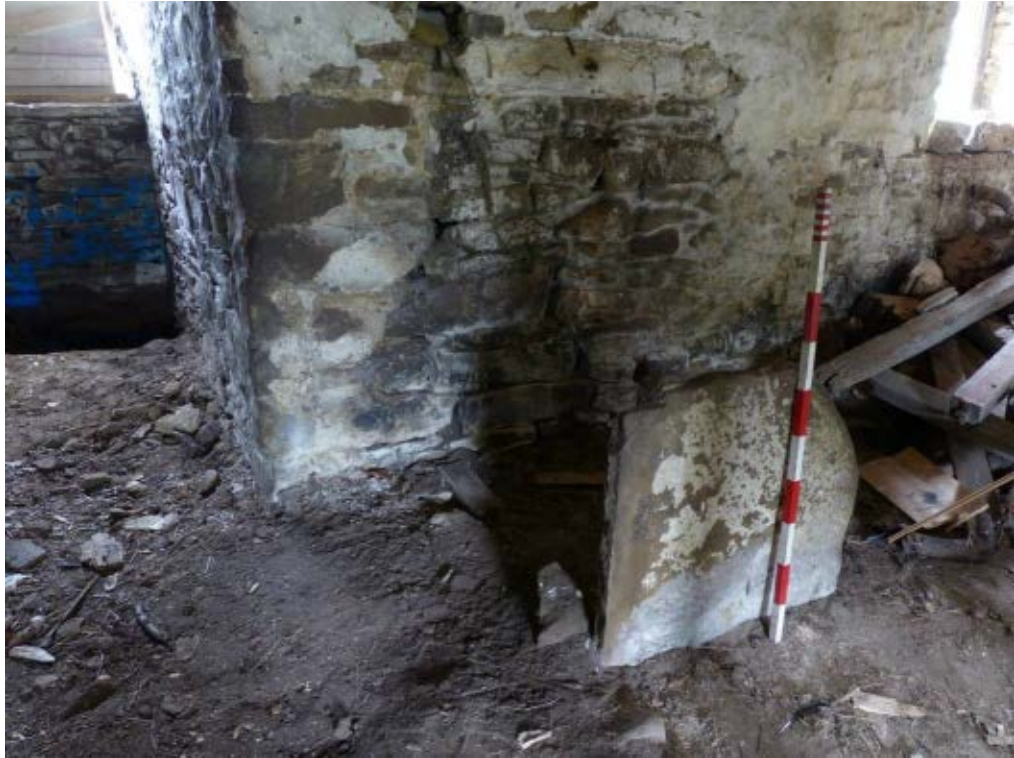
Plate 17: Interior of the cow house, *in-situ* slab divider, looking south-east

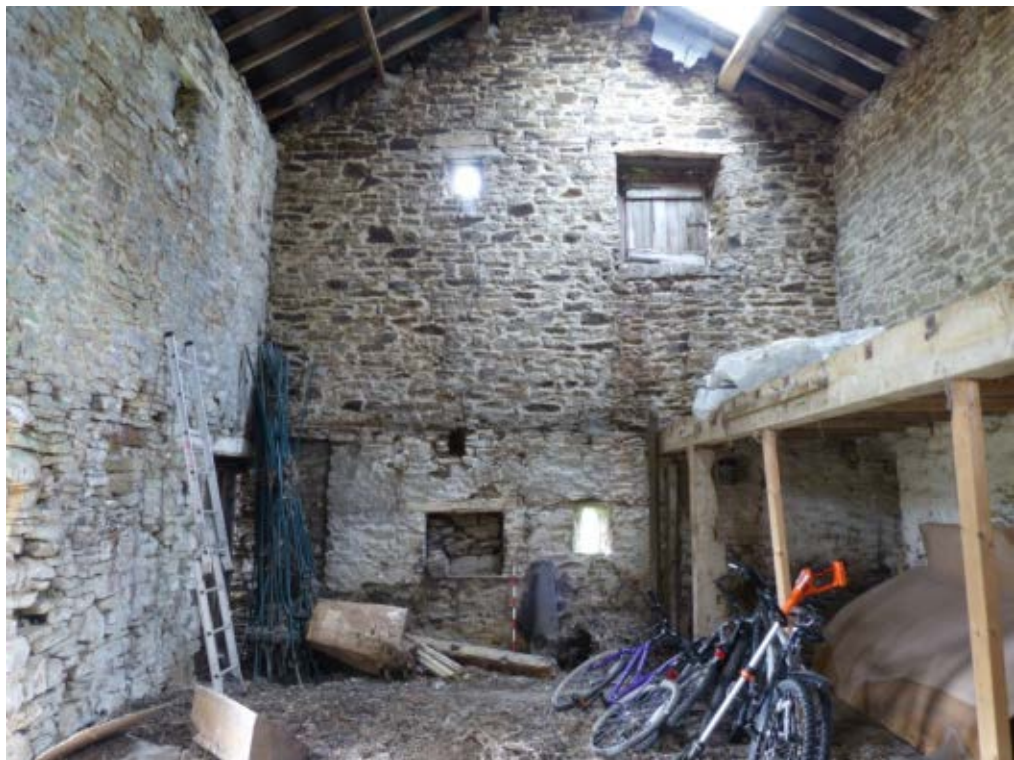
Plate 18: Interior of cow house, a blocked muck hole can be seen as well as the forking hole above, looking north

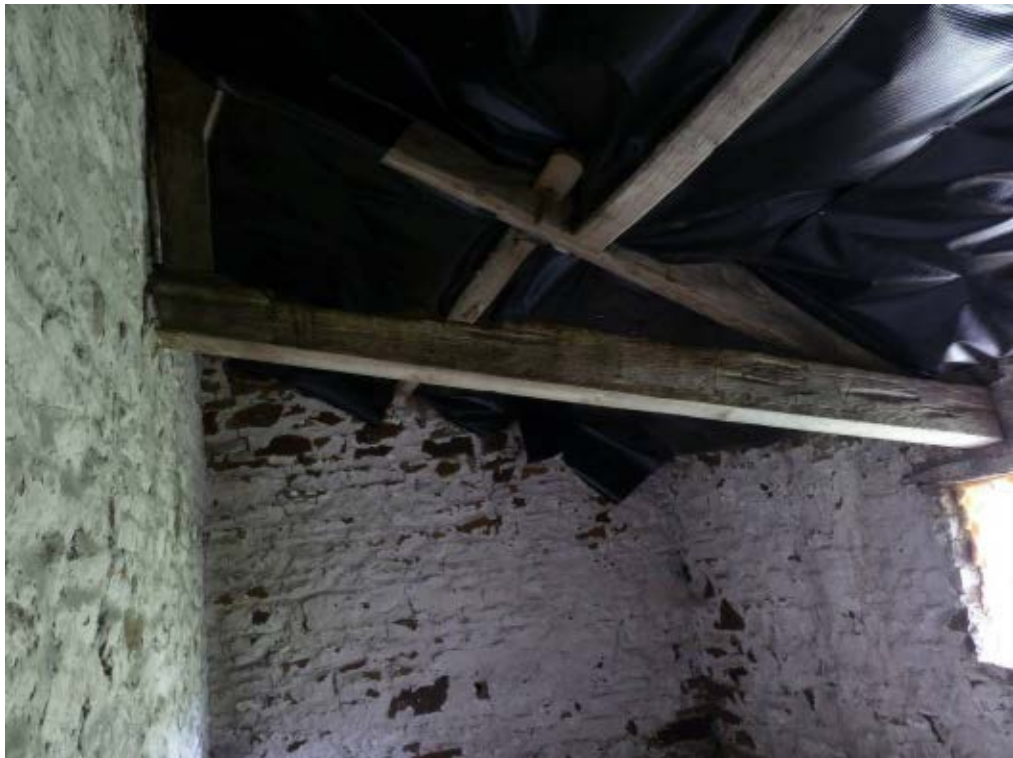
The lean-to's roof is constructed similarly to the main barn and consists of a single half king-post truss with butt purlins, through tenons and face keys (Plate 20). The timbers are of softwood and display merchant's marks on the tie beam. The common rafters are mostly obscured by a modern covering but those that are visible appear to be contemporary with the truss and purlins. Although the first floor of the lean-to almost certainly functioned as a hayloft, it is unknown whether there was direct access between floors within the lean-to the four south-

Plate 20: First floor of lean-to, merchant's marks are visible on the right of the tie beam, facing north
