Archaeological Investigations at
Broomhill Library Garden, Sheffield
Evaluation report

ArcHeritage 2019

Archaeological Investigations at Broomhill Library Garden, Sheffield

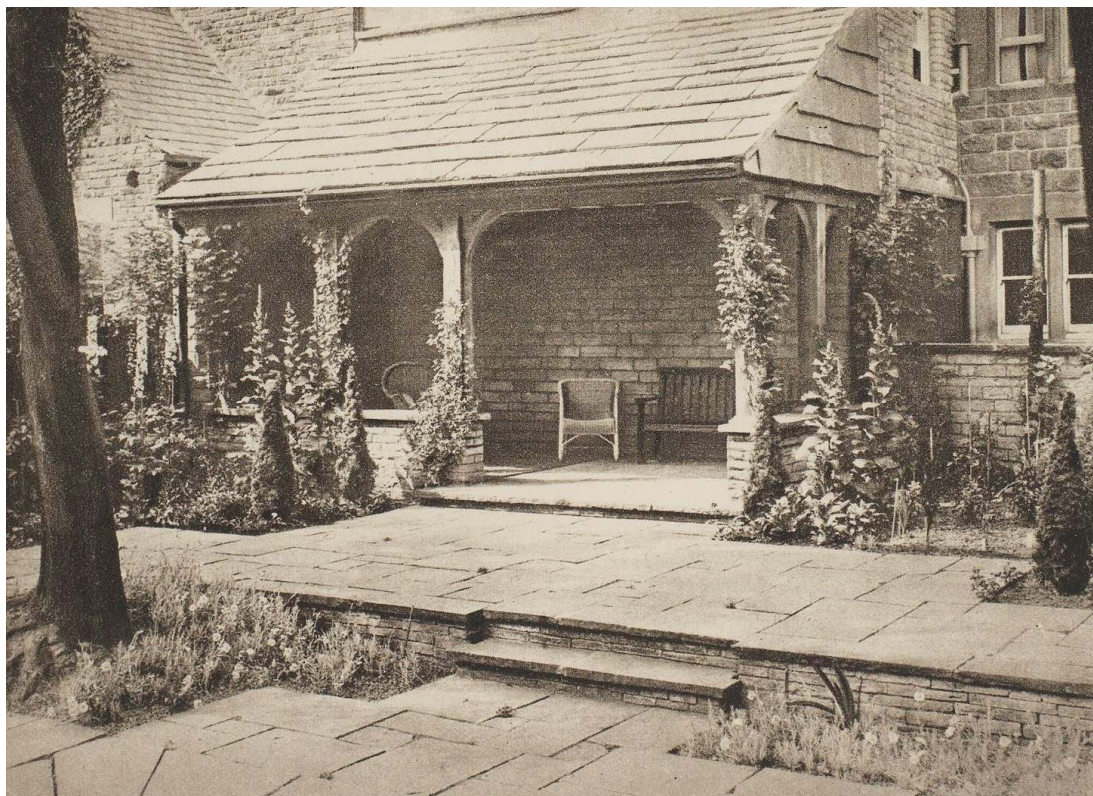
Plate 4: Detail of the loggia, viewed facing southwest

The loggia structure in the southwest corner of the garden had east and north walls surviving up to eight and six courses respectively (107). Photographic evidence (Plate 4) shows that these provided a base for wooden posts supporting a slate-covered lean-to roof. The walls were neatly coursed thin sandstone blocks bonded with a grey-black mortar. The eastern wall had surviving stone capping slabs (Plate 8). Only a few flagstones survived on the internal floor surface, in the northwest and southeast corners (108; Figure 5 C). The remainder of the floor comprised a clay and mortar bedding deposit (109), which survived patchily across the area, in places overlying concrete or mixed clay with stone and brick fragments. Some of the variation may derive from root damage, or the historic replacement/repair of flagstones. There was a shallow step up to the loggia in the entrance at its northeast side. Cleaning of the area around the loggia revealed some surviving flagstones from the path immediately outside it (110; Plate 9). There was also a small surviving group of flags to the southeast (111), its south and west edges probably defining the edge of former flowerbeds.

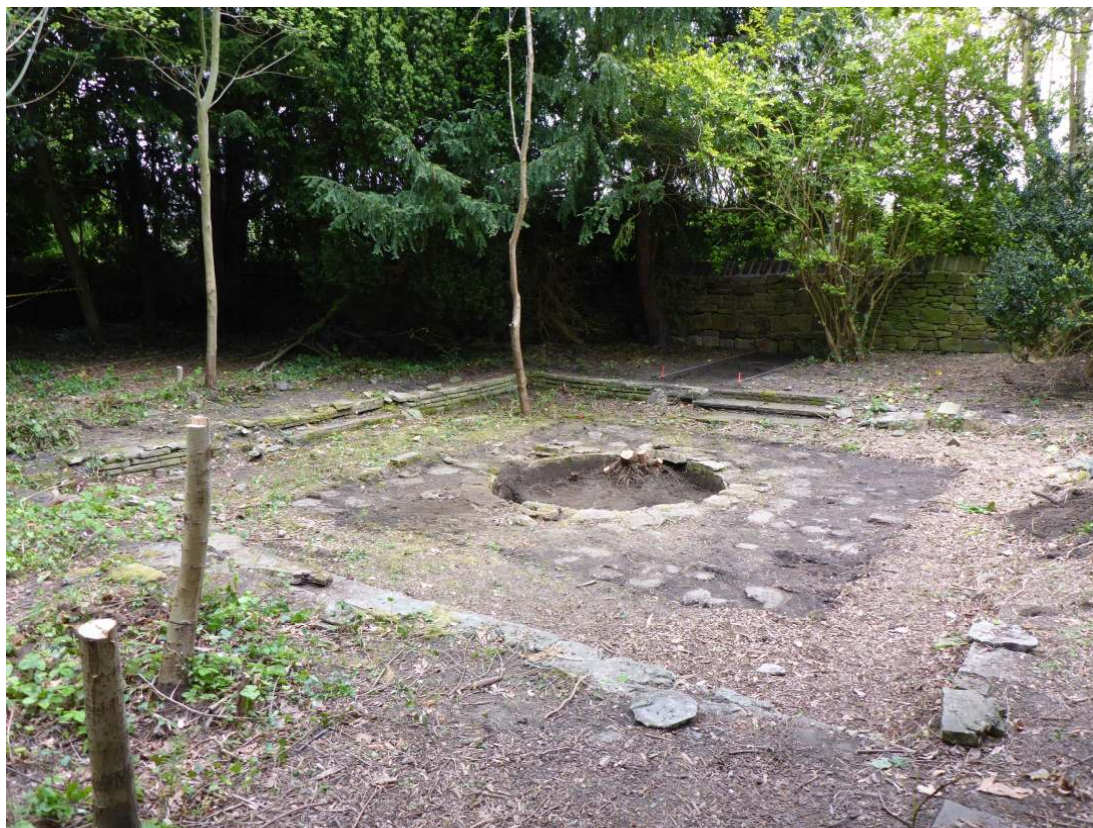
The topsoil (context 100) was a rich silty leaf-mould overlying the majority of features, and largely post-dated the theft of the flagstones in 2003. It varied in depth between 5 and 10cm across the site. The central pond is located in a slightly sunken square enclosure, which has a step up to the paths on each side (106). The area immediately around the pond was cleared, revealing a circular structure with an internal diameter of 1.9m (context 102). The top of the structure comprised a ring of bricks, one course wide (0.23m). This lay under a layer of broken concrete slab and stone fragments, which is likely to have formed a bedding layer for the York Stone flags within the pond enclosure (105; Plate 6). Only one quadrant of the pond was excavated to examine the depth of the feature and condition of the base. The interior was rendered with a thin concrete or hard mortar lining on the sides and base, and the pond was 0.90m deep (Plate 7). A small circular hole in the base of the pond close to the eastern edge may have been for drainage or the former location of a feeder pipe.

Plate 6: Pond enclosure, showing bedding layer 105 and pond 101, viewed facing southeast

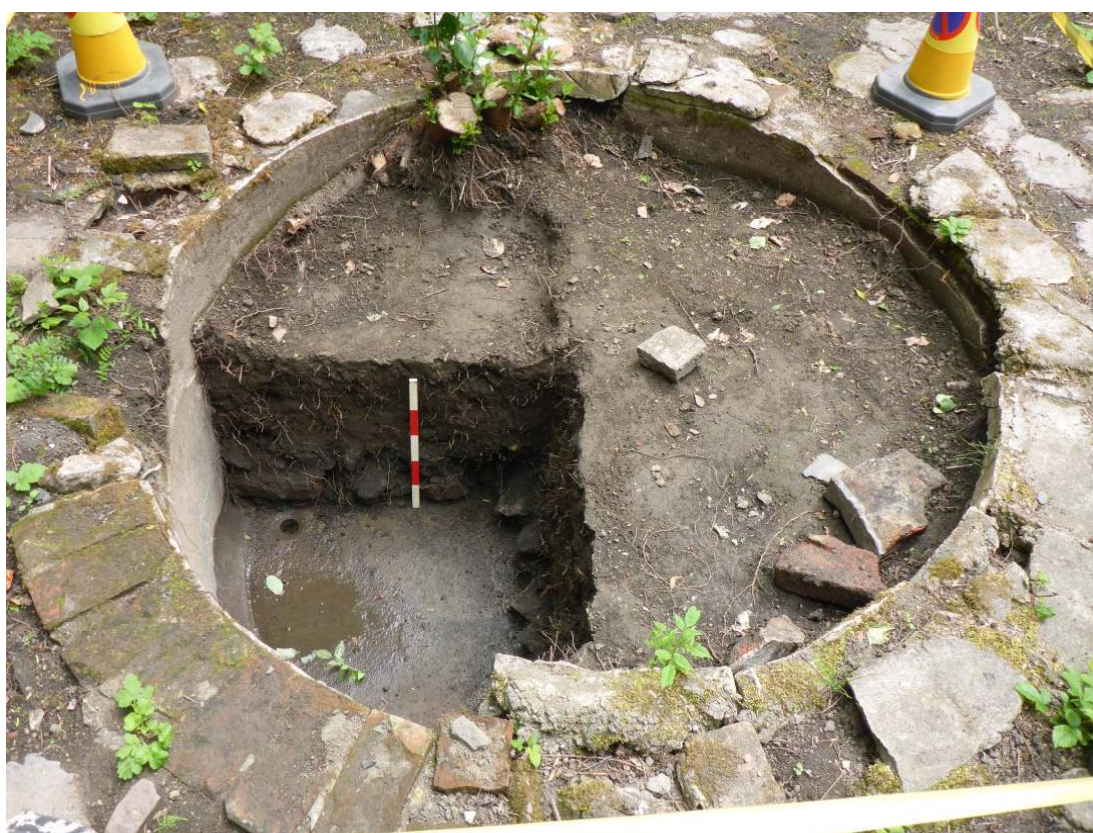
Plate 7: Plan view of the pond structure with one quadrant excavated, facing south

There were three distinct fills within the pond, the lowest (104) being a damp clay-silt deposit at the base, probably the last build-up of silt at the end of the pond's use-life. This deposit was 9cm thick and finds included whole milk bottles and a large broken stoneware jar. Overlying it was a 16cm thick rubble deposit (103) consisting of large stone and brick fragments and appearing to be a deliberate backfill after the pond went out of use. The uppermost deposit was a 0.65m deep homogenous grey-brown clay silt deposit, with frequent small stone and brick inclusions and lots of broken glass. This appeared to represent a single backfilling incident, possibly undertaken by the Council to remove a safety hazard, given the depth of the pond.

The pond structure survives relatively well, the cement lining appearing to be intact within the quadrant examined. However, it is unlikely that pipe connections for water supply and drainage survive in a re-usable condition. Reinstating a functioning pond would probably require substantial reconstruction or disturbance to insert new pipework.

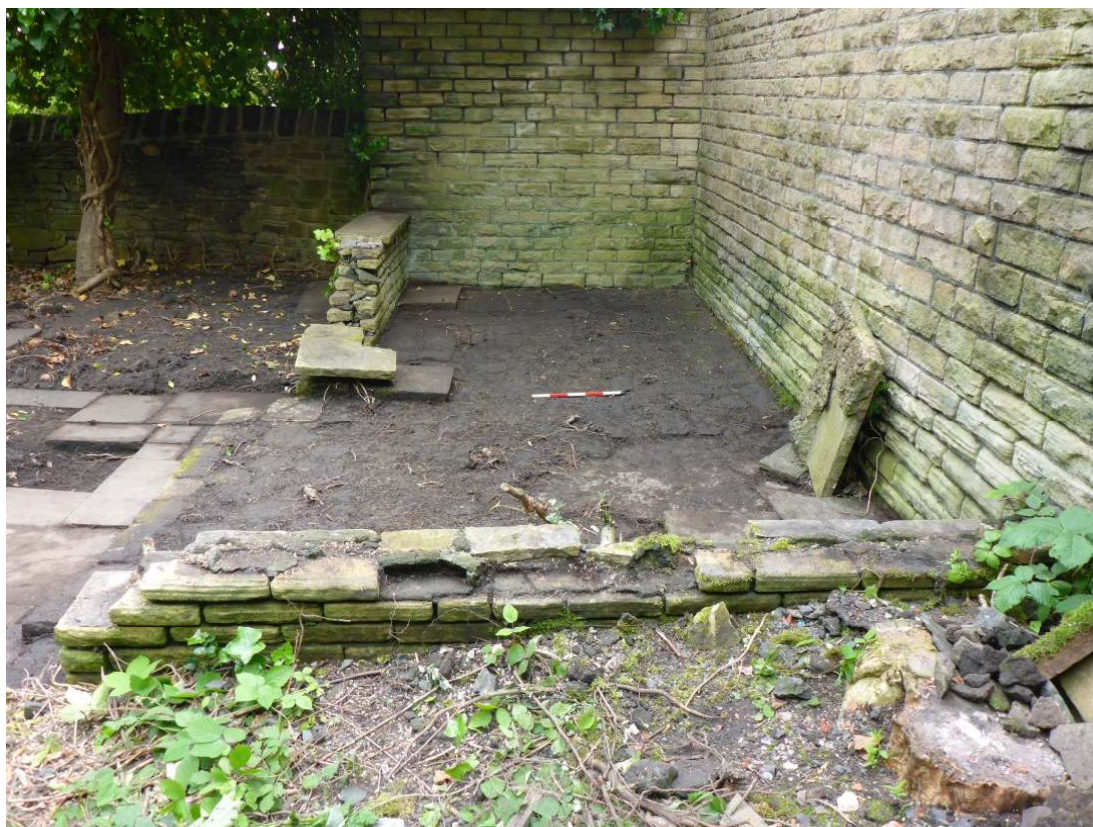
Plate 8: South-facing view of the loggia showing walls 107, slabs 108 and bedding layer 109

Though the majority of the flooring slabs were stolen from the loggia, a compact levelling deposit survives; this is a harder, more coherent mortar deposit than the bedding for the garden flagstones, with concrete patching in places. At least parts of the walls around the loggia survive, which formed the base for wooden struts supporting the lost roof. The pergola base largely survives as a foundation layer, with neat edging facing onto the garden and more broken-up rubble stone behind. One stone flag survives near the eastern side of the pergola, which may have supported one of the wooden columns forming the main part of the structure. Infilled put-log holes are visible in the retaining wall north of the pergola base, which would have held the horizontal timbers forming the top of the structure.

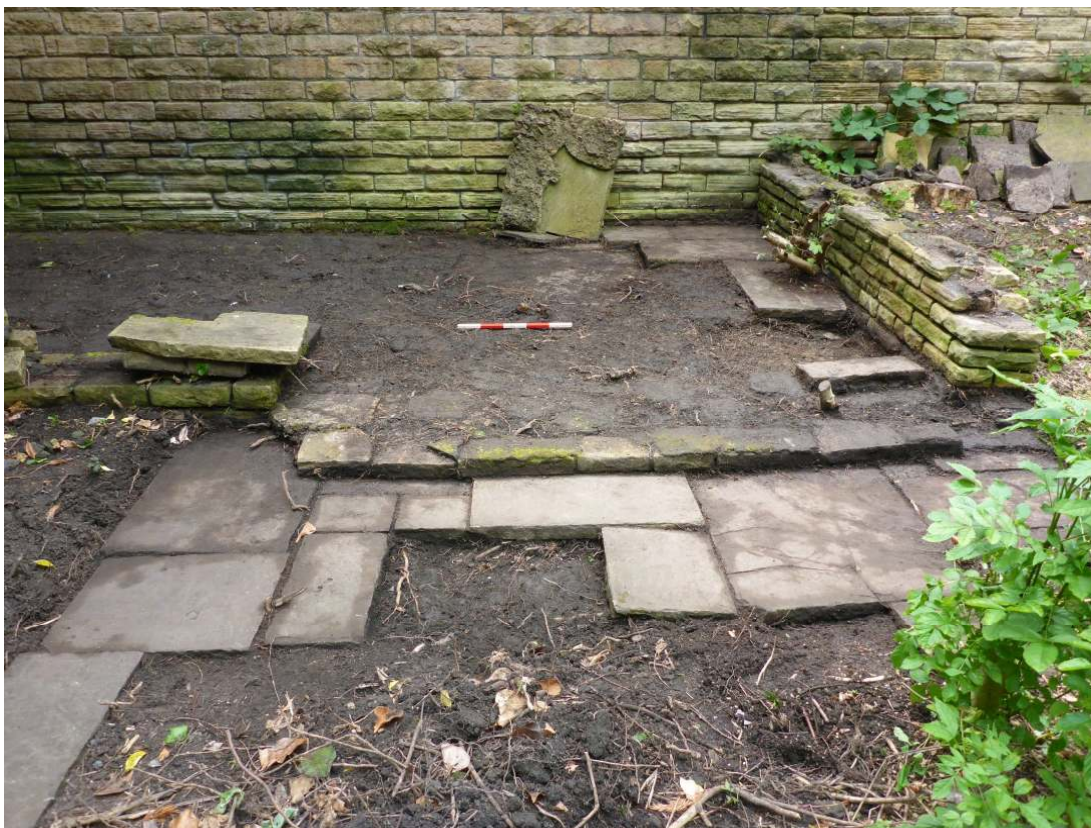
Plate 9: Entrance to the loggia showing step and external flagstones 110, viewed facing west

In the cleaned areas within the main part of the garden where flagstones had been removed, a dark grey-black compact deposit rich in slag, clinker and mortar inclusions (112) appeared to be the remains of a bedding layer for the flags. A small trench was excavated to the south of the pond enclosure to investigate the potential remains of a pedestal for a decorative urn thought to have been located in this approximate area. No features associated with this were found, and the soil in this area was a mid-brown sandy-silt deposit (120), probably the remains of a flowerbed. It is likely that the pedestal was slightly further west, where excavation was prevented by a tree.

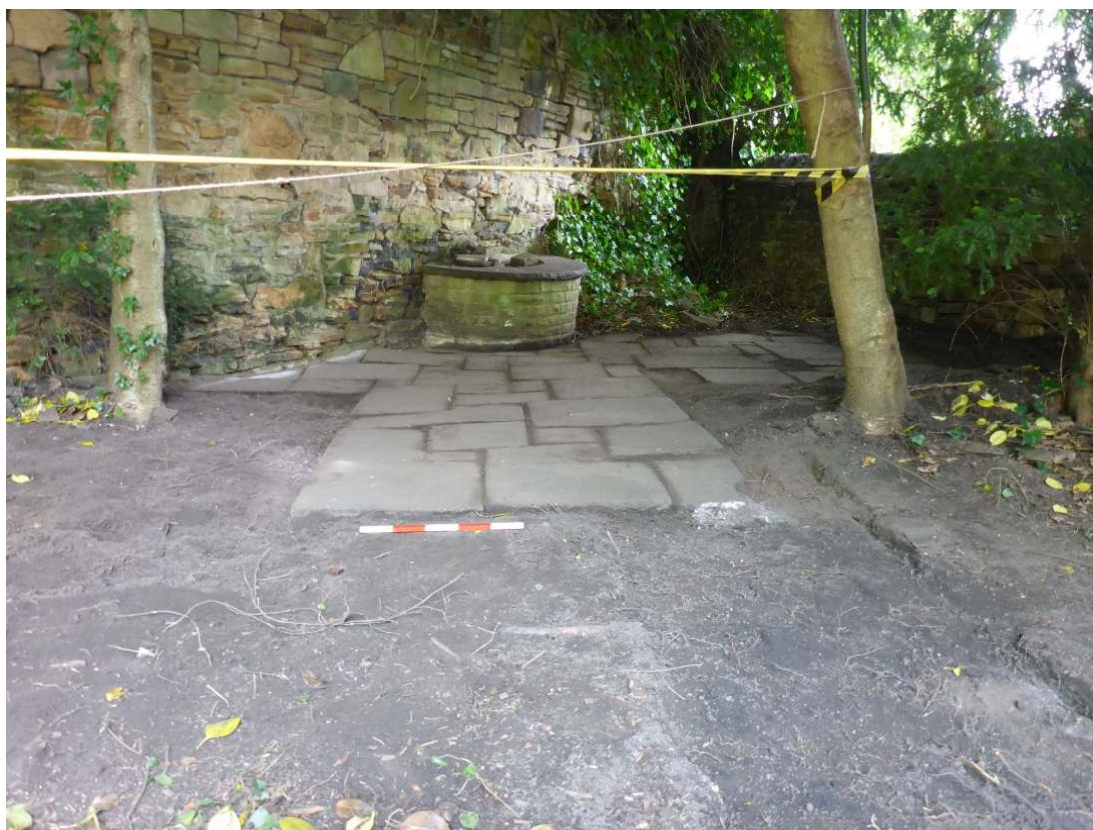
At the eastern end of the garden, removal of the leaf-mould topsoil revealed an area of surviving flagstones (115) within the triangular tip of the garden abutting the dipping well (Plate 10; Figure 5 B). To the south of this was a deposit of a pale yellow-brown sandy silt, which was also found in a narrow strip to the west (114). This was interpreted as the remains of flower beds, appearing to be quite narrow and possibly the location of planting beds set within the flagstones, as depicted on Plate 2. Slabs 115 may have survived the thieves due to their location at the far end of the garden from the entrance.

Plate 10: View east across flags 115, flanked by possible flower beds, with bedding layer 112 to the fore

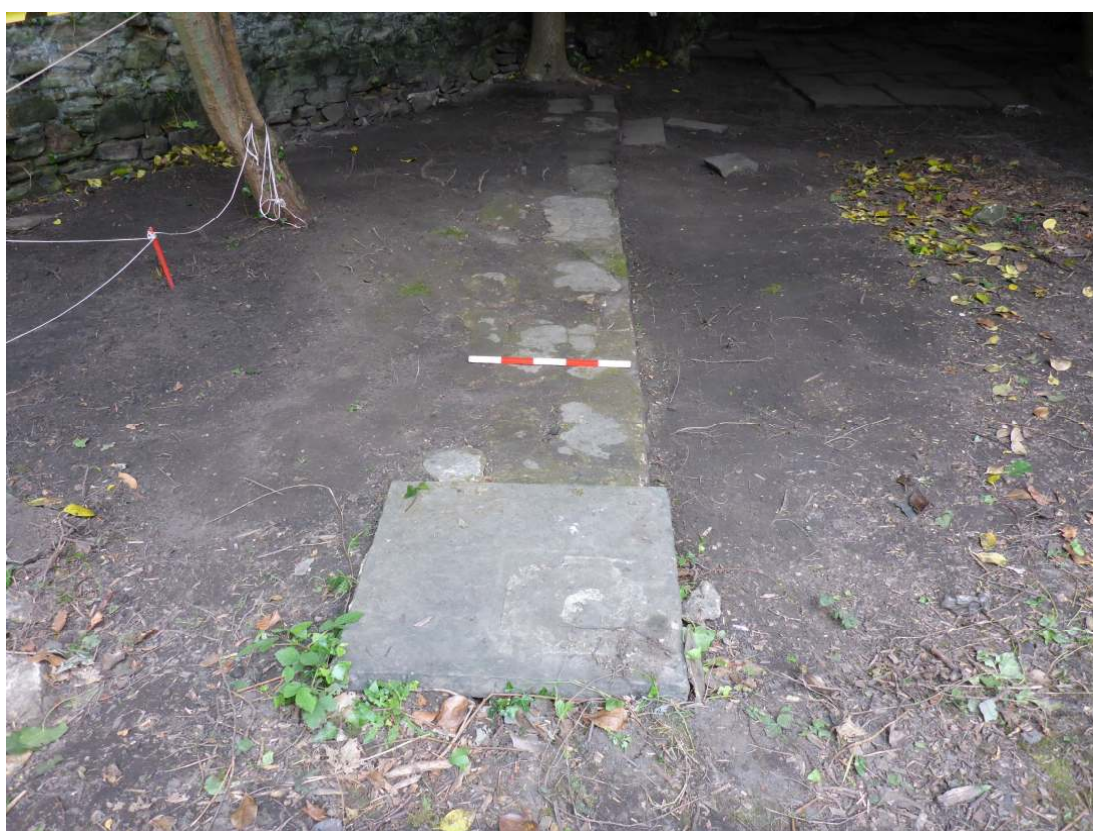
The remains of a low wall foundation were uncovered to the northwest of the slabs; this was interpreted as part of the base of the pergola (113). A stone slab at its western end (Plate 11) may be the base for one of the wooden pergola columns (Plate 11). An alternative theory is that it may be the setting for an urn pedestal shown on Plate 2, though in this 1931 photo the urn appears to be set further east than this edge of the pergola. The base of the pergola was further investigated in 2018.

Plate 11: Eastern part of the pergola base (113) and surviving slab, viewed facing northeast

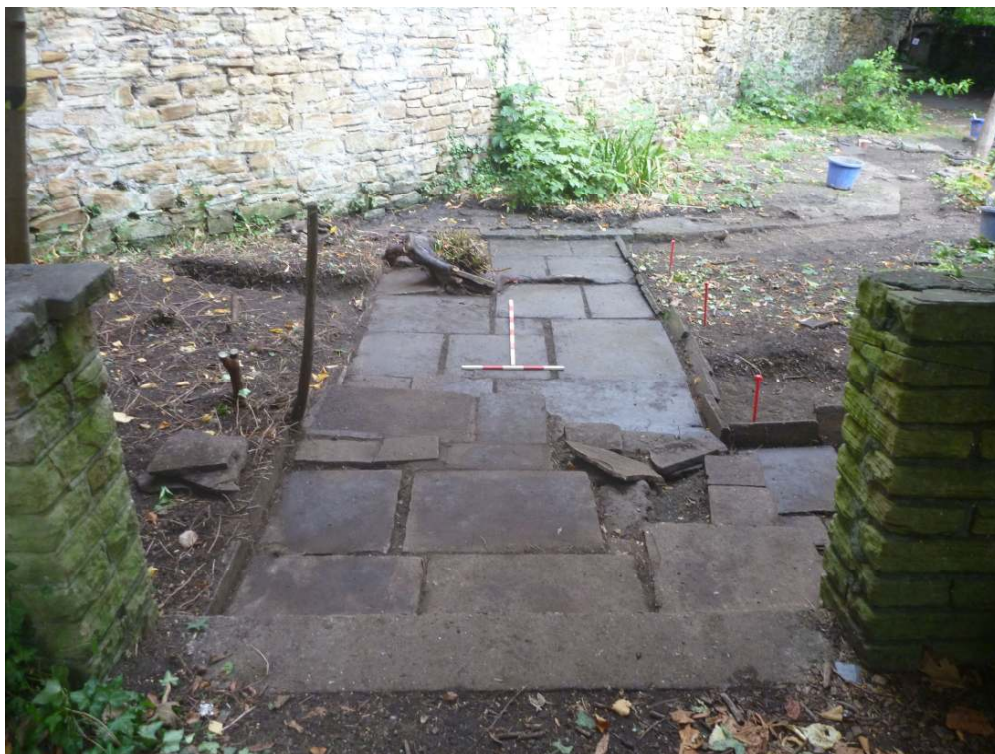
Removal of vegetation, a turf stack and between 8-12cm of topsoil (context 100) revealed reasonably well-preserved remains of a step down into the garden (118) and a pathway (117) leading northeast to the edge of the pergola (Plate 13). Another path (116) leads southeast from the step in the direction of the loggia (Plate 14; Figure 5 A). The paths were made of York Stone flags and flanked with narrow edge-set stones, though most of these had been robbed from the southeast path (116), which was also missing several flags. The shallow step 118 was formed of several slabs, at least one missing and another that had been replaced with concrete, probably a repair undertaken during the Council's ownership of the garden. The concrete step in the gateway leading from the driveway into the garden is substantially higher than top of the flagged step, suggesting the level of the yard/driveway may have been raised at some point.

Plate 13: Northeast path 117 and step 118, viewed facing northeast towards the pergola (119)

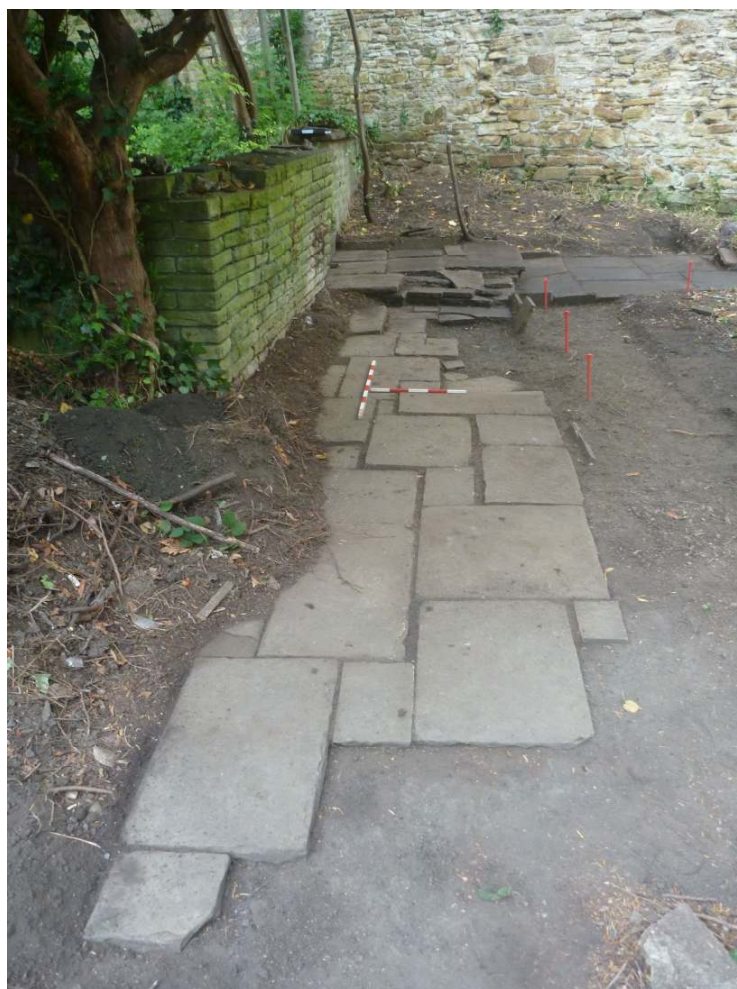
Plate 14: Southeast pathway 116, viewed facing northwest

Within the area of missing flags in path 116, there were fragments of broken stone underlain by the compact clinker-rich bedding deposit identified in the 2017 investigations (112). A similar layer was found in the area between the two paths, indicating that it is likely that this area was also covered by stone flags, as is suggested by the historic photographs of the garden (Plates 2-3). As the bedding layer in this area is slightly higher (c.4-5cm), it is possible that the paths were sunken in relation to the flagged surfaces of the garden.

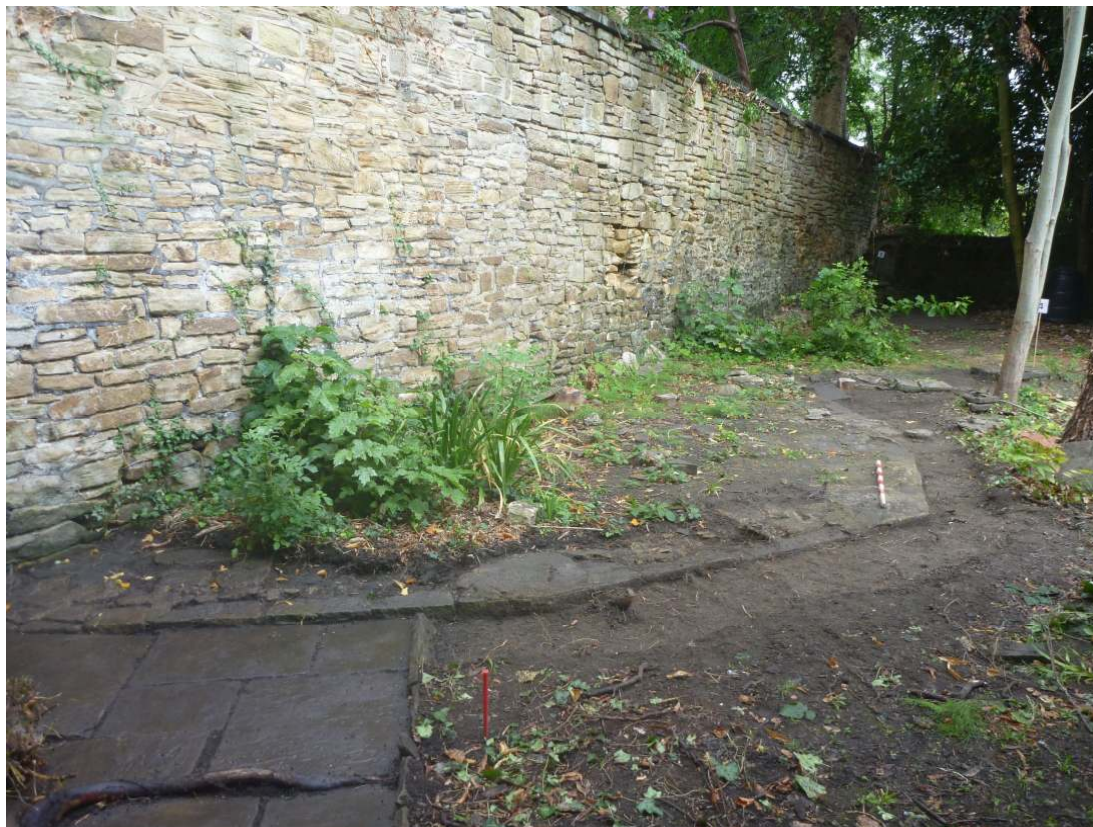
Plate 15: Western end of the pergola base, viewed facing east

The northeast path leads directly to the base of the pergola (119), the edge of which was also exposed in the 2017 investigations (113). This is of rubble stone construction, and it appears that only the foundation layer survives (Plate 15). The compact bedding layer 112 was found in the area surrounding the pergola, indicating that this area was probably also flagged. A small sondage through the deposit to the north of path 116 and west of the pergola revealed a firm mid-brown sandy-silt deposit (120), less compact than the bedding layer, suggesting that this triangular area in the northwest corner of the garden was a flowerbed rather than being paved, supporting previous interpretations.

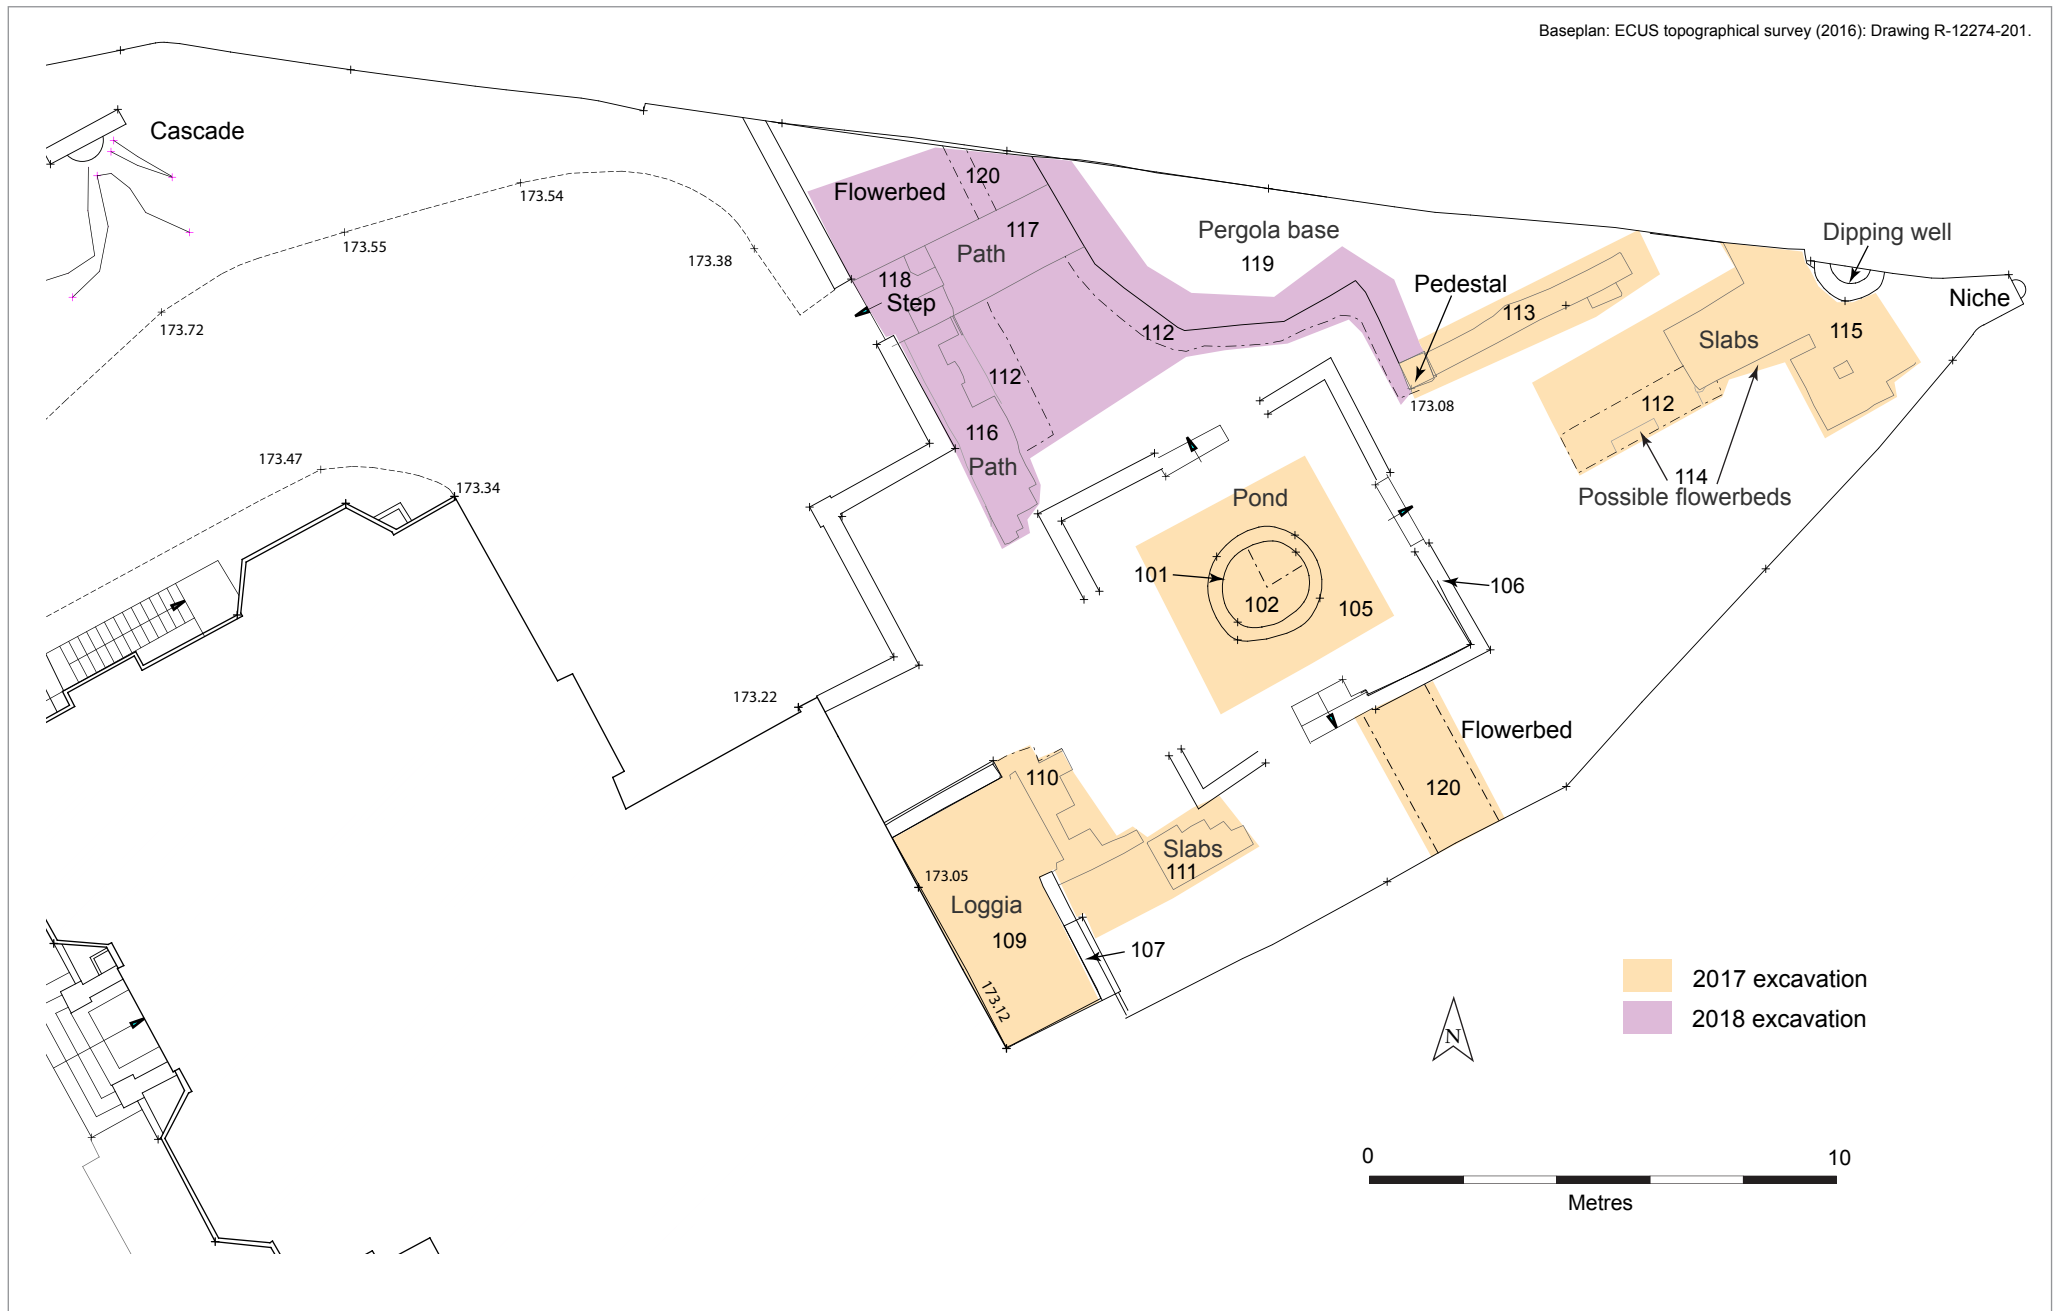
Figure 4: Broomhill Library: post-excavation plan

A plan showing the location of investigations and features is reproduced in Figure 4. Ortho-rectified photogrammetric plans of specific features are shown on Figure 5. Scale rods used in the plates are marked in 10cm divisions.
