St Paul's Church, Brierley

Archaeological Watching Brief

**Report on an Archaeological Watching Brief at St Paul's Church, Brierley,
South Yorkshire**

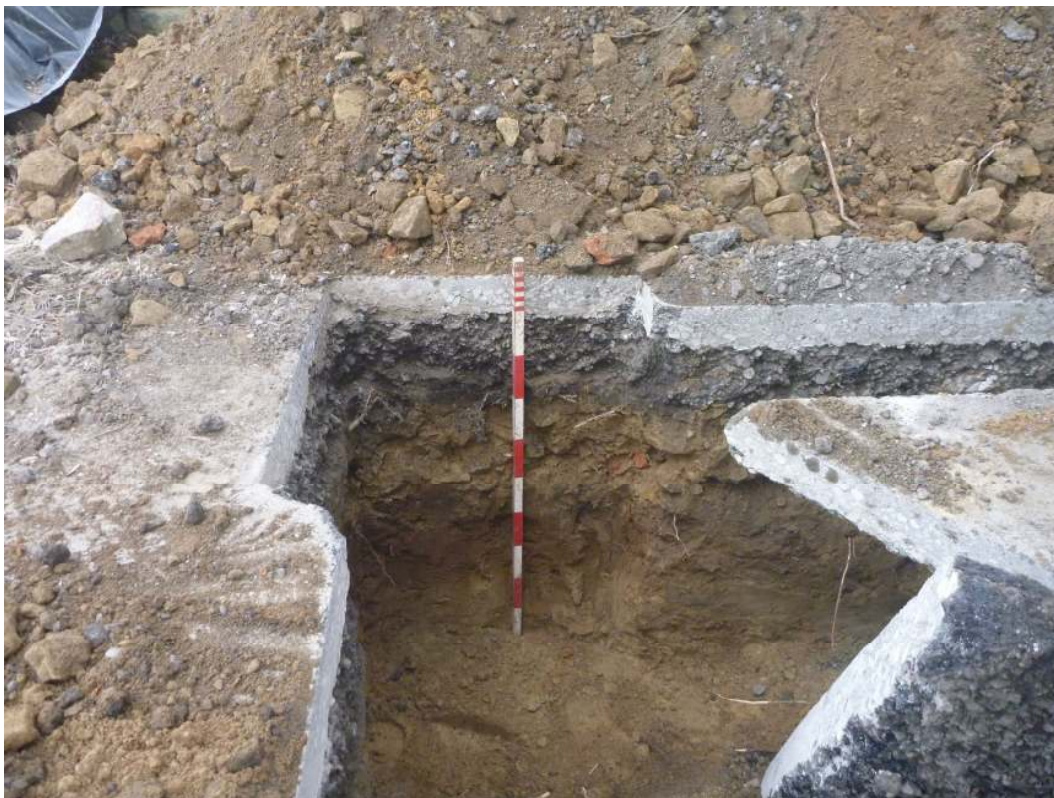
Plate 1: General stratigraphic sequence in southeast-facing section, viewed facing northwest

The majority of the monitored trenches were excavated within the line of the pathway encircling the church. The stratigraphic sequence of excavated deposits was generally consistent comprising a modern concrete path (context 100), an associated bedding deposit 101 consisting of grey-black gritty sand containing inclusions of clinker, tarmac, coal and slag, which in turn overlaid a thin deposit of redeposited sandstone rubble 102. The sandstone rubble 102 was interpreted as a post-construction levelling layer derived from surplus or waste material spread around the perimeter of the church upon completion of construction in the 1860s. This sequence was consistently represented in the monitored excavations observed around the northwest side of St Paul's (Plate 1). The basal deposit 105 underlying 102 in this area consisted of a compact matrix of silty sand with frequent sub-angular inclusions of sandstone fragments. Context 105 was not impacted to any great extent by the monitored excavations, and was interpreted as the top of a natural subsoil.

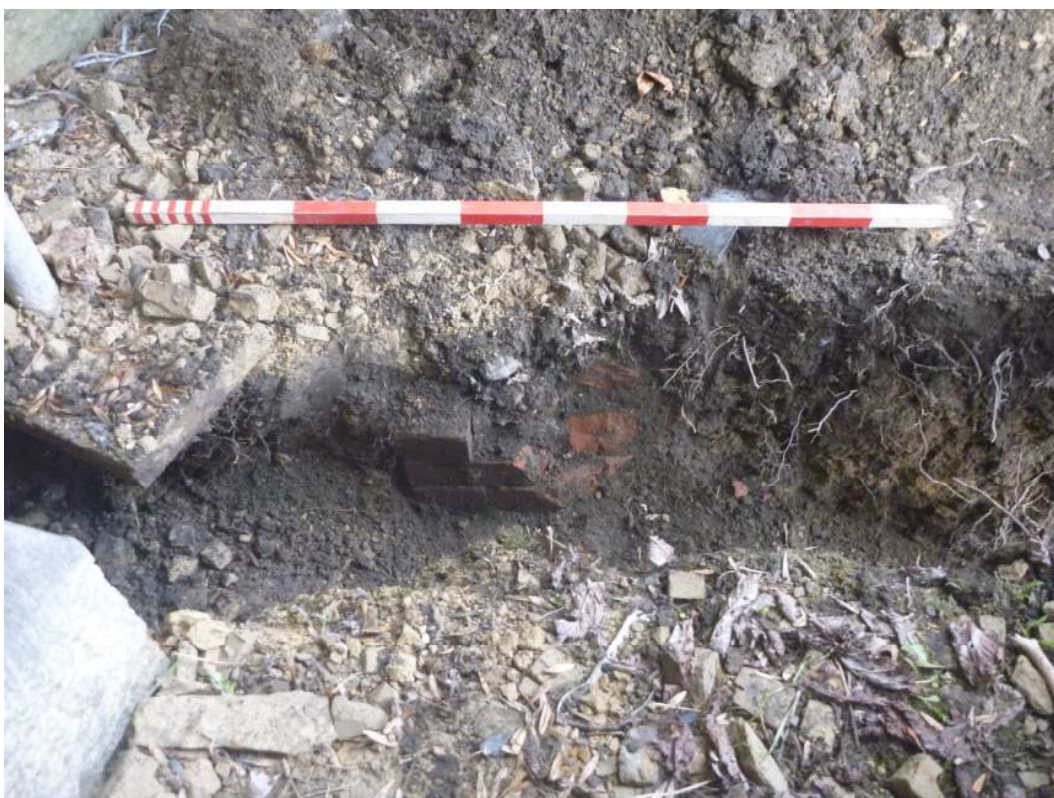
Plate 2: Brick structure 125 to northwest of church, viewed facing southwest

In pipe trenches excavated between the church and the path to the northwest of the church, context number 104 was ascribed to the current topsoil. Only one feature was observed within the area to the northwest of the church, a small brick structure 0.7m out from the church, close to one of the buttresses (Plate 2). This structure (125) was 0.15m below the ground surface and

was constructed of machine-pressed red brick. It was visible to three courses in height (0.2m) and three bricks wide (0.33m). The modern appearance of the brick and the narrow width of the feature suggest it may be associated with drainage, as it is close to a downpipe. Only one external face was visible in the edge of the trench.

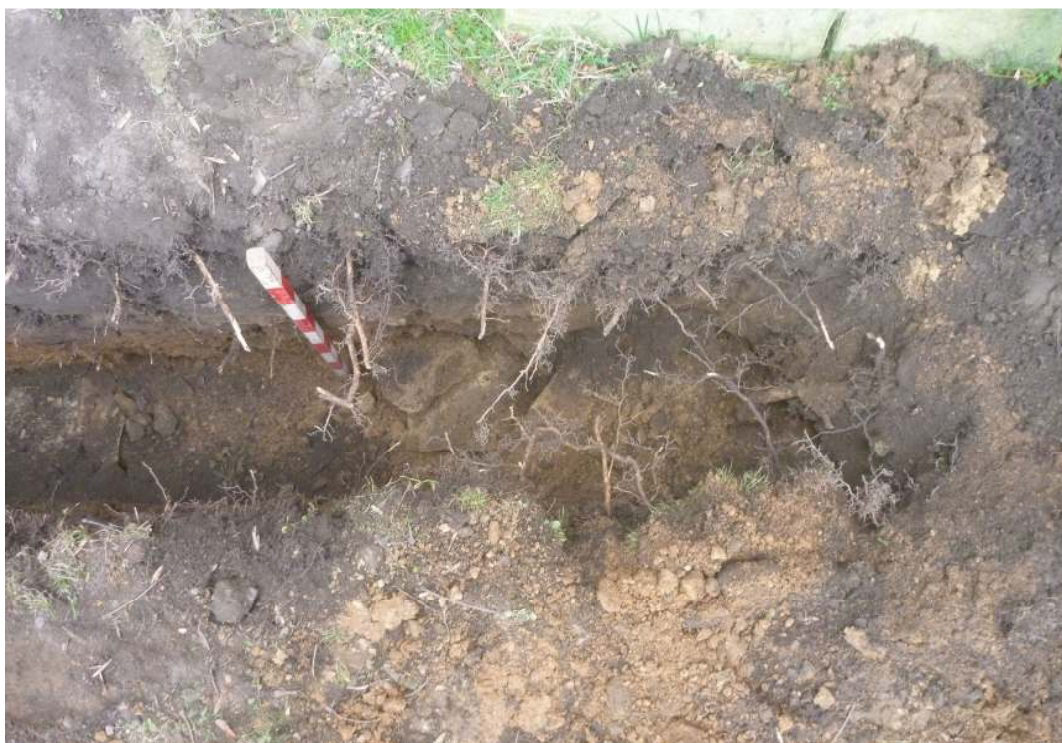
Plate 3: Plan view of structure 109 as seen in drainage trench, viewed facing northwest

Structure 109, (Figure 3, Illustrations 1 & 2; Plate 3), was immediately beneath deposit 110, and directly to the southwest of one of the church tower buttresses. This structure consisted of an irregular arrangement of large sub-angular sandstone fragments which appeared to have been roughly dressed with some straight faces in a range of sizes from 22 x 20 x 8 cm to 45 x 20 x 20cm (Plate 4). Some of the individual sandstone elements retained residual traces of pale grey lime mortar. The impact of the drainage trench into this context was relatively limited, as the trench only measured 0.3-0.4m wide. The excavated depth of approximately 1.05m below ground level in this area. was sufficient to record the limited vertical extent of the context as 0.3m. Context 109 was interpreted as the possible outer edge of a spreading foundation pad pertaining to the construction of the church tower.

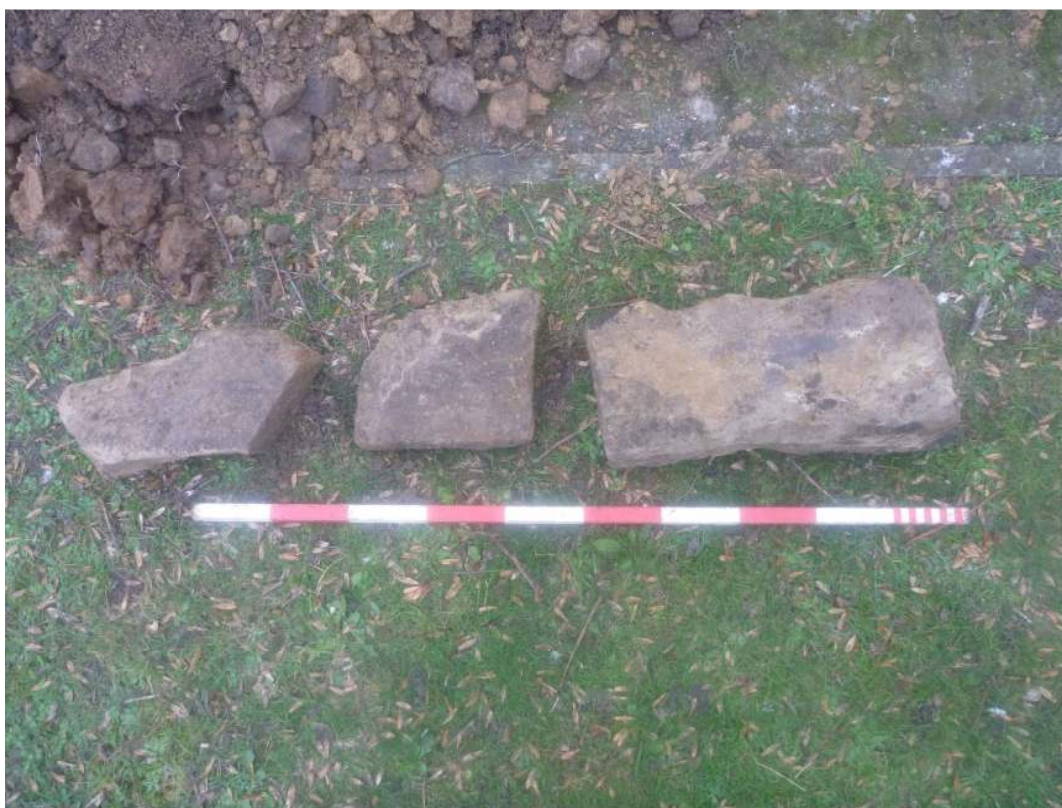
Plate 4: Stones removed from structure 109 during monitored excavation

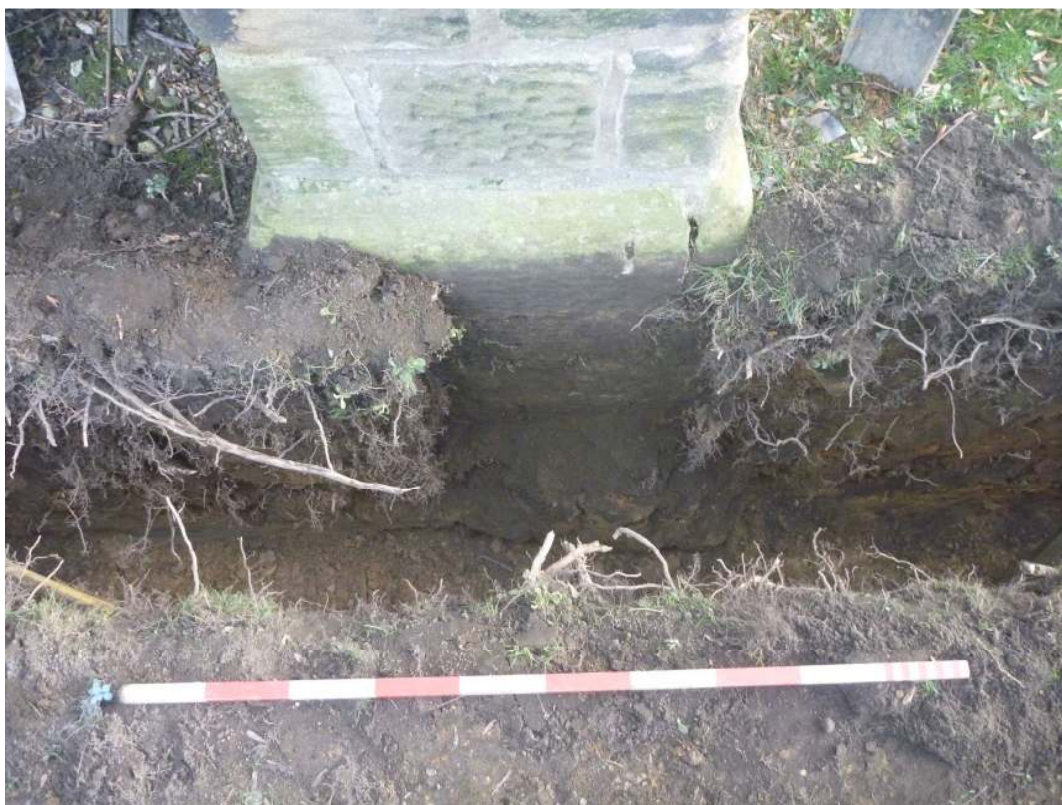
Plate 5: Structure 113 beneath south corner of the church tower, viewed facing northwest

A similar feature to 109 was impacted upon as the excavation of the drainage trench continued to the southeast along the southwest elevation of the church tower; structure 113 consisted of a substantial arrangement of roughly dressed sandstone blocks bonded together with pale yellowish-grey sandy lime mortar (Plate 5). The constituents varied in size up to a maximum of 40 x 35 x 12 cm, and were typically roughly shaped on one or two sides. As with 109, it seems reasonable to interpret 113 as the outer edge of a spreading foundation pad for the church tower. The stratigraphical sequence overlying 113 was perhaps a little more demonstrative than was the case with 109. Structure 113 appeared to be situated within a broad construction cut, which had been backfilled with a mixed deposit of silty sand with inclusions of rubble fragments, sandstone fragments and occasional sherds of later post-medieval pottery. This context was similar in nature to deposit 110 overlying 109, leading to the interpretation that the two backfill contexts were contemporary and sealed a single phase of construction in the form of structures 109 and 113

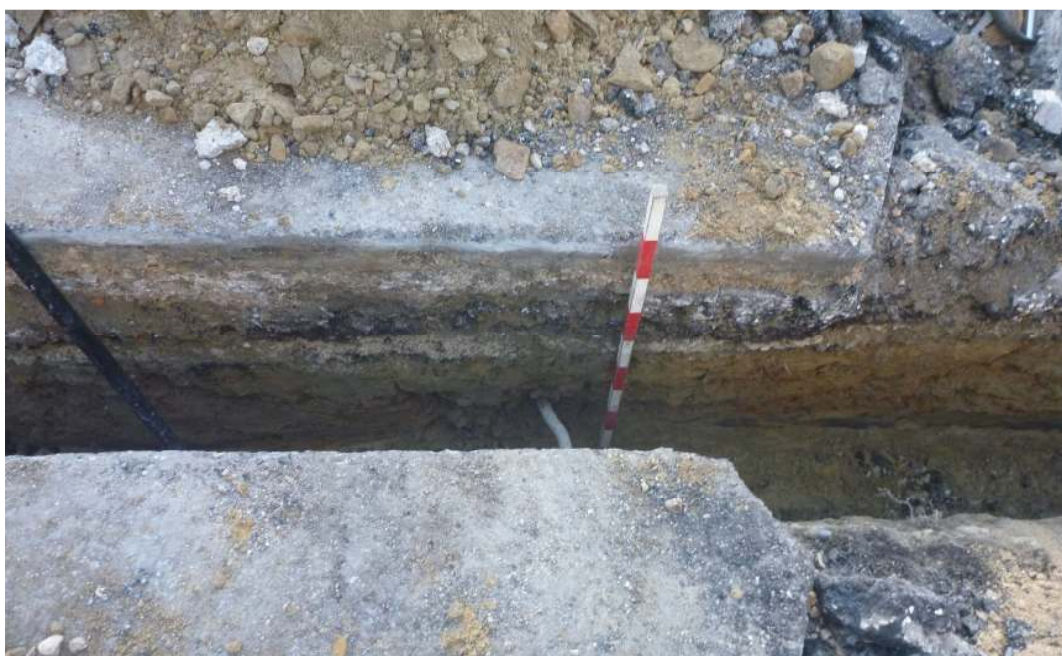
Plate 6: Trench section south of the porch, showing sequence of surfacing, viewed facing south

Within the area below the pathway to the south of the church, and the branch of the pipe trench leading to the road, the concrete path surface and bedding layer (100 and 101) were found to directly overlie the probable natural subsoil 108. This suggests that if earlier structures were located in this area, the landscaping associated with construction of the church and entrance way has removed any associated remains. In the area outside the church porch, a sequence of tarmac and concrete layers were observed below the most recent concrete, indicating a sequence of ground raising events outside the porch (Plate 6).

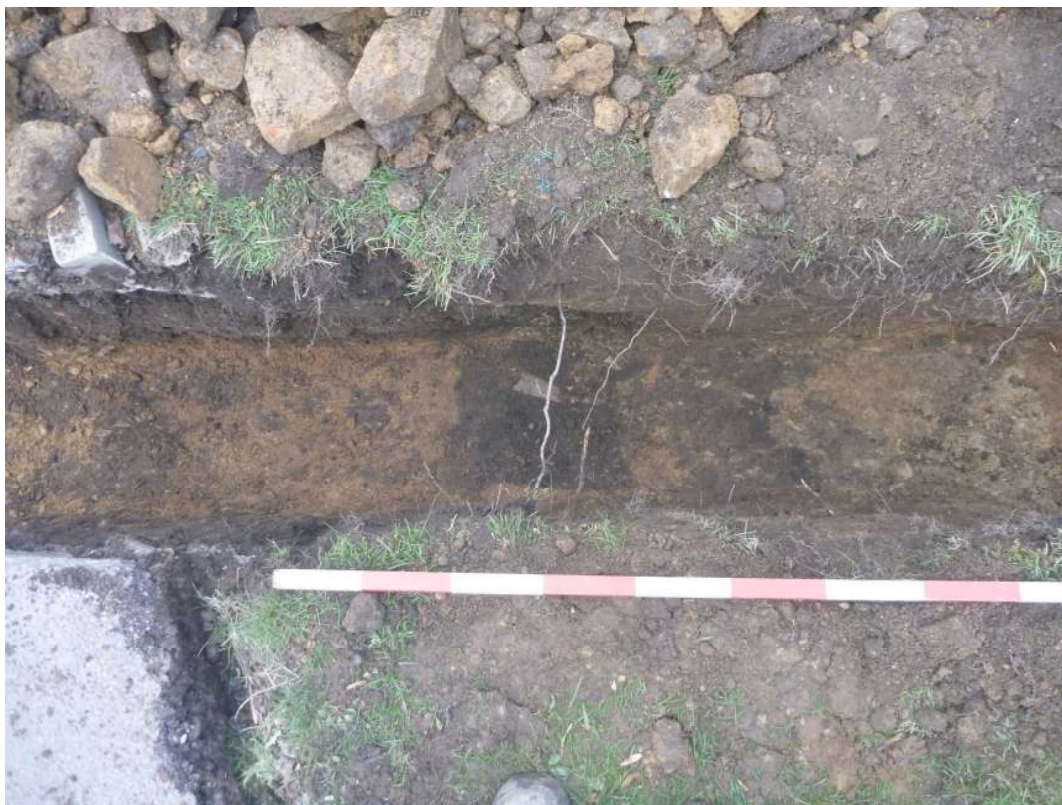
Plate 7: Plan view of cuts 120 (centre) and 122 (right) in subsoil 103, viewed facing southwest

Continued excavation of the drainage trench through deposit 117 towards the northeast end of the church along the southeast side led to the exposure of some negative features of indeterminate function. Feature 120 was fully visible in plan within the narrow confines of the service trench, measuring 0.25m by 0.3m (Plate 7) The feature was square with steeply sloping sides terminating at a flat base. The feature was cut into natural subsoil 103, and was backfilled with dark black-brown sandy silt 119. The fill contained few inclusions aside from infrequent small sandstone fragments, and no artefacts were present within the fill. Without any artefacts or other relevant details to inform an interpretation of this feature a definitive explanation of its purpose remains elusive.

Three features were found directly to the north of 120 at a similar depth of 0.2-0.3m below ground level. As these features were very similar and appeared to be the product of a single episode they were ascribed a single common cut (122) and fill (121) number. The features were in a similar position within the site stratigraphy; directly cut into subsoil 103 and sealed by overlying graveyard soil 117. The features appeared to be linear, but once again the limited width of the drainage trenching did not allow for an extensive investigation into specific features in this area. Although within close proximity to 120, the backfill of features 122 was clearly different to 119; consisting of a loose pale grey-yellow sand 121 with occasional inclusions of small sandstone fragments. The backfill of these features was, therefore, quite similar to the underlying subsoil (108) suggesting the interpretation that these features were the product of a rapid sequence of excavation and backfilling. They may have been trenches for earlier land drains, or were perhaps related to the construction of St Paul's.

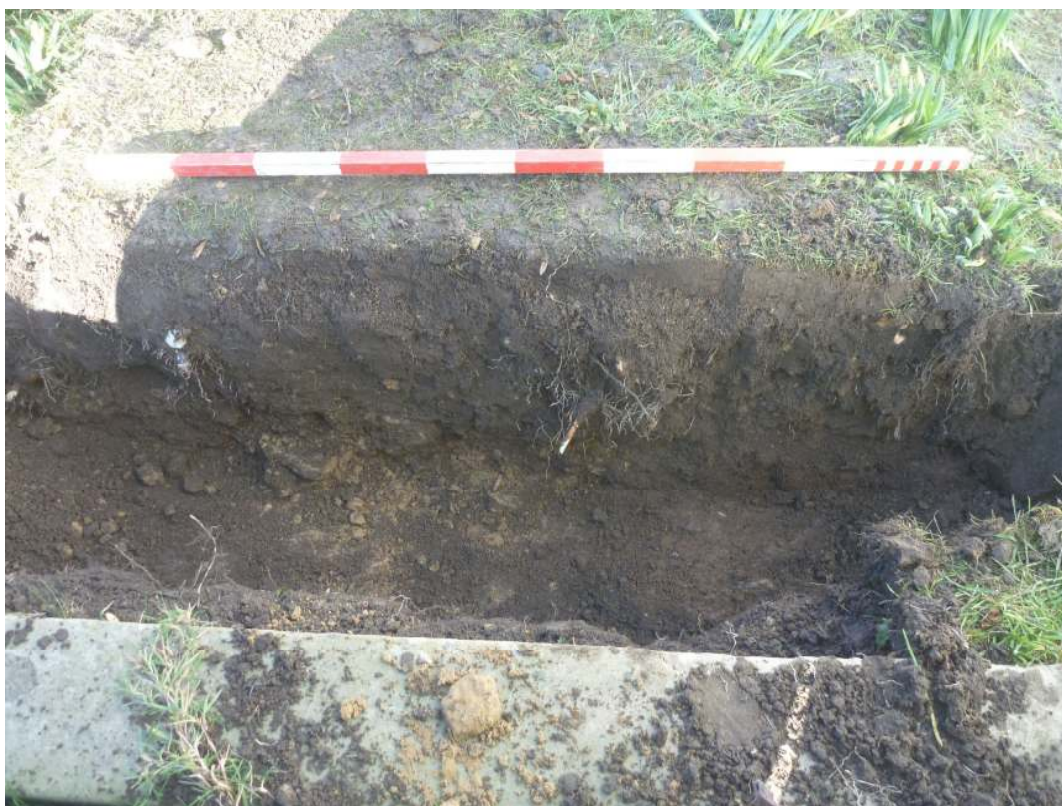
Plate 8: Drainage trench through lower end of grave, viewed facing southwest

trenches as far away as possible from the visible graves it was necessary to excavate a shallow trench across the lower portion of a grave or memorial belonging to Emily Saunders. Unfortunately the writing on the headstone has been subjected to considerable damage over the years; it appears from the surviving text that her husband James was interred at Felkirk, the location of the mother church to St Paul's. The drainage trench was hand-excavated through the northwest end of the demarcated 'grave' area to a maximum depth of 0.3m below ground level (Plate 8). No human remains were encountered during the excavation of the drainage trench, although irregularities were observed in the interface between topsoil and subsoil which could be interpreted as the upper margins of a grave cut.

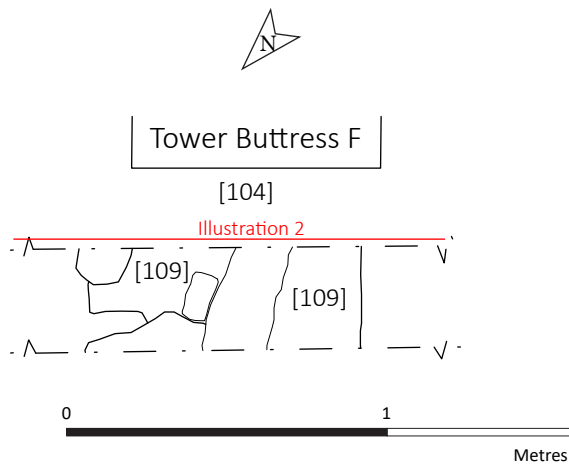
Illustration 1: Plan of Structure 109

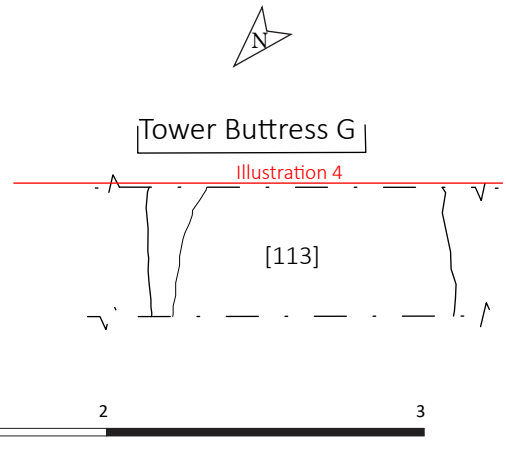
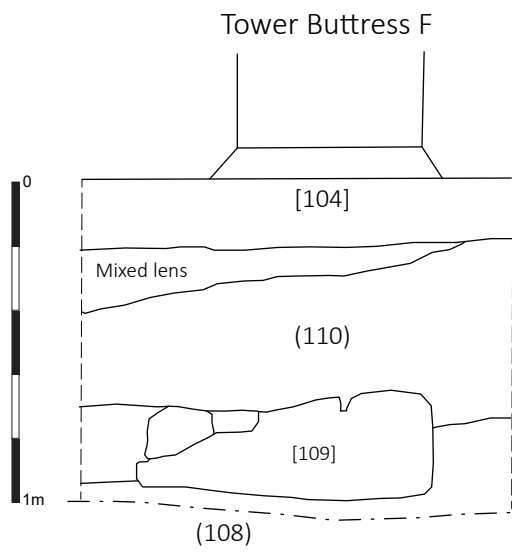
Illustration 3: Plan of Structure 113

Illustration 2: Southeast-facing section showing Structure 109

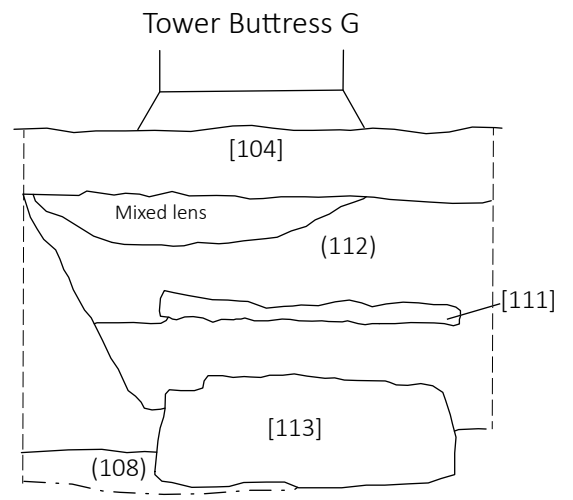
Illustration 4: Southeast-facing section showing Structure 113

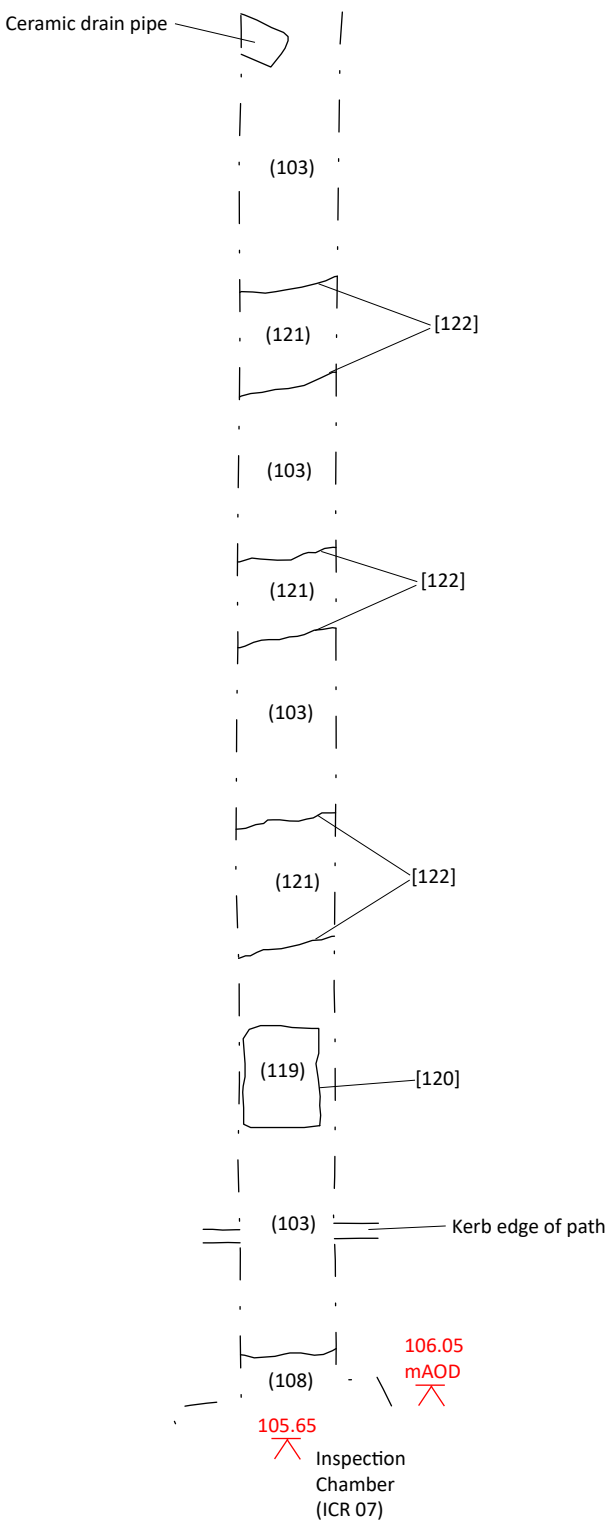
Figure 4: Plan of features [120] & [122]
