Elsecar Beam Engine Boiler House

Archaeological investigation

**Archaeological Investigation at the Elsecar Beam Engine Boiler House,
South Yorkshire**

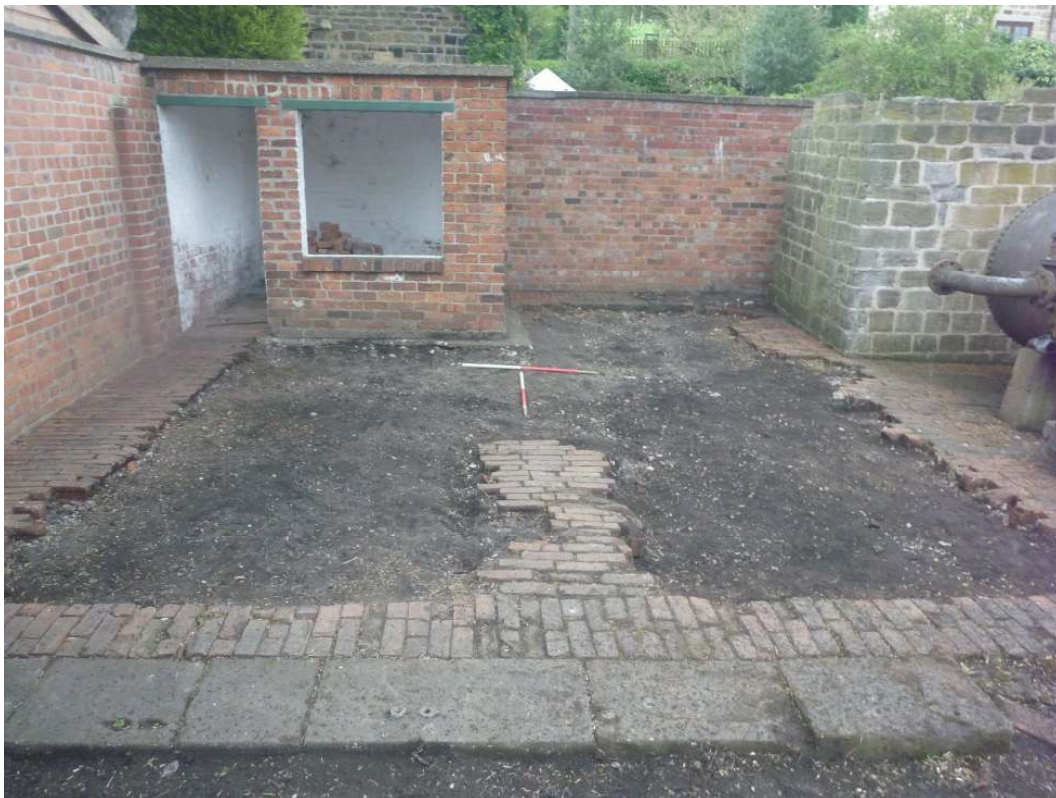
Plate 1: View east across the boiler house after concrete removal

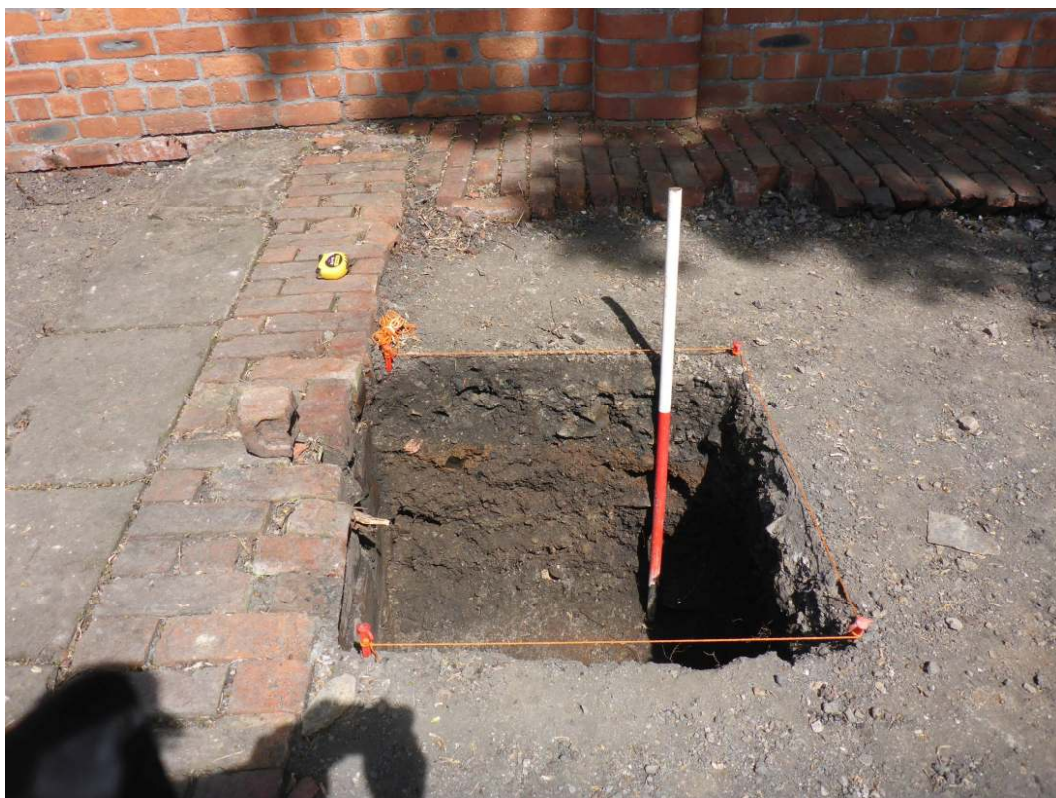
Plate 2: Section through deposit 102 in TP1, viewed facing north

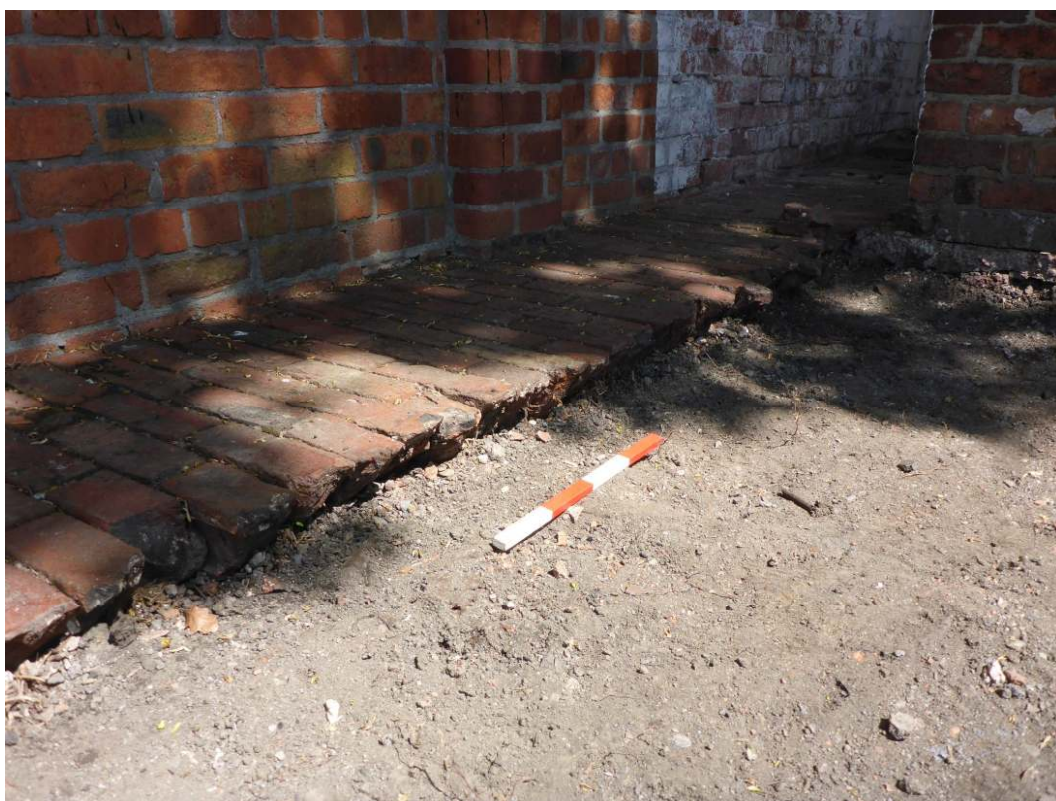
Structure 107, at the northern side of the site, had chamfered bricks preserved along much of its southern edge (Plate 3). These were cut diagonally inwards across the edge, suggesting they had

been laid around an *in situ* curving boiler cylinder. A small patch of similarly chamfered bricks survived at the southeast side of the site, forming part of the northern edge of structure 114. This edge has been lost across most of the floor 108, which has only one chamfered brick surviving (Plate 4). The preservation of the chamfered bricks within parts of the site suggests the boilers were cut up *in situ* and removed in pieces with some care, to avoid damaging the structure, perhaps indicating that the people removing the boilers were well aware of the significance of the steam engine and its infrastructure.

Plate 3: Chamfered bricks at the edge of the boiler cavity, structure 107, viewed facing northeast

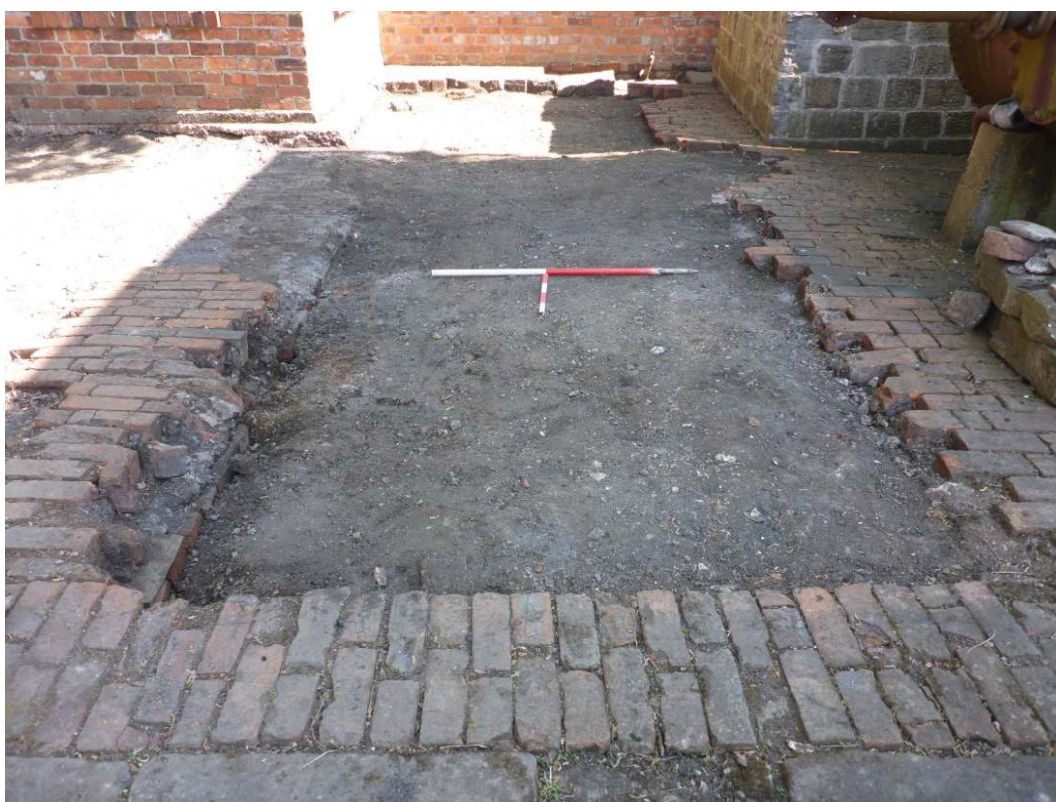
Plate 4: View east across southern boiler cavity showing walls 105, 106, 108 & 114

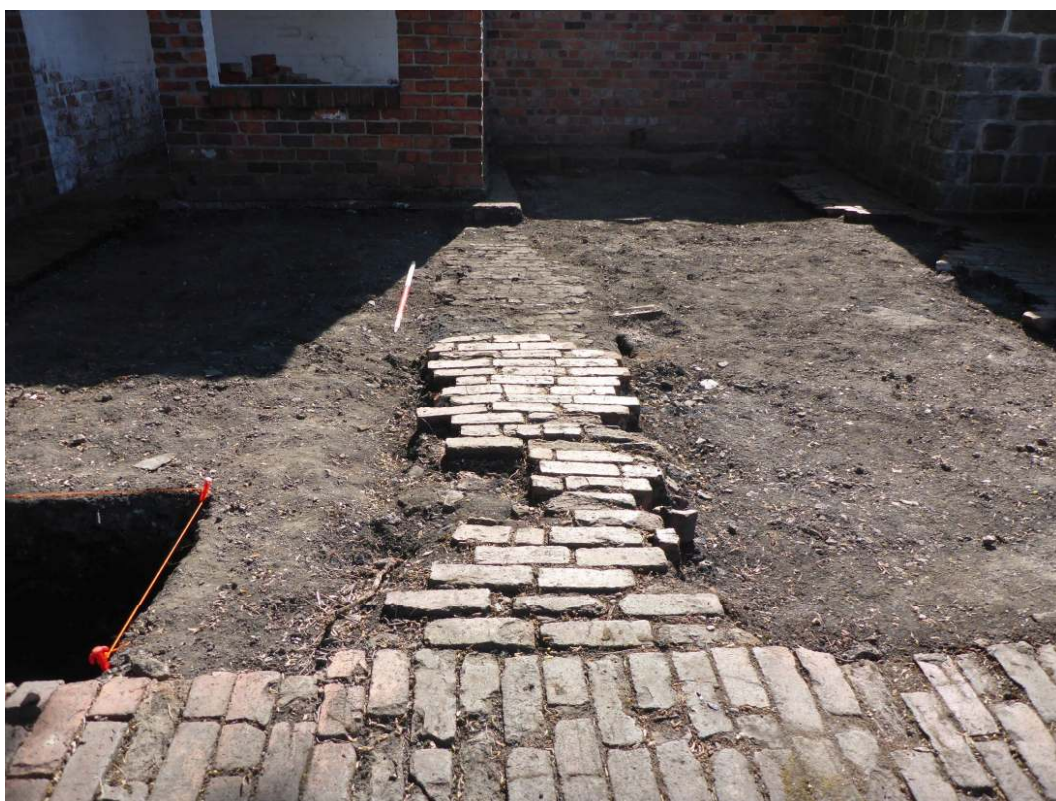
Structure 106 runs east-west across the centre of the boiler house separating the two boiler cavities. Voids along its edge reveal that this is a wall rather than just a floor layer, though it would also have formed a maintenance access walkway between the boilers. Removal of the concrete exposed more of this wall than was previously visible. This has lost its upper course of bricks along most of its length, but a hard dark grey mortar layer is present along its eastern half, covering bricks below (Plate 5). A small patch of pink asbestos fabric was found embedded in this mortar to the southwest of the mid-20th-century shed. A gap in the bricks at the western end and two areas of slightly different mortar along the lower section of wall may indicate the location of former pad-stones, possibly for roof supports. These features are a fairly regularly spaced and at the eastern and western sides they line up with brick supports in the northern boundary wall of the site.

There was further damage at the eastern end of wall 106, and its junction with structure 109 was not visible, though probing suggests that 106 continues below 102 across this gap at a slightly lower level. The upper course of this wall, as with 107 and 114, comprises bricks laid in stretcher courses on their narrow edges. All the surface bricks appear to be a uniform size (22 x 11 x 8cm) and machine-pressed. At least some are frogged, and a couple of stamped examples were recorded ('James Smith & Co, Skyers Spring, Barnsley', see discussion). The surfaces of walls 106 and 107 were probably originally three and a half stretcher bricks wide (0.82m), whilst 114 appears to have been slightly narrower at three bricks, possibly constrained by the chimney to the south.

Plate 5: Wall 106 viewed facing east

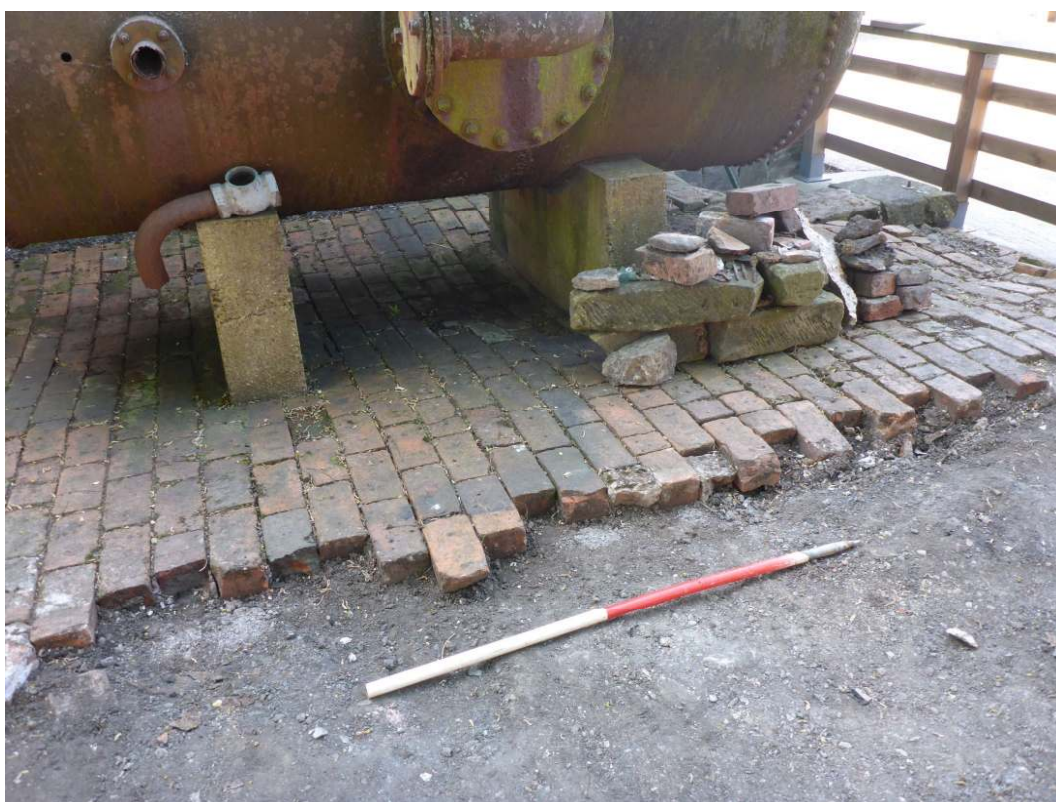
Surface 108 forms the base for the steam receiver and merges with 114 on its eastern side. It is constructed of similar-sized red bricks, but these are laid on their wider face. The surface has sunk below the steam receiver setting (Plate 6), possibly due to the weight of the receiver, though this may indicate a void or soft area below the surface, perhaps associated with earlier boiler provision.

Plate 6: Surface 108 showing sunken area below steam receiver, viewed facing south

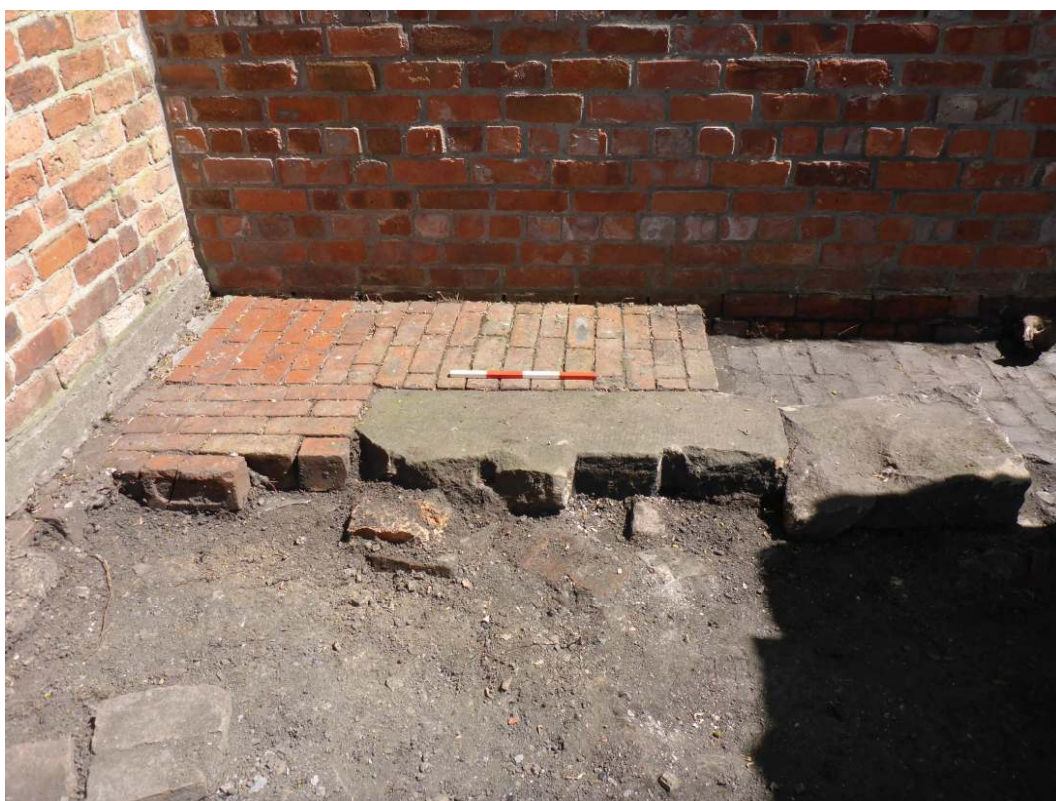
At the eastern edge of the boiler house, surfaces 109 and 111 were separated by the concrete capping, but below this is an area of hard dark grey mortar overlying bricks (110), at least one of which is a firebrick. It is likely that this area originally had a continuous surface running along the east side of the chimney and boilers. Much of the upper surface of 109 and 111 are red bricks in the same style as 106-107 and 114, but there is an area of more recent brick infill at the northeast corner, just south of the modern shed (Plate 7). Two stone slabs are set into the western edge of 109, one with mouldings on its western face, which appear to form a setting in the centre of the cavity, possibly associated with a boiler fitting. A metal pipe is set into the base of the eastern boundary wall of the site adjacent to the lower area 110, and it is possible that the upper course of bricks in this area was damaged or removed during the insertion of the pipe. The pipe bends upwards to the west of the wall, and its purpose is unclear.

Plate 7: Surface 109 and 110, showing brick infill to left and stone settings, facing east

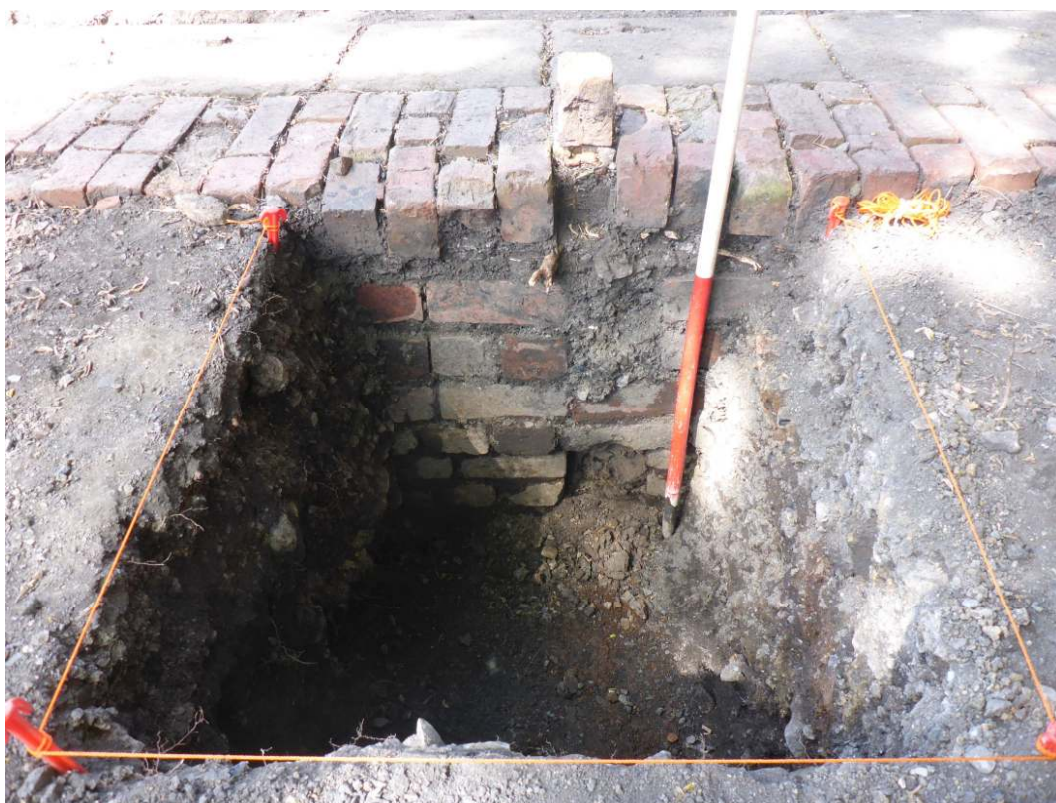
The western edge of the boiler house is formed by two parallel walls, 104 and 105. The former has an upper layer of stone, whilst the latter is surfaced in brick. It is possible that below the surface these form a single wide wall with different surface treatments. The sondages to either side

suggest some differences in the construction details, though these were offset and may indicate differences in detailing along the length of the wall. Considered together, the two are a similar width to wall 106. The eastern of the two, wall 105, was examined in TP1 (see Figure 8, Plate 8). The upper course is of red bricks laid on their narrow edges in a similar fashion to structures 106 and 107, though only two stretcher-bricks wide (0.36m). There was some root intrusion and soil below the brick surface of 105; however, it was unclear if the roots were exploiting a soil deposit or that the roots separated and offset the bricks and enabled the soil to accumulate. A rectangular soil-filled void or recess was present in the northern side of the elevation below the upper course, up to 30cm deep. It is uncertain if the recess was original to the structure, possibly for pipe access, or the result of loss of bricks during demolition of the boiler. Eight courses of bricks were exposed in the elevation of 105 within TP1. The upper four courses are red bricks, whilst the lower four courses appear to be fire bricks. A straight joint is visible on the southern side of the elevation, in the lower three courses of red bricks. This may indicate some alteration to the wall. Below the rectangular void is another void, capped by a firebrick with a slightly curved indentation along its bottom face. This slight shaping suggests that the void is a former opening in the wall, perhaps for a pipe or small hatch. The void is 17cm tall by 17cm wide.

Plate 8: Elevation of wall 105, viewed facing west

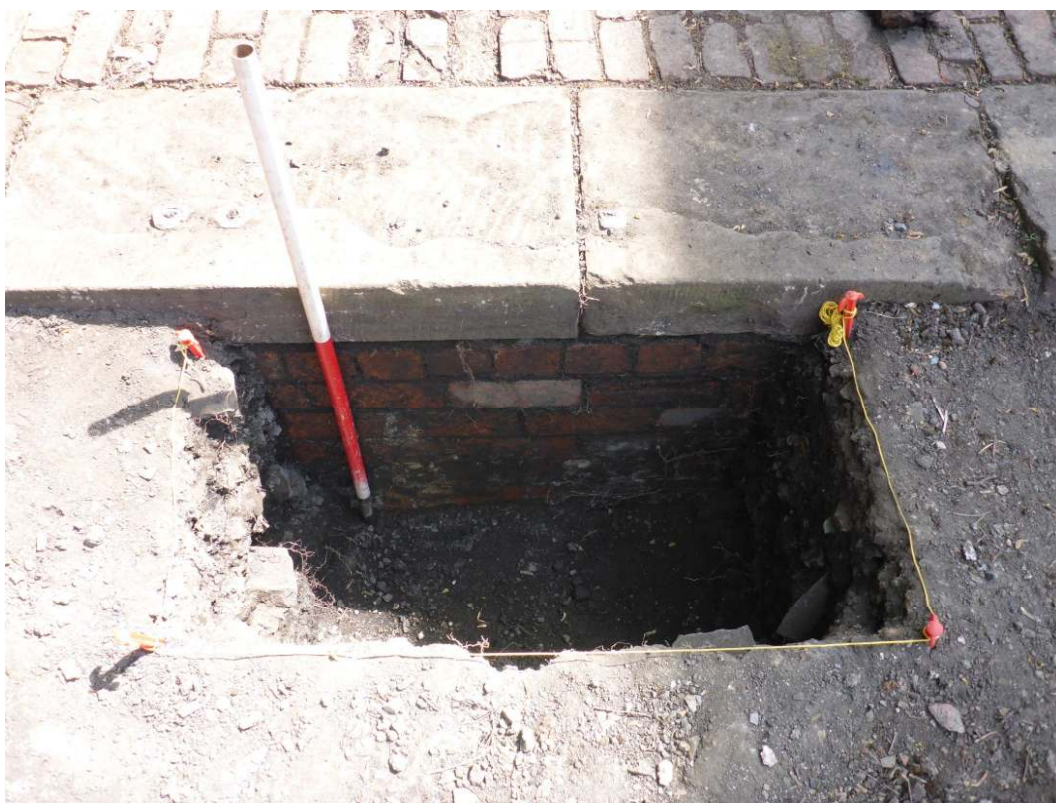
The western side of this structure, wall 104, is capped by a course of dressed sandstone slabs 0.42m wide. Four of the slabs have fittings for former railings along the western edge, with slight differences in their form suggesting there may have been two successive sets of railings. A test pit adjacent to this wall (TP2) revealed a brick wall below the slabs, extending down beyond the base of the test pit, in which excavation ceased at 70cm below the current ground surface. The part of this wall exposed in the test pit had a thick layer of hard, dark mortar below the stones, overlying neatly coursed red bricks. The upper brick course was set header-on, with all the lower courses revealed being arranged mainly as stretchers (see Figure 8, Plate 9). The bricks are of a uniform size identical to those in the areas of surfacing.

Plate 9: Elevation of wall 104, viewed facing east

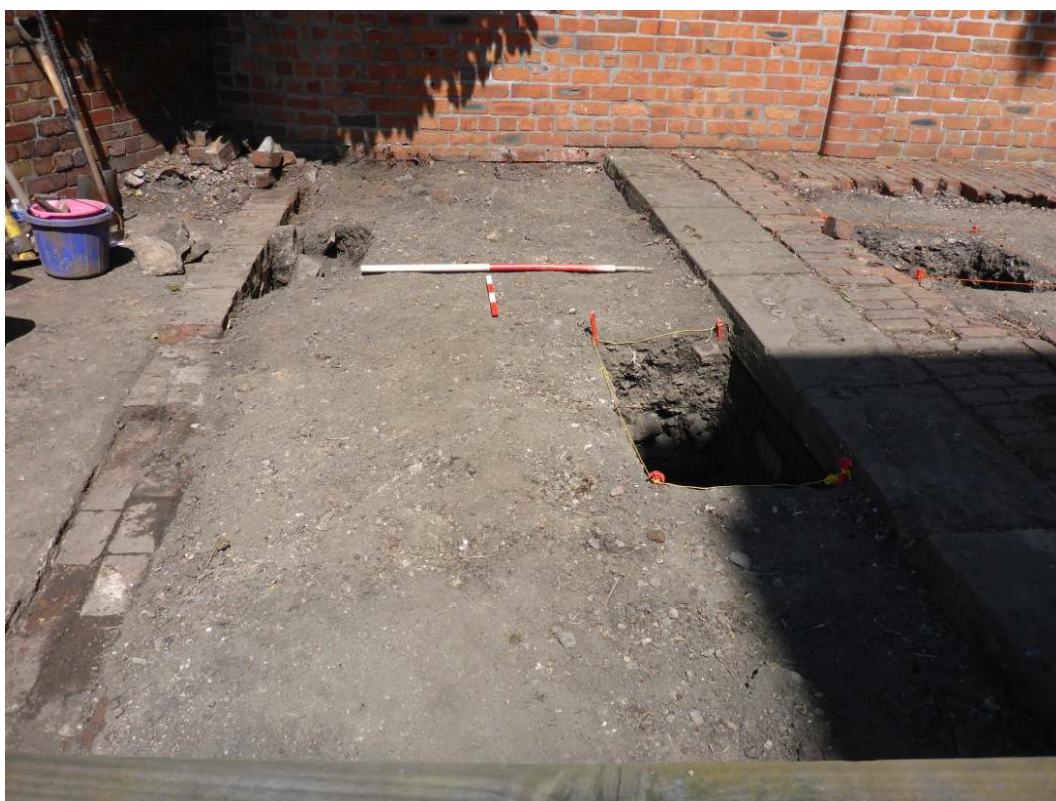
West of wall 104 was a double skin brick wall 112 (Plate 10) and between them was another area of infill. The southern end of wall 112 has lost the upper course of bricks, but the wall continues south at a lower level. The bricks are similar to those found in the other structures on the site. A small slot excavated adjacent to this wall confirmed that it extends down and appears to be in a good condition. This wall forms the western edge of a cavity adjacent to the main part of the boiler house, probably an access cellar for stoking the furnaces below the boilers and removing ash. The cavity was infilled with deposit 103, examined in TP2. This is similar in nature to 102, including yellowish clayey deposits and darker blackish gritty sand and clinker deposits; however, a paler deposit of sub-rounded pebbles in a sandy matrix was only found in TP2, as well as a deposit containing pieces of asbestos-cement tiles. These tiles appeared to be in a single tipping layer, found between 0.24 and 0.36m below the ground surface. Samples of the tiles were recovered for testing, and soil samples were subsequently taken from this area to test for loose asbestos fibres in the soil. The latter tests were negative (T. Roberts pers. comm.). At the western side of 103, some larger rubble fragments (bricks and stone) were recovered in the upper layers adjacent to wall 112.

Plate 10: View north over infilled area (103) between walls 112 and 104

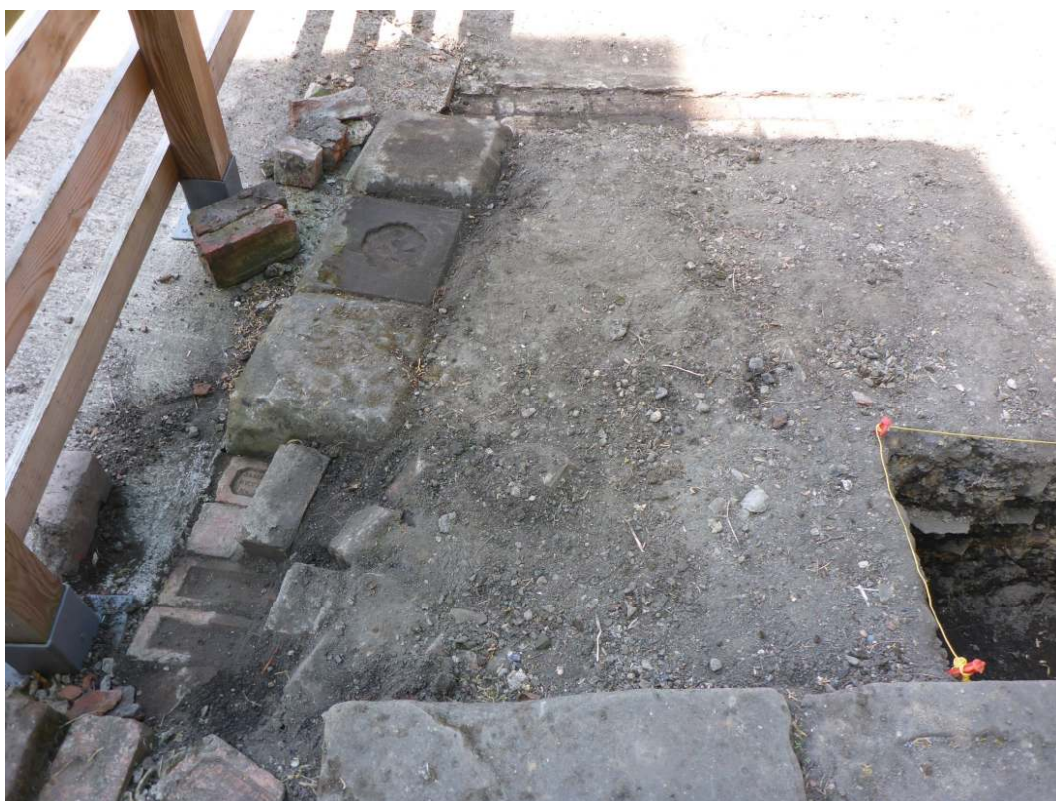
It is likely that the stoking cellar was accessed via a former stairwell just north of the northwest corner of the engine house, which would suggest that the cavity extends further south from the evaluated area, up to the edge of the engine house. However, a structure of brick with stone capping (113) crosses the infilled area 103 at the southern edge of the cleaned area. It is not clear whether 113 extends down as a blocking wall, though at least two courses are visible. One of its

stone blocks has an incised octagonal setting on its upper face, possibly a base for a former support, suggesting these may have been reused from elsewhere in the boiler house (Plate 11).

Plate 11: Structure 113, viewed facing west

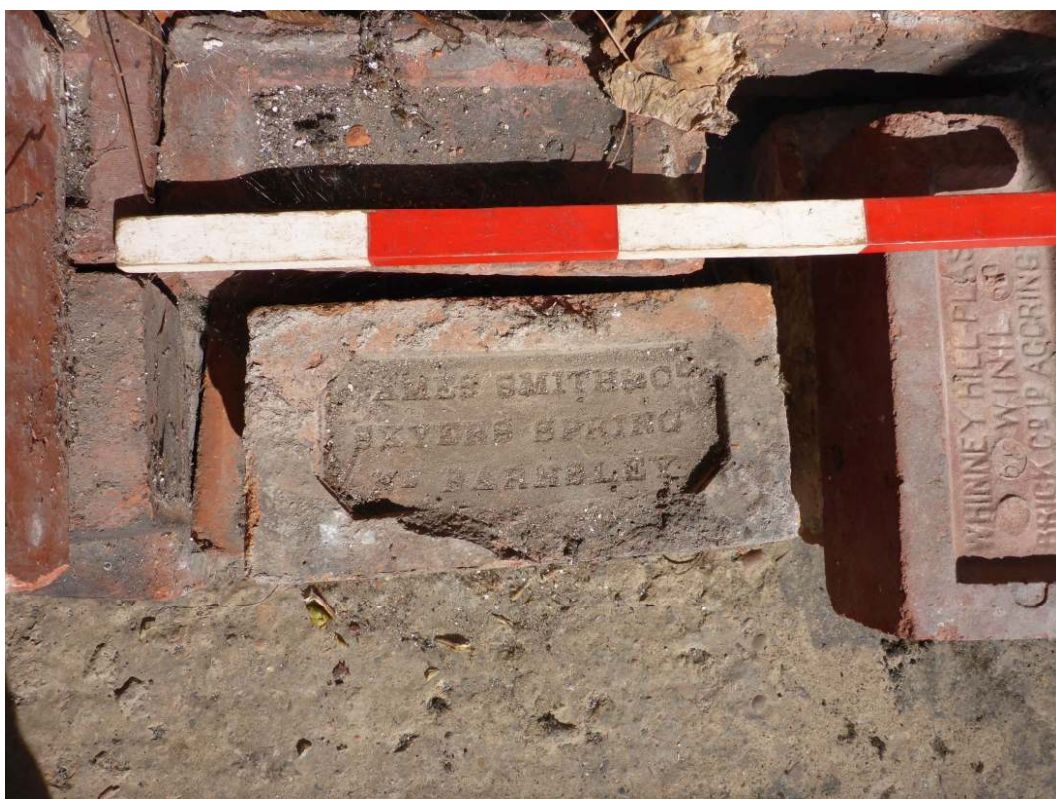
A number of bricks stamped 'James Smith & Co, Skyers Spring, Barnsley' were noted in the upper level of brickwork at the site (Plate 12). Smith's Skiers Spring brickworks was in business from 1878 to c.1900, before being taken over by Earl Fitzwilliam (Chris Jones pers. comm. [Friends of Hemingfield Colliery]). These bricks may indicate a date for the construction of the latest phase of the boiler house, though as these are from the uppermost levels, it is equally possible that they relate to later repairs to the surfaces. This latter suggestion is supported by map evidence that indicates the boiler house had been constructed on its current plan by 1859 (Figure 3).

Plate 12: Example of a 'James Smith Skyers Spring' brick
