Sanderson's Weir, Attercliffe, Sheffield
Archaeological Watching Brief Assessment Report

Sanderson's Weir, Attercliffe, Sheffield, South Yorkshire
Archaeological Watching Brief Assessment Report

Project Name	Sanderson's Weir, Attercliffe
Report Title	Archaeological Watching Brief: Assessment Report
Report status	Final
ArcHeritage Project No.	2173
Type of Project	Watching Brief
Client	ECUS Ltd
NGR	SK 37188 88921
OASIS Identifier	archerit1-369045
Author	Laura Strafford
Illustrations	Laura Strafford
Editor	Rowan May & Jennifer Oliver
Report Number and Date	2019/53 4 th October 2019
Version and filename	Version 2. 2173 Sanderson's Weir WB report V2

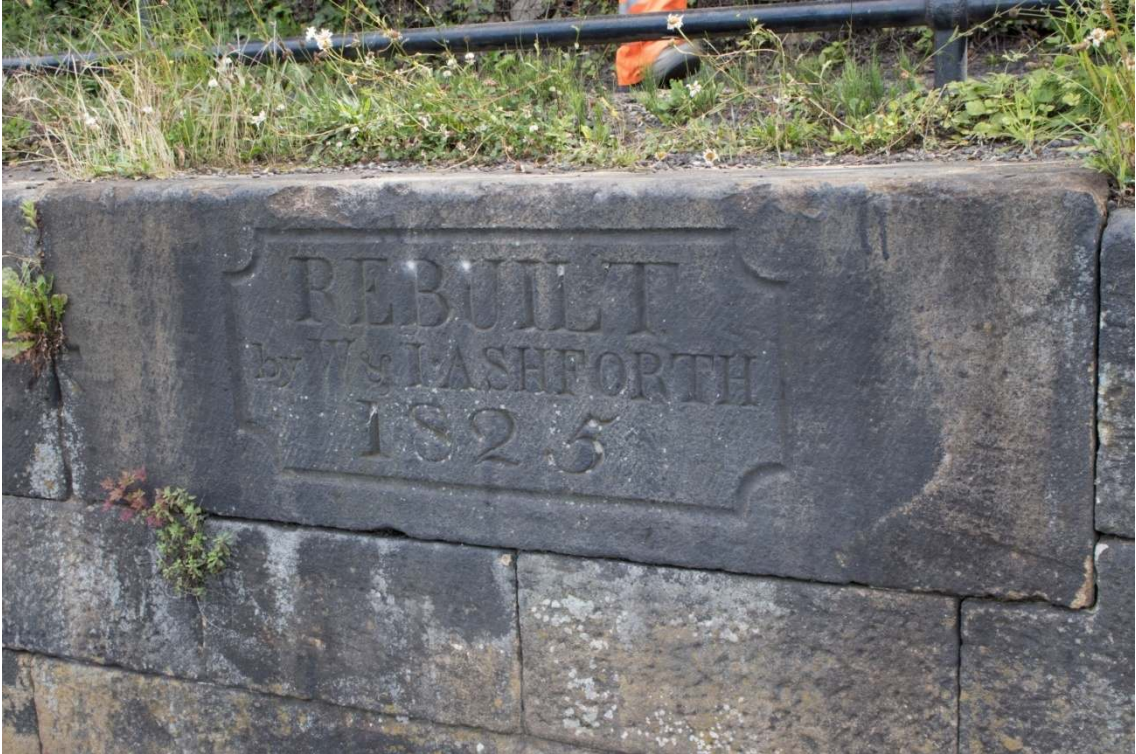
Plate 1: Date stone on the eastern bank. Looking north east

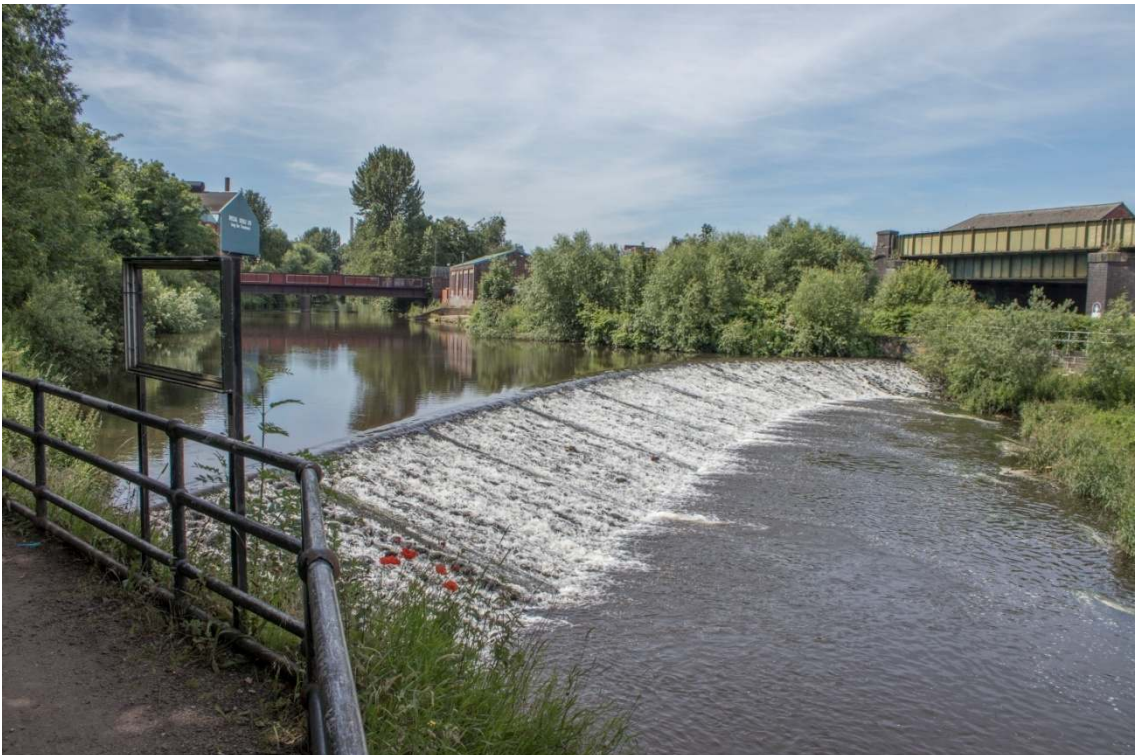
Plate 2: The weir prior to commencement of works. Looking south-west

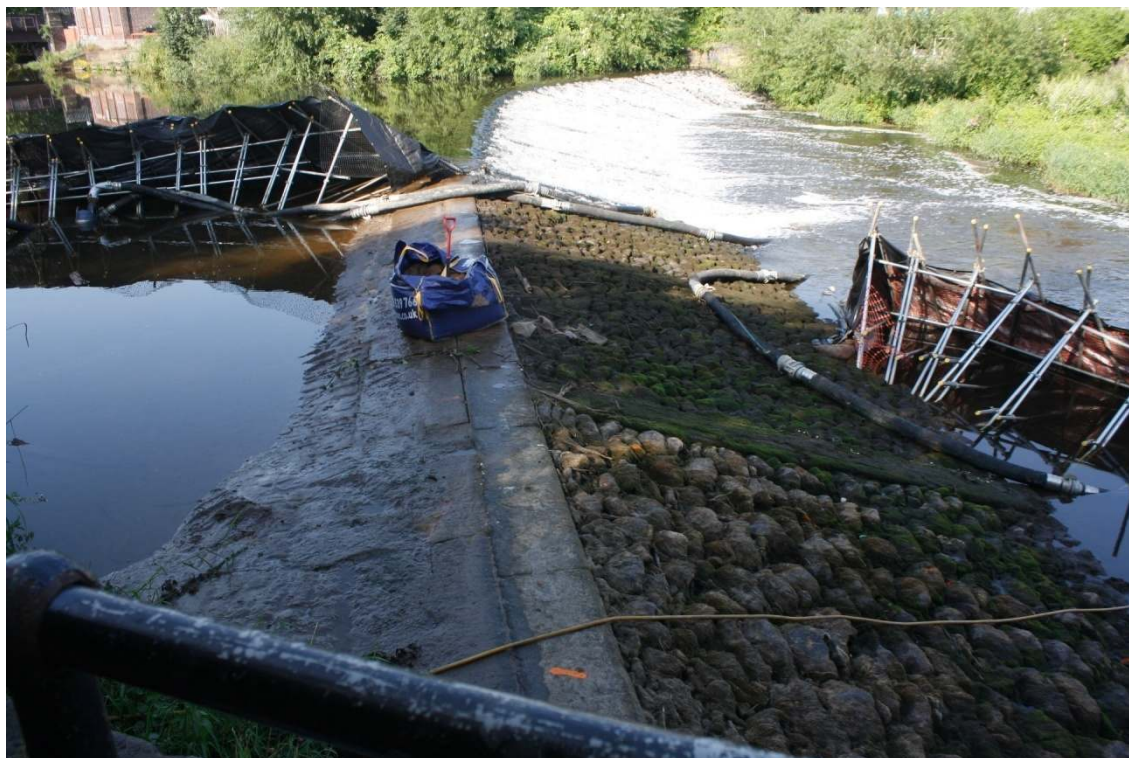
Plate 3: Pre-excitation shot of the exposed weir structure. Looking south-west

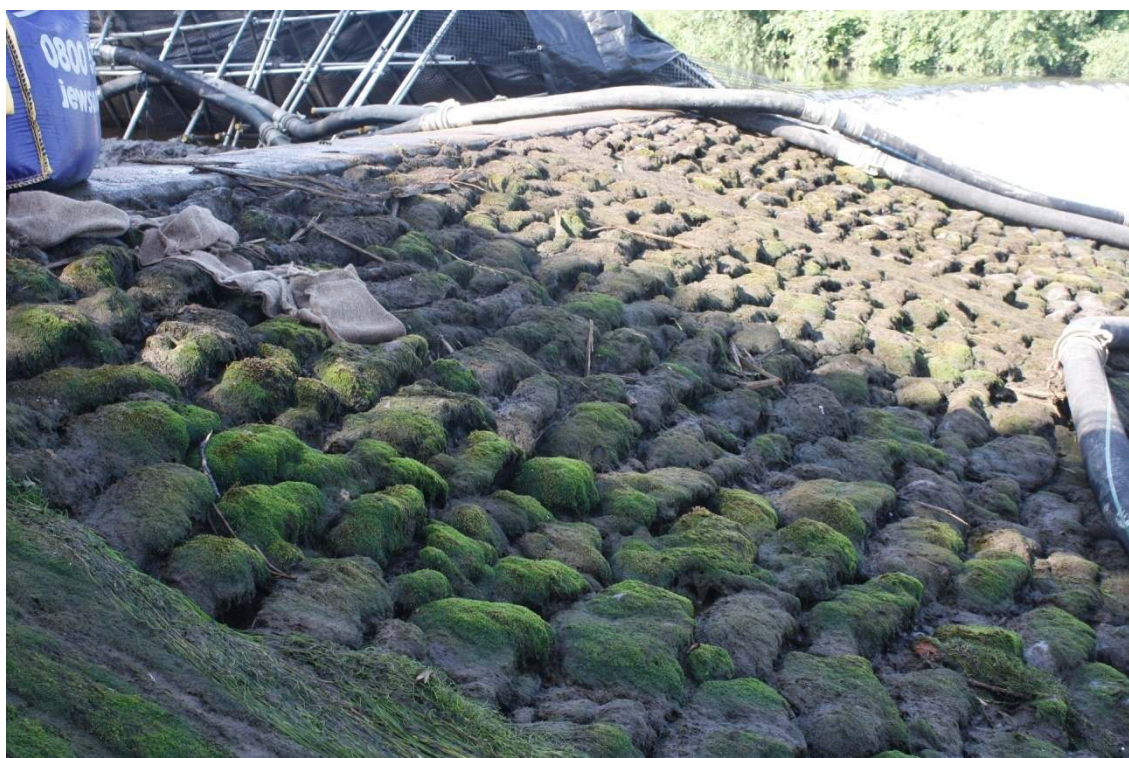
The ribs were secured with iron straps and fittings, with no mortar observed. The crozzle structure (100) in between the stone ribs on the downstream face was secured with iron bolts.

Plate 4: Detail of slag and crozzle structure (100). Looking west

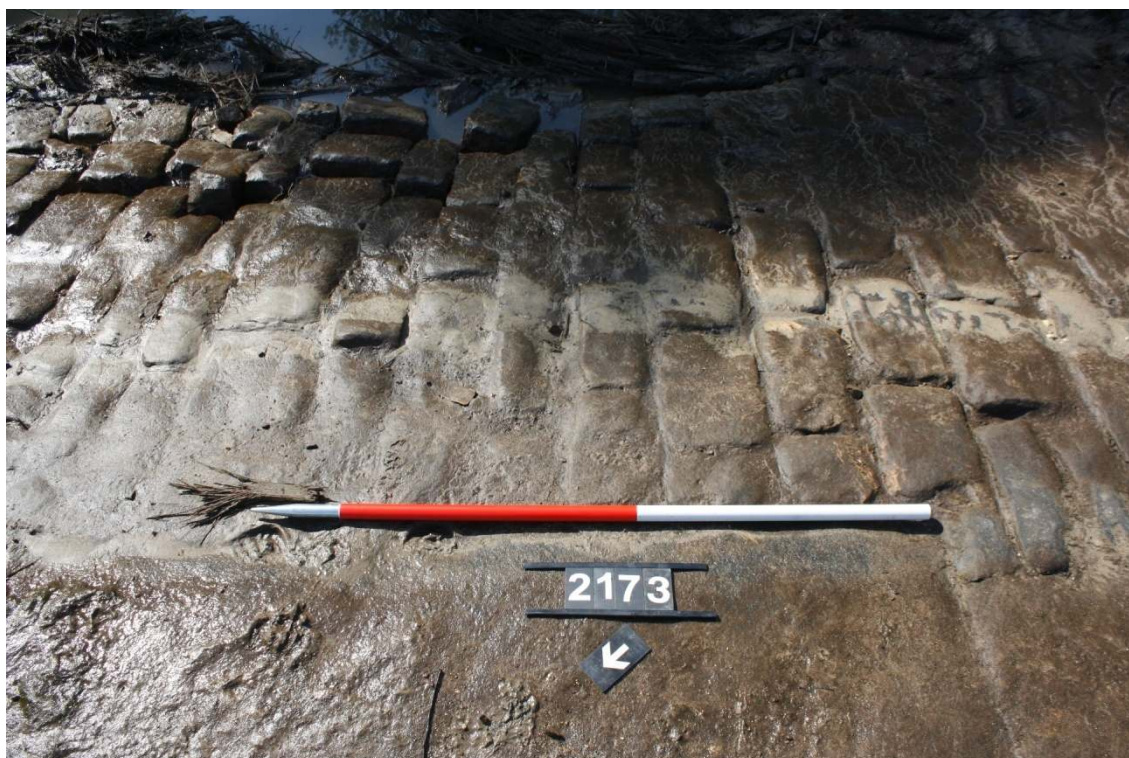
Plate 5: Detail of stone structure (104). Looking south-east, scale 1m

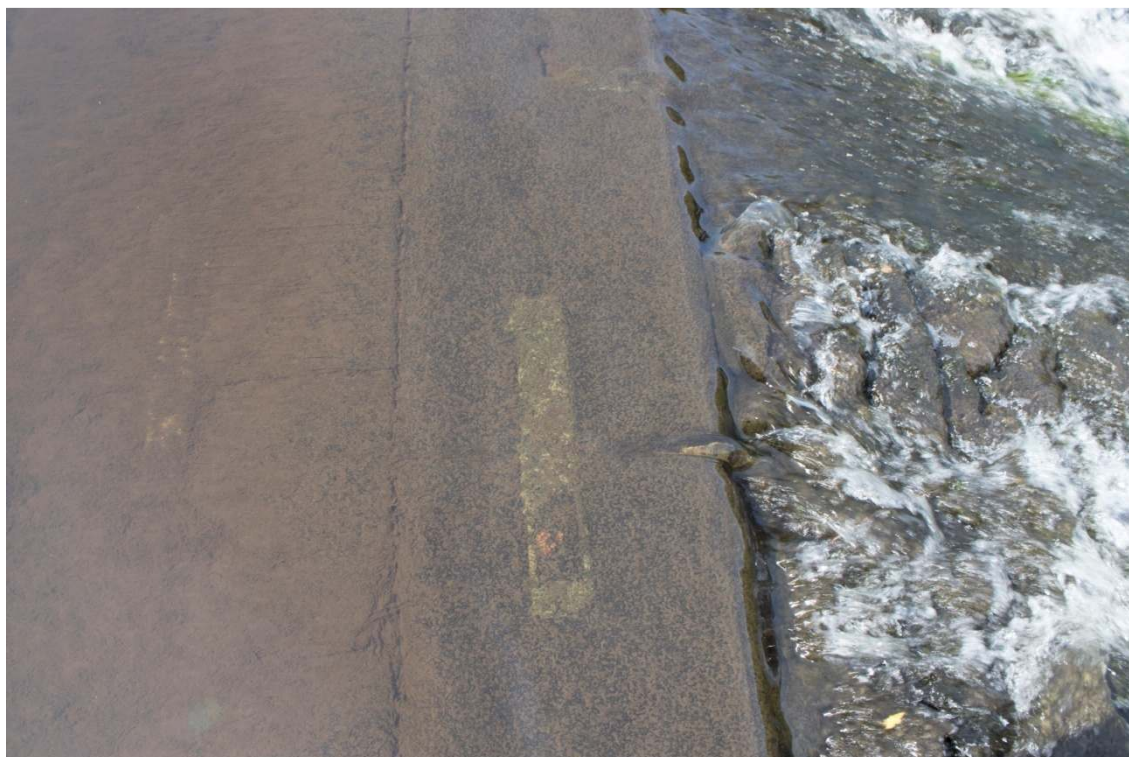
Plate 6: Detail of the metal strapping fastening together (102). Structure (103) also with metal strapping is just visible to the left, with the slag and crozzle structure (100) to the right. Looking south-west. Taken prior to commencement of works

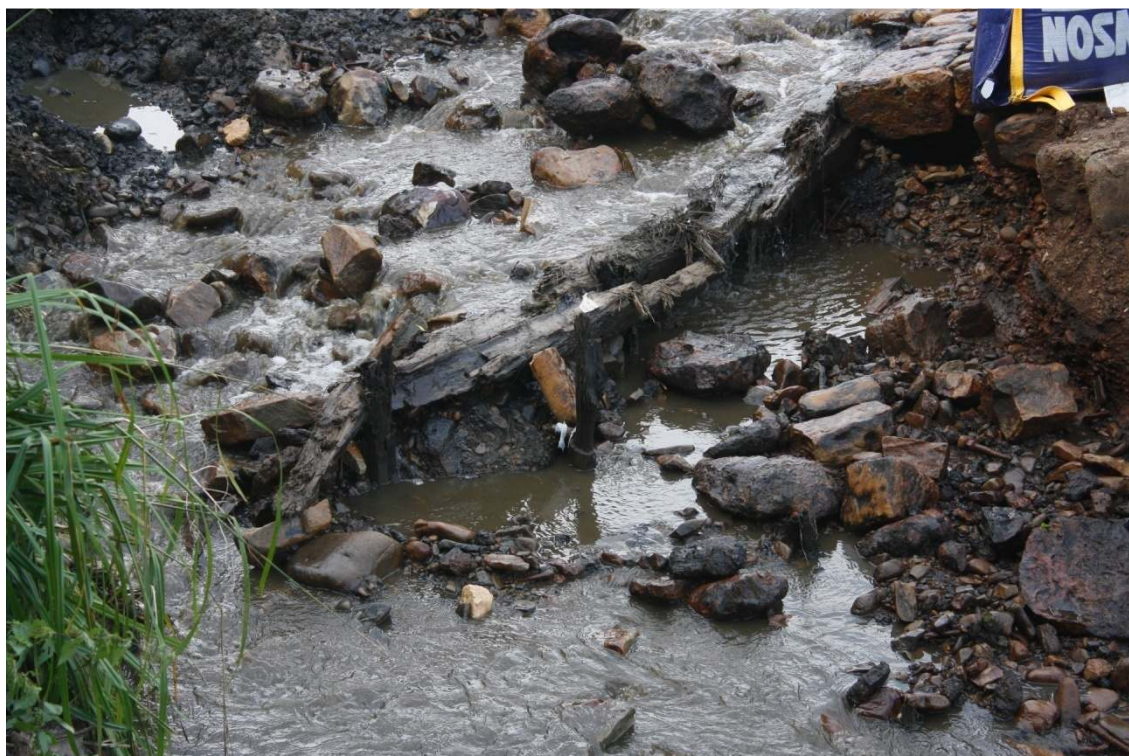
Upon removal works, it became apparent that the stone structure (104) of the upstream face of the weir was supported by a timber frame comprising upright timber posts (106) which had been secured through horizontal timber beams (105) (Plates 7 to 9). Iron spikes were also observed to be intermittently driven through the beams (105) to hold them in place. The horizontal beams were laid in pairs and continued into and beyond the eastern river bank. The southern edge of cobbles (104) are built over the northernmost row of beams (105), and butt up to the edge of the southern row of beams (Plate 9).

Plate 7: Detail of wooden beam (105) in situ behind stone structure (104). Looking south-west

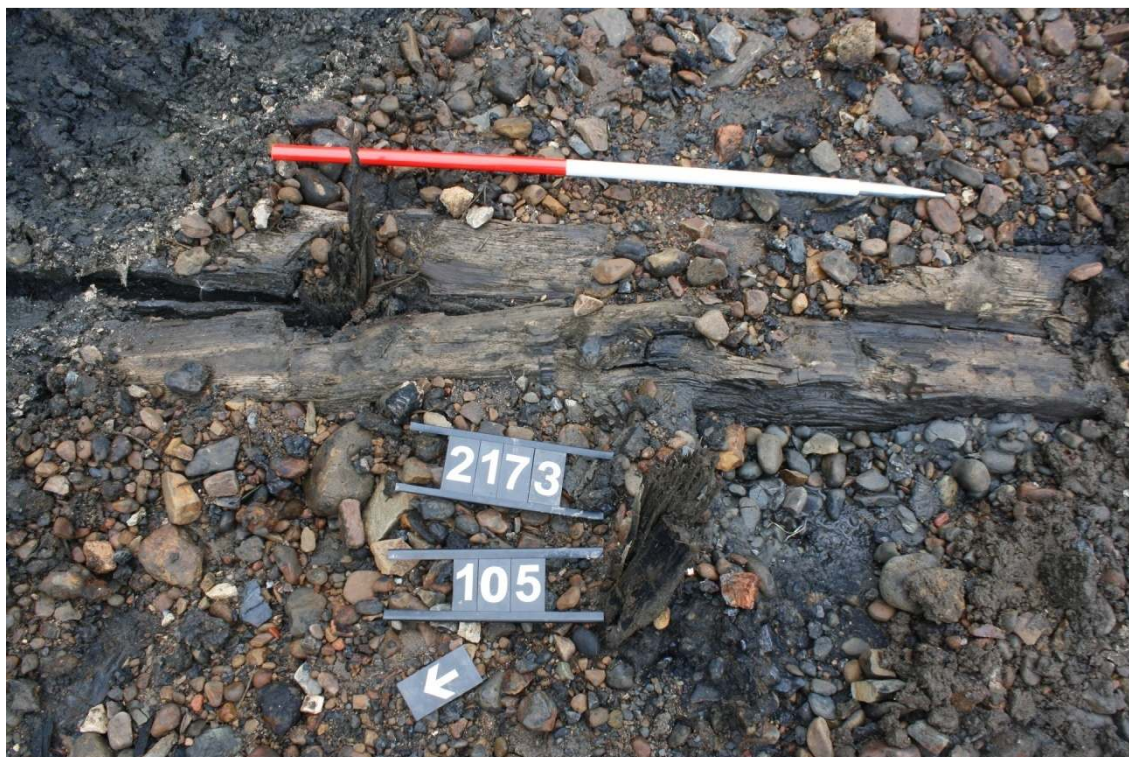
Plate 8: Wooden beam (105) and stake (106) in situ. Scale 1m

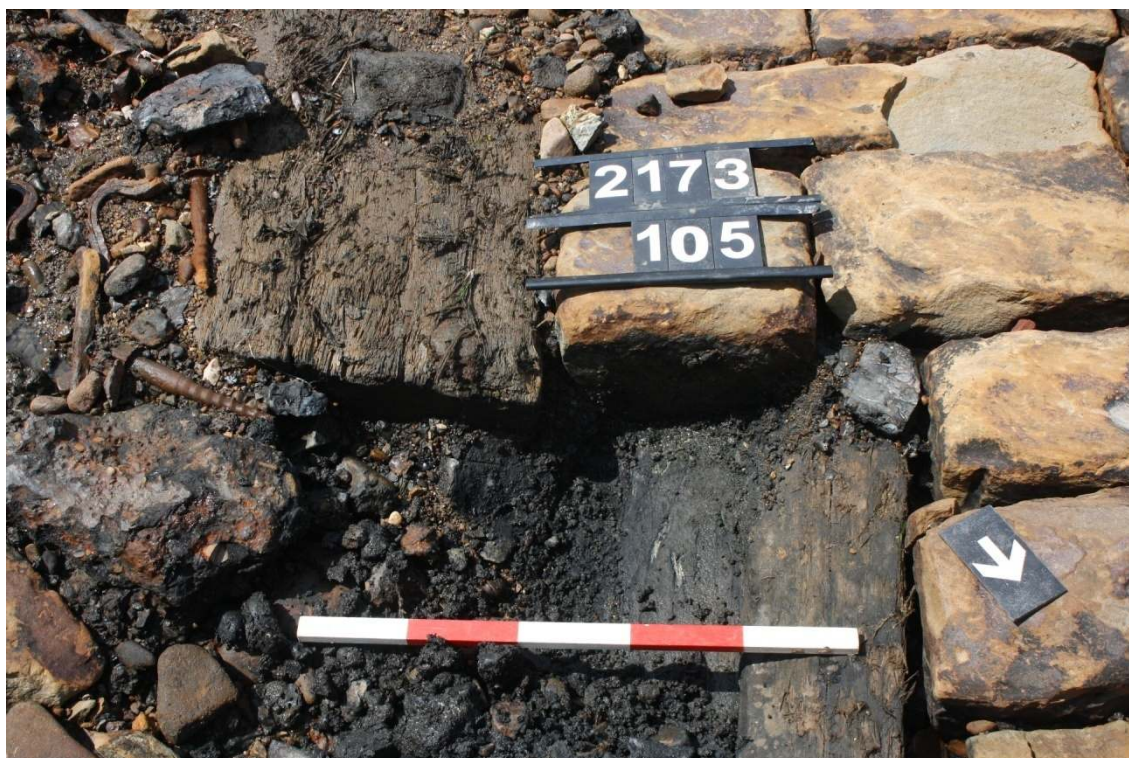
Plate 9: Detail of section of wooden beams (105) and relationship with stone structure (104). Looking south-west, scale 1m

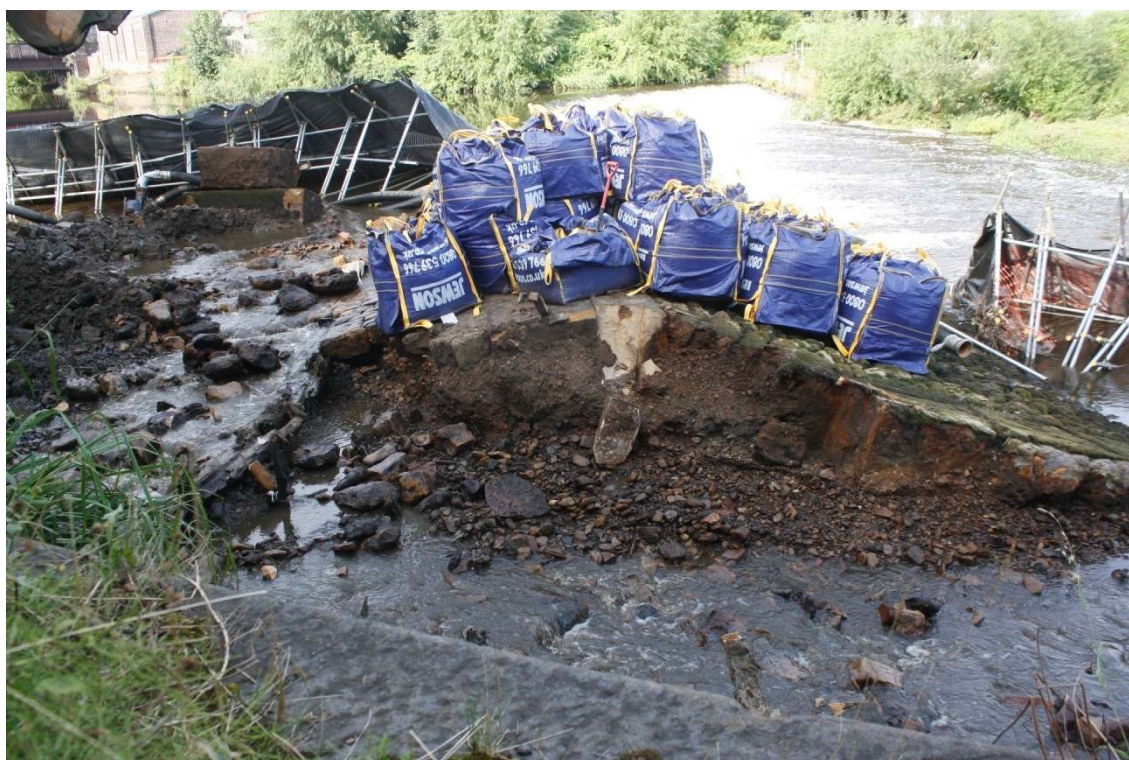
Plate 10: East-facing section through the weir. Looking south-west

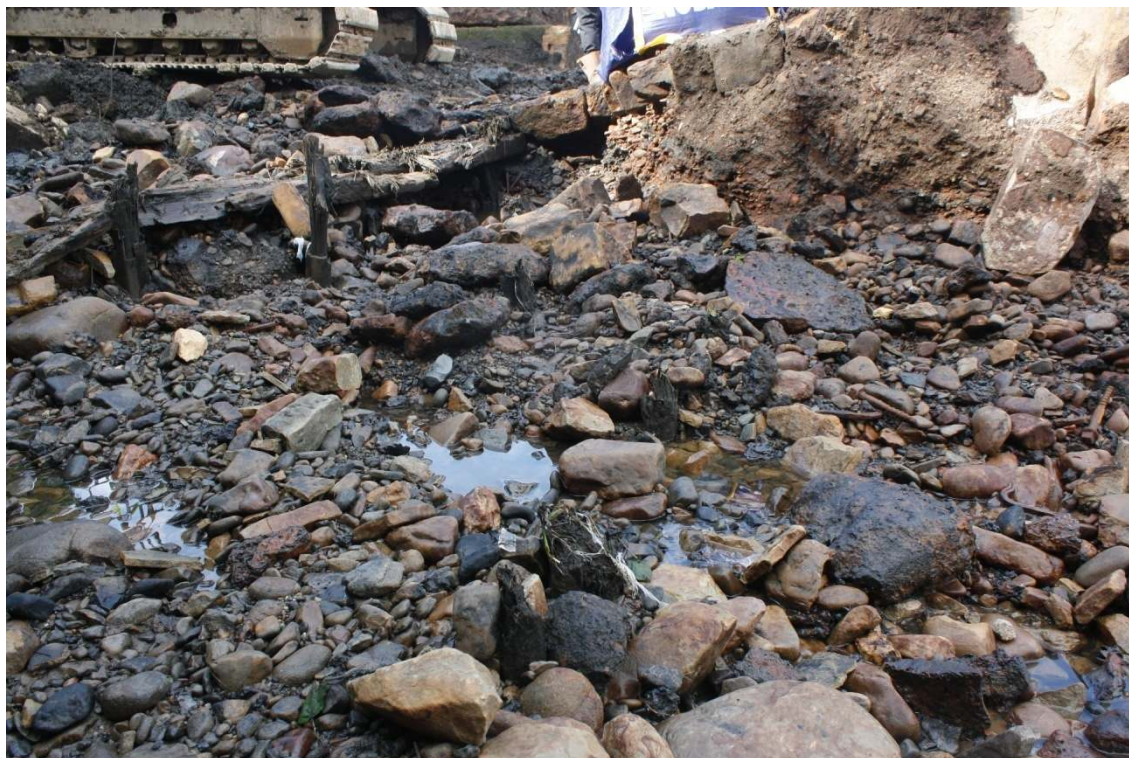
A possible observance of the earlier weir structure was noted in the form of a number of upright stakes. These were observed within three distinct locations; at the northern end of the weir (120-128), at the base of the downward face of the weir and below crozzle structure (100); mid-way through the weir (108-109), just to the north of the top kerb stones (102); and at the southern end of the weir (112-118), roughly on the same alignment as structure (103). One stake from the southern end of the weir (115), one from the middle of the weir (108), and one from the northern end (126) were retained for assessment (Appendix 4). With the exception of the stakes removed for assessment, these stakes remain *in situ*. The northern limit of the downstream face of the structure was not observed during the works, hence is not known if there is a similar wooden frame support to (105) at this end of the weir.

Plate 11: Stakes (112-118) with beam (105) and associated stakes (106) in the background. Looking south

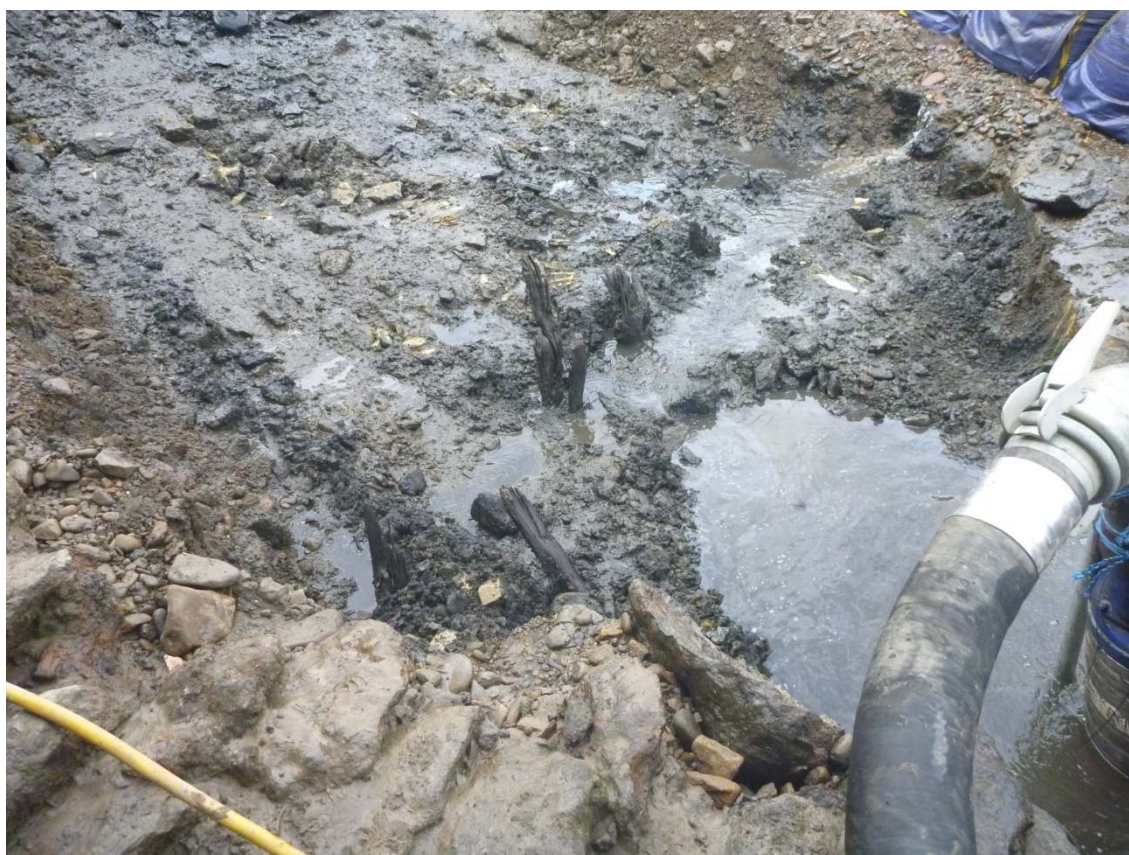
Plate 12: Stakes 120-128 in situ. Looking south-west

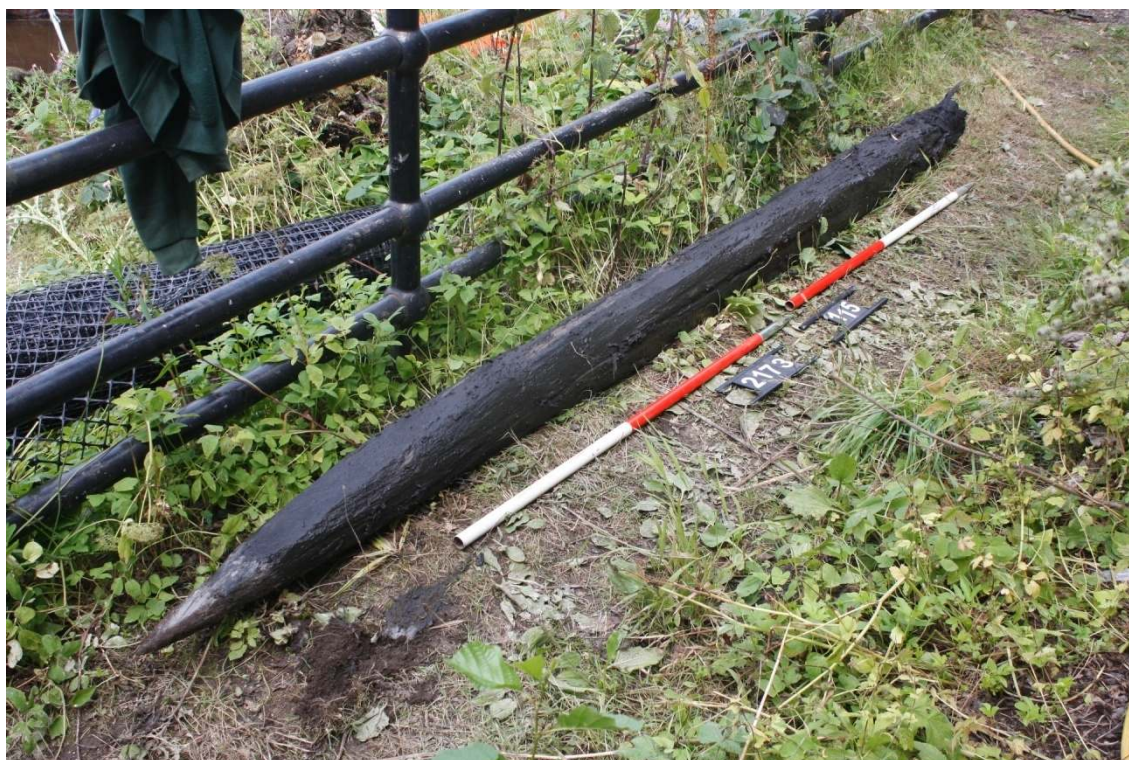
The stakes that were removed for assessment were found to be in a fairly uniform condition, waterlogged with significant amounts of mineralisation. The assessment of the timber was not able to determine any date for the working of the timbers or either support or contradict the suggestion that they may belong to the earlier weir. The only timber of interest was the base section of stake (115), which had a iron shoe fitted to the end spike. This was formed by a sheet

of iron, formed into a hollow conical tip that was nailed to the wood of the pile. These were used in circumstances where a pile or stake was intended to be driven into a deposit that was very resistant to pile driving; such as the stony bed of a watercourse. The shoe serves to protect the wooden tip from damage or breakage and to make it easier to drive the tip to the required depth. It is a known post-medieval practice. None of the timbers assessed displayed any diagnostic woodworking technology; having been cut with iron/steel bladed axes; they could date from the late prehistoric period up to the present day. All but one of the timbers was of oak, the other being Scots Pine. None were suitable for dendrochronological dating.

Plate 13: Stake (115) after removal. Scales 2x1m

(115) 1 of 2. "Top Weir Stake" Pile cut from roundwood. Sapwood present but no bark. One trimmed face along length present with a partial trimmed adjacent face around the mid-point of the timber. Eroded and mineralised surfaces. Upper end recently sawn away and missing. Tip broken away and missing with much surface damage and loss of sapwood zone. 1272 l, 150 w, 147 th. *Quercus spp.*

(115) 2 of 2 "Base Weir Stake" Pile cut from roundwood. Sapwood present but no bark. Two adjacent trimmed faces creating a near boxed heart conversion. Multi-faceted tip with rounded cross section fitting into socket of Fe shoe shaped to a conical sharp tip. Eroded and mineralised surfaces. Upper end recently sawn away and missing. Some minor surface damage. 1956 l, 154 w, 150 th. Shoe 152 l, 04 th. *Quercus spp.*

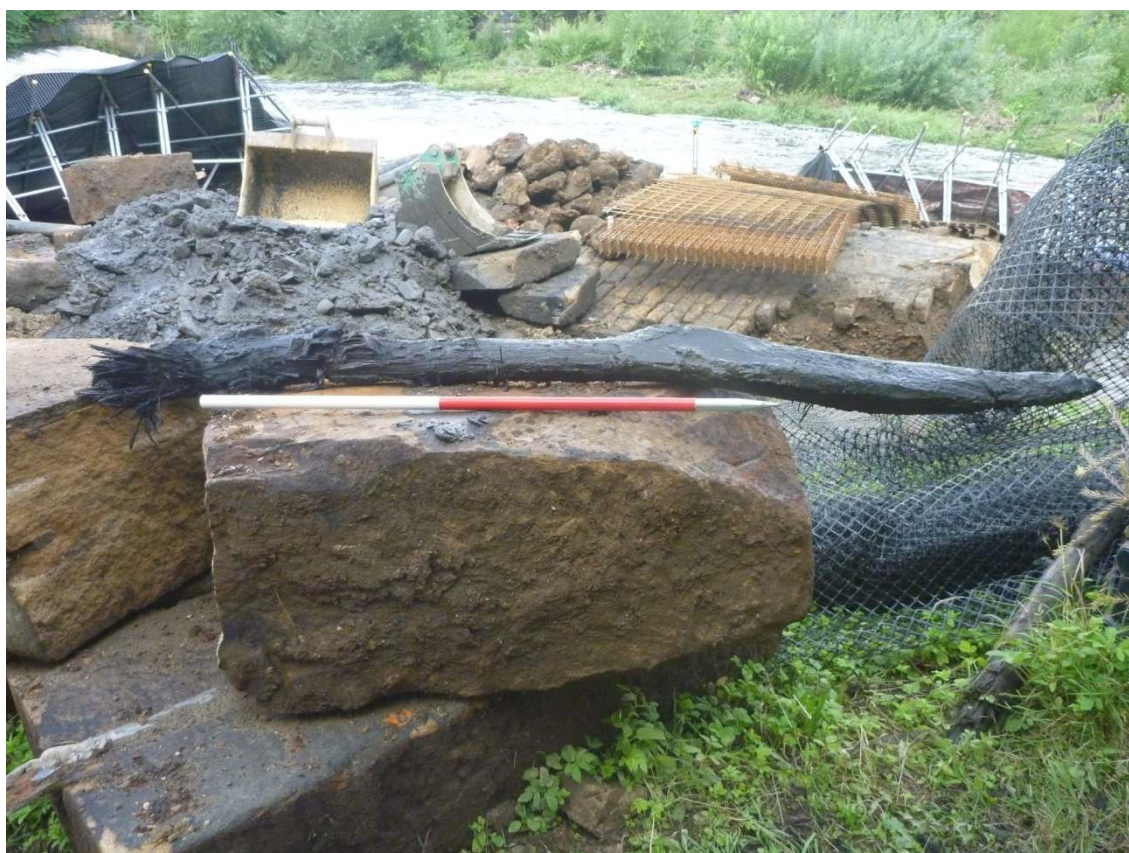
Plate 14: Stake (126) after removal. Scale 1m

(126) Stake or pile cut from roundwood branch. Sapwood present but no bark. Working at tip suggestive of a sub rectangular cross section with chamfered corners creating a sub-octagonal finished cross section. Eroded and mineralised surfaces with much surface damage and near complete loss of sapwood zone. Upper end torn away (?by machine bucket) and missing. 2246 l, 118 w, 100 th. *Quercus spp.*

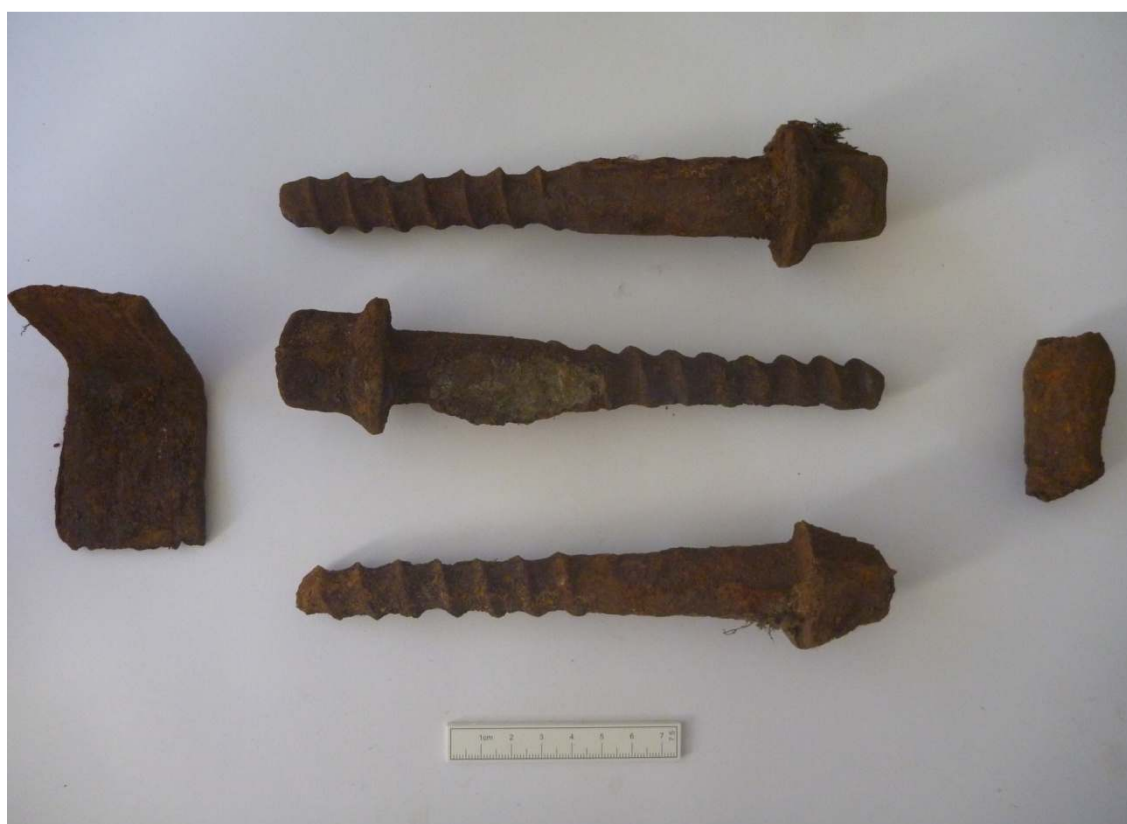
Context No.	Qty.	Weight (g)	Notes
100	5	1950	3 iron screws used to fasten structural element of weir together. Plus 2 indeterminate fe. Objects, likely other types of fastening within the structure Screws 195x35 \emptyset , each weigh ~580-600 each
105	1	385	Iron spike, used to hold the current weir structure together. One on many observed, all the same/ no noticeable differences in them. Tapers to the end to form a spike. 270lx15x15
110	1	350	Fe object. Shape similar to cotton reel. Weight? 55l x40 \emptyset
110	1	405	Fe object. Possible lock although indeterminate. 85x80x30
110	1	665	Fe. 95lx 40hx35wmmmer head, partial wooden handle still attached

Fe. objects recovered from (100)

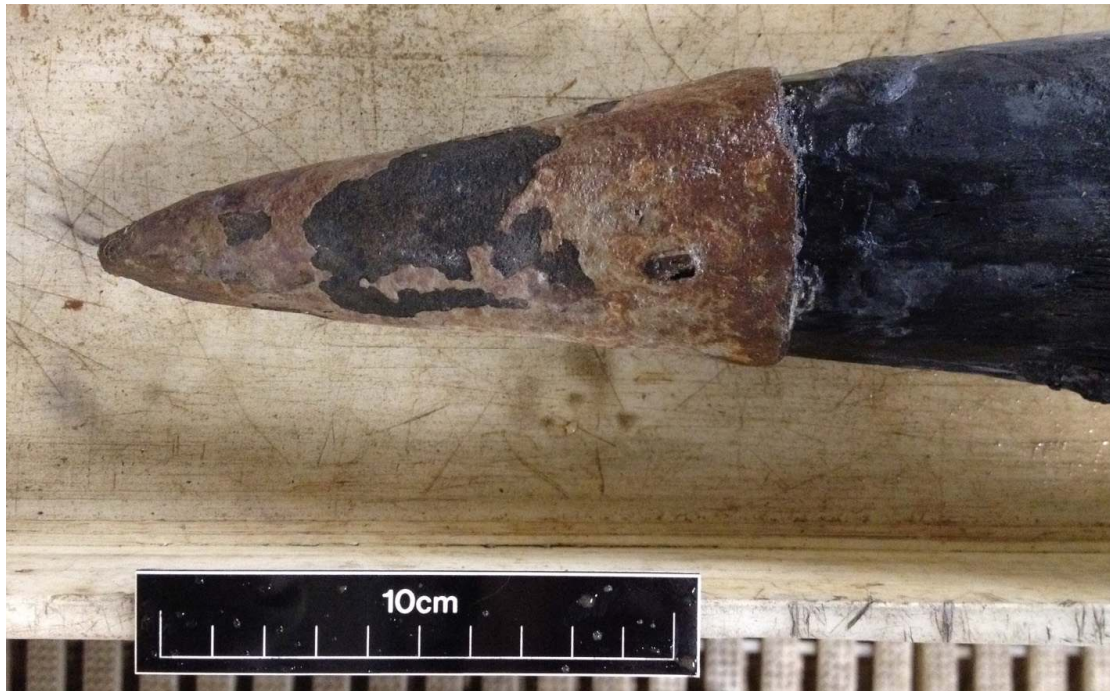
The one intrinsic feature of interest is the Fe shoe covering the tip of (115, 2 of 2) (*Plates 1 and 2*). This is a sheet of iron, formed into a hollow conical tip that was nailed to the wood of the pile. These were used in circumstances where a pile or stake was intended to be driven into a deposit that was very resistant to pile driving – such as the stony bed of a watercourse. The shoe serves to protect the wooden tip from damage or breakage and to make it easier to drive the tip to the required depth. It is a known post medieval practice but one that is not often represented in the archaeological record- usually because piles are sampled by removal of their upper ends rather than by extracting the whole timber. To have one recovered in such good condition is quite rare – typically they are embedded in concreted material and/or so highly corroded as to be unintelligible as artefacts. It is not clear whether the seam on the Sanderson's weir example is simply butted or has been welded and further investigation would be worth undertaking.

Plate 1. Fe shoe on tip of Pile (115) 2 of 2. Note nail hole 20mm from socket end showing as a dark rectangle. Scale 100mm (SJ Allen)

Conservation: Though in good condition, none of the stakes merit retention as objects for archive or display. However the Fe shoe on the tip of (115, 2 of 2) is very well preserved and an example of an object that rarely finds its way into the archive or a museum display. The tip of this pile should be detached from its parent timber retained and the wood brought to dry storage by stabilisation with polyethylene glycol polymers followed by freeze drying. Investigative conservation of the Fe tip to identify the technology used in closing up the seam should be undertaken. Costs for this conservation work may be obtained from the Head of Conservation, Ian Panter, at York Archaeological Trust.

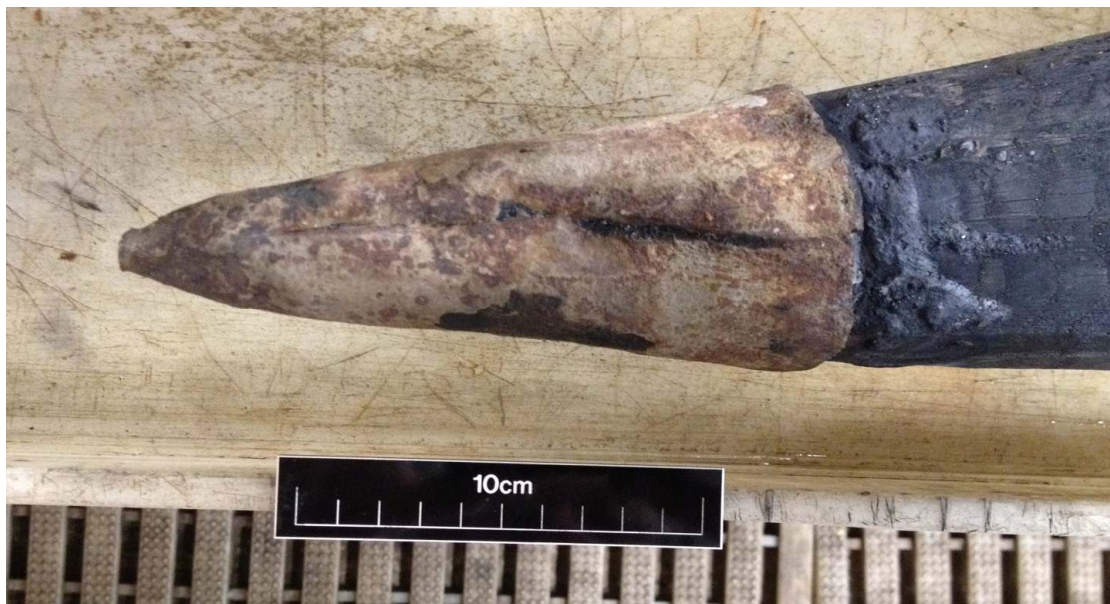
Plate 2. Fe shoe on tip of Pile (115) 2 of 2. Note seam from socket end towards tip. Scale 100mm (SJ Allen)
