Former Central Post Office, Sheffield Archaeological evaluation assessment report

Report 2020/32 version 2

**Archaeological Evaluation at the Former Central Post Office,
Flat Street, Sheffield: Assessment Report**

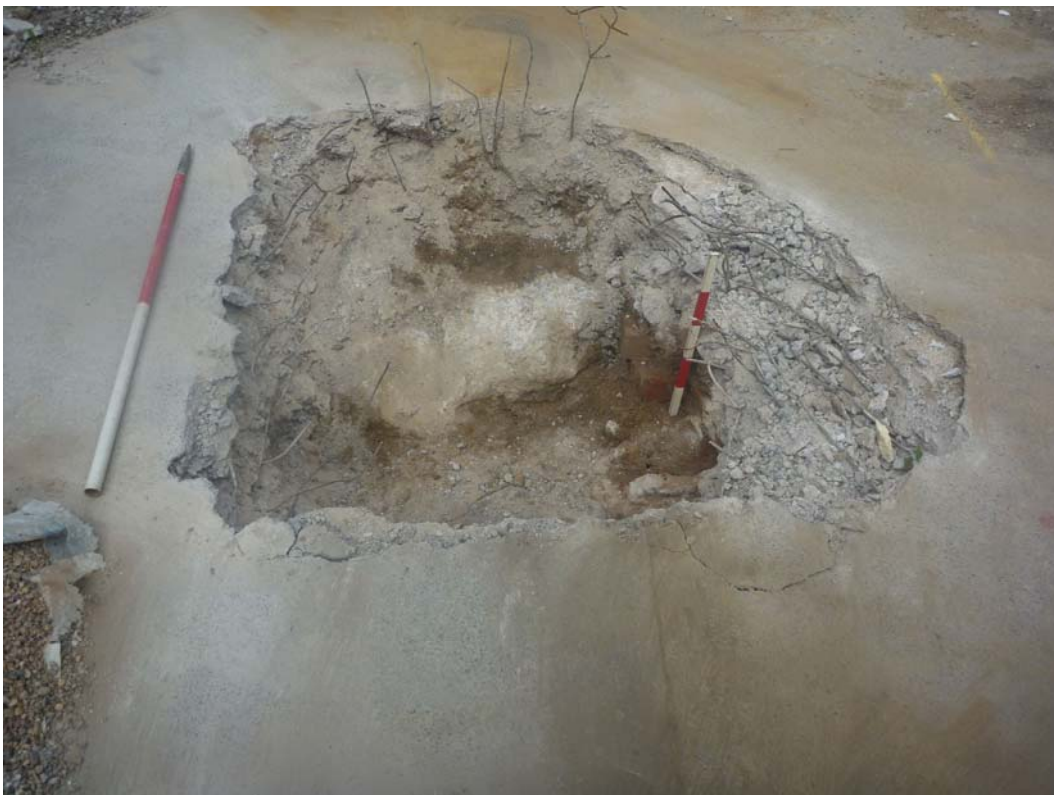
Plate 1: Trial pit at north end of Trench 1, showing concrete surface 101 and underlying concrete 109, viewed facing north (scales in 50cm and 10cm divisions)

The southern end of the trench was excavated for a length of 6.2m (Figures 3 and 4), where excavation was halted by the presence of a substantial concrete wall (108) and concrete surfacing with thick steel rebars (101), the latter likely to be the floor level of the 1950s 'basement'. Within the excavated area was a very extensive backfill or made ground deposit (102) largely comprising brick rubble, as well as plastic, sandstone and other modern building materials, in a mid-grey-brown loose silty sand matrix (Plate 2). This was excavated to a depth of 2m within the stepped central part of the trench, with no signs of the base of the deposit encountered. Given the loose nature of the deposit and the potential for collapse of the sides, it was not excavated any further.

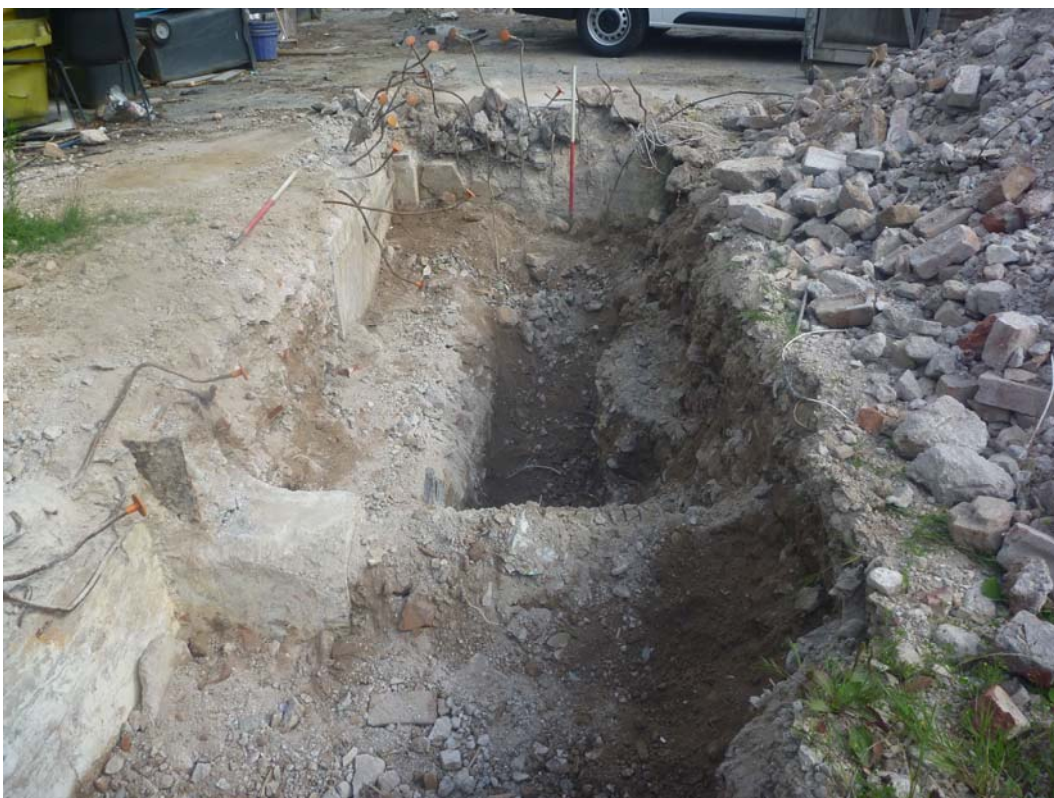
Plate 2: Trench 1, south end, viewed facing north

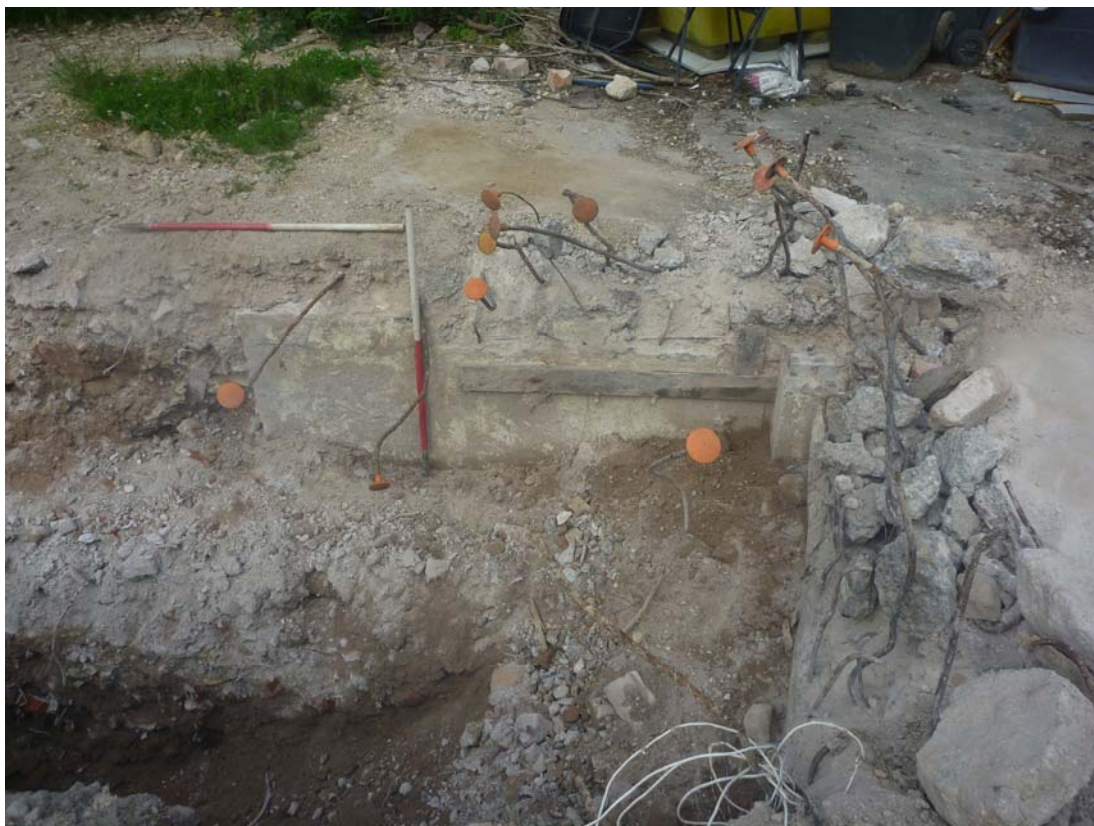
Plate 3: Wall 105, wooden planks 106 and base for metal pad 107 (at right end of trench), viewed facing north (scales in 50cm divisions)

The western side of the trench was formed by two stretches of concrete wall, 103 at the south end and 105 to the north. Wall 108 formed the northern end of the trench, possibly forming a return of 105. All three were of a pale grey, smooth concrete reinforced with thick steel bars. Their location corresponds approximately with dividing walls in the basement level above, as shown on Figure 12. The walls were observed to a depth of 1m below the current surface, but continued down beyond the base of excavation, likely to at least 2m in depth as indicated by the backfill or made ground deposit 102. Two wooden planks, each 4 inches (10cm) wide and 1 inch (2cm) thick, were attached to the west face of wall 105, one horizontally, the other vertically (Plate 3). These planks (106) may have been supports for cables or fixtures attached to the walls.

narrower concrete base was present at the junction of walls 105 and 108. This (107) was topped by a thick steel pad, flat topped, with a large bolt in the corner. The full extent of this pad was not exposed, but it is likely to be square in plan, and cannot extend much further to the north or west given the presence of the walls.

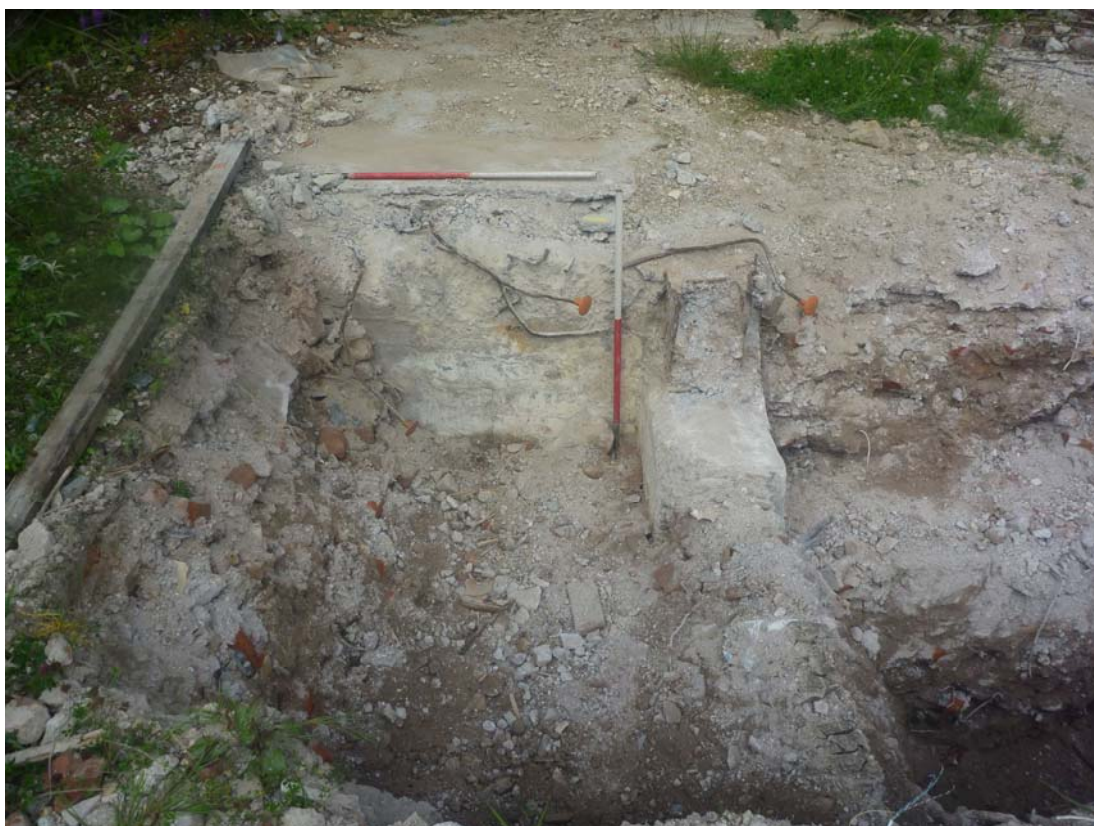
Plate 4: Wall 103 and column base 104, viewed facing west

A concrete base at the north end of wall 103 supported a steel I-beam set as a column (104), presumably part of the frame of the 1950s building (Plate 4). The column had been cut off at ground level. The concrete surfacing (101) did not continue over the column or the southern end of the trench, and was largely present at the north, roughly contiguous with wall 105. A further,

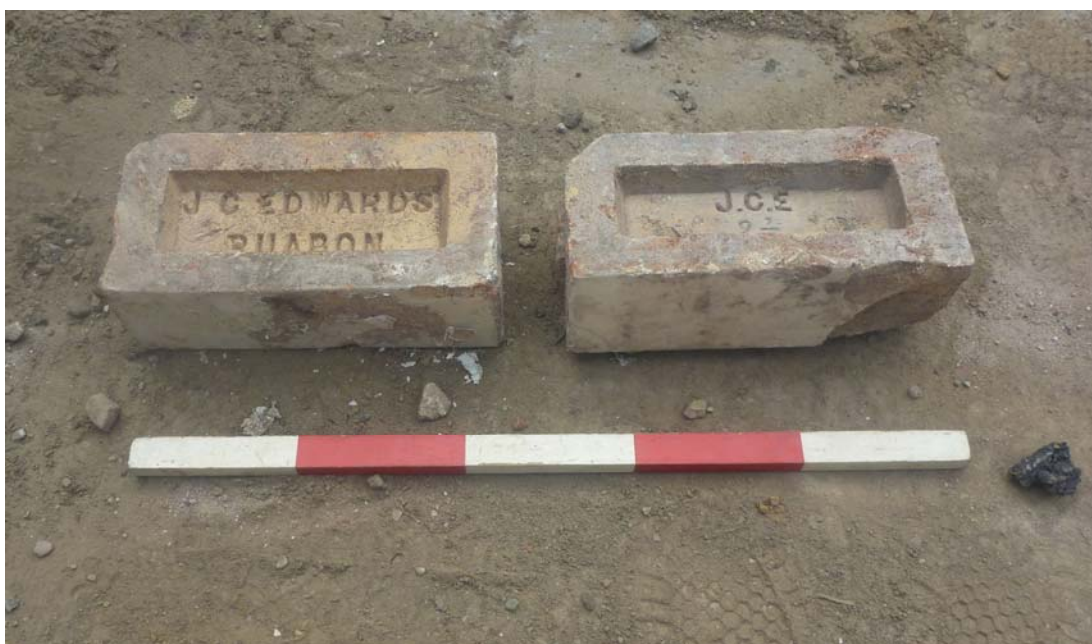
Plate 5: White-glazed J.C. Edwards bricks from the demolition backfill 203 (scale in 10cm divisions)

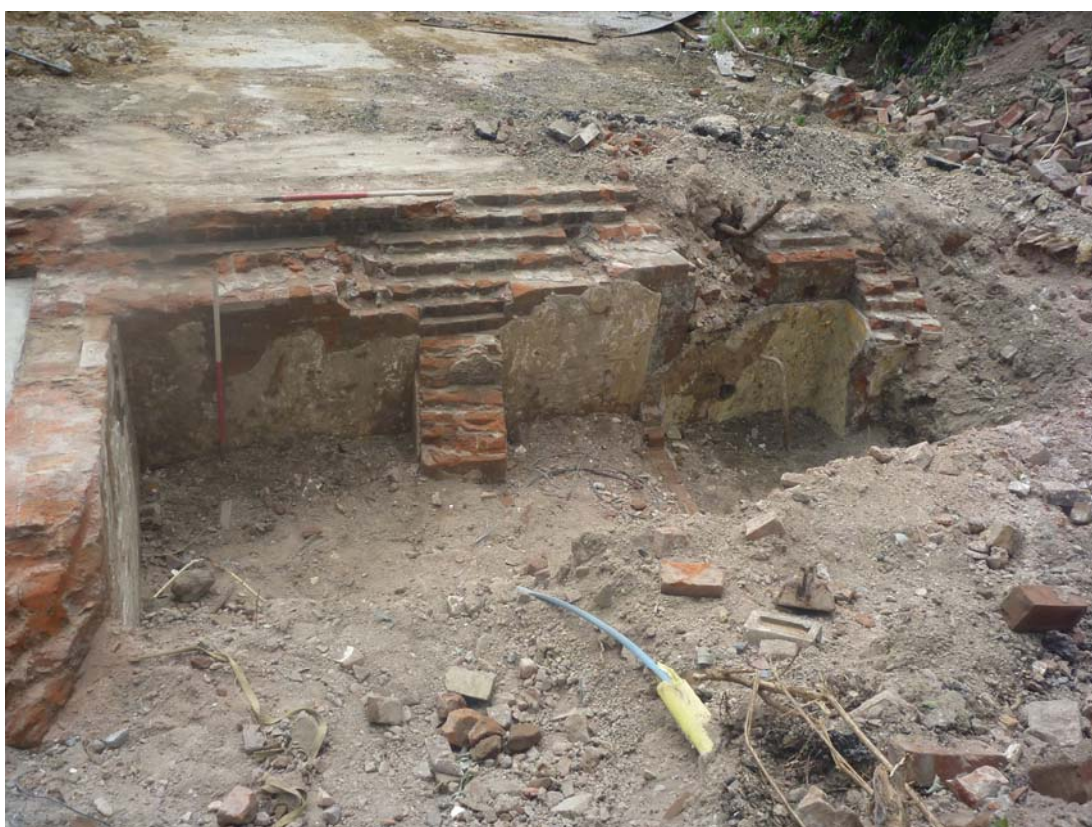
Plate 6: Wall 209, viewed facing south, with wall 208 to the left and buttresses 210 and 212 to centre and right

The southern edge of the trench was formed by a substantial brick wall, 209, which was 0.9m wide. It was truncated to different levels at various points, presumably during demolition of the superstructure, so it is uncertain if this was a single phase of wall or perhaps two adjacent walls. The highest point was at 56.84m, level with the current ground surface. To the south was a continuation of the concrete surfacing that probably formed the floor level within the 1950s basement (219), analogous to 101. The southern edge is likely to have been the outer wall of the 1893 Post Office building and corresponds with a dividing wall shown on the main basement plan (Figure 8). The northern part of this wall seems to have formed the south side of a sub-basement room, and had a thick plaster finish on its north face (Plate 6). A rough cut through the wall towards the western end of the trench (217) contained several inactive pipes in a fill similar to 203. It is not clear if this extended down the full depth of the wall, due to plaster coverage in the lower half of the trench (Plate 7). Another large diameter cast iron pipe extended through the plaster near the base of excavation in this area. It is likely that the cut and the pipes were associated with the provision of services to the 1950s extension.

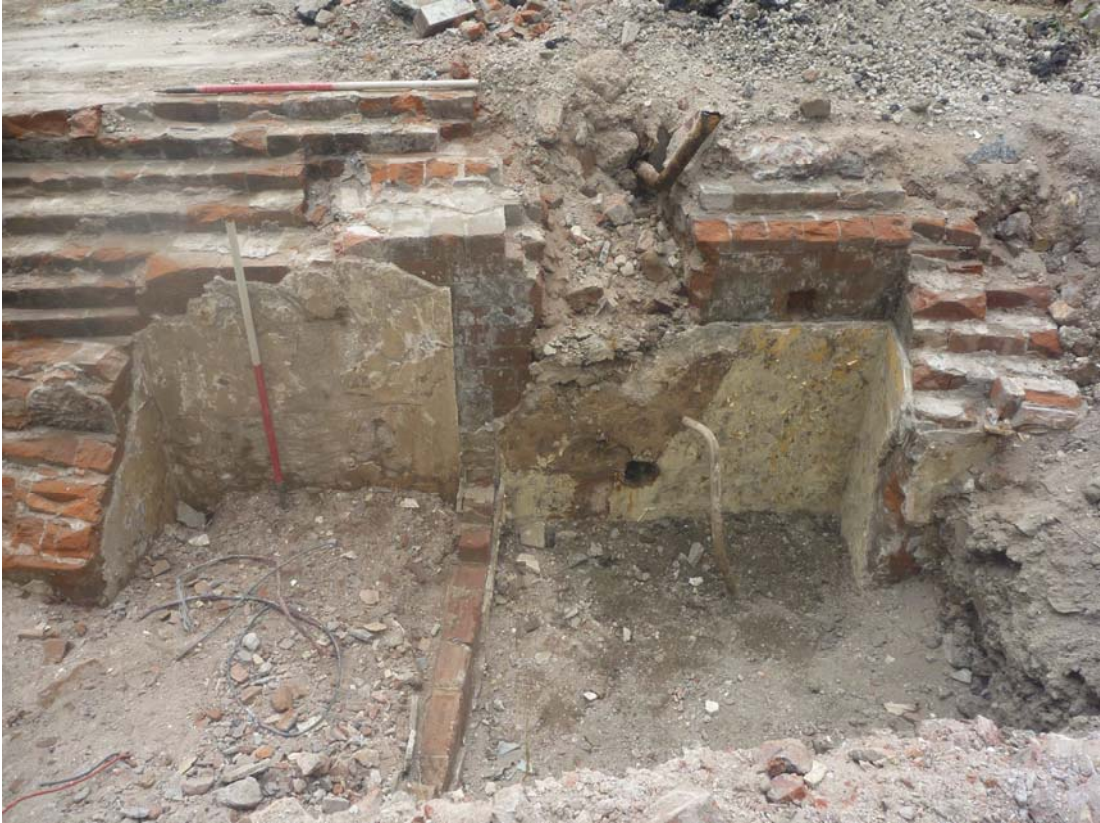
Plate 7: West part of wall 209, showing pipe cut 217, and partition wall 211 in the centre, viewed facing north

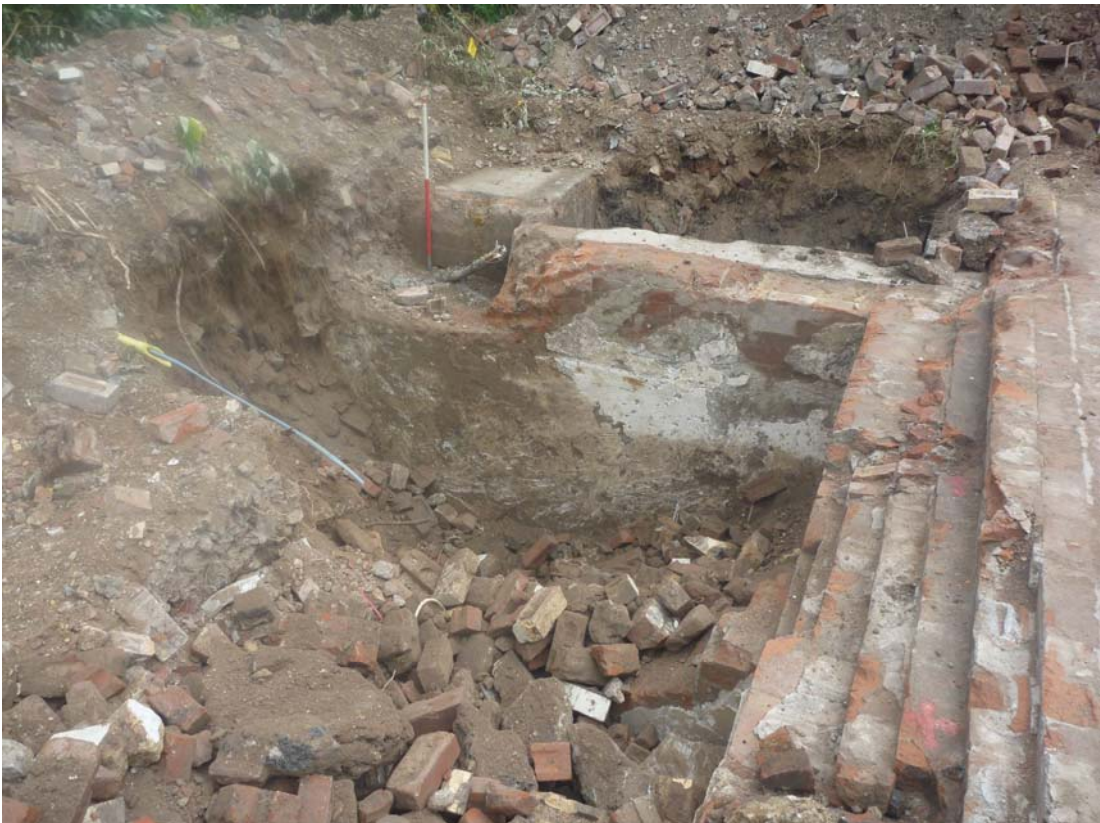
Plate 8: West elevation of wall 208, viewed facing northeast

Wall 208, also plastered on its west face forms the eastern side of this room, and corresponds with the wall at the edge of the separate room shown on the basement plan in the northeast corner of the site, and the electricity sub-station shown on the 1955 map. The base of this wall was not reached at 2.2m below the current ground surface (Plate 8), and it is likely that wall 209 is equally deep. The plaster finish obscures the junction of the walls and the nature of an area of possible rebuild at the south end of 208. The upper surface here is at least different to the main part of wall 208 (Plate 9). The northern end of 208 had been truncated, possibly during demolition but more likely earlier, as it was crossed by a substantial bundled electrical cable that extended out from concrete structure 206/207 (Plate 10). The junction between walls 208 and 209 was not quite a right angle, being slightly more acute at 85 degrees.

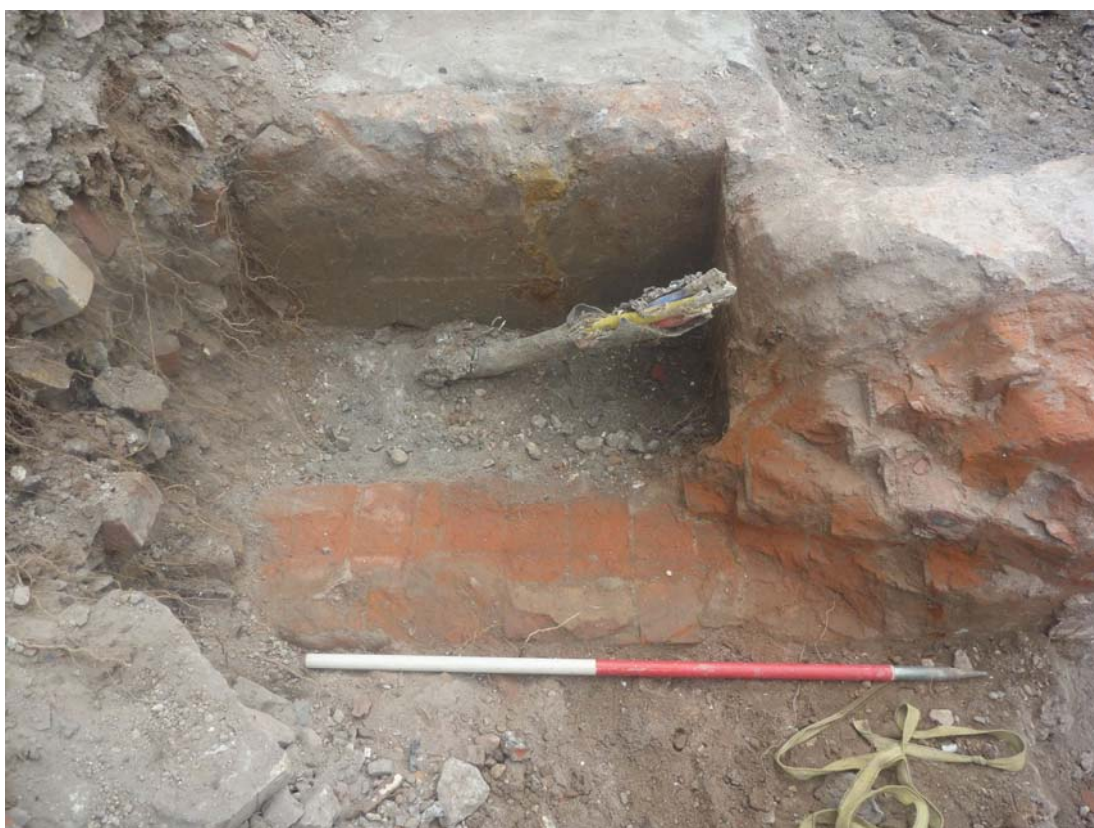
Plate 10: Electrical cable emerging from under 206, within fill 214, viewed facing east

under 206, possibly running into the room west of 208 (plate 10). A gap between the pad and the wall was filled by a dark grey sandy material containing frequent concrete fragments (214).

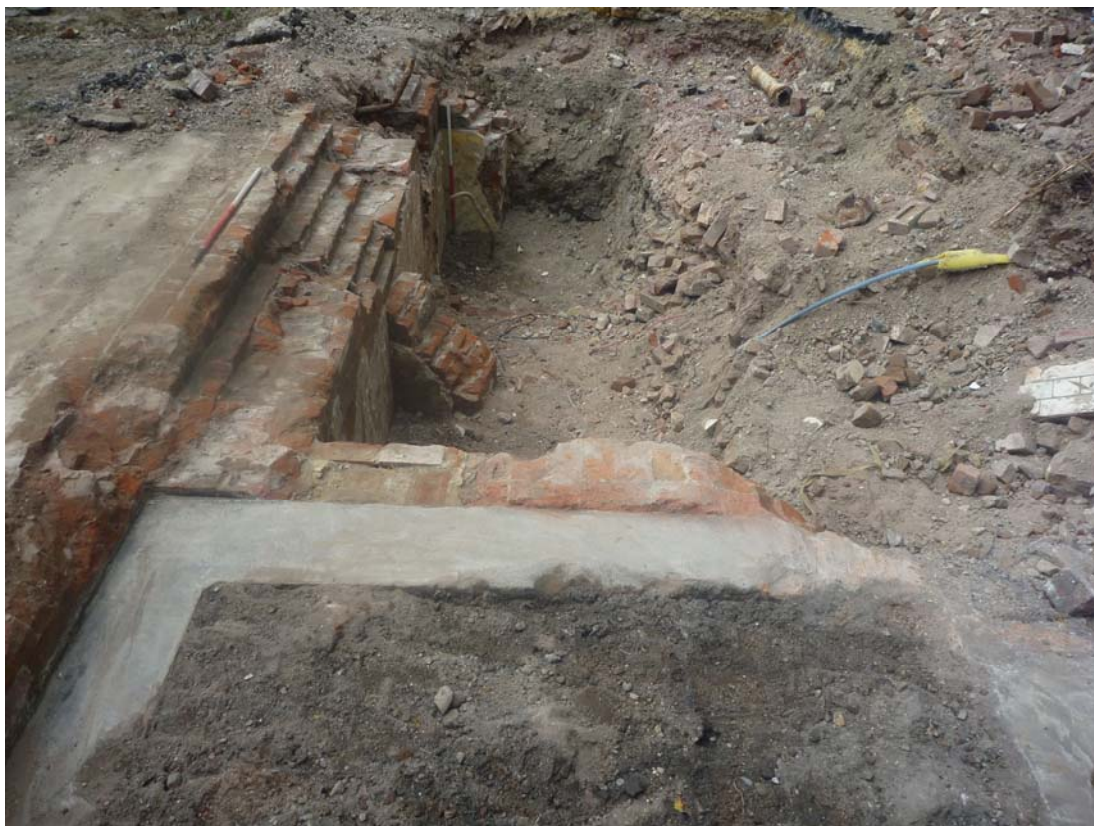
Plate 11: View of Trench 2 facing west, showing buttresses 210 and 212, with structure 207 in the foreground

Two buttresses or stub walls (210 and 212) extend through wall 209 and into the room, both also with the same plaster finish (Plate 11). They each are 0.47m wide, with rounded bullnose bricks at the outer corners. Buttress 210 is more truncated in height, but this appears to be due to demolition activity, as well as damage caused by the machine during opening of the trench. As with 208, both are at a slightly acute angle to wall 209, being longer on the western sides. The plaster finish obscured their junctions with 209, but the bricks around the top of 210 suggested that at least the northern edge of 209 was built around 210. In between the two buttresses was a single-skin wall of frogged red bricks, with 'GREGORY' stamps (211), laid in stretcher rows (Plate 7). As with those in walls 208, 209 and the two buttresses, the bricks were 22 x 11 x 8cm in size. Wall 211 also had a thick skin of plaster skin on either side, but loss of some of the upper courses demonstrated that the wall butted against the north face of 209. This wall was again at a slight acute angle to 209, suggesting that this angled alignment is not due to an earlier structure. The 'north-south' walls on the east side of the building may have been aligned parallel to the Pond Street frontage. A slightly different backfill deposit, 204, was noted in the area to the west of wall 211, underlying a thinner spread of 203. This was a darker brown than 203, with a lesser rubble content, and was revealed to a depth of 55.254m aOD, where excavation ceased.

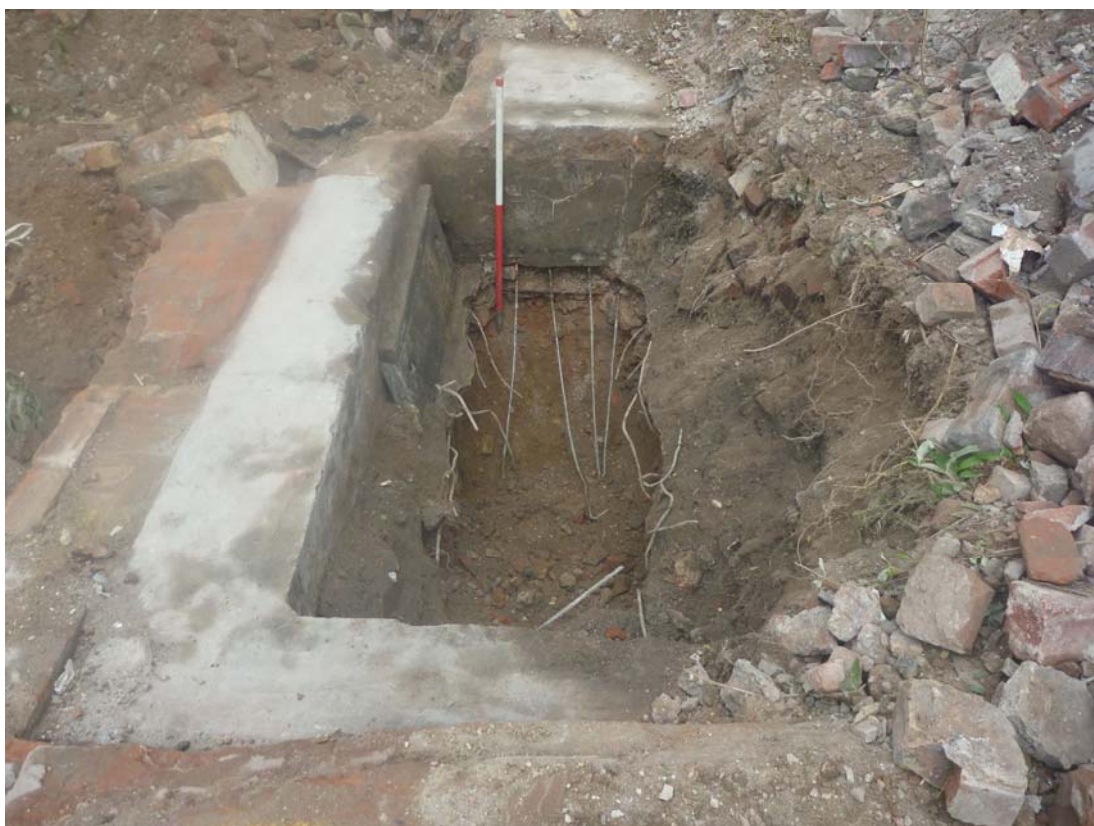
Plate 12: Structure 207 following removal of part of the floor, viewed facing north

At the eastern edge of the trench, east of wall 208, was a concrete structure within the area shown on the basement plan as a separate room. This area was labelled as an electricity sub-station on the 1955 map. The structure had smooth concrete walls around the south and west sides (207), extending into a wider concrete pad at the northern side (206). A concrete floor (213) was found at a depth of 55.876m aOD, 0.6m below the top of wall 207 and 1m below the current ground surface. The area between the walls and the floor had been backfilled with a rubble deposit (205) that is probably the same as 203. Removal of part of the floor with the JCB demonstrated that it was 0.13m thick and reinforced with a steel bar mesh, at 10cm intervals (Plate 12). It was laid on a 0.18m thick levelling layer of crushed red brick, which overlay a yellow-brown sandy clay deposit with sandstone fragment inclusions (216), that appears to be natural bedrock. This was exposed at 55.566m aOD, and the upper surface was partly removed by the machine due to difficulties in excavating between the steel mesh of the floor. No evidence for any features cut into the bedrock was noted in the small area exposed. The bedrock in this area is at a minimum of 1.31m below the current ground surface. Wall 207 continued down below the level of the floor and base of excavation within this area, and it is possible that it extends as deep as the adjacent wall 208. Concrete pad 206 appeared to stop at the level of the base of the floor. As noted above, a thick electrical cable extended west from

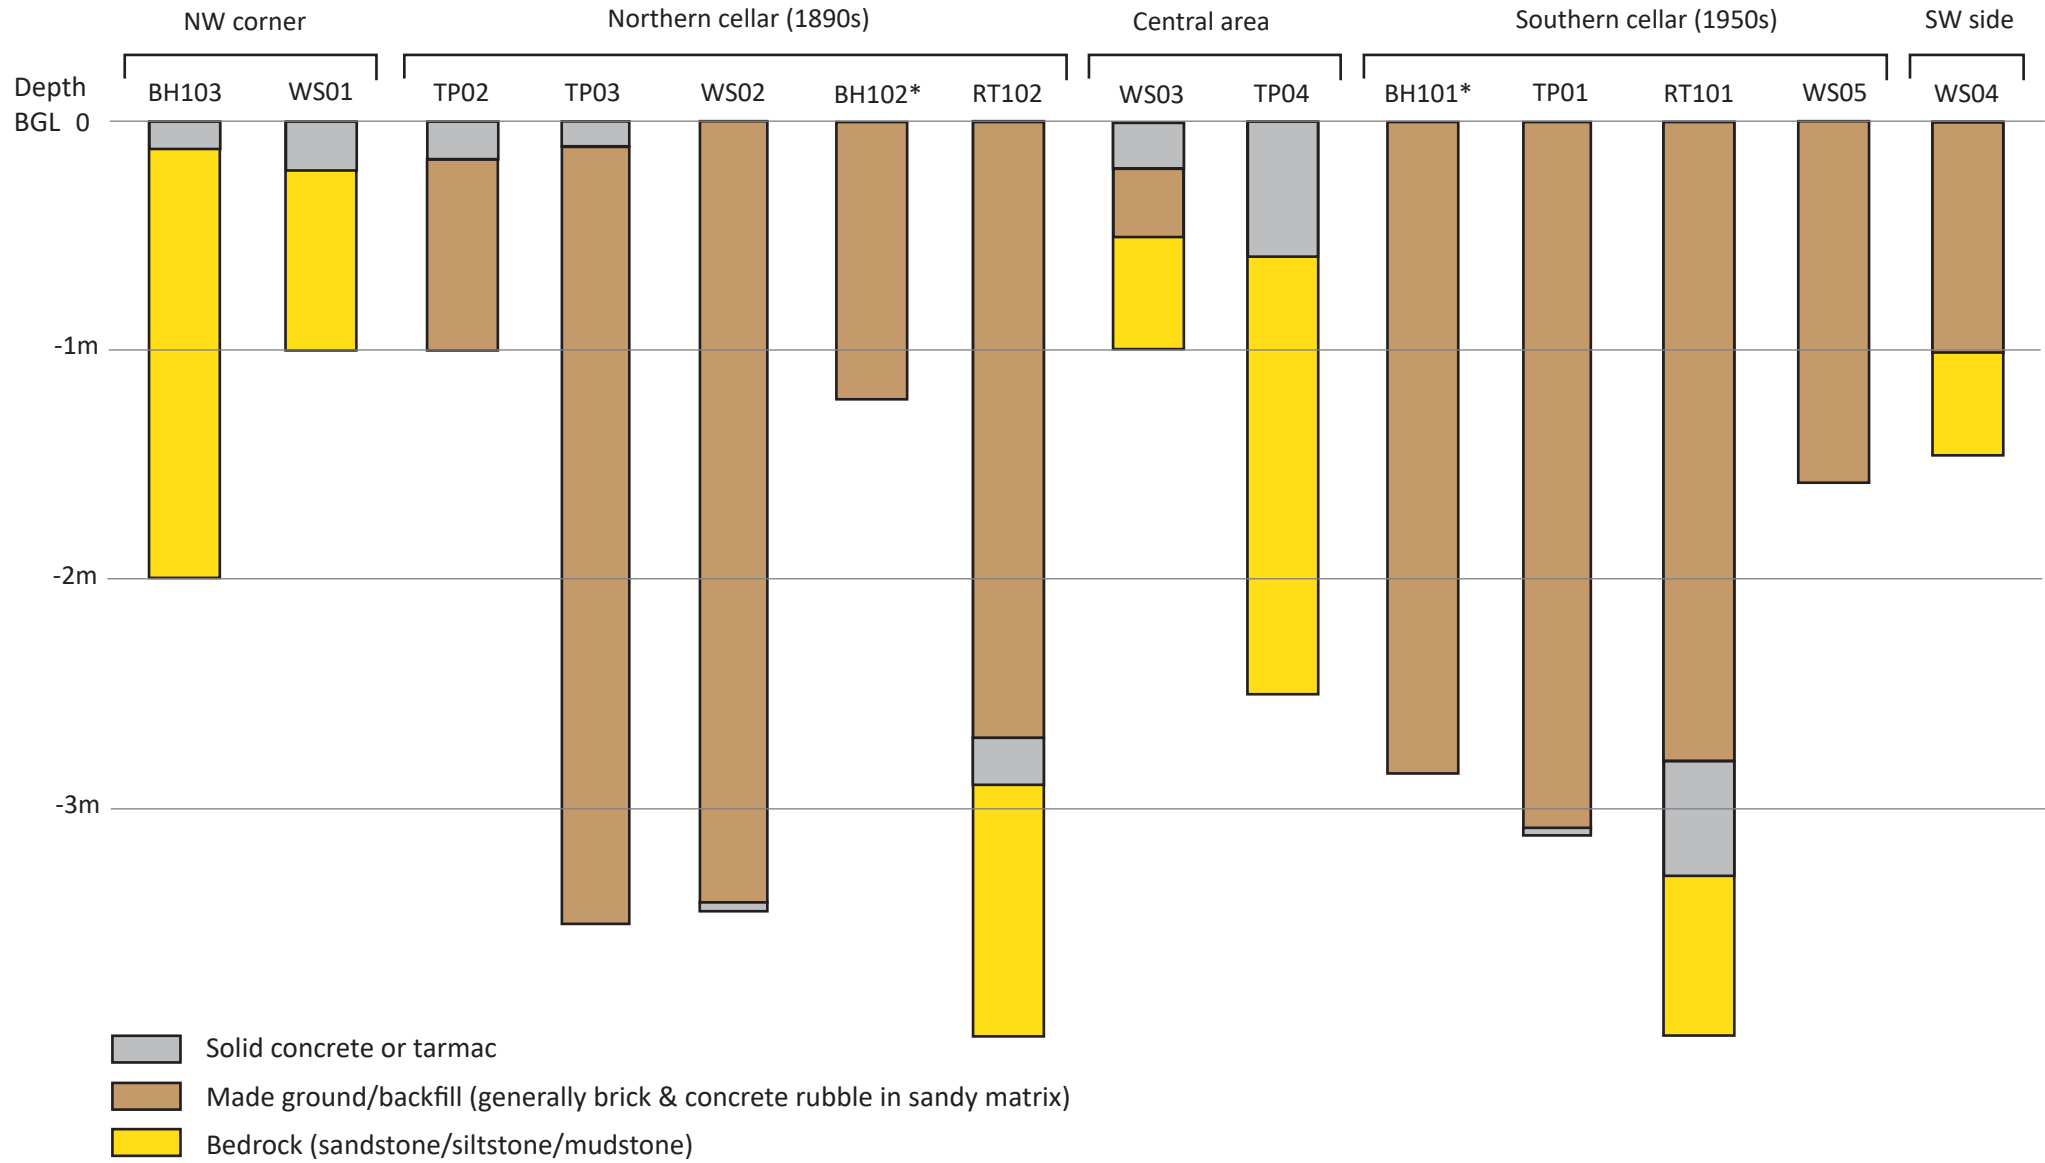
Figure 8: Schematic sections of geotechnical pits

* Logs for BH101 and 102 not seen, summarised in Clancy Consulting 2020

The geotechnical investigations indicates that deep cellarage is present at the north end of the site, under the 1890s wing of the Post Office (TP02-03, WS02, BH102 & RT102), in the area of Trench 2. In some cases, the base of cellar backfill was not encountered due to obstructions or instability of the sides, but where concrete floors were encountered, these indicated that the cellarage extends to depths of 2.7-3.4m below the current ground level, although the base was not encountered in TP03 when it was terminated at 3.5m BGL. Two boreholes at the northwest corner (BH103 and WS101) indicate that this northern cellarage does not extend across the full width of the site, with bedrock encountered immediately below the concrete slab surface.

Further deep cellarage is present at the southern end of the site, as investigated in Trench 1. Three boreholes and a test pit in this area recorded cellar fills, extending to depths of 2.8-3.1m below the current ground surface where concrete surfaces were encountered (RT101 and TP01). The base was not reached in BH101 and WS05, which were terminated due to instability. These indicate that the cellar extends south from wall 109 recorded in Trench 1 to the southern end of the site. One borehole to the west of the trench (WS04) suggests that the cellar does not extend to the same depth to the west of walls 103 and 105, with bedrock encountered below demolition fill at 1m BGL.

The central area of the site, between walls 108 and 209, appears to have been less disturbed by cellarage, although this area was only investigated by two trial holes (WS03 & TP04). This area is crossed by live electrical cables and could not be safely investigated as part of Trench 1. Bedrock was encountered at shallow depths in both of these test pits, at 0.5m BGL in WS03. The thick reinforced concrete surface recorded in the northern part of Trench 1 was also present in TP04, to a depth of 0.6m, where it directly overlay bedrock.

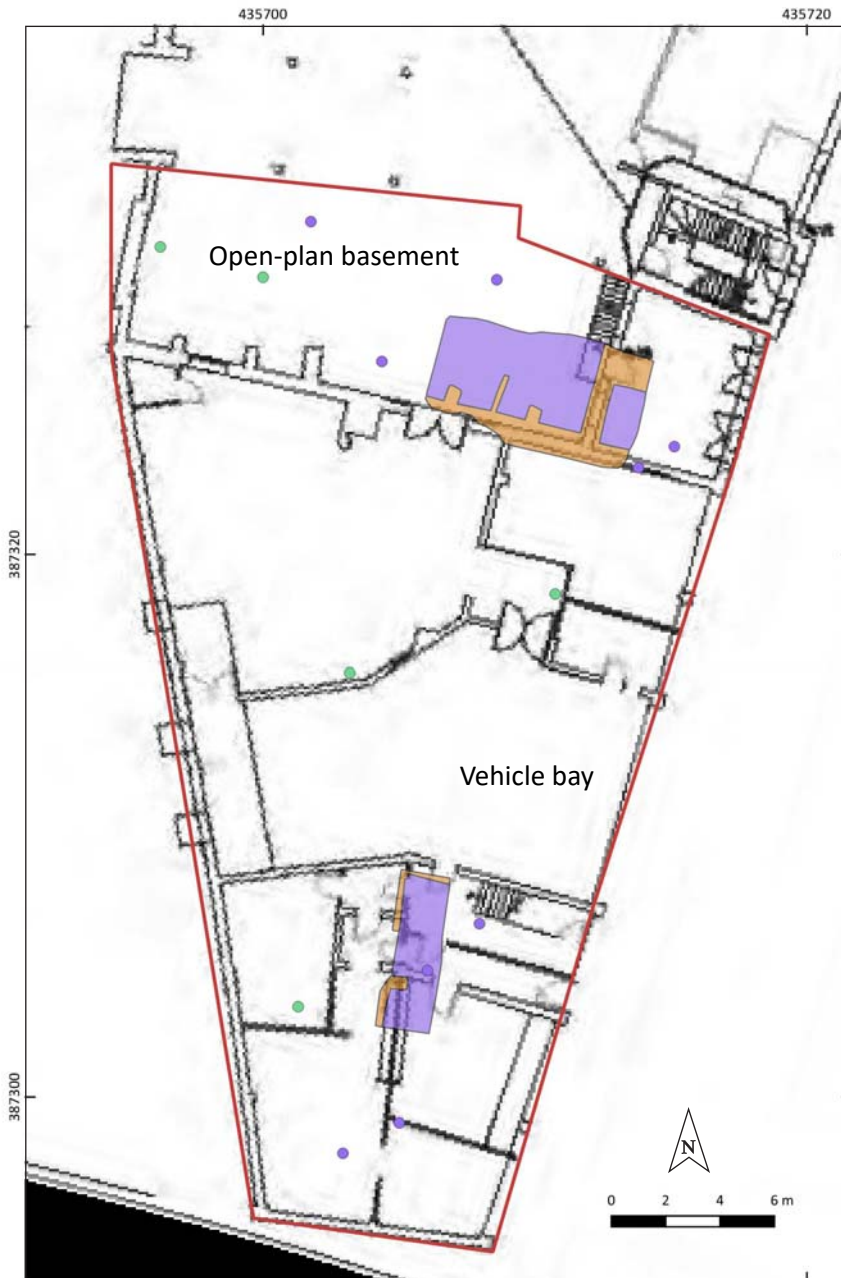
Figure 12: Post Office basement plan and building elevations

Reproduced from Poole 2005, figures 12 (below) and 21 (above).

This section is summarised from information in a desk-based assessment and buildings appraisal of the site undertaken by L-P Archaeology (Poole 2005). Historic map extracts are shown in Figures 9-11, and a plan of the basements in Figure 12.
