Archaeological Watching Brief at  
Church Street, Crowle  
Assessment report

Report 2021/17 v1

**Archaeological Watching Brief at Church Street, Crowle, North  
Lincolnshire**

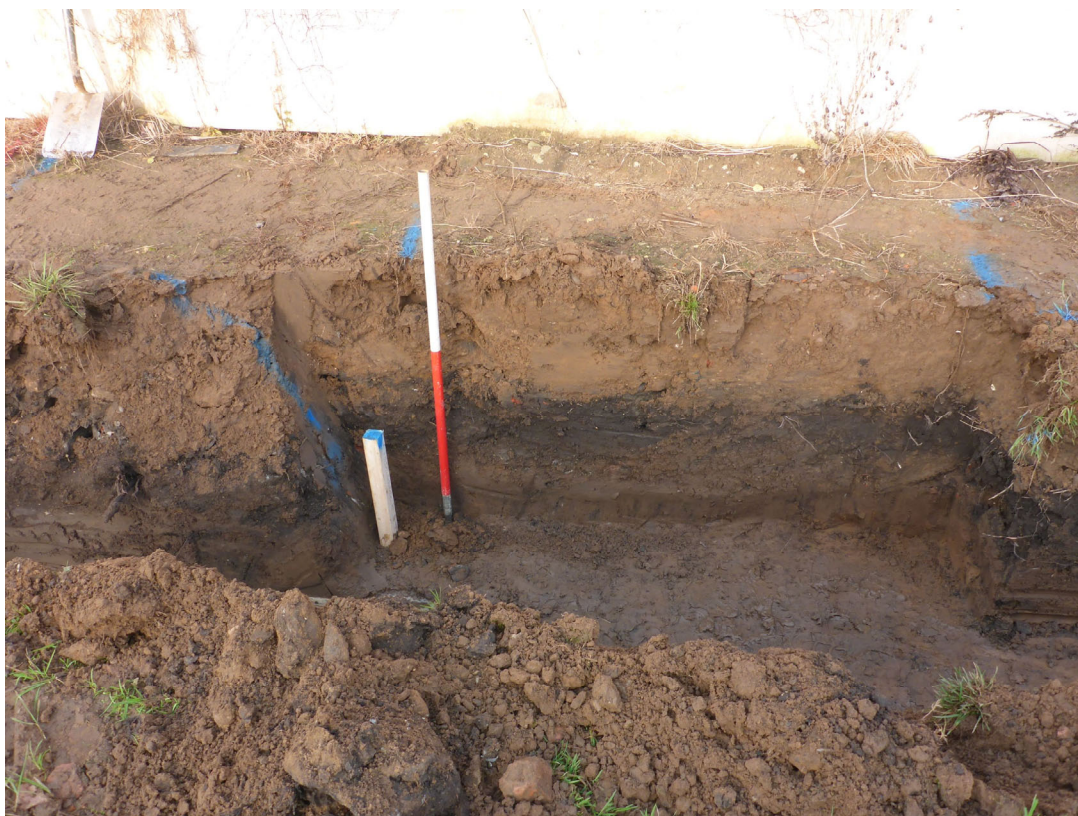
Plate 1: South-facing section of northern foundation trench in Plot 1

Within the foundation trenches of Plot 1, the uppermost deposit was a loose orange silty sand (101), up to 0.4m deep, that appeared to be a recently laid levelling deposit. This is likely to be associated with recent use of the site as a storage area during activities associated with construction of houses to the north, as reported by the contractors. It may represent a reinstatement of ground impacted by works vehicle movements and possible turf stripping. This deposit was thickest towards the northern, higher end of the plot. It overlay a dark grey-brown, humic sandy silt (102) that varied in thickness between 0.25 and 0.5m from the northwest to the southeast of the plot. This appeared to be the former topsoil, and in places contained moderate quantities of bricks (mostly frogged) and stone fragments. The buried topsoil overlay a firm, mid-orange-brown slightly clayey sand subsoil (103), that was present to the base of the trenches at around 0.8m below the ground level (BGL), c.4.5m AOD (Plate 1).

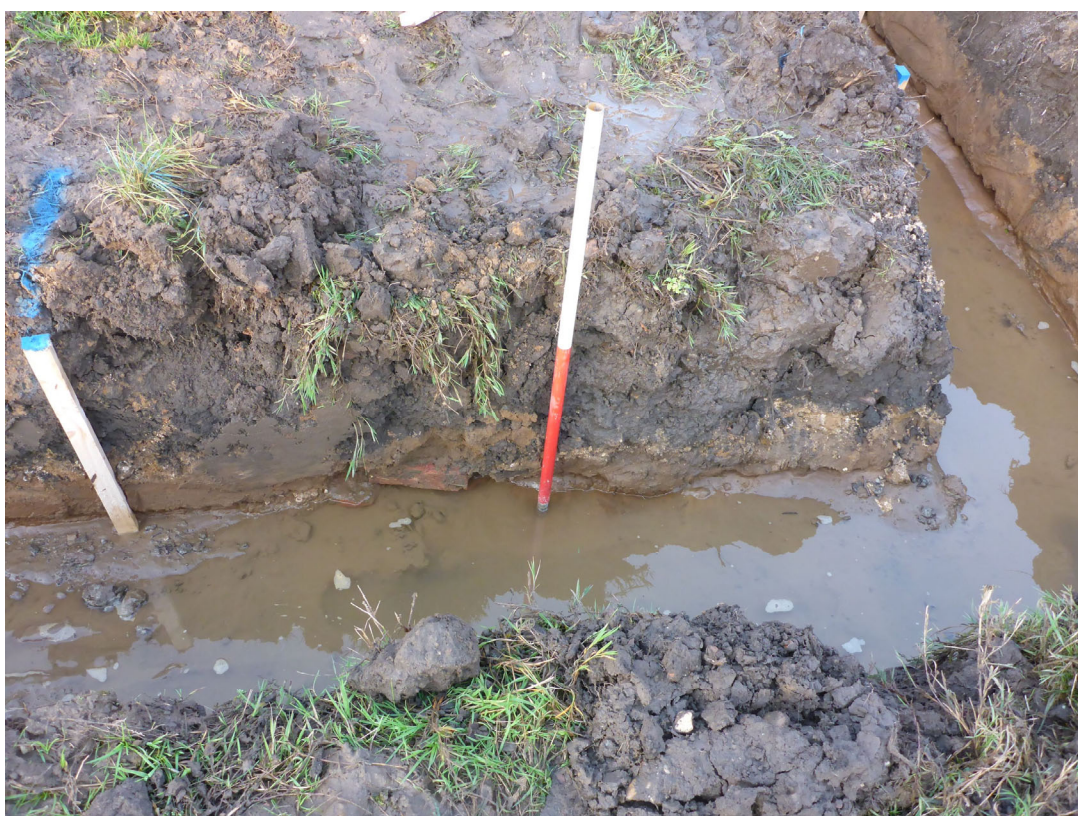
Plate 2: South-facing section of southern foundation trench in Plot 1, showing brick drain

The only feature identified within Plot 1 was a brick-built land drain (104), that crossed the eastern edge of the plot on a northeast to southwest alignment, and continued into Plot 2. The drain was present at the base of the trench (c.0.75m BGL), and the brick capping was removed by the excavation (Plate 2). Water from the drain rapidly filled the base of the trench, so observations were restricted, but it appeared to be constructed of plain, unfrogged red bricks, with edge-set bricks forming the sides and brick capping. The base was not seen.

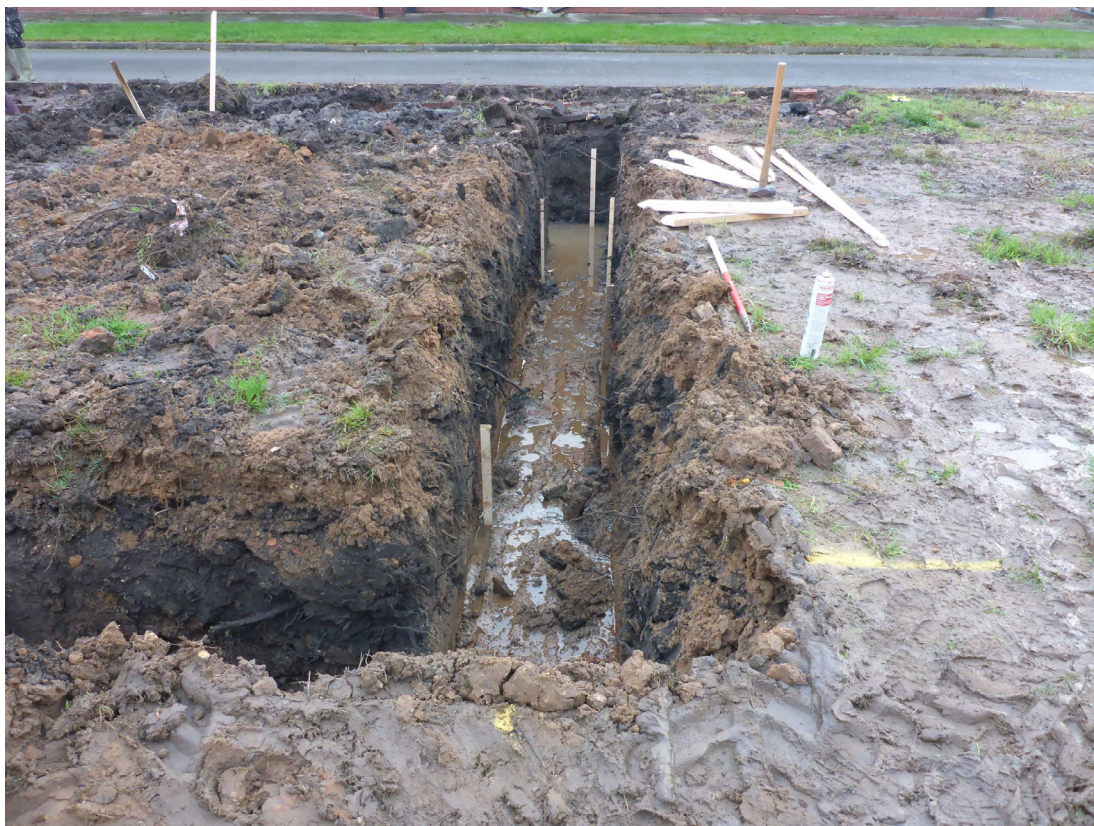
Plate 3: General view of western foundation trench in Plot 2, facing south

Within Plot 2, the spread of the orange-brown sandy deposit (101) was present at the northern end, but tapered out towards the south. It overlay a thick dark-grey-brown humic clay-silt (205), which appeared to be largely the same as former topsoil (102; Plate 3). Towards the south end of the plot, this appeared to merge with the backfill (201) of a wide cut (204) for a sunken boundary/revetment wall at the south edge of the site (203). The material of both deposits was very similar, though fill (201) was slightly paler than topsoil 205, and the division between them was difficult to distinguish. As with 102, deposits 201 and 205 contained significant quantities of modern dumping material, including brick, suggesting that the topsoil deposit was heavily disturbed during previous construction works. In the northern foundation trench, a mortar spread was visible at the base of 205, but it could not be ascertained if this related to an *in situ* modern structure or a dump of building rubble (Plate 4). It may have been related to the building shown on the 1971 OS map and encountered in the previous evaluation trenching (MAS 2018b). The topsoil 205 overlay subsoil 202, identical to that in Plot 1 (103).

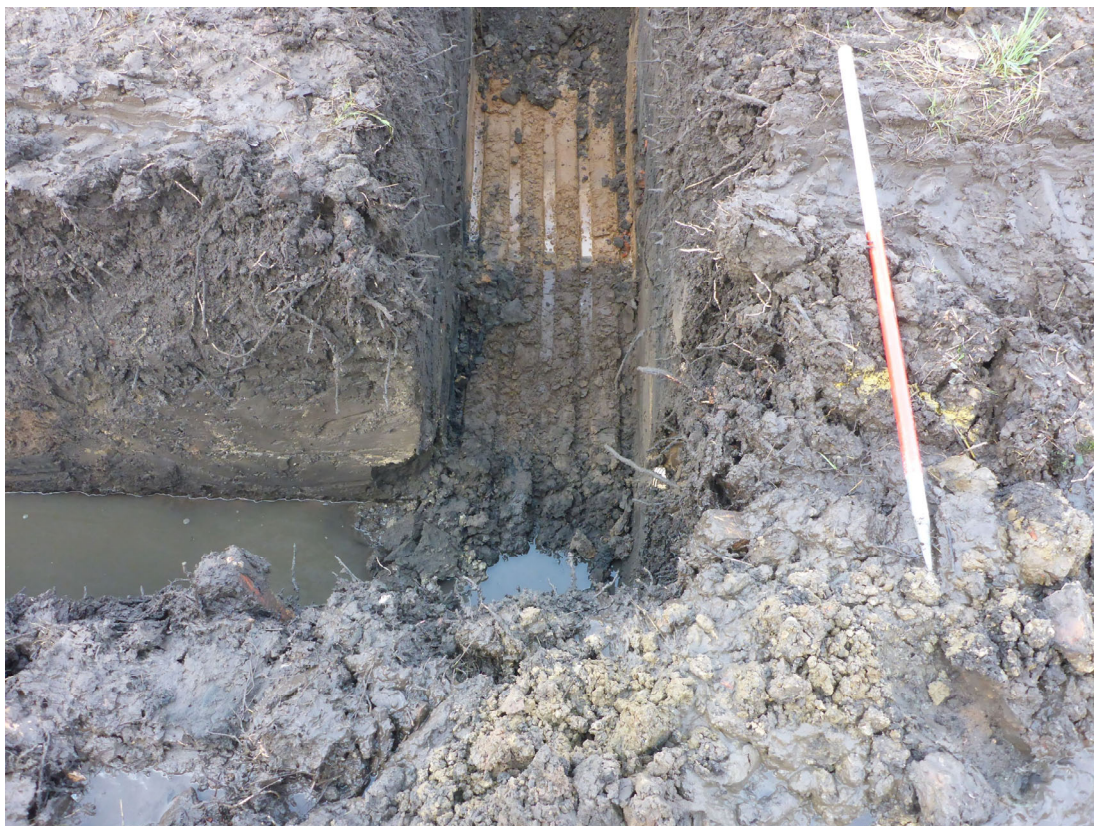
Plate 5: Wall cut 204 at the southeast corner of Plot 2, viewed facing north

The base of fill 201 was not reached at the southern edge of Plot 2, at a depth of 1.10m, but it tapered upwards to the north, where it merged with 205. The cut for the wall (204) through subsoil 202 was visible in plan and section at in the base of the eastern foundation trench (Plate 5), where its edge was 1.8m north of the wall, but was difficult to distinguish in section. The boundary wall (203) was truncated at ground level, but continued down to at least 1.1m below

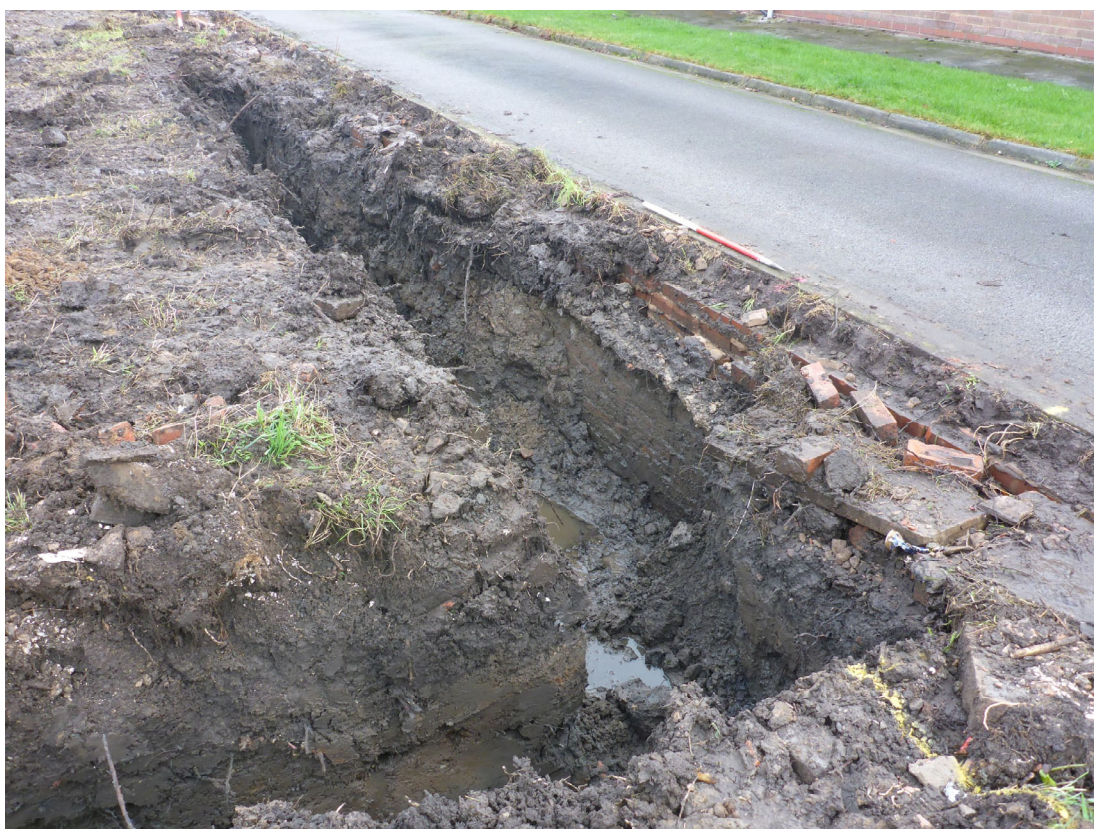
Plate 6: Wall 203 at the south edge of Plot 2, surrounded by fill 201, viewed facing southeast

the ground surface. It was constructed of modern frogged bricks bonded with a yellow cement mortar, and was only exposed where the soil fell away from it, as it technically lay just outside the area of the foundation trench (Plate 6). The wall appears to be associated with the road accessing modern housing to the south of the site, which was laid out between 1956 and 1971.

The land drain (104) continued across Plot 2, and again caused the trenches to rapidly fill with water. Due to the depth of the trenches at the south end of the plot and the instability of the wall backfill, the southern part of the trench was immediately infilled with concrete to prevent further collapse.

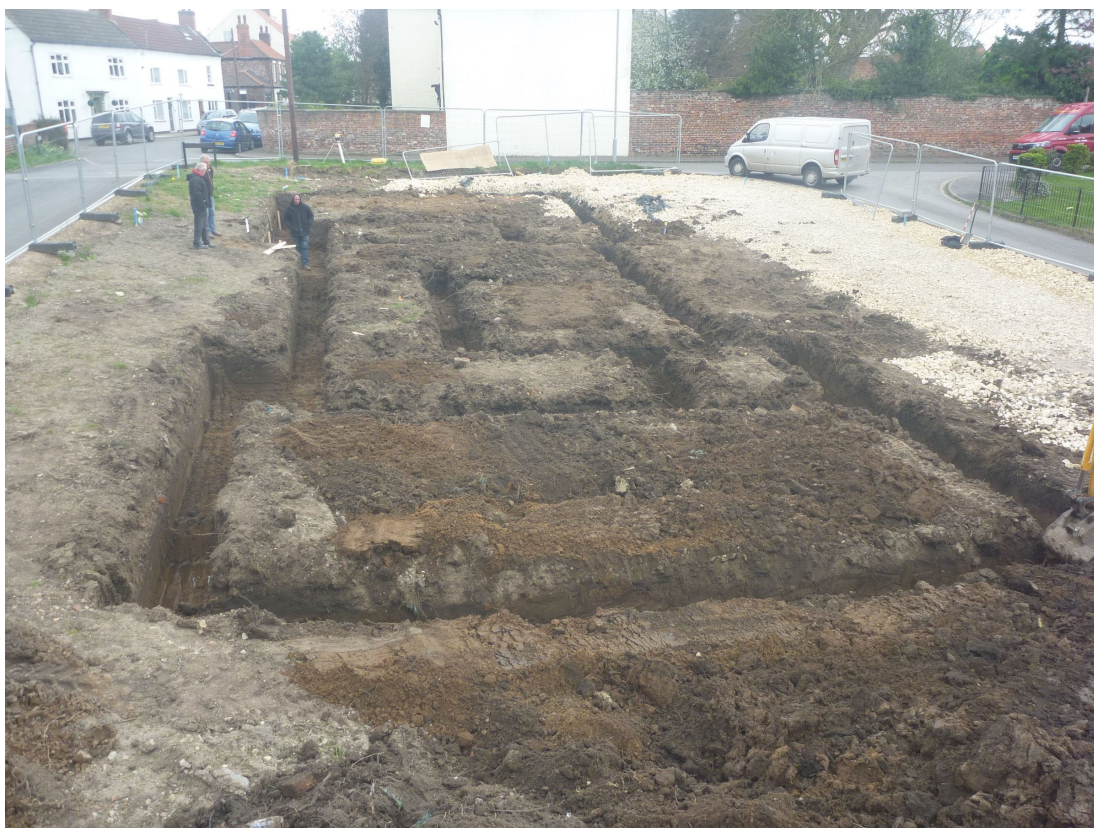
**Plate 7: View east across the excavated foundations in Plots 3-5**

Within the foundation trenches for three terraced houses in the eastern part of the site (Plots 3-5), the stratigraphic sequence was broadly similar across the excavated area (Plate 7). The upper deposit comprised a dark brown loose silty sand (301) between 0.3-0.4m thick, with occasional rubble inclusions including sandstone and brick fragments. This appeared to be a recent levelling deposit, directly overlying topsoil (302). This area was very waterlogged at the time of the first monitoring visit, and it is likely that activities associated with previous use of the site as a construction storage area may have caused some disturbance to the upper layers. Topsoil 302 was similar in consistency to 301, but had fewer inclusions, largely occasional sub-rounded sandstone pebbles. It was between 0.2-0.25m in thickness (Plate 8).

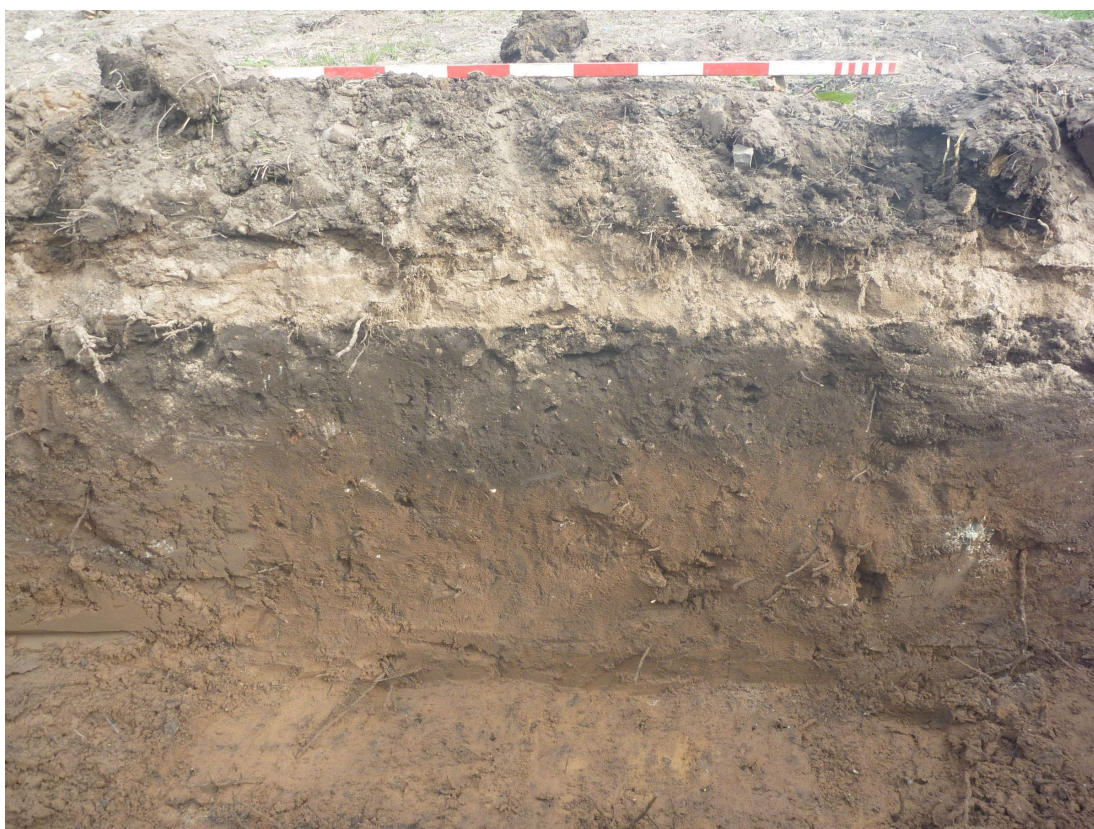
**Plate 8: South-facing representative sample of Plots 3-5**  
(1m scale in 10cm and 1cm units)

The base of the topsoil merged with subsoil 303, and frequent root action was visible within the subsoil. The subsoil was a firm mid-orange-brown sand with a very small silt component, and inclusions of occasional small pebbles. No changes in texture or constituency were noted, but the subsoil did appear to be darker in colour towards the western part of the plot. The trenches were excavated to a depth of c.1m. No features were exposed during the watching brief in Plots 3-5, and no artefacts of earlier than 20<sup>th</sup>-century date were observed.

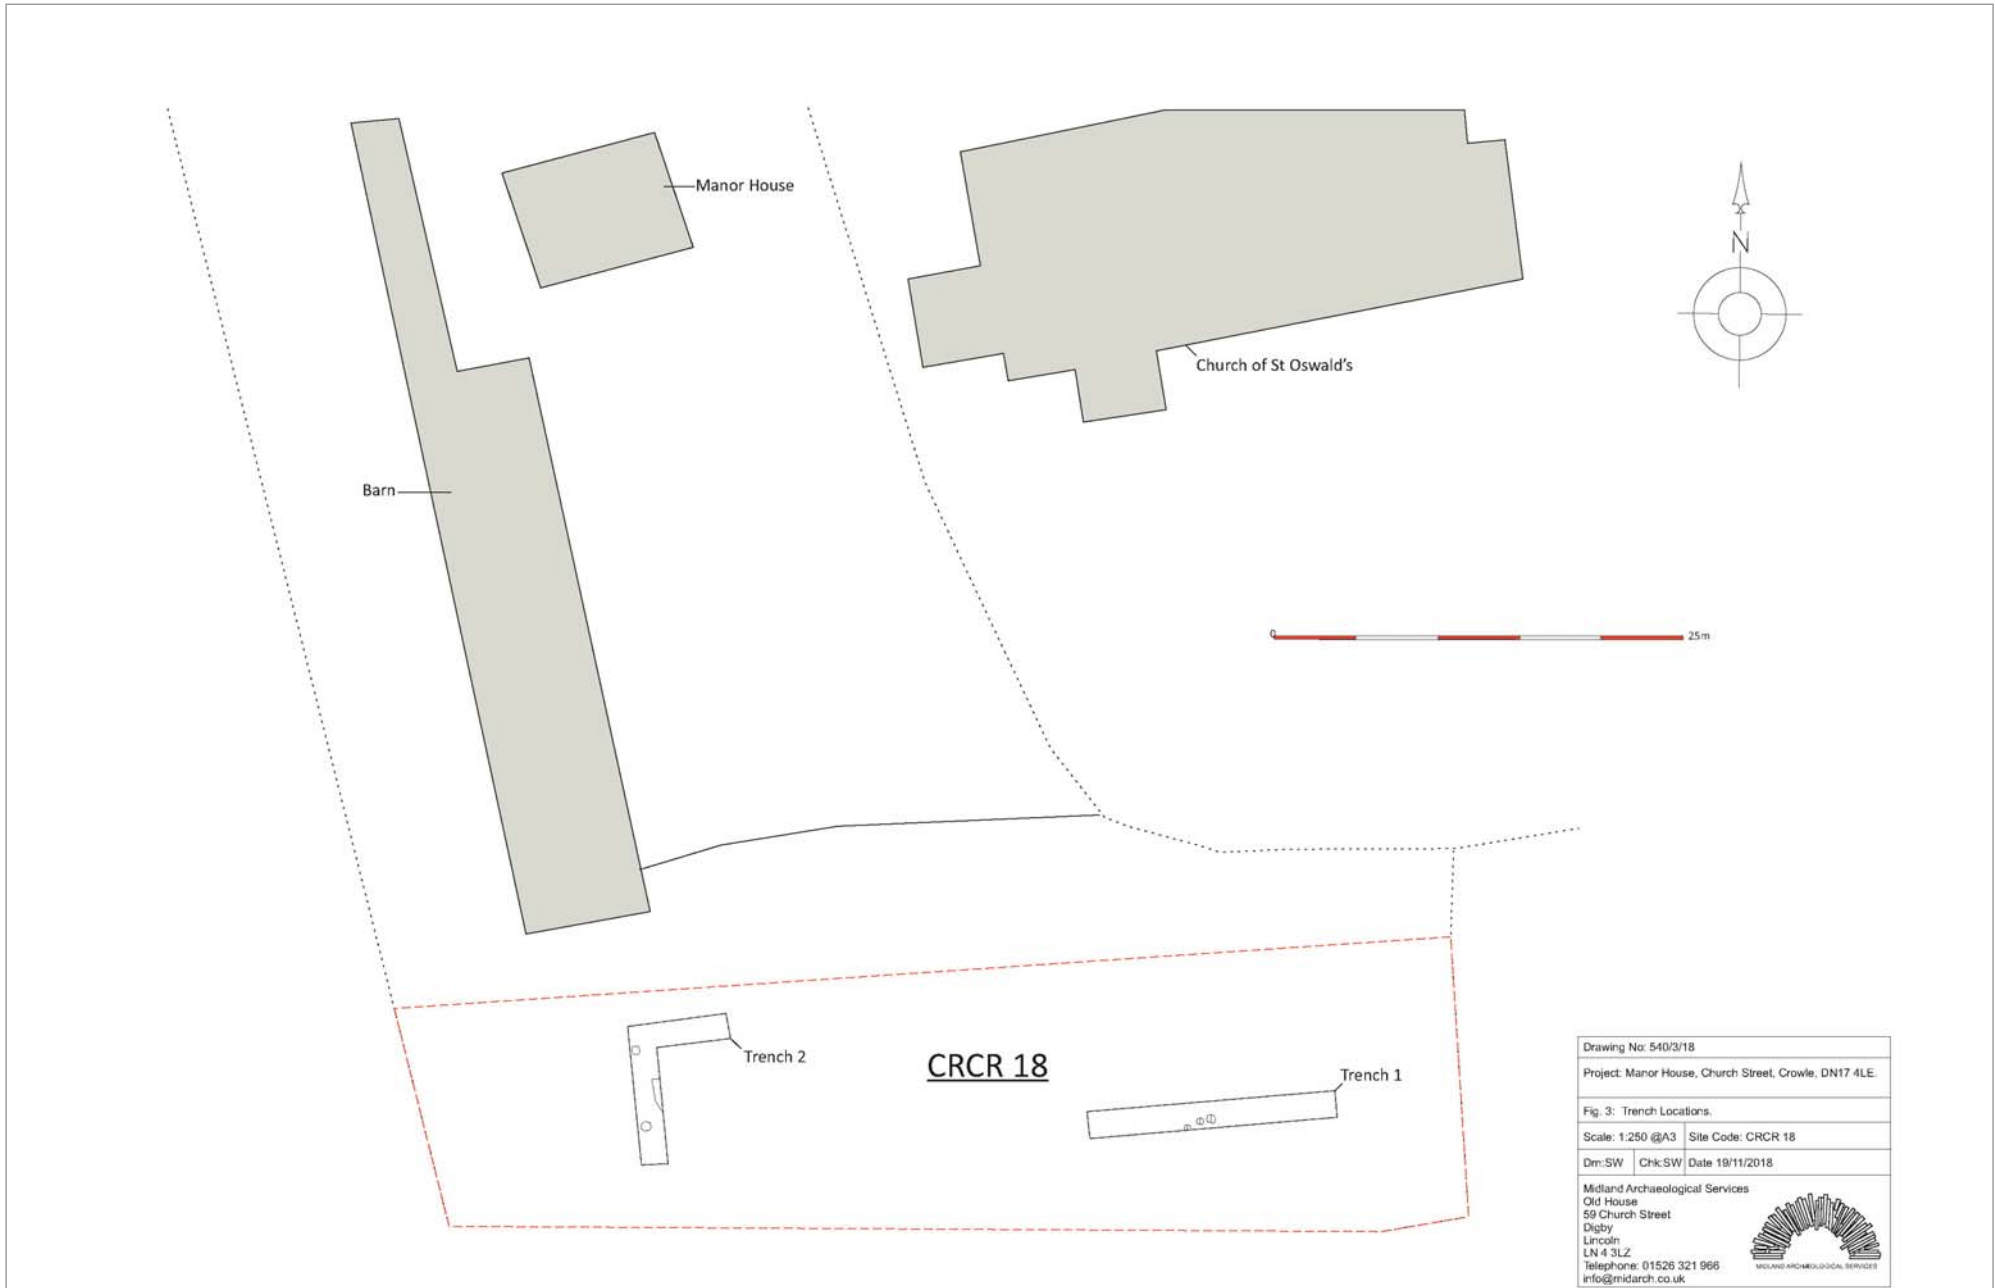
**Figure 2:** Location of 2018 evaluation trenches

An archaeological trial trench evaluation was undertaken within the site in 2018 (MAS 2018a). This comprised the excavation of a rectangular trench (T1) across the eastern part of the site, and an L-shaped trench (T2) towards the western side (Figure 2). Modern disturbance associated with a brick building foundation was recorded in Trench 2, possibly associated with the structure shown on the 1971 OS map. Two modern post holes likely associated with a former fence line were also recorded in this trench. Within Trench 1, three shallow pits or post holes were recorded, located in close proximity, one of which contained post-medieval tile and brick. The other two features did not contain any dating material and samples from their fills were very limited in composition, with no potential for further analysis. The features were overlain by an imported sand layer, and it was concluded that this was likely to be associated with the site's former use as a small holding.
