**HISTORIC BUILDING
RECORD**

**BIRCH'S TERRACE,
STATION STREET,
ASHBOURNE**

Radleigh Group Ltd

Date: August 2009

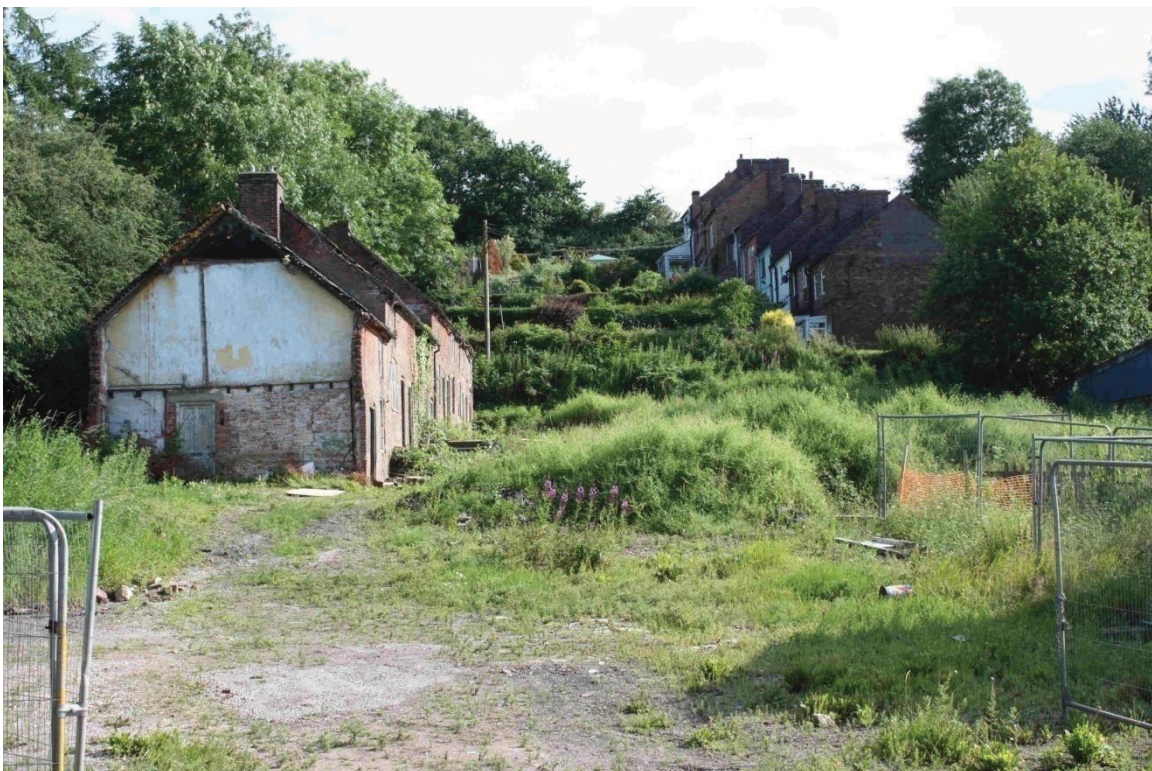
Plate 1: View from the north-west

1.1 Birches Terrace is a derelict row of workers' cottages located on rising ground on the south side of Station Street, Ashbourne, Derbyshire (Plate 1). The properties have been vacant since the 1970s, and part of the southern end of the terrace has been lost.

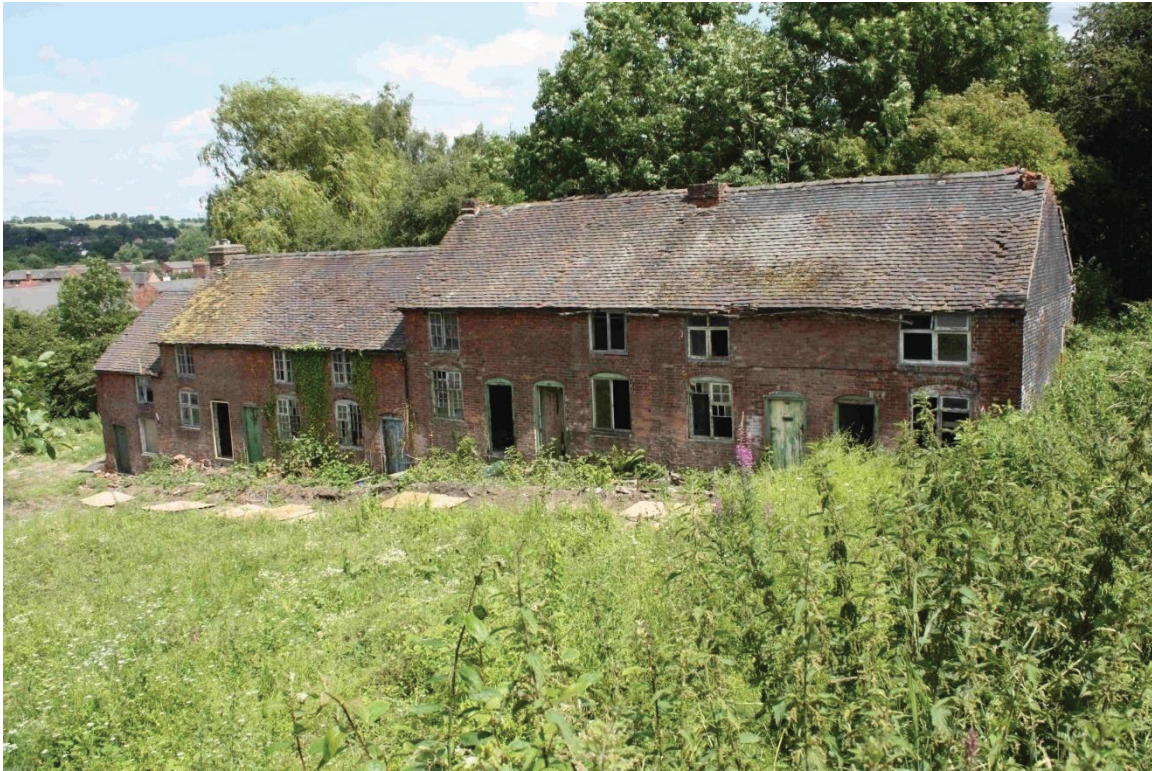
Plate 2: View from the north

- 2.7 The land between Birch's Terrace and Station Street is currently cleared and forms part of the proposed development site (Plate 2). To the immediate west of the cleared area is a short terrace of two-storey houses on the south side of Station Street (Plate 9). Immediately south of this is a two-storey workshop, which is the only surviving building from the former foundry that stood to the west of Birch's Terrace (Plate 8). South of the workshop is a modern industrial building that occupies the remainder of the former foundry site (Plate 10). Some remnants of brickwork from the former foundry structures are incorporated in the eastern boundary (Plate 6).

- 2.8 South of the former foundry is a terrace of nine dwellings (Plate 2). This terrace is similarly aligned with Birch's Terrace, and climbs steeply up the rising land to the south, each of the dwellings being stepped at progressively higher levels. Although this terrace is of later date than Birch's Terrace, the two have a strong visual relationship, particularly when viewed from Station Street. Further south are open fields.

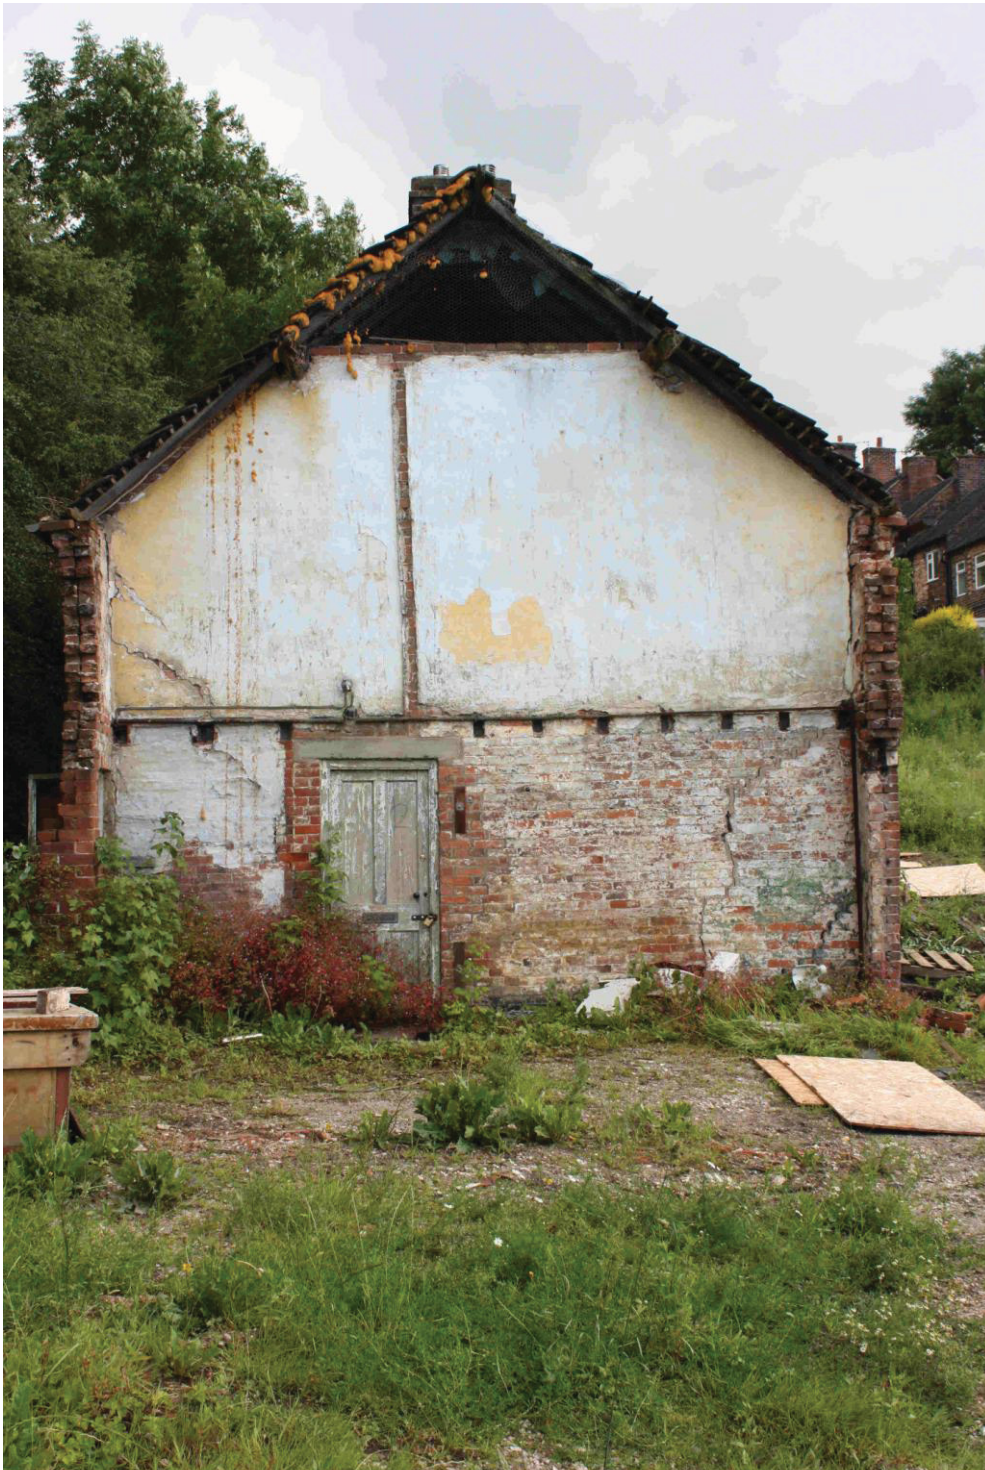
Plate 12: Clamp-fired brickwork - Flemish garden wall bond

- 3.2 Visual inspection suggests a building from the first half of the nineteenth-century, based on the use of clamp-fired bricks of narrow height (Plate 12) in combination with use of early mechanically sawn structural timbers. Narrow ridge boards are rarely found before 1800. Purpose-built terraces of cottages for workers had been introduced in Derbyshire by Arkwright at Cromford in 1776 but were not common until the 1800s.

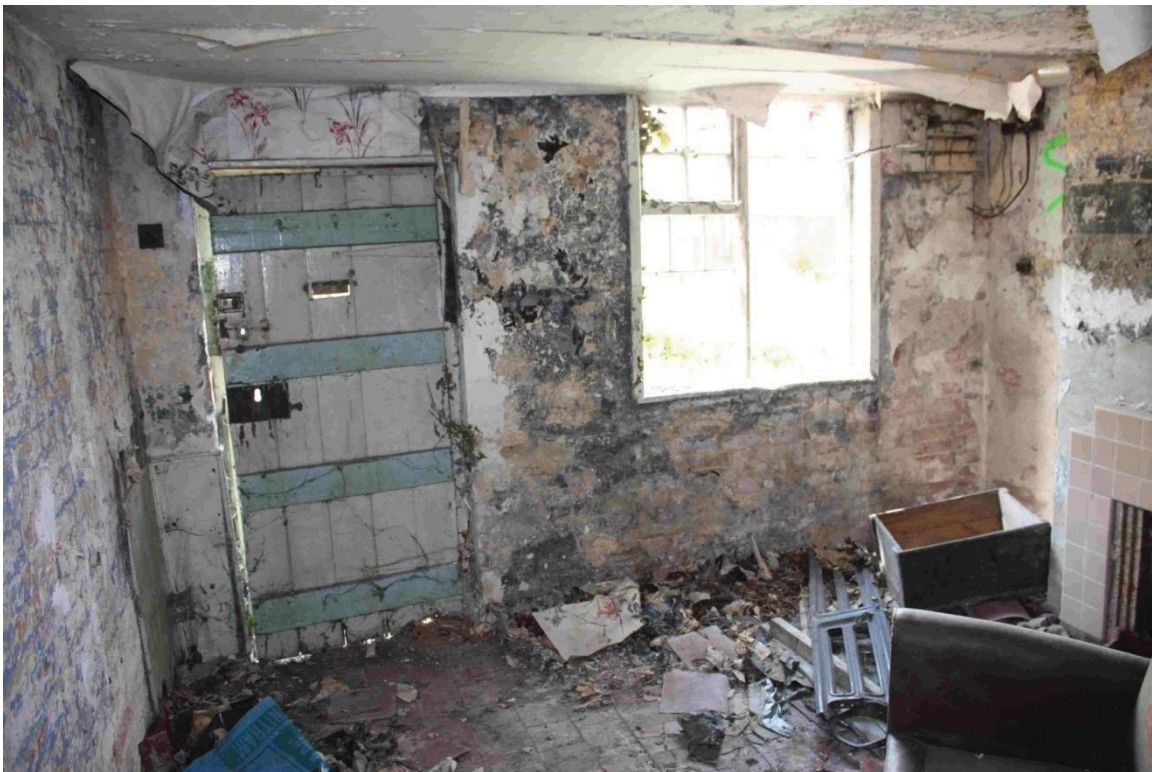
Plate 14: View from the east showing rear extensions

- 4.5 Single storey flat roofed extensions have been added to each dwelling on the east side (Plate 14). These are arranged in pairs, with the exception of the additions to no's. 8 and 11. The small gap between the extensions to no's. 7 and 8 was infilled, when numbers 4-7 were converted to storage use.

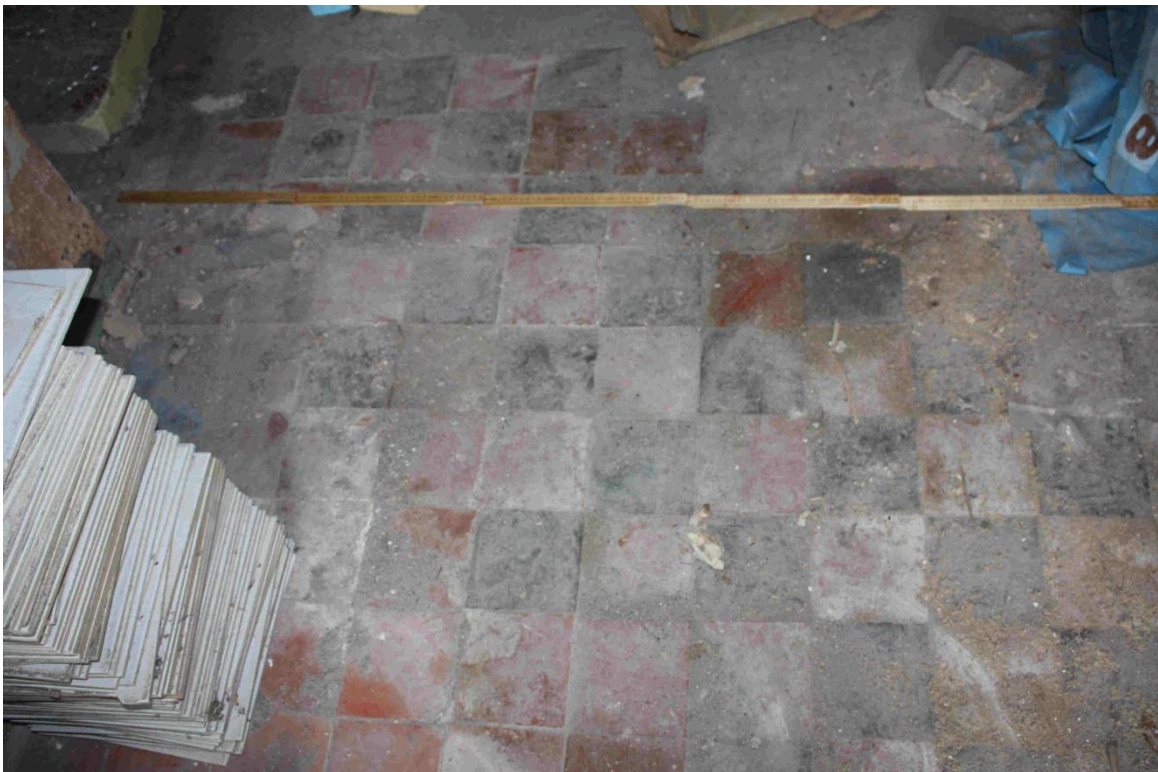
Plate 26: Floorboards (first floor)

- 4.17 The first floor joists span in the north-south direction, resulting in the joists being bedded in the dry cross walls, with the exception of the gable ends. The first floors of the standing dwellings mostly retain wide floorboards of varying widths up to 250mm (Plate 26). No's. 6 and 9 have regular narrower boards (140/150mm respectively) but these do not appear to be replacements.

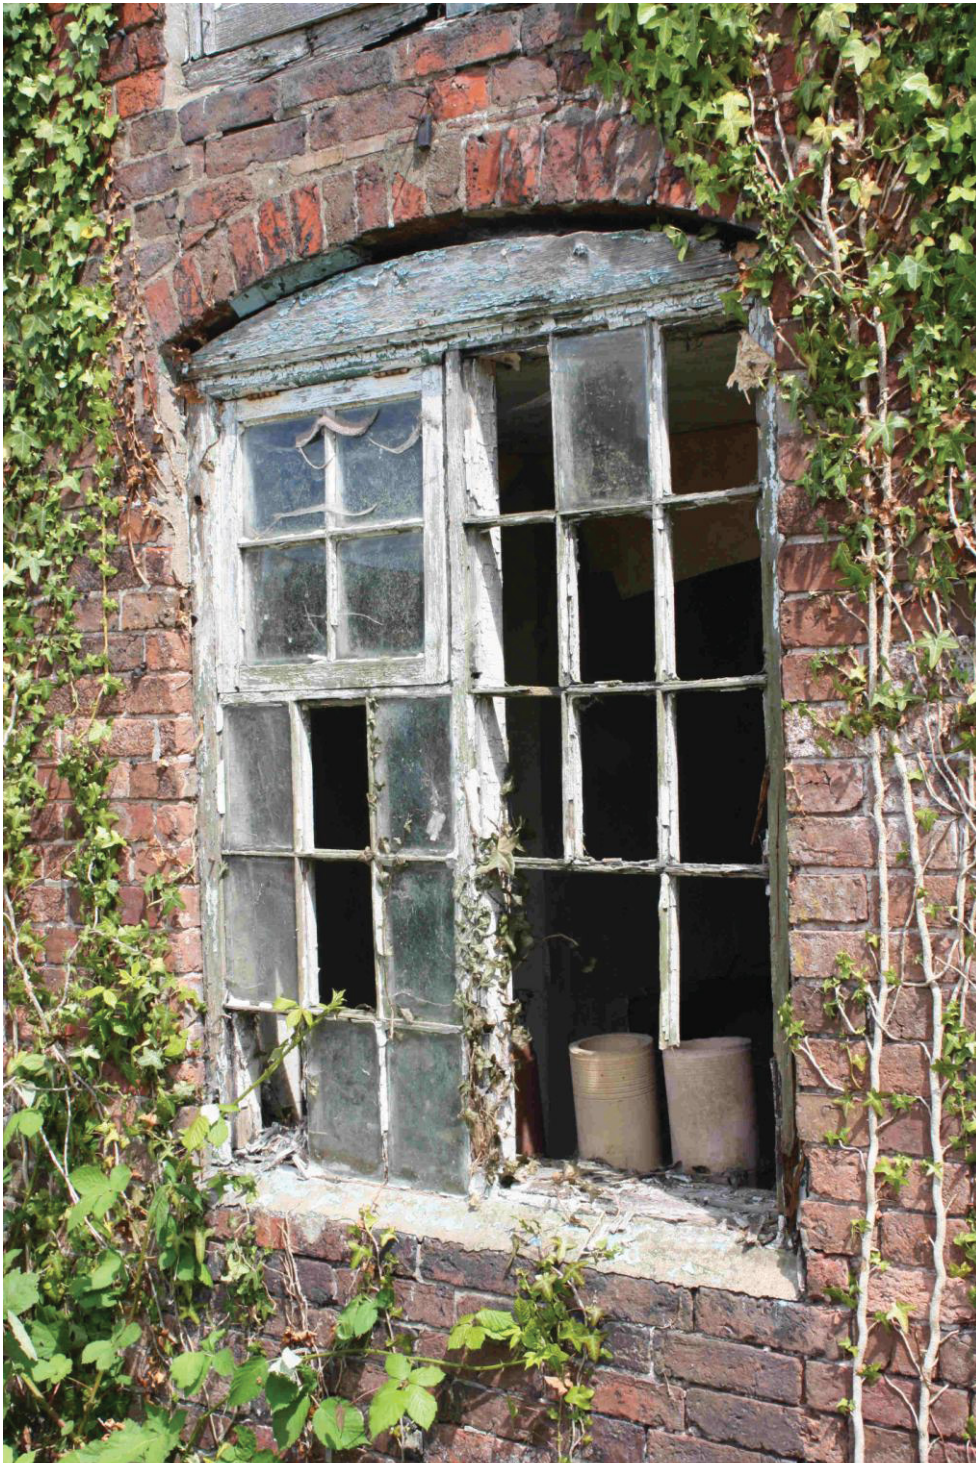
Plate 40: External plank door (No.6)

- 4.24 Original doors would have been ledged plank doors, a number of which survive (Plate 40). Most of the original stone doorsteps have been replaced with blue bricks on edge.

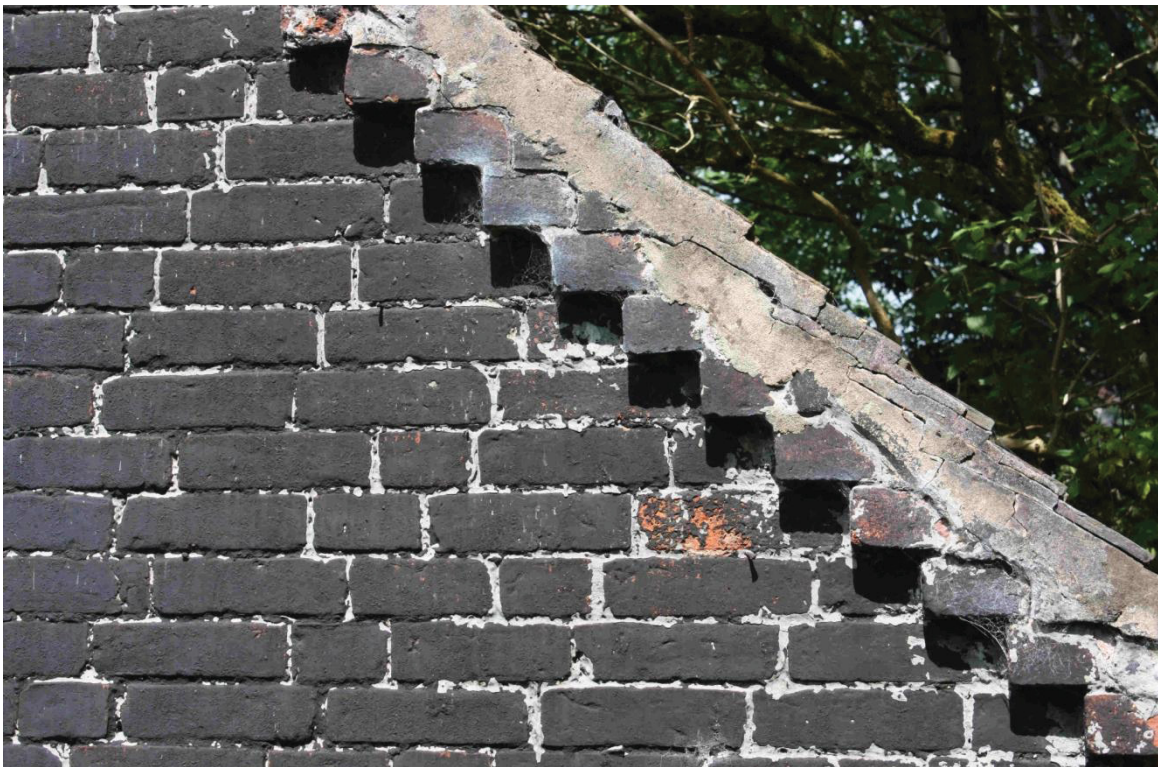
Plate 45: First Floor rear (east) window (No.10)

- 4.32 First floor window openings of 900x900mm on the east side are smaller than those on the west side (Plate 45). They are equally spaced being positioned centrally for each unit. The openings contain a variety of window frames, the majority being subdivided with two horizontal bars. Apart from the modern replacements to no's 5 and 8, the others appear to retain their original frames with adaptations to glazing bars and replacement casements. Only no. 11 retains a 6-pane casement, which was almost certainly the original pattern.

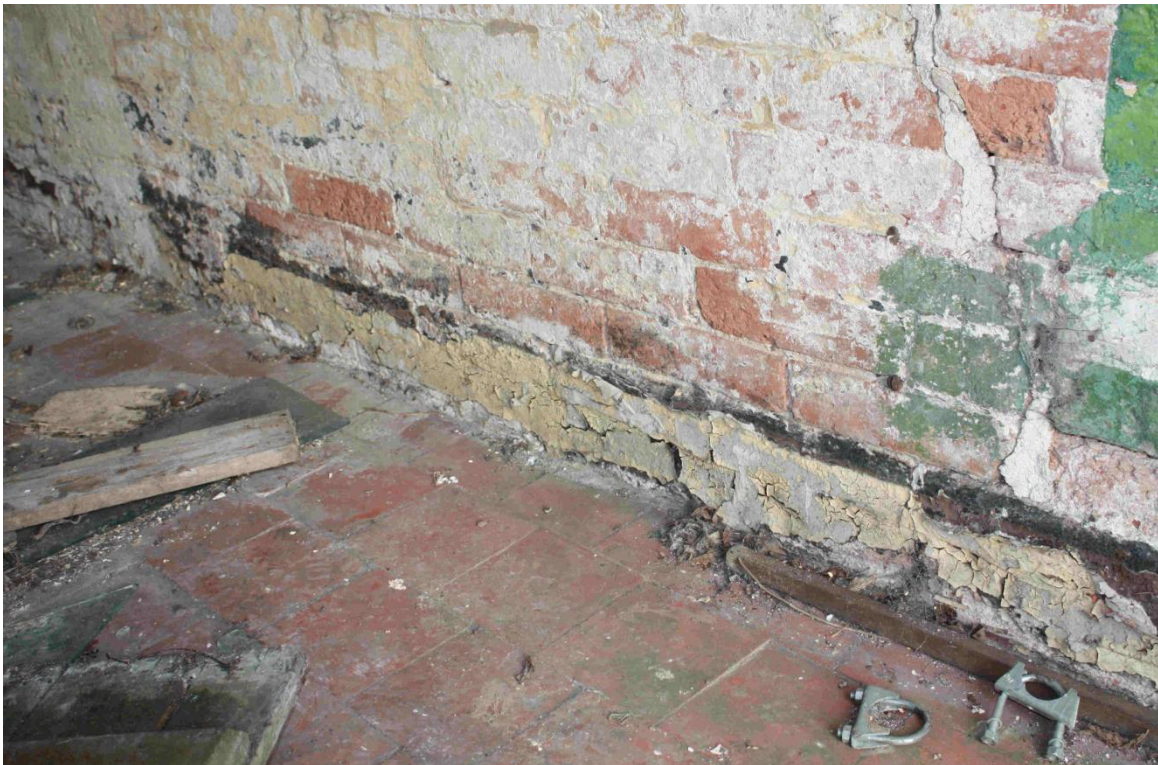
Plate 48: Original fireplace (No.8)

- 4.35 The original units were built to an identical pattern, the general arrangement of which is described above, under *Plan Form and Section*.
- 4.36 Original chimney breasts survive in the majority of the units but most have been plastered over and some accommodate relatively modern twentieth century tiled fireplaces (Plate 47). The ground floor chimney breast in no. 8 is in its original condition (Plate 48) and can be seen to be a cantilevered breast. The plastering

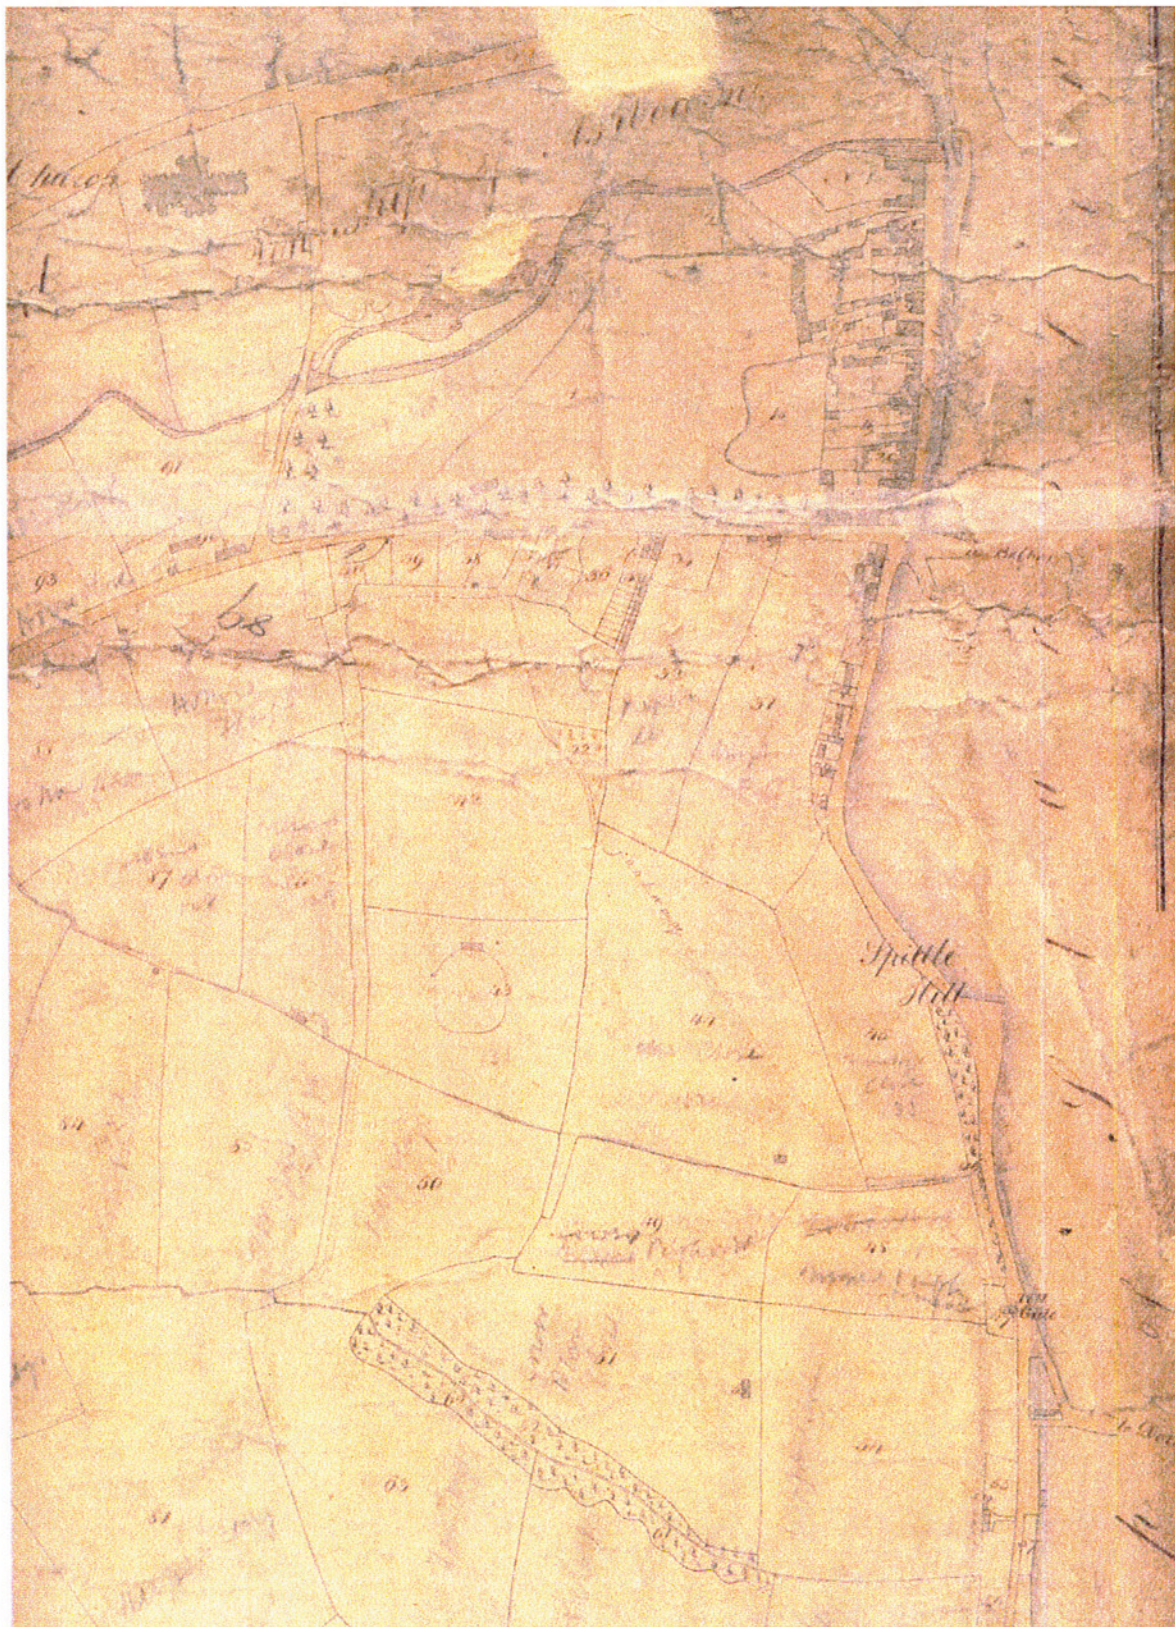
Figure 4: The Clifton Tithe Map, 1846 (extract)

- 3.4 However, earlier historic maps suggest otherwise. The Clifton Tithe Map and Award of 1846 (this area was administratively part of Clifton rather than Ashbourne at that time), shows the terrace was in existence by that date (Fig. 4). The associated award shows that at that time the property was owned by Robert Docksey Goodwin, together with a further four houses on the front part of the site. The ten houses are individually identified, together with long, slender gardens extending westwards. The adjoining foundry was yet to be built, its site being shown partly as a garden, owned jointly by Elizabeth Ayre, Edward Corden, and James Haynes and occupied by Ellen Ward. The remainder of the foundry site was a house and garden owned by Edward Corden and occupied by John Stubbs and Ellen Ward. The house still stands on the corner of North Leys and displays a matching verge detail to that of the southern end of Birch's Terrace.
