Ironbridge Archaeological Series No.211
Final Report

Archaeological Desk-Based Assessment of Lloyds Head and Lloyds Road, Telford

November 2007

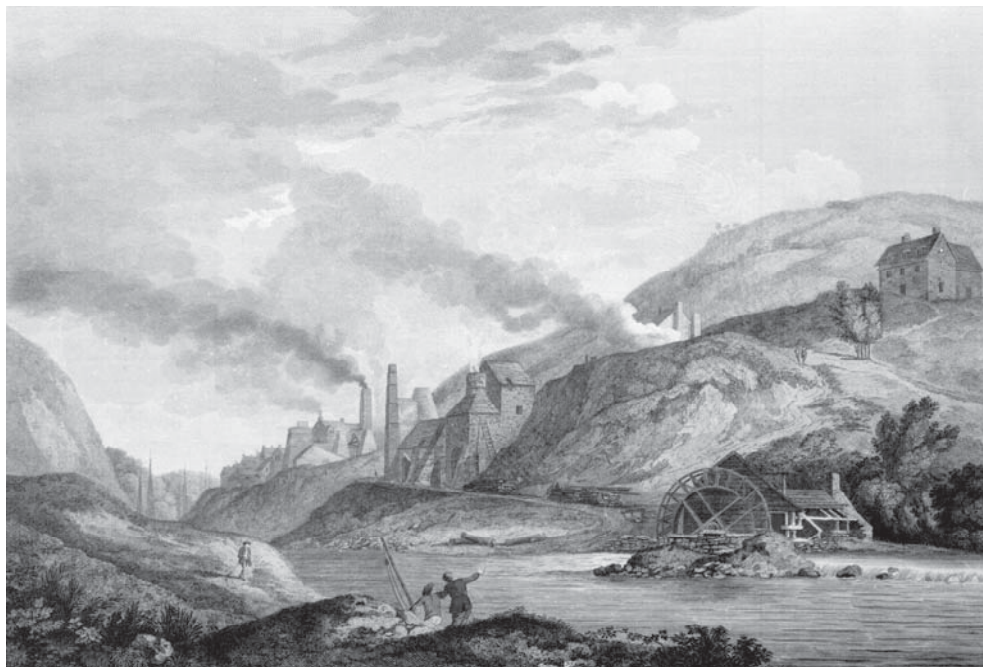
Figure 8: ‘An ironwork for Casting Cannon’ – from the IGMT Elton Collection (A185.760)

An early view of the south bank of the river by George Robertson in 1788 (*‘An Ironwork for Casting Cannon’*), shows the Calcutts Ironworks and Calcutts House. However, it also depicts a ‘ruined corn mill’, with a large water wheel adjacent to the river (Trinder 2000). The proximity of the corn mill to Calcutts House in the image suggests that the mill lies within the current assessment area.

Stone remains do survive along this section of the river bank which may relate to this mill (**Fig. 11**). There was certainly no evidence of a corn mill

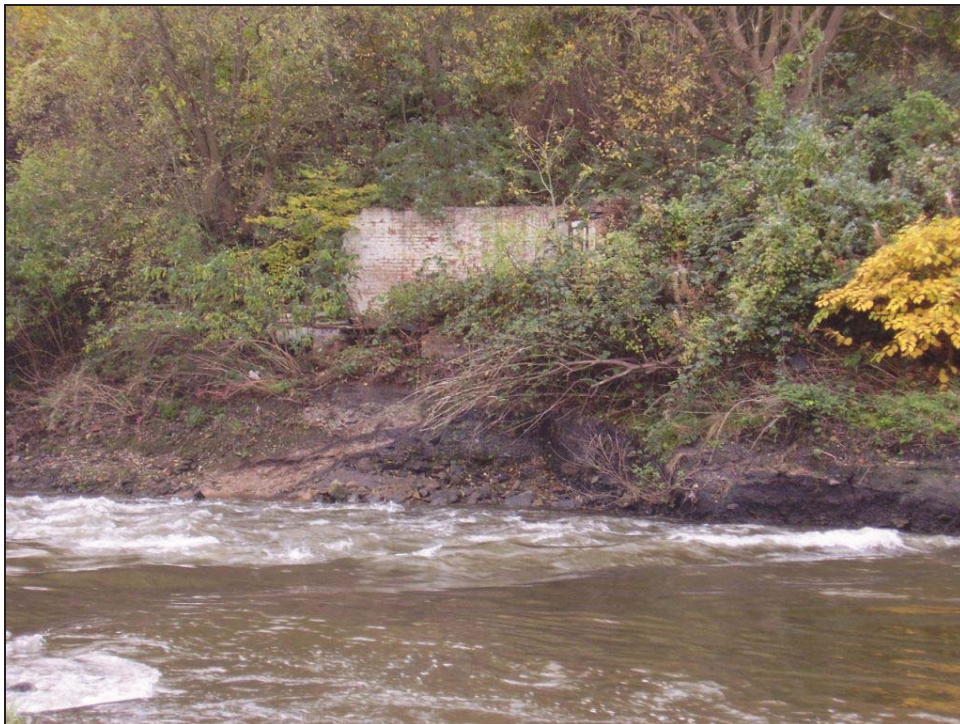
The area directly south of Lloyds Road was seen upon the site visit to consist of a great deal of furnace slag fragments, which was also plentiful along the river bank, as well as brick and tile rubble. The area to the south of the river, known as Lloyds Head, is populated by housing, the Black Swan pub and the disused Severn Valley Railway line, interspersed with wasteland with shrubs and trees. The river bank – viewed from the Lloyds Road side was seen to consist of considerable quantities of brick rubble, coal dust and re deposited clay. The tipping layers could be clearly seen (Fig. 9).

Figure 9: South side of the River Sever - showing tipping layers and late boundary or garden wall

Brick structures were noted along the riverbank, including a relatively late brick wall of insubstantial construction (**Fig 8**). This was interpreted as a possible boundary or garden wall, or part of a former outbuilding. More significantly, brick coursing was also seen close to river level, together with some brick steps (**Fig. 9**, highlighted with red box). It is possible that this brickwork in fact represents the remains of one of the former wharves.

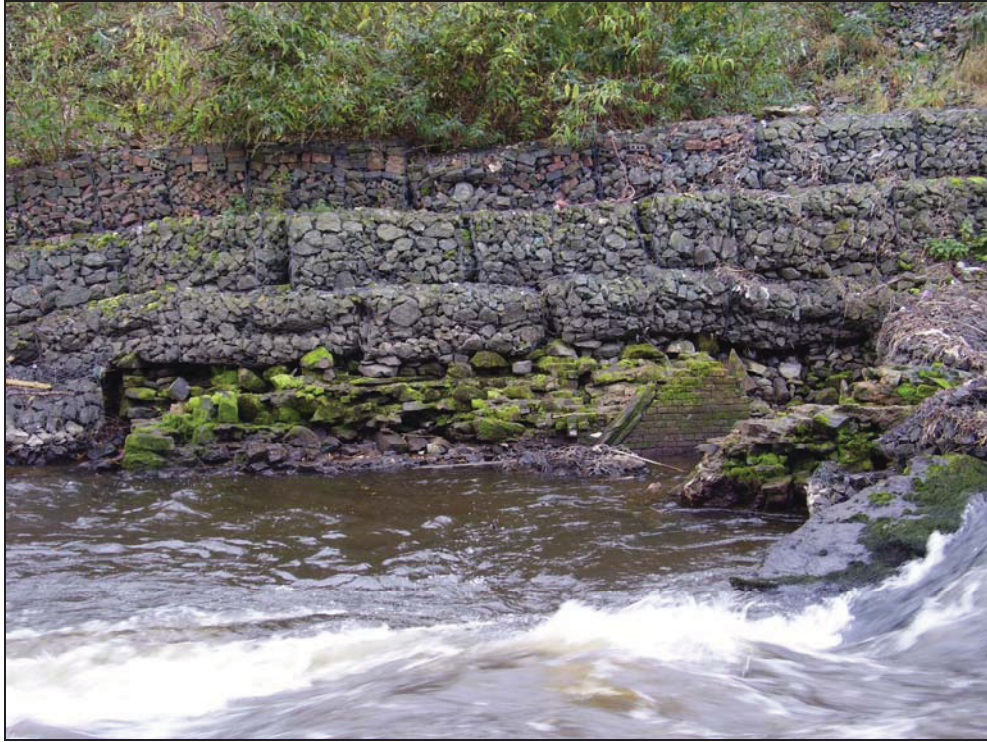
Brick and stone work was also seen to survive in the location of the ruined corn mill. The stone work may be the footings of the mill, and the small section of surviving brick work part of the wheel pit, possibly with part of the wooden water wheel still attached. If this is the remains of the water wheel seen on the image by George Robertson in 1788, it is possible that further remains of the mill building survive beneath the present river bank.

Figure 11: South side of the River Sever – showing possible remains of ruined corn mill

Remains of this mill are thought to survive within the south bank of the river in the way of stone footings and the possible remains of a brick wheel pit with a fragment of the waterwheel still attached. If this is the water wheel depicted on the image by George Robertson (1788), it is possible that further remains of the mill building structure survive further back.
